07 November 2017

Our ref: 2316208-495  
Your ref: N186765

## **Shoalhaven Starches Paper Mill Shoalhaven River Bank Stability Assessment**

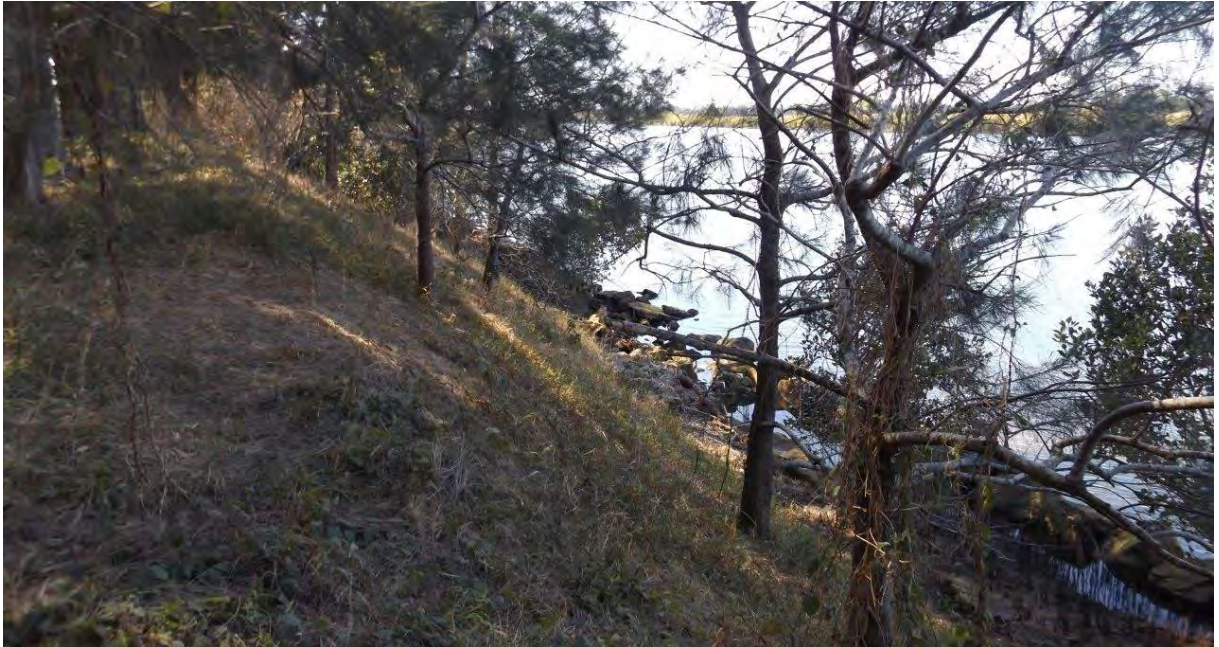
**Photo 1. View looking east along riverbank showing top of bank and batter slope down to river, with large rocks placed along shoreline of river in tidal zone. Note typical vegetation in riparian zone over riverbank and along top of bank.**

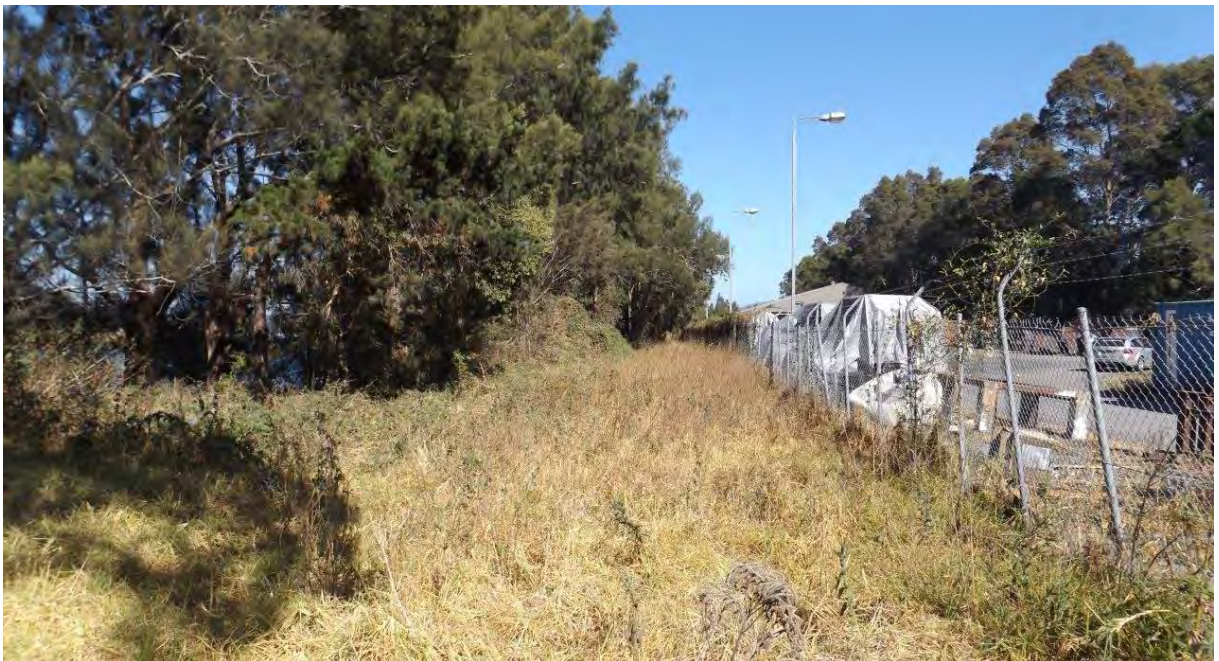
**Photo 2. View looking west along top of riverbank showing thick grass and weed growth along top of bank and established trees, fence and equipment storage.**

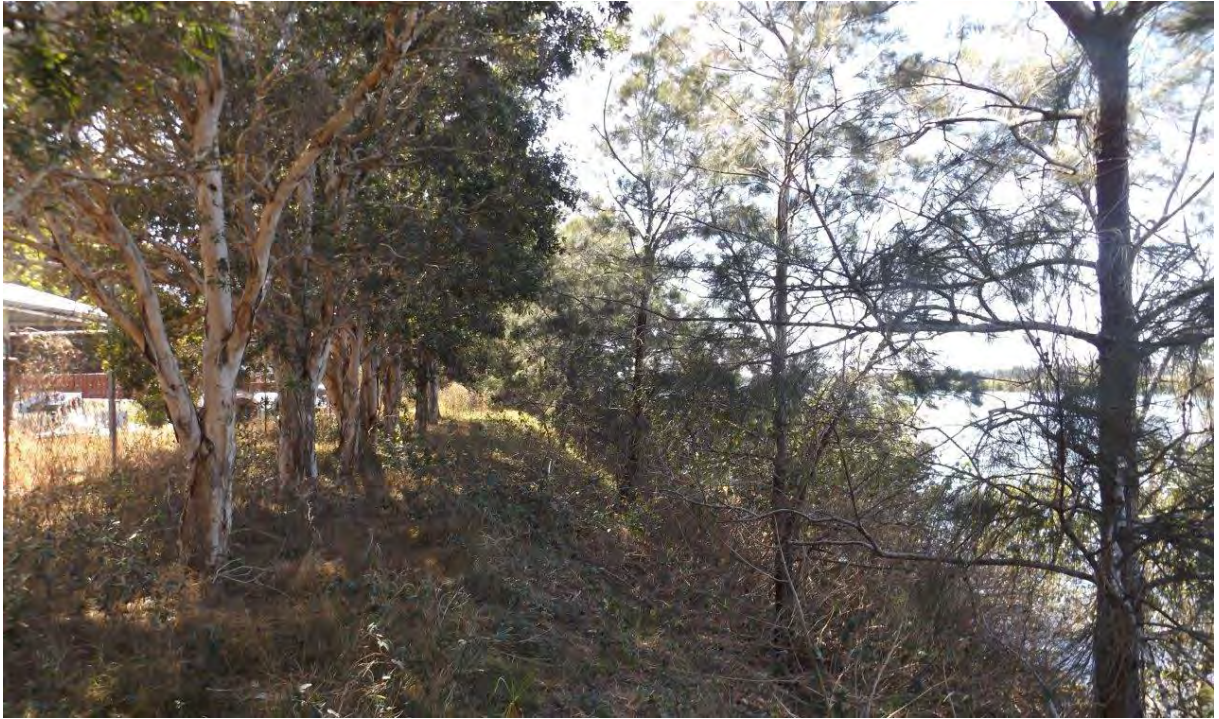
**Photo 3. View of riverbank looking east showing established trees and undergrowth along riverbank and top of bank.**

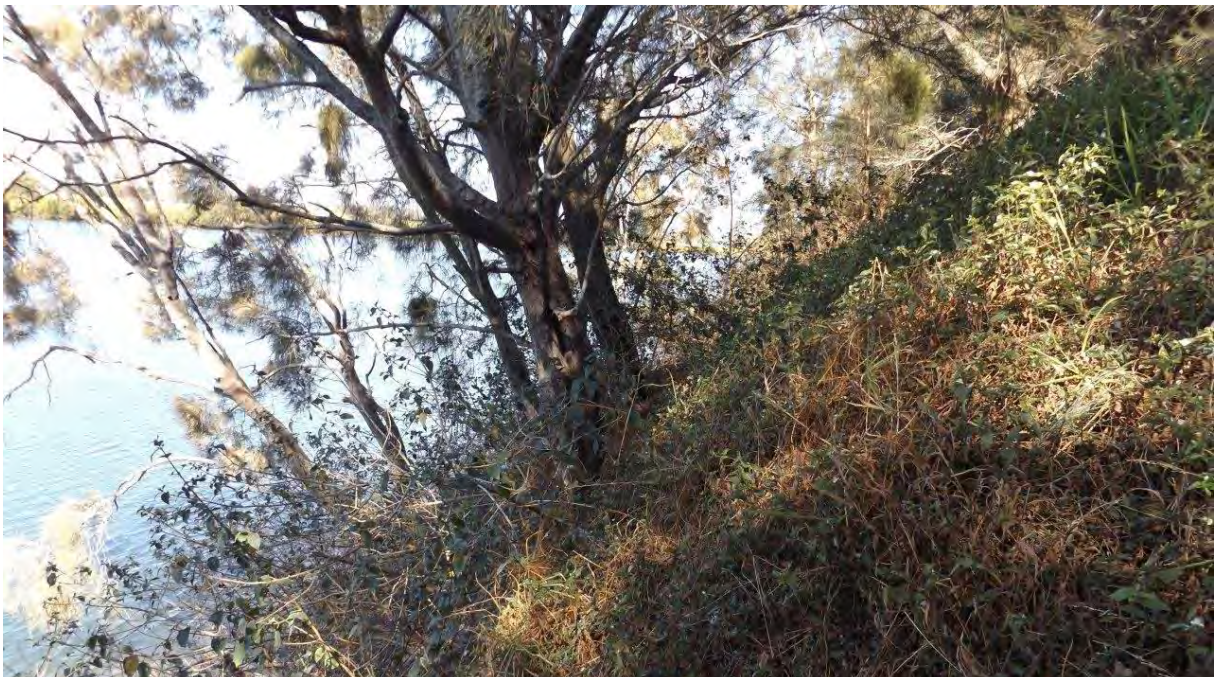
Typically the riverbank is about 4m to 5m above the low tide level and the bank has been graded to about 1H:1V with some locally steeper areas near the toe and locally higher on the bank where erosion has occurred. The bank is also locally steeper at the eastern end of the development area where the bank geometry changes near a drainage outlet structure. The riverbank erosion is likely to be the result of long term tidal and wave effects as well as raised river levels during flood events. The toe of the bank is partially protected by large rocks positioned along the shoreline.

**Photo 4. View of steep section of riverbank near south-east corner of proposed storage area. Toe of bank is oversteepened in this area.**

In addition to the above conclusions and recommendations, we also recommend that existing vegetation over the riverbank be maintained and managed, and that the rock protection of the toe of the bank be repaired if damaged by flooding.

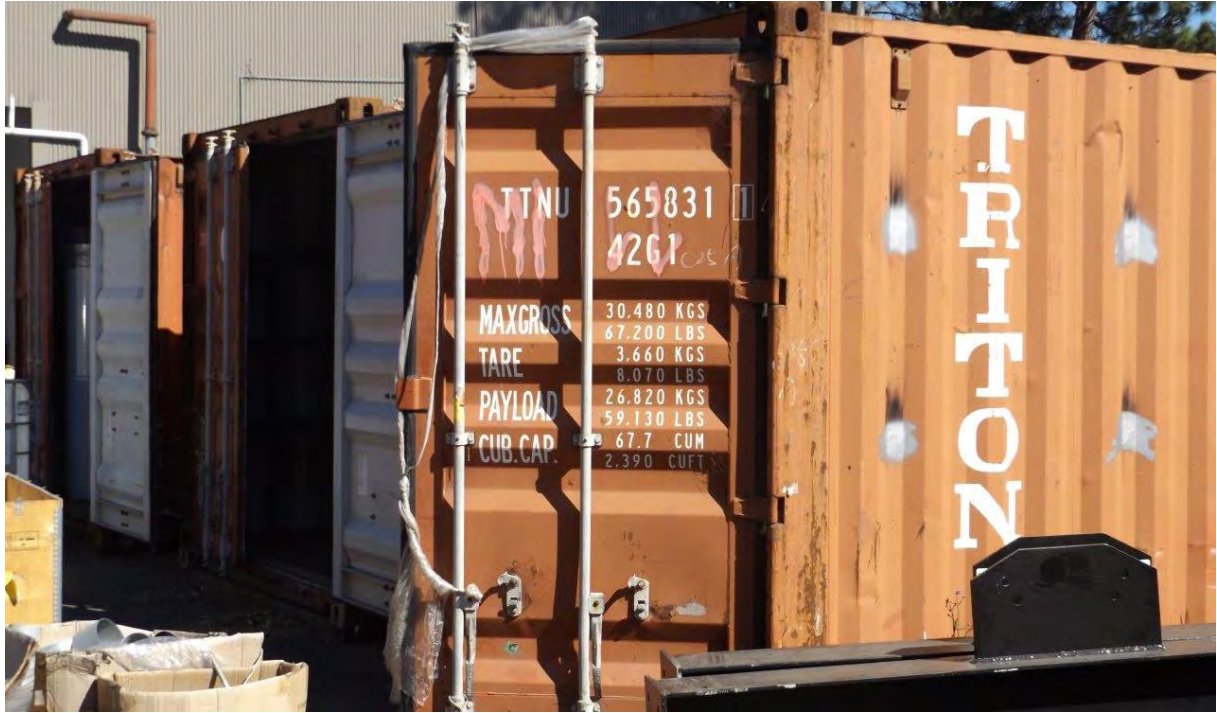
**Photo 5. Typical shipping container within storage area with loads shown.**

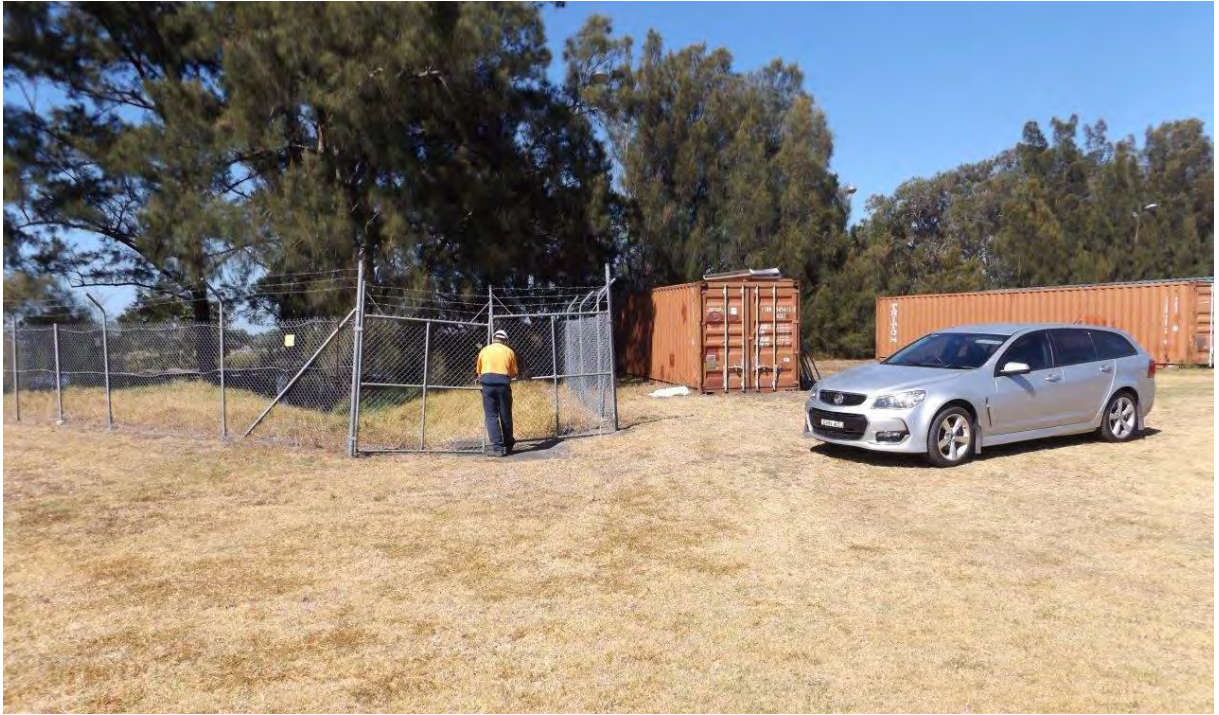
**Photo 11. View of south-east corner of storage area looking south towards river, drainage outlet and location of steep section of riverbank.**

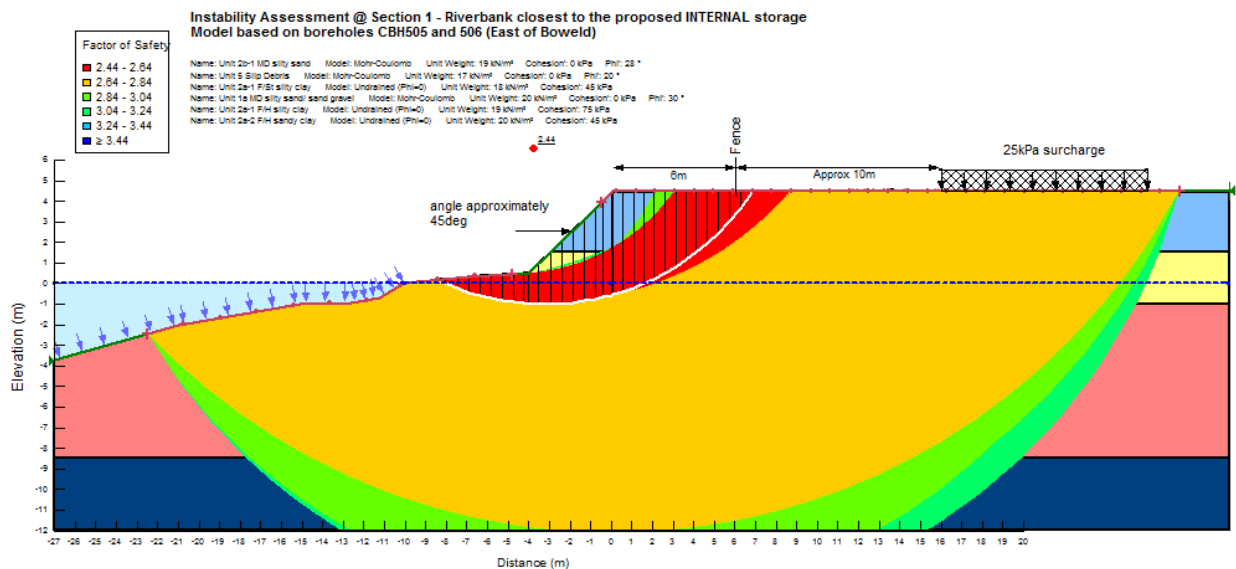
**Figure 3. Short term – undrained condition with surcharge located approx. 16m away from the crest**

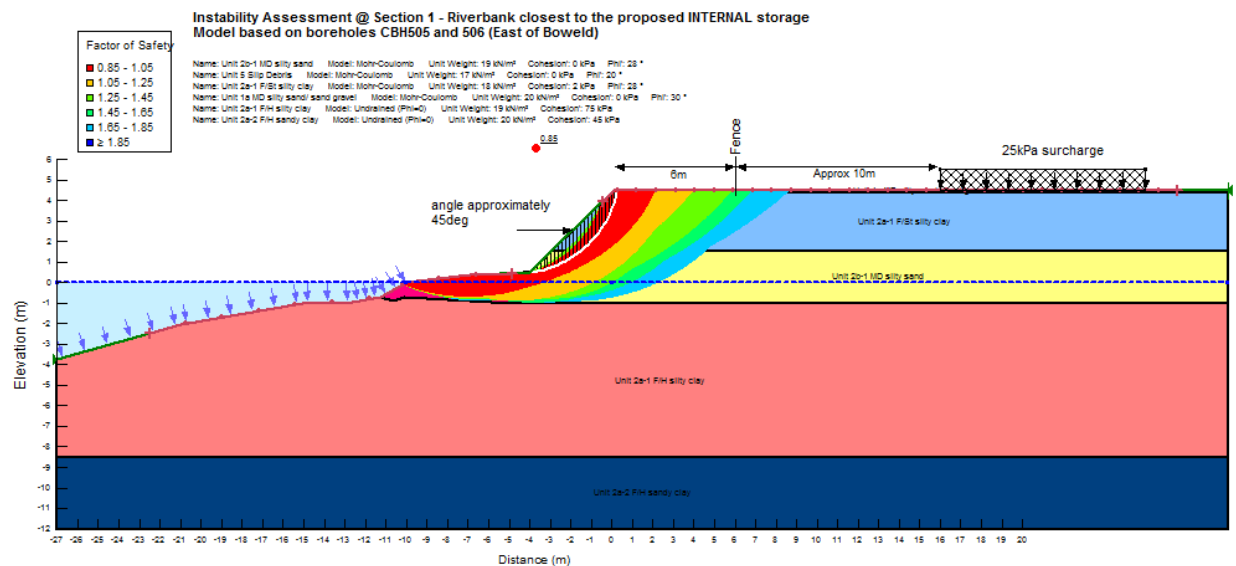
**Figure 4. Long term – drained condition with surcharge located approx. 16m away from the crest**

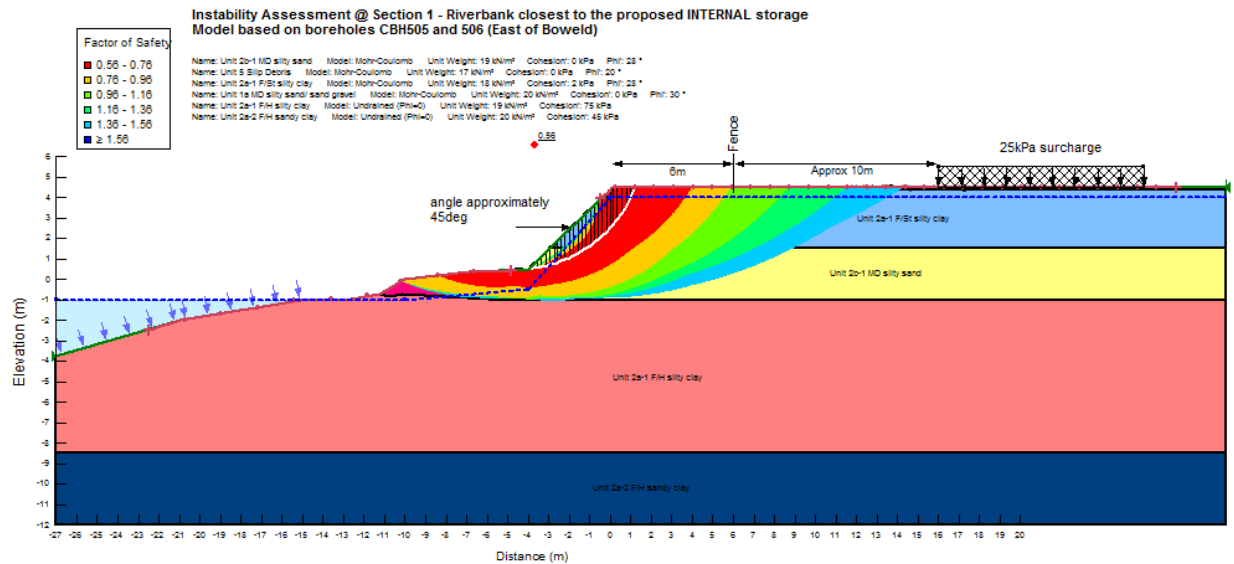
**Figure 5. Rapid drawdown post flooding – drained condition with surcharge located approx. 16m away from the crest**

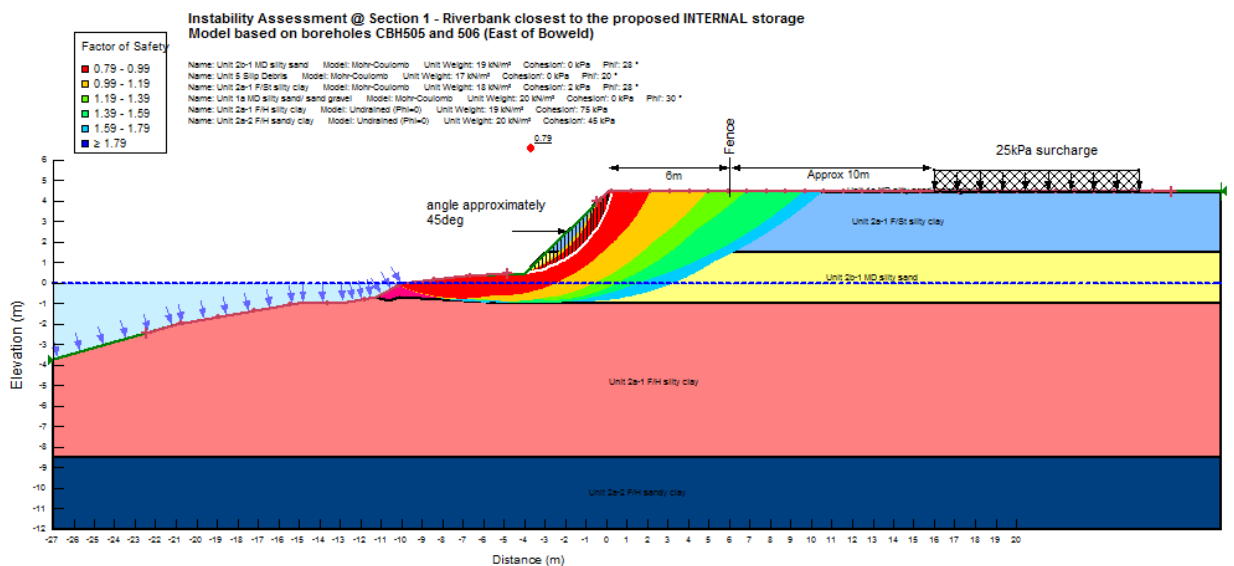
**Figure 6. Seismic case – drained condition with surcharge located approx. 16m away from the crest**

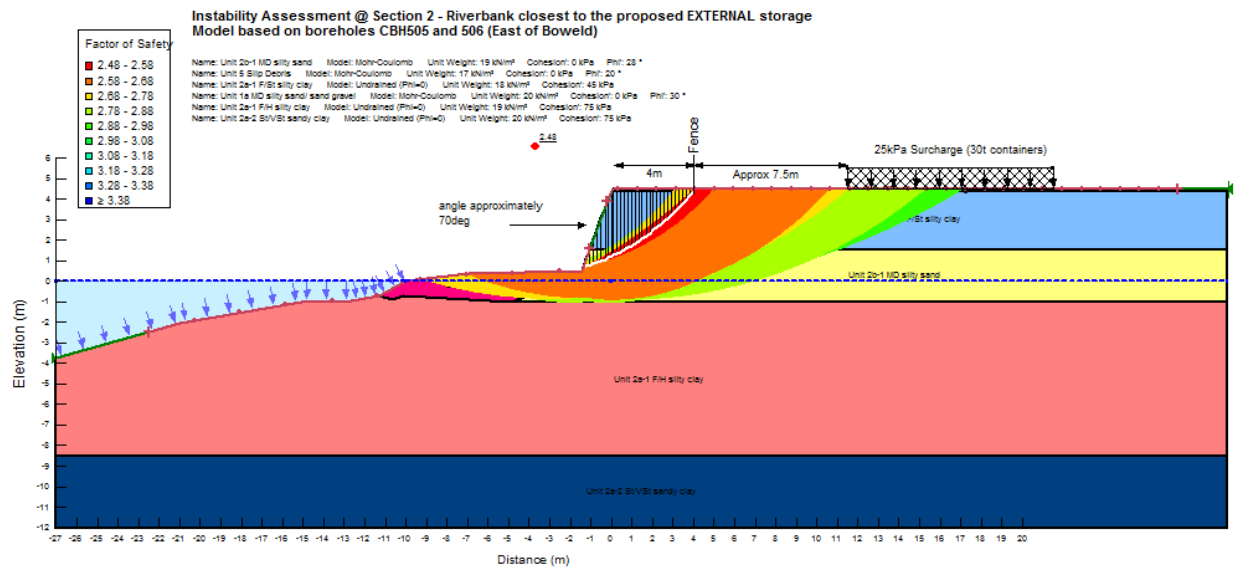
**Figure 7. Short term – undrained condition with proposed surcharge located approx. 11.5 away from the crest**

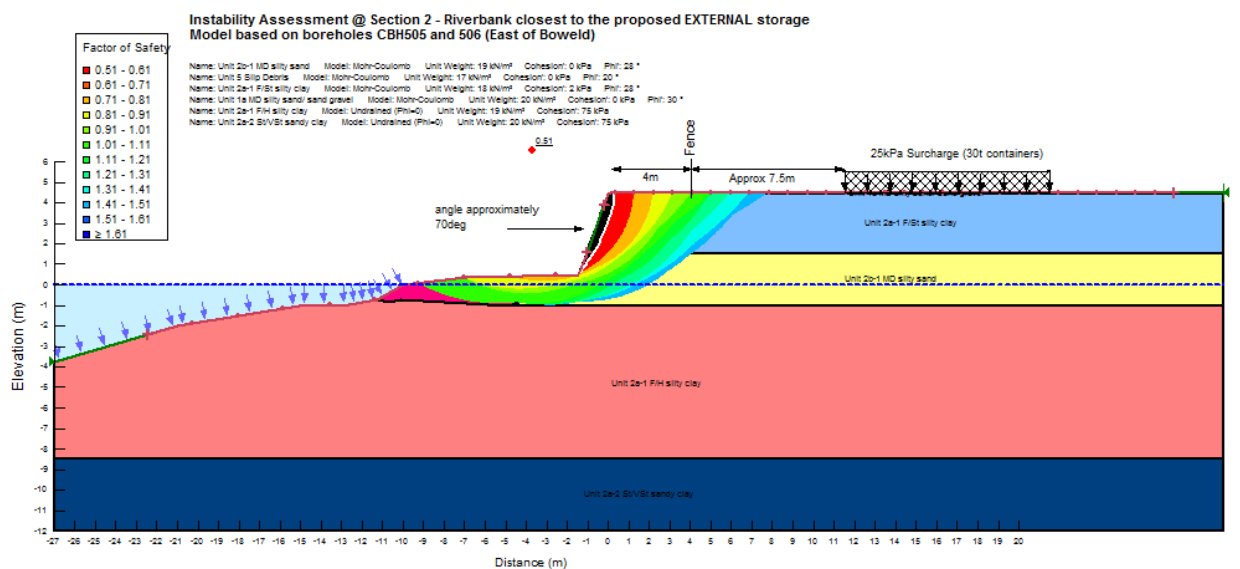
**Figure 8. Long term – drained condition with proposed surcharge located approx. 11.5 away from the crest**

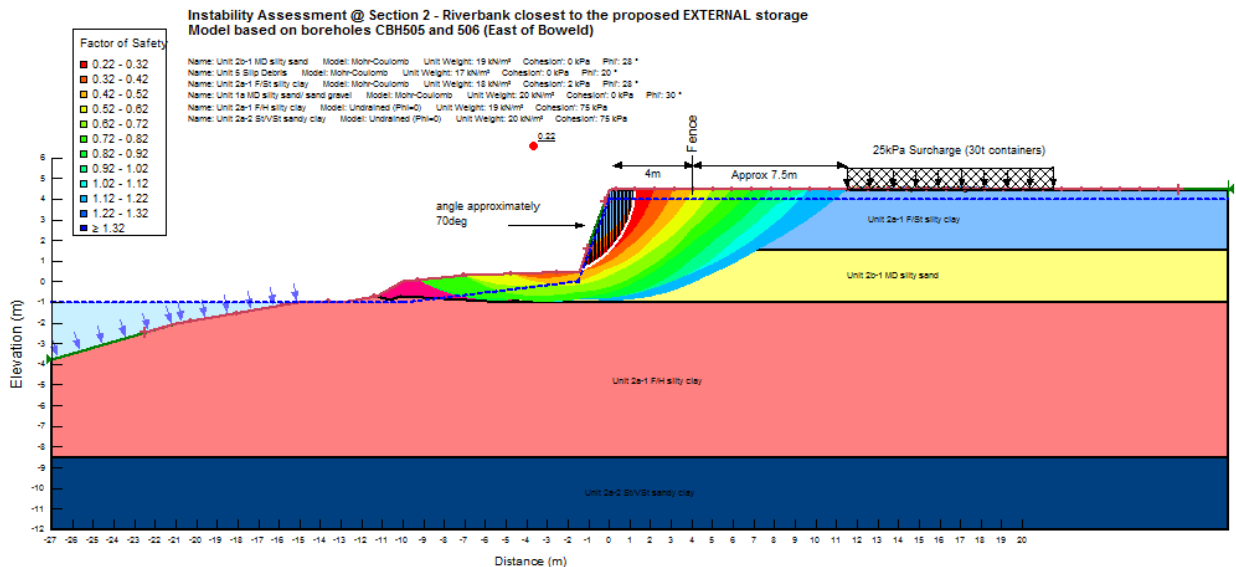
**Figure 9. Rapid drawdown post flooding – drained condition with proposed surcharge located approx. 11.5 away from the crest**

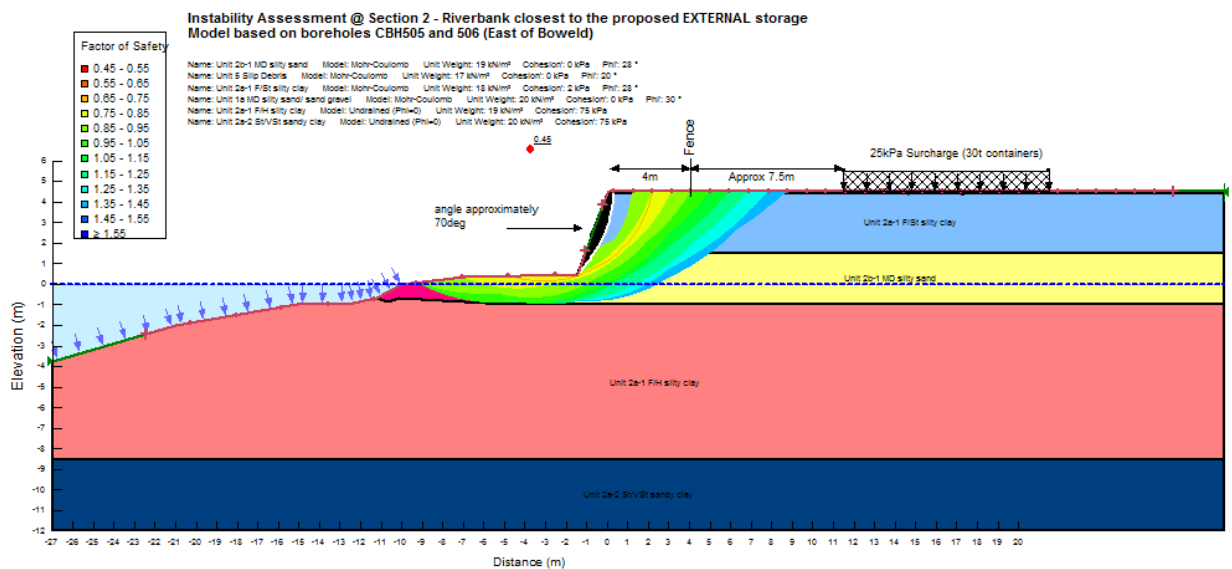
**Figure 10. Long term – drained condition with proposed surcharge located approx. 11.5 away from the crest**
