# BOUNDARY FIRE ASSESSMENT REPORT

**PROPOSED SUBDIVISION OF THE DAVID MADDISON BUILDING  
SITE FROM THE ROYAL NEWCASTLE HOSPITAL SITE.**

Date: 7 August 2006

Project No: 9839

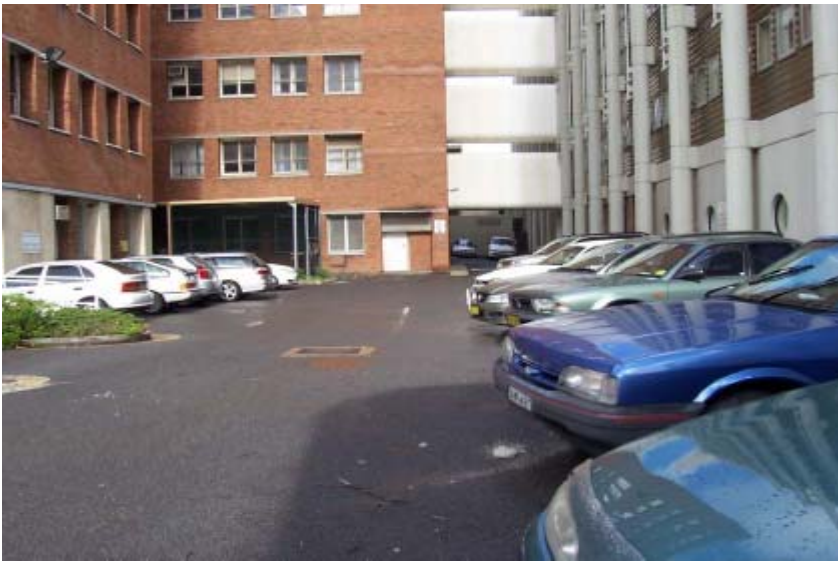
Photo 1

1. Access road and carpark east side of DMB looking south
2. Access road and carpark east side of DMB looking north to King Street
3. Access road and carpark east side of DMB looking north to King Street.
4. Access road and carpark east side of DMB looking north to King Street between McCaffrey Wing (MWB) and DMB.
5. Access road and carpark east side of DMB looking south near rear of McCaffrey Wing
6. Carpark at the south eastern corner of the DMB, looking south
7. Carpark at the south eastern corner of the DMB, looking north
8. Carpark at the south side of the DMB, looking east

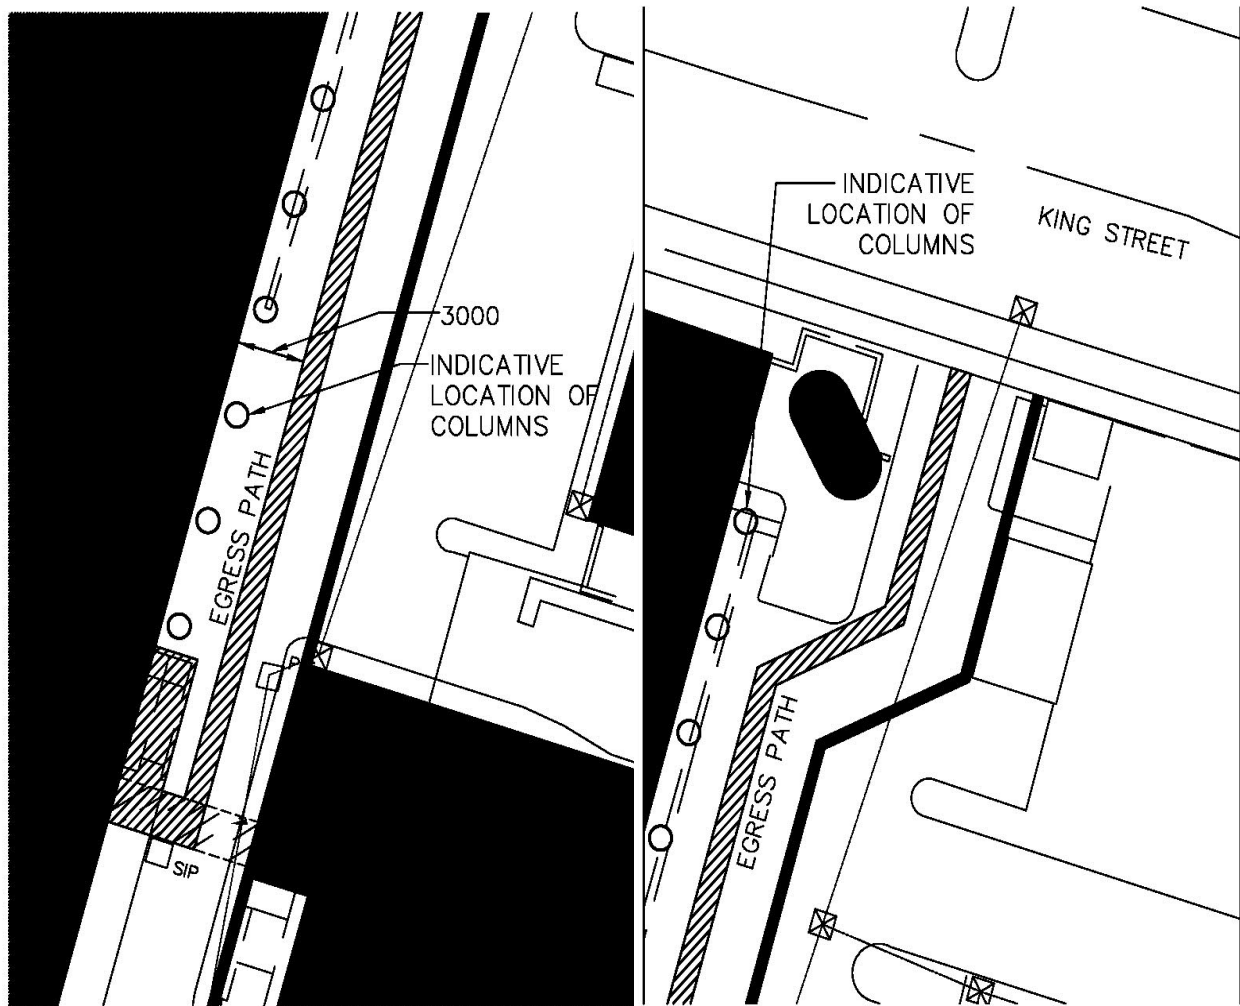
Figure 1

A boundary will be created east and south of the David Maddison Building (DMB) as noted in figure 1.

In the event of a fire, occupants evacuating from the basement carpark of the DMB will egress in the direction as shown in figure 1. Installation of additional illuminated exit signs to indicate the new egress path, and pedestrian ground markings located at a minimum distance of 3 metres east of the DMB will be required in the access road to King Street.

In the event of a fire, occupants evacuating from the DMB basement carpark will egress the building in the direction as shown in figure 1. Installation of additional illuminated exit signs to indicate the new egress path, and pedestrian ground marking at a minimum distance of 3 metres east of the DMB will be required in the access road to King Street.
