Annex A

Archival Photographs

Figure A.1
Photograph Location Plan

Client:	Manidis Roberts		
Project:	Incitec Pivot Remediation and Demolition HA		
Drawing No:	0080481s_GIS01	Suffix No:	R1
Date:	19/03/08	Drawing size:	A4
Drawn by:	JS	Reviewed by:	GC
Source:	Manidis Roberts		
Scale:	Refer to Scale Bar		
<div><div>

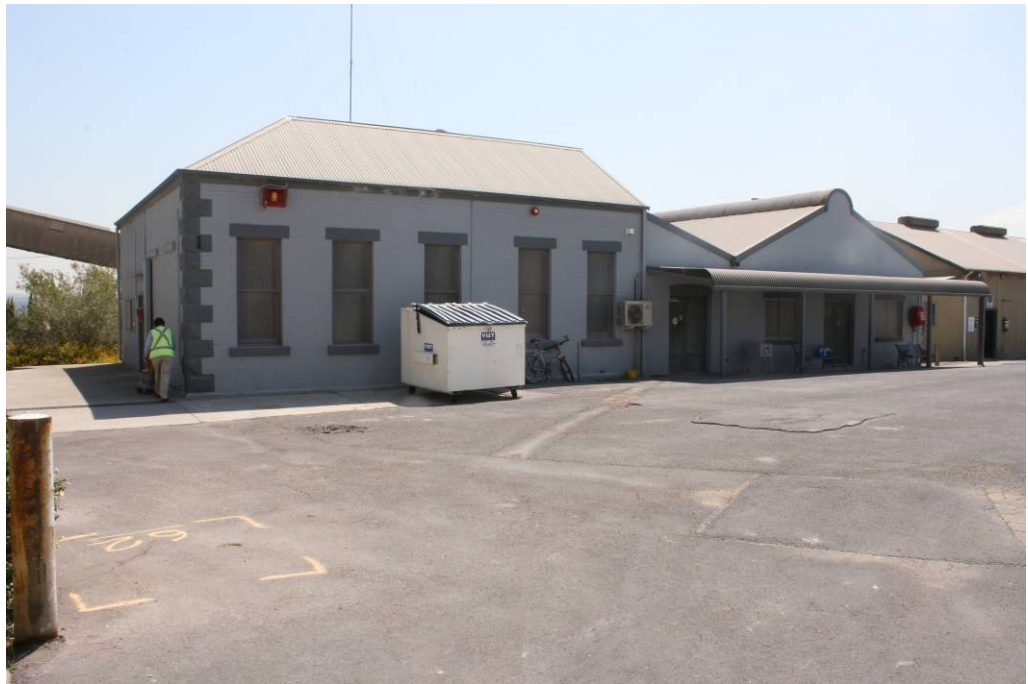
Photograph A.1 Sandstone and brick building (Facing East)

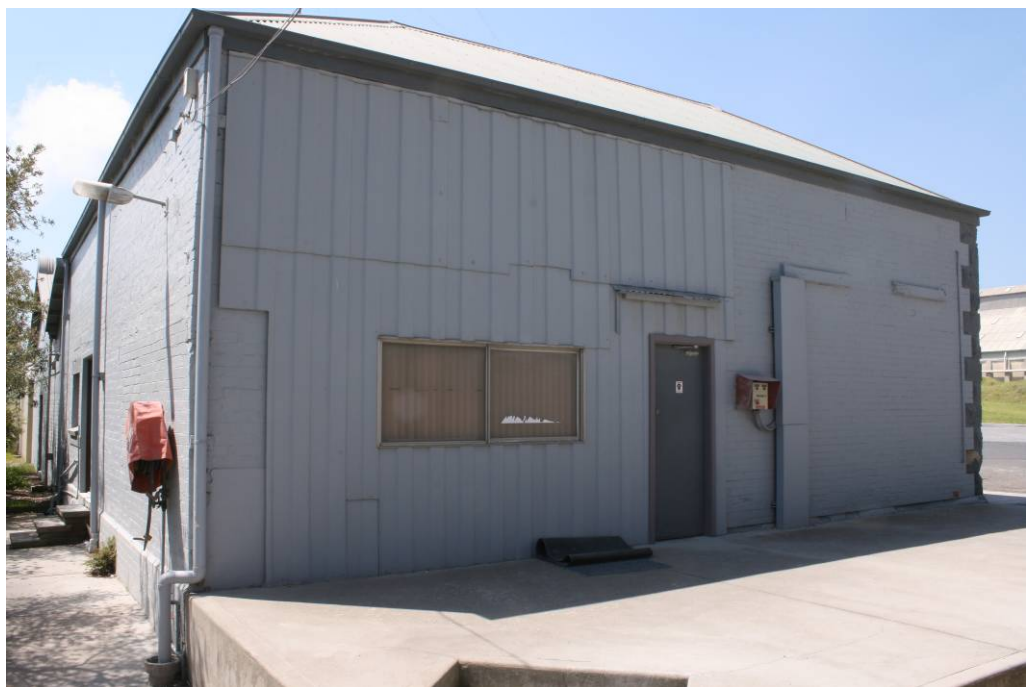
Photograph A.2 Southern end of brick and sandstone building

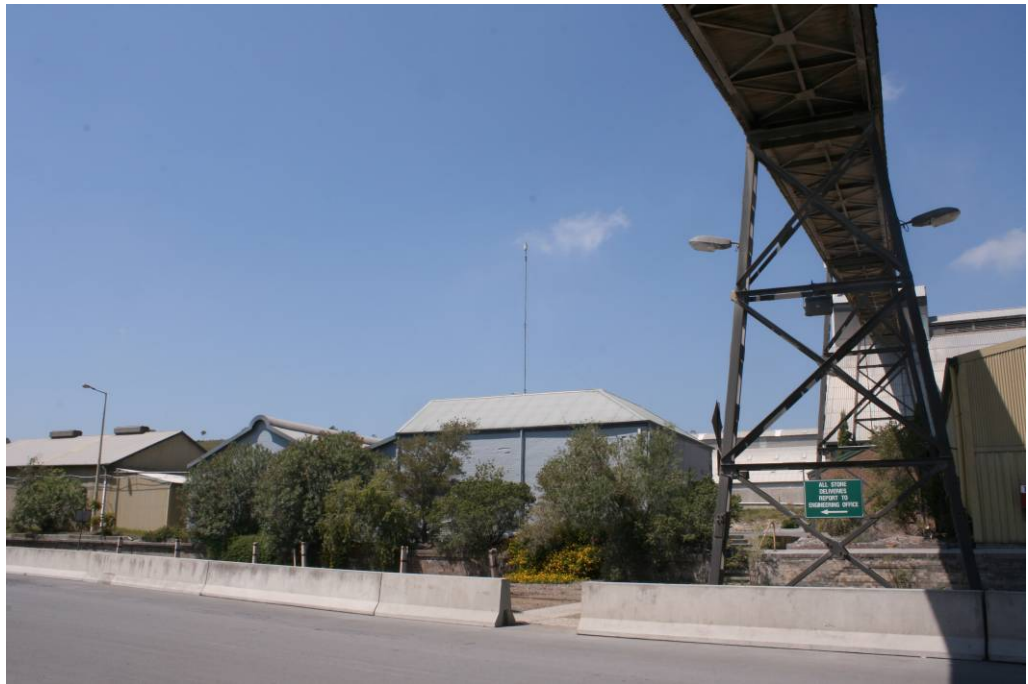
Photograph A.3 Sandstone and brick building and gantry overhead

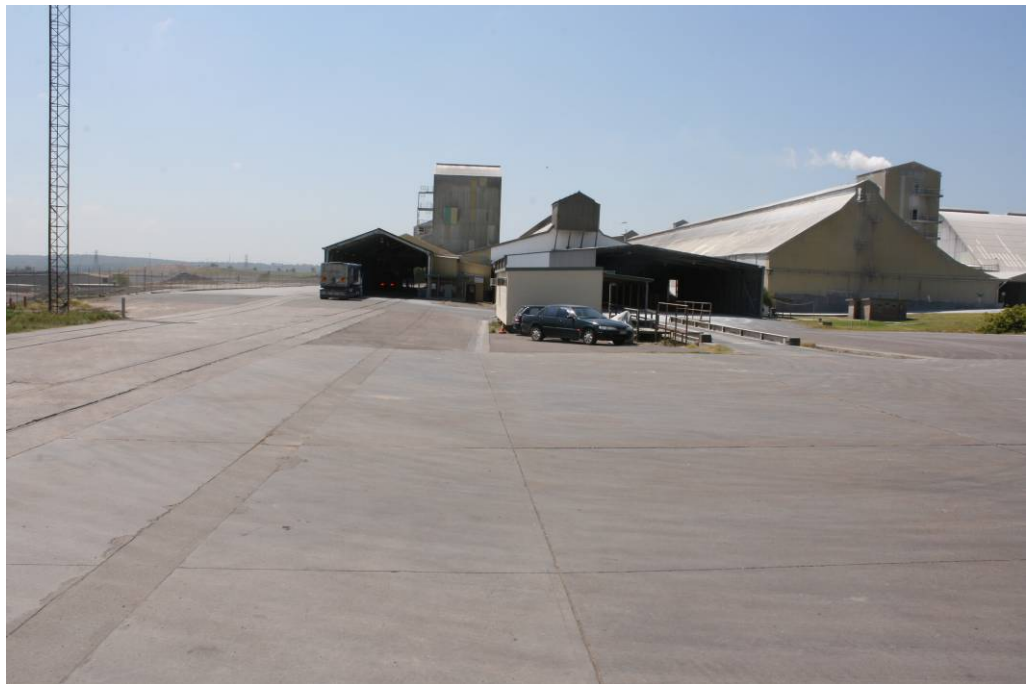
Photograph A.6 Shed 1, showing the railway line

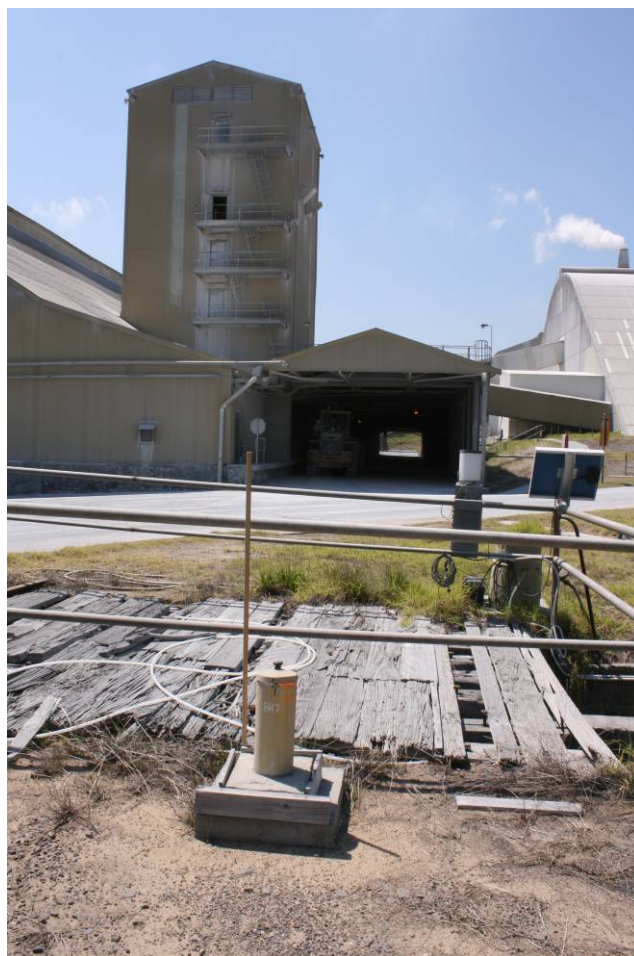
Photograph A.10 Shed 2 and 3 with pipe covering in foreground

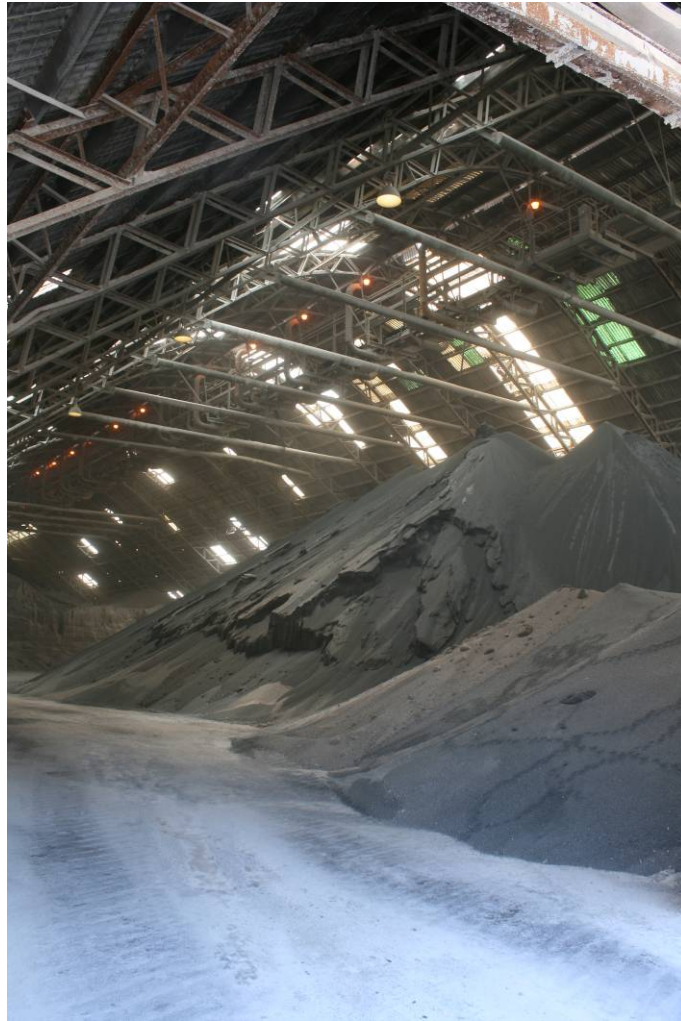
Photograph A.11 Interior of Shed 3

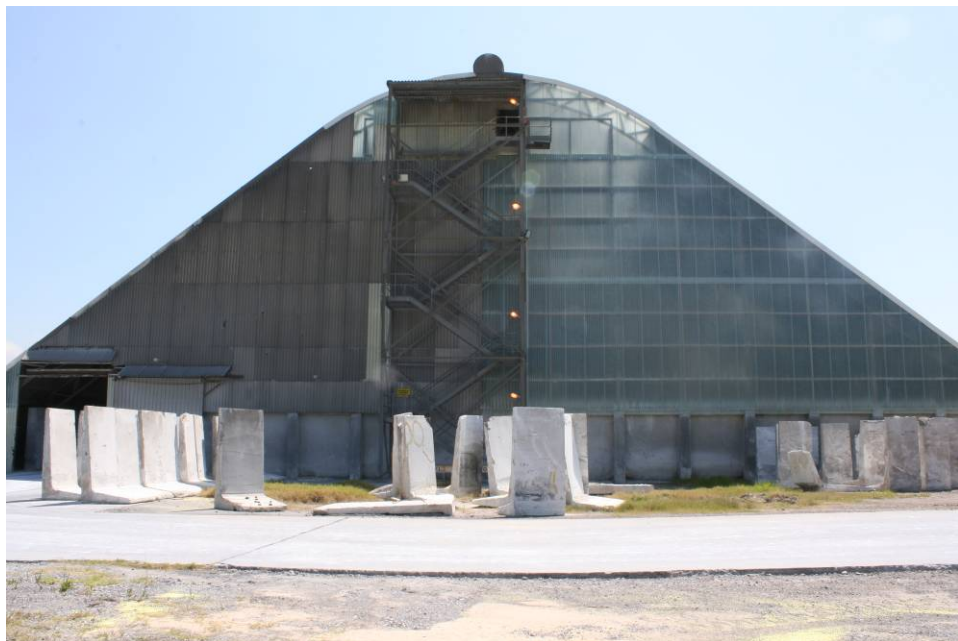
Photograph A.12 Rear of shed 3

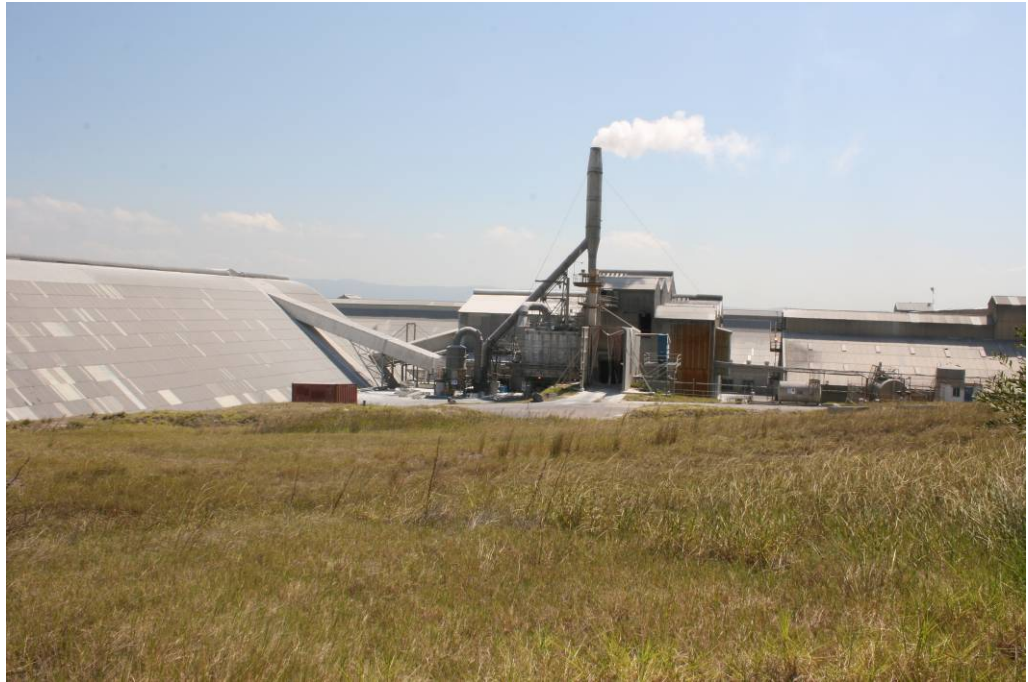
Photograph A.13 Shed 3 and fertilizer manufacturing plant

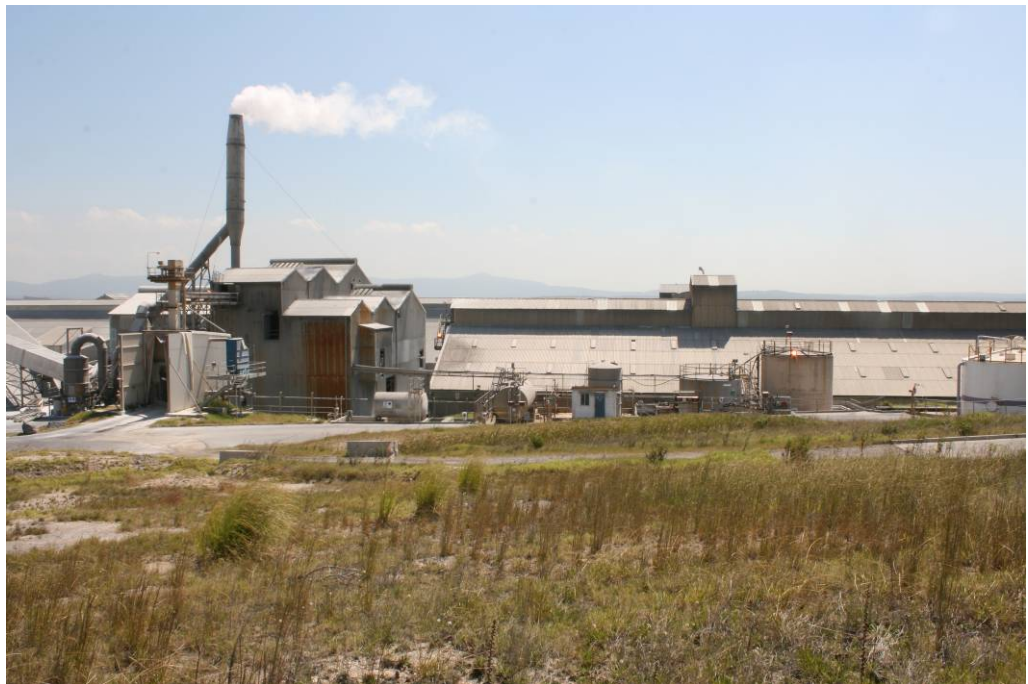
Photograph A.14 Taken from property boundary, Shed 4 and fertilizer manufacturing plant

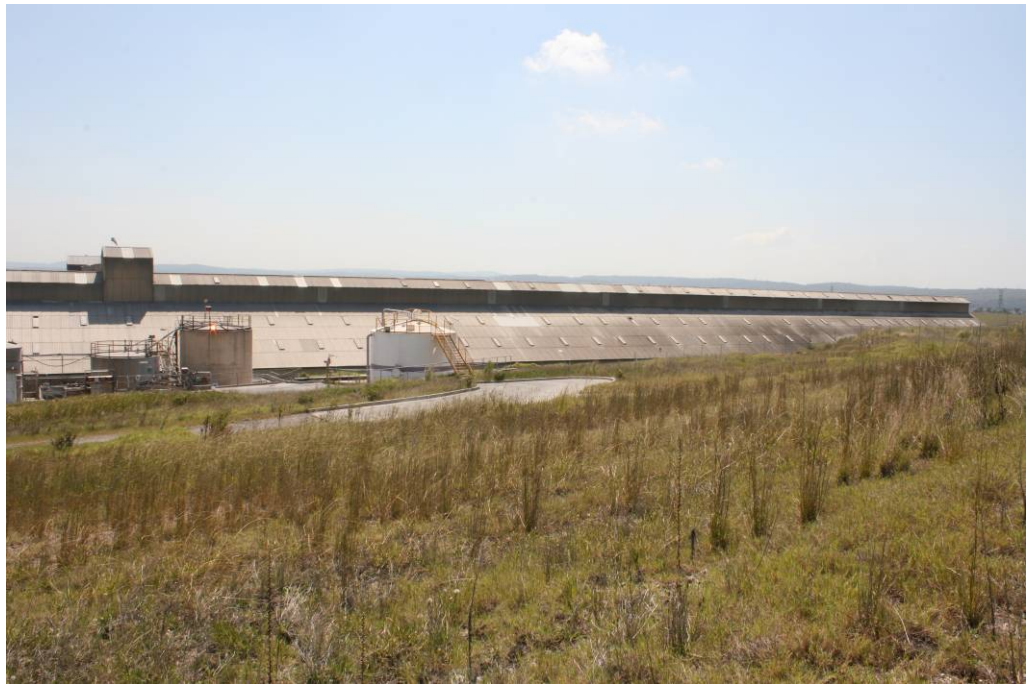
Photograph A.15 Taken from property boundary, Shed 4.

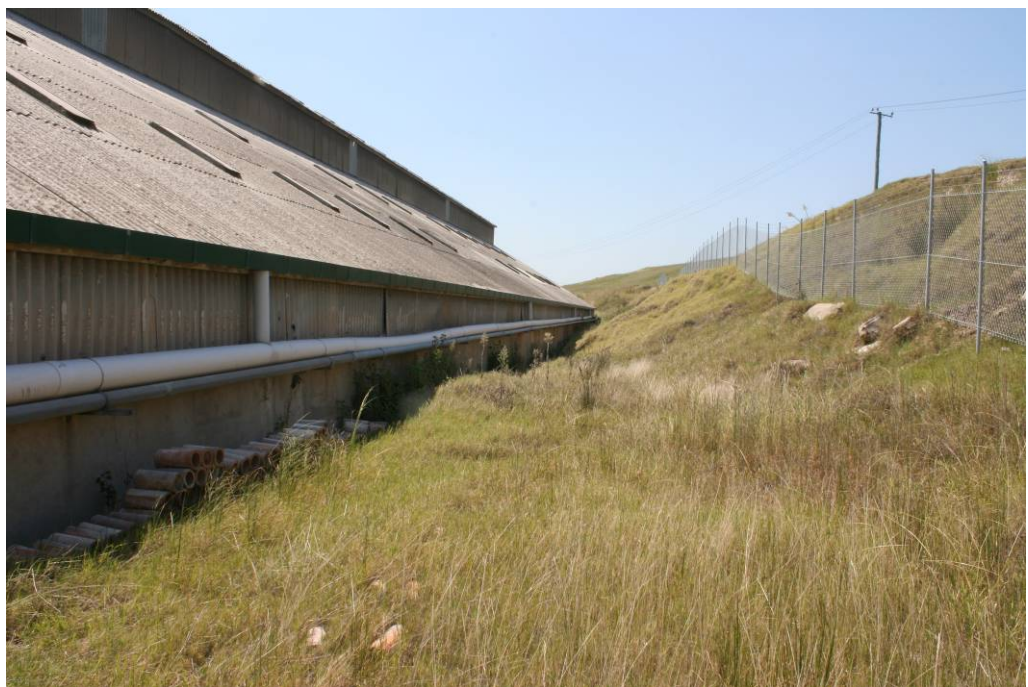
Photograph A.16 Rear of shed 4 and property boundary

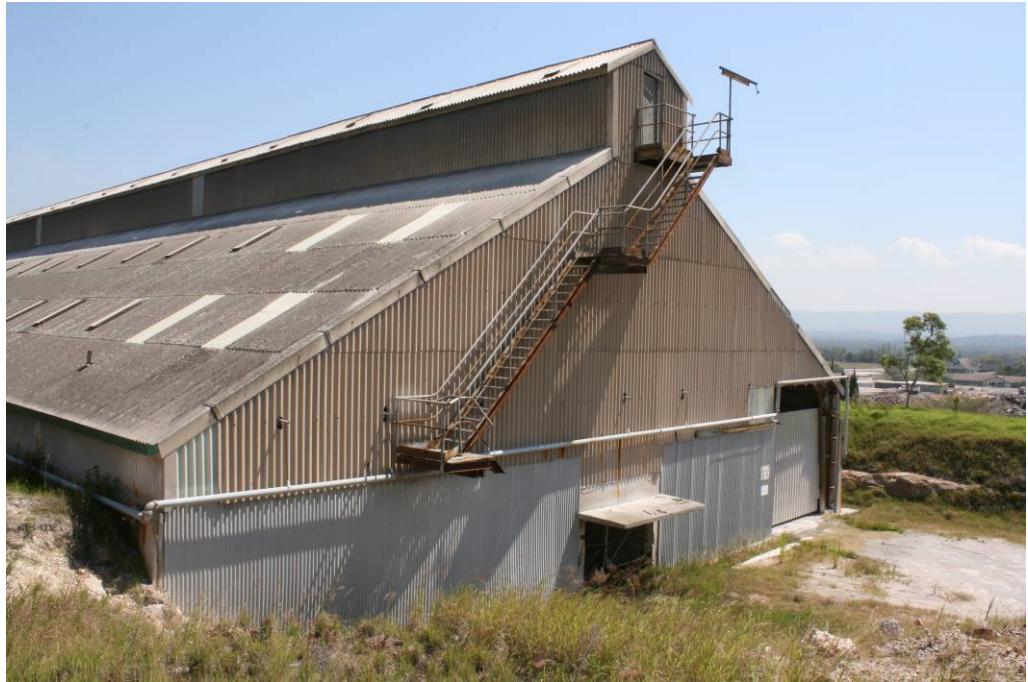
Photograph A.17 Rear of shed 4

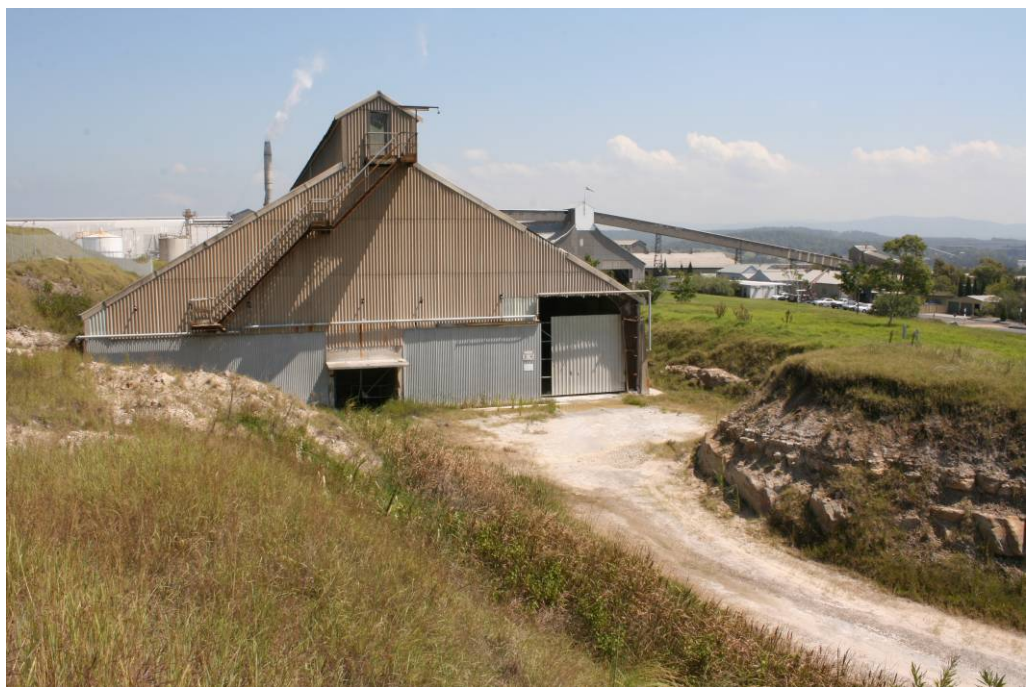
Photograph A.18 Rear of shed 4 and view of looking to Pasmaenco site.

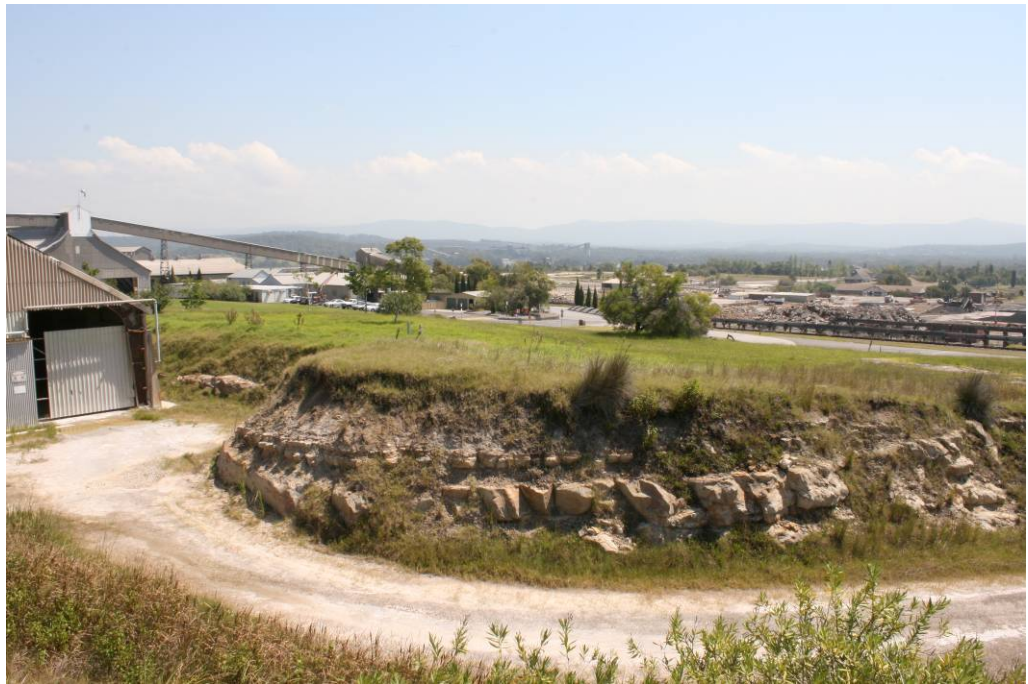
Photograph A.19 Northern end of shed 4 and view to Pasmaenco site

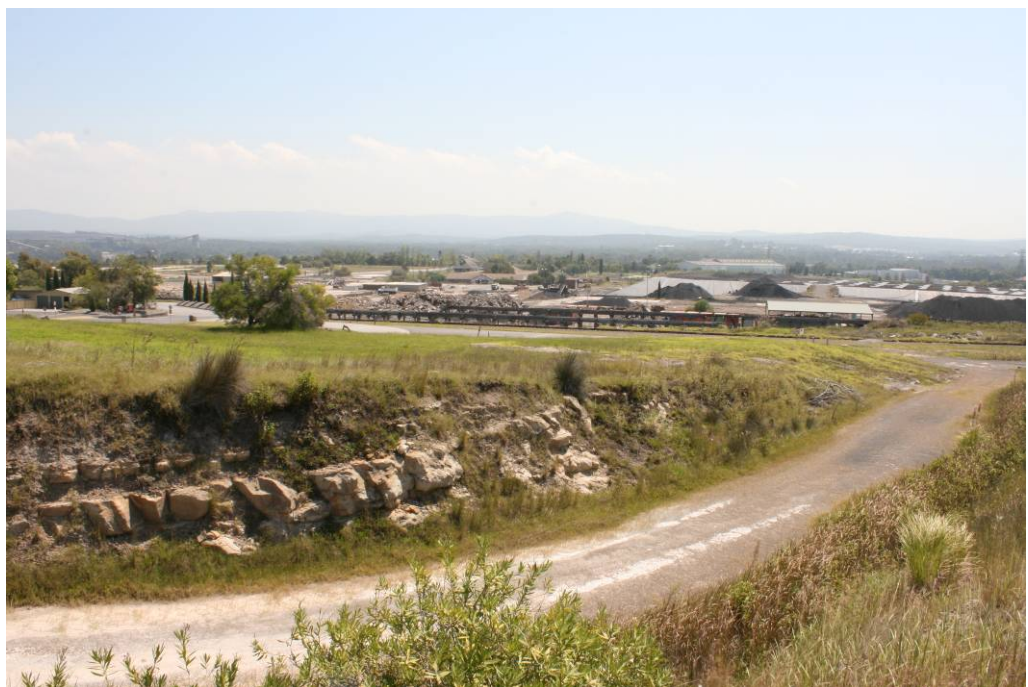
Photograph A.20 View across IFL to Pasmaenco site

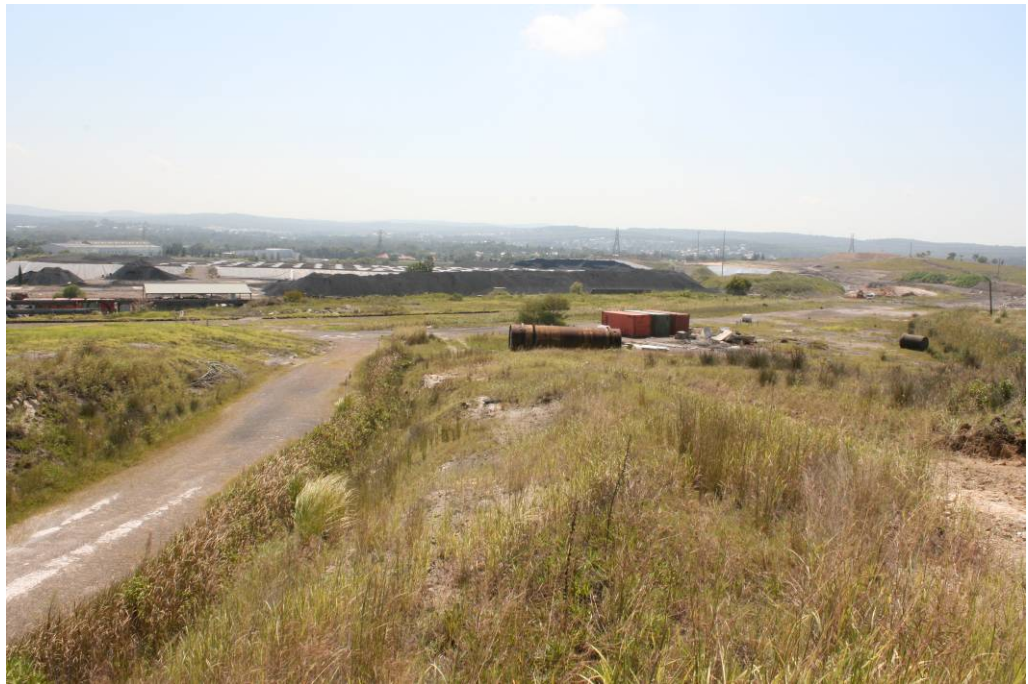
Photograph A.21 View across IFL to Pasminco site

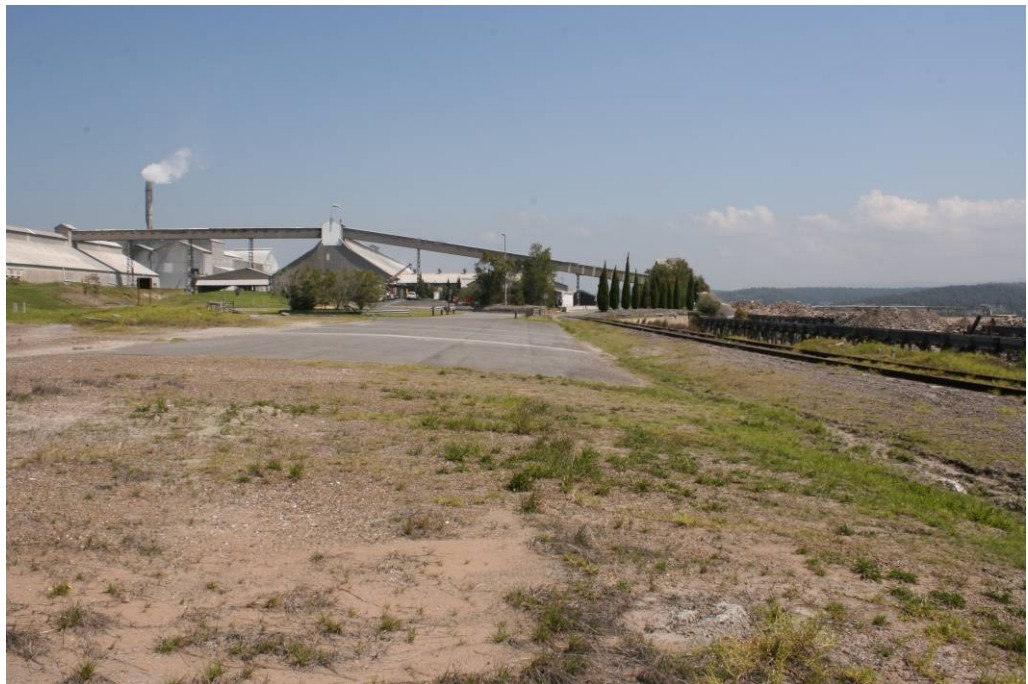
Photograph A.22 View across IFL site to sheds 1, 2 with railway line to the west

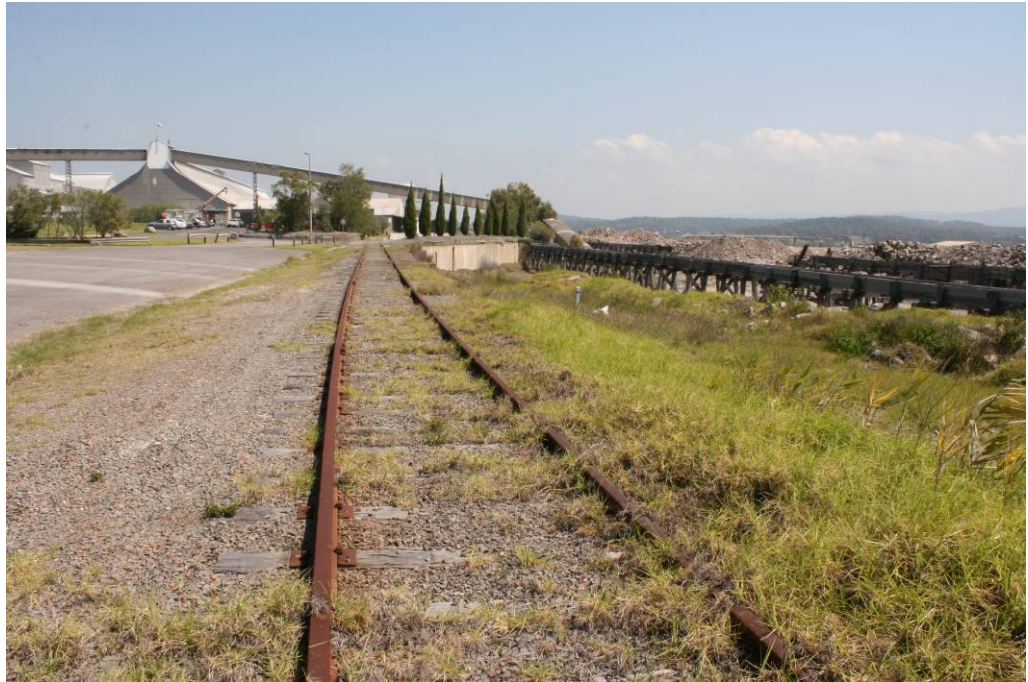
Photograph A.23 View of railway line on IFL site with shed 1 at rear

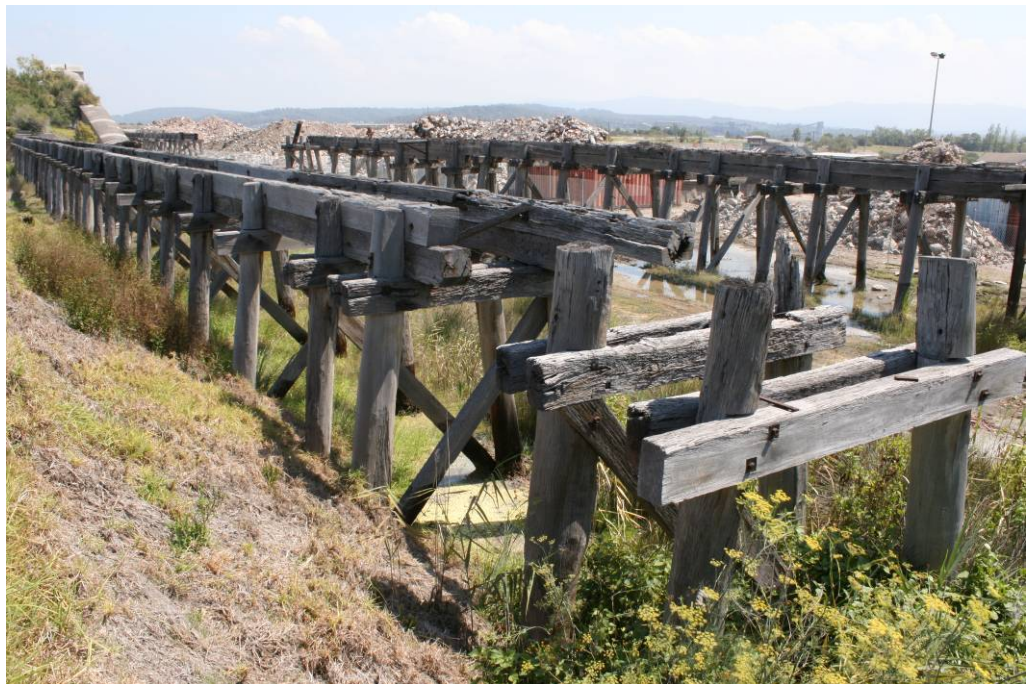
Photograph A.24 Wooden A frame gantry on site

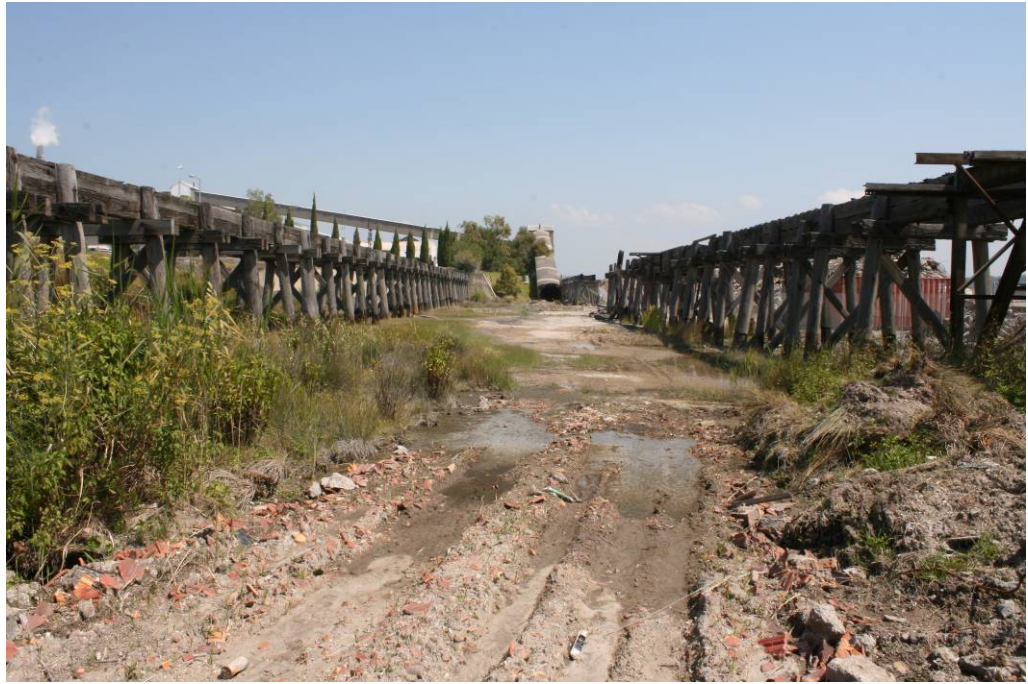
Photograph A.25 The two parallel wooden gantries

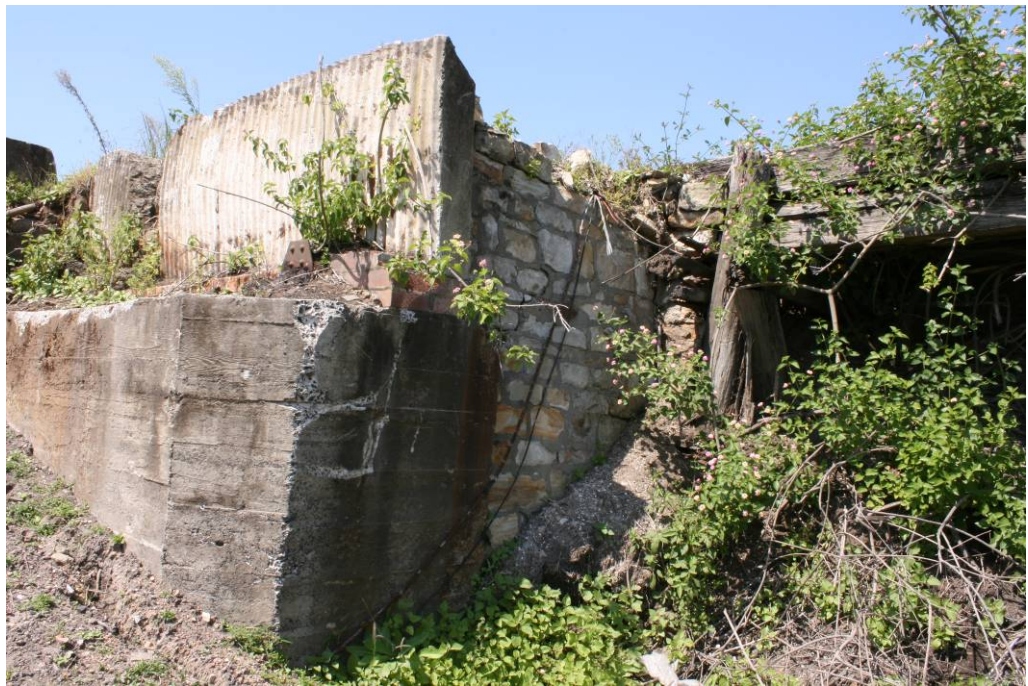
Photograph A.26 Brick and concrete structure at northern end of gantry

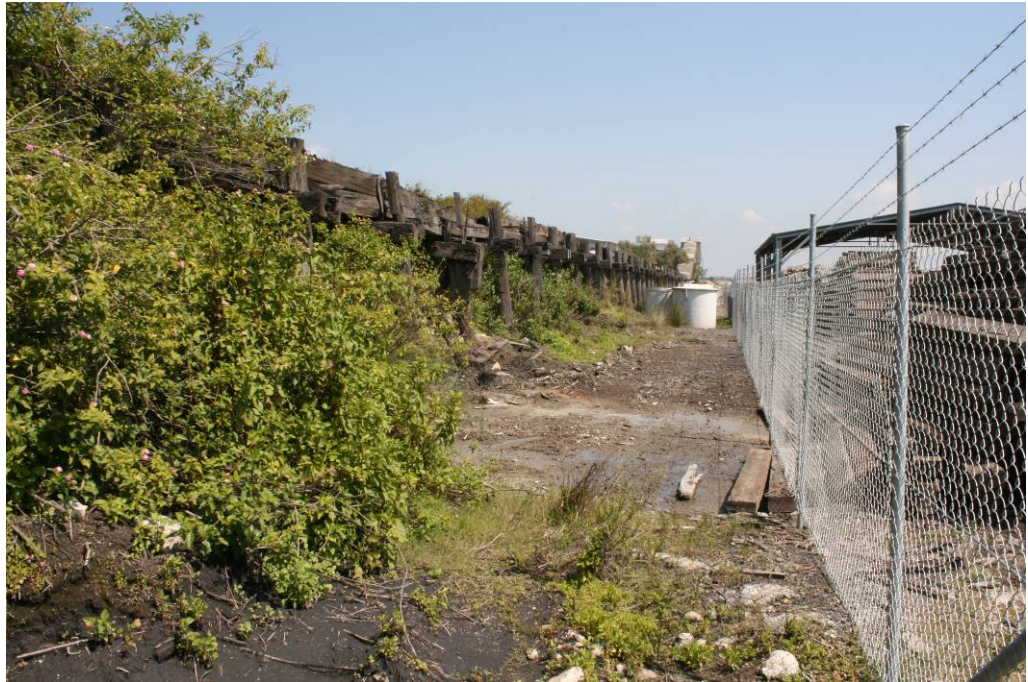
Photograph A.27 Western boundary of IFL site with Pasminco, gantry running south

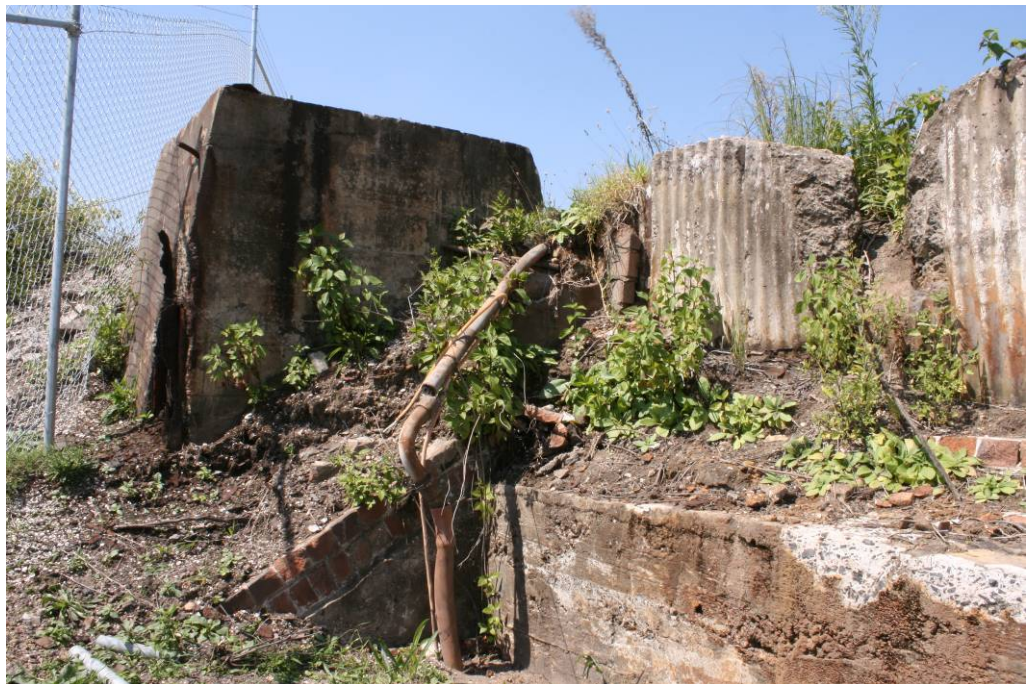
Photograph A.28 Brick and concrete structure at northern end of gantry

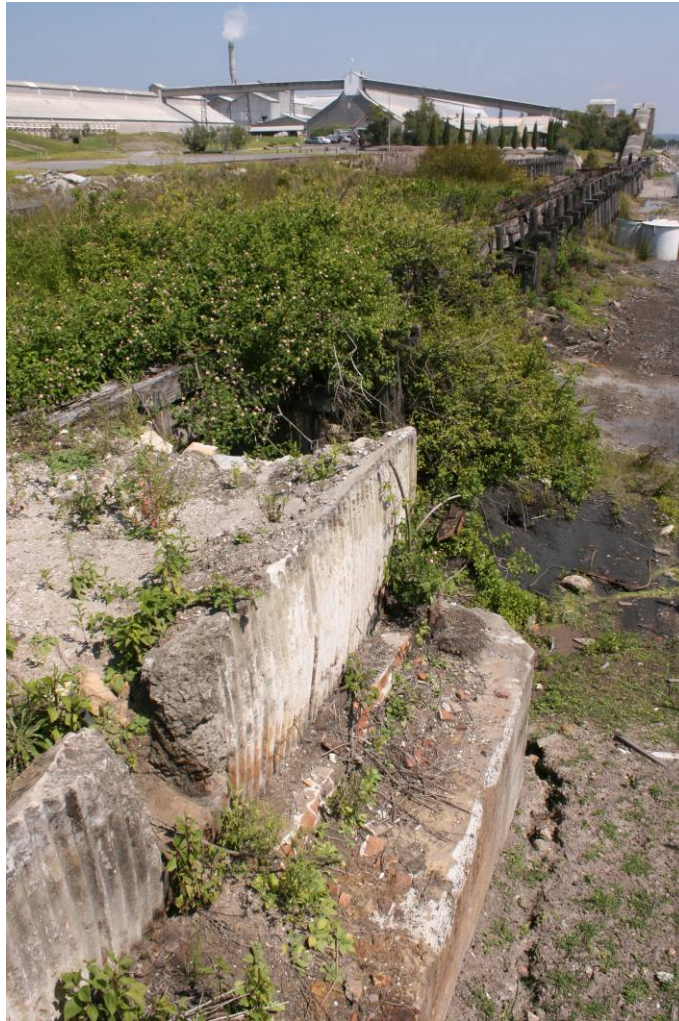
Photograph A.29 Brick and concrete structure at northern end of gantry
