**Section 75W Modifications
Project Application No 07_0032
Sandon Point Residential Subdivision**

Hazardous Materials Identification Survey: Wrexham Road Railway Bridge, Thirroul NSW

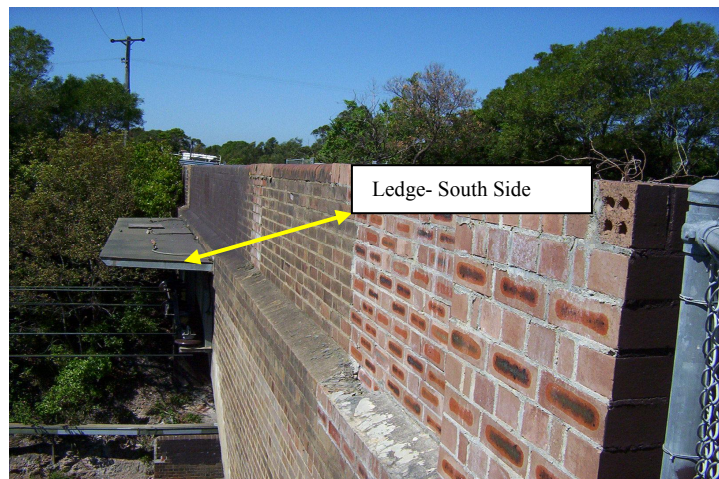
The bridge had two extruding platform ledges on either side. These metal constructions held a thin layer of unidentified dust particles surrounding the cable covers. Samples of dust were taken from these platforms for presence of asbestos (originating from train brake pads). Dust sampled from the south side of the bridge showed no detection of asbestos material/fibres or any traces of Synthetic Material Fibres (SMF). Results concluded there was a consisted mixture of dust particles, sand, organic fibres, corroded metal, plant matter and fragments of bitumen.

No ACM's were identified in these areas during the survey.

Figure 5.1a) Extruding platform ledge on the South Side. Patchwork nature of brickwork is evident on bridge structure

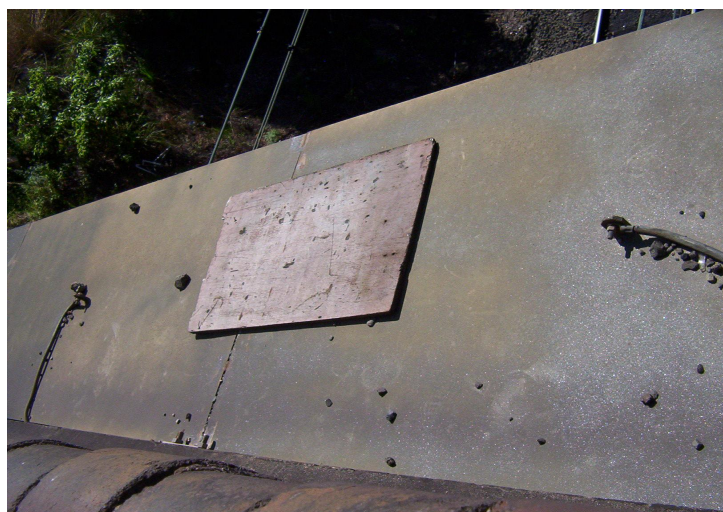
Figure 5.1b) Close up of the ledge showing evidence of dust.

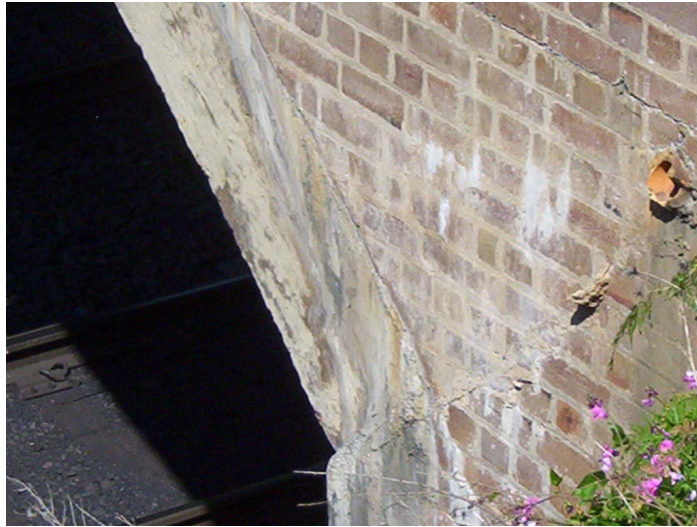
This foundation was also thought to have evidence of Asbestos material/fibres and SMF within the concrete, although samples returned non-detection for such materials. The concrete foundation contained fragments of plaster cement like material.

Figure 5.2- Close up of brick works where concrete sample was taken.

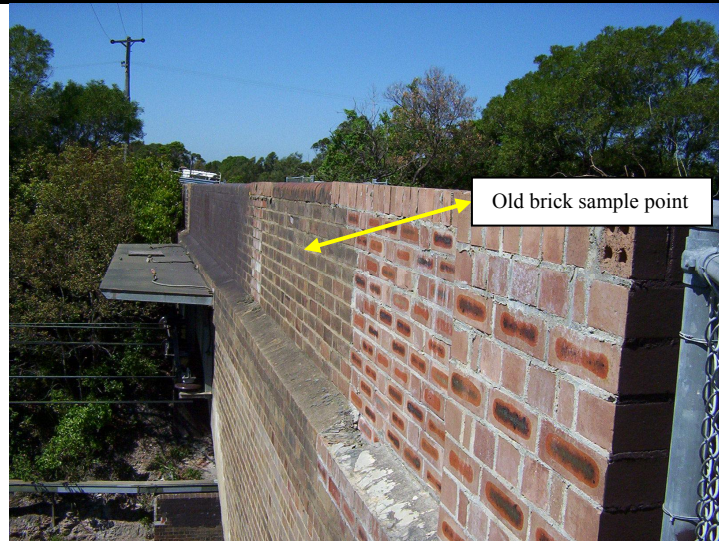
As previously mentioned in Section 3.3, the bridge is made of a combination of old and newer bricks, where previous renovations have occurred. The one sample was taken from the original brick area with no paint application, due to the old bricks having more of a chance of containing hazardous material than the new products. The sample returned with no detection of either Asbestos material/fibres or any SMF material.

The sample contained fragments of refractory brick like material, glass and debris.

Figure 5.3- Brick works where sample was taken.

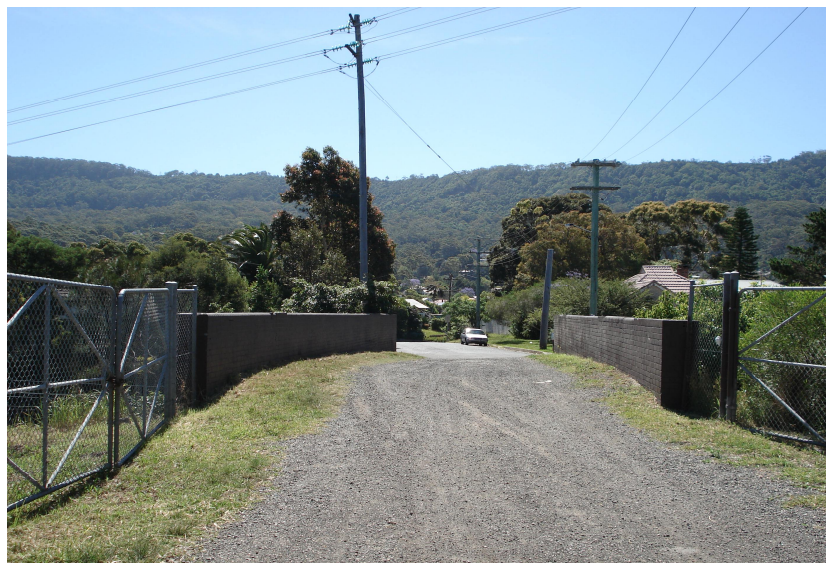
The bridge top consisted of a narrow two lane road of loose gravel, with ½ strips of grass on either side. The sample was taken underneath the gravel, where imported fill material may contain Polychlorinated Biphenyls (PCB), Polynuclear Aromatic Hydrocarbons (PAH), and Organochlorine Pesticides (OC/OP PCB'S). The analytical results returned low levels of lead attributable to background concentrations and non-detection limits for all other parameters

Testing was also carried out for accumulation of free friable asbestos material/fibres and SMF, but no detection was evident.

Figure 5.4- Top of the bridge looking out to Wrexham road.

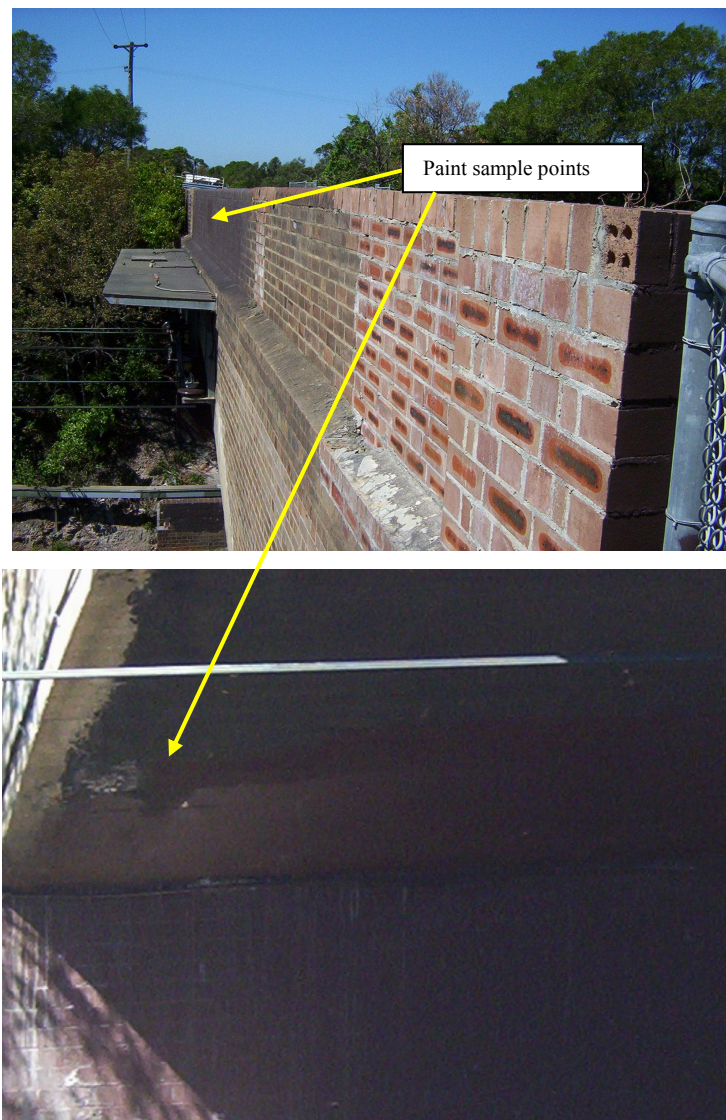
The risk of human health from lead based paints is considered minimal if there is no significant liberation of particles from paint deterioration, and hence no significant risk of inhalation of those particles. The condition of paint on the bridge is considered good. Demolition of all painted surfaces should be done so without sanding. However, if removal of paint before demolition is required, procedures such as wet blasting or use of power tools fitted with HEPA-filtered local exhaust ventilators should be implemented. All personnel involved in the task will be required to wear appropriate P2 rated dust masks as per the *Occupational Health and Safety Regulation 2001*.

The bridge has a thick cover of purple paint to approximately $\frac{3}{4}$ of the brickworks. One sample was taken on the external south side of the bridge to test for Lead (Pb). The search identified two separate lead based paints used on brickwork on the bridge. The purple paint used on the upper surface and the black “resin” underneath the arch both contained lead as determined by analytical analysis

Figure 5.5- Sample points where paint fragments taken.

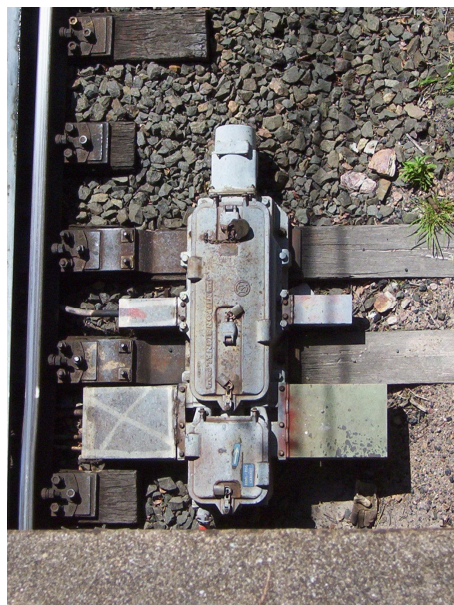
Figure 5.7 Points Box

There was no access afforded to the points boxes and associated hydraulic lines. It is unlikely that the oil or points boxes contains any hazardous material.
