Arborist development assessment report

Australian Institute of Police Management (AIPM)
Collins Beach Road, Manly, NSW, 2095

December 2008

Prepared by: Paul Vezgoff
Consulting Arborist

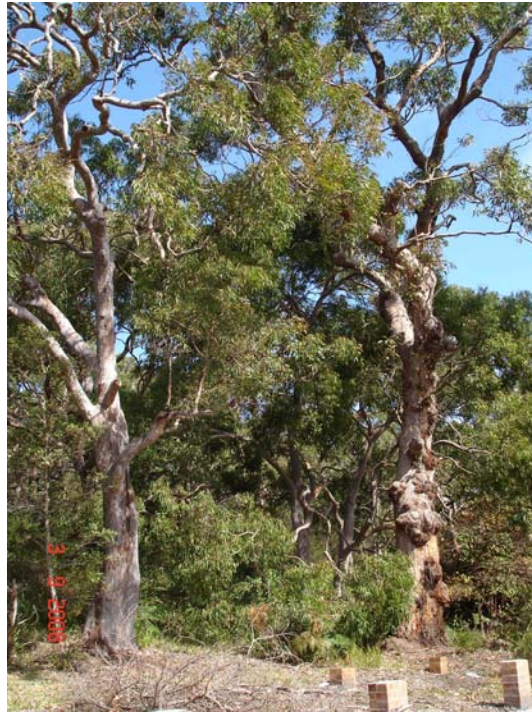
Tree 7 is a mature Bangalay (*Eucalyptus botryoides*) located near the southern boundary (Plate 1). This tree is in good health and appears structurally sound. The tree has a symmetrical, decurrent canopy that is codominant with Trees 6 and 9. Woody surface roots can be observed at ground level on the northern side of the tree. It is apparent that there are hollows within old wounds that have been colonised by bees. This tree is proposed to be retained. It is likely that the proposed development will affect at least 30% of the root zone due to excavation required for the new building (Plate 2). The lowest branch on the northern side is 8.6 metres from ground level. The lower northern branches on Trees 6 and 7 may have to be removed to accommodate the new structure.

Plate 1: Trees 6 (left) and 7 (right). P. Vezgoff.

- 4.2 Trees 6 and 7:** It is recommended to undertake further investigation due to the proposed design of the administration building that will require up to 30% of the root zone to be excavated to allow for the footings of the new building. The issue with excavating such a large proportion of root zone is the likelihood of structural woody roots being severed. This will affect the overall health of the tree but more importantly will affect the structure of the tree. Severing large woody roots can lead to whole tree failure.

Root mapping is recommended to determine the presence of roots. This is undertaken by excavating a trench by hand to expose roots at a specified location. A trench is dug (approximately 300mm wide x 800mm deep) and roots are exposed and recorded so that a factual assessment can be undertaken and applied to the proposed design.

Tree 7 has evidence of hollows and may, due to the lower bulges in the trunk, have decay or a termite nest in the base. Having a large proportion of unsound wood in the root crown area (termite damage or decay pathogens) can render a tree structurally compromised. This tree requires further testing.

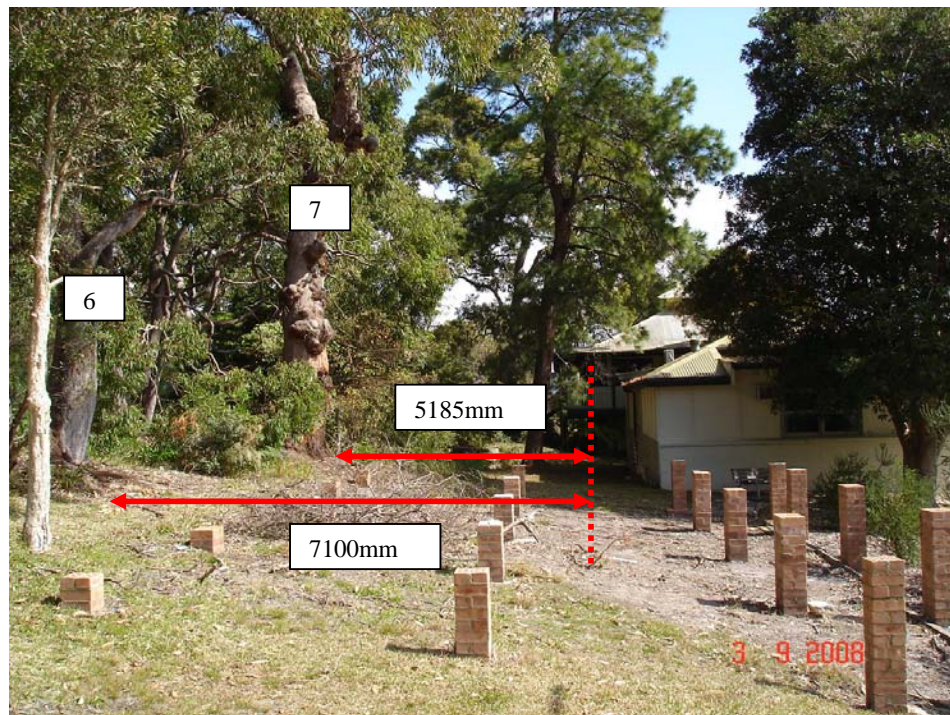
Plate 2: Trees 6 and 7 showing the approximate distance of the new administration building.
P. Vezgoff.

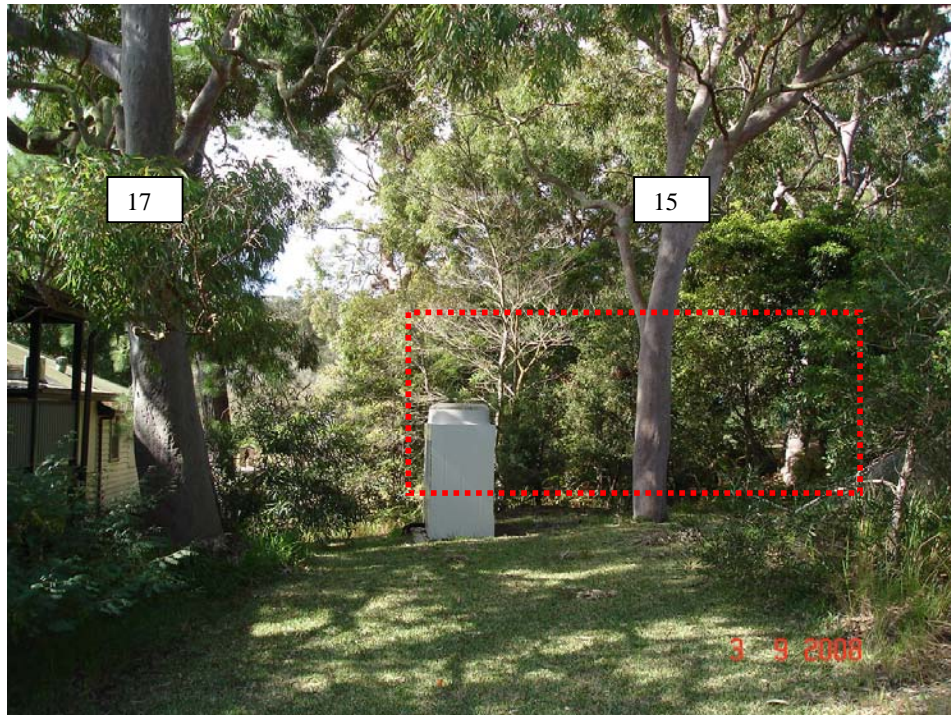
Plate 3: The low growing trees within the red square are proposed to be removed to enable landscaping of a small creek area. Trees 15 and 17 are to be retained. P. Vezgoff.

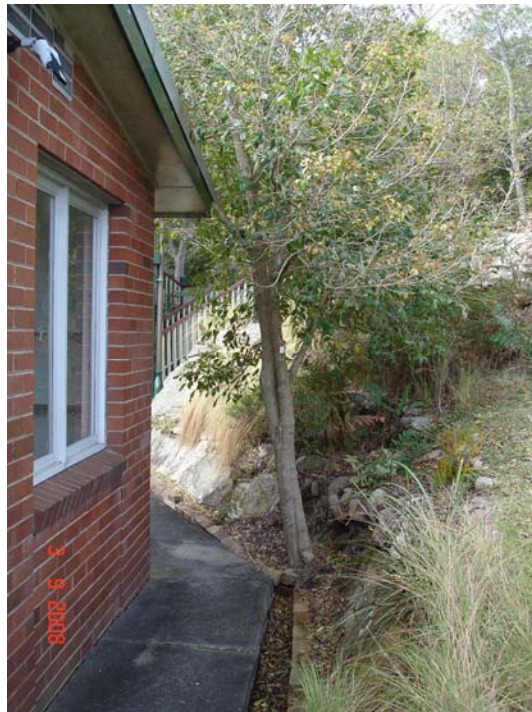
Tree 28 is a mature Cheese Tree (*Glochidion ferdinandii*) growing in the drainage gutter located south of Building 20 (common room) (Plate 4). This tree is in good health and appears structurally sound. The tree has a symmetrical, decurrent canopy that is dominant. This tree is proposed to be removed as it will continue to cause damage as it reaches maturity.

Plate 4: Tree 28 proposed to be removed. P. Vezgoff.

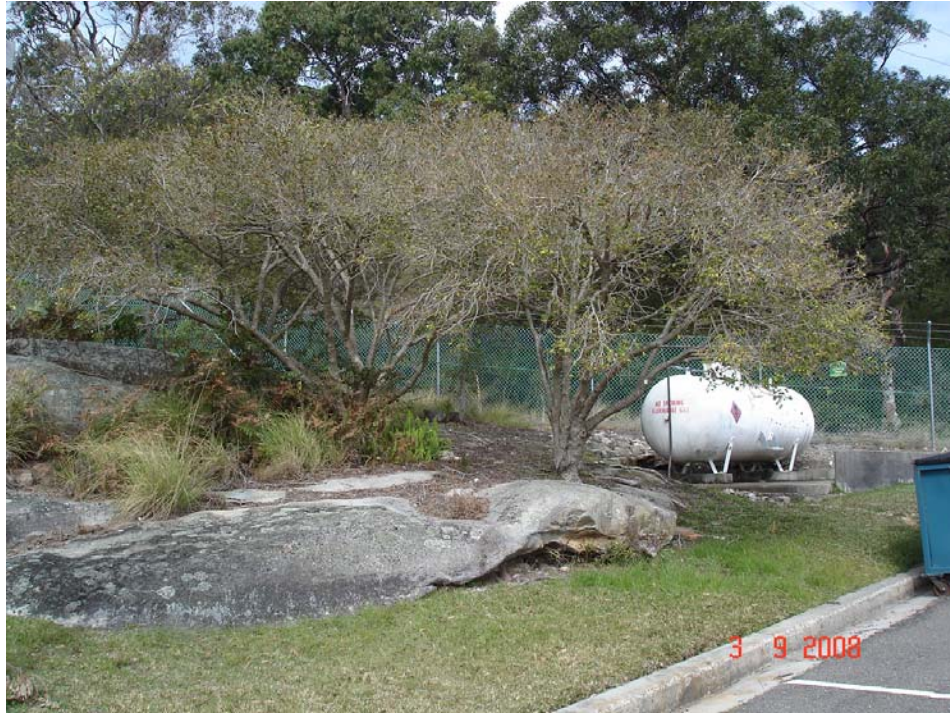
symmetrical, decurrent canopy that is codominant with Trees 30 and 33. This tree is proposed to be removed for the purpose of development.

Plate 5: Trees 30-33 are proposed to be removed to allow for the new library extension.
P. Vezgoff.

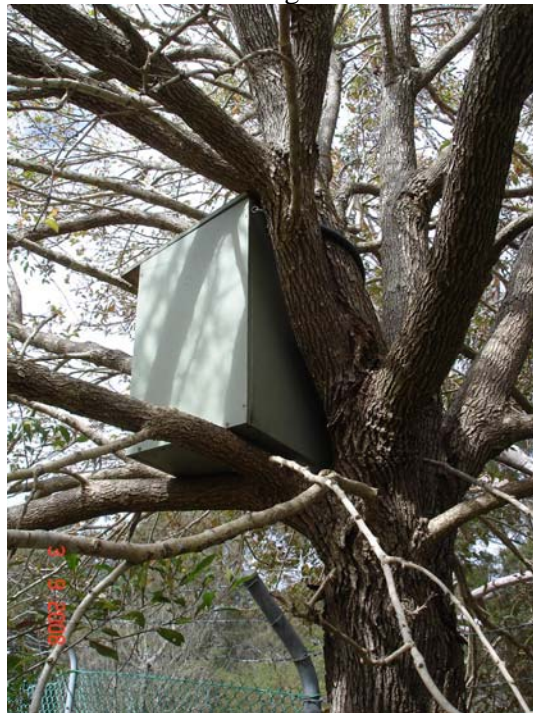
Tree 36 is a mature Cheese Tree (*Glochidion ferdinandii*) located near the southern boundary between the stores (Buildings 19 and 25). This tree contains a possum box at approximately 2 metres from ground level (Plate 6). Many of the trees on site contain possum boxes. They appear to have been attached by a rubber coated wire so as to reduce damage to the trunks of trees. This tree is in good health and appears structurally sound. The tree has a symmetrical, decurrent canopy that is dominant. This tree is proposed to have car parking spaces located very close to it however it is proposed to be retained.

Plate 6: Possum box within Tree 36 (Proposed to be retained). P. Vezgoff.

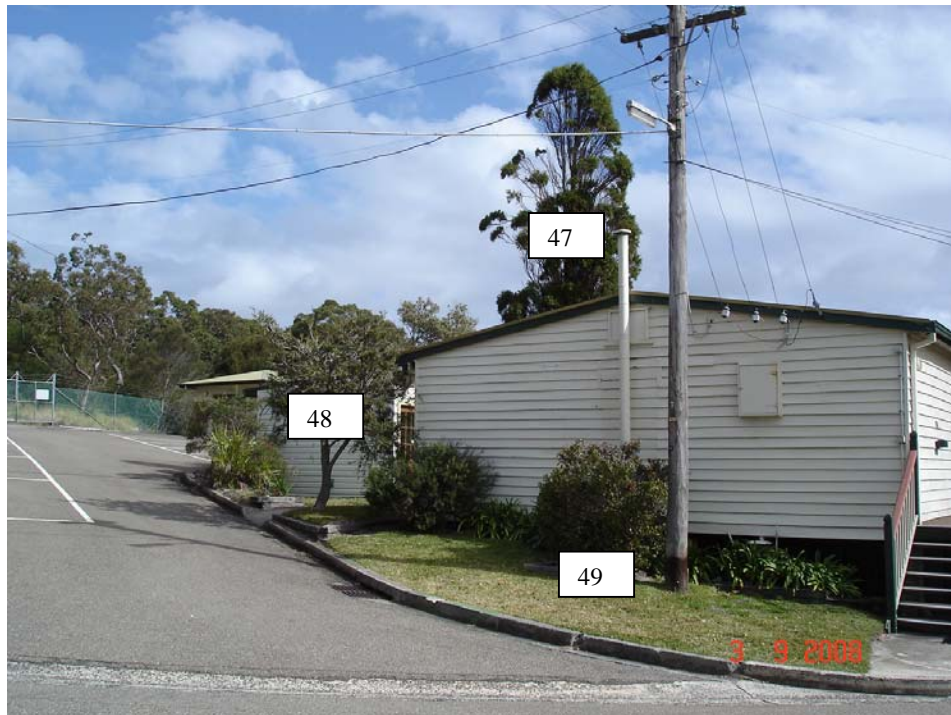
Plate 7: Trees 47, 48 and 49. All proposed to be removed. P. Vezgoff.

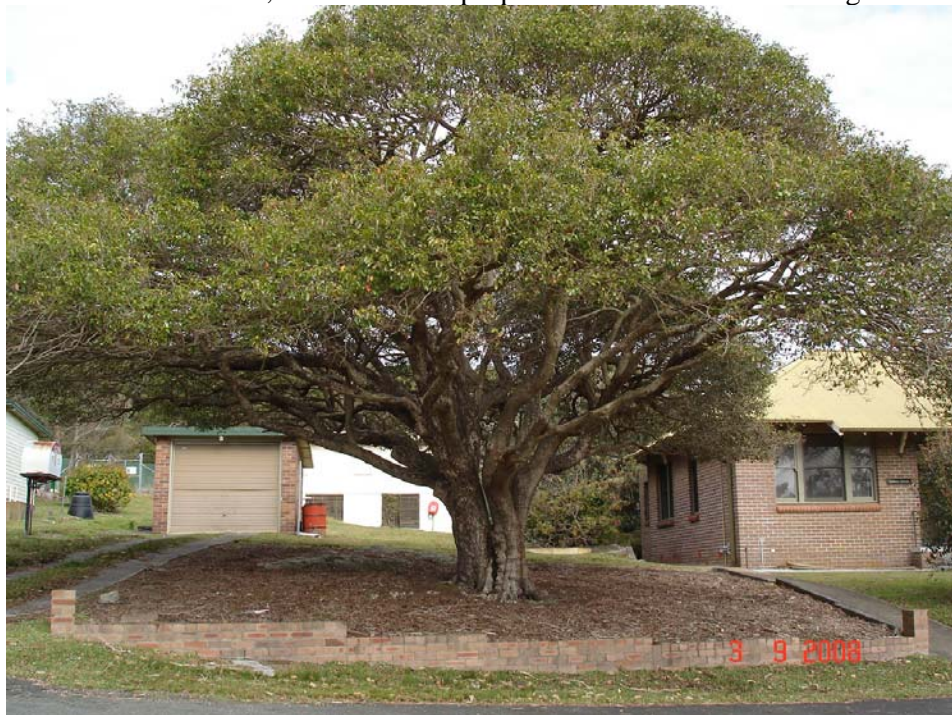
Tree 50 is a mature Cheese Tree (*Glochidion ferdinandii*) located near the western boundary (Plate 8). This tree is in excellent health. It has a symmetrical, decurrent broad spreading canopy that is dominant. The tree appears to have poor structure. This poor structure is due to a major bark inclusion at ground level where the trunk bifurcates (Plate 9). The bifurcation of the trunk has caused a build up of organic matter that is retaining moisture within the central stem of the tree. This tree is proposed to be removed to allow for the new classroom No. 1 building.

Plate 8: Tree 50, proposed to be removed. P. Vezgoff.

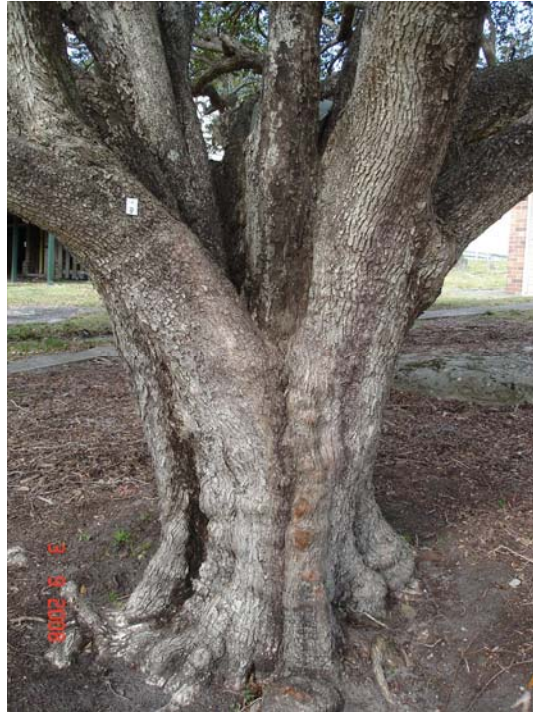
Plate 9: Image showing the trunk of Tree 50. The bifurcation of the trunk has caused a build up of organic matter that is retaining moisture within the central stem of the tree.

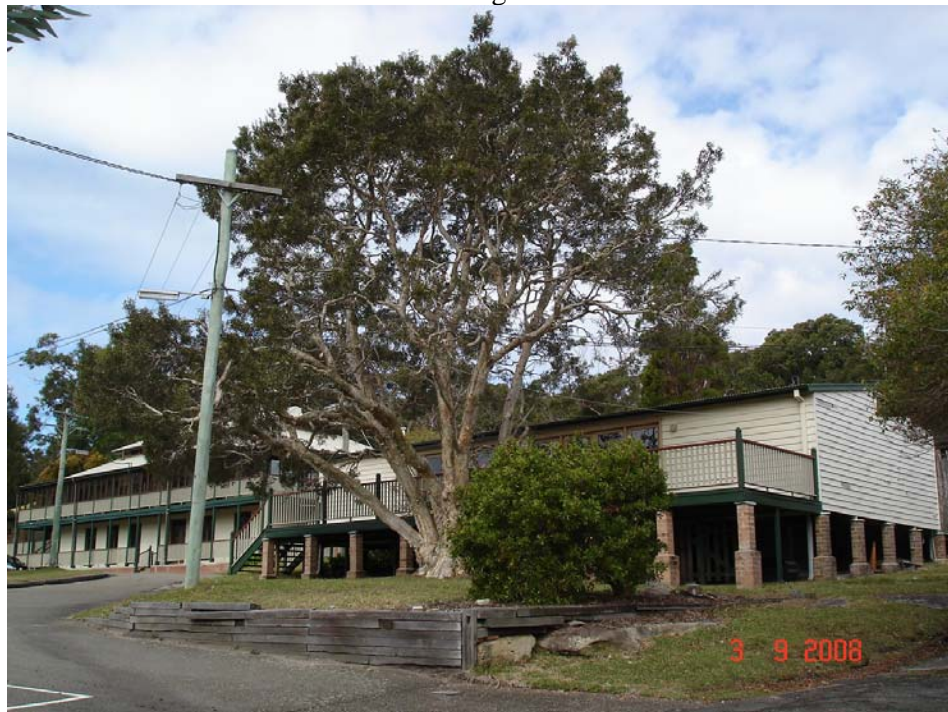
Plate 10: Tree 50a to the north of the senior common room (Building 15), proposed to be removed. P. Vezgoff.

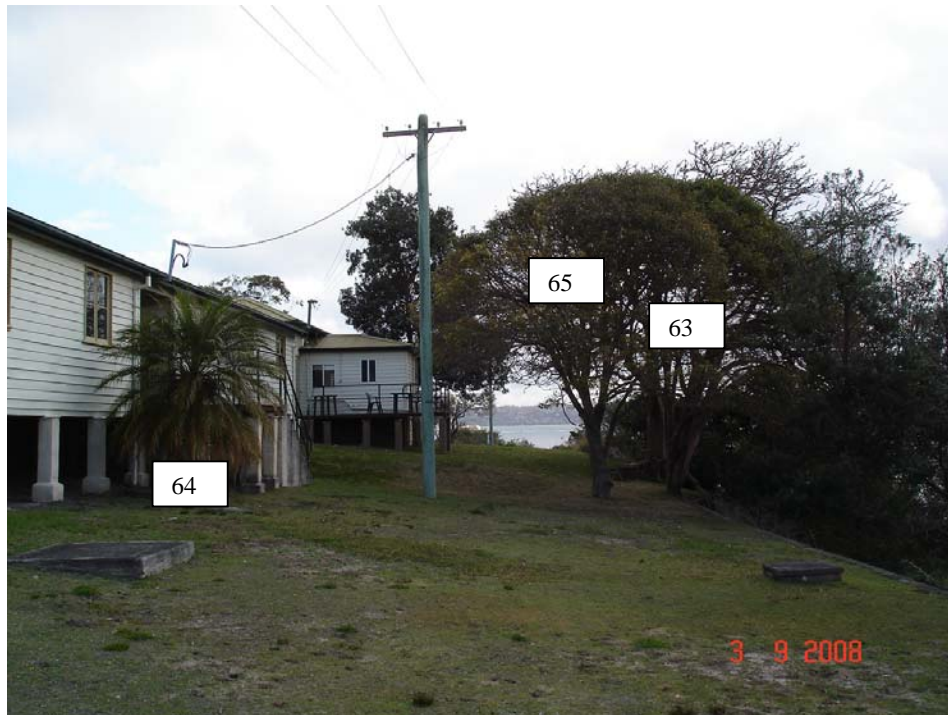
Tree 63 and 65 are mature Cheese Trees (*Glochidion ferdinandii*) located near the northern boundary on a lawn area (Plate 11). These trees are in good health and appear structurally sound. Discolouring was observed on the trunk possibly due to raised soil levels at the base of the tree. The canopy of these trees are codominant with surrounding trees and as with the other Cheese trees on site, they are suffering from caterpillar damage. There is minor borer damage on old pruning wounds. These trees are proposed to be retained.

Plate 11: Trees 63, 64 and 65. P. Vezgoff.

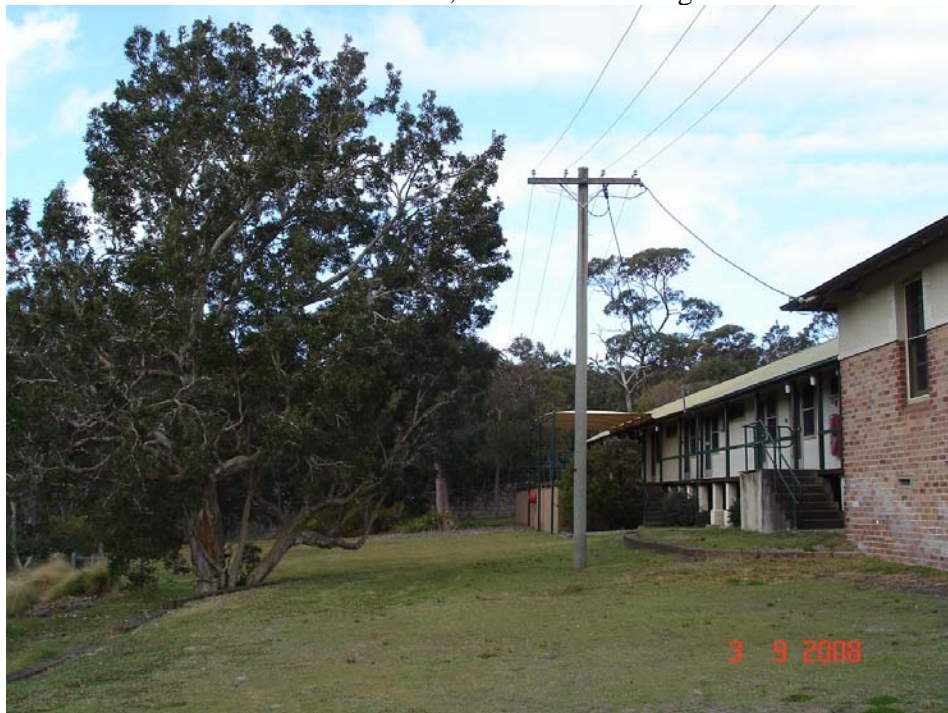
Plate 12: Tree 78 is to the left of the image. The buildings to the right are proposed to be demolished. Trees 60-80 are located along the cliff edge that is to the left of the image. Trees 60-80 will not be affected by the proposed development. P. Vezgoff.

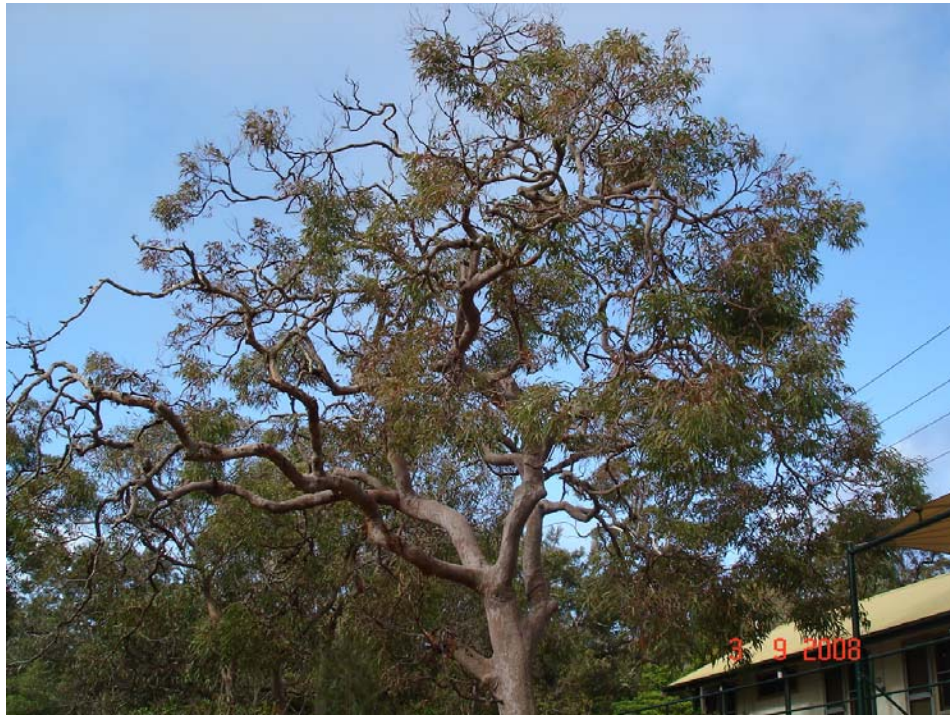
Plate 13: The canopy of Tree 79. P. Vezgoff.

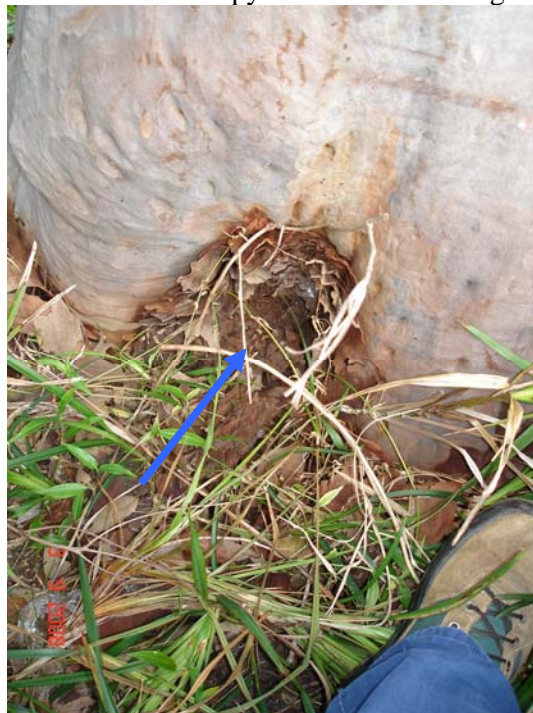
Tree 79 has evidence of a termite nest at the base (Plate 14). Due to the location of this tree being in a lawn area it would be recommended to assess the quantity of damage at the base of the tree to determine whether the tree is viable to retain in an open lawn area.

Plate 14: Termite nest (Blue arrow) at the base of Tree 79. P. Vezgoff.

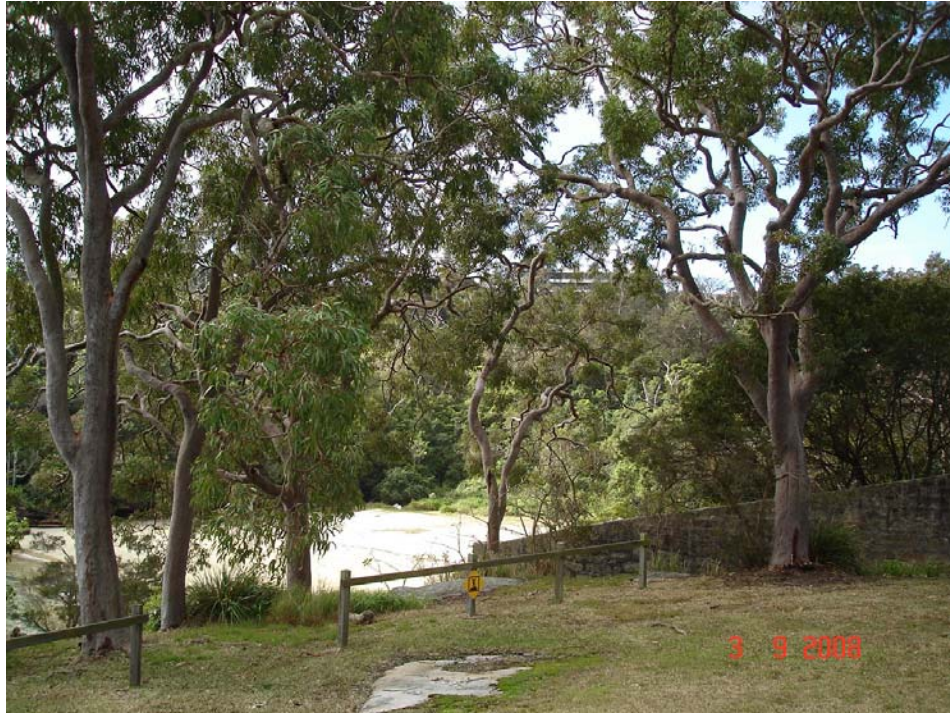
Plate 15: Trees 82-86. P.Vezgoff.

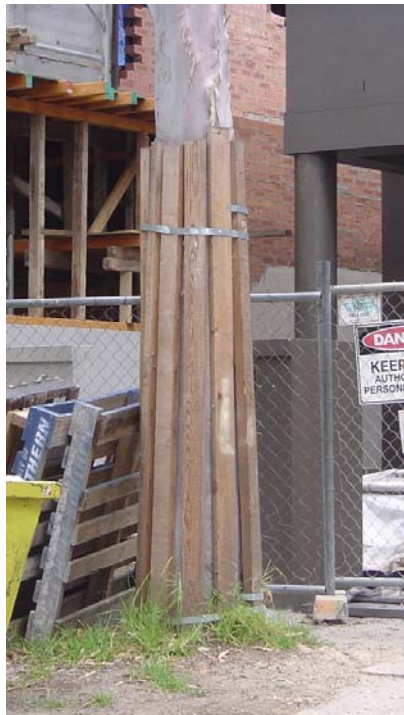
Plate 16: Example of trunk protection recommended for Trees 6, 7, 15, 18 and 58.
P. Vezgoff.

5.4 Individual trunk protection: Trees 6, 7, 15, 17, and 58 will require trunk protection. It is important to protect the bark on trees. Bark is a very effective barrier that helps to protect trees from pest, disease and decay pathogens. Trunk protection is highly recommended on any construction site. This is achieved by attaching lengths of timber (75mm x 50mm x 2000mm) fastened to the trunk. These timbers are to be fastened with hoop iron strapping and not attached directly into the bark of the tree. These timbers are only to be removed when all construction is complete. Some of these trees also have fencing. The trunk protection is an additional measure in case the fencing is required to be moved to complete works. See Plate 16 for an example of trunk protection.
