# Asbestos Materials Re-Inspection Report

**Sydney Water Corporation**

**Sydney Water Accommodation Site, Brunker Road,  
Potts Hill NSW**

**March 2009**

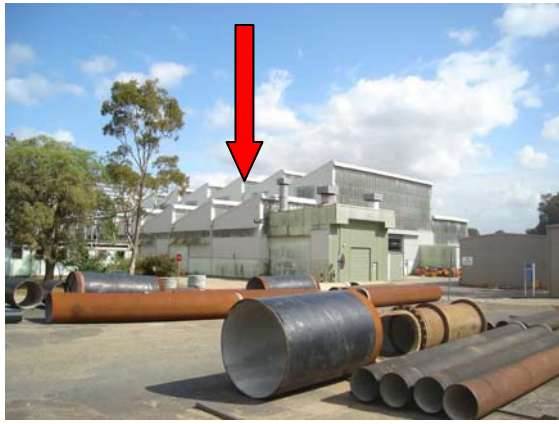
**Photo 1.** Area 1: Building 3, Critical Inventory Store, External Roof – Asbestos containing corrugated fibre cement sheeting

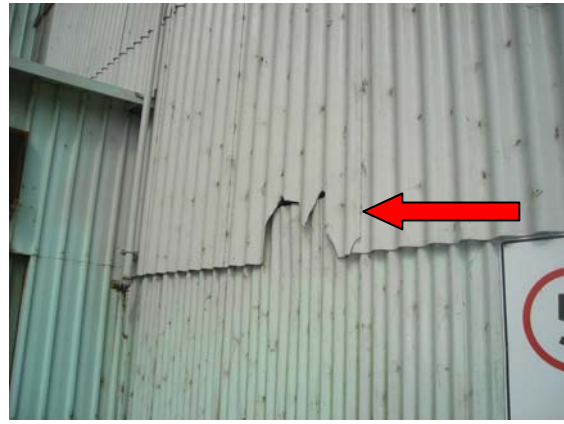
**Photo 2.** Area 1: Building 3, Critical Inventory Store, External Walls - Asbestos containing corrugated fibre cement sheeting

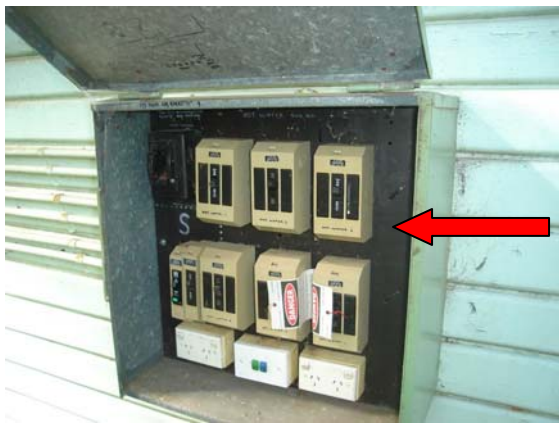
**Photo 3.** Area 1: Building 4, Administration, External, Northern Wall, Switch Board – Suspected asbestos containing electrical backing board

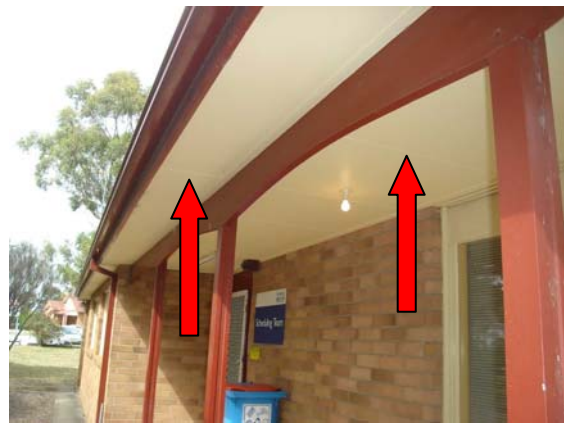
**Photo 4.** Area 3: Building 4, Scheduling Team Office, External, Awning & Eaves – Asbestos containing fibre cement sheeting

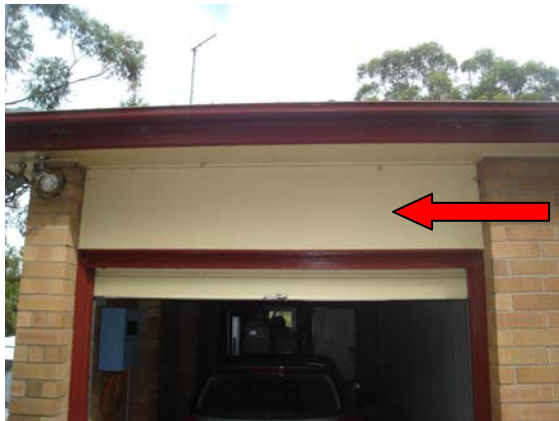
**Photo 5.** Area 3: Building 4, Scheduling Team Office, External, Above Roller Door, Infill Panel – Asbestos containing fibre cement sheeting

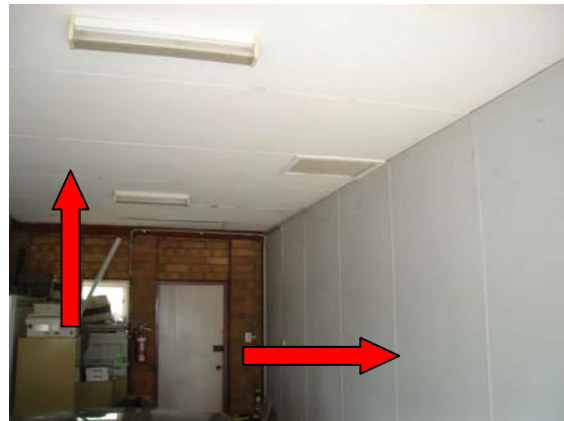
**Photo 6.** Area 3: Building 4, Scheduling Team Internal, Garage, Ceiling & Walls – Asbestos containing fibre cement sheeting

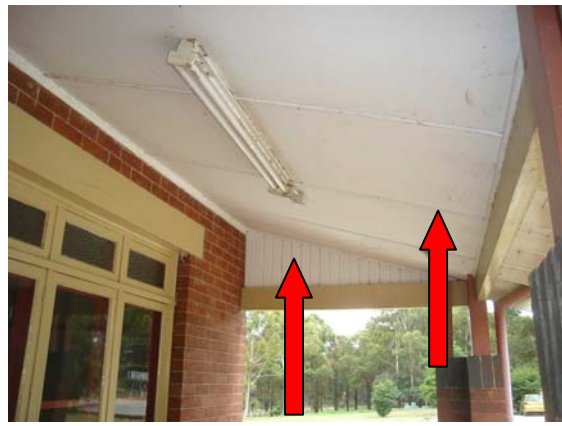
**Photo 7.** Area 3: Building 5, OH&S Team Office, External, Awning & Gable Ends – Asbestos containing fibre cement sheeting

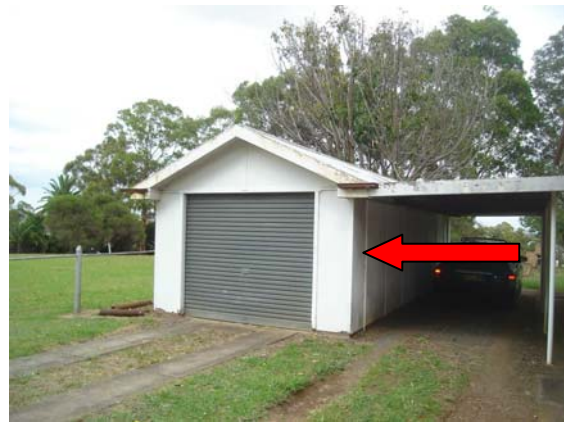
**Photo 8.** Area 3: Building 7, Garage, External Walls – Asbestos containing fibre cement sheeting

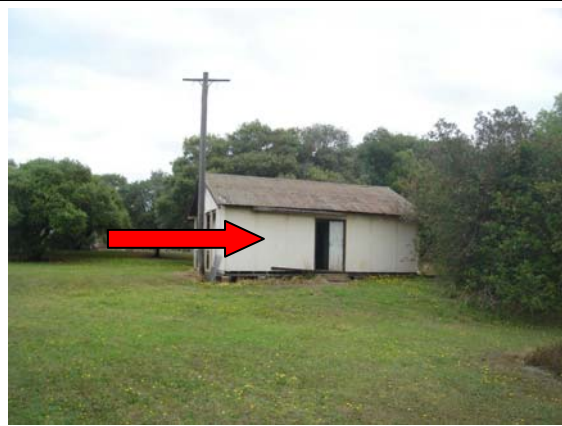
**Photo 9.** Area 4: Building 1, Dilapidated, External Walls – Asbestos containing fibre cement sheeting

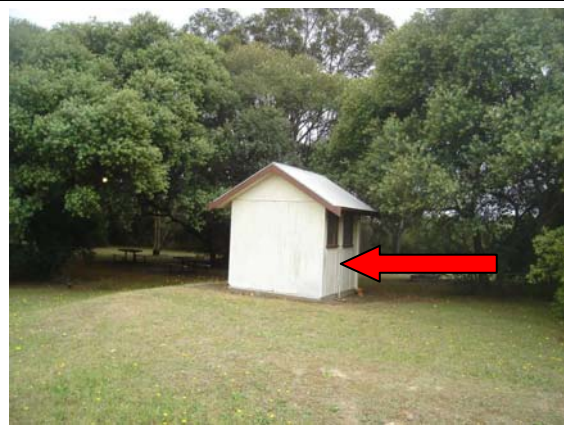
**Photo 10.** Area 4: Building 2, Amenities Block, External Walls – Asbestos containing fibre cement sheeting

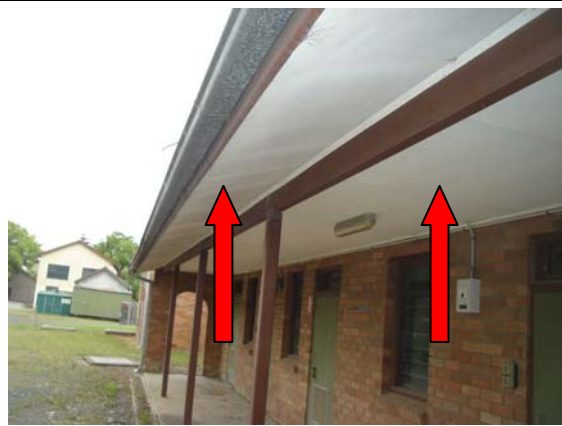
**Photo 11.** Area 5: Building 2, Suction Well, External, Awning & Eaves – Asbestos containing fibre cement sheeting

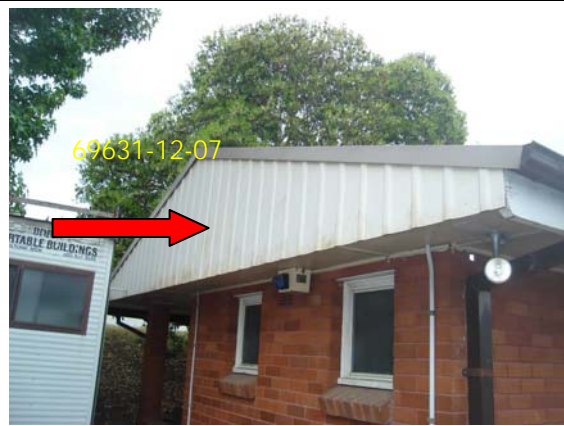
**Photo 12.** Area 6: Building 2, Offices, Gable Ends – Asbestos containing fibre cement sheeting

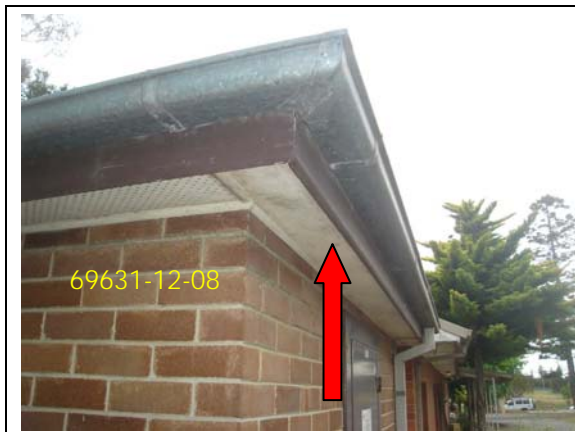
**Photo 13. Area 6:** Building 2, Offices, Attached Electrical Building, Eaves – Asbestos containing fibre cement sheeting

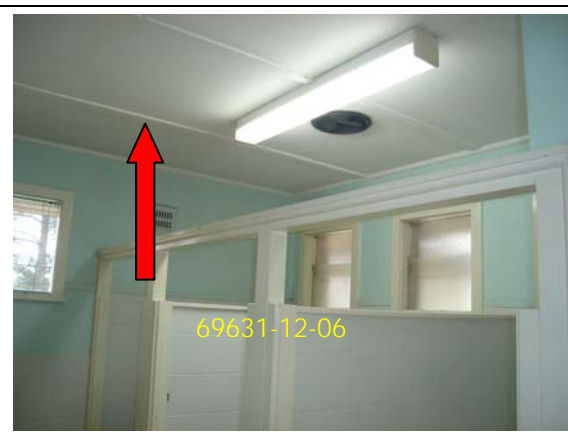
**Photo 14. Area 6:** Building 2, Offices, Toilet, Ceilings – Asbestos containing fibre cement sheeting

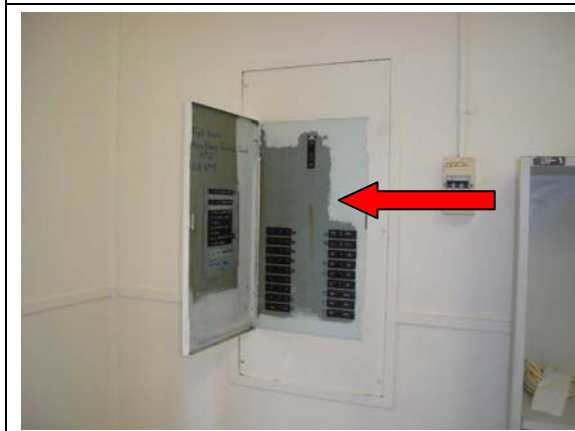
**Photo 15. Area 6:** Building 2, Offices, Conference Room – Suspected asbestos containing electrical backing board

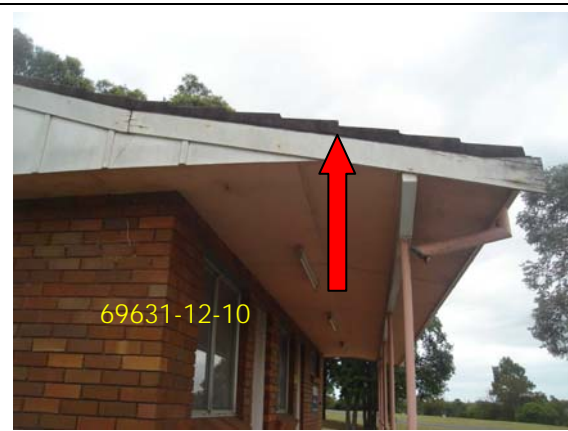
**Photo 16. Area 9:** Building 3, Re-chlorination Team Lab, Gable verge lining – Asbestos containing fibre cement sheeting

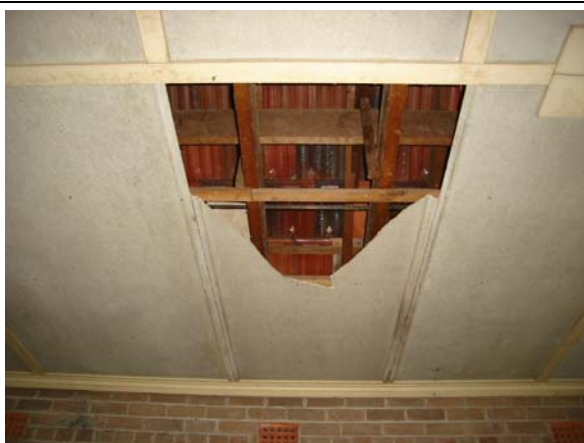
**Photo 1:** Beecroft Depot, Pump Room – Damaged ceiling sheet

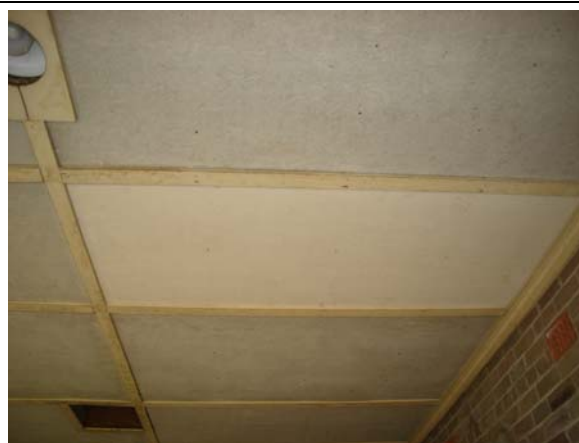
**Photo 2:** Beecroft Depot, Pump Room – Damaged ceiling sheet removed and replaced with a non-asbestos containing sheet

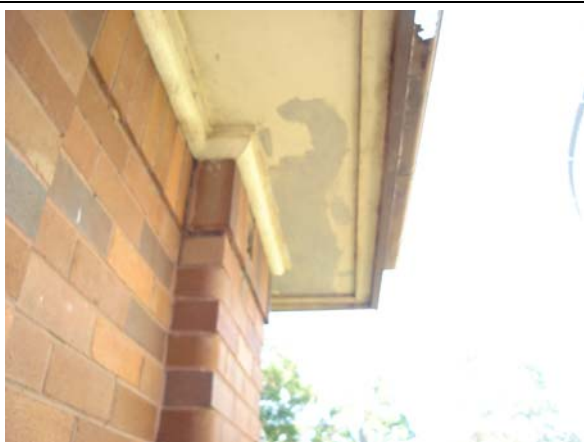
**Photo 3:** Beecroft Depot, Pump Room – Damaged eave sheet encapsulated (sealed) with grey paint

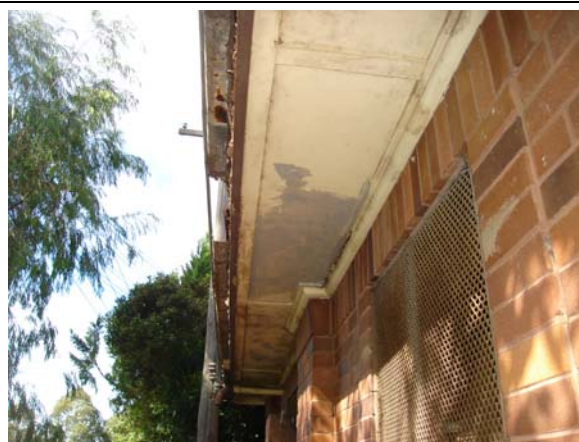
**Photo 4:** Beecroft Depot, Pump Room – Damaged eave sheets encapsulated (sealed) with grey paint

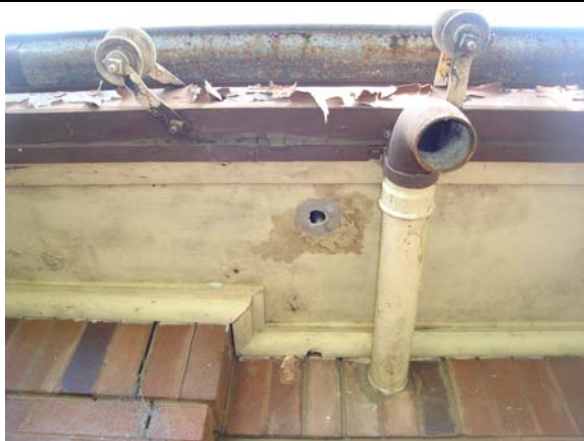
**Photo 5:** Beecroft Depot, Pump Room – Damaged eave sheet encapsulated (sealed) with grey paint
