Hazardous Substances Audit

17 O'Riordan Street Green
Square, Alexandria NSW
Final

for Goodman International Limited

August 2008

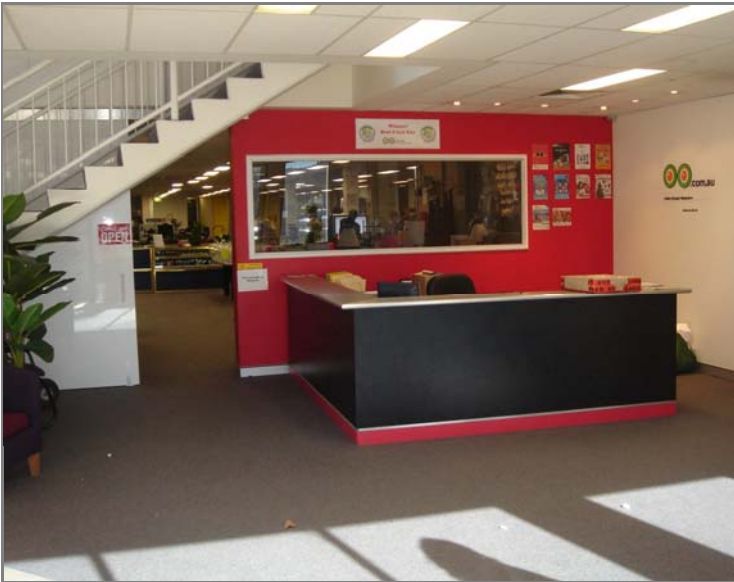
Photograph 1

View foyer and stairwell.

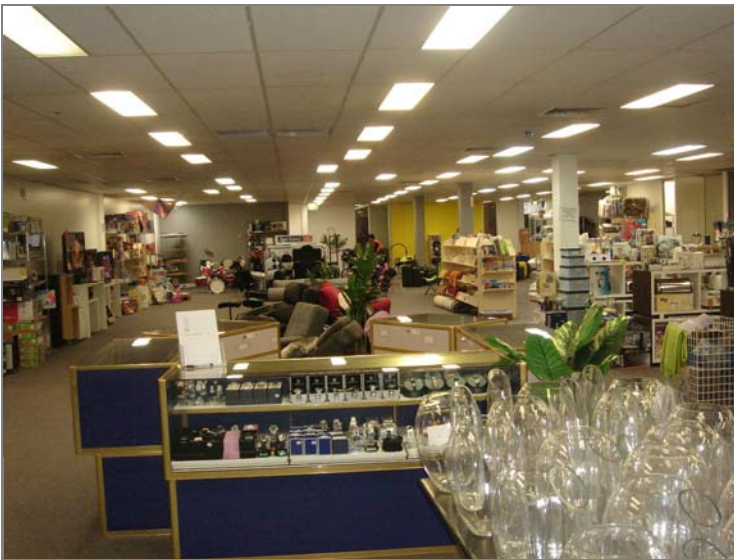
Photograph 2

View of display room.

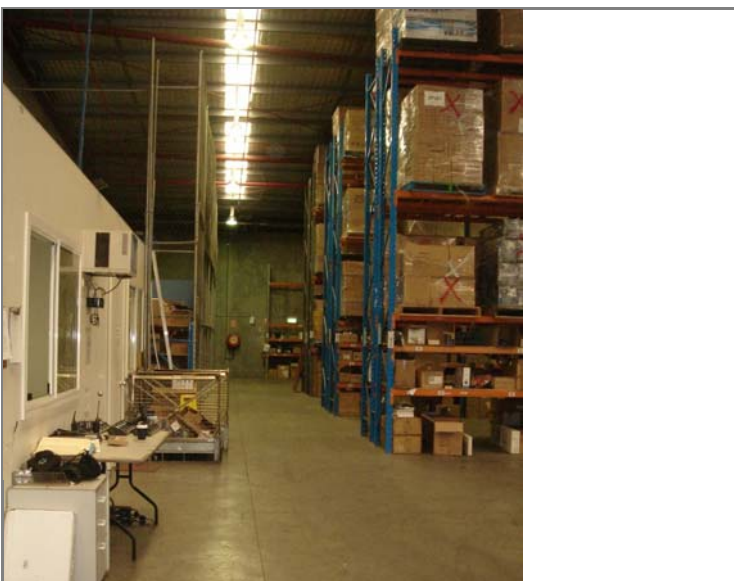
Photograph 3

View of warehouse office.

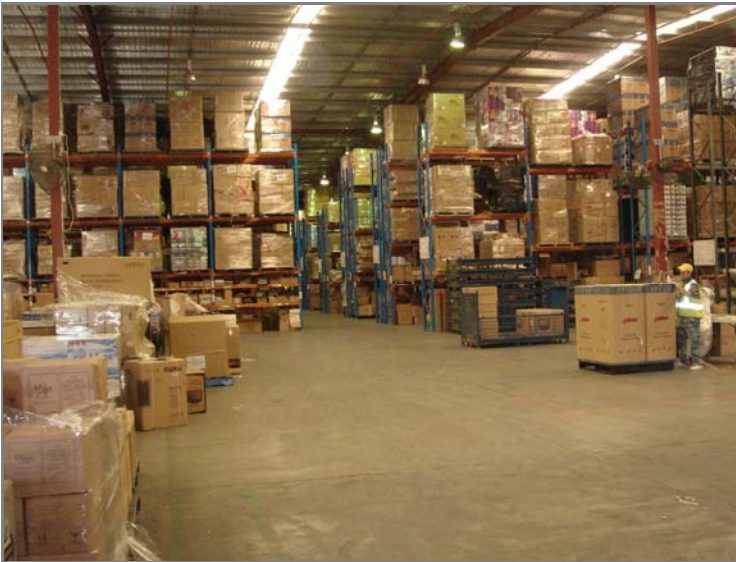
Photograph 4

View of warehouse pallet racks.

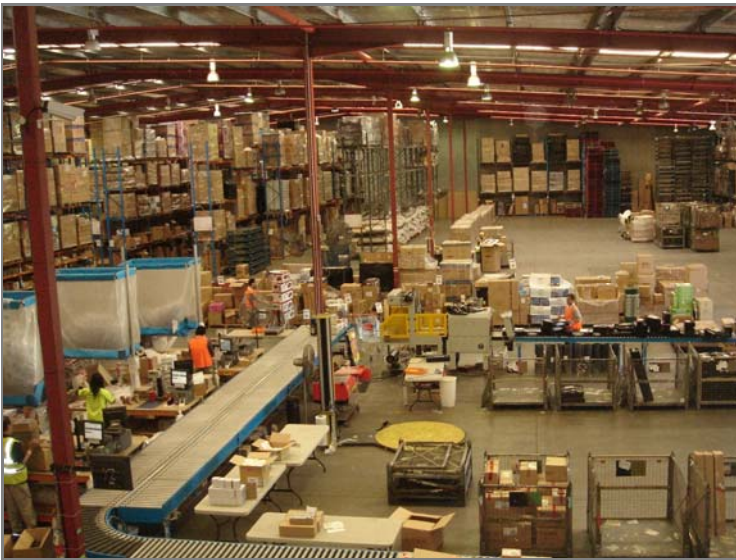
Photograph 5

View of delivery/dispatch bay.

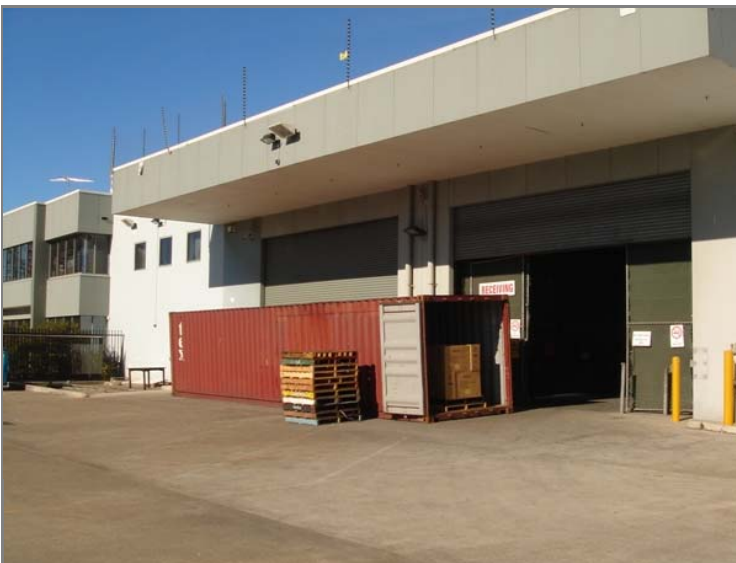
Area	Observations	Sample results	Photographs
Roof	No potentially hazardous substances observed	No samples collected	Photograph 6
Walls	No potentially hazardous substances observed.	No samples collected	
Eaves	No potentially hazardous substances observed.	No samples collected

View of warehouse exterior.

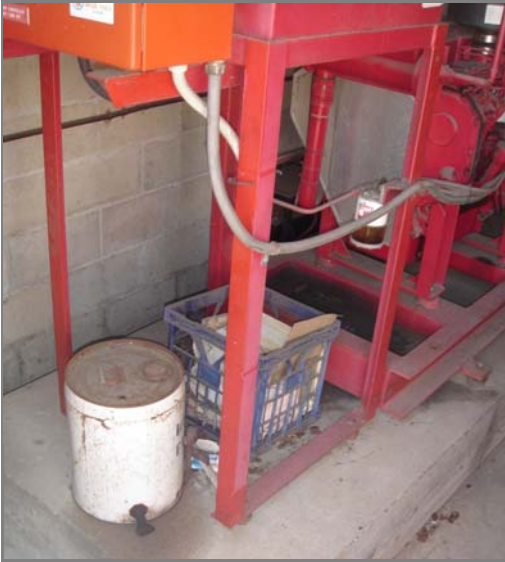
Area	Observations	Sample results	Photographs
Fire Suppression Shed	No potentially hazardous substances observed in shed proper. Diesel used to power emergency generator (less than 200L stored on site)	No samples collected	Photograph 7 Photograph 8

View inside of fire suppression shed.

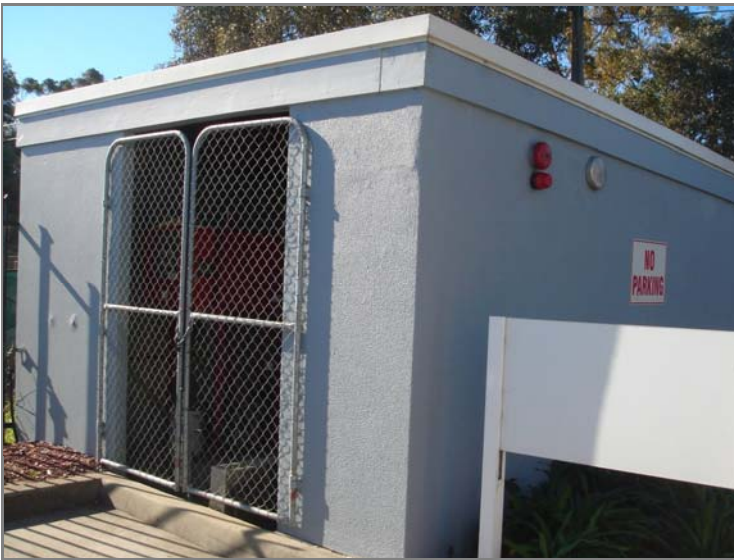
Photograph 8

View of fire suppression shed.
