# **Preliminary Environmental Site Assessment**

17 O'Riordon St, Green  
Square, Alexandria, NSW  
Final

for Goodman International Limited

J0086939RP01 FINAL

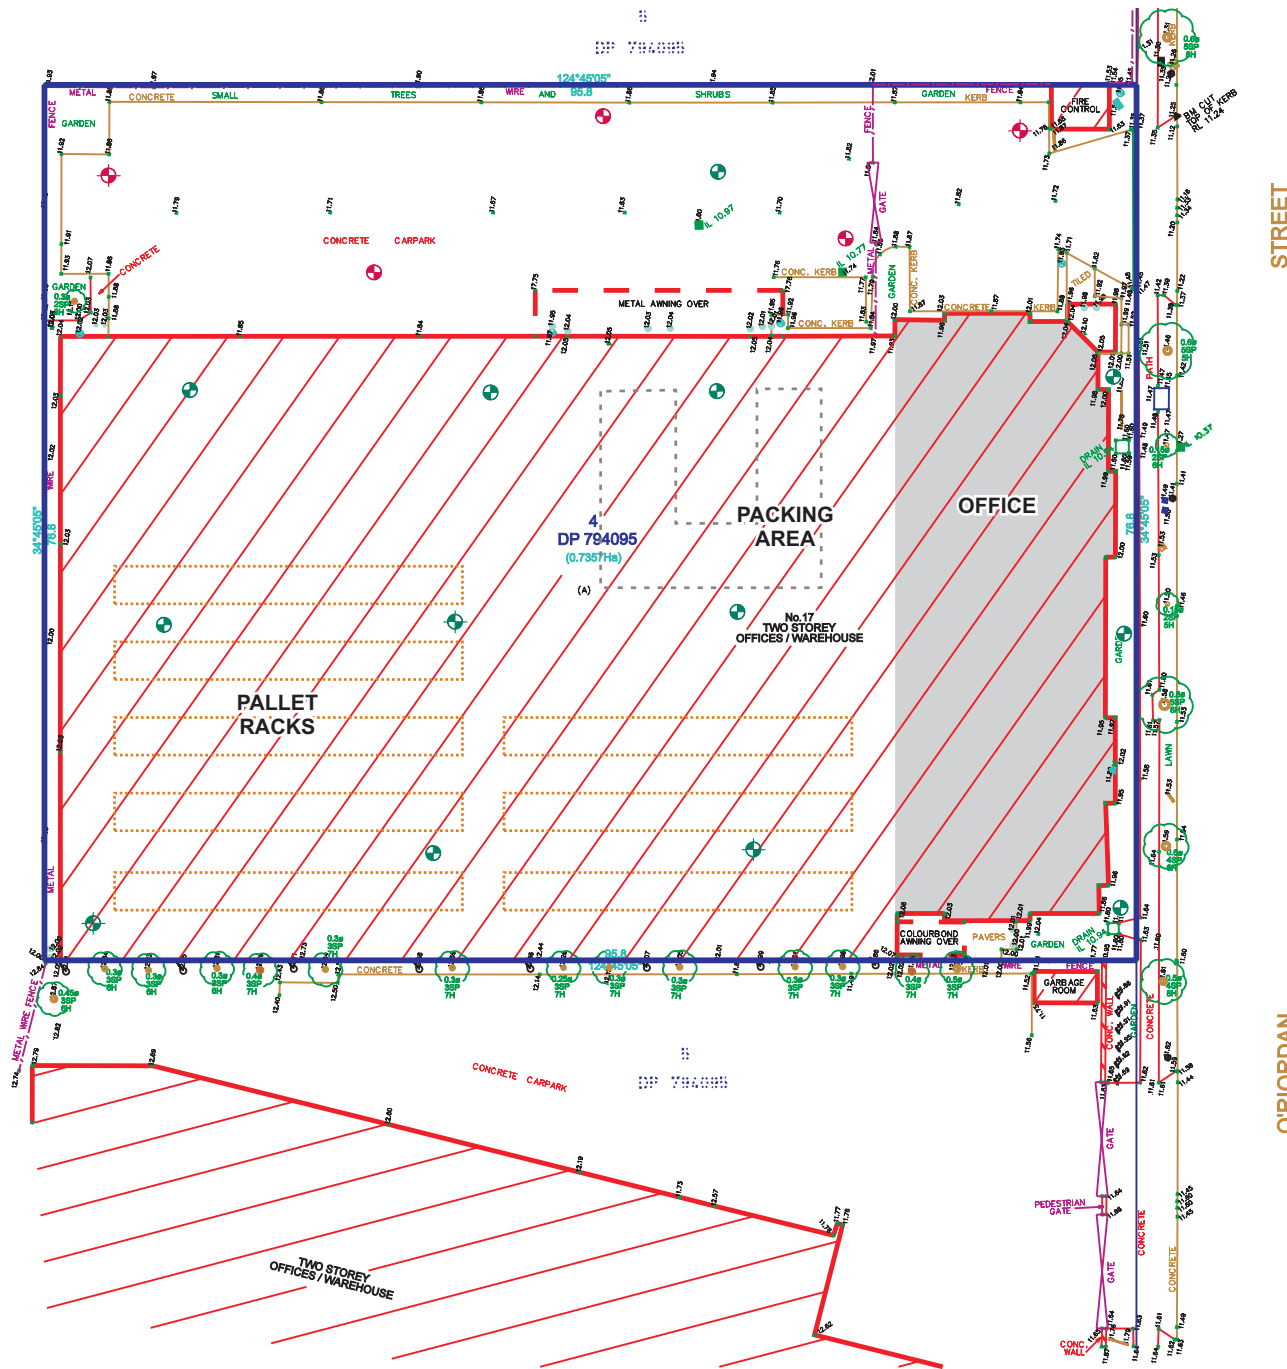
ERM proposes to advance up to 17 boreholes on the site to characterise subsurface conditions. In addition, groundwater monitoring wells will be installed in six of the 17 proposed boreholes. *Figure 3 of Annex A* illustrates the location of the proposed borehole/monitoring well locations. The following activities are proposed as part of this task:

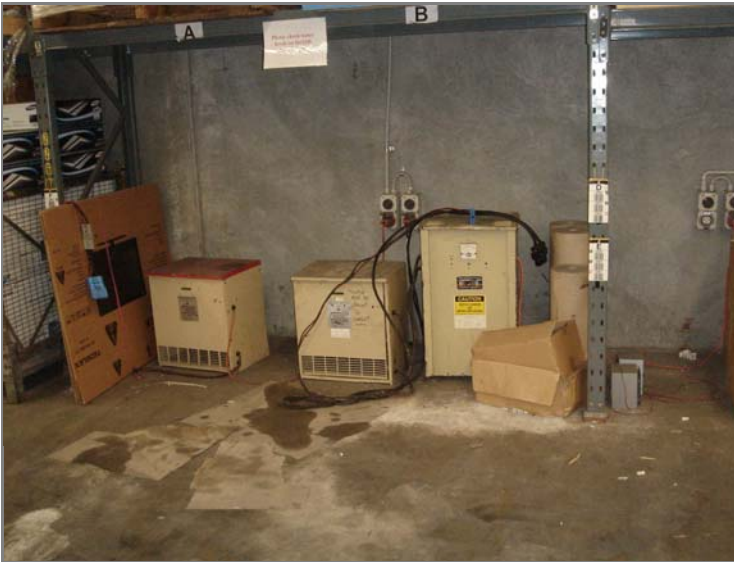
Photograph 4

Staining on the warehouse floor surrounding the forklift battery recharge area.

- Forklifts on site are electrically operated. It was not possible to confirm the state of the recharge area or assess the number of, or condition of, battery storage during the site inspection. It is recommended that confirmation be sought.*

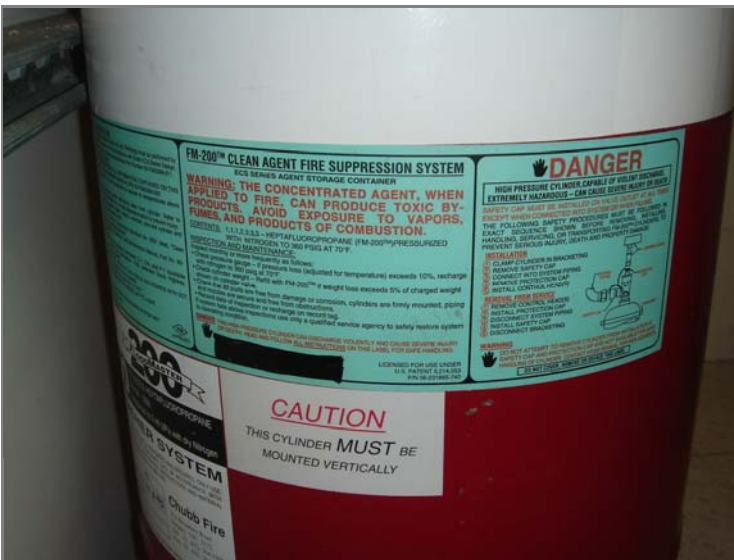
Photograph 5

Gas cylinder containing heptafluoropropane, which was used as a fire suppressant within the computer server room.

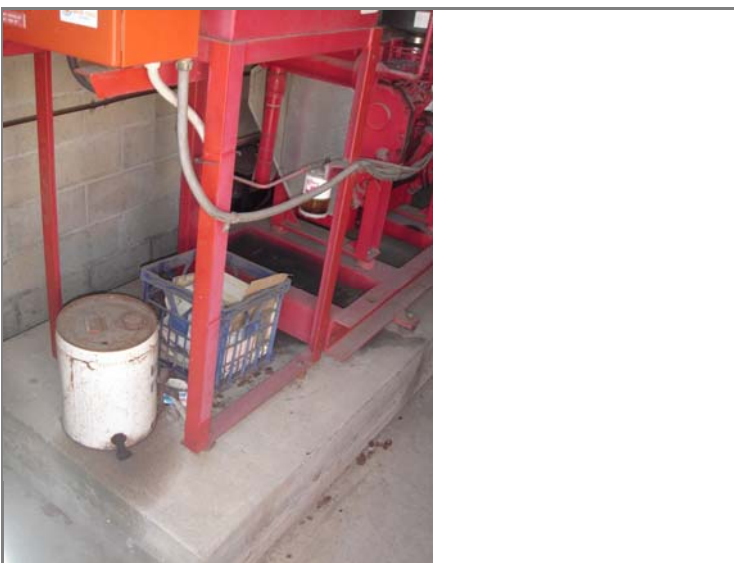
Photograph 6

- potential spills or leaks from the 200 L diesel AST in the fire pump room;

200 litre aboveground storage diesel tank, used to power the emergency generator for the fire system.

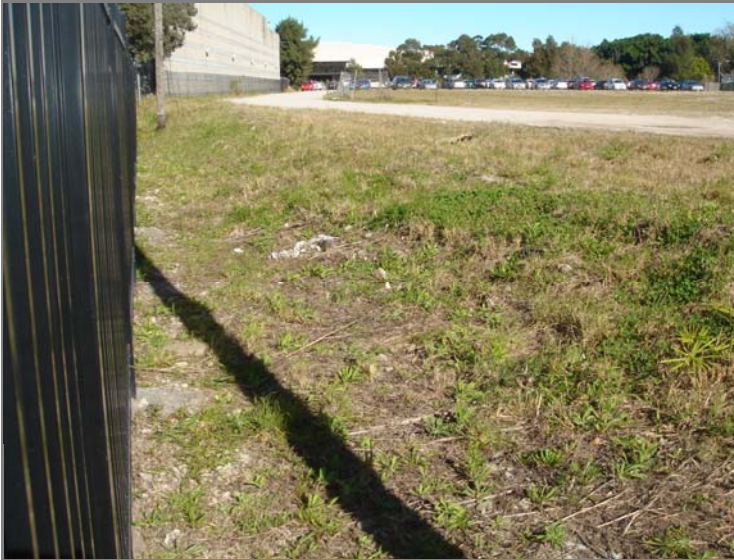
**Photograph 7**

- No new sources or evidence of asbestos containing material (ACM) were observed during the site visit. Although no ACM was observed within the uncontrolled fill, observed adjacent to the western boundary of the site its presence cannot be discounted.

Uncontrolled fill adjacent to the western boundary of the site.

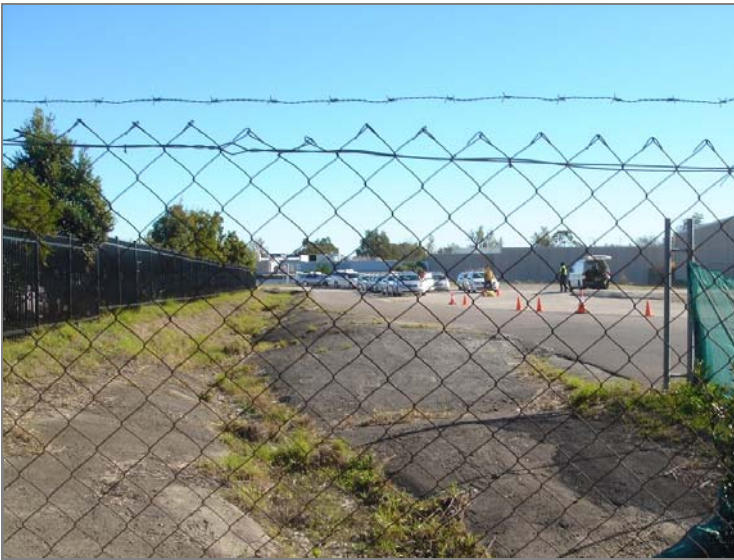
**Photograph 8**

- North: Adjacent to the site is a vacant lot which appears to be utilised by several taxis companies for parking (*Photograph 8, Annex A*). The majority of the area is partially sealed with bitumen or concrete, which appears to be in poor condition. It is understood that this lot was used to obtain access to the airport line rail tunnel, constructed in 2000. An unsealed, open drain also runs along the boundary, adjacent to the site. Beyond the vacant lot is a distribution warehouse occupied by Combines Communication Network.

Taxis car parking on the adjacent vacant block, to the north of the site.

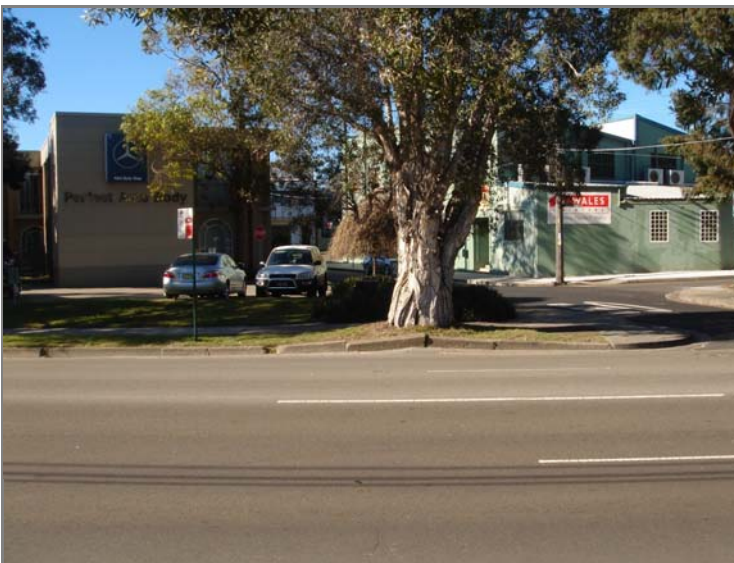
**Photograph 9**

- East: No changes were noted to the surrounding land use (*Photograph 9, Annex A*).
- South: Adjacent to the site is a modern office and warehouse storage and distribution facility occupied by True Alliance.

Surrounding properties to the east of the site.

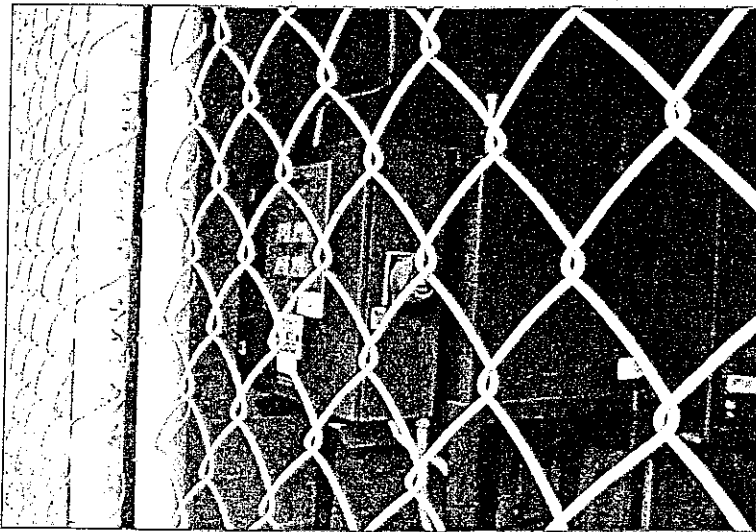
Photograph 2

Above ground storage tank (200L)  
in fire pump building  
(north eastern corner)

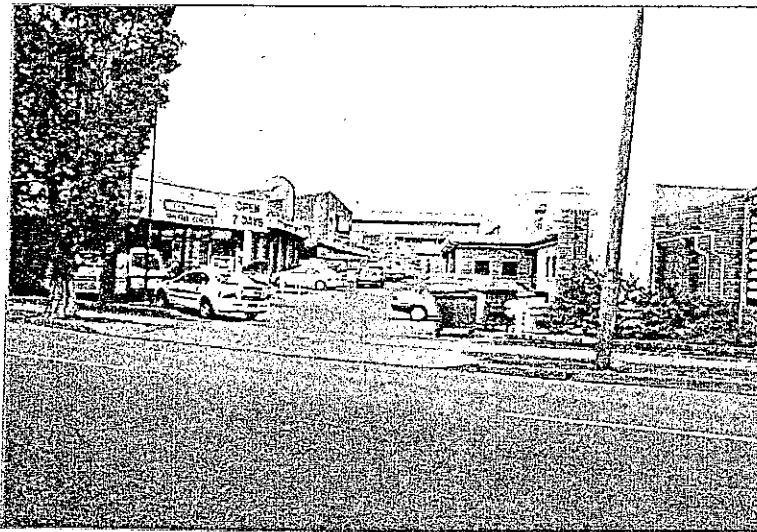
Photograph 5

Taxi centre and LPG tank located approx. 70 metres to north east of site across O'Riordan Street
