Report on
Geotechnical Investigation

Proposed Hornsby Hospital Redevelopment
Corner Palmerston and Lowe Roads, Hornsby

Prepared for
Health Infrastructure

Project 72247.00
February 2011

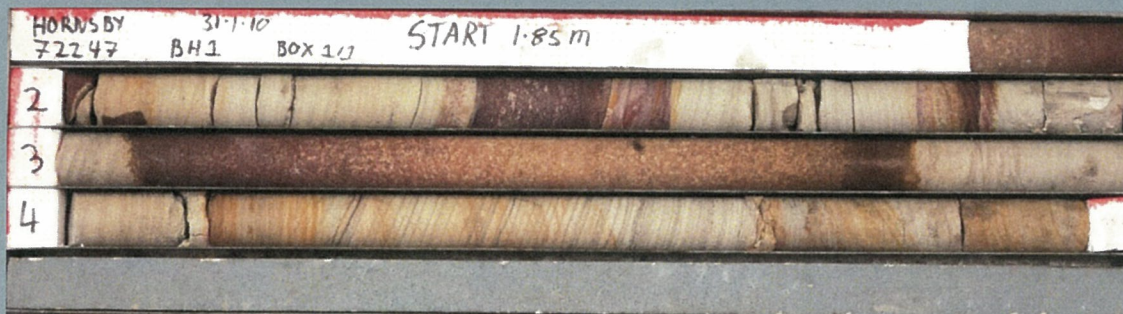
DOUGLAS PARTNERS PTY LTD
HORNSBY HOSPITAL REDEVELOPMENT - HORNSBY
BORE 1 PROJECT 72247 JAN 2011

1.85																									
175	2	SANDSTONE - high strength, moderately to slightly then slightly weathered, slightly fractured and unbroken, light grey brown to red brown, medium to coarse grained sandstone. Some very low strength bands																								PL(A) = 1.1

2.6-2.9m: medium strength sandstone																								
	3																									PL(A) = 0.7
174																										PL(A) = 1.1
	4																									
173																										PL(A) = 1.2

1.85 - 4.95m

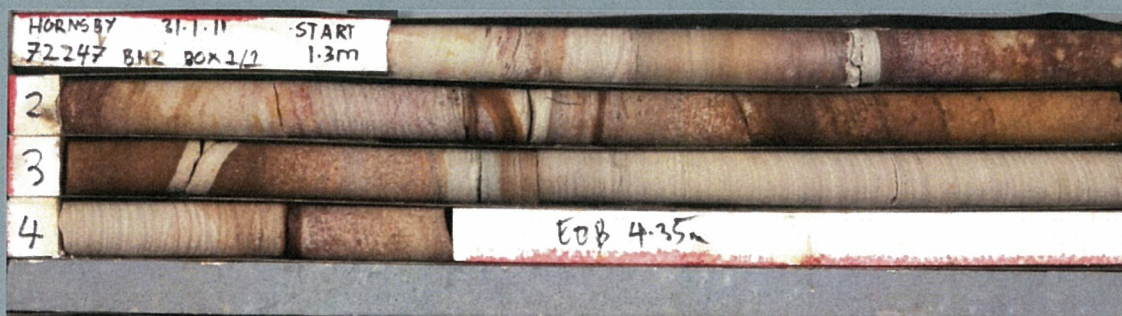
DOUGLAS PARTNERS PTY LTD
HORNSBY HOSPITAL REDEVELOPMENT - HORNSBY
BORE 2 PROJECT 72247 JAN 2011

1.3	SANDSTONE - extremely low strength, light grey brown, fine grained sandstone - very low strength at 1.1m																								10/50mm refusal
175	2	SANDSTONE - medium and high strength, moderately and slightly weathered, slightly fractured, light grey brown to red brown, medium to coarse grained sandstone																								PL(A) = 0.8
	3	2.65-2.85m: very high strength ironstone band																								PL(A) = 3.9
174	4	3.45-4.0m: fresh sandstone																								PL(A) = 0.8

1.3 - 4.35m

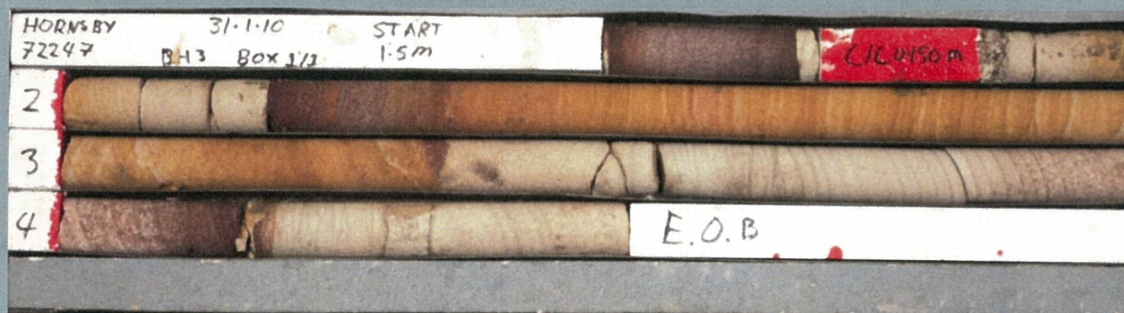
DOUGLAS PARTNERS PTY LTD
HORNSBY HOSPITAL REDEVELOPMENT - HORNSBY
BORE 3 PROJECT 72247 JAN 2011

1.5	SANDY CLAY - hard, light grey and yellow, fine to medium grained sandy clay with ironstone band (possible extremely low strength sandstone)															S			
176	1.85	SANDSTONE - high then medium strength, moderately and slightly weathered, slightly fractured and unbroken, light grey and brown, medium to coarse grained sandstone															C	95	91	PL(A) = 1.2
	2																			PL(A) = 1.2
	3																			PL(A) = 1.3
	4																			PL(A) = 0.8
173	4.5	Bore discontinued at 4.5m																		
	5																			
	6																			
	7																			
	8																			
169	9

1.5 – 4.5m

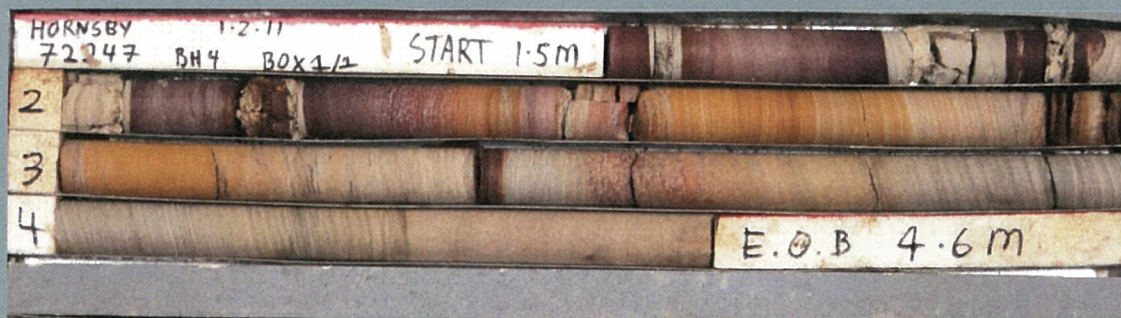
DOUGLAS PARTNERS PTY LTD
HORNSBY HOSPITAL REDEVELOPMENT - HORNSBY
BORE 4 PROJECT 72247 FEB 2011

1.5 – 4.6m

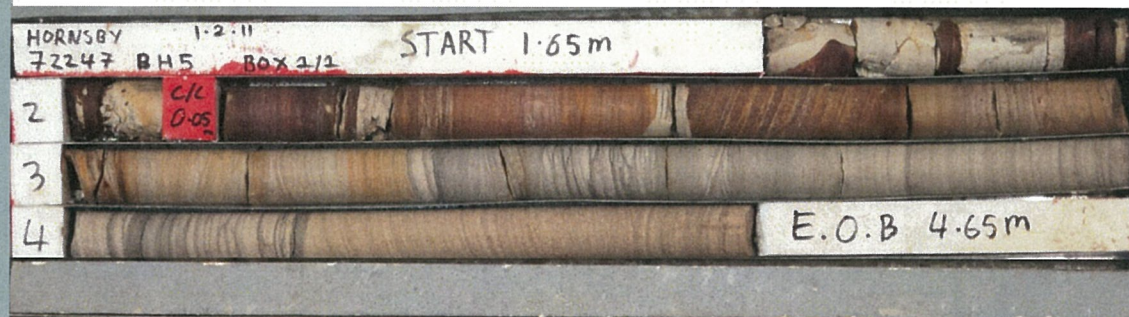
DOUGLAS PARTNERS PTY LTD
HORNSBY HOSPITAL REDEVELOPMENT- HORNSBY
BORE 5 PROJECT 72247 FEB 2011

1.65	SANDSTONE - alternate bands of very low and high strength, highly weathered, fractured, light grey and red brown, fine grained sandstone																								PL(A) = 0.2
2	2.15

2.3	SANDSTONE - medium strength, moderately and slightly weathered, slightly fractured, light grey brown, medium grained sandstone																								PL(A) = 0.4
3																										
174																										
4	4.0	SANDSTONE - high strength, fresh, slightly fractured, light grey, medium to coarse grained sandstone																								PL(A) = 0.7

1.65 - 4.65m
