## **Asbestos Materials Re-Inspection Report**

### **Northern Sydney Central Coast Area Health Service**

**Hornsby Ku-ring-gai Hospital  
Palmerston Road, Hornsby NSW**

#### **Building 6**

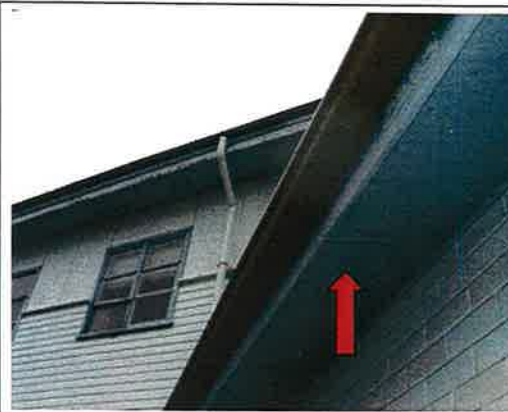
**Photo 55** Exterior, Godfrey Ward, Eaves – Asbestos containing fibre cement sheeting

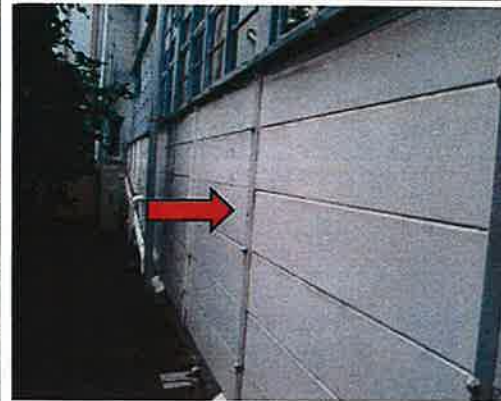
**Photo 56** Exterior, Storey Ward, Northern wall cladding below windows – Asbestos containing fibre cement sheeting

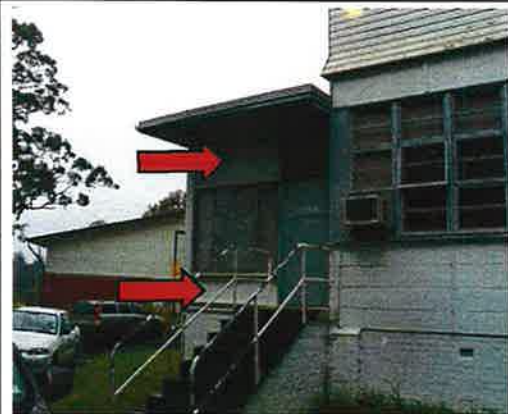
**Photo 57** Exterior, Storey Ward, Northern Annex, Fire exit, Infill panels above and below windows – Asbestos containing fibre cement sheeting

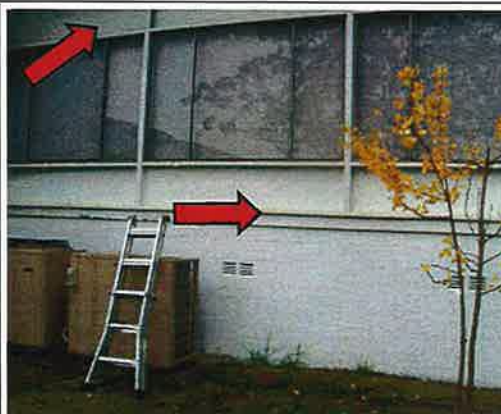
Eastern side, Nursing Unit entrance Infill panels above and below windows Fibre cement sheeting	Previously sampled by NAA 66419-6-11	Positive	58	~2m <sup>2</sup>	Good	Non-Friable	Low	Low	Jun 2011	4	Maintain in good condition. Remove by a licensed asbestos contractor prior to refurbishment/ demolition works.	Labelled Nov 2010

**Photo 58** Exterior, Eastern side, Nursing Unit entrance, Infill panels above and below windows – Asbestos containing fibre cement sheeting

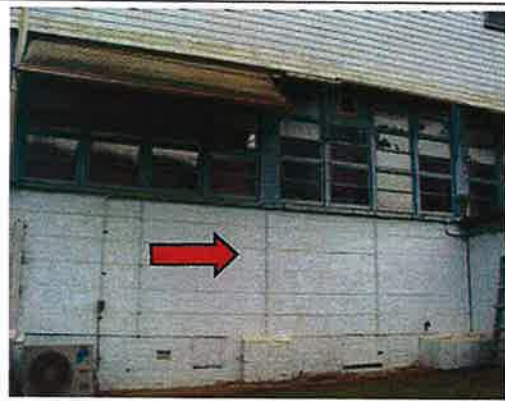
**Photo 59** Exterior, Delivery Ward, Fire exit, Infill panels – Asbestos containing fibre cement sheeting

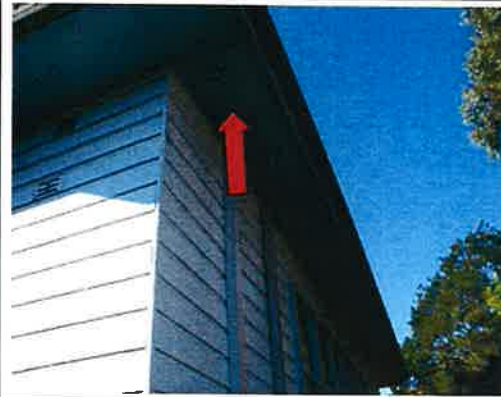
Western Entrance Awning Fibre cement sheeting	Previously sampled by NAA 34641-12	Negative	-	-	-	-	-	-	-	-	-	-
Surrounding Building Eaves Fibre cement sheeting *Not sampled due to height restrictions	-	Suspected Positive	60	>200m <sup>2</sup>	Good	Non-Friable	Low	Low	Jun 2011	4	Confirm status. Maintain in good condition. Remove by a licensed asbestos contractor prior to refurbishment/ demolition works.	Labelled Nov 2010

**Photo 60** Exterior, Surrounding Building, Eaves – Suspected asbestos containing fibre cement sheeting

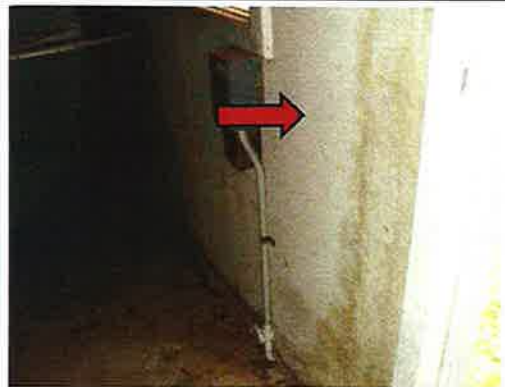
**Photo 61** Exterior, Ground Level, Eastern side, Wall cladding – Asbestos containing fibre cement sheeting

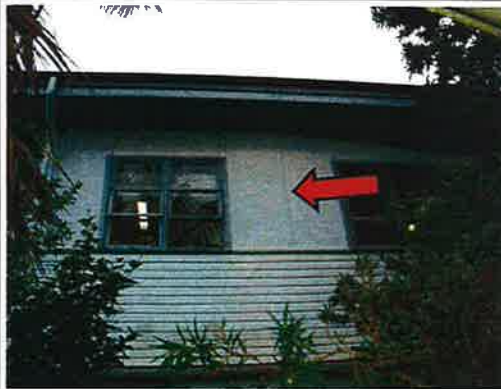
**Photo 62** Exterior, Level 1, Southern side, Wall cladding – Asbestos containing fibre cement sheeting

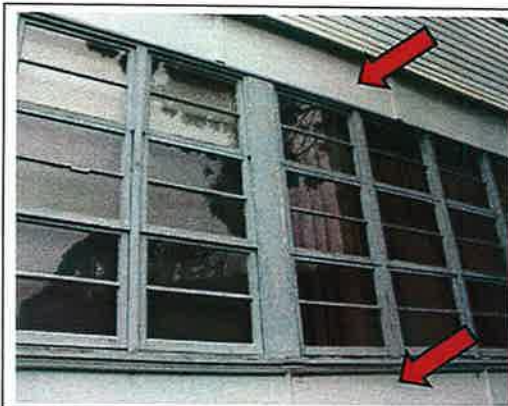
Surrounding Building Infill panels above and below windows Fibre cement sheeting	81691-41	Positive	63	~50m <sup>2</sup>	Good	Non-Friable	Low	Low	Jun 2011	4	Maintain in good condition. Remove by a licensed asbestos contractor prior to refurbishment/ demolition works.	Labelled Nov 2010
Central Annex Eaves Fibre cement sheeting	Previously sampled by NAA 34641-08	Positive	64	~25 m <sup>2</sup>	Good	Non-Friable	Low	Low	Jun 2011	4	Maintain in good condition. Remove by a licensed asbestos contractor prior to refurbishment/ demolition works.	Labelled Nov 2010

**Photo 63** Exterior, Surrounding Building, Infill panels above and below windows – Asbestos containing fibre cement sheeting

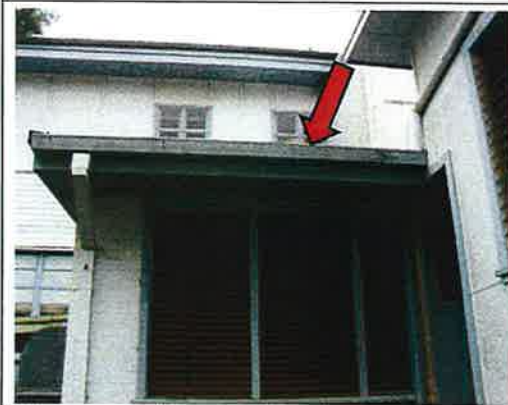
**Photo 65** Exterior, South eastern A/C Plant Room, Eastern guttering – Asbestos containing moulded fibre cement

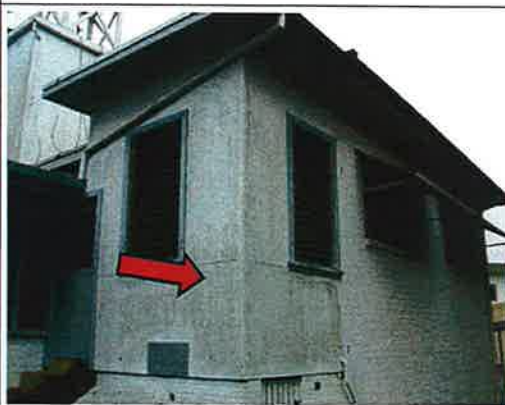
**Photo 66** Exterior, South eastern A/C Plant Room, Wall lining – Asbestos containing fibre cement sheeting

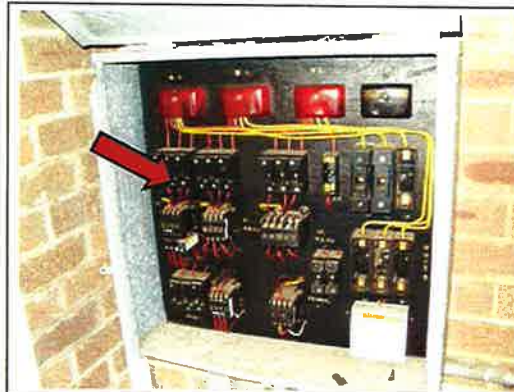
**Photo 67** Interior, South eastern A/C Plant Room, Upper Level  
Interior Northern wall, Electrical Distribution Panel – Asbestos containing electrical backing board

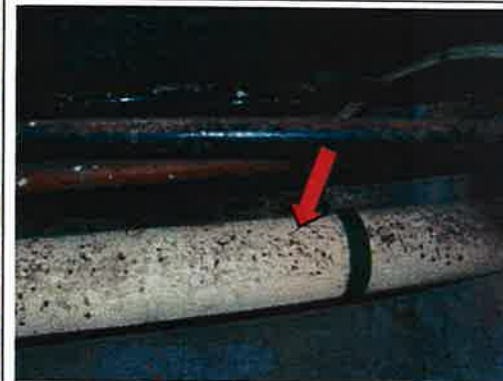
**Photo 68** Subfloor, Throughout, Pipe work – Asbestos containing pipe lagging

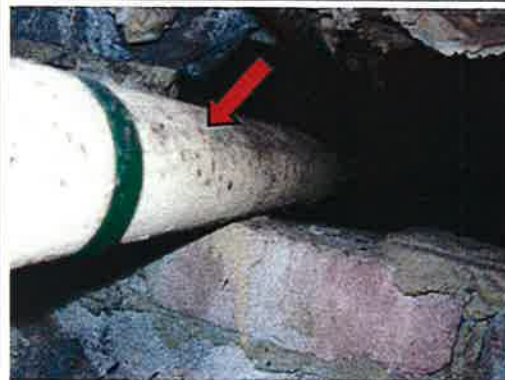
**Photo 69** Subfloor, Beneath Nursing Unit, Managers Office, Pipe work – Asbestos containing pipe lagging

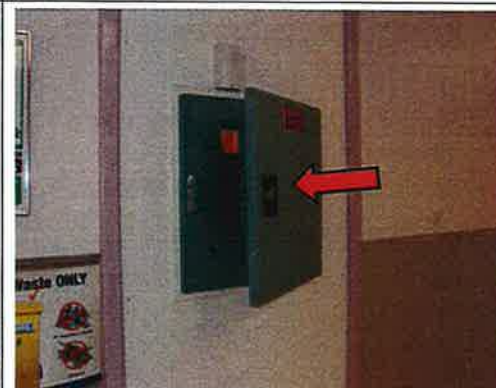
Beneath Old Nursing Unit Managers Office, adjacent Reception *No access at time of inspection.	-	-	-	-	-	-	-	-	-	-	-	-
<b>Interior - Ground Level</b>												
Throughout Electrical Distribution Cupboards Electrical backing board *Not sampled due to live electricity	-	Suspected Positive	70	~4 units	Good	Non-Friable	Low	Low	Jun 2011	4	Confirm status. Maintain in good condition. Remove by a licensed asbestos contractor prior to refurbishment/ demolition works.	Labelled Nov 2010

**Photo 70** Interior, Ground Level, Throughout, Electrical Distribution Cupboards – Suspected asbestos containing electrical backing boards

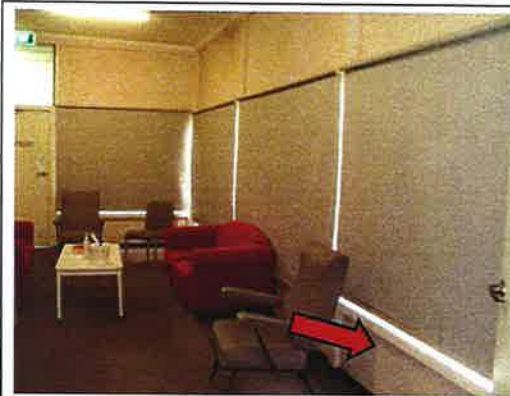
**Photo 71** Interior, Ground Level, Storey Ward, Eastern Lounge/Sunroom, Infill panels above and below windows – Asbestos containing fibre cement sheeting

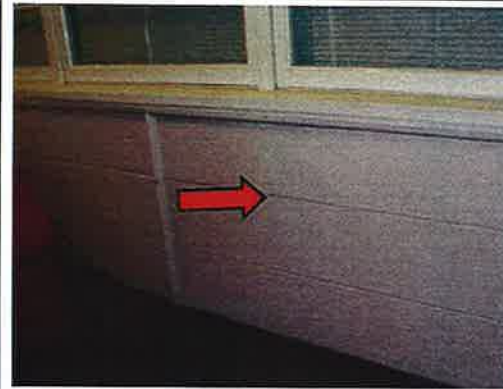
**Photo 72** Interior, Ground Level, Storey Ward, Eastern Lounge/Sunroom, Southern wall lining – Asbestos containing Fibre cement sheeting

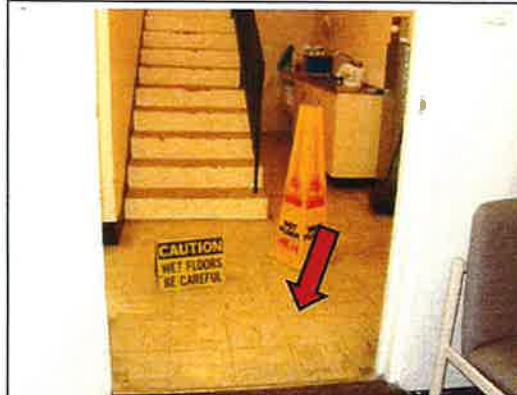
**Photo 73** Interior, Ground Level, Storey Ward, Eastern stairs, Flooring – Asbestos containing cream vinyl floor tiles

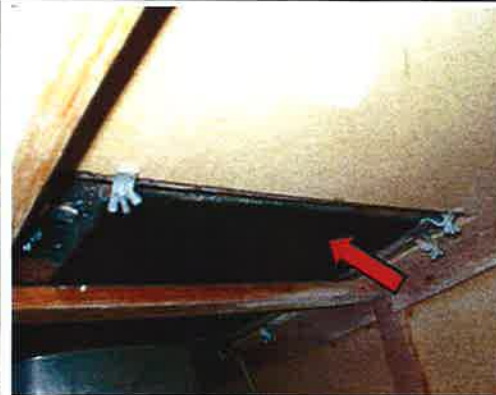
**Photo 74** Malcolm Ward, Kitchen, Sink pad – Asbestos containing bituminous adhesive attached to the upper-side of the sink pad

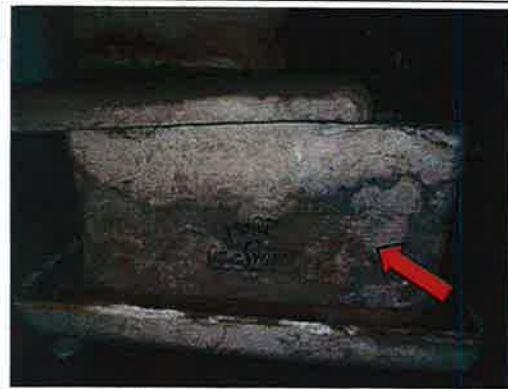
**Photo 75** Interior, ground Level, Birthing Unit, Eastern side of corridor, Office adjacent Room 1, Ceiling space, Toilet cistern - Asbestos containing moulded fibre cement

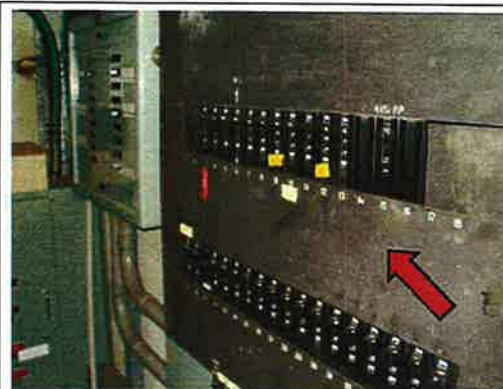
**Photo 76** Interior, Ground Level, Godfrey Ward, Electrical Switch Room, Beneath northern stairs, Electrical Distribution Panels - Suspected asbestos containing electrical backing boards

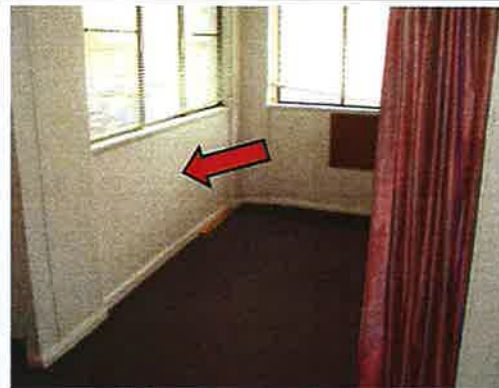
**Photo 77** Interior, Ground Level, Storey Ward, Room 11, Infill panels below window - Asbestos containing fibre cement sheeting

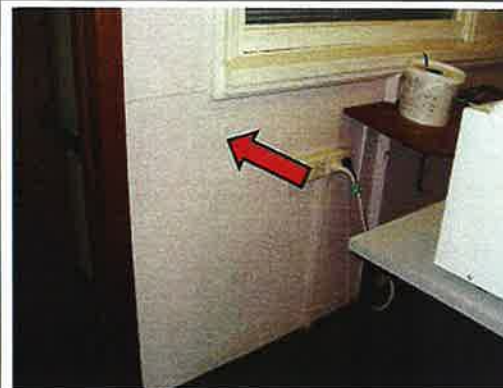
**Photo 78** Interior, Ground Level, Storey Ward, Kitchen area adjacent door, Wall lining - Asbestos containing fibre cement sheeting

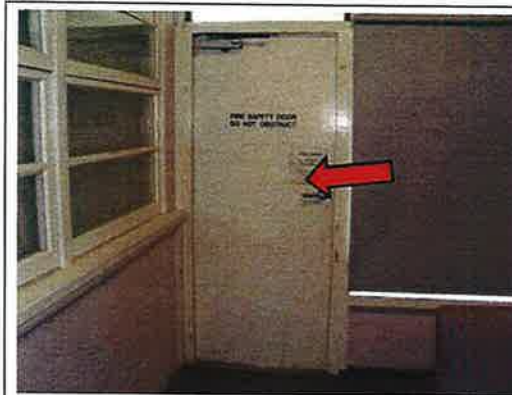
Staff area, Surrounding Doorways Wall lining Fibre cement sheeting	Previously sampled by NAA 34641-10	Negative	-	-	-	-	-	-	-	-	-	
Corridors, Throughout Fire doors Core insulation *Not sampled due to encapsulation of material	-	Suspected Positive	79	~20 units	Good	Friable	Med	Low	Jun 2011	3	Confirm status. Maintain in good condition. Remove by a AS-1 licensed asbestos contractor prior to refurbishment/ demolition works	Labelled Nov 2010
Godfrey Ward, Adjacent entrance to Malcolm Ward Flooring at fire stairs Grey vinyl floor tiles	Previously sampled by NAA 66419-6-07A	Positive	80	~3m <sup>2</sup>	Good	Non-Friable	Low	Low	Jun 2011	4	Maintain in good condition. Remove by a licensed asbestos contractor prior to refurbishment/ demolition works.	Labelled Nov 2010

**Photo 79** Interior, Ground Level, Corridors, Throughout, Fire doors – Suspected asbestos containing core insulation

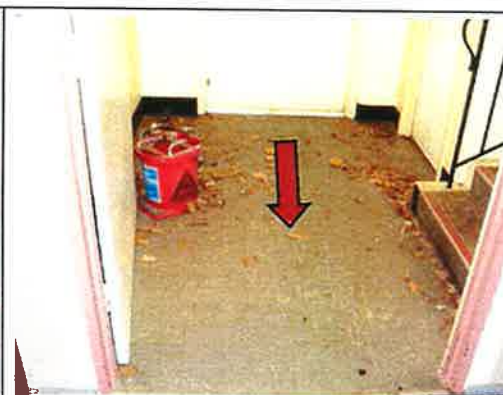
**Photo 80** Interior, Ground Level, Godfrey Ward, Adjacent entrance to Malcolm Ward, Flooring at fire stairs – Asbestos containing grey vinyl floor tiles

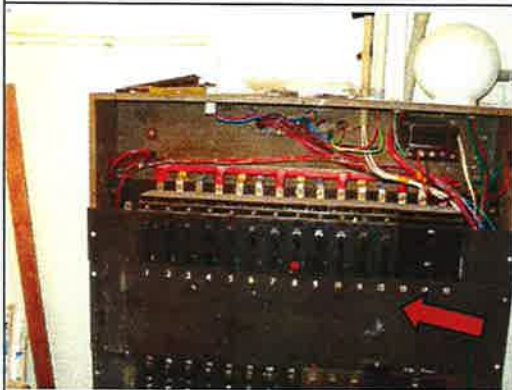
**Photo 81** Interior, Ground Level, Southern entrance, Beneath stairs, Electrical Distribution Panel – Suspected asbestos containing electrical backing board

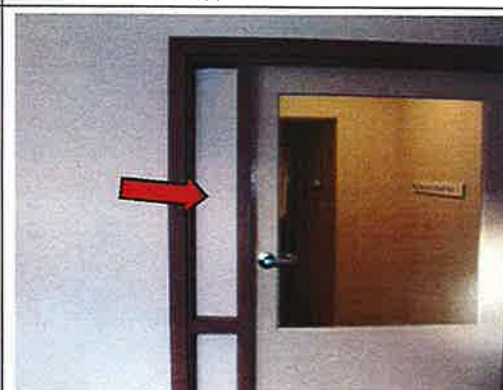
<b>Interior – Level 1</b>												
Southern entrance door Vertical infill panel Fibre cement sheeting	Previously sampled by NAA 34641-01	Positive	82	~2m <sup>2</sup>	Good	Non-Friable	Low	Low	Jun 2011	4	Maintain in good condition. Remove by a licensed asbestos contractor prior to refurbishment/ demolition works.	Labelled Nov 2010
Counselling, Kitchen Flooring Vinyl floor tiles	Previously sampled by NAA 34641-02	Negative	-	-	-	-	-	-	-	-	-

**Photo 82** Interior, Level 1, Southern entrance door, Vertical infill panel - Asbestos containing fibre cement sheeting

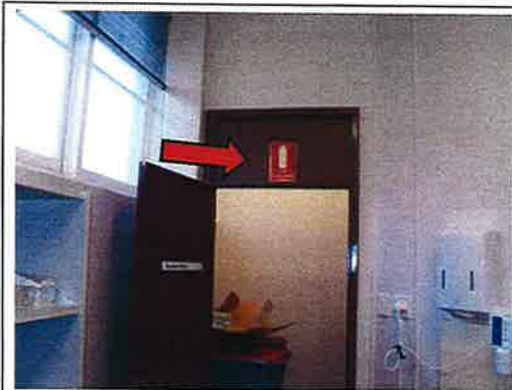
**Photo 83** Interior, Level 1, Throughout, Infill panels above doors – Asbestos containing fibre cement sheeting

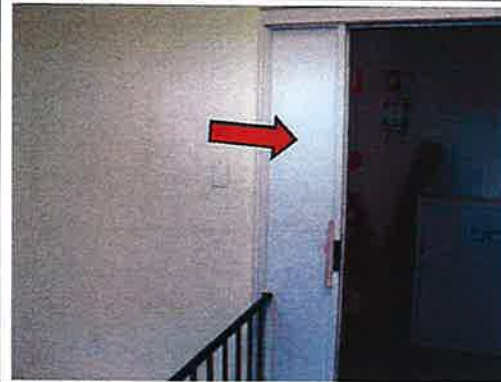
**Photo 84** Interior, Level 1, Northern fire stairs, Infill panel beside door – Asbestos containing fibre cement sheeting

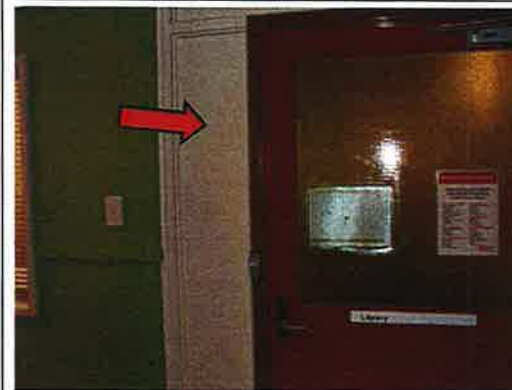
**Photo 85** Interior, Level 1, Library, Entrance door, Infill panels adjacent and above door – Asbestos containing fibre cement sheeting

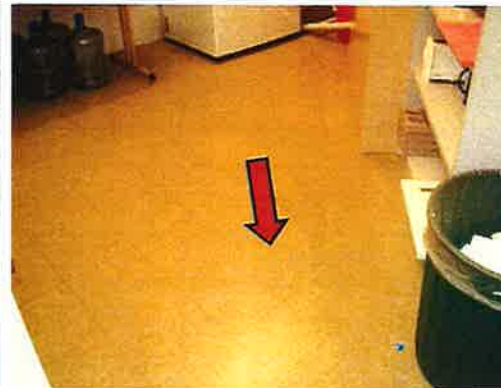
**Photo 86** Interior, Level 1, USYD Kitchen Flooring – Asbestos containing green vinyl floor tiles

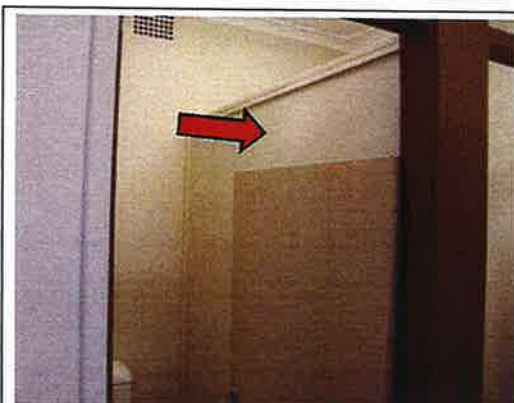
**Photo 87** Interior, Level 1, Toilet cubicles, Wall panels – Asbestos containing fibre cement sheeting

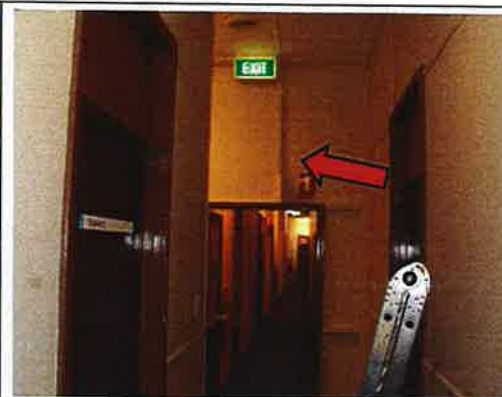
USYD, Northern doorway Wall lining Fibre cement sheeting	Previously sampled by NAA Same as 34641-01	Assumed Positive	88	~4m <sup>2</sup>	Good	Non-Friable	Low	Low	Jun 2011	4	Maintain in good condition. Remove by a licensed asbestos contractor prior to refurbishment/ demolition works.	Labelled Nov 2010

**Photo 88** Interior, Level 1, USYD, Northern doorway, Wall lining – Asbestos containing fibre cement sheeting
