# Arborist's Report

**ARBORISTS REPORT: 266 WINDSOR ROAD, BAULKHAM HILLS**  
**VEGETATION ON PROPERTY FRONTAGE**

**Prepared for: LEIGHTON CONTRACTORS PTY LIMITED**

**DECEMBER 2009**

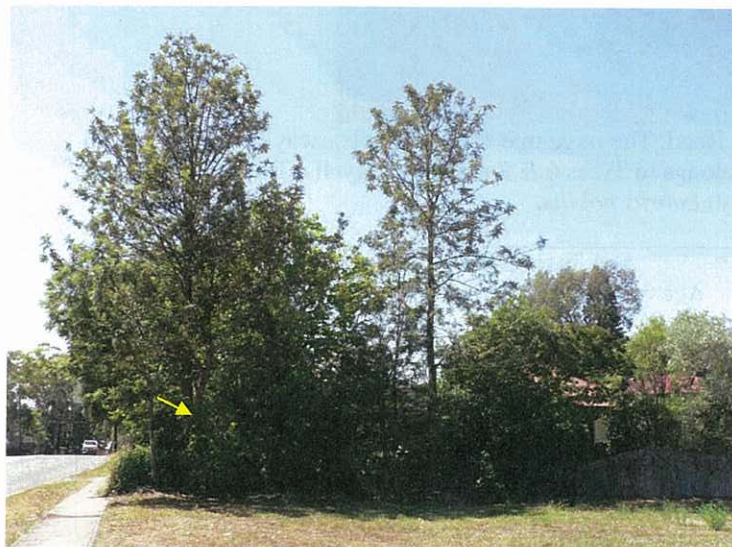
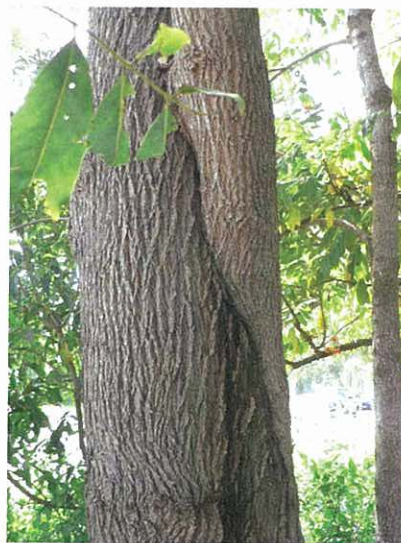
no	Species *provenance	H x R in m	Age, inspection comments Age code: Y = Young, EM = Early-mature M = Mature, A = Aged, S = Senile	SULE rating
1	<i>Grevillea robusta</i> <b>Silky Oak</b> * coastal r/f Nth NSW-Qld	11 x 5	EM: canopy healthy, primary trunk has a suspect narrow fork with fissure & sap bleed, (see photo below)	2d
2	<i>Castanospermum australe</i> <b>Black Bean</b> *coastal, Nth NSW & Qld	8.5 x 4.5	M: callused branch stubs, limited small dead wood, healthy	1
3	<i>Grevillea robusta</i>	11 x 3.5	Y: OK	1
4	<i>Pittosporum undulatum</i> <b>Native Daphne</b> * native inc. locally	6 x 3	EM: OK	2

View of trees 1 to 4 lining the northwest boundary of the property. The tall trees are Silky Oaks 1 & 3, the broad tree on the left is the Black Bean T.2. The right photo shows the suspect trunk fork on Silky Oak T. 1 (location arrowed in left photo).

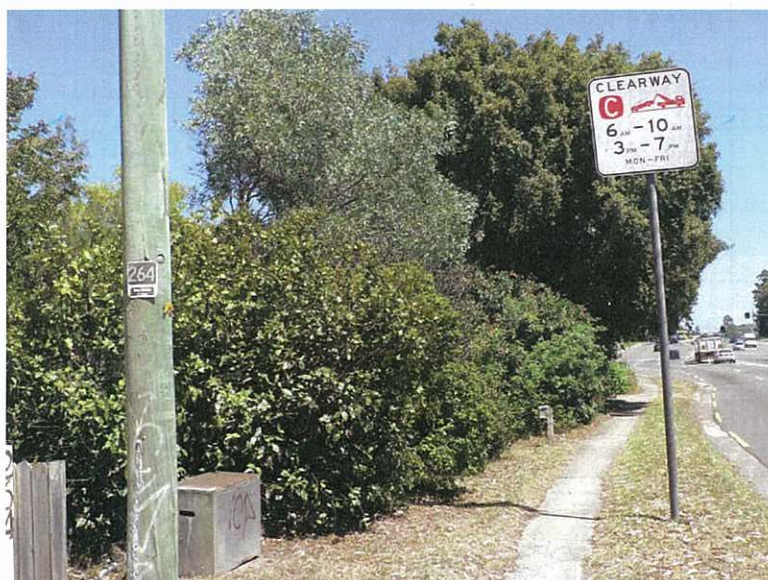
no	Species *provenance	H x R in m	Age, inspection comments Age code: Y = Young, EM = Early-mature M = Mature, A = Aged, S = Senile	SULE rating
5	<i>Syzygium paniculatum</i> <b>Brush Cherry</b> * native inc. regionally (uncommon)	9.5 x 5	<b>M:</b> multi-trunked at base, the trunk forks presently sound, tree healthy	2
6	<i>Acacia binervia</i> <b>Coast Myall</b> * native inc. regionally	6.7 x 2	<b>M:</b> leans to NE about 20°, healthy	2
7	<i>Acacia binervia</i>	7 x 2	<b>EM:</b> twiggy dieback on SW side	2

Southeast view of Trees 5, 6, 7 from Windsor Road. The large tree behind the clearway sign is the Brush Cherry (T. 5). The central blue-grey foliage belongs to Trees 6 & 7 the Coast Myalls. The shrub border in the foreground is hedged Bay Tree (Sweet Bay) *Laurus nobilis*.

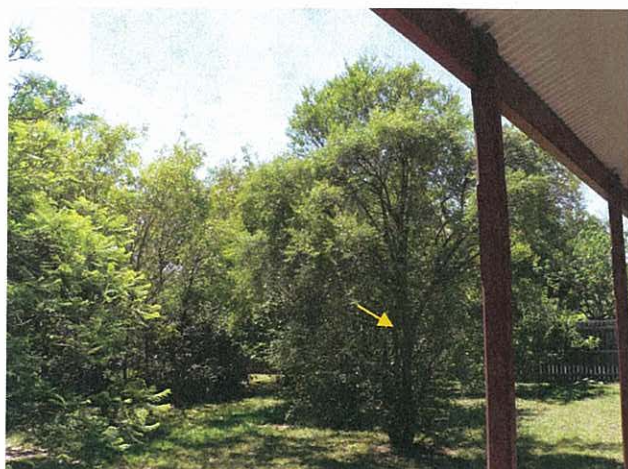
no	Species *provenance	H x R in m	Age, inspection comments Age code: Y = Young, EM = Early-mature M = Mature, A = Aged, S = Senile	SULE rating
8	<i>Callistemon salignus</i> <b>Willow Bottlebrush</b> * native inc. regionally	5 x 2	<b>Y:</b> (shrublike) limited twiggy dieback lower 1.8m of trunks	2
9	<i>Lagerstroemia indica</i> <b>Crepe Myrtle</b> * Indian subcontinent & sth China	4.5 x 2.2	<b>M:</b> lopped at ~ 1.4 m, decay where lopped, upper branches are all watershoots (epicormics) growing from the lopped stubs. Photo next page.	2(3)
10	<i>Leptospermum petersonii</i> <b>Lemon Scented Tea Tree</b> * border ranges NE NSW-Sth Qld	5 x 2.5	<b>M:</b> shrublike, healthy	2

Right: View of trees 8, 9, 10 as seen from the verandah. The Lemon Scented Tea Tree (T. 10) is arrowed in the foreground

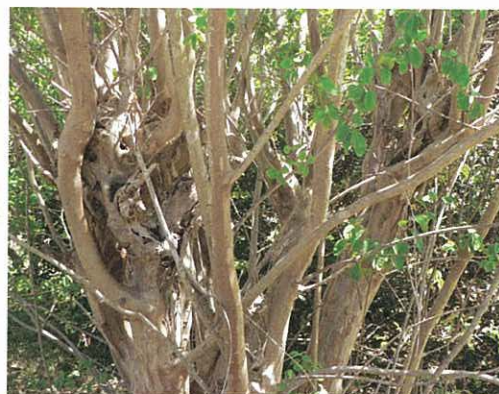
Left: effect of "lopping" on Crepe Myrtle T. 9

Lopping and topping: a structurally and pathologically destructive method of pruning trees. It is an unacceptable tree working method under AS 4373-2007 Part 8 “Pruning of Amenity Trees”

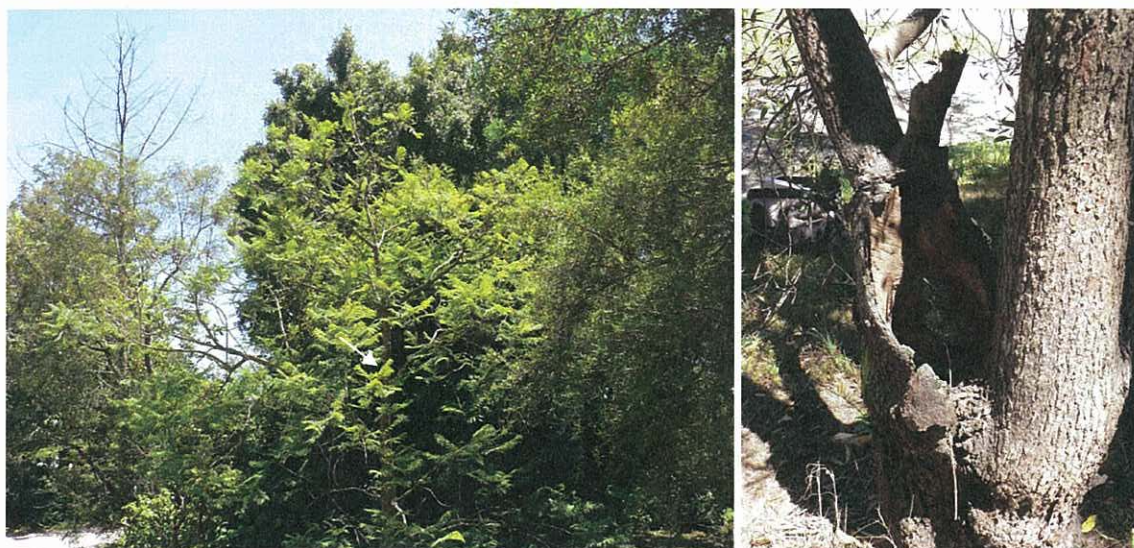
no	Species *provenance	H x R in m	Age, inspection comments Age code: Y = Young, EM = Early-mature M = Mature, A = Aged, S = Senile	SULE rating
11	<i>Jacaranda mimosifolia</i> <b>Jacaranda</b> * Brazil	4 x 1.8	<b>Y:</b> OK	1
12	<i>Photinia x fraseri</i> 'Robusta' <b>Photinia</b> * Orient	4.5 x 2	<b>M:</b> OK	1
13	<i>Ceratopetalum gummiferum</i> <b>NSW Christmas Bush</b> * native inc. regionally	6 x 2.5	<b>M:</b> large lesion & hollow in base (Photo next page)	2(3 ?)
14	<i>Grevillea robusta</i>	9 x 2.5	<b>Y:</b> upper half dead, advancing dieback, will die off	4

Left: view including Trees 11-14, in a foliage mix of trees and shrubs. The dying Silky Oak T. 14 can be seen in the left background. The foreground shrub arrowed is a small Macadamia *Macadamia tetraphylla*. Right photo shows the decay and hollow in the base of NSW Christmas Bush T. 13

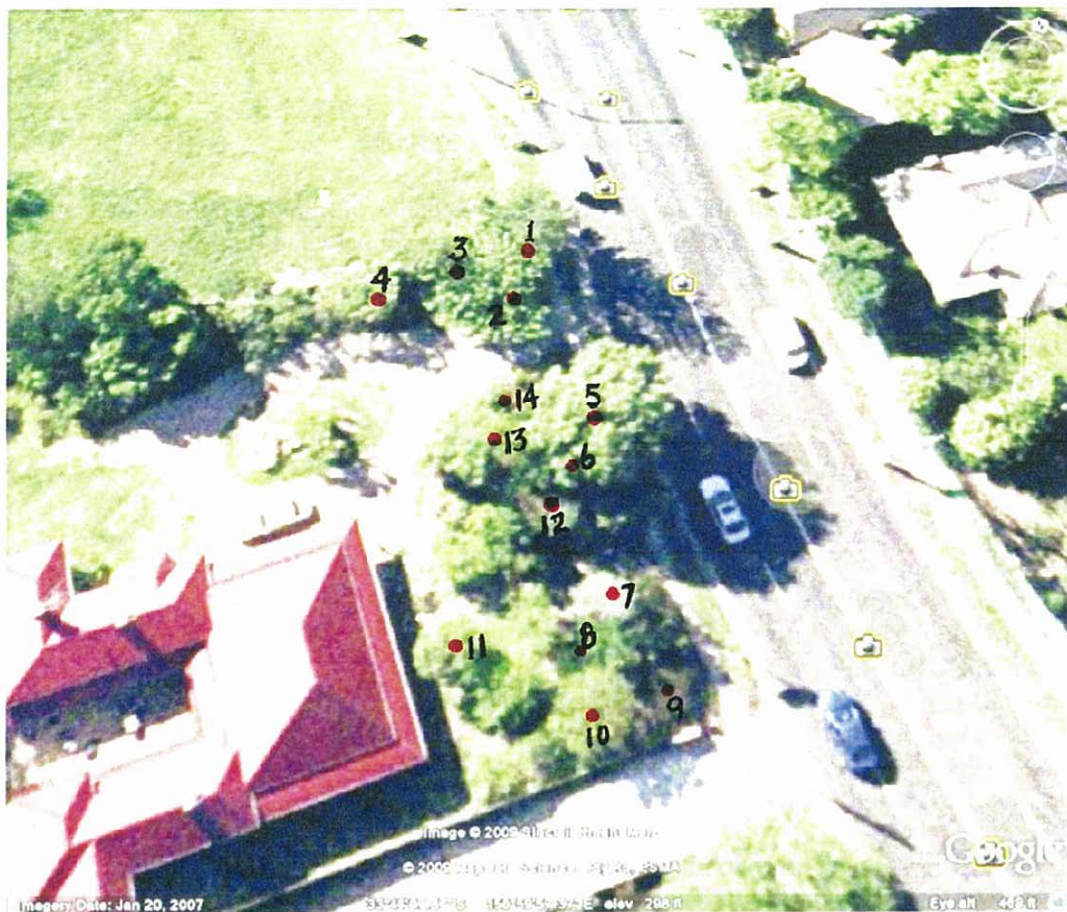
### APROXIMATE TREE LOCATIONS

Individual tree locations. The remaining vegetation filling in the gaps in this photo is shrubbery, to be discussed in report Part 2 on page 8.
