# **HAZARDOUS MATERIALS SURVEY AND REGISTER**

**Former Pelican Beach Resort  
740-742 Pacific Highway  
Sapphire Beach NSW 2450**

**DAVID LANE ASSOCIATES**

**June 2009**

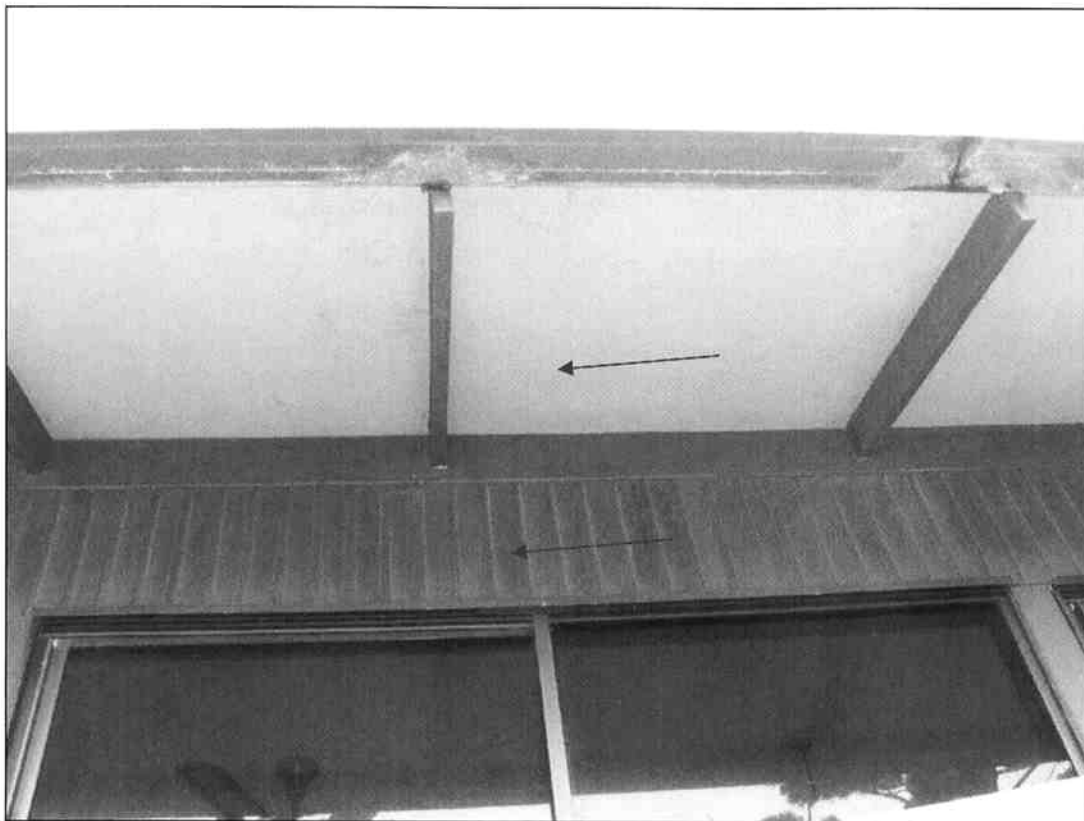
**Print 1**  
**Restaurant Eaves and External Wall Panels**

The eaves of the restaurant appeared to be asbestos cement sheeting – No Sample Available – **Asbestos Detected**

The maroon sections of the external walls present on the eastern, northern and southern frontages of the building are fibrous cement sheet – Sample R1 – No Asbestos Detected

The removal of any asbestos contained within a building or soil, should be undertaken by a professional licensed contractor in accordance with the methods and procedures as outlined in the *Guide to Control of Asbestos Hazards in Buildings and Structures [NOHSC: 3002(1998)]*, the *Code of Practice for the Safe Removal of Asbestos [NOHSC: 2002(1988)]* and *Guidance Note on the Membrane Filter Method for Estimating Airborne Asbestos Dust [NOHSC: 3003 (1988)]* and the *Waste Guideline (NSW EPA 2008)*.

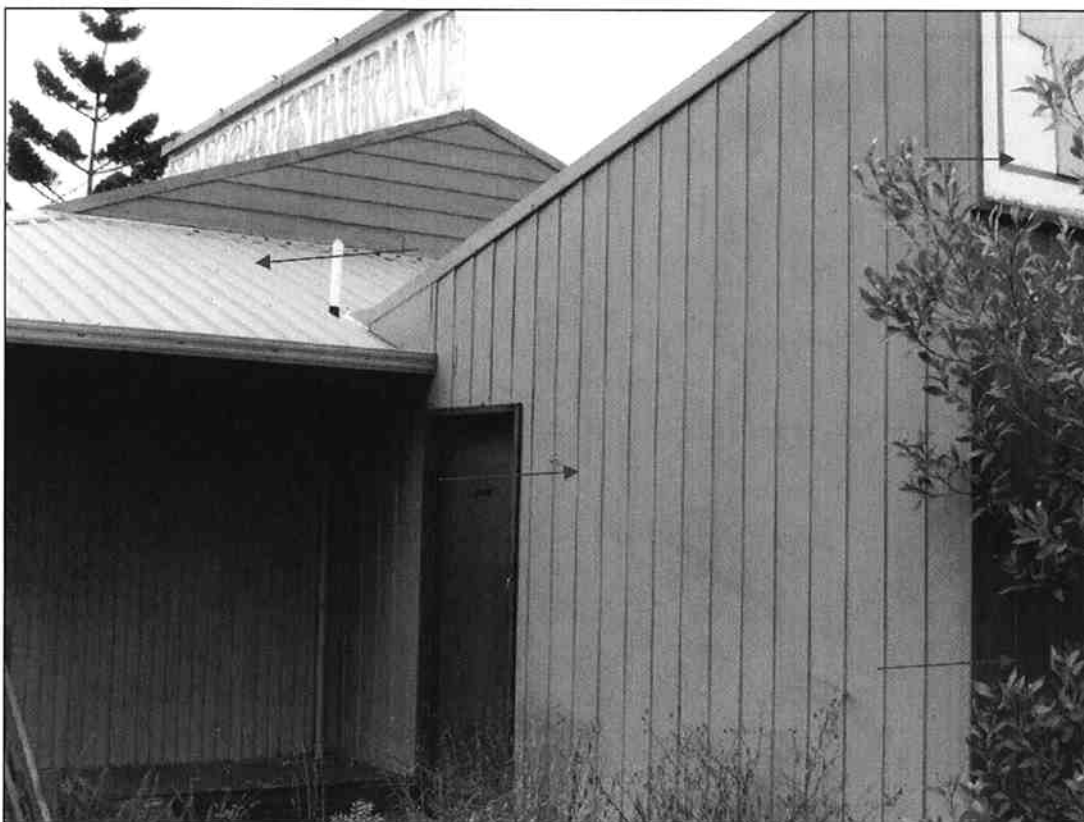
**Print 2**  
**Western Section of Restaurant. Note Wall Panels Advertising Sign and Roof**

The maroon external walls of the western frontage of the building, including the cool room appeared to hardy plank – Sample R3 - No Asbestos Detected

The roof of the building is of tin construction – No Asbestos Detected

The western frontage advertising sign is of timber construction - No Asbestos Detected

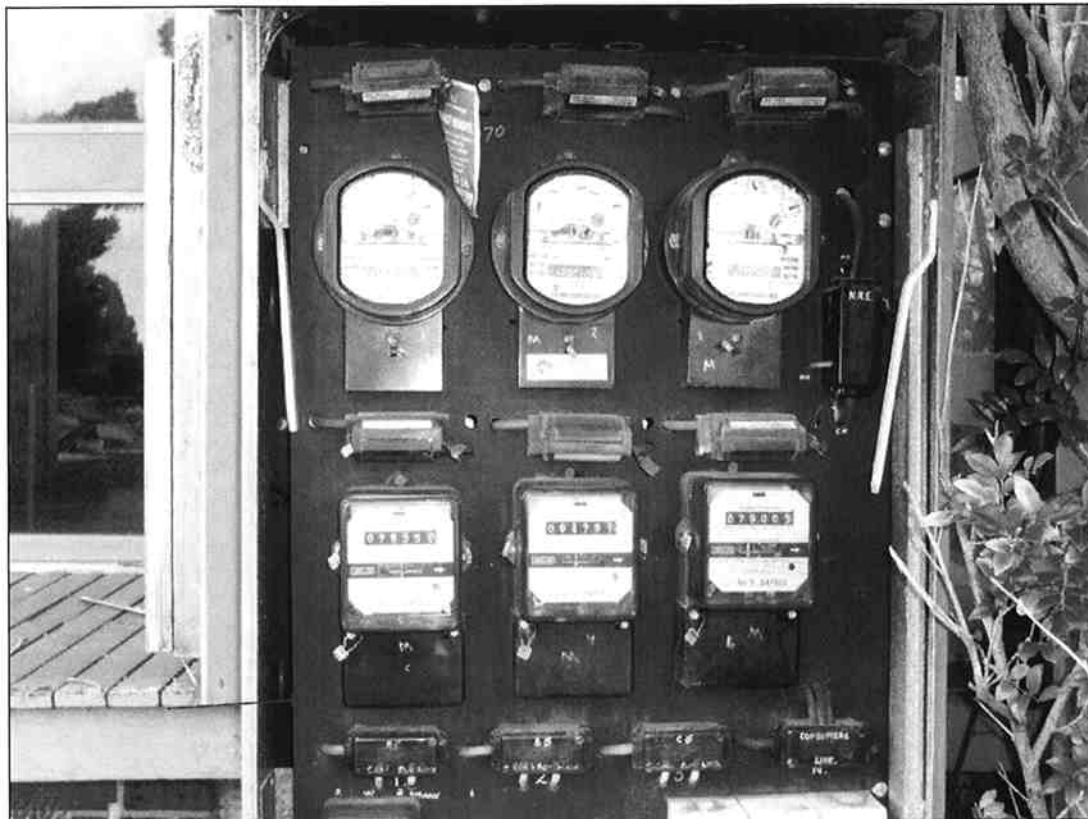
**Print 3**

The electrical distribution board present on the eastern frontage of the building contains an asbestos containing Zelminite backing board – No Sample Available - **Asbestos Detected**

**Restaurant External Asbestos Containing Electrical Distribution Board**

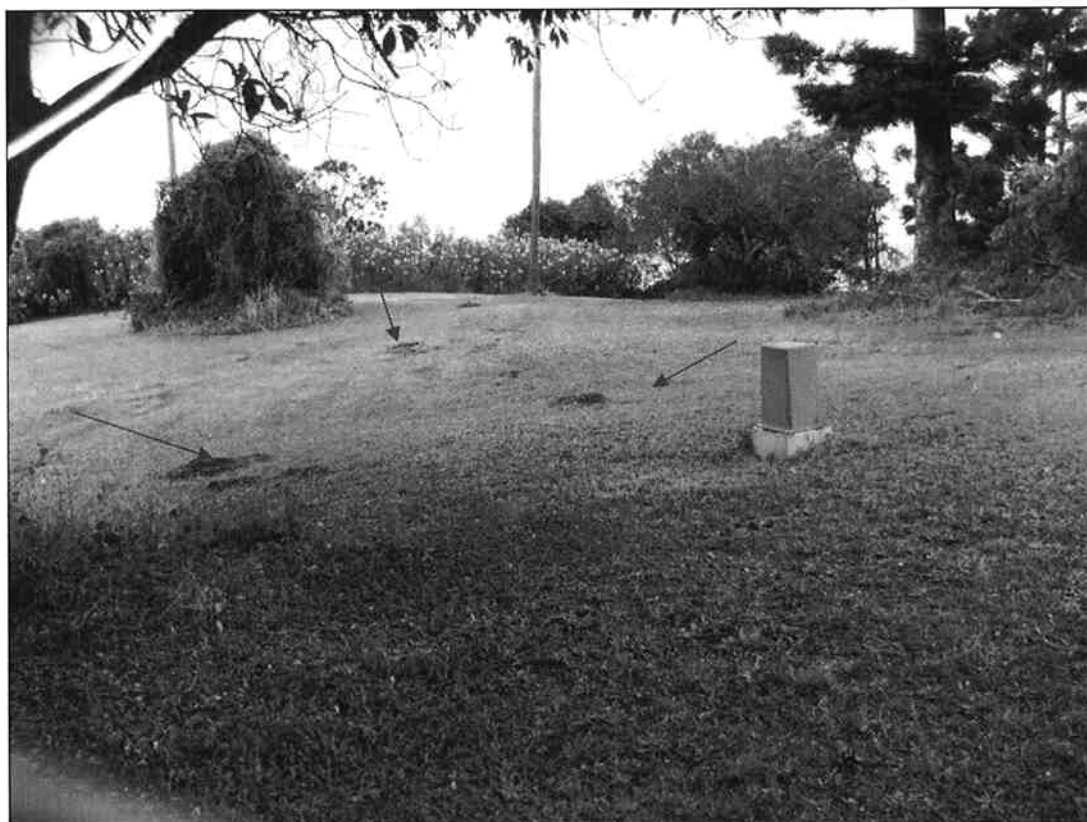
**Print 4**

Asbestos containing fibro fragments were found within a layer of fill located in the elevated plateau area to the east of the restaurant. The fill covers an area of approximately 150m<sup>2</sup> to a maximum depth of 0.3m. Soil samples collected from the fill and immediate surrounds did not indicate the presence of either fibrous or bonded asbestos containing materials – Sample C9-2 - **Asbestos Detected**

**Asbestos Containing Fill Area**
