CHULLORA
HERITAGE ASSESSMENT, 1990

GODDEN MACKAY PTY. LTD.

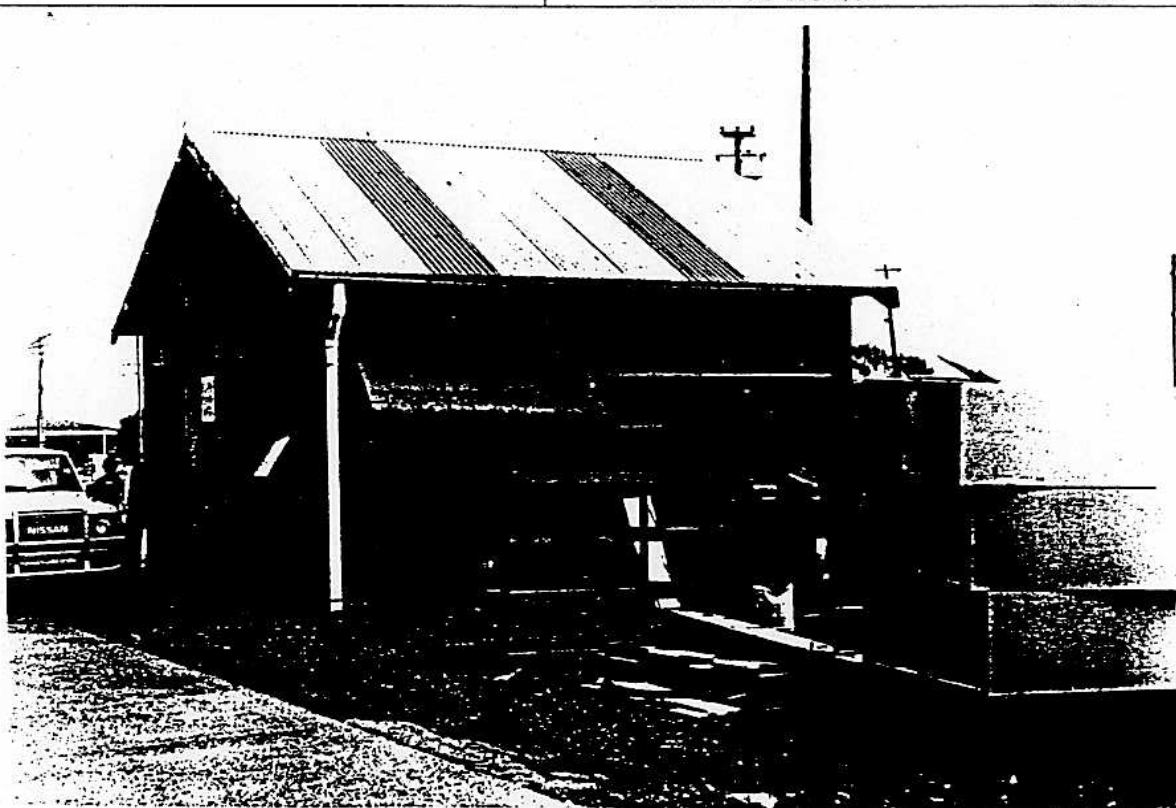
NAME OF ITEM: Returned Material Depot															
No. B54	Map Ref:														
Location: Per Way No. 1, north-west of road, first building.	Precinct G														
Condition: Fair															
Associated Items: Dismantling Yard B55															
<p>Description: The Returned Materials Depot is a store room and has always functioned as such. It is a small (approximately 6x6m) wooden framed corrugated iron clad structure which houses rows of wooden racks for the receipt and consignment of materials. Windows in the store are small casements and are located high on the west face of the building and one is located at eye level on the south face. The southern elevation has a large sliding door. Two corrugated fibreglass panels in the roof provide daylighting.</p>															
<p>SIGNIFICANCE ASSESSMENT</p>

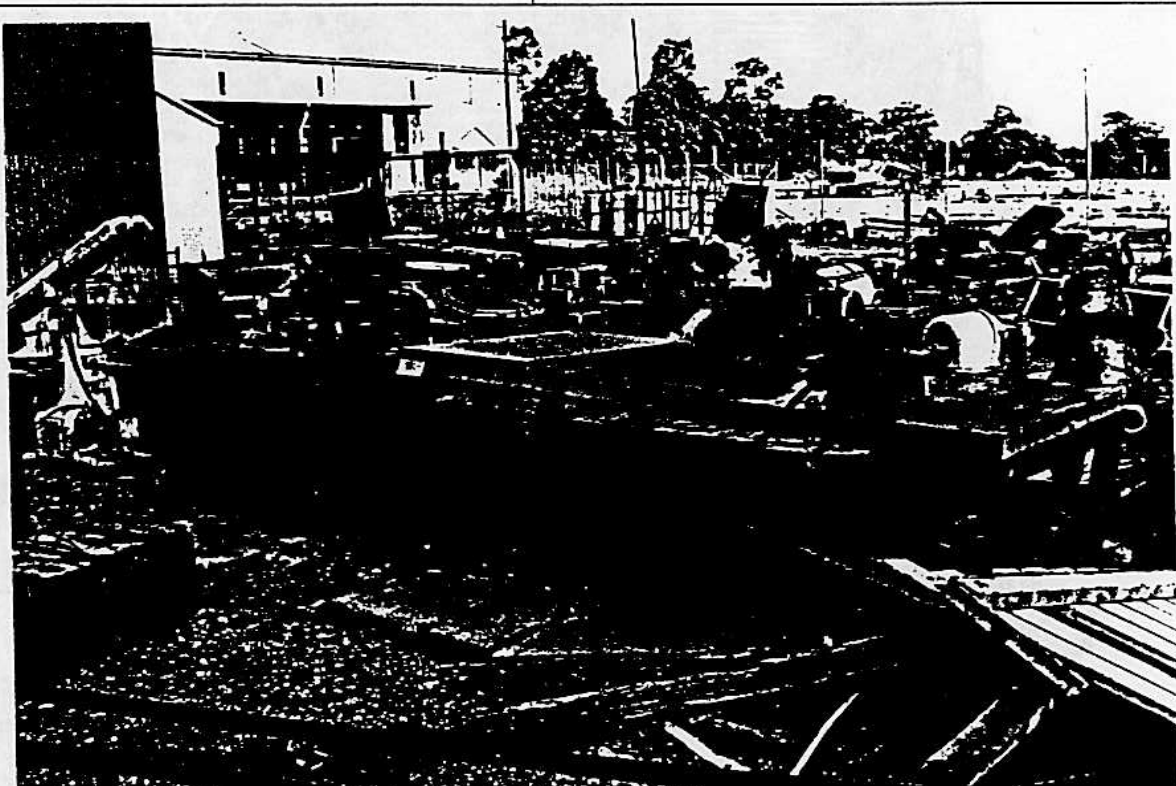
NAME OF ITEM: Equipment Dismantling Yard													
No. B55	Map Ref:												
Location: North-west of Returned Material Depot	Precinct G												
Condition: Poor													
Associated Items: Returned Material Report B54													
<p>Description: This area housed equipment which was intended to be dismantled for the salvage of useful metals. The solid metal frame of the workbench in the foreground is an example. The fire boxes were also stored in this area prior to being cleaned in the pot ash tank (M57) and reused.</p>													
<p>SIGNIFICANCE ASSESSMENT</p>

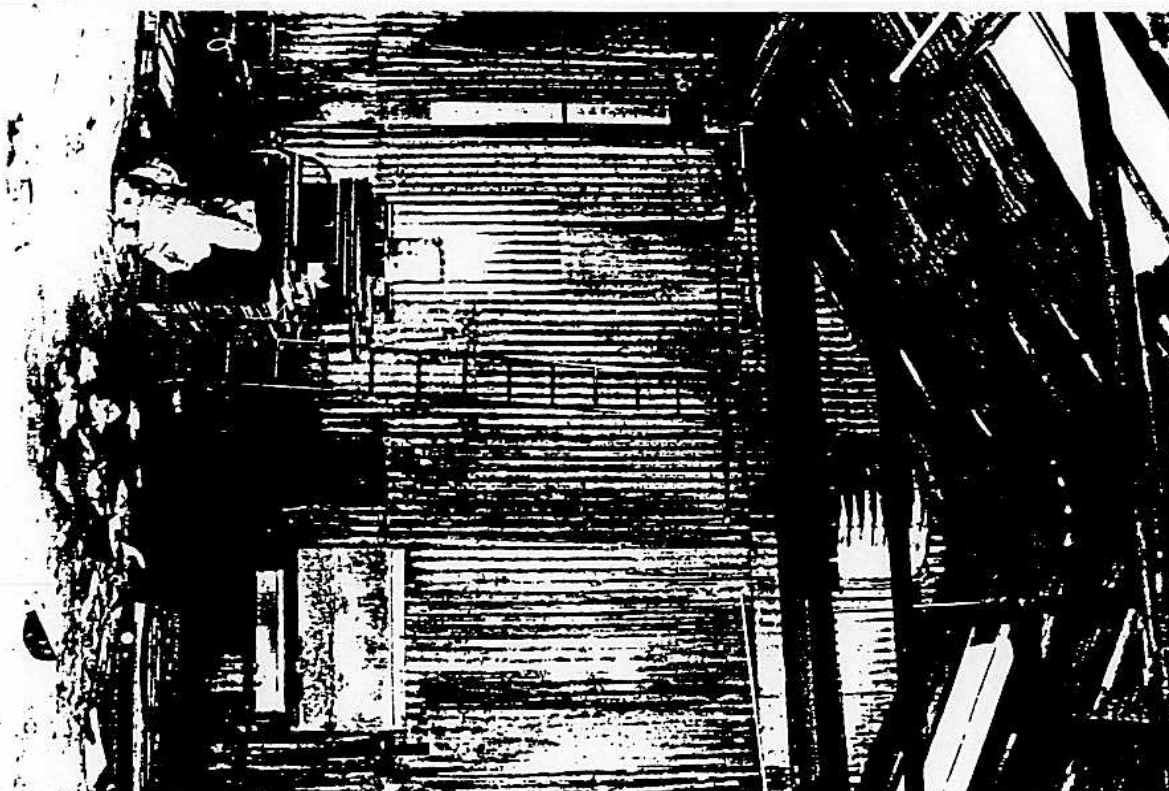
NAME OF ITEM: Footwarmers Room		
No. B56	Map Ref:	
Location: South/East corner	Precinct G	
Condition: Poor		
Associated Items:		
<p>Description: The footwarmers room was used for filling sheet steel footwarmers. The building is corrugated iron clad and timber framed. Double gabled, with a series of 10 posts running down the middle. Elevations are in 8 bays with high 16 paned timber framed casement windows. A sliding wooden door of 1/2 one bay width, slides to the side locking against the main central post.</p> <p>The lamp storage room is a lean to on the north elevation. It is skillion roofed, timber framed and corrugated iron clad. The floor is concrete.</p>		
SIGNIFICANCE ASSESSMENT Aesthetic Value Historic Association Technological Importance Structural Integrity Interpretive Ability Social Significance	2/5 2/5 4/5 2/5 1/5 2/5 1/5	INFORMANTS: Theo REFERENCES:
RECOMMENDATION: Record	PHOTOGRAPHS: B & W: 90-038-5/3 4 Slides:

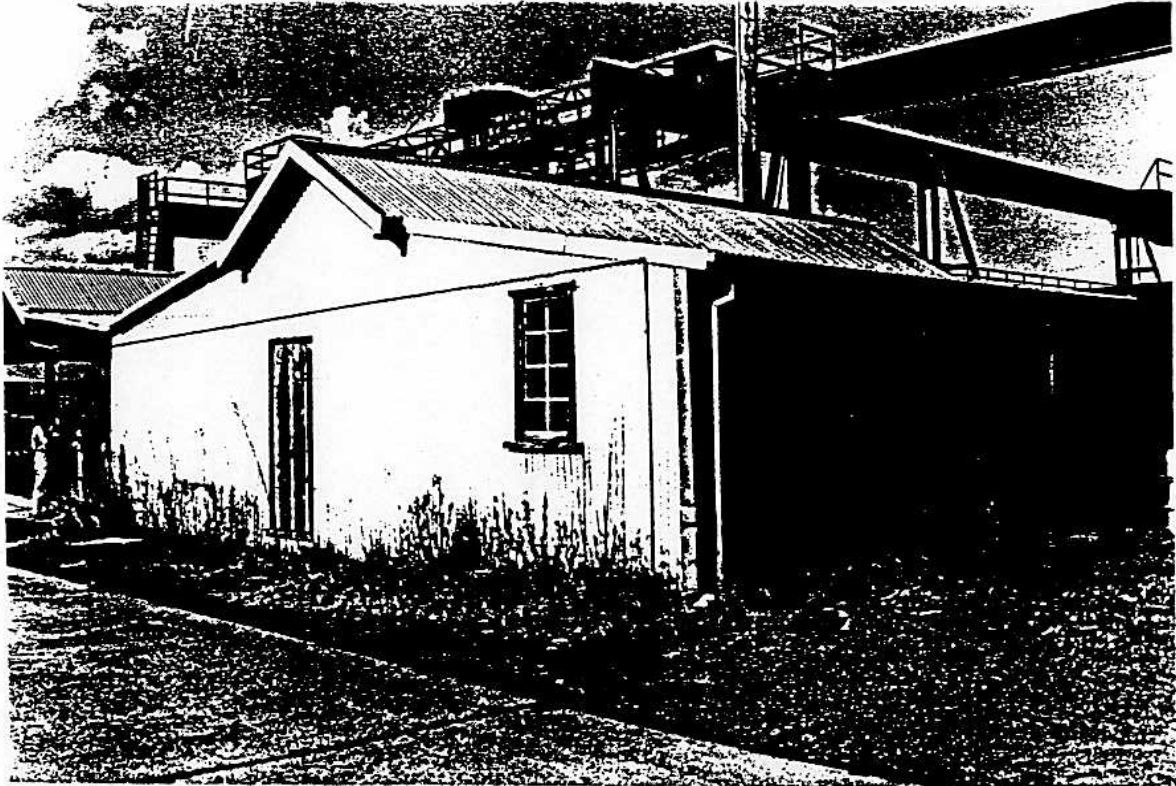
NAME OF ITEM: Small Hipped Roof Structure - Possibly a Sub Station		
No. B60	Map Ref:	
Location: Behind Garage Per Way No. 1 - near the timber crane.	Precinct G	
Condition: Good		
Associated Items:		
<p>Description: This small hipped roof structure has twin skillions. The portal frame consists of very heavy RSJs so the building was obviously purpose built in the past. The building frame is timber and steel. The cladding is relatively new corrugated iron. The main entrance door is on the eastern side, consisting of double swing doors. The 8 paned wooden framed windows are located in the northern, southern and eastern elevations.</p>		
SIGNIFICANCE ASSESSMENT Aesthetic Value 2/5 Historic Association 3/5 Technological Importance 2/5 Structural Integrity 3/5 Interpretive Ability 1/5 Social Significance 1/5	INFORMANTS: REFERENCES:	
RECOMMENDATION: Record	PHOTOGRAPHS: B & W: 90-038-4-10 Slides:

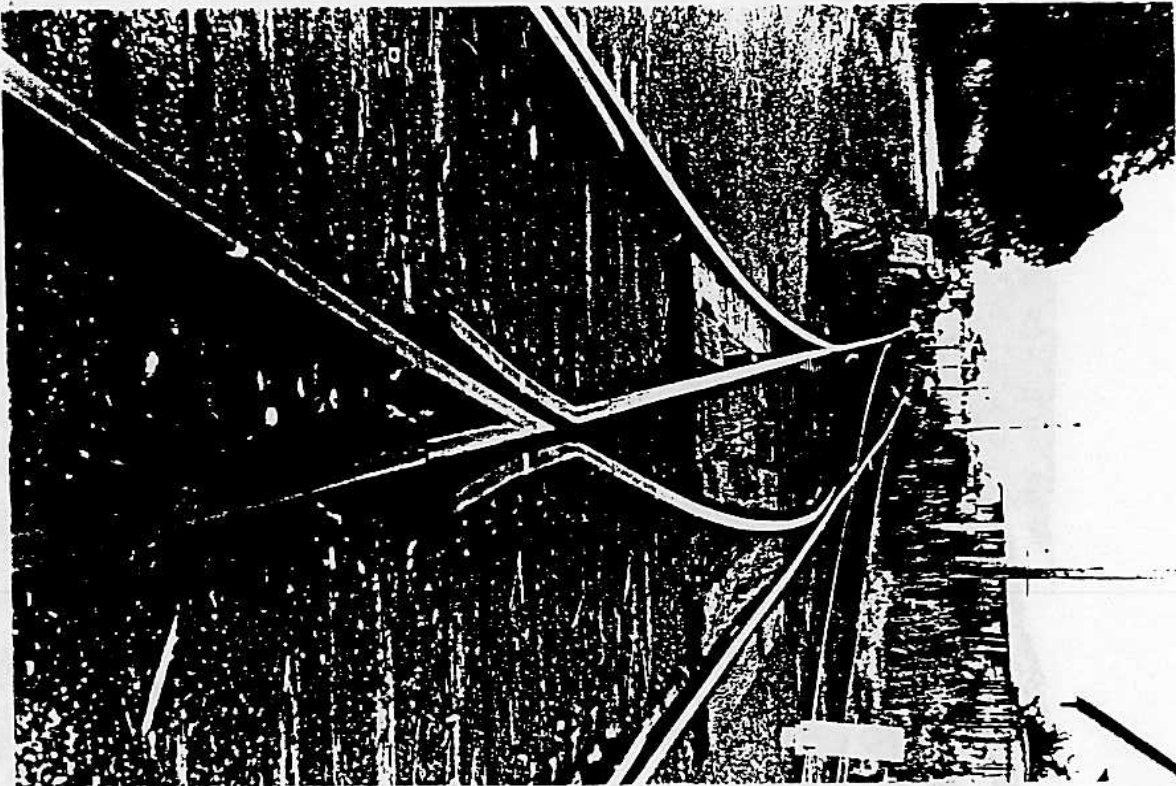
NAME OF ITEM: Sigway Platform	
No. B58	Map Ref:
Location: Per way workshops No. 1 beside main line	Precinct G
Condition:	
Associated Items:	
Description: The sigway platform is an earth filled raised platform, sheathed with railway sleepers on its face. There are two small waiting sheds and very few other embellishments.	
SIGNIFICANCE ASSESSMENT Aesthetic Value 2/5 Historic Association 1/5 Technological Importance 3/5 Structural Integrity 1/5 Interpretive Ability 3/5 Social Significance 2/5	INFORMANTS: REFERENCES:
RECOMMENDATION: Record	PHOTOGRAPHS: B & W: 90-038-5-37 Slides:

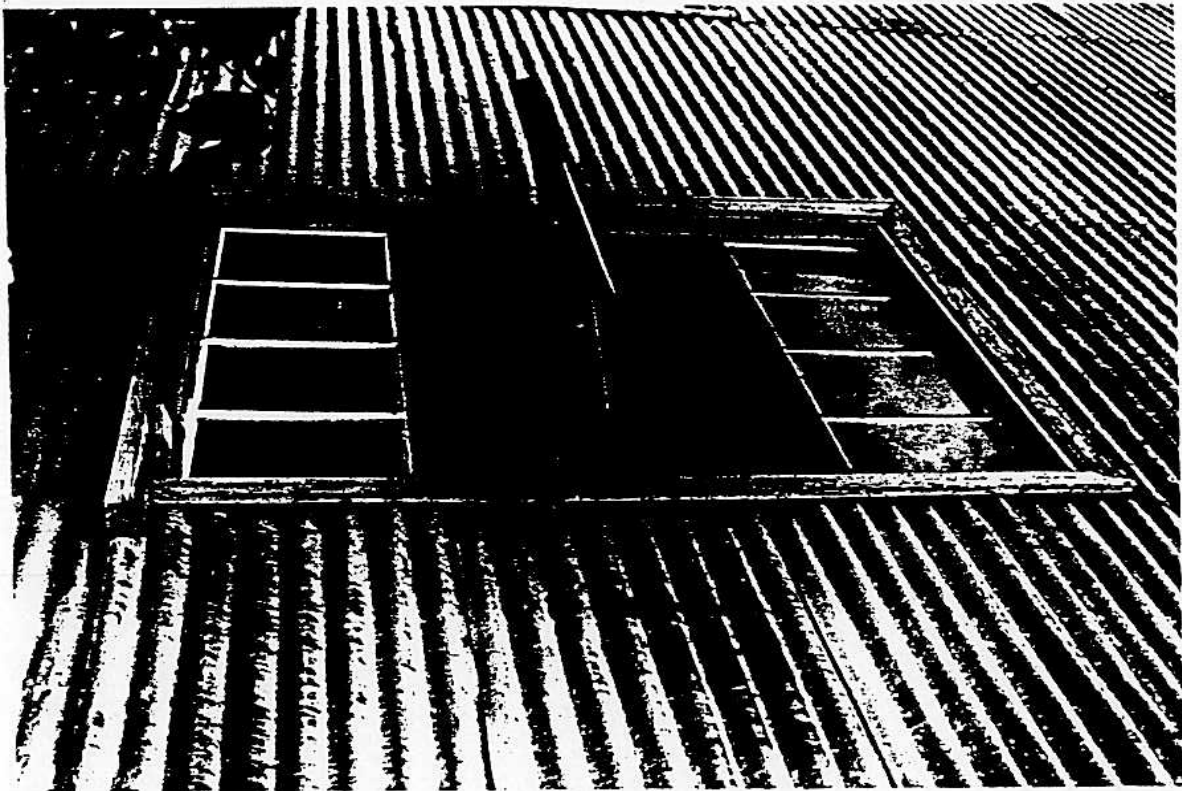
NAME OF ITEM: Garage	
No. B59	Map Ref:
Location: Per way No. 1	Precinct G
Condition: Fair	
Associated Items:	
<p>Description: The garage is a double gable ended, wooden framed corrugated iron clad building with 3 double sliding doors in the Western elevation. Each bay houses 3 cast iron 16 pane casement windows. The top and bottom rows are fixed and the central 8 frame section swivels about its central axis. There is a skillion roofed lean to at the eastern end of the garage. It is timber framed and corrugated iron clad. One double door leads from the lean to to the main building. The roof has standard king post trusses with a ridge pole and 4 purlins.</p>	
SIGNIFICANCE ASSESSMENT Aesthetic Value 2/5 Historic Association 3/5 Technological Importance 2/5 Structural Integrity 2/5 Interpretive Ability 2/5 Social Significance 2/5	INFORMANTS: Col Barclay REFERENCES:
RECOMMENDATION: Record	PHOTOGRAPHS: B & W: 90-038-4/2 Slides:
