# Tree Report

Redevelopment of Eastlakes Town Centre

Joint Venture between Prosha Pty Ltd and Crown  
International Holdings Group (Crown Prosha JV)

April 2012

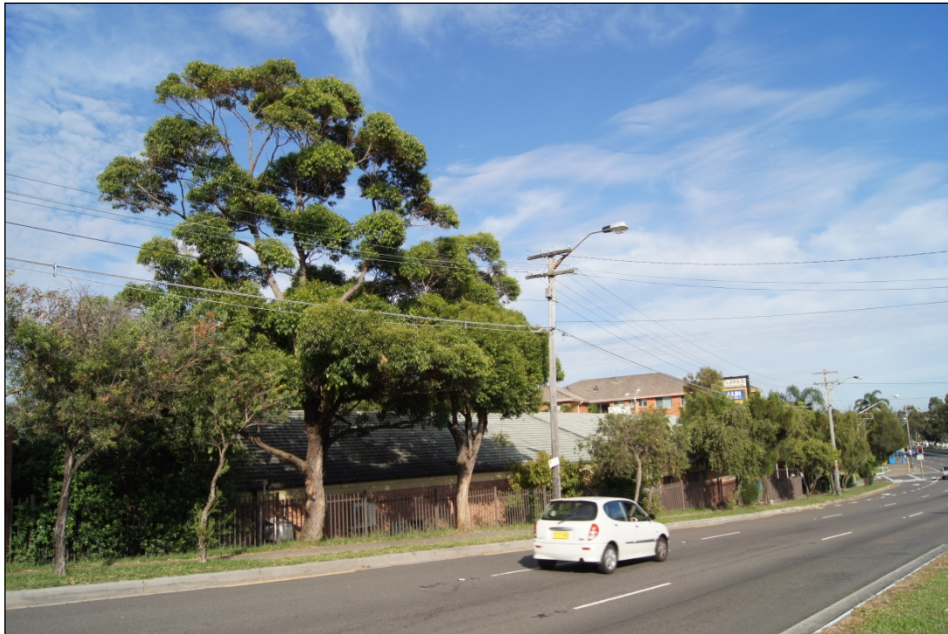
Plate 1: Gardeners Road frontage viewed from the northeast showing Trees 16 and 19 *Eucalyptus microcorys* (Tallowwood) left

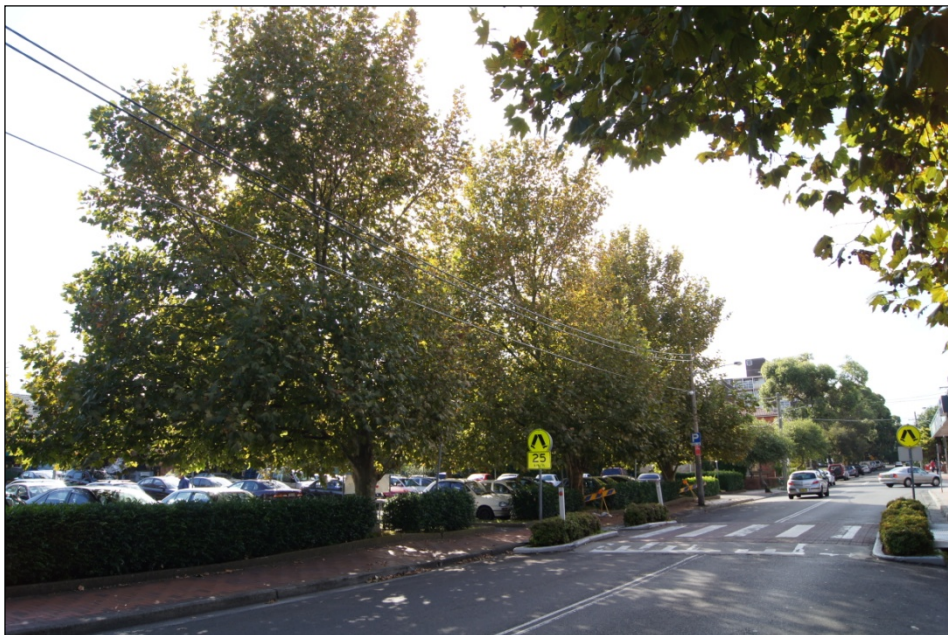
Plate 2: Evans Avenue viewed from the west showing Trees 22, 23 and 24 *Platanus x hybrida* (London Plane)

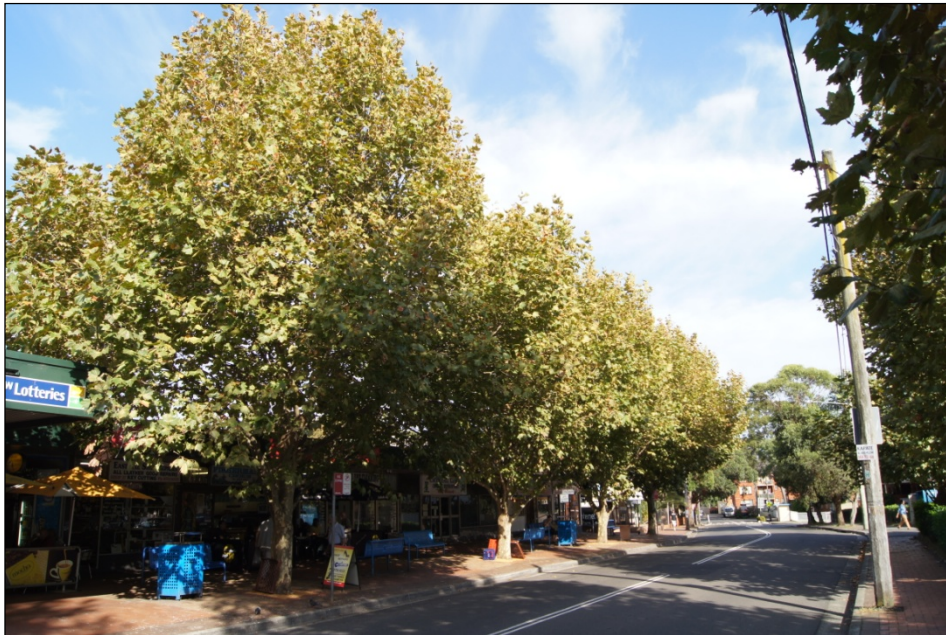
Plate 3: Evans Avenue viewed from the east showing Trees 26, 27, 28 and 29 *Platanus x hybrida* (London Plane)

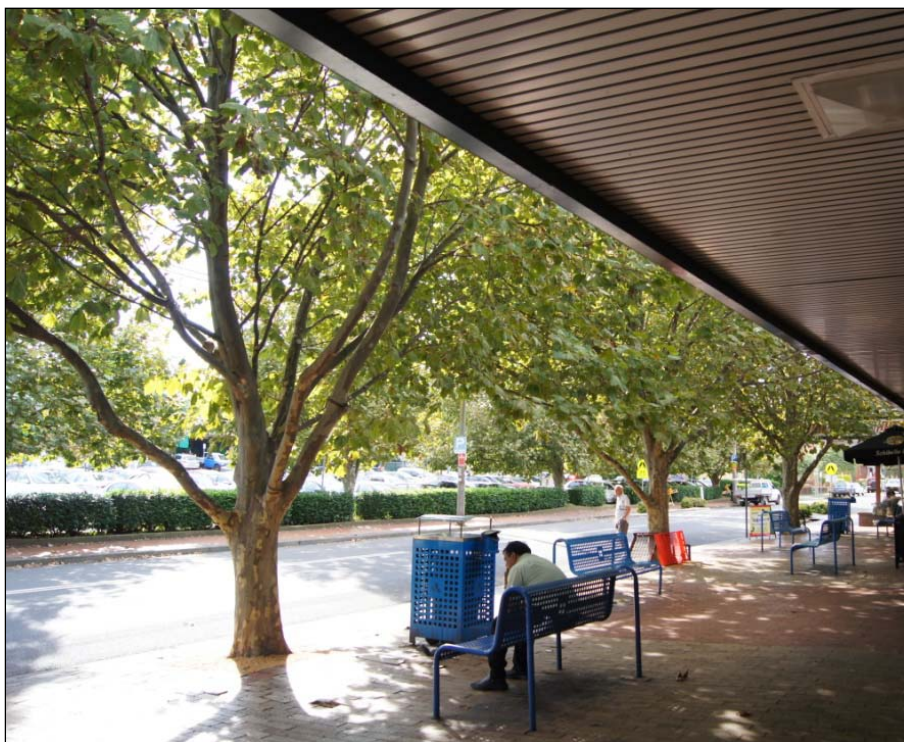
The proposed awnings to the frontages of the buildings would need to be modified to provide clearance from the trunks and branches of retained trees. Clearances would need to conform to the spread of the branch scaffolds to avoid drastic pruning of major lower branches. The awnings are approximately 4m above ground level and many large branches extend towards the buildings within the envelopes (Plate 4). Trees 22 and 23 are within the awnings. Minor pruning of upper overhanging branches for building clearance would be acceptable.

Plate 4: Trees 28, 27 and 26 *Platanus x hybrida* (London Plane) showing lower branches within line of awning (ie approximately 1m from trunk centre)

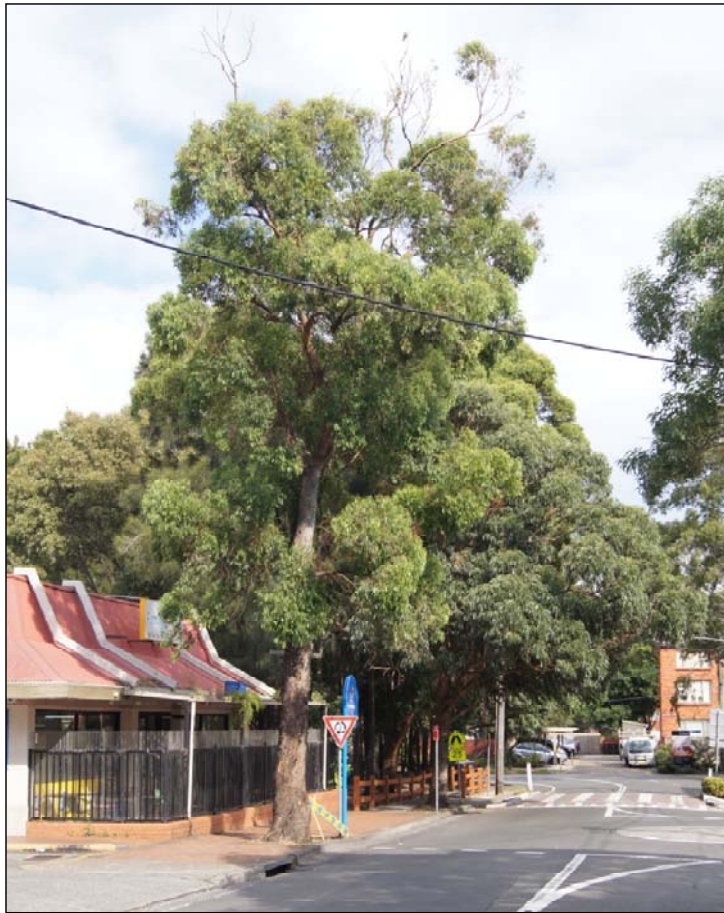
Trees 31 and 32 *Eucalyptus microcorys* (Tallowwood) are Council street trees and are prominent in the Evans Avenue streetscape (Plate 5). They are within or very close to the proposed carpark entry and would be removed.

Plate 5: Tree 30 *Eucalyptus microcorys* (Tallowwood) showing branch dieback in upper crown

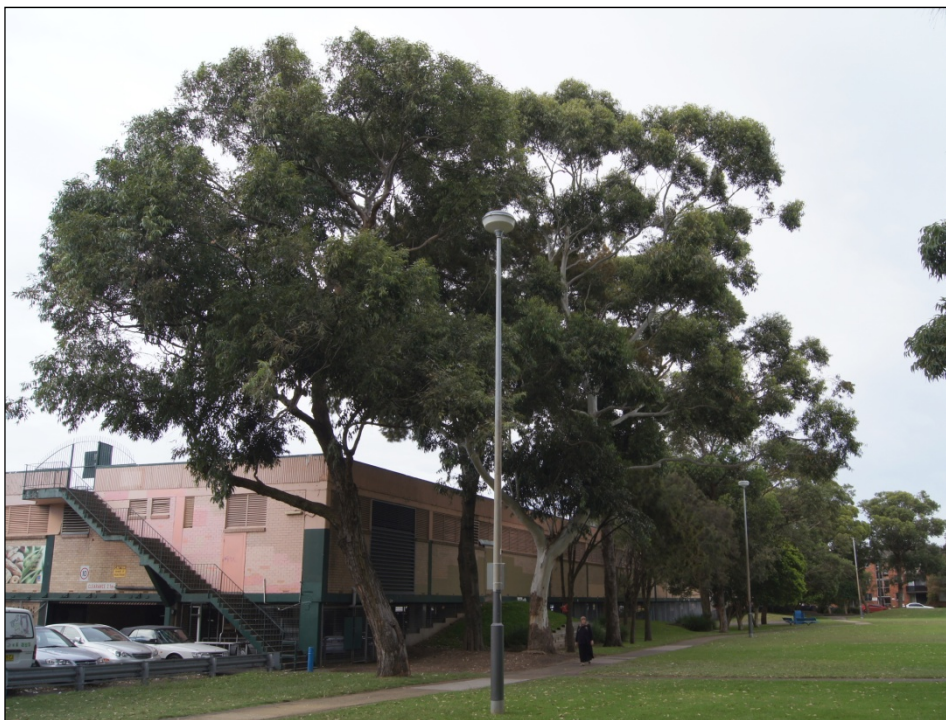
Trees located near the site in Eastlakes Reserve, Trees 33 to 52, (Plate 6) would not be affected by the proposed development because there are already large buildings adjoining the boundary which would have confined the root systems. However it is noted that there is a raised soil mound in the vicinity of Tree 37 *Eucalyptus botryoides* (Bangalay) and this should be left undisturbed during demolition and construction.

Plate 6: Eastlakes Reserve viewed from the northwest showing left to right Tree 33 *Eucalyptus botryoides* (Bangalay), Tree 34 *Eucalyptus grandis* (Flooded Gum) and Tree 35 *Casuarina cunninghamiana* (River Sheoak)

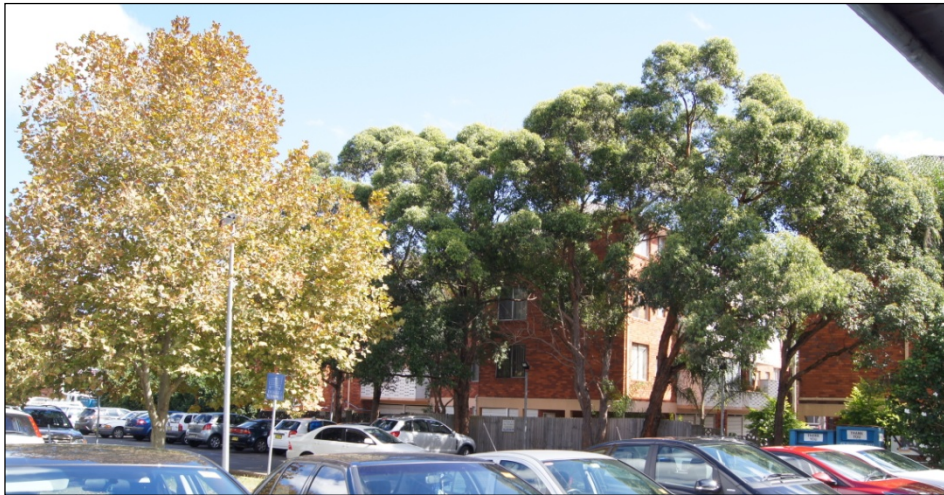
Plate 7: Evans Avenue carpark viewed from the northeast showing Tree 63 *Platanus x hybrida* (London Plane) left; Trees 55 to 60 *Eucalyptus microcorys* (Tallowwood) to the rear

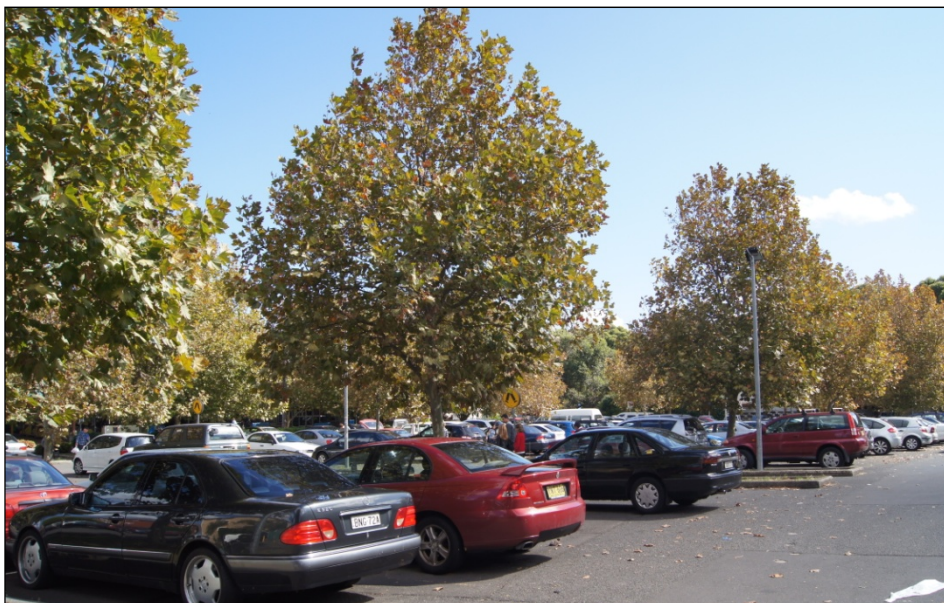
Plate 8: Evans Avenue carpark viewed from the northeast showing Trees 74 to 79 *Platanus x hybrida* (London Plane)

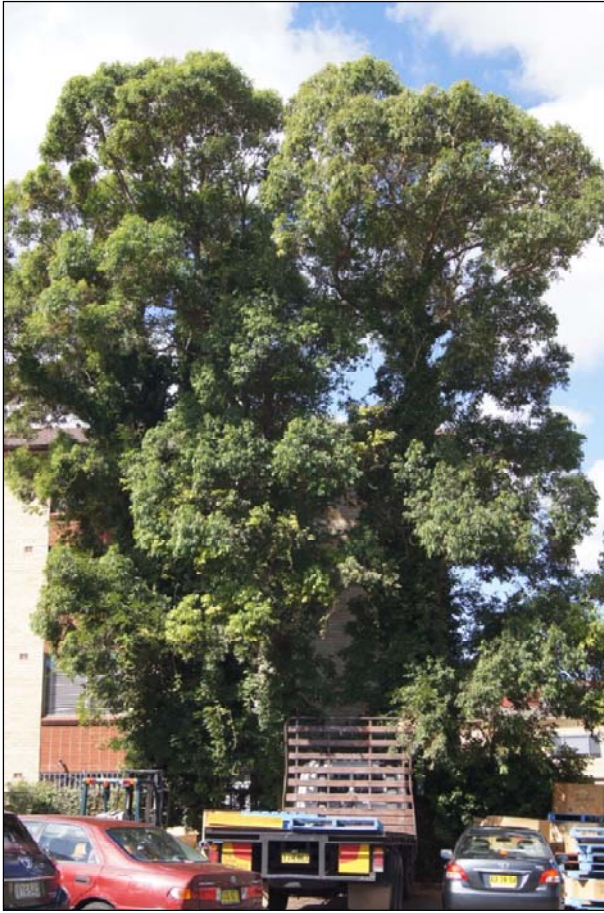
Plate 9: Trees 70, 71 and 72  
*Eucalyptus microcorys*  
(Tallowwood)

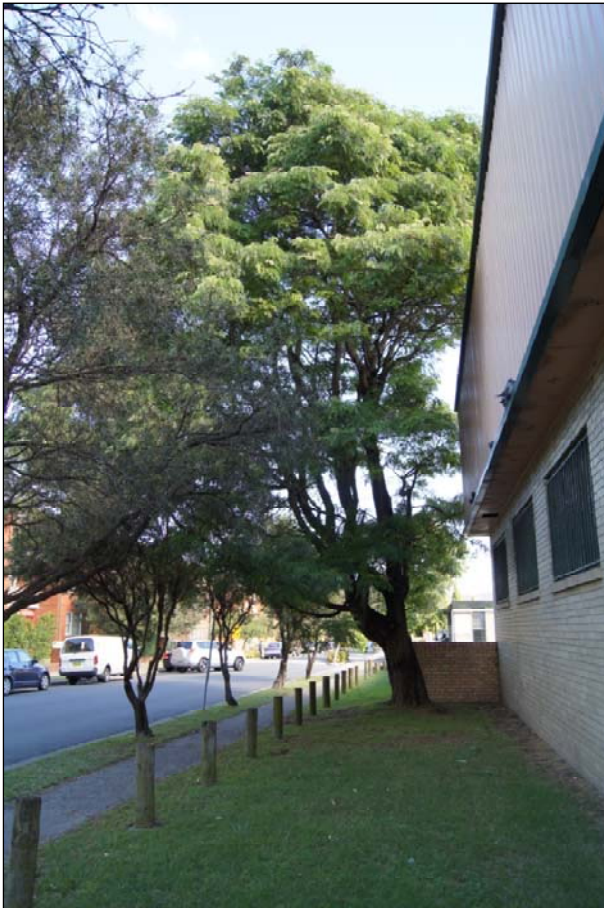
In Barber Avenue most of the trees, including Council street trees, would need to be removed. Most of the individuals in the row of small and insignificant *Callistemon viminalis* (Weeping Bottlebrush) street trees (Trees 84 to 90) in the north of the Avenue (Plate 10) would be beneath the proposed awning and would need to be removed. Modifications to the design in order to retain them are not warranted by their poor state. Trees 91 and 92 are two large specimens of *Acacia elata* (Cedar Wattle); these are prominent in the streetscape but would be within the building (Plates 10 and 11).

Plate 10: Barber Avenue  
viewed from the north  
showing Trees 89 to 90  
*Callistemon viminalis*  
(Weeping Bottlebrush) and  
Tree 91 *Acacia elata* (Cedar  
Wattle)

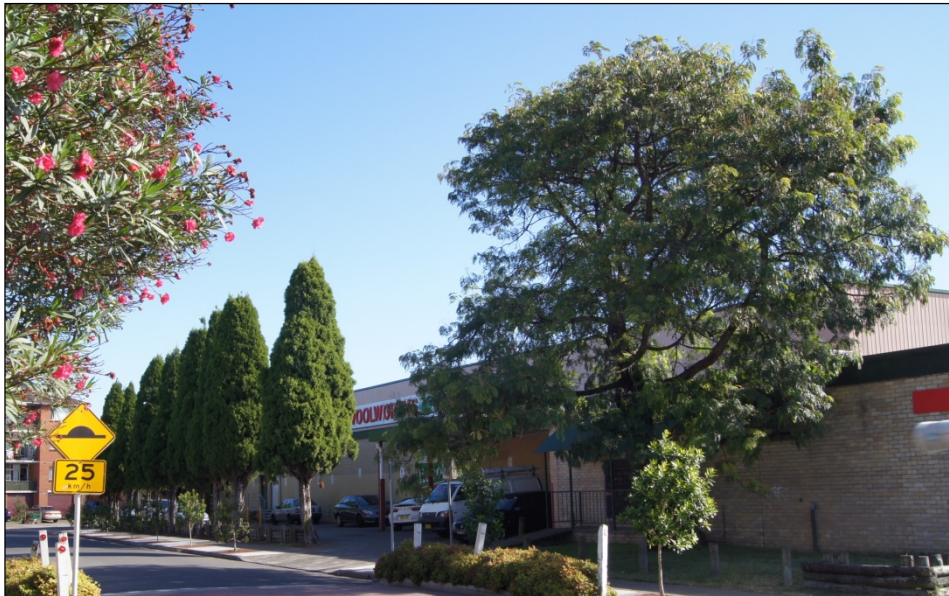
Tree group 105 is a closely spaced row of 22 specimens of *Cupressus torulosa* (Bhutan Cypress) located within the site near the corner of Barber Avenue (Plate 11). Most of these would be within the proposed building and would be removed. A few individuals could be retained on the corner, but this is not considered desirable: they are not good examples of the species, having lost the characteristic form due to the lower branches having been pruned.

Plate 11: Barber Avenue viewed from the northeast showing Tree 92 *Acacia elata* (Cedar Wattle) and Tree group 105 *Cupressus torulosa* (Bhutan Cypress)

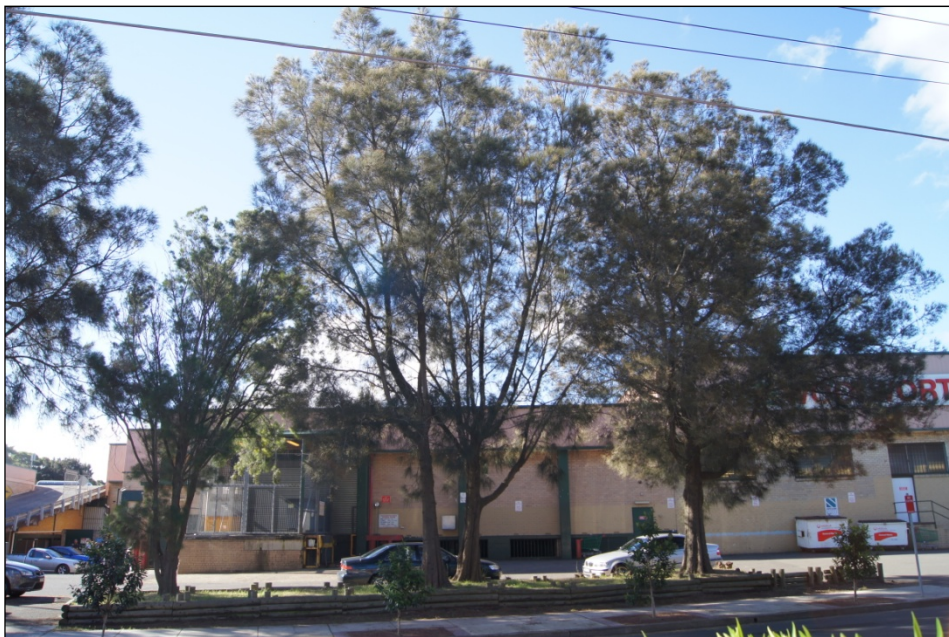
Trees 93 to 104 are various specimens of She Oak, mostly *Casuarina glauca* (Swamp Sheoak) with a few *Allocasuarina torulosa* (Forest Sheoak) and *Allocasuarina littoralis* (Black Sheoak). These trees are prominent in the streetscape but have short life expectancy due to their root systems being confined within raised planter beds (Plate 12). They are within the building footprint and would be removed.

Plate 12: Barber Avenue viewed from the south showing right to left: Trees 93, 94 and 95 *Casuarina cunninghamiana* (River Sheoak) and Tree 96 *Allocasuarina torulosa* (Forest Sheoak)
