Client	UNSW c/o Capital Insight Pty Ltd
Location	Tyree Energy Technologies Building UNSW.
Document Type	Arboriculture Assessment for Project Application
Date/Time	26 th November 2009

Client	UNSW c/o Capital Insight Pty Ltd
Location	Tyree Energy Technologies Building UNSW.
Document Type	Arboriculture Assessment for Development Application
Date/Time	26 th November 2009

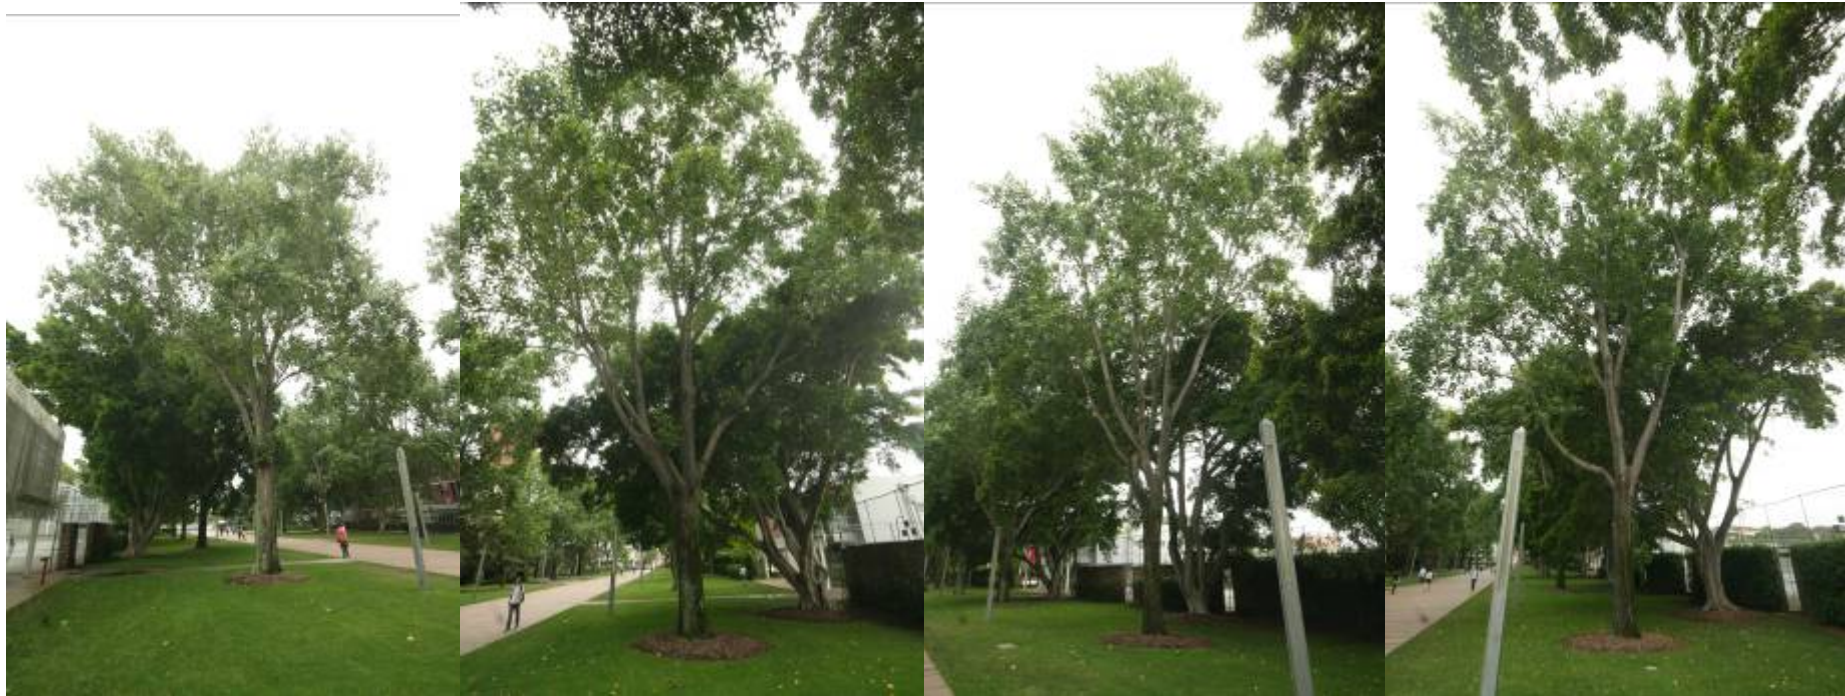
Plate 1 above left shows tree 1 on site. Plate 2 above left centre shows trees 2 & 5 on site. Plate 3 above right shows tree 3 & 6 on site. Picture 4 above right shows trees 4 & 7 on site.

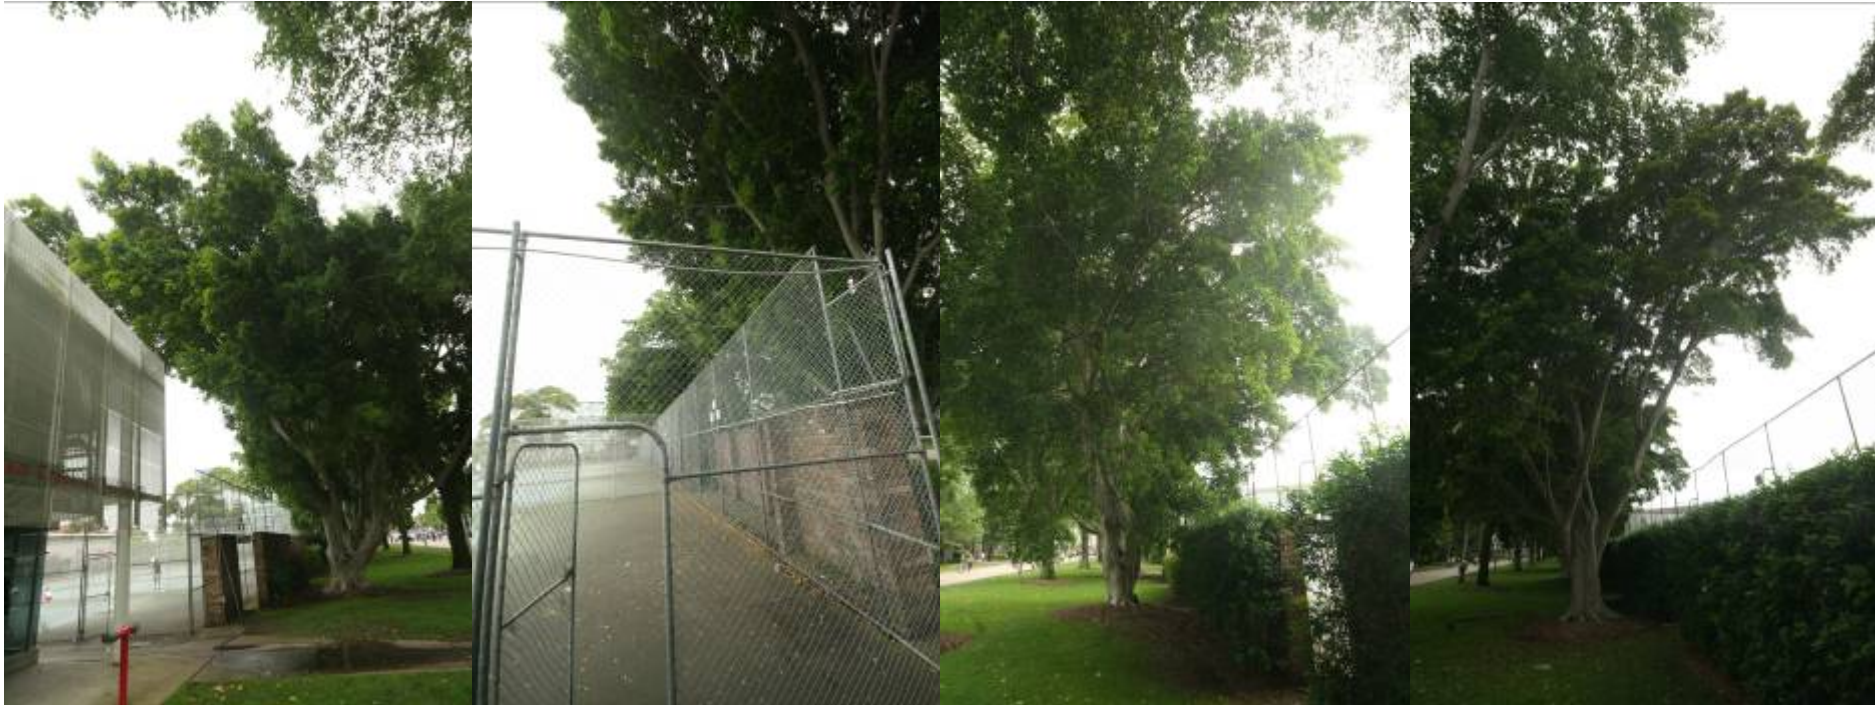
Plate 5 above left shows tree 5 on site, note the foliage extending towards the south with end weight, some minor pruning would favour this tree. Plate 6 above left centre shows the outer row of figs and thier high crowns raised previously. Plate 7 above right centre shows tree 6 on site. Plate 8 above right shows tree 7 on site.

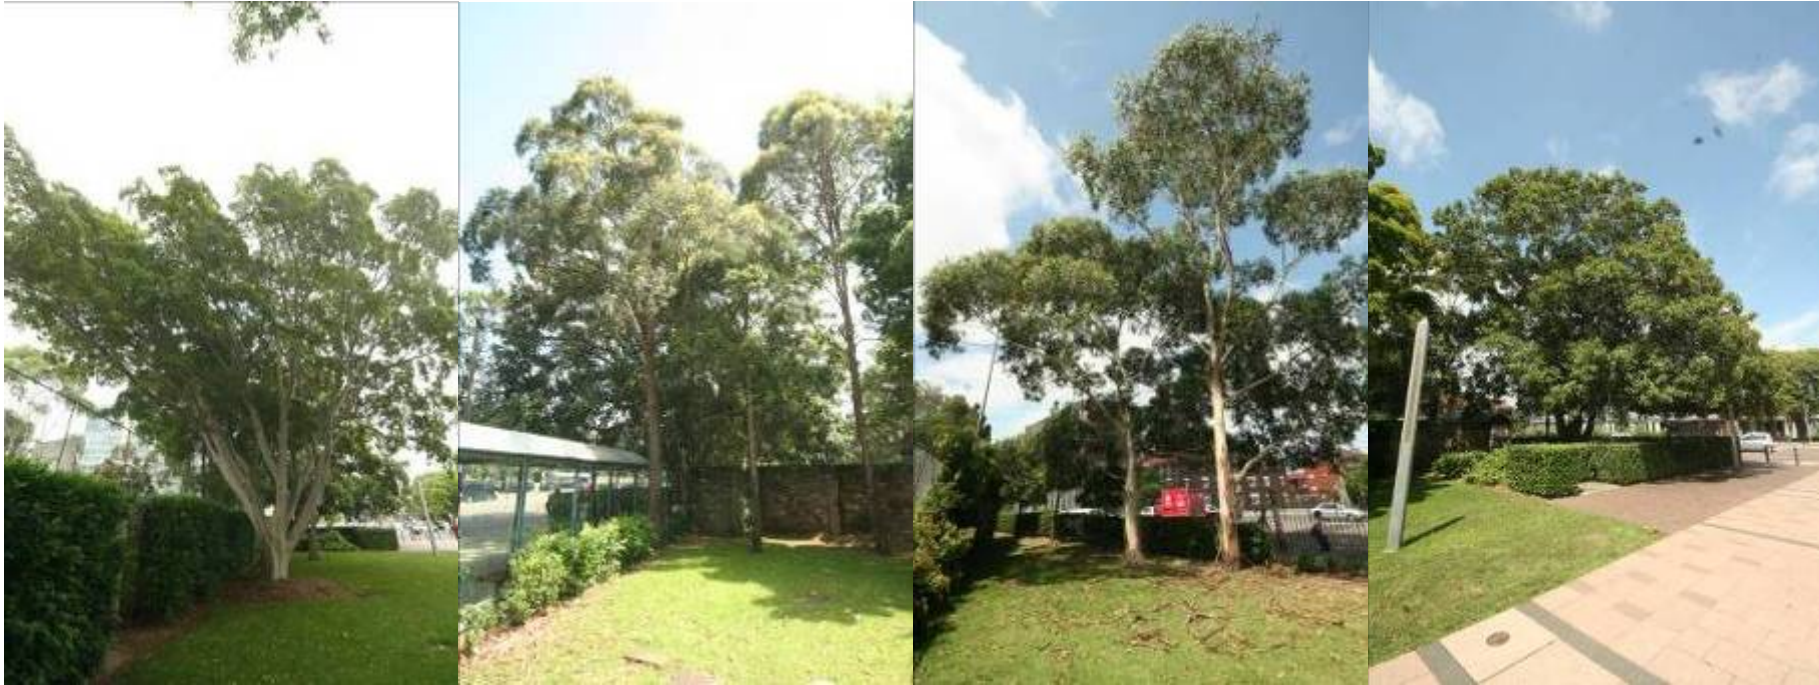
Plate 9 above left shows tree 8 on site. Plate 10 above right shows trees 10,10a & 11. Plate 11 above right centre shows trees 12 & 13. Plate 12 above right shows tree 9 on site at the SW end of the main walk.

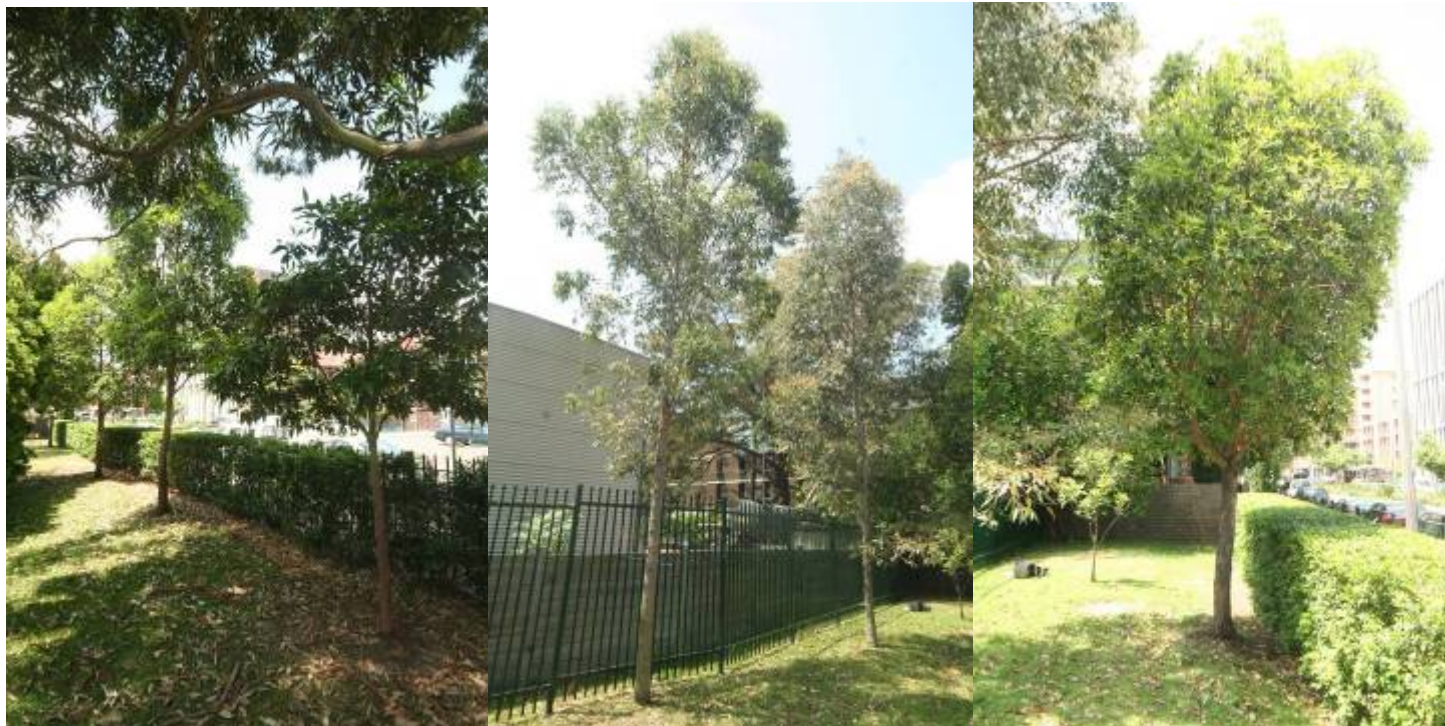
Plate 13 above left shows trees 13a, 14 & 15. Plate 14 above centre shows trees 16 & 17 onsite. Plate 15 above right shows tree 19, please note tree 18 has been removed.

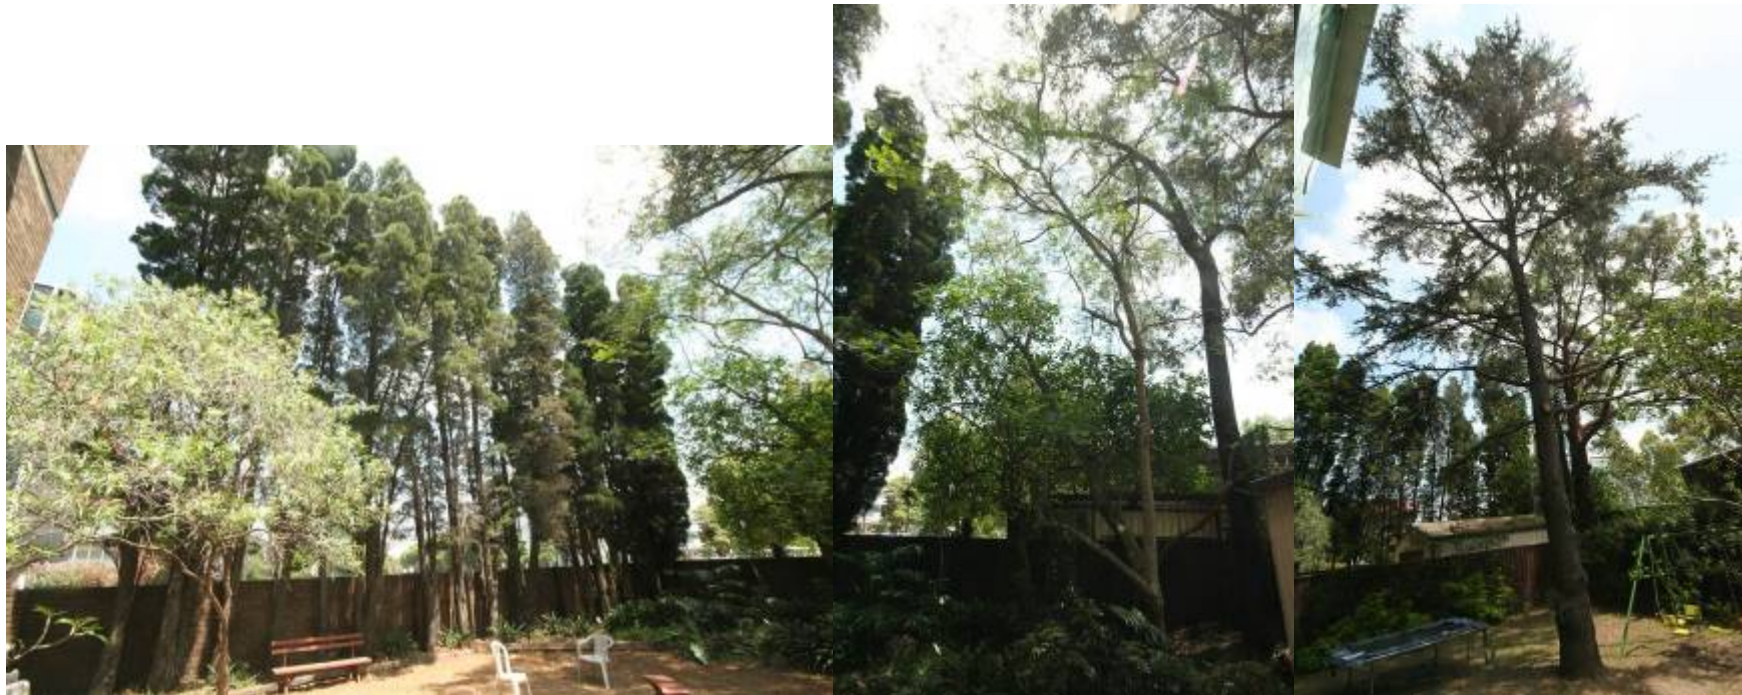
Plate 16 above left shows tree group 20a on site away from the works. Plate 17 shows trees 20b, 20c and tree 21 on site. Plate 18 shows tree 23 on site away from the works.

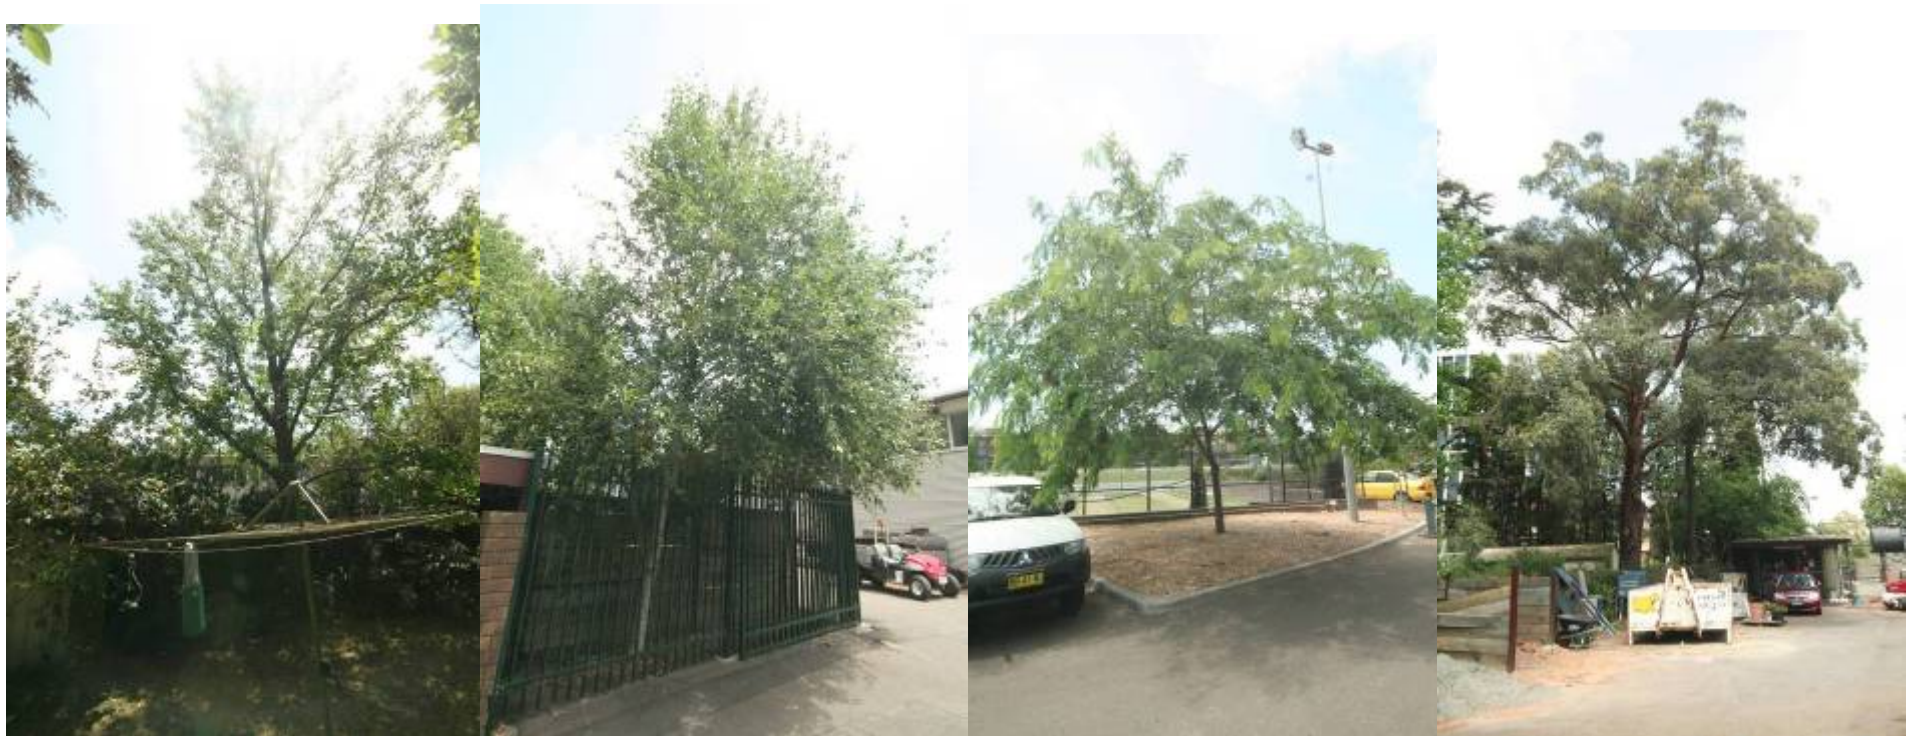
Plate 19 above left shows tree 24 on site. Plate 20 above centre left shows trees 25 & 25a on site. Plate 21 above centre right shows tree 26 on site. Plate 22 above right shows tree 22 on site.
