VEOLIA - ED1& 2 Integrity Assessment

ED-1 & 2 Layout & Inferred Leakage

Veolia - ED1 & 2 Integrity Assessment

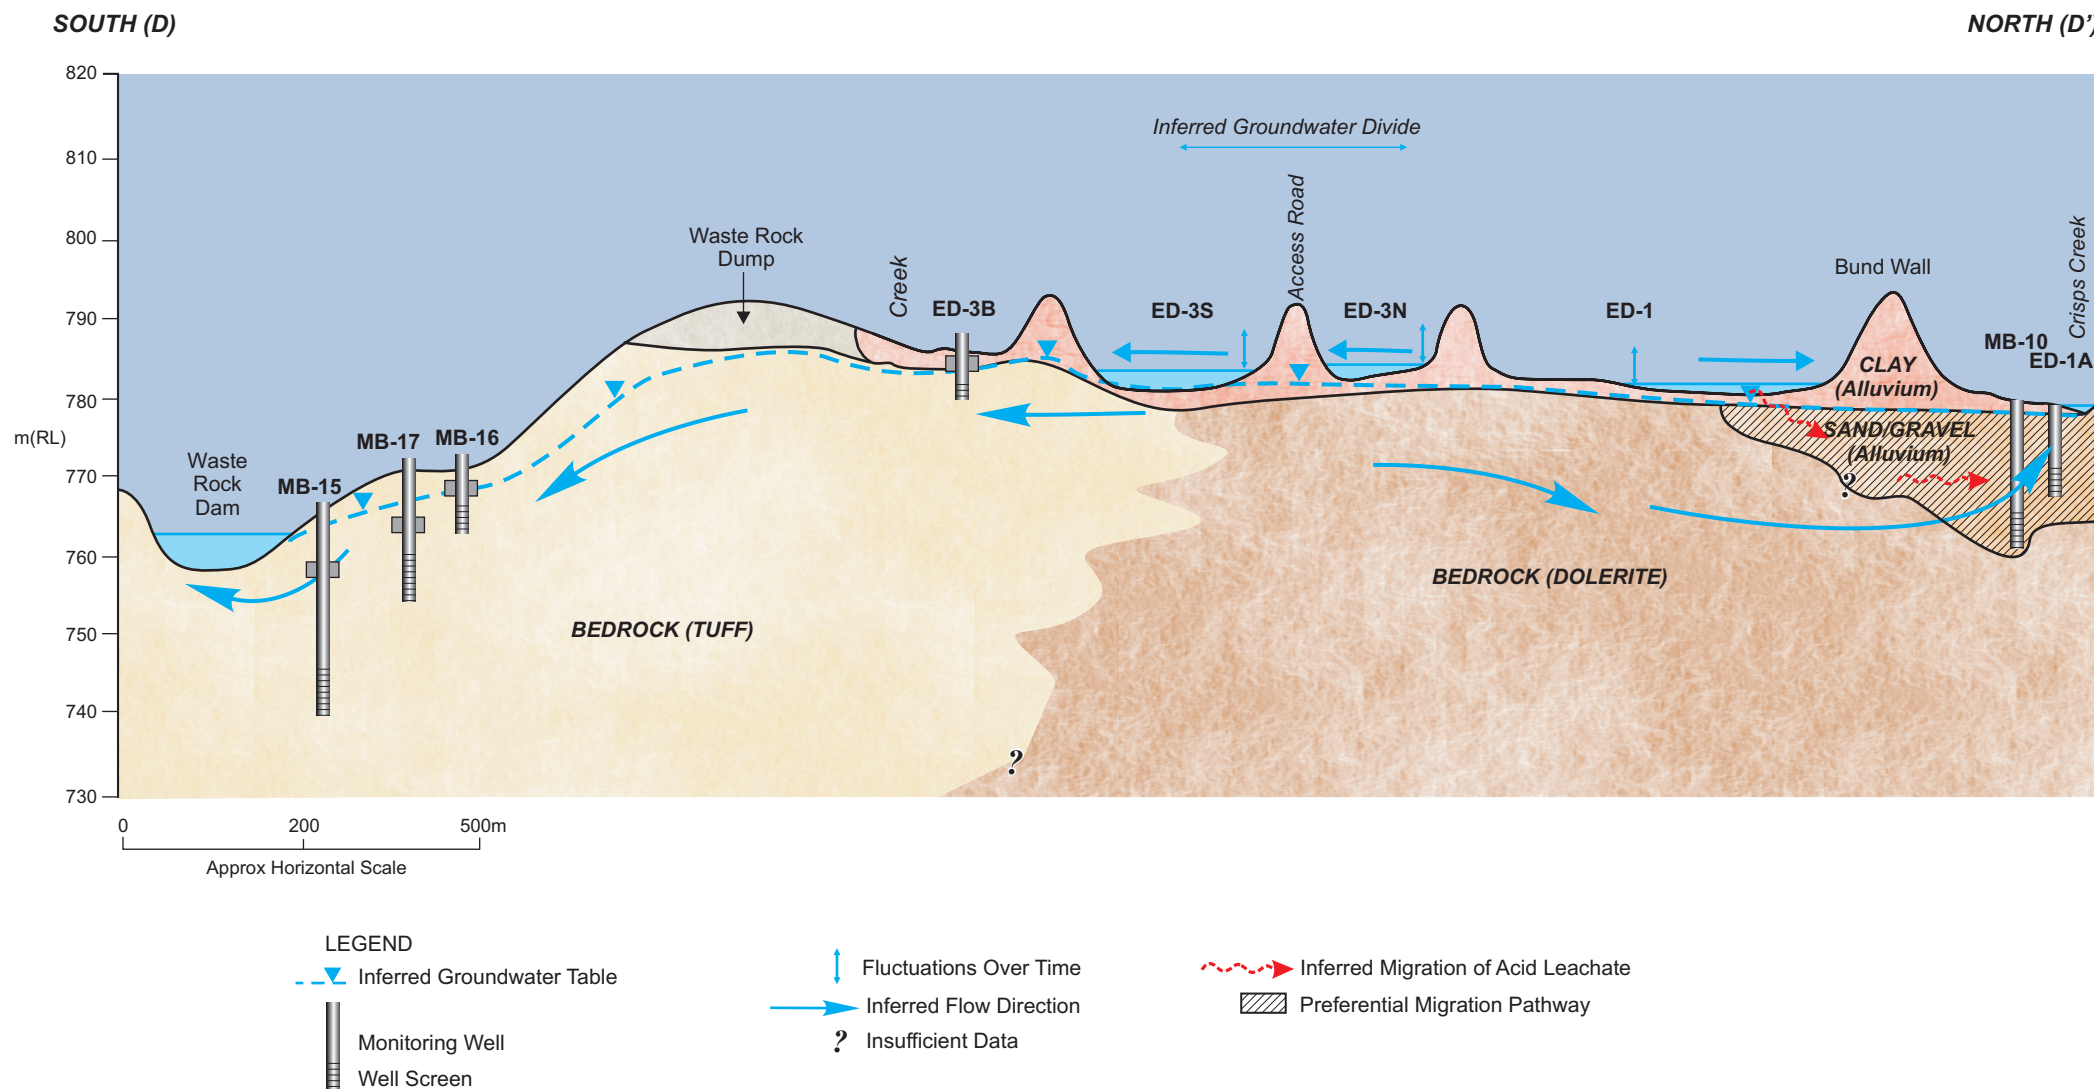
Figure 5

INFERRED HYDROGEOLOGICAL SECTION - ED1 TO WRD

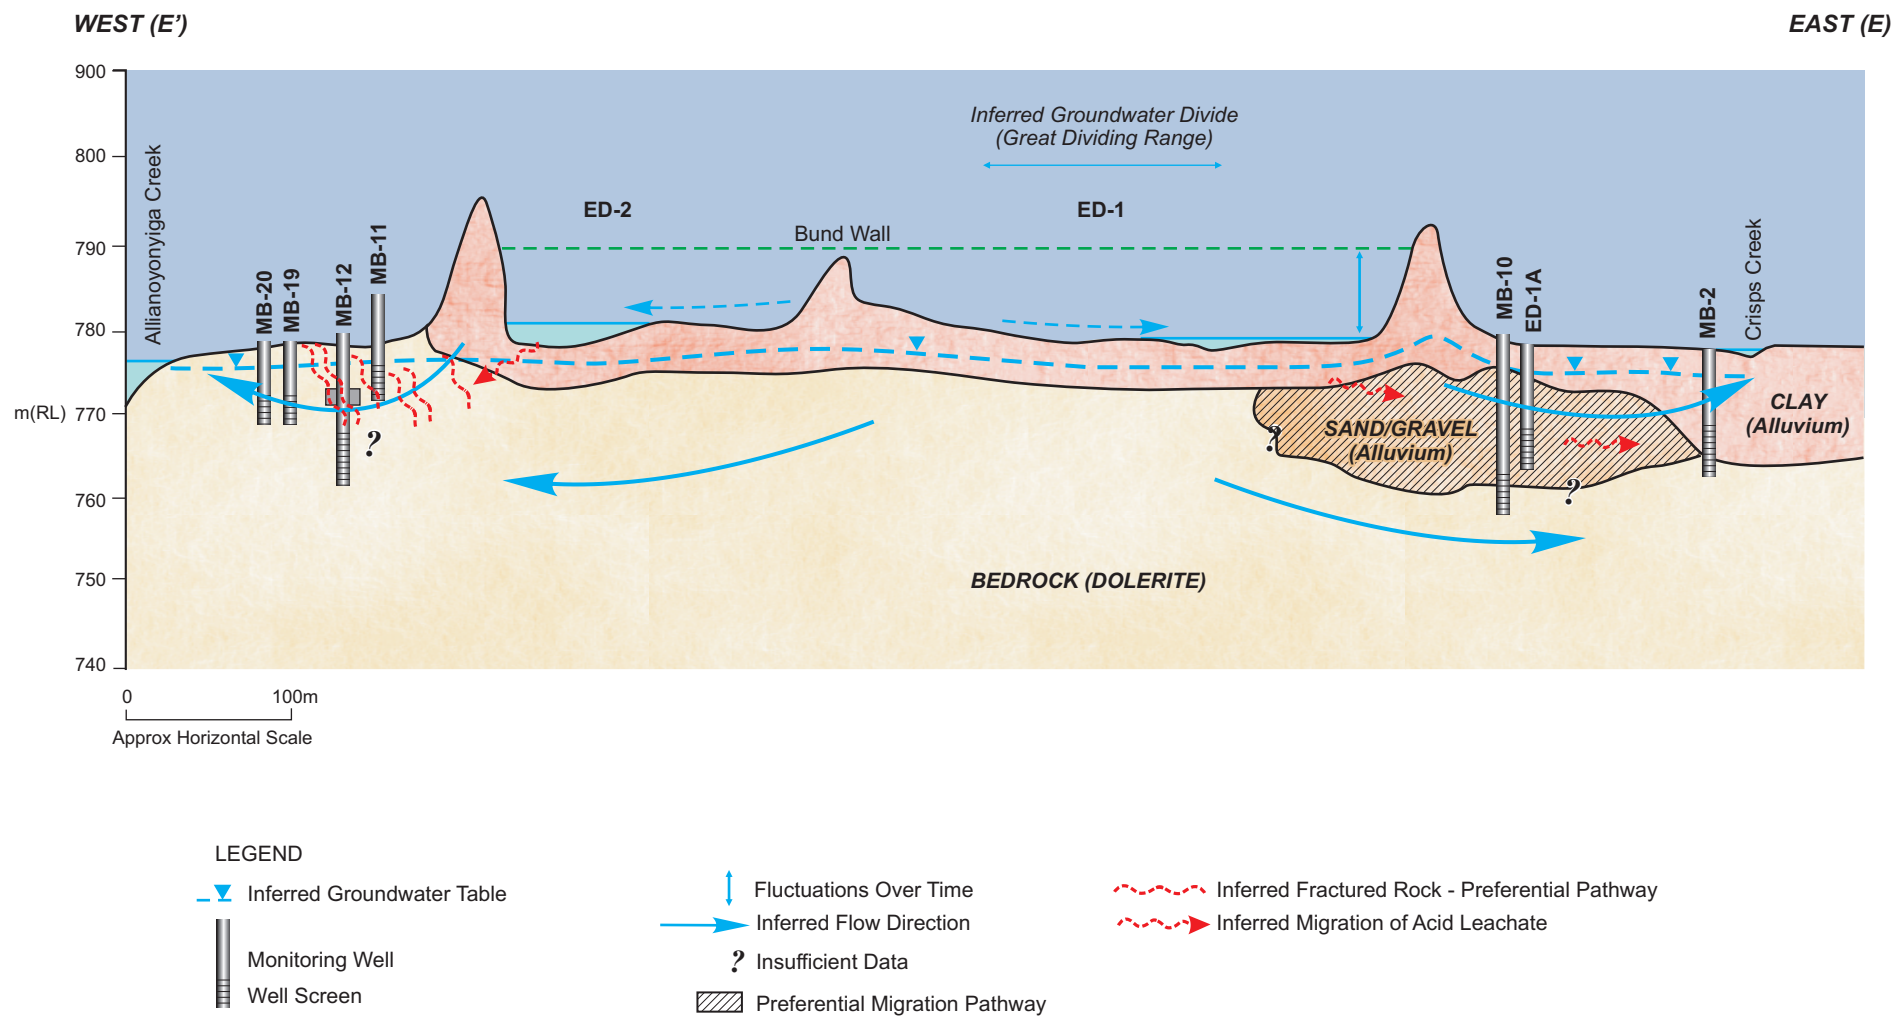
Figure 6

INFERRED HYDROGEOLOGICAL SECTION: ED1 & 2

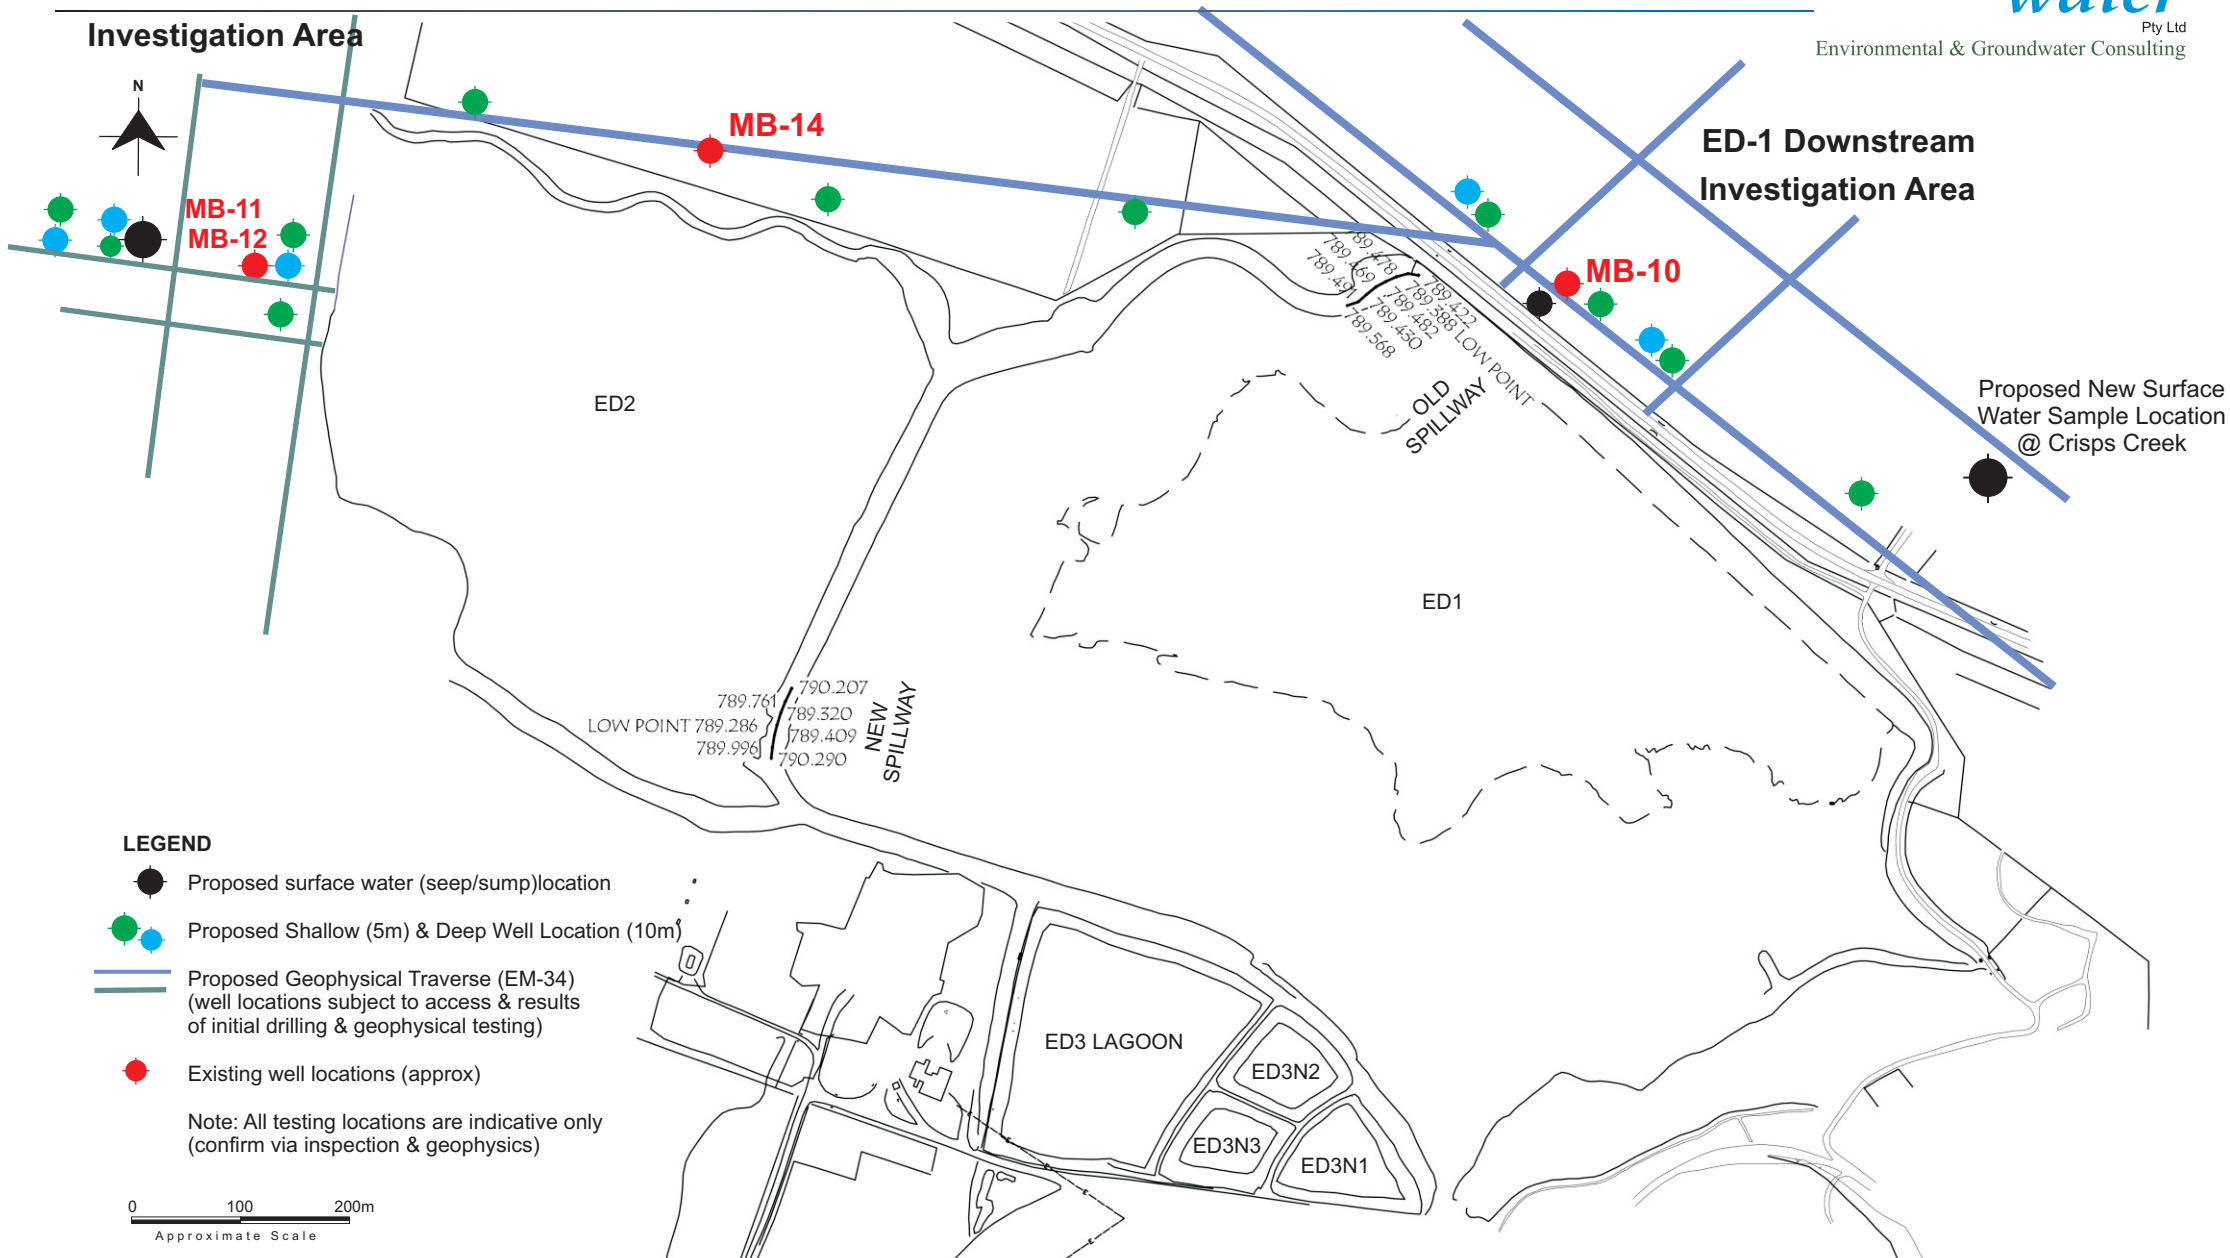
Figure 7

ED1& 2 Proposed Geophysical & Preliminary Monitoring Locations
