Report on
Geotechnical and Hydrogeological Assessment

Proposed Scottish Hospital Redevelopment
Nield Avenue, Paddington

Prepared for
The Presbyterian Church (NSW) Property Trust

Project 71484.01
September 2010

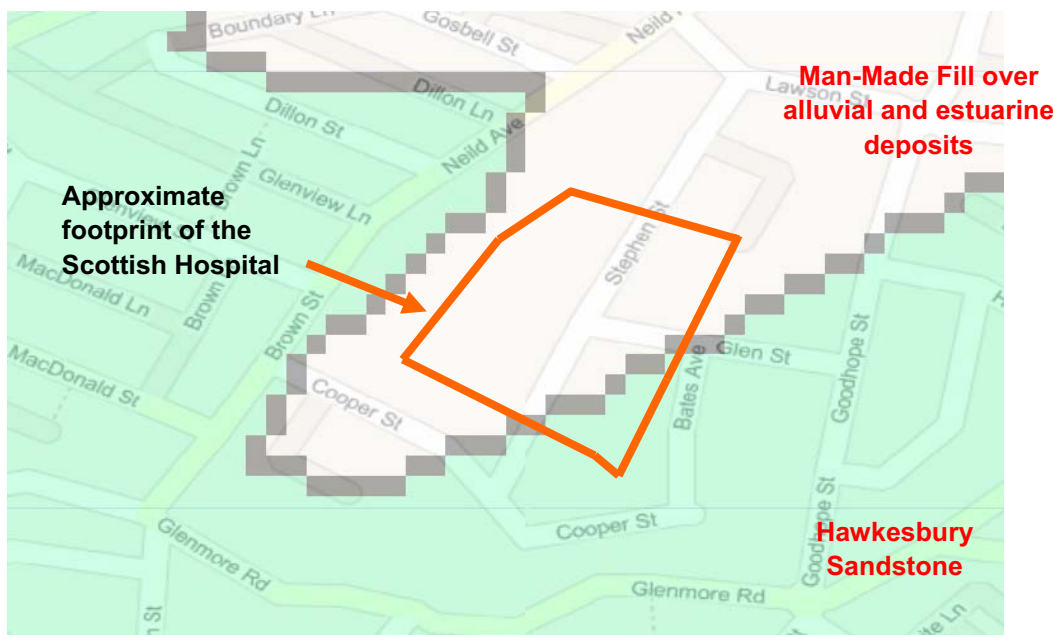
Figure 1: Distribution of Geological Units

Reference to the Sydney 1:100 000 Geological Series Sheet 9130 indicates that the site is underlain by Hawkesbury Sandstone of Triassic age on the western boundary and south-west corner. The bedrock is mantled by man-made fill overlying alluvial and estuarine deposits, comprising mainly peaty quartz sand, silt and clay, within the remainder of the site. A map showing the different geological units relative to the site boundaries is provided below in Figure 1.
