Client	Health Infrastructure c/o Capital Insight
Location	Westmead Millennium Research Institute & Research Hub.
Document Type	Arboriculture Assessment for Development Application
Date/Time	16 th August 2010

THE ENTS TREE CONSULTANCY

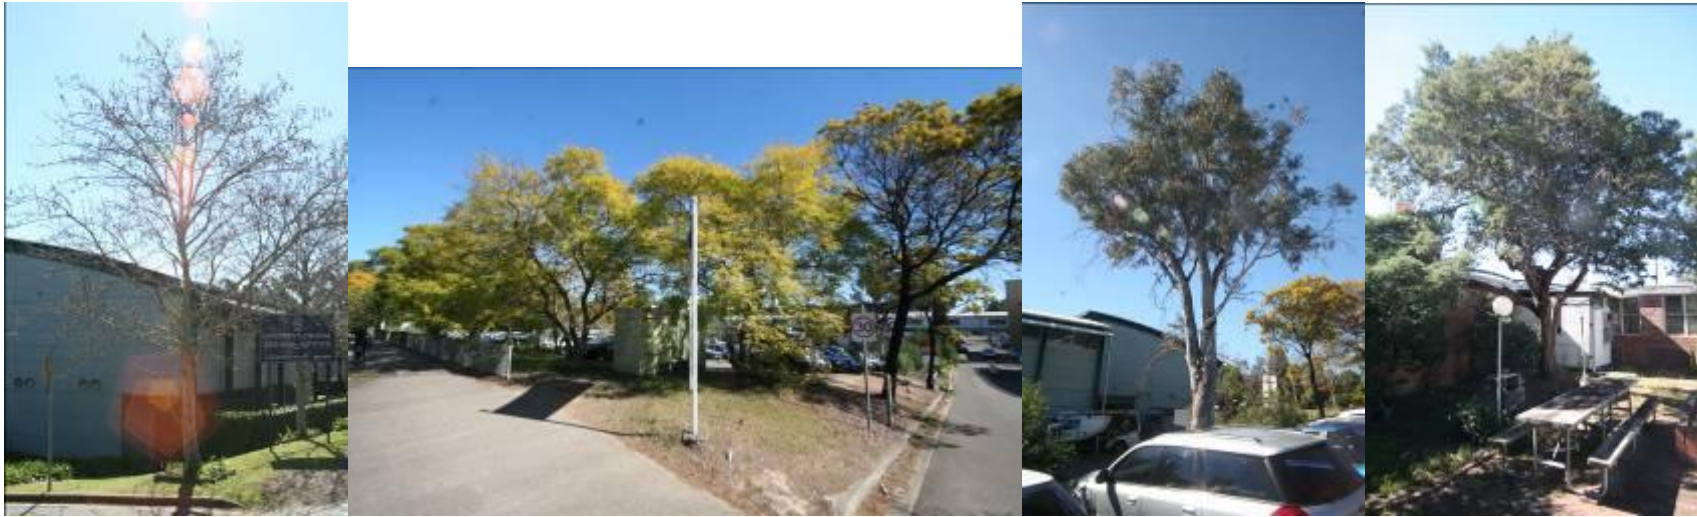
Tree No	Species	Height (m)	Trunk Diameter (DBH*)	Canopy Spread (m)	Estimated Age Class	TPZ ** (M)	SULE ***	Observations and comments
1	<i>Platanus x hybrida</i>	8	.25	6	Semi mature	3 ^m SRZ 1.85	Long	This semi mature tree is located close to the foot path and driveway. The tree has average health and average form for the species. The tree has no significant wounds or defects evident. Possible crown lift required to the South of the tree for access.
2	<i>Jacaranda mimosaeifolia</i>	6	.20 (multi)	6	Semi mature	2.4 SRZ 1.7	Medium	This semi mature tree is located close to the foot path and driveway. The tree has average health and below average form for the species. Proposed to be removed.
3	<i>Jacaranda mimosaeifolia</i>	7	.42	7	Semi mature	N/A	Medium	This semi mature tree is located close to the foot path. The tree has average health and below average form for the species. Proposed to be removed.

3a	<i>Jacaranda mimosaeifolia</i>	7	.31	5	Semi mature	N/A	Medium	This semi mature tree is located close to the foot path. The tree has average health and below average form for the species. Proposed to be removed.
4	<i>Jacaranda mimosaeifolia</i>	8	.42	7	Semi mature	N/A	Medium	This semi mature tree is located close to the foot path. The tree has average health and below average form for the species. Proposed to be removed.
5	<i>Acacia decurrens</i>	8	.32	6	Semi mature	N/A	Short	This mature tree is located close to the driveway. The tree has below average health and form for the species. The tree is proposed to be removed.
6	<i>Acacia decurrens</i>	7	.15	4	Semi mature	N/A	Short	This mature tree is located close to the driveway. The tree has below average health and form for the species. The tree is proposed to be removed.
7	<i>Eucalyptus scoparia</i>	9	.49	6	Mature	N/A	Medium	This mature tree is located close to the driveway. The tree has below average health and form for the species. The tree is proposed to be removed.

8	<i>Juniperus chinensis</i>	11	.37	4	Semi mature	N/A	Medium	A mature tree with below average health, vigour and form. The tree has dieback throughout crown and is in position of building, proposed to be removed.
9	<i>Acacia decurrens</i>	6	.10	2	Young	N/A	Medium	A group of semi mature trees with good health, vigour and form. Trees are self sown and are fast growing. These trees are located in the position of the proposed building.
10	<i>Grevillea robusta</i>	8	.29	5	Semi mature	N/A	Medium	A self sown semi mature tree with average health, vigour and below average form. This tree is located in the position of the proposed building.

Tree No	Species	Height (m)	Trunk Diameter (DBH*)	Canopy Spread (m)	Estimated Age Class	TPZ ** (M)	SULE ***	Observations and comments
11	<i>Chaamocyparis lawsoniana</i>	12	.41	8	Mature	N/A	Medium	A mature tree with average health, vigour and form. In position of building, proposed to be removed.
12	<i>Liquidambar styraciflua</i>	7	.10	4	Semi mature	N/A	Medium	This group of 15 semi mature trees are located close to the existing building to be demolished. The trees have average health and below appear to have been self sown. Proposed to be removed.
13	<i>Cinnamomum camphora</i>	5	.09	2	Young	N/A	Medium	A young tree with average health, vigour and form. In position of building, proposed to be removed.
14	<i>Corymbia citriodora</i>	15	.36	10	Mature	4.2 SRZ 2.15	Medium	A mature tree with average health vigour and form. No significant defects evident.
15	<i>Corymbia citriodora</i>	15	.31	8	Mature	3.6 SRZ 2	Medium	A mature tree with average health vigour and form. No significant defects evident.

Picture above left shows tree 1. Picture above centre left shows trees 2- 4. Above centre right shows tree 7. Above right shows tree 11. Below left shows tree s 10, 11 & 8. Below right shows tree12 & 13

5.2 Trees 2-13, 16, 17 & trees 19 – 24 are removed. The majority of these trees are not significant and an effort should be made to incorporate new tree specimens in the new landscape management plan.

5.3 It is recommended that trees 1, 14, 15, 18 and trees 25 -28 are retained in good condition for the duration of the works using the Australian Standard AS4970 2009 Protection of trees on development sites. Some trees with road or pedestrian paths within their nominated tree protection area will require modified tree protection zone to allow for continued pedestrian access and continued vehicular movement. Pruning for crown clearance is required on trees 1 & 14. The pruning will be minimal and allows for 10% of the trees total crown to be removed.

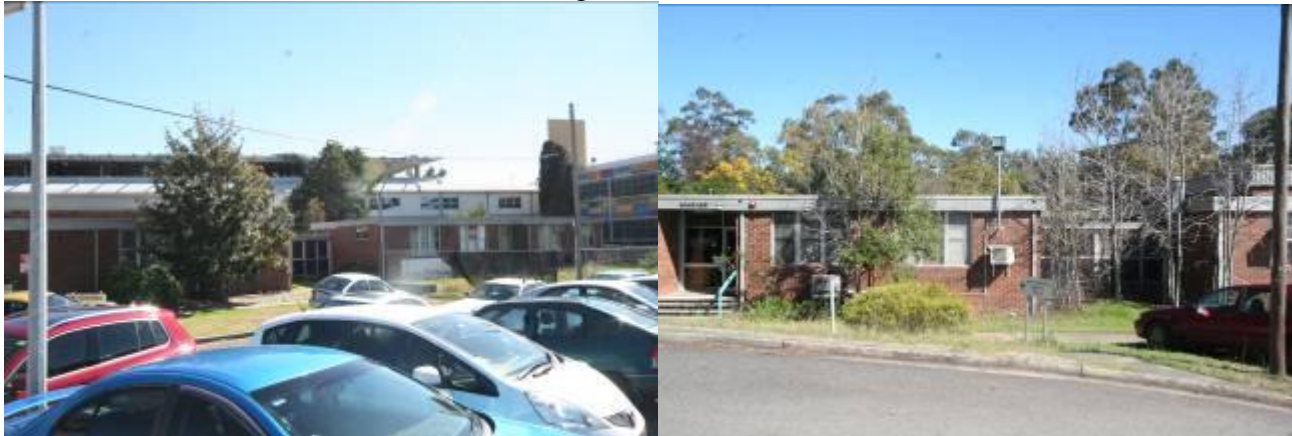
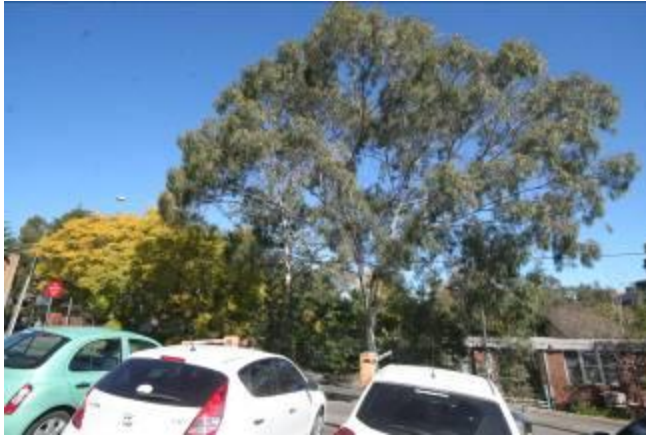
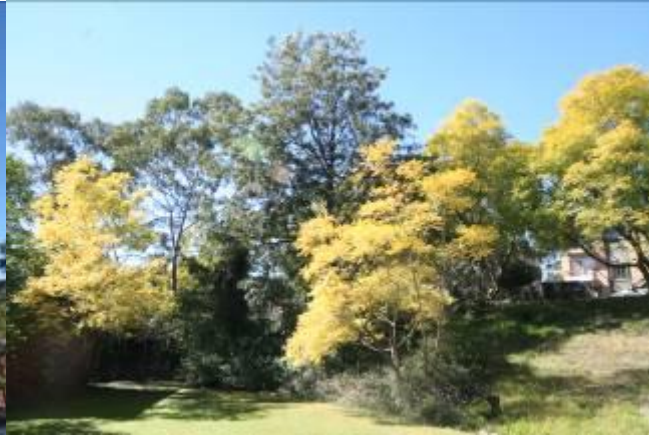
Tree No	Species	Height (m)	Trunk Diameter (DBH*)	Canopy Spread (m)	Estimated Age Class	TPZ ** (M)	SULE ***	Observations and comments
23	<i>Grevillea robusta</i>	9	.11	3	Semi mature	N/A	Medium	A self sown semi mature tree with average health, vigour and below average form. This tree is located in the position of the proposed car park.
24	<i>Ligustrum lucidum</i>	5	.10	4	Semi mature	N/A	Medium	A self sown semi mature tree with average health, vigour and below average form. This tree is located in the position of the proposed car park
25	<i>Jacaranda mimosaeifolia</i>	12	.42	9	Mature	4.6 SRZ 2.25m	Medium	This mature tree is located close to the footpath and forms part of an avenue. Tree to be retained no impacts are anticipated.
26	<i>Jacaranda mimosaeifolia</i>	11	.27	7	Mature	3.6 SRZ 2m	Medium	This mature tree is located close to the footpath and forms part of an avenue. Tree to be retained no impacts are anticipated.

27	<i>Jacaranda mimosaeifolia</i>	11	.35	7	Mature	4.2 SRZ 2.15	Medium	This mature tree is located close to the footpath and forms part of an avenue. Tree to be retained no impacts are anticipated.
28	<i>Jacaranda mimosaeifolia</i>	11	.31	8	Mature	3.6 SRZ 2m	Medium	This mature tree is located close to the footpath and forms part of an avenue. Tree to be retained no impacts are anticipated.
29	<i>Jacaranda mimosaeifolia</i>	11	.39	9	Mature	4.6 SRZ 2.25m	Medium	This mature tree is located close to the footpath and forms part of an avenue. Tree to be retained no impacts are anticipated.
30	<i>Jacaranda mimosaeifolia</i>	11	.31	7	Mature	3.6 SRZ 2m	Medium	This mature tree is located close to the footpath and forms part of an avenue. Tree to be retained no impacts are anticipated.
31	<i>Grevillea robusta</i>	15	.35	8	Mature	4.2 SRZ 2.15	Medium	A self sown mature tree with average health, vigour and below average form. This tree has a wound on the E side at the base.

32	<i>Grevillea robusta</i>	9	.32	6	Mature	3.6 SRZ 2m	Medium	A self sown mature tree with average health, vigour and below average form.
33	<i>Grevillea robusta</i>	15	.35	8	Mature	3.6 SRZ 2m	Medium	A self sown mature tree with average health, vigour and below average form.

Tree No	Species	Height (m)	Trunk Diameter (DBH*)	Canopy Spread (m)	Estimated Age Class	TPZ ** (M)	SULE ***	Observations and comments
34	<i>Corymbia maculata</i>	17	.45	8	Mature	5.4 SRZ 2.37	Medium	A mature tree with average health, vigour and form. No significant defects were observed at the time of the inspection.
35	<i>Corymbia citriodora</i>	14	.12	4	Semi mature	2 SRZ 1.5	Medium	A mature tree with average health, vigour and form. No significant defects were observed at the time of the inspection.
36	<i>Syncarpia glomifera</i>	13	.19	5	Semi mature	2.4 SRZ 1.7m	Medium	This semi mature tree is located close to the footpath and forms part of an informal stand. Tree to be retained no impacts are anticipated.
37	<i>Eucalyptus scoparia</i>	14	.33	7	Mature	3.6 SRZ 2m	Medium	This mature tree is located close to the footpath and forms part of an avenue. The tree has winter bronzing. Tree to be retained no impacts are anticipated.

Picture above left shows trees 14, 15 & 18. Picture above right shows trees 19 – 27.
Picture below left 21 – 37. Pictured above right are trees 34 – 25

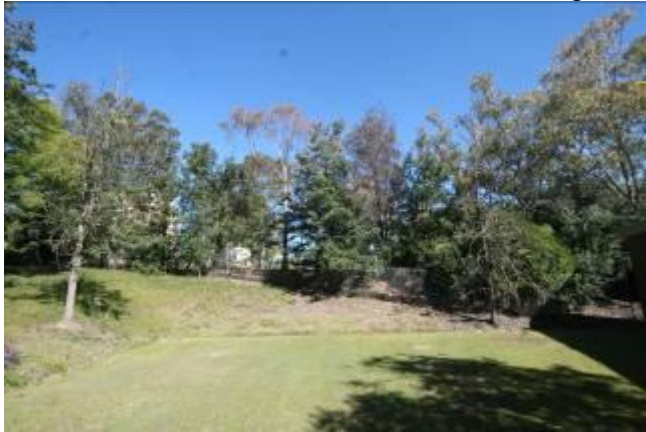
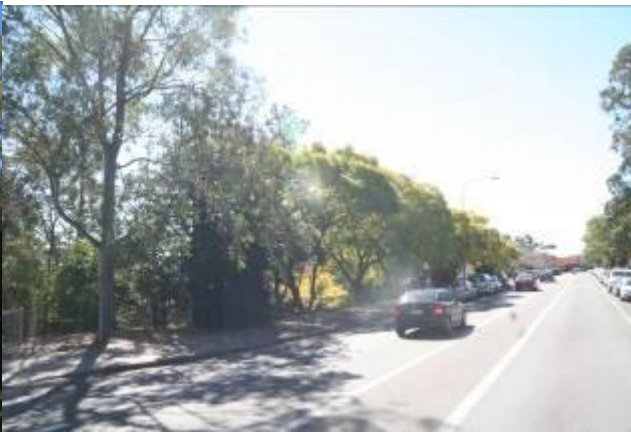
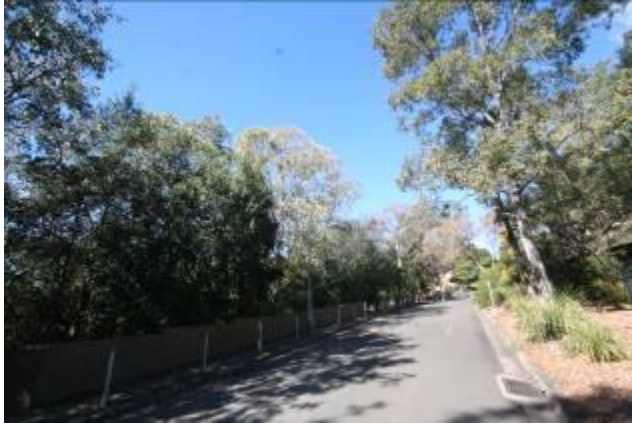
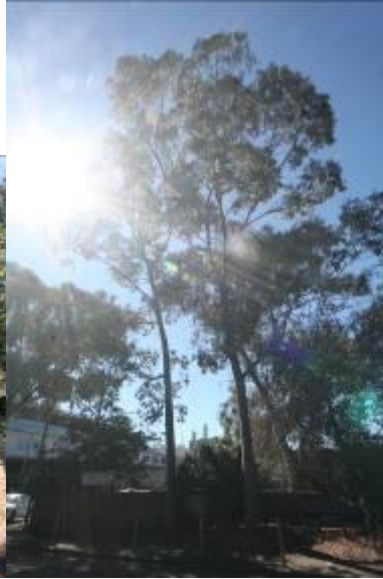
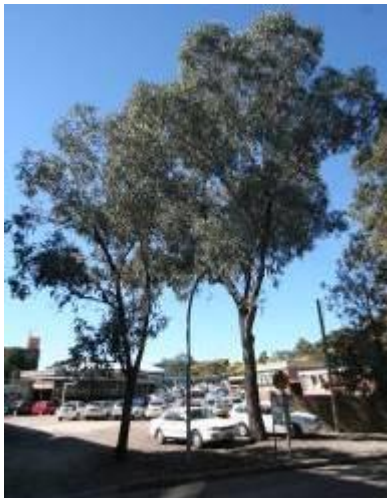
38	<i>Casuarina littoralis</i>	9	.21	6	Mature	2.4 SRZ 1.7m	Medium	This semi mature tree is located close to the footpath and forms part of an informal stand. Tree to be retained no impacts are anticipated.
39	<i>Eucalyptus scoparia</i>	14	.27	7	Mature	3.6 SRZ 2m	Medium	This mature tree is located close to the footpath and forms part of an avenue. The tree has winter bronzing. Tree to be retained no impacts are anticipated.
40	<i>Eucalyptus scoparia</i>	14	.33	7	Mature	3.6 SRZ 2m	Medium	This mature tree is located close to the footpath and forms part of an avenue. The tree has winter bronzing. Tree to be retained no impacts are anticipated.
41	<i>Eucalyptus scoparia</i>	13	.25	6	Mature	3.6 SRZ 2m	Medium	This mature tree is located close to the footpath and forms part of an avenue. The tree has winter bronzing. Tree to be retained no impacts are anticipated.
42	<i>Eucalyptus scoparia</i>	12	.21	5	Mature	3.6 SRZ 2m	Medium	This mature tree is located close to the footpath and forms part of an avenue. The tree has winter bronzing. Tree to be retained no impacts are anticipated.

43	<i>Corymbia maculata</i>	18	.43	8	Mature	5.4 SRZ 2.37	Medium	A mature tree with average health, vigour and form. Tree has winter bronzing. No significant defects were observed at the time of the inspection.
44	<i>Corymbia maculata</i>	17	.42	8	Mature	5.4 SRZ 2.37	Medium	A mature tree with average health, vigour and form. Tree has winter bronzing. No significant defects were observed at the time of the inspection.

Tree No	Species	Height (m)	Trunk Diameter (DBH*)	Canopy Spread (m)	Estimated Age Class	TPZ ** (M)	SULE ***	Observations and comments
45	<i>Eucalyptus scoparia</i>	17	.72	8	Mature	8.4 SRZ 2.85	Short	This mature tree is located close to the existing building, the tree has been lopped and has decay. The tree has winter bronzing. Tree to be retained no impacts are anticipated. If retained further investigation of decay required.
46	<i>Grevillea robusta</i>	9	.21	4	Semi mature	2.4 SRZ 1.7m	Medium	A self sown mature tree with average health, vigour and below average form.
47	<i>Eucalyptus moluccana</i>	17	.57	9	Mature	7.2 SRZ 2.7	Medium	This mature tree is located close to the existing driveway and road. Tree to be retained no impacts are anticipated.
48	<i>Eucalyptus moluccana</i>	9	.30	5	Mature	3.6 SRZ 2m	Medium	This mature tree is located close to the existing driveway and road. Tree to be retained no impacts are anticipated.

Pictured above left are trees 36-42. Pictured above right are trees 43 & 44.
Pictured below are trees 47 & 48.

4.6.4 Trees 35 to 44 will have little or no disturbance to their biological root zones occur, (less than 10%) and no disturbance to the trees structural root zone. This is due to their position away from the works. In some cases retaining wall and or physical barriers will separate these trees form the work zone. Tree 45 is close to the demolition zone and limited access to the trees TPZ will be permitted with no machinery access allowed with the trees SRZ.

4.6.5 Trees 46 to 48 are located in an area of proposed and existing traffic movement. No building works are planned to occur here and the areas use will remain largely unchanged. These trees will require tree protection fencing to ensure no damage to the trees vascular tissue occurs. All three trees nominated to be assessed are to be retained in good condition for the duration of the works using the Australian Standard AS4970 2009 Protection of trees on development sites as the basis for a tree management plan.
