Asbestos & Synthetic Mineral Fibre Survey & Register Gosford Hospital, Holden Street, Gosford

22 June 2005

Central Coast Health Service

HLA-Envirosciences Pty Limited

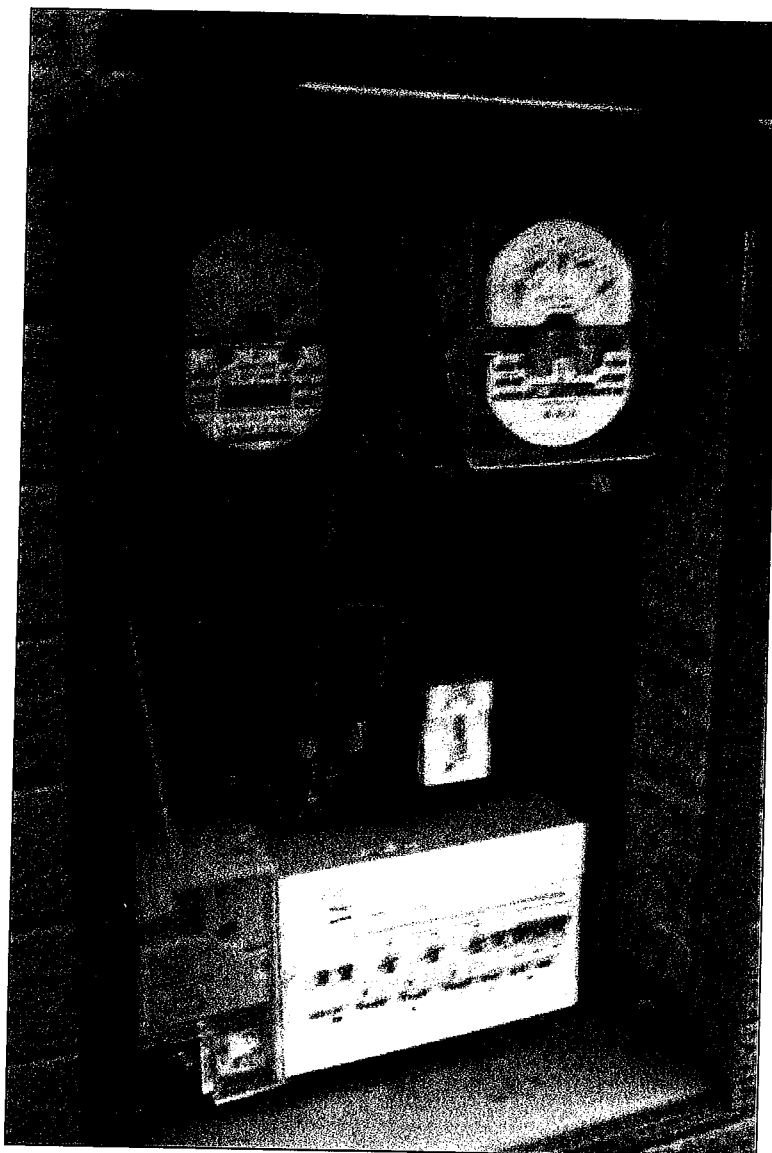
Photograph No. 3: Suspected Zelnite Backing Board in Electrical Switchboard

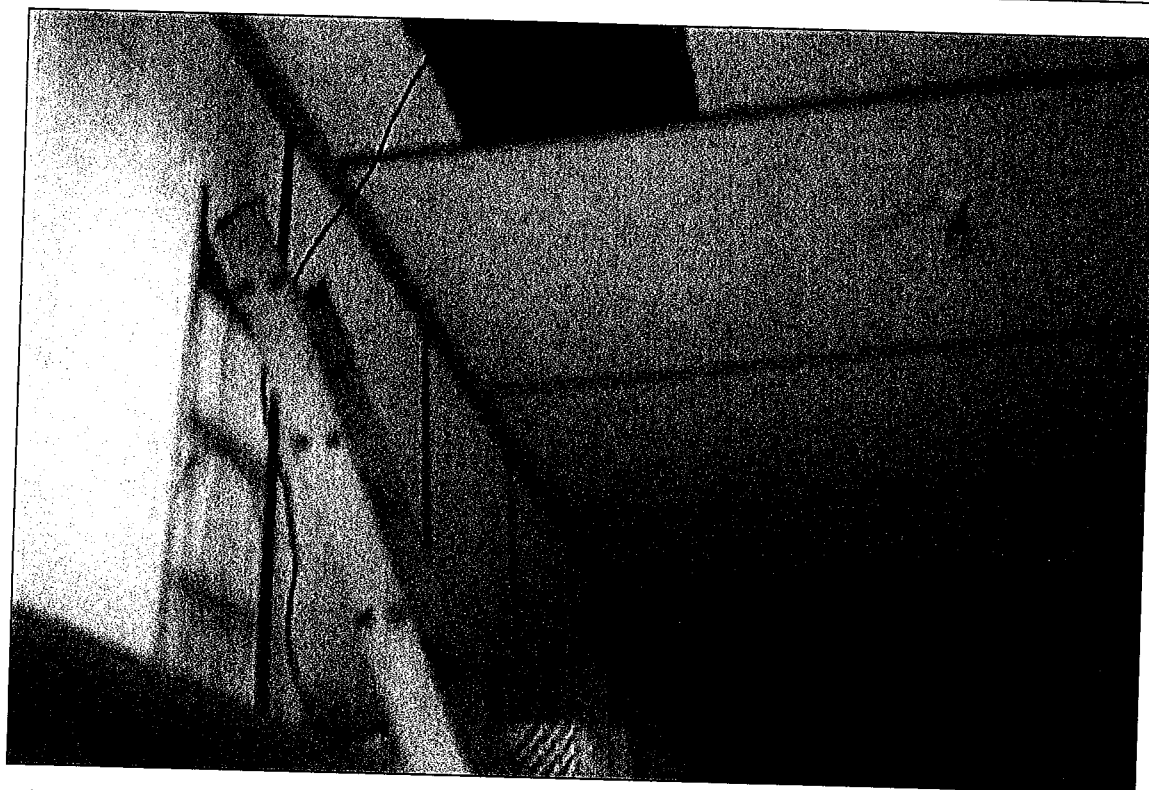
Photograph No. 4: Suspected Asbestos Cement Wall and Ceiling Lining to Old Garage

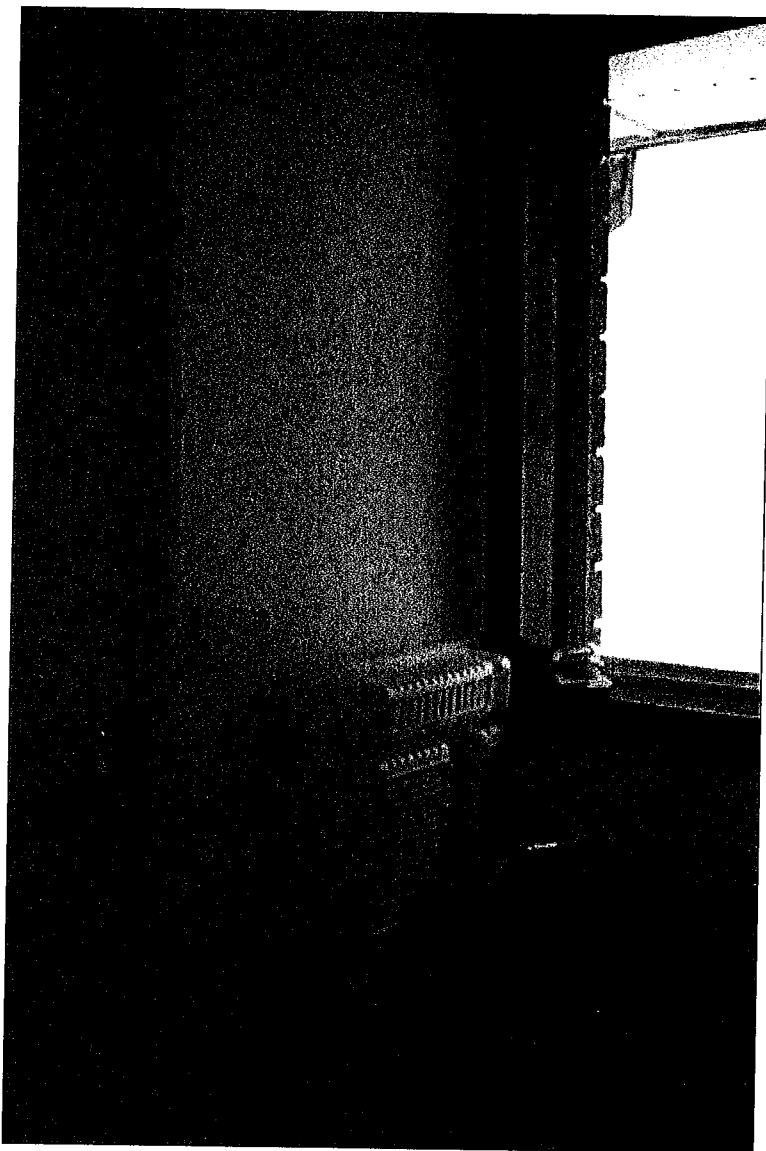
Photograph No. 6: Suspected Asbestos Cement Wall Lining to Laundry

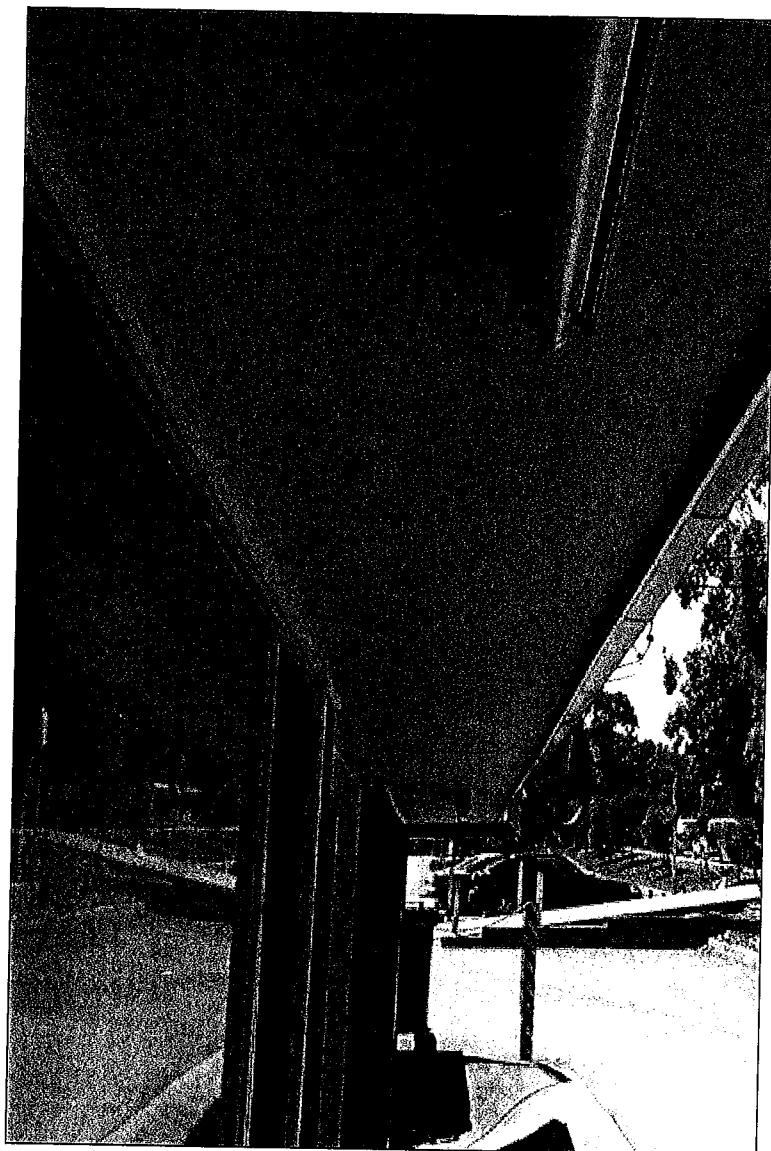
Photograph No. 10: Suspected Asbestos Cement Eave Lining to Building

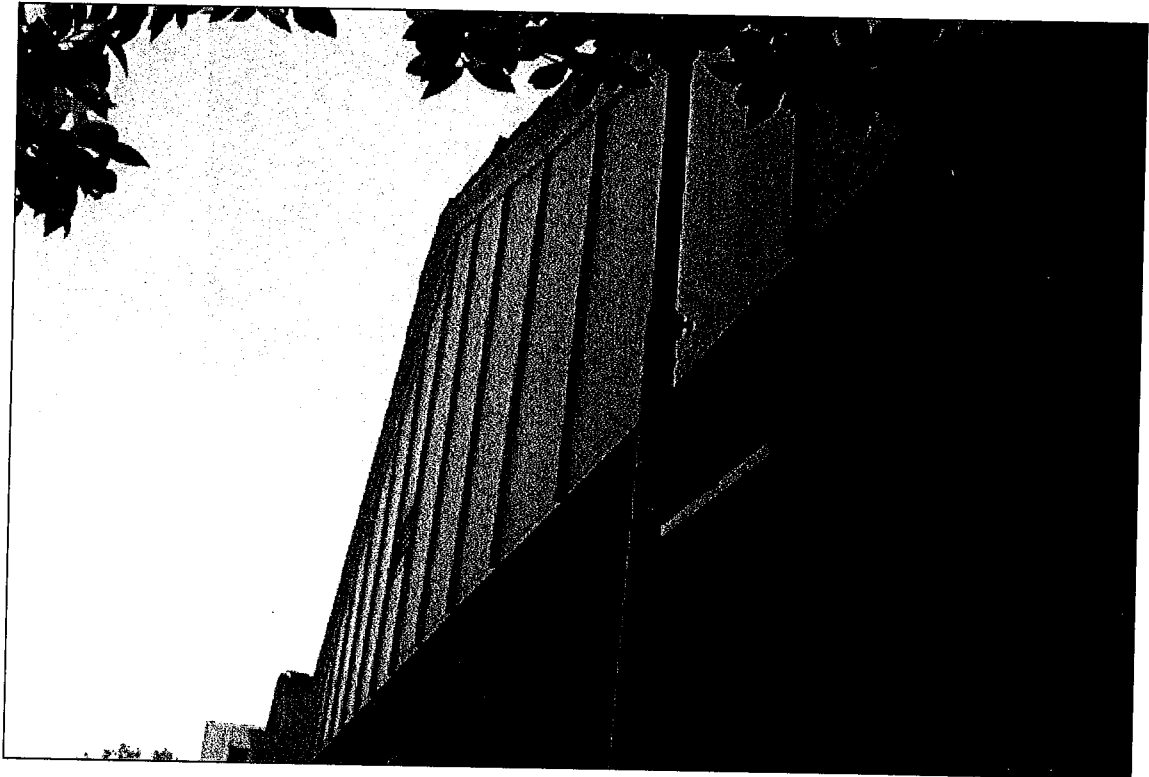
Photograph No. 11: Suspected Asbestos Cement Gable to Building (one end)

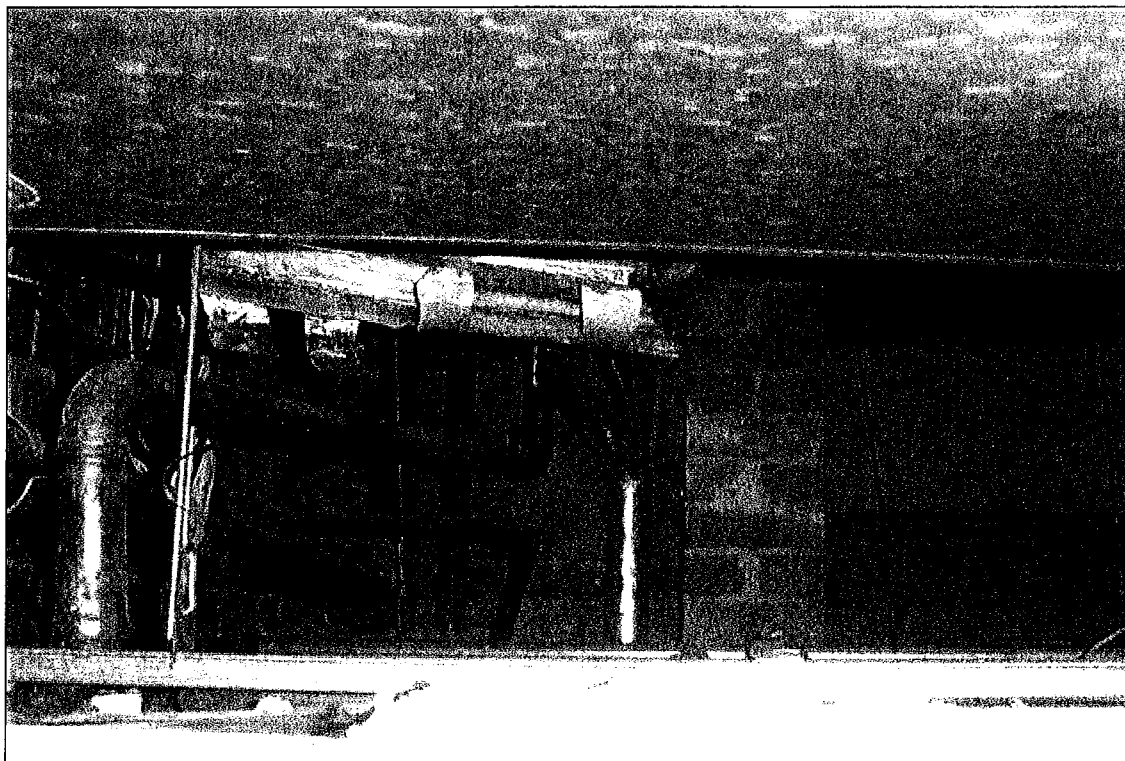
Photograph No. 45: SMF Insulated Pipe in Ceiling Space/Riser (Note: Damage)

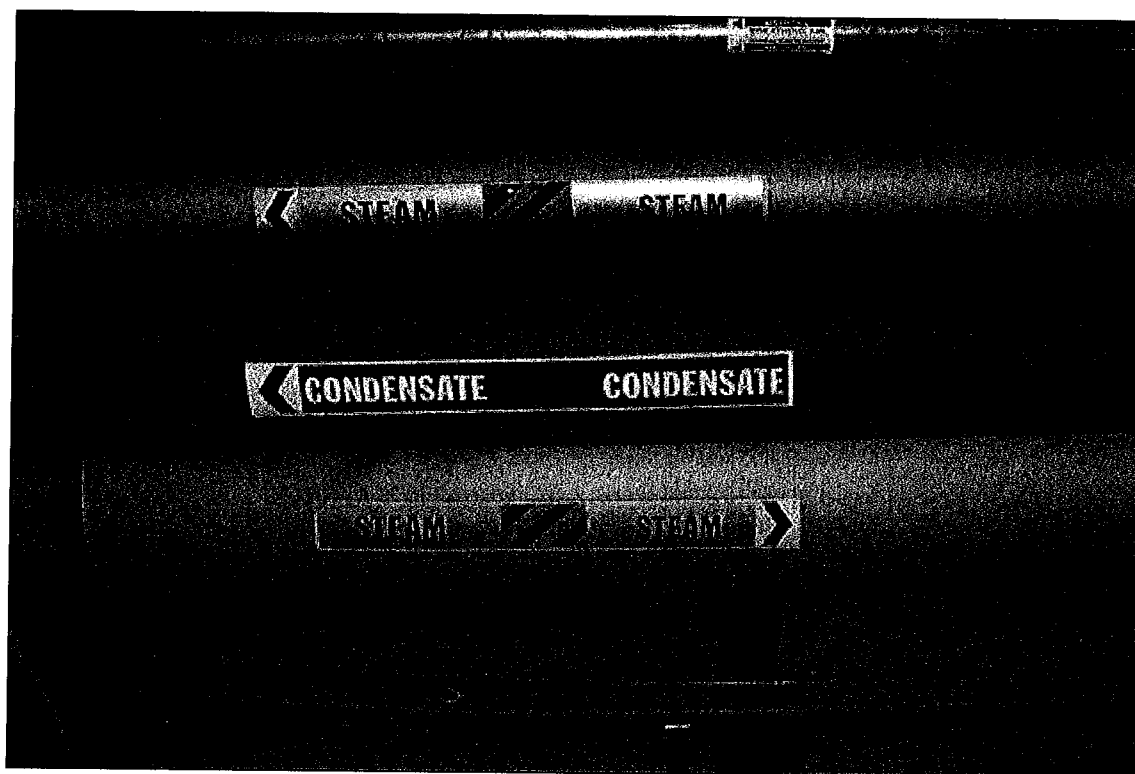
Photograph No. 51: SMF Insulation (in Metal) to Steam Lines in Plant Room

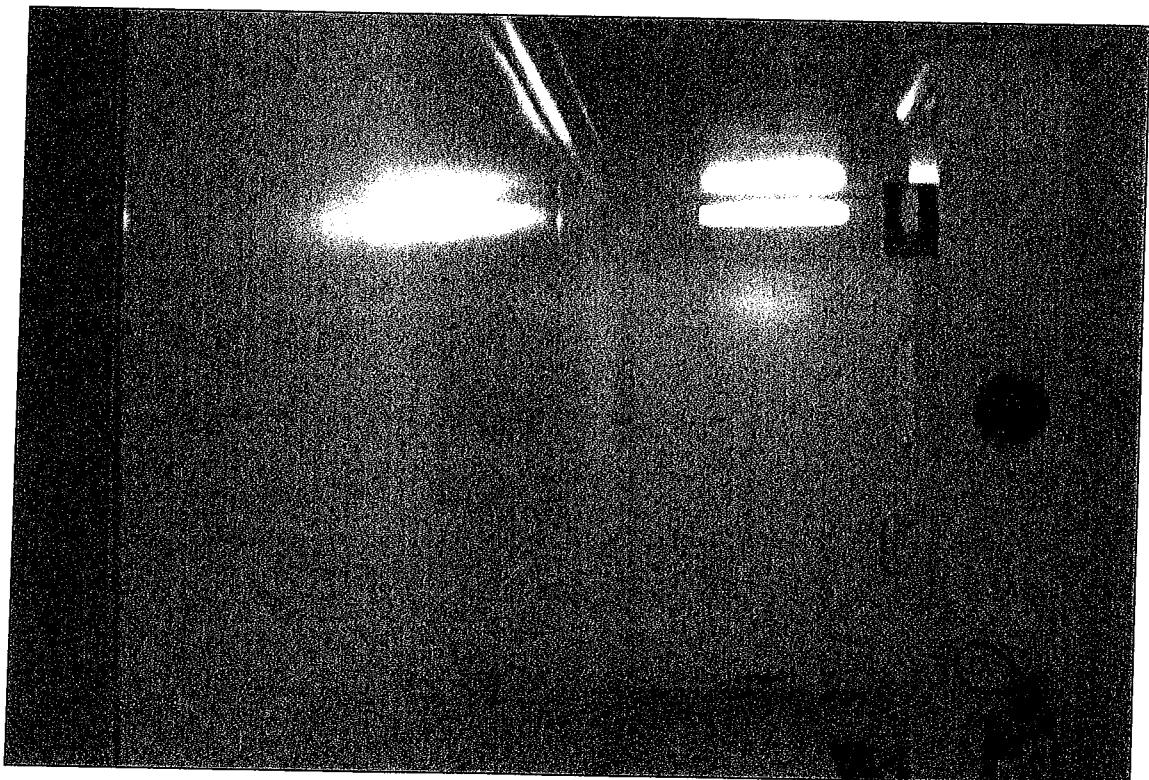
Photograph No. 59: Fibrous Cement wall Lining between Kitchen and Linen Services

The wall lining to the corridor between the kitchen and linen services is hard flat fibrous cement sheet. As in the internal dividing walls in the kitchen (see **Photographs No. 59** and **No. 60**).

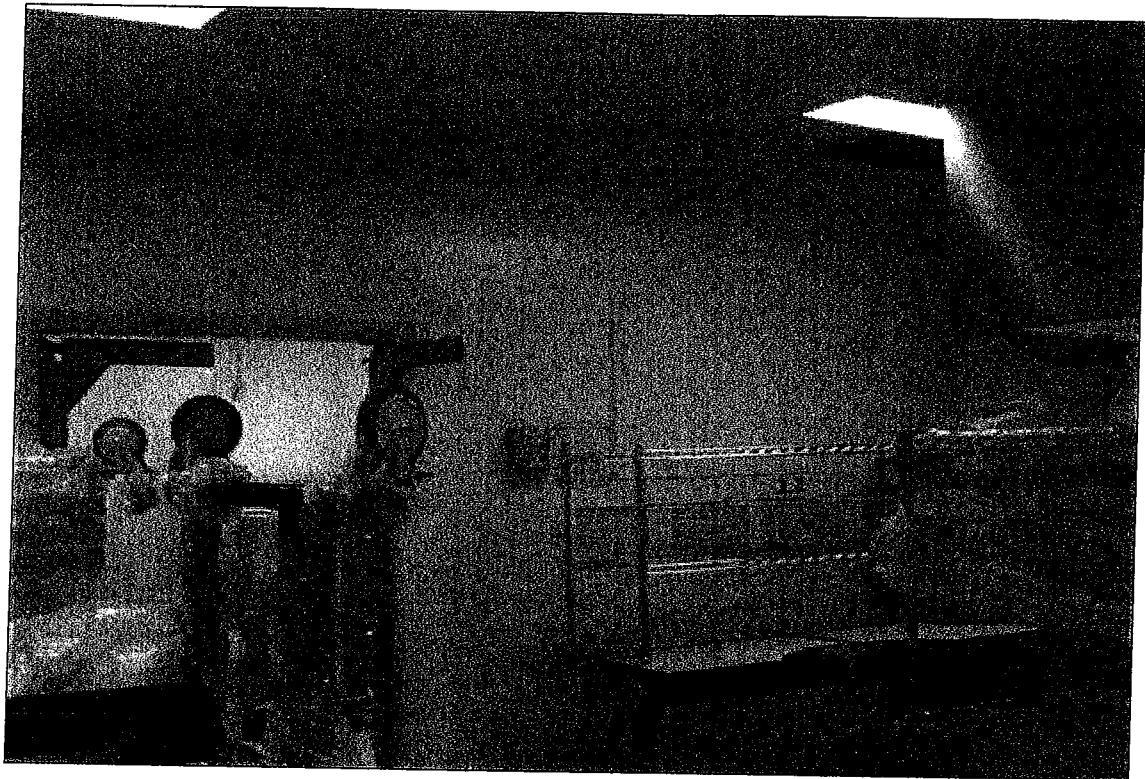
Photograph No. 60: Fibrous Cement Wall Lining to Dividing Walls in Kitchen Washing / Serving Area

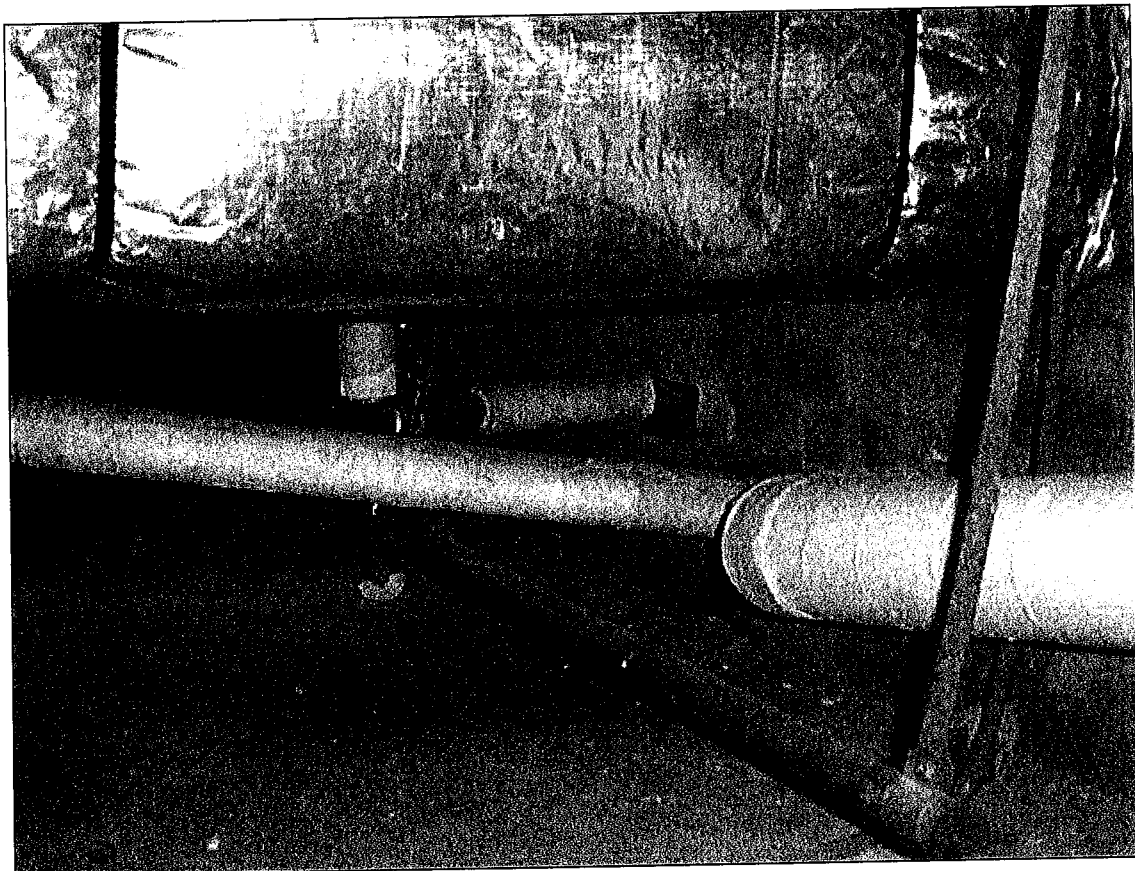
Photograph No. 73: Roof and A/C Duct Insulation above Old Theatres

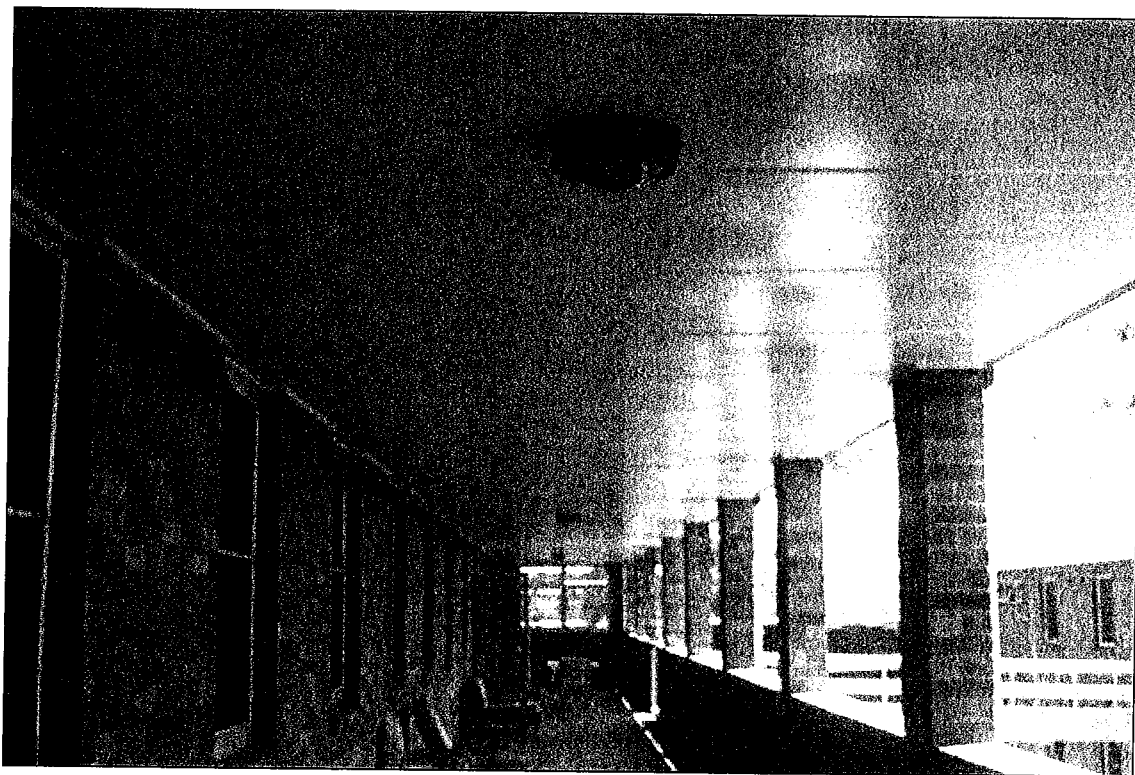
Photograph No. 93: Suspected Asbestos Cement Sheet to Verandah Ceiling Lining

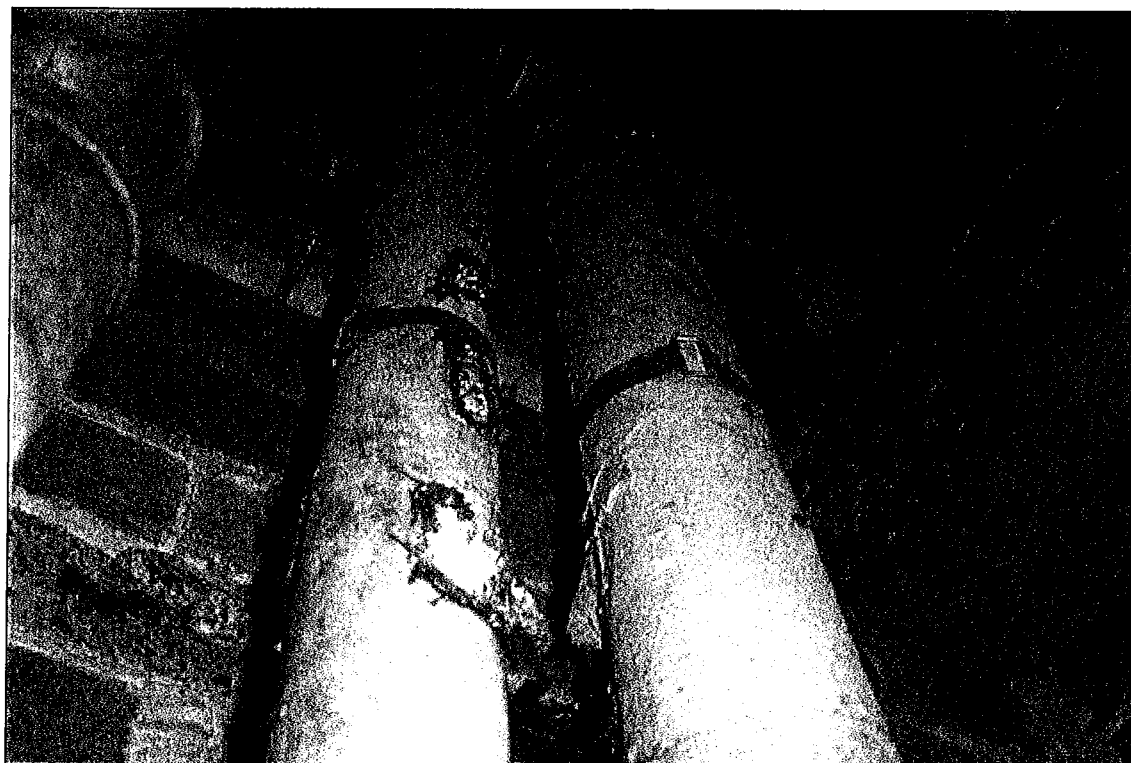
Photograph No. 97: Suspected Asbestos Insulated Pipes in Laundry Riser (Note Poor Condition)

The two risers with asbestos insulated pipes in the Cleaners Room and old Laundry on all levels are contaminated. The access should be sealed and programmed for removal under controlled conditions.

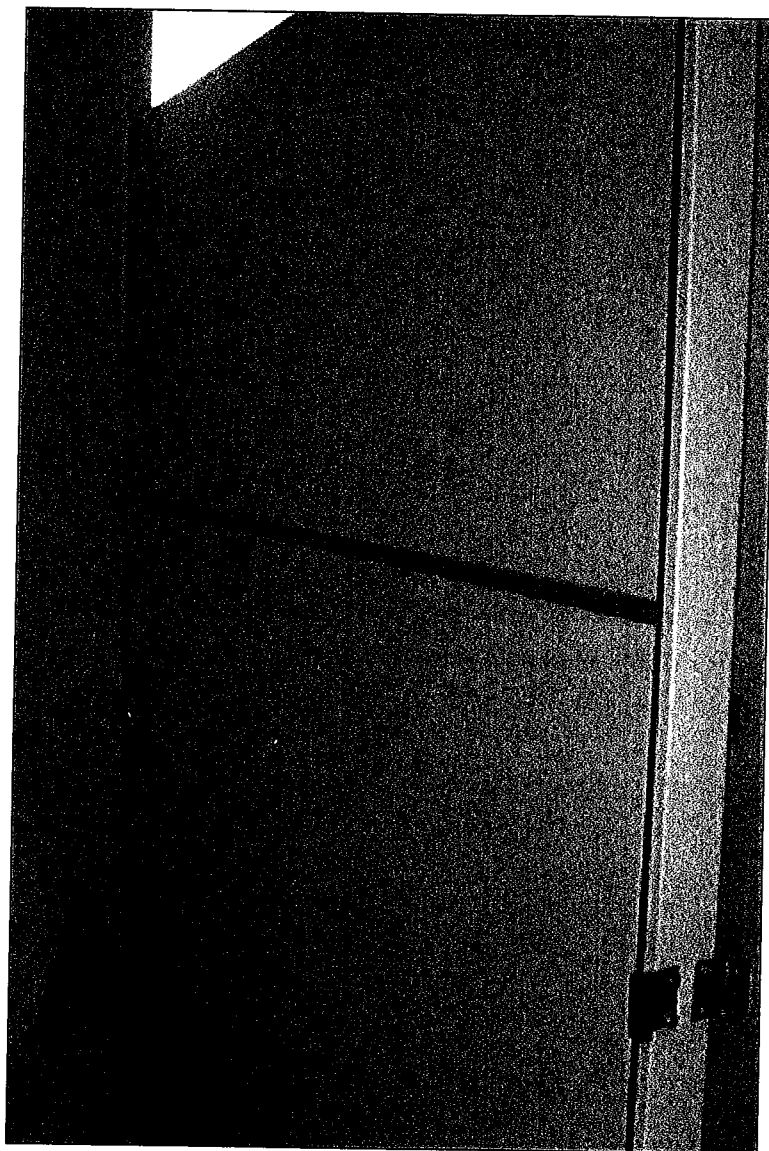
*Photograph No. 109: Suspected Compressed Asbestos Cement Toilet Cubicle Partition
(Typical)*

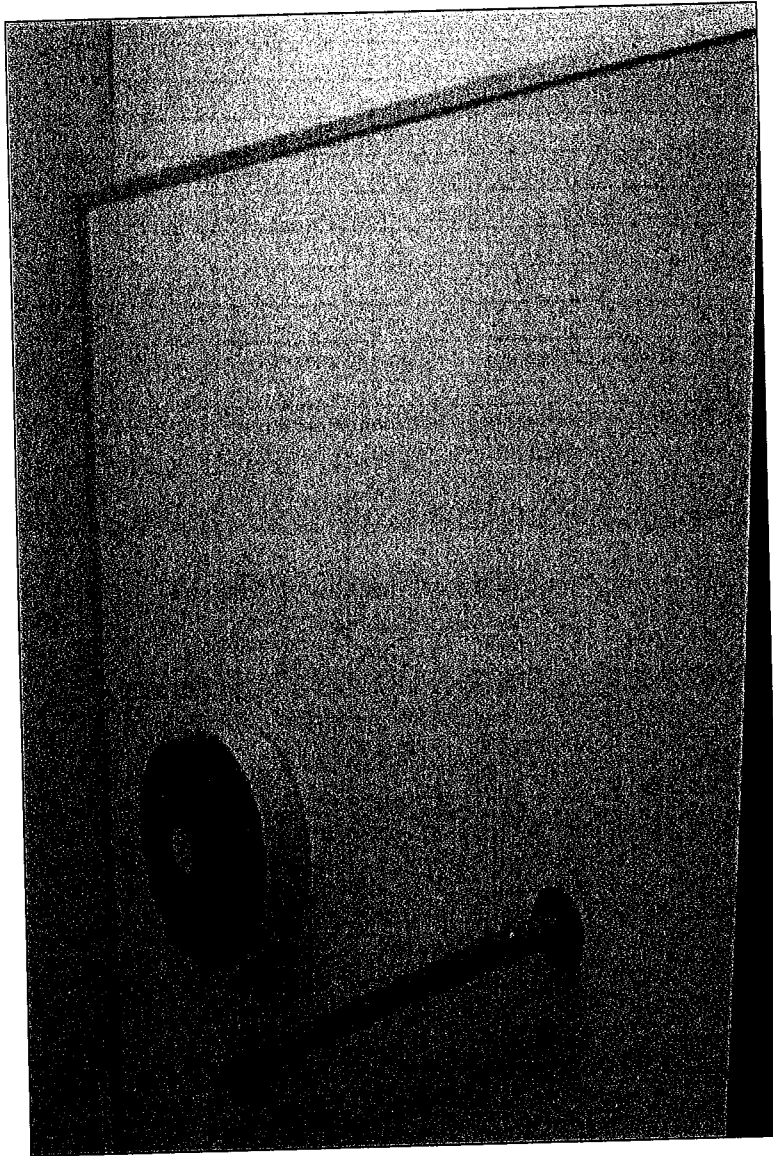
Photograph No. 124: Suspected Compressed A/C Cubicle to Toilets

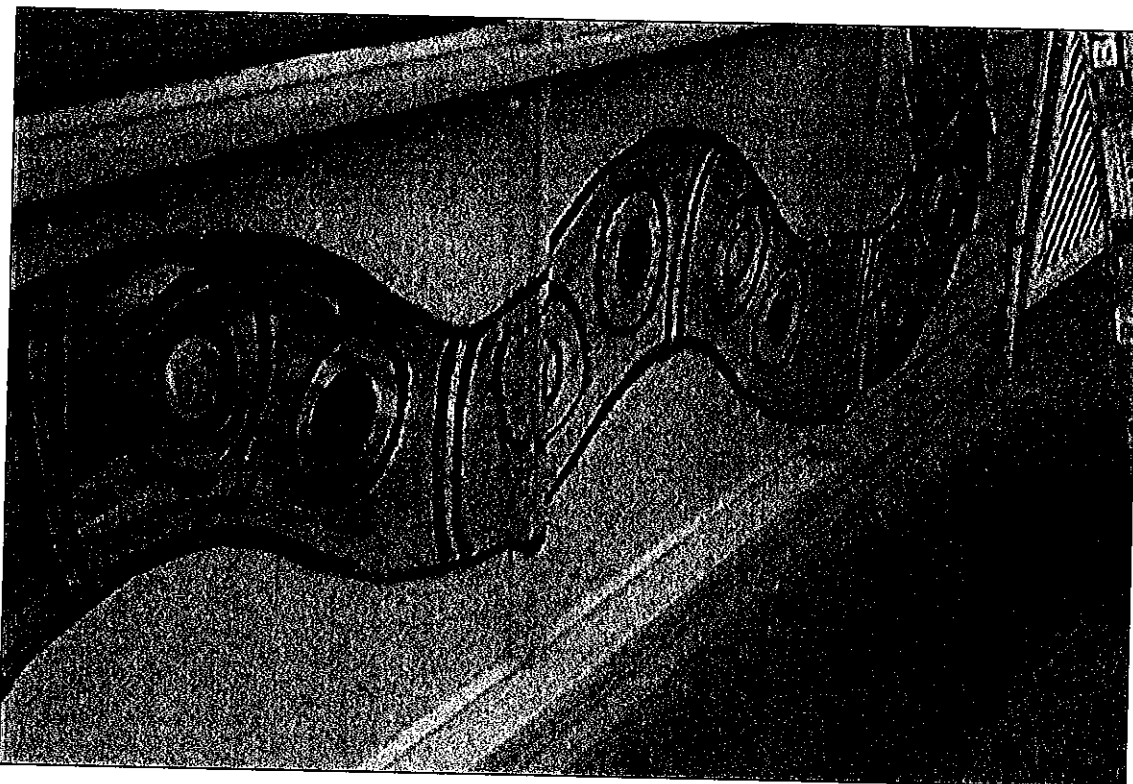
Photograph No. 136: Suspected Asbestos Cement Window Spandrel Panel

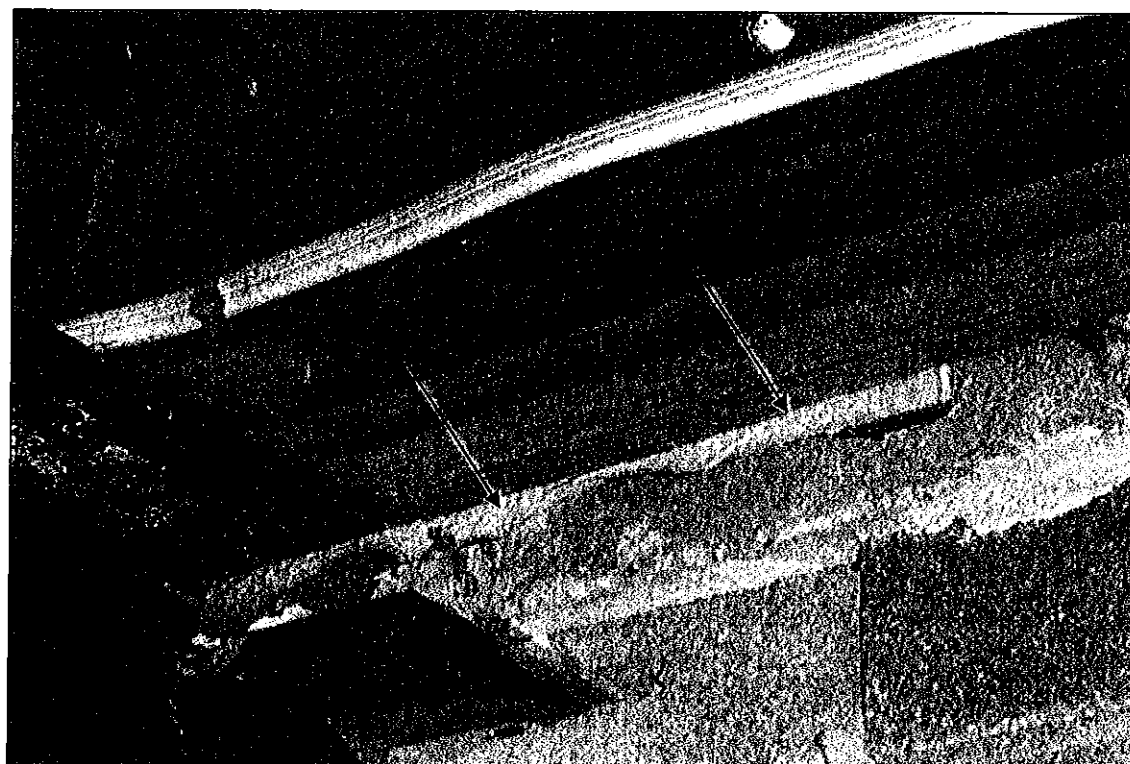
Photograph No. 145: Broken Asbestos Cement Sheet Between Brickwork

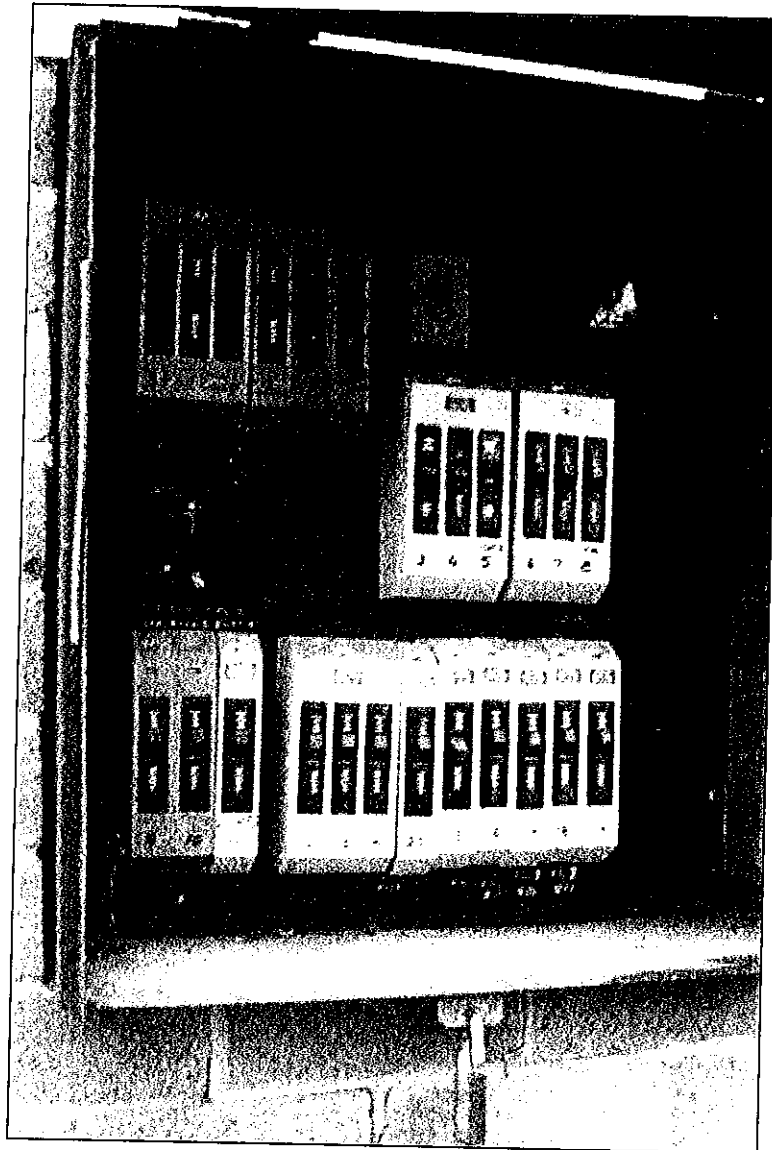
Photograph No. 146: Suspected Zelnite Backing to Electrical Switchboard

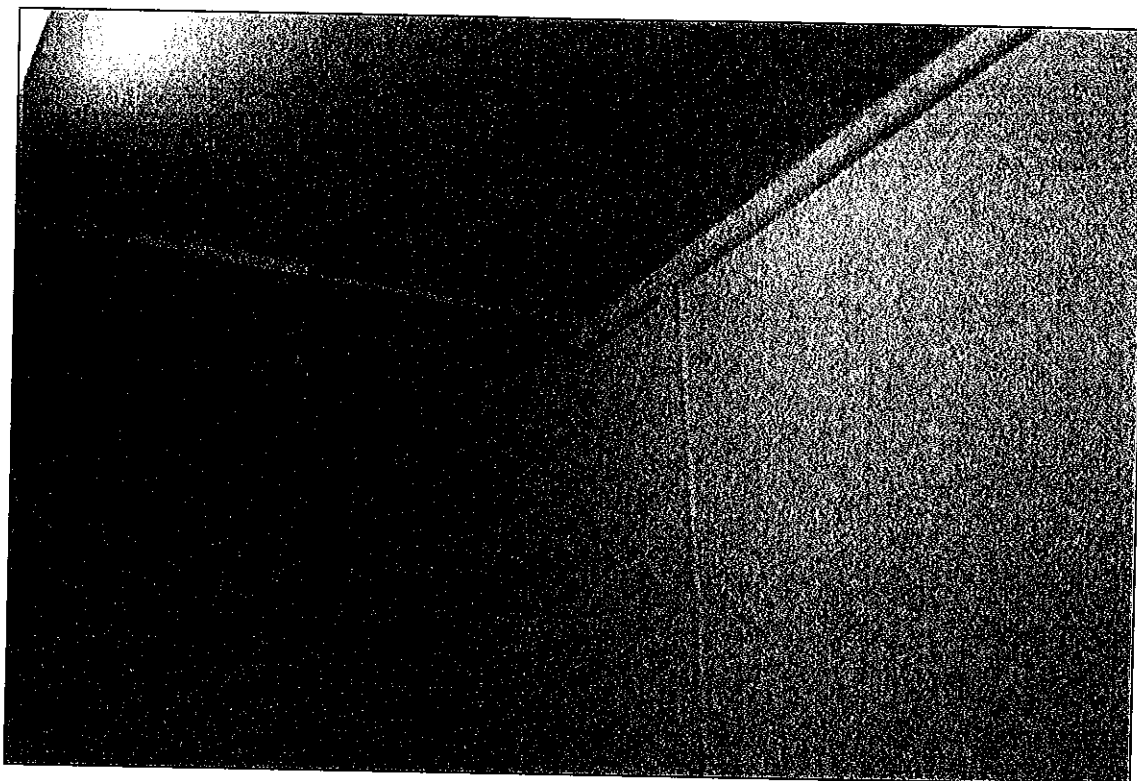
Photograph No. 147: Suspected Asbestos Cement Wall Lining to Bathroom

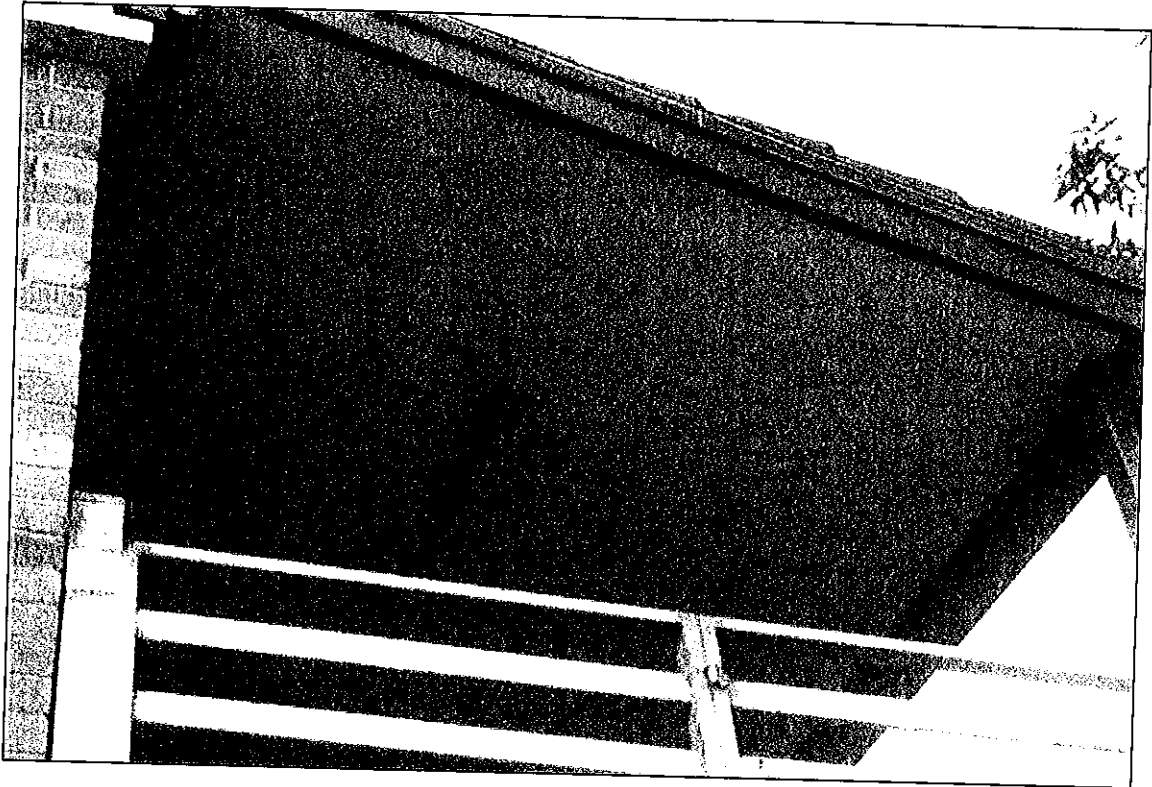
Photograph No. 155: Asbestos Cement Ceiling to 1st Floor Verandah

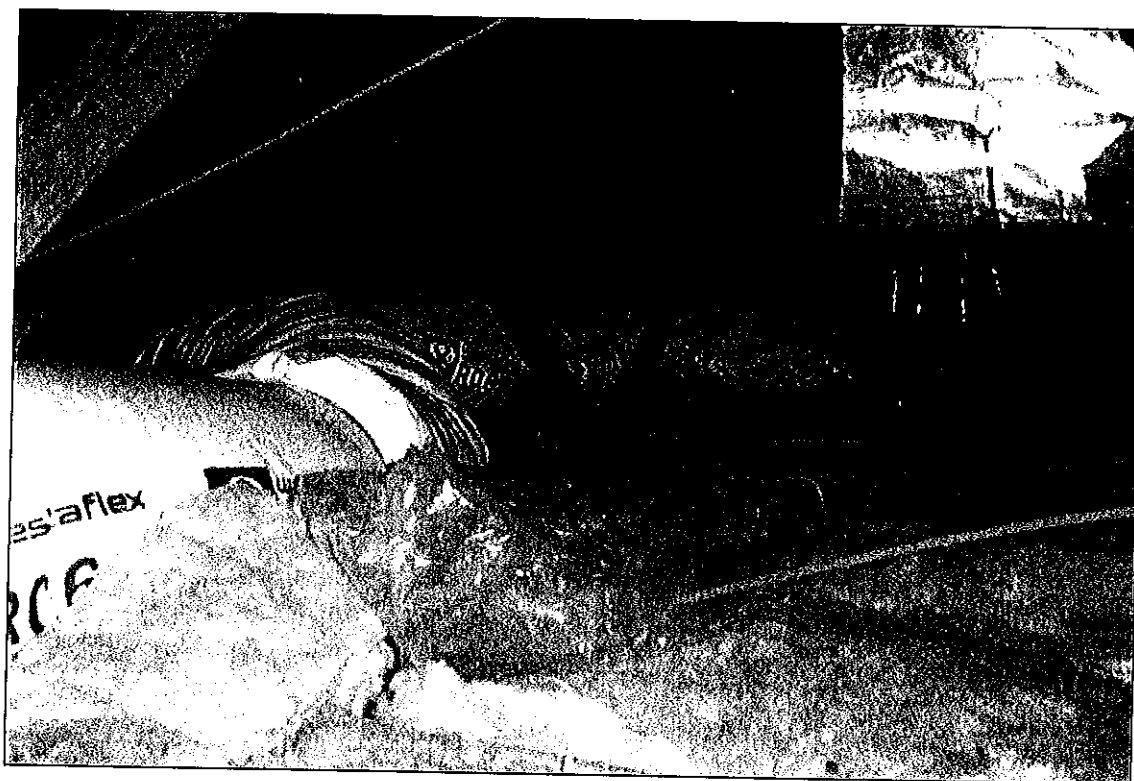
Photograph No. 157: Flexible A/C Ducts in Ceiling Insulated with SMF in Plastic

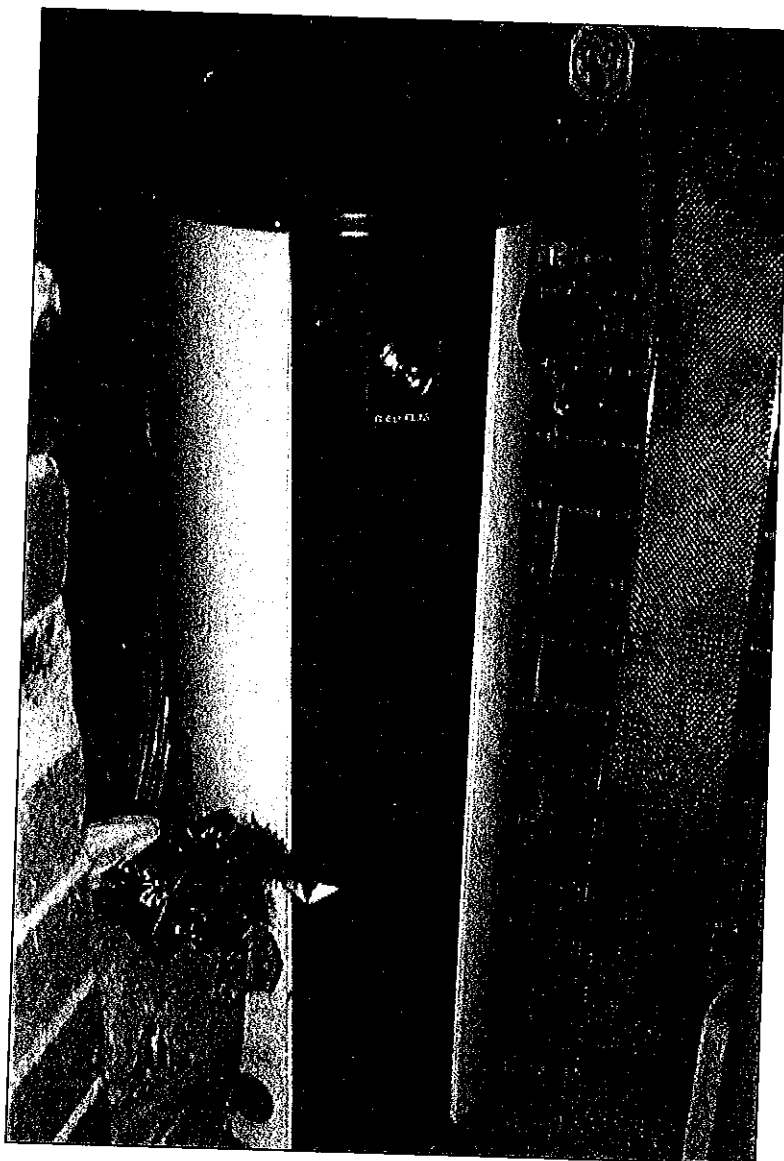
Photograph No. 159: SMF Insulated Hot Water Unit Under Stairs

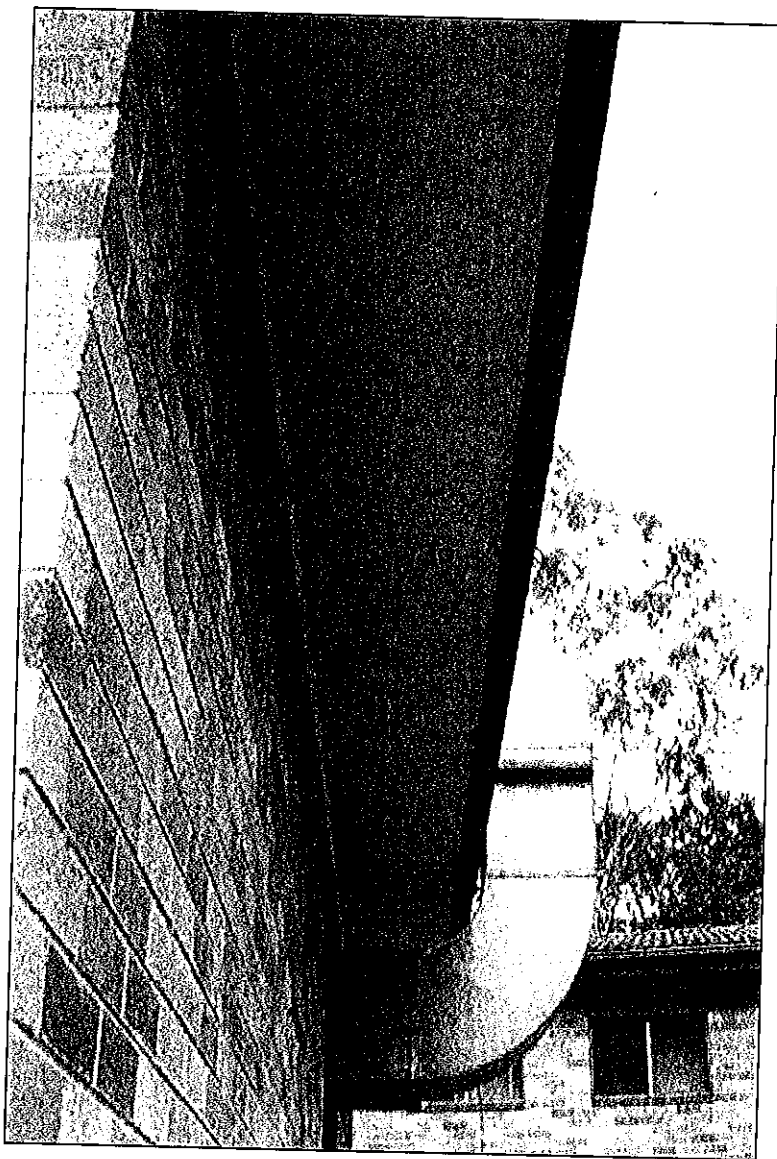
Photograph No. 164: Suspected Asbestos Cement Eave Lining to Building (Side)

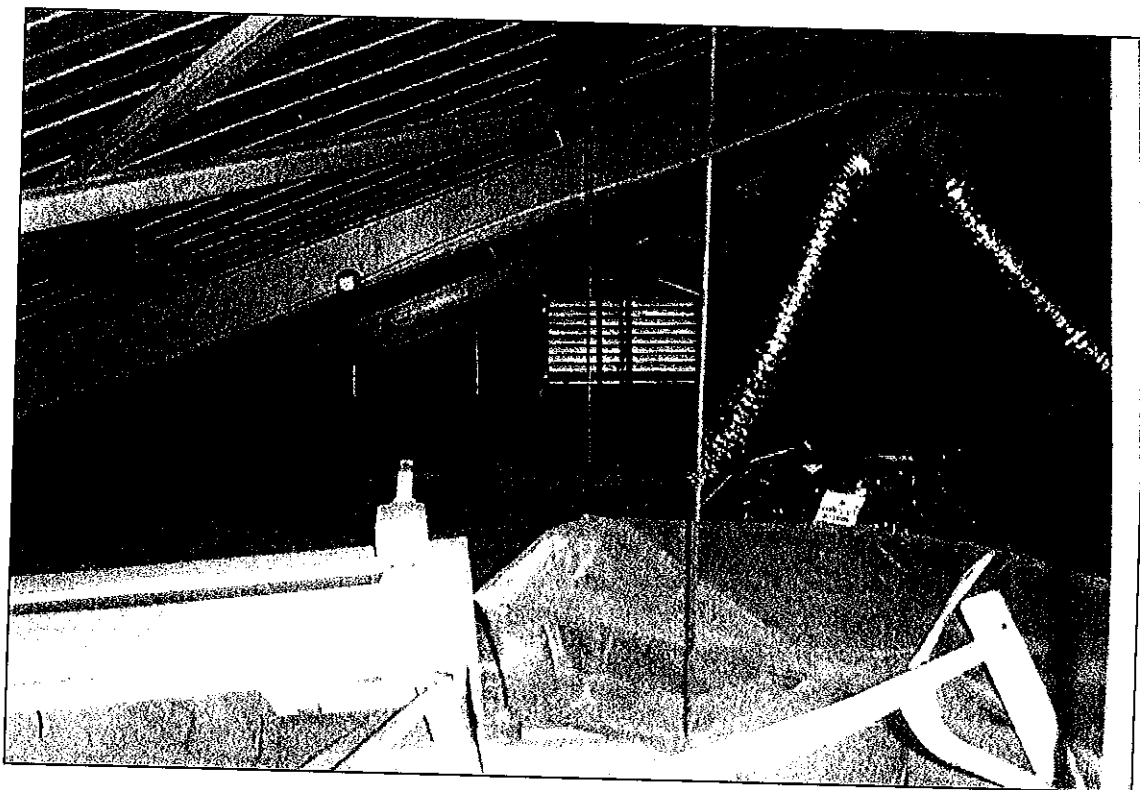
Photograph No. 167: SMF Batt Insulation in Part to Ceiling Above Workshop

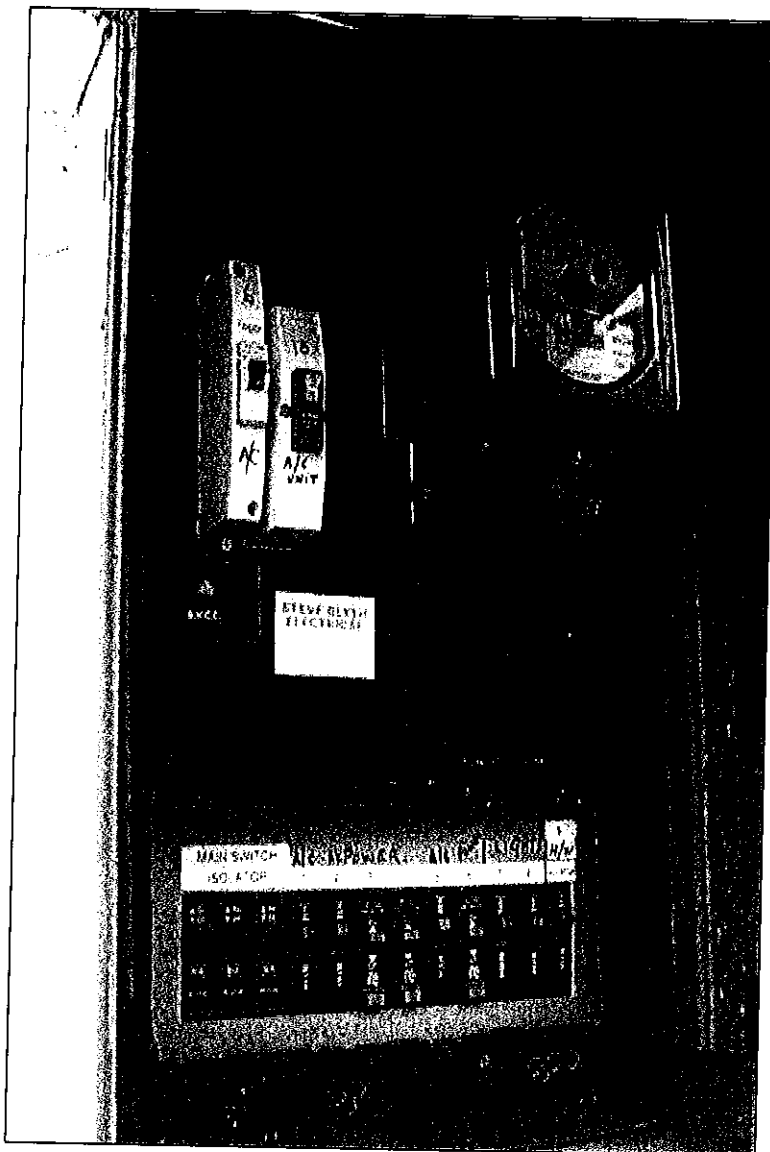
Photograph No. 172: Suspected Zelnite Backing Board to Electrical Switchboard

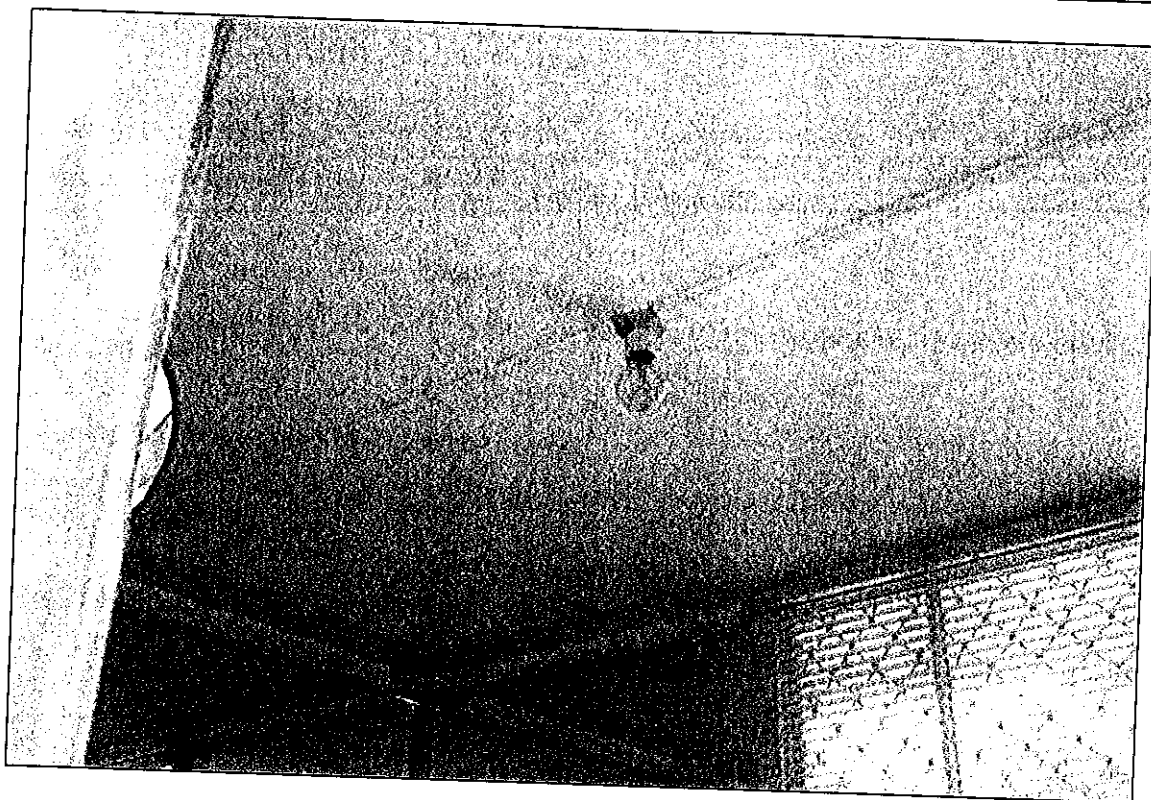
Photograph No. 174: Suspected Asbestos Cement Ceiling lining to Old Laundry
