STAGE 1 ENVIRONMENTAL SITE ASSESSMENT

PROPOSED WARNERVALE TOWN CENTRE

SPARKS AND HAKONE ROADS WARNERVALE, NSW

***PROJECT 41118A
March, 2006***

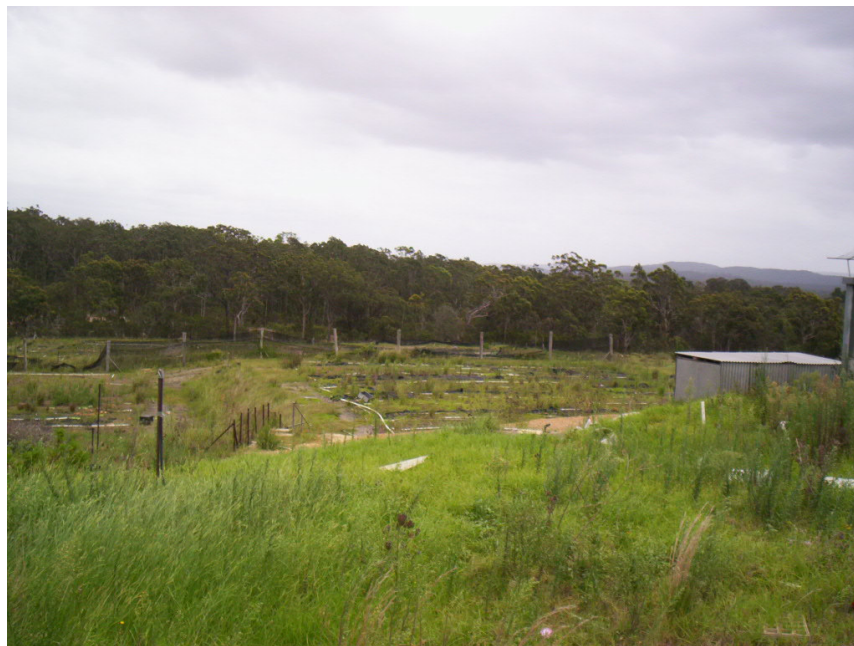
Photo 1

The former nursery land uses consisted of several derelict and partially demolished buildings, levelled cleared land and several dams. Buildings at the site consisted of brick veneer cottage, corrugated iron storage sheds and a glass house. Areas around the buildings were generally gravel surface with smaller areas of bitumen spray seal and concrete pavements. The areas marked as “cleared” on Drawing 1B appeared to be the former growing beds and were generally surfaced with gravels and geofabric (Photo 1). The greenhouses observed in the 2001 aerial photograph had been removed. Surface levels of the former growing beds had been modified to create level working areas. Visual inspection indicated that the level working platforms are likely to be the result of on-site cutting and filling.

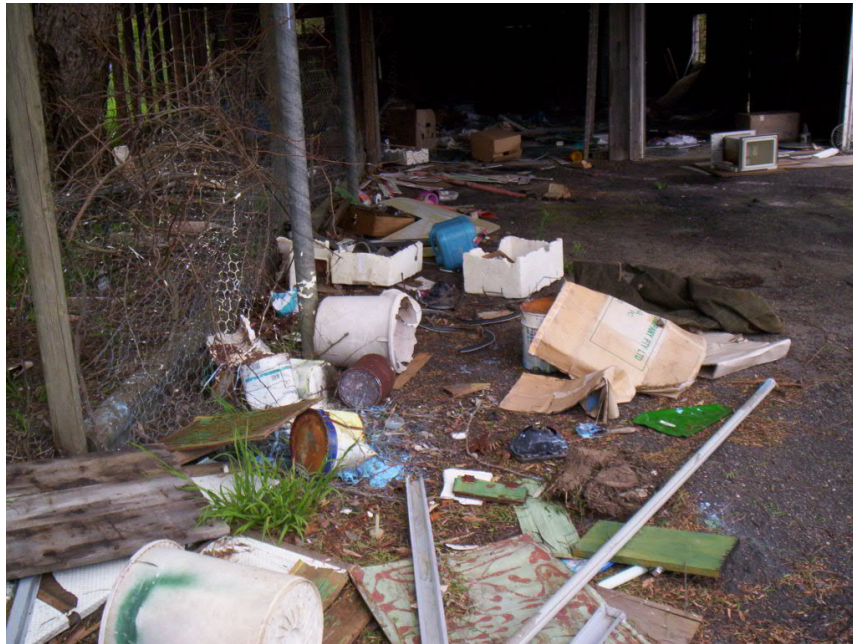
Photo 2

Various materials were dumped around the formerly operational areas of the site. The materials included nursery items (plastics, metal, and paper work), a small number of paint tins (Photo 2), miscellaneous items and building products. Fibrous cement sheeting was observed to have been dumped at one location and was used in the construction of the brick veneer building. No evidence of fuel storage tanks were observed during the site walkover, and no records were evident from the Workcover search.

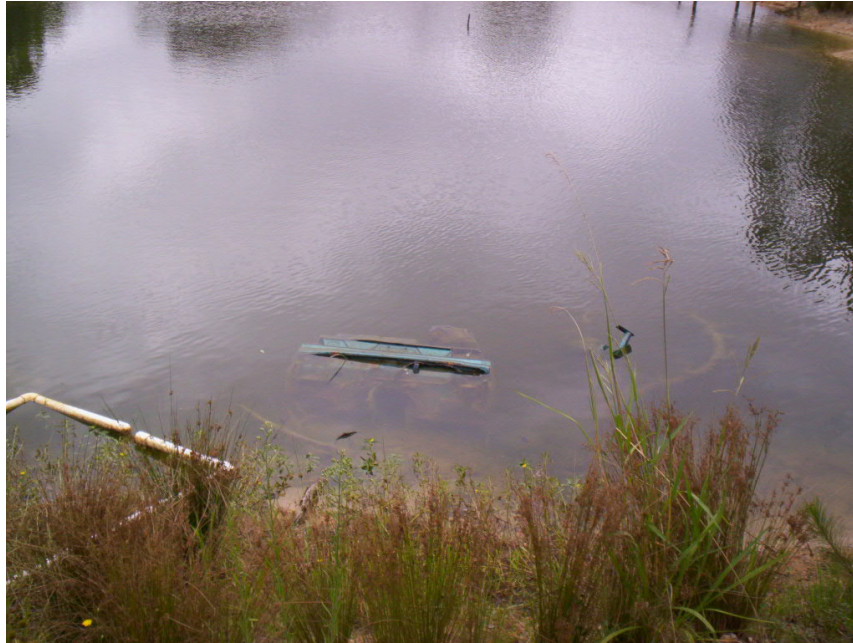
Photo 3

Inspection of the main dam observed car parts placed below the water line (Photo 3) which may have resulted in water contamination from heavy metals, petroleum hydrocarbons and asbestos.

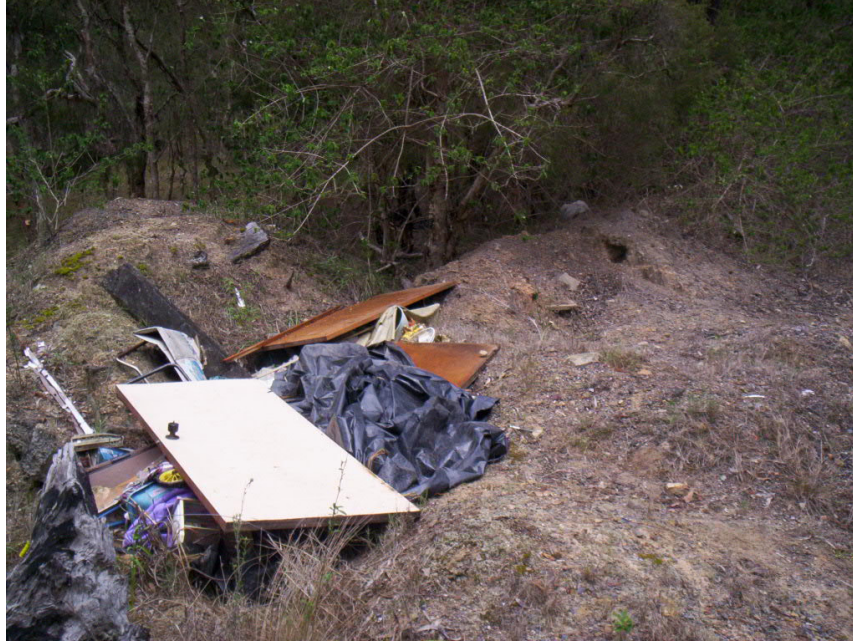
Photo 4

As noted in Ref 7 various materials had been dumped along the side of the access trails and extended up to approximately 30 m into the surrounding bushland in some locations. The materials observed were generally considered to be consistent with those recorded in Ref 7 and included excavated soils, concrete, road construction materials, general garbage, engine parts and demolition waste including bricks, tiles, fibrous cement sheets/pipes (Photo 4)

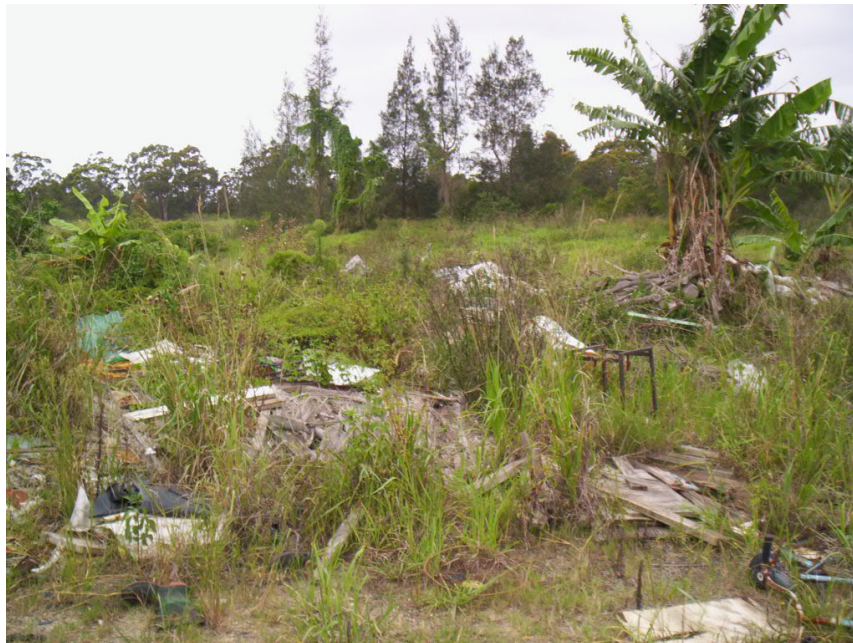
Photo 5

Further dumping was observed where the access track entered the cleared area (Photo 5), skirting the southern side of the cleared area and then to the south east of the cleared area where the access track existed into Lot 51.

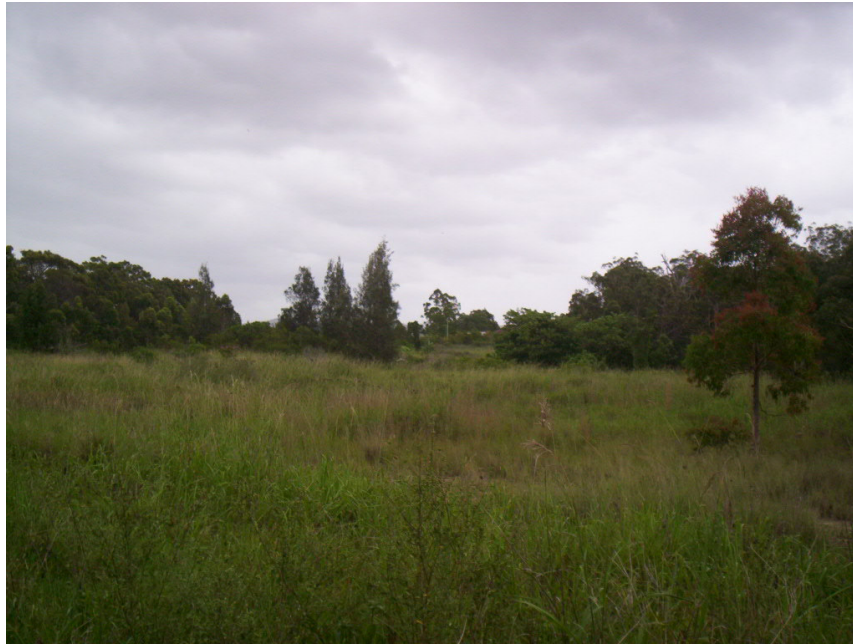
Maximum dimensions of the cleared area were approximately 250 m by 100 m and as noted in Ref 7 surface levels in the former quarry/landfill area were considered to be significantly modified from natural surface levels, Ref 7 indicated that depth of filling may have been up to 7 m base on the surrounding surface levels. Ref 7 noted unvegetated surface soils/filling in the south eastern section of the cleared area contained waste materials including bricks, concrete and fibrous cement sheeting and piping. Photo 6 was taken from the south eastern corner of the cleared area facing north west.

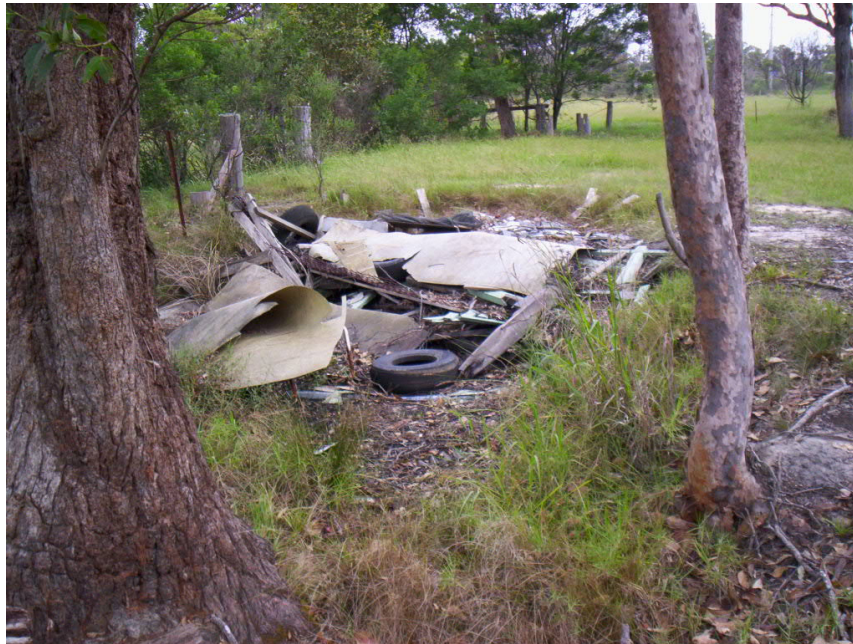
Photo 7

Building and waste materials were observed to have been dumped in areas scattered between the south western corner of the site and the open drain. Specifically, building materials were observed to have been placed in what appeared to be a small pond/dam (Photo 7) and also in the open drain in at least two locations.

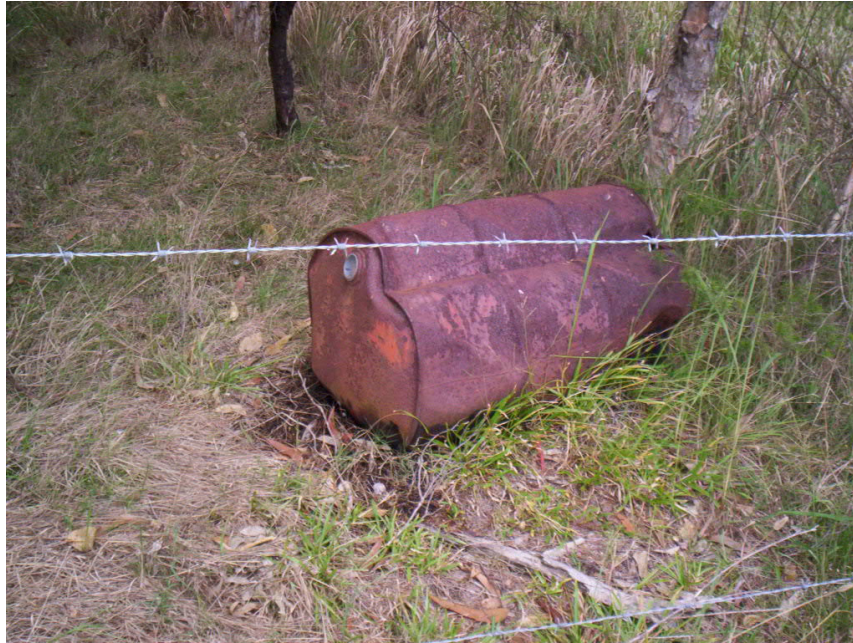
Photo 8

A rusted leaking oil drum was also observed on the boundary of the unformed Nikko Road (Photo 8) and a small volume of soil had been recently dumped in the south western corner of the site.

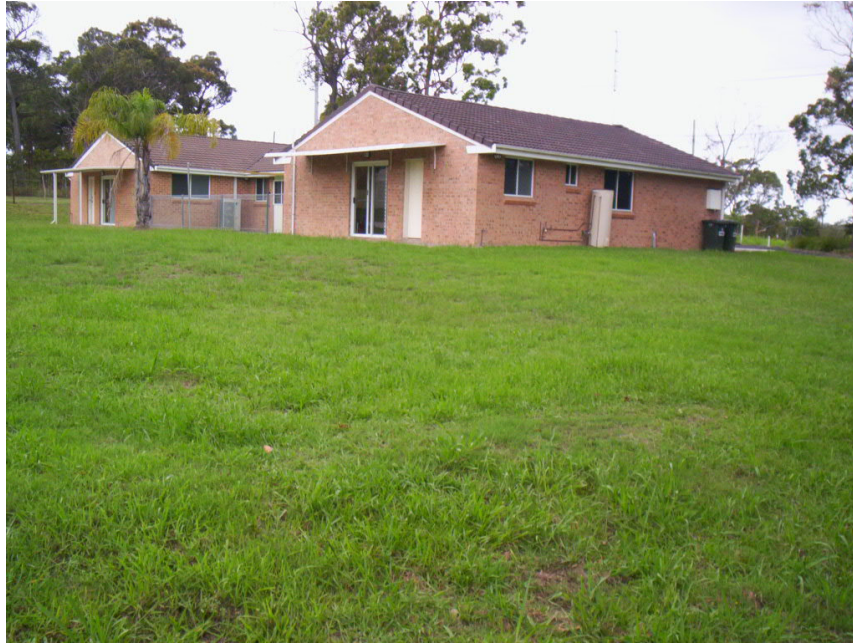
Photo 9

Entry to Lot 2 was via the old Sparks (Wallarah) Road alignment. Site topography generally slopes up to the north east. The lot consisted of bitumen spray sealed carpark, a brick veneer building (Photo 9) operated as a medical centre and a small weatherboard cottage, all located within approximately 60 m of the southern boundary. The southern third and a central strip extending to the north are generally cleared of vegetation, with the remainder of the generally comprising of medium to dense bushland.

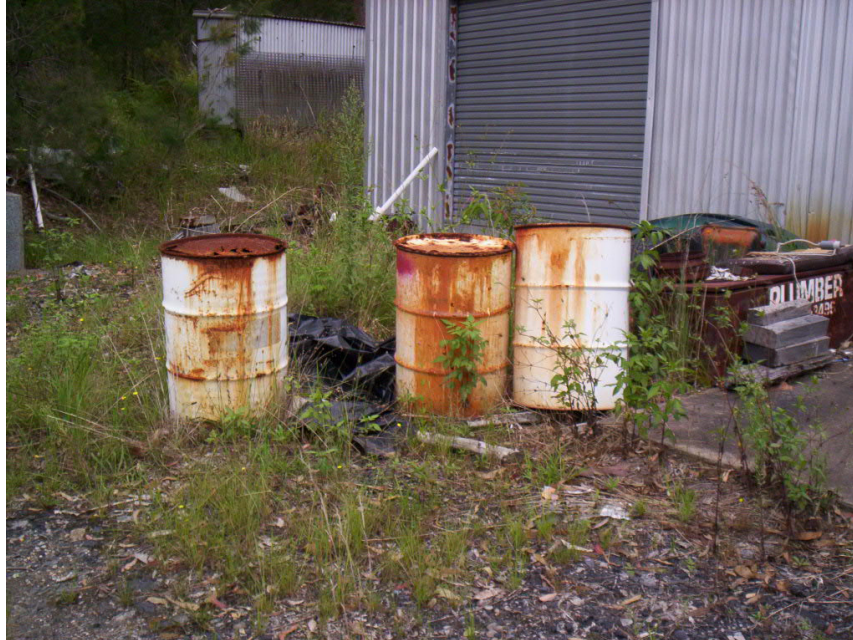
Photo 10

Visual inspection identified various mechanical parts, oil drums, batteries and other miscellaneous items placed on the ground surface in the area directly to the west of the large metal shed (Photo 10). Ref 7 noted various pieces of machinery and construction materials including fibrous cement sheeting and piping in this area.

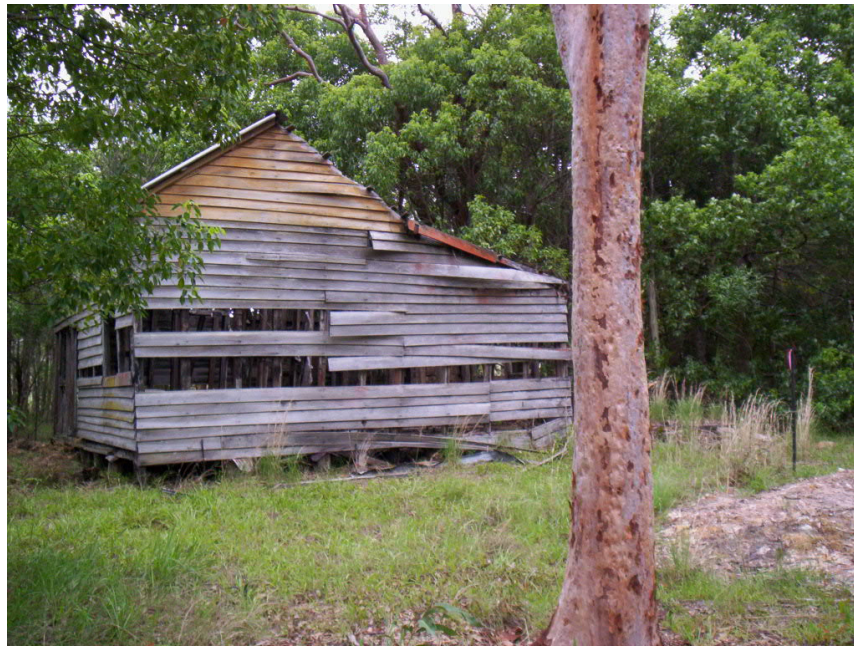
Photo 11

Entry to Lot 3 was via the old Sparks (Wallarah) Road alignment. Site topography generally slopes up to the north. As noted in Ref 7, the site appears largely undeveloped, with dense vegetation covering the majority of the site. A small cleared area adjacent to the southern boundary leads to a derelict timber cottage (Photo 11). Ref 7 noted a burnt out car was located in the south of the site, although inspection only encountered several car body panels. Evidence of a recent test pit excavation was noted adjacent to the derelict cottage and was considered to be associated with Ref 9.

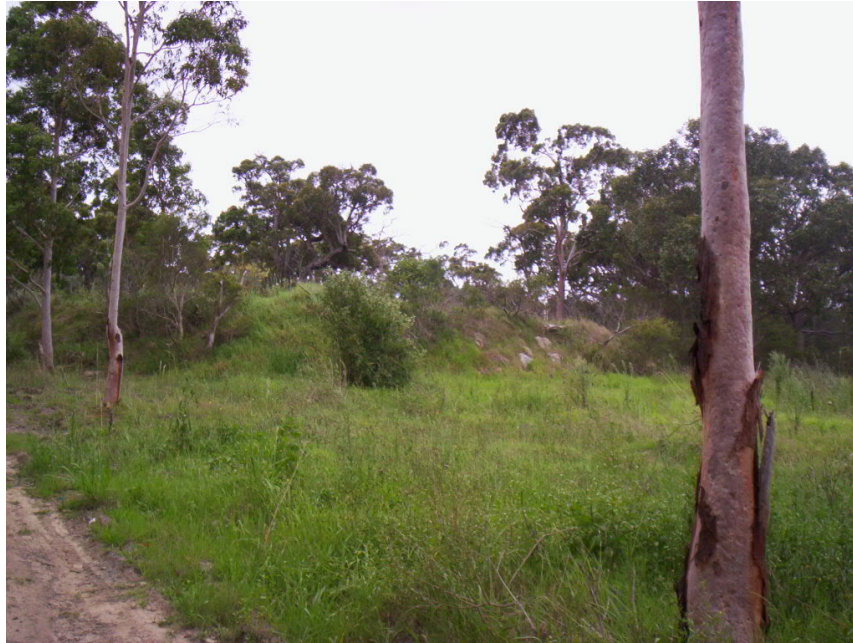
Photo 12

Entry to Lot 51 was via the old Sparks (Wallarrah) Road alignment. Site topography generally slopes up to the north and north west. The southern half of the lot was generally cleared with some scattered trees where the northern half was generally more densely vegetated with some trails accessing the area. An access road located adjacent to the western boundary lead to the former quarry/landfill area in Lot 54. A dam was located approximately mid-way along the western boundary and inspection of the dam wall indicated that imported filling may have been used in its construction (Photo 12). No evidence of the dam observed in the 1954 aerial photograph was encountered during the site walkover.

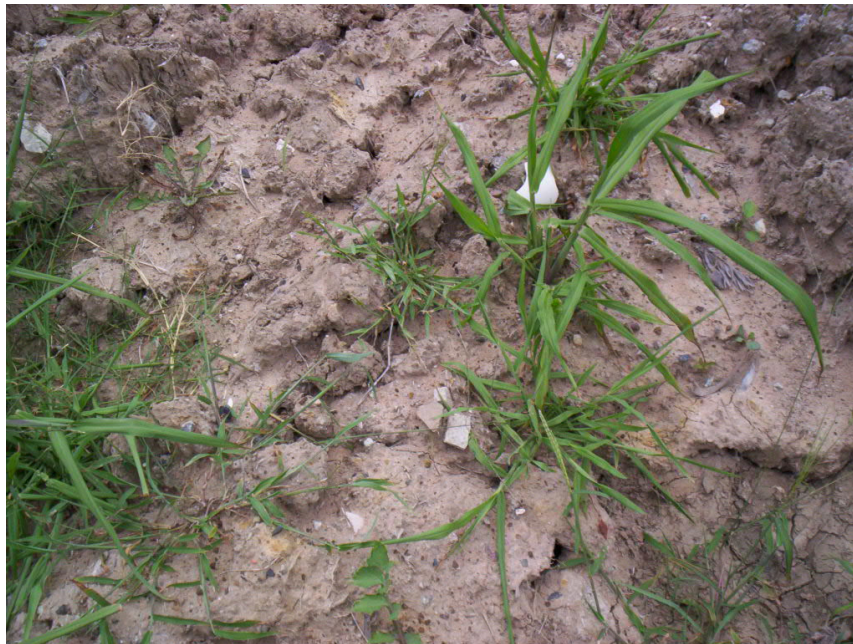
Photo 13

Visual inspection indicated that all buildings formerly located within the lot had been previously demolished and removed from site. The surface soils/filling in the vicinity of the former building footprints were disturbed with minor quantities of building/demolition materials at the soil surface. The materials observed included bricks, plastic, imported gravels, concrete fragments and fibrous cement fragments (Photo 13).

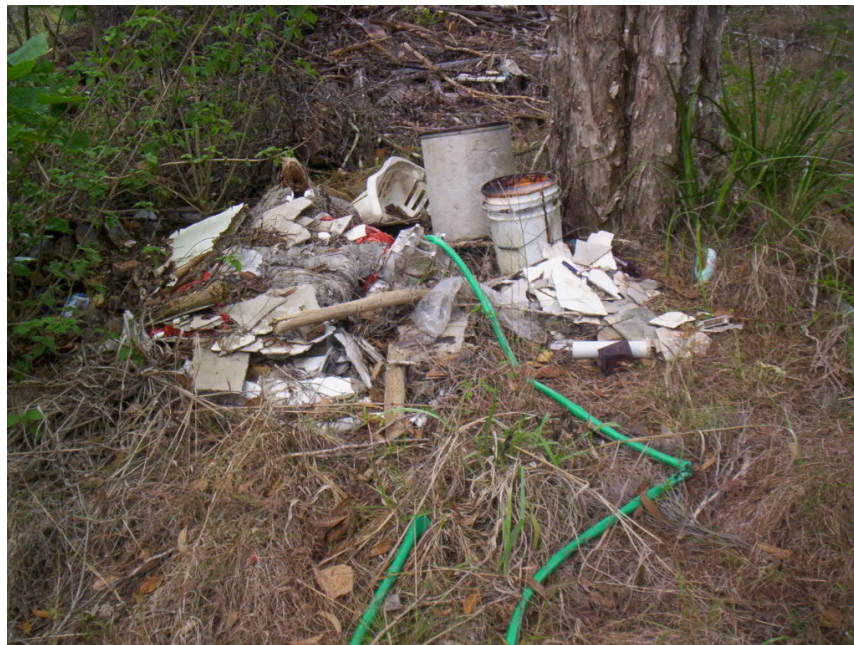
Photo 14

Visual inspection indicated that all buildings formerly located within the lot had been previously demolished and removed from site. The surface soils in the vicinity of the former buildings contained some minor inclusions including concrete fragments and gravels. Two small concrete building pads were observed approximately midway along the eastern boundary. Isolated areas of illegal dumping were observed to be concentrated in the northern half of the lot (Photo 14). Materials dumped included soils, paint/chemical tins, municipal waste and fibrous cement fragments.
