Ref: 13113

19 December 2010

**Report: Arboricultural Hazard Assessment & Resistograph Testing
Wollongong Hospital, Wollongong NSW (*the site*).**

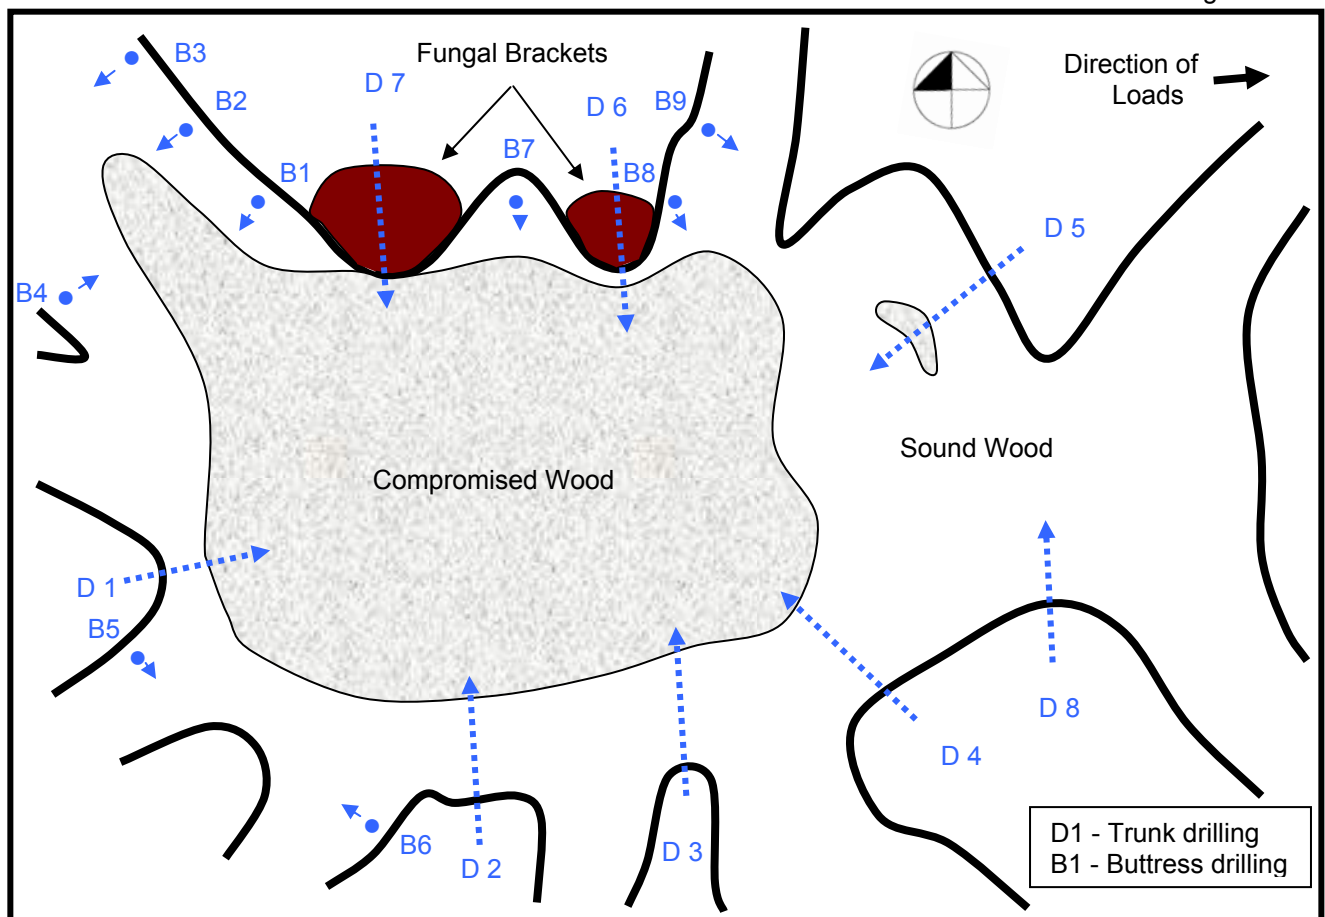
Figure A

Reduced residual walls were detected proximate to the fungal brackets below ground level. Decay movement was detected within the north/west buttress only. Decay was positioned basally only and tapered off relatively suddenly between 300 mm and 500 mm above ground level.

Significant sound buttresses provided additional support reaching heights of 1.5 m to 2.5 m, and some reaching the first order structural branches. The tree has responded very well to the previous and current load distribution of the crown with the placement of additional adaptive wood along the length of the trunk.

As *Ganoderma* species maintain considerable tensile strength and flexure, it may take many years before the decayed zone becomes dangerously large in relation to the extent of sound wood. This allows suitable time for the production of compensatory growth (Lonsdale 1999, p. 104). However, this may alter in the future due to the current reduced vigour.

Adequate sound wood is currently expected with ample sound wood situated above the decay within the buttress to the north/west.

The failure potential at the lower trunk is currently considered low to medium.

Tree 1 should again be assessed with Resistograph testing undertaken in 3 -5 years to determine the speed of deterioration and pattern of internal decay.

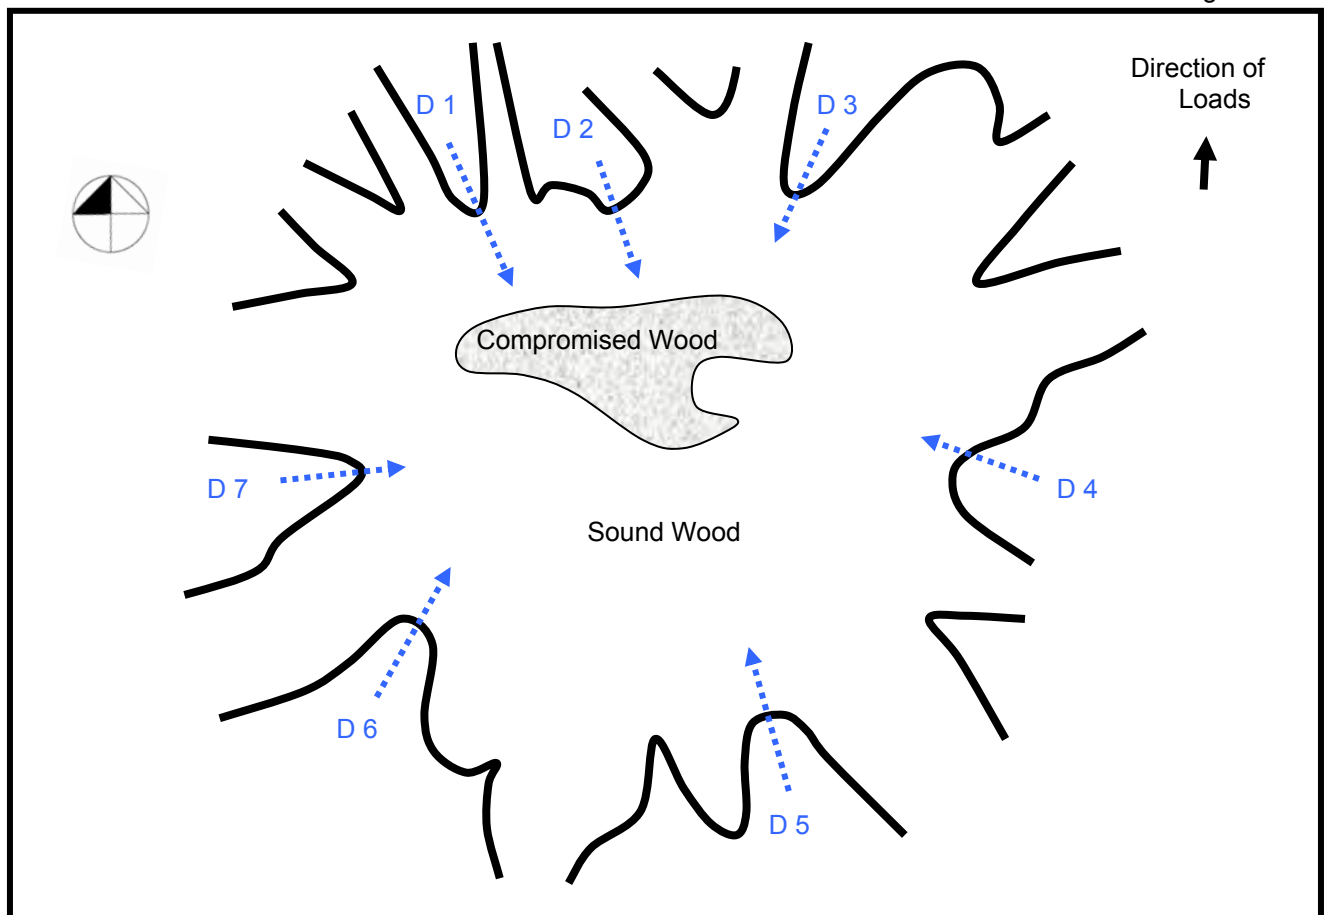
Figure B

Sufficient supporting wood remained at the lower trunk in cross section. Minimal decay only was detected, with no adverse affect on the mechanical strength expected.

The tree was observed to be currently structurally sound and stable, with no indication of potential failure by bending fracture or cross sectional flattening. The failure potential for Tree 2 at the cross section examined is currently considered low.

Tree 2 is currently expected to be retained for the short to medium term as such is reflected by Tree 1.

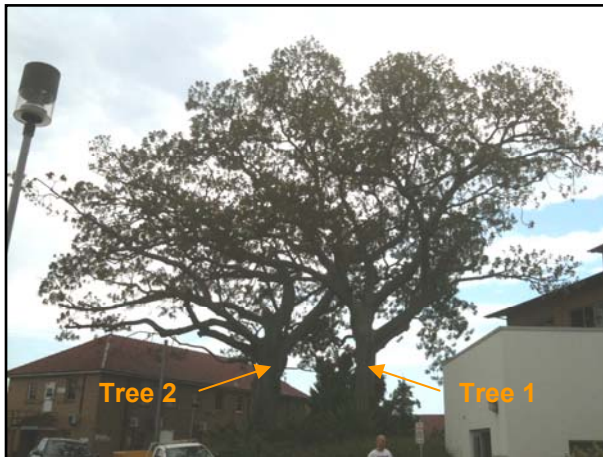
Photo 1

Left – View of trees facing east.

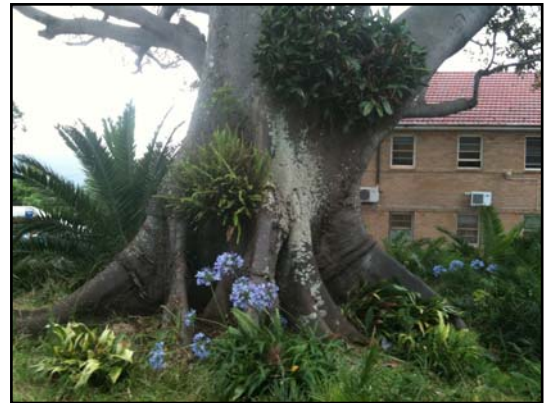
Photo 2

Above – View of trunk facing north.

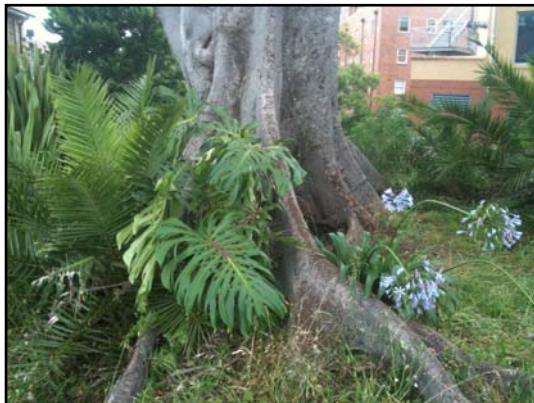
Photo 3

Above – View of trunk facing east

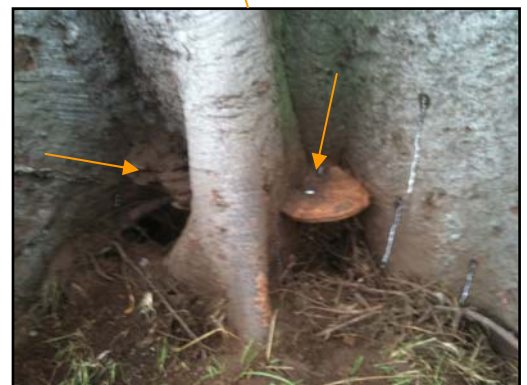
Photo 6

The fungal fruiting brackets observed on Tree 1 were characteristic of *Ganoderma* species. These typically cause a root- and butt-rot which is where investigative works were concentrated. Partially decayed wood by *Ganoderma* retains considerable tensile strength, for this reason the residual wall thickness of sound wood tends to be much less than the 30 – 35% t/R (Lonsdale 1999, p. 104).

Right – Fungal fruiting brackets.

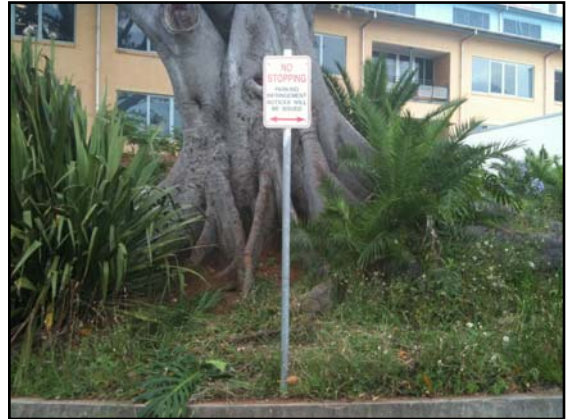
Photo 7

Right – View of
trunk facing south.

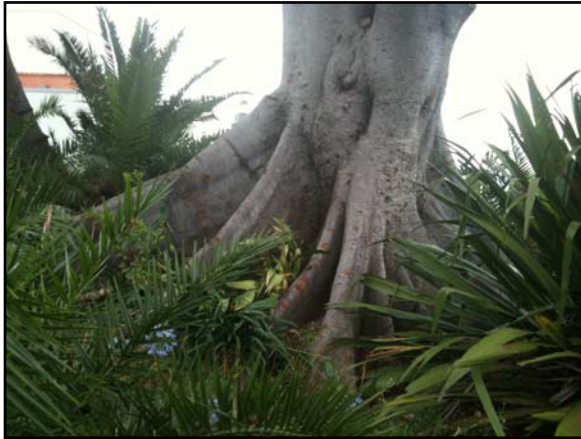
Photo 8

Left – View of
trunk facing west.

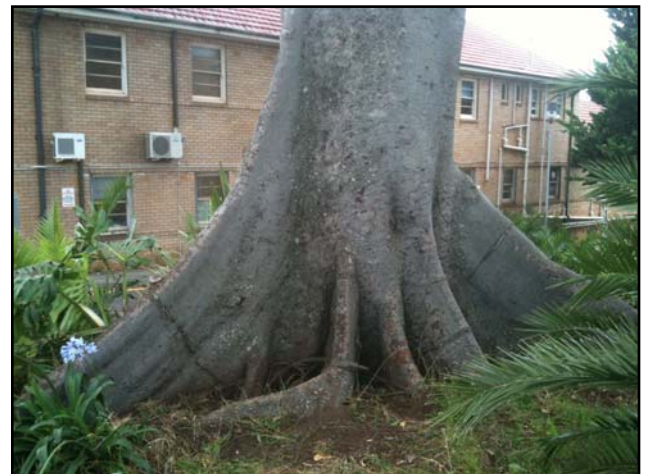
Photo 9

Right – View of
trunk facing
north/east. .
