SOTO Consulting Engineers

Document Reference No. 14235-RPT-001 Addendum
SOTO Project No. 2014-00235

Date: 04 November 2014
To: Fulton Hogan
Attn: Mr David Bender
Re: **Structural Engineering Report - Foxground Berry Bypass**
Structural Vibration Assessment of Dry Stone Wall (G2B H54)
455 Princes Highway Broughton Village, NSW

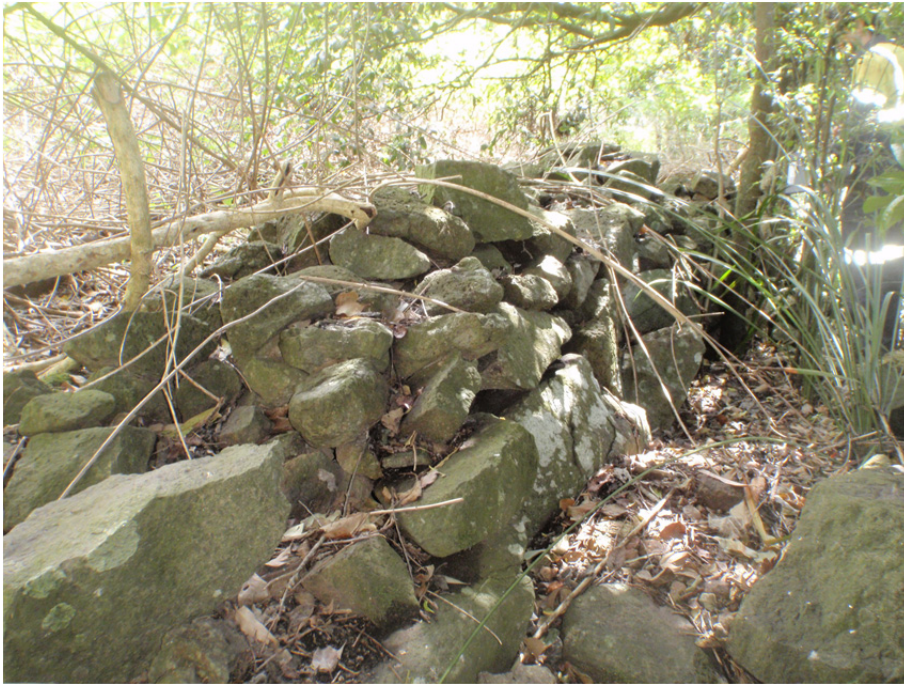
Photograph 2.1 - View from North.

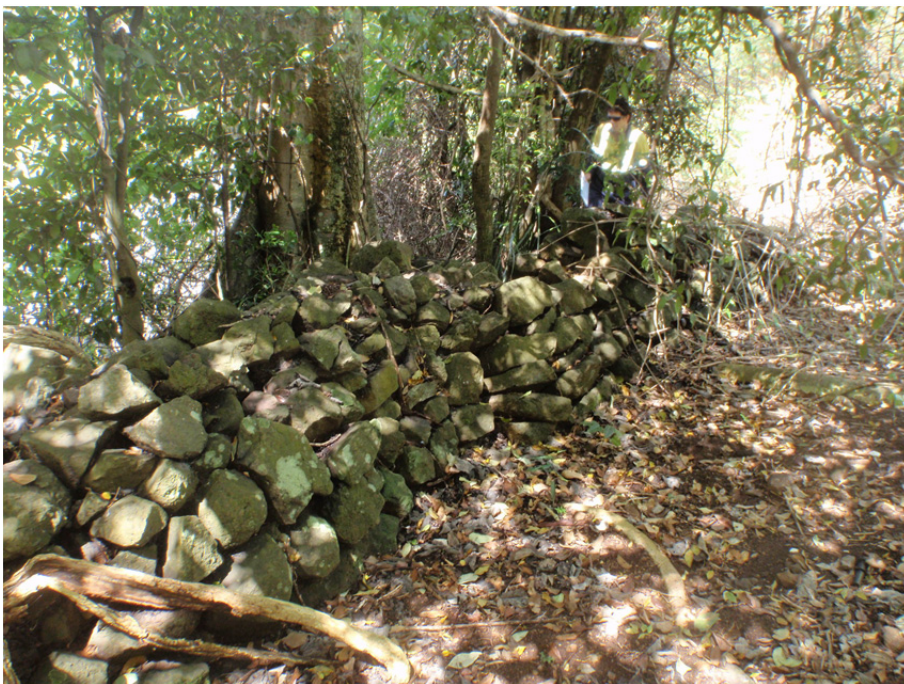
Photograph 2.2 - View from South.
