**HERITAGE IMPACT ASSESSMENT
PROPOSED BLASTING CLOSE TO
HERITAGE LISTED DRY STONE WALL
(G2B H54) ON TOOLIJOOA RIDGE
FOXGROUND AND BERRY BYPASS**

Prepared for Fulton Hogan Construction

Mayne-Wilson & Associates

October 2014

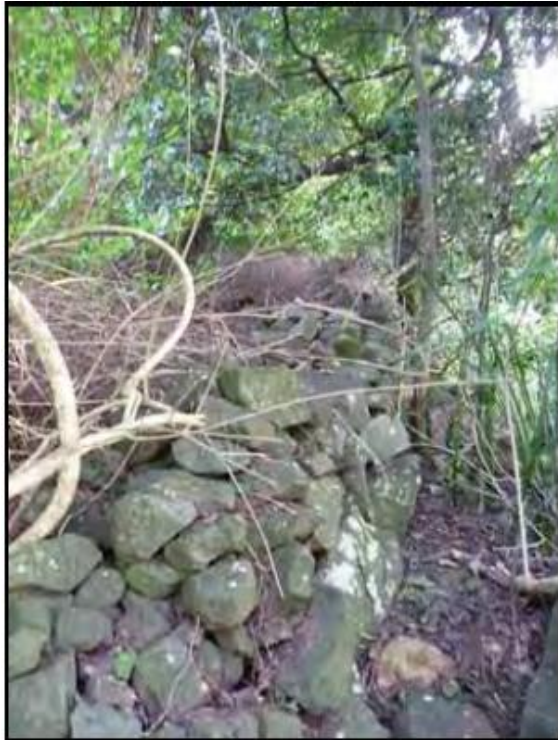
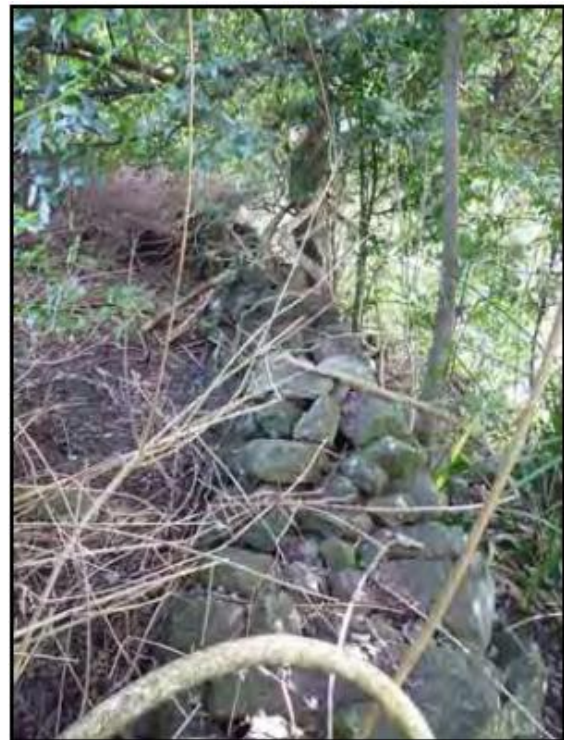
These show use of the A frame technique, but some loss of coping stones. It is reasonably intact

As can be seen from these images, the wall is already in a partially dilapidated condition with only a few small sections retaining its original A-frame construction. This is due to a number of factors:

- Loss of some or a lot of the coping stones which were placed on top of the original wall to provide the pressure that was intended to hold the two 'skins' (double dyke) together
- Intrusive vegetation, particularly lantana, the branches of which have grown between both the side stones and the internal rubble stones and through swelling, loosening their binding
- Storms and heavy rainfall causing the underlying ground to become temporarily soggy and allow some shifting of the heavy blocks at the base, and consequently up through the skins of the wall.
- Neglect of the landholder/s to maintain the wall, especially the coping stones, and the invasive vegetation
- Only moderate skill sets by the waller himself; and
- The awkward shape of some the basaltic rocks which made tight fitting together (cohesion) quite difficult.

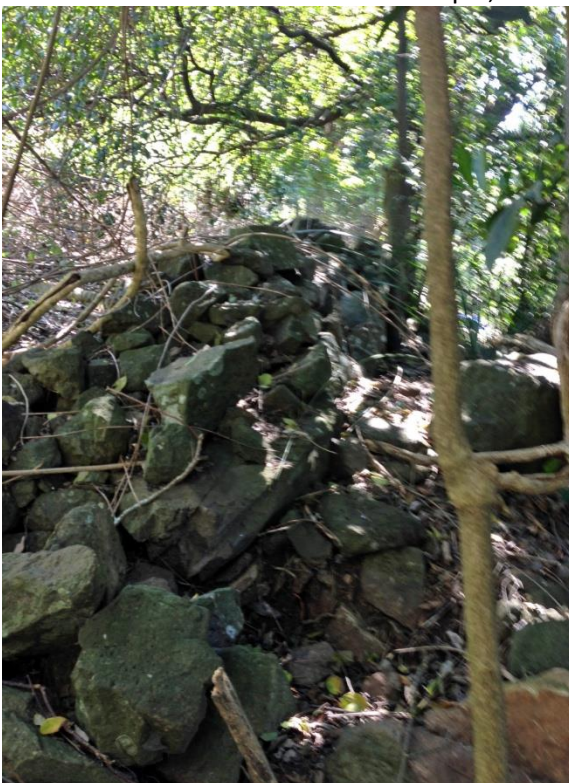
This shows poorly selected and fitted basaltic stones, resulting in some collapse, to which adjacent vegetation is contributing

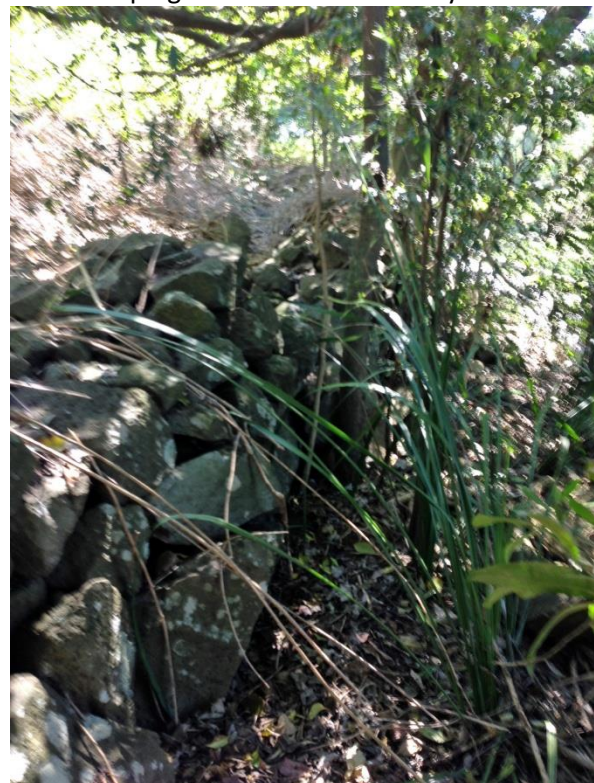
These basaltic rocks are harder to fit than weathered latite and have not been well graded; nor do they tilt inwards.

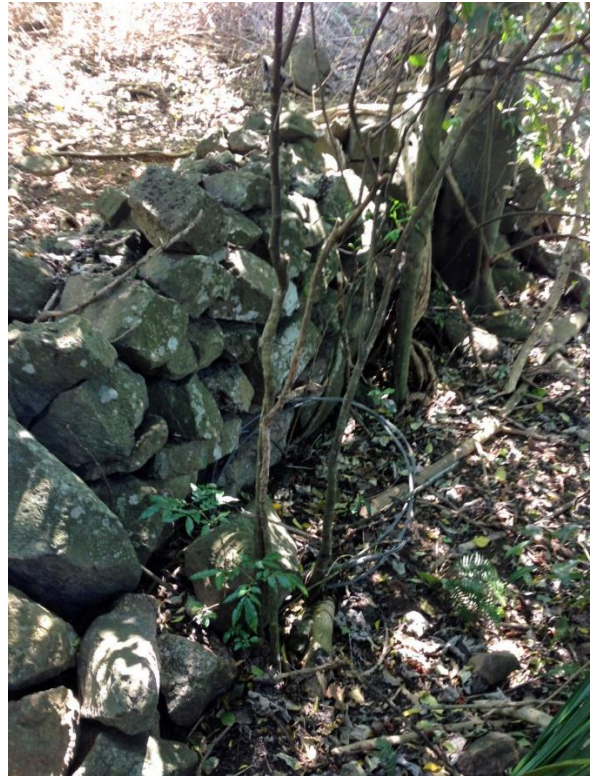
This sector of the wall generally follows the principles described in the sketch opposite, serving both as a boundary and retaining wall, although soil may have washed down from upslope and accumulated, adding to pressure.

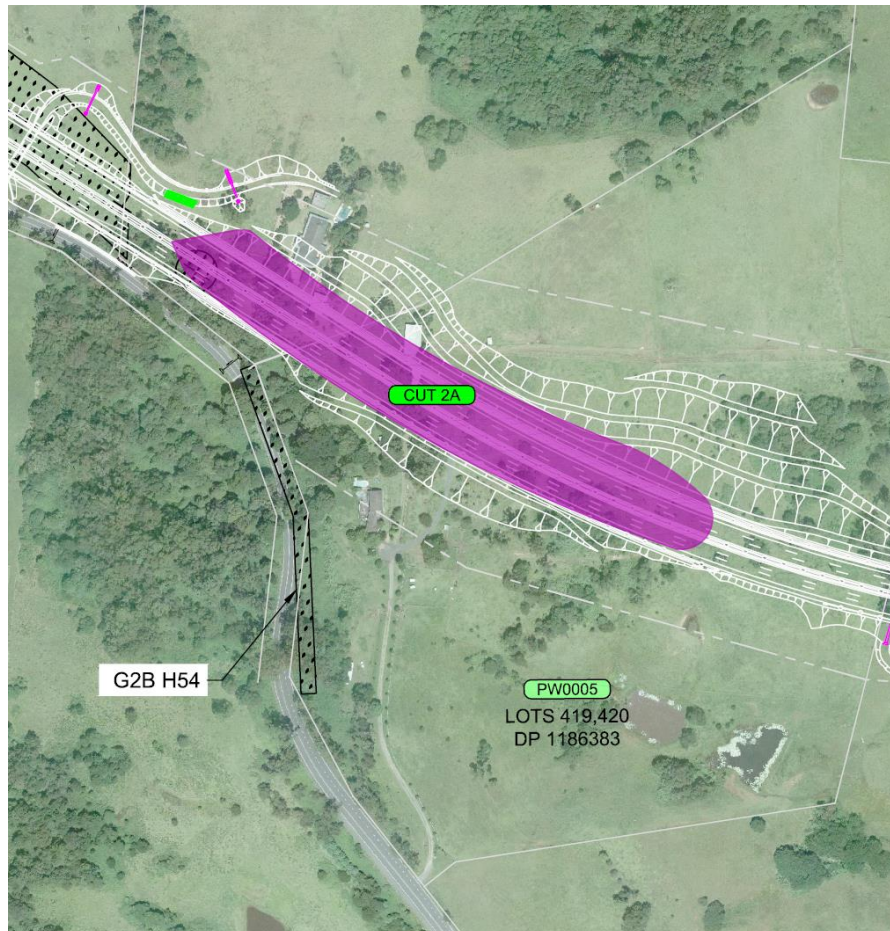
Figure 4 Dry stone wall location in relation to blasting area

Figure 4 indicates the section of the Princes Highway that is to be cut, by means of blasting and hammering (shaded purple), and the relationship of the dry stone wall G2B H54 to it. The wall is at about 45 degrees from the proposed blasting area, and the closest part of the wall is 18 metres away from it. The wall then veers southward along a country road to an angle of about 60 degrees.

It appears only a small, partially dilapidated portion of the wall will be affected by blasting operations. MWA understand that a structural engineer's report has been prepared for the wall and that it indicates low probability of displacement of the stones or collapse of the wall as the result of increased blasting criteria.

Given the existing condition of wall and its very moderate degree of local significance, it is MWA's opinion that there would be no serious loss of heritage significance in an unlikely scenario of a partial collapse of the wall or displacement of the stones.

- Undertake trial blasts to determine future vibration levels near the wall
- Undertake detailed photographic recording of the current condition of the wall in the area likely to be affected by increased blasting criteria, and
- Undertake an inspection of the affected section of the wall before and after each blast to monitor the effects of blasting on the wall.
