# ARBORIST'S REPORT

PROPERTY:	3 Murray Rose Avenue, Sydney Olympic Park
NUMBER OF SUBJECT TREES:	50
DATE OF REPORT:	11/7/2012
REQUESTED BY:	Lend Lease Project Management and Construction
CONTACT:	Grant Eckett

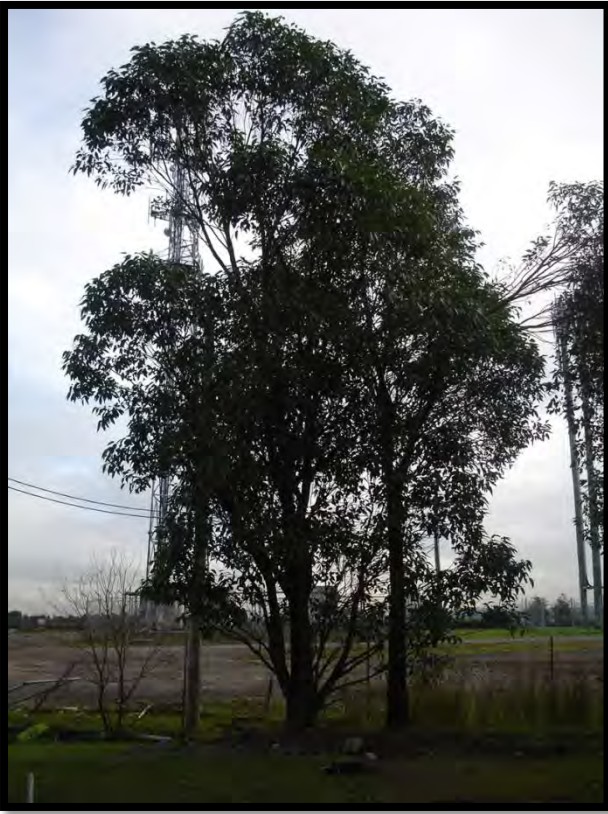
Tree 1 (left) & Tree 2 (right).

Tree Identification	Description		Health	Structure	U.L.E. (Useful Life Expectancy)
<b>Tree 1</b> <b>Botanical Name</b> <i>Eucalyptus robusta</i>	<u>Age:</u>	Mature	The tree is in fair health, having a leaf density of 60% coverage. Slight deadwood to 70mm diameter is present. The central leader is dead from 4 metres high to the top.	The tree has a poor structure having 3 dominant stems from 400mm high. Two large epicormic shoots measuring 6 metres long x 150mm diameter are present from 400mm high.	The tree has been given a ULE of 3B due to the poor structure.
	<u>CBH</u>	1560mm (at 200mm high)			
	<u>DBH</u>	496mm (at 200mm high)			
<b>Common Name</b> Swamp Mahogany	<u>Height:</u>	11 metres			
	<u>Canopy Spread:</u>	10m X 7m			
<b>Tree 2</b> <b>Botanical Name</b> <i>Eucalyptus robusta</i>	<u>Age:</u>	Early Mature	The tree is in fair health, having a leaf density of 60% coverage. Slight deadwood to 50mm diameter is present.	The tree has a poor structure having lost the central leader (broken off) at 6 metres high, which has been replaced by a large epicormic shoot 4 metres long x 80mm in diameter.	The tree has been given a ULE of 3B due to the poor structure.

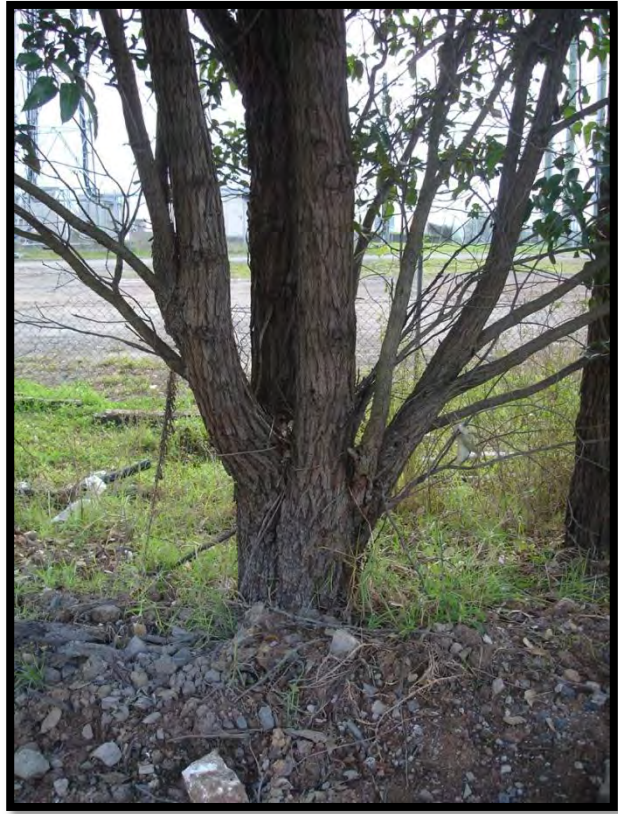
The base of Tree 1.

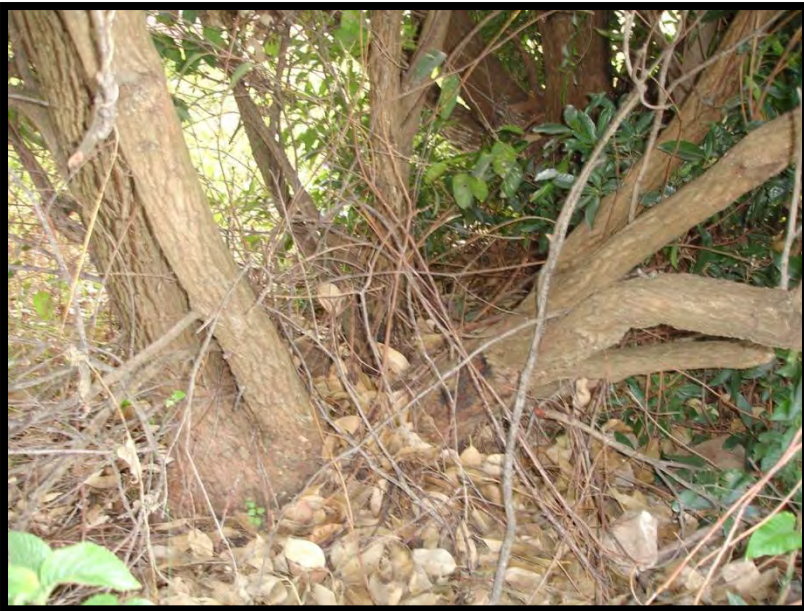
<u>CBH</u>	920mm			
	<u>DBH</u>	290mm			
<b>Common Name</b> Swamp Mahogany	<u>Height:</u>	10 metres			
	<u>Canopy Spread:</u>	10m X 6m			
<b>Tree 3</b> <b>Botanical Name</b> <i>Eucalyptus robusta</i>	<u>Age:</u>	Semi Mature	The tree is in fair health, having a leaf density of 60% coverage. Slight deadwood to 50mm diameter is present.	The tree has a poor structure having 5 dominant stems from ground level. A moderate amount of small epicormic growth is present around the lower canopy.	The tree has been given a ULE of 3B due to the poor structure.
	<u>CBH</u>	470mm (largest stem)			
	<u>DBH</u>	149mm (largest stem)			
<b>Common Name</b> Swamp Mahogany	<u>Height:</u>	9.5 metres			
	<u>Canopy Spread:</u>	10m X 8m

The base of Tree 3.

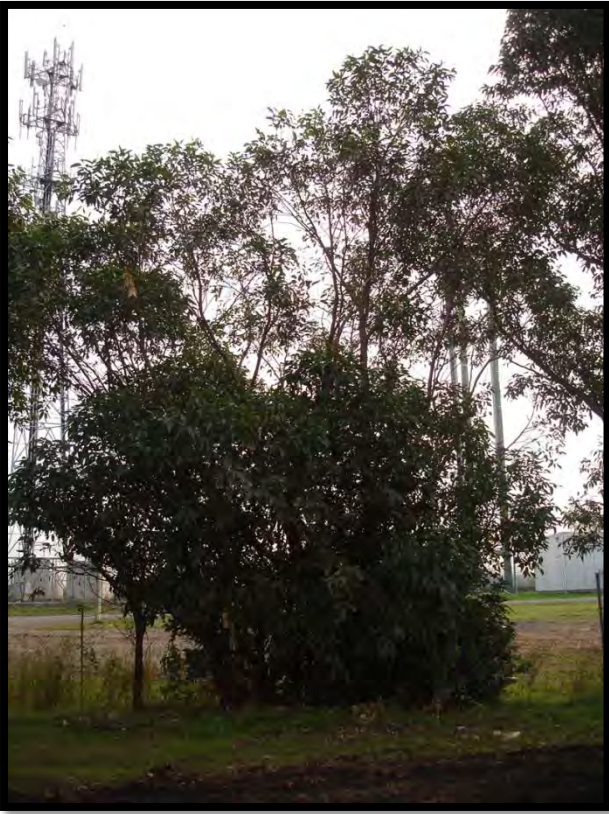
Tree Identification	Description		Health	Structure	U.L.E. (Useful Life Expectancy)
<b>Tree 4</b> <b>Botanical Name</b> <i>Eucalyptus robusta</i>	<u>Age:</u>	Early Mature	The tree is in poor health, having a leaf density of 40% coverage in the main [upper] canopy and 60% in the lower canopy. Slight deadwood to 60mm diameter is present, as well as a deadwood stub 500mm long x 120mm diameter.	The tree has a poor structure having 6 dominant stems from 250mm high, with 1 stem dead and broken off at 1 metre high. A moderate amount of small epicormic growth is present around the lower canopy (60% leaf density).	The tree has been given a ULE of 4C due to the poor structure.
	<u>CBH</u>	780mm (at 1100mm high)			
	<u>DBH</u>	248mm (at 1100mm high)			
<b>Common Name</b> Swamp Mahogany	<u>Height:</u>	10 metres			
	<u>Canopy Spread:</u>	10m X 8m			
<b>Tree 5</b> <b>Botanical Name</b> <i>Eucalyptus robusta</i>	<u>Age:</u>	Mature	The tree is in fair health, having a leaf density of 60% coverage. Slight deadwood to 60mm diameter is present.	The tree has a fair structure having 2 large epicormic shoots measuring, 5 metres long x 100mm diameter, at the base.	The tree has been given a ULE of 3B due to the age and fair structure.

Tree 4, thin upper canopy & lower epicormics.

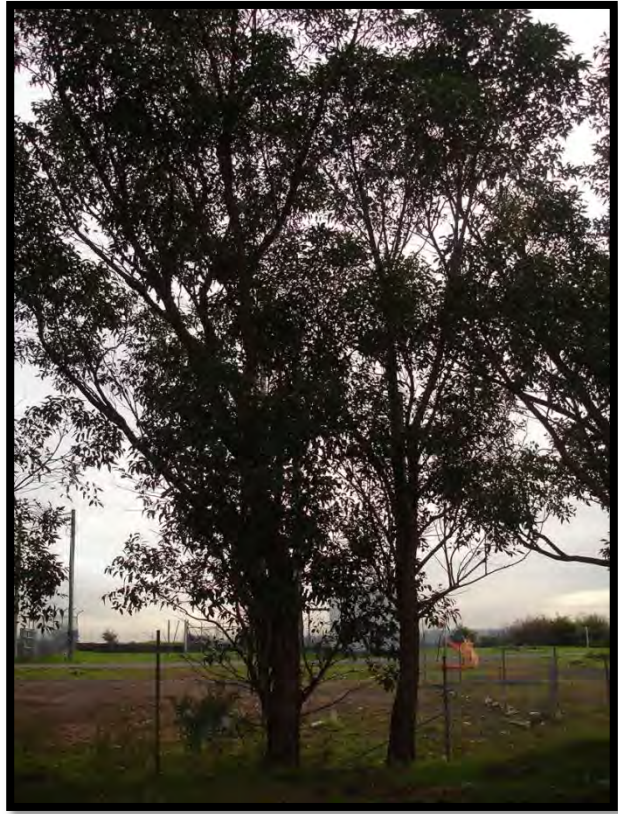
Trees 5 & 6.

<u>CBH</u>	1230mm			
	<u>DBH</u>	391mm			
<b>Common Name</b> Swamp Mahogany	<u>Height:</u>	12 metres			
	<u>Canopy Spread:</u>	11m X 9m			
<b>Tree 6</b> <b>Botanical Name</b> <i>Eucalyptus robusta</i>	<u>Age:</u>	Early Mature	The tree is in fair health, having a leaf density of 60% coverage. Slight deadwood to 50mm diameter is present.	The tree has a fair structure having co - dominant stems from 2.5 metres high.	The tree has been given a ULE of 3B due to fair condition.
	<u>CBH</u>	870mm			
	<u>DBH</u>	277mm			
<b>Common Name</b> Swamp Mahogany	<u>Height:</u>	11 metres			
	<u>Canopy Spread:</u>	8m X 16m

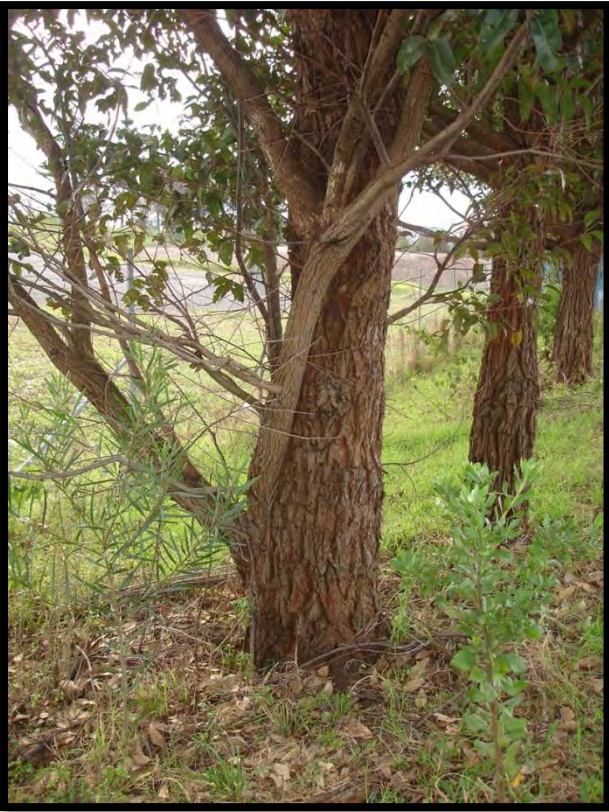
The base of Tree 5 (centre).

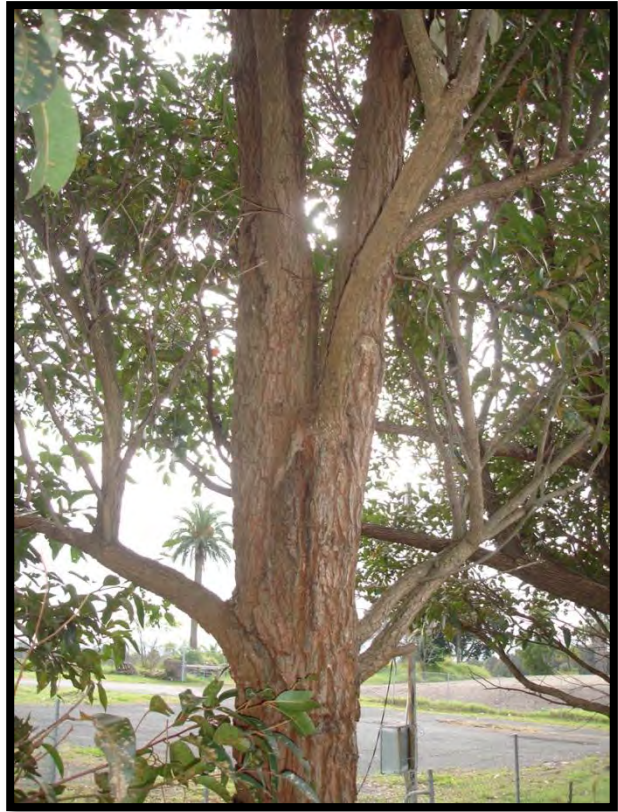
The stem union of Tree 6.

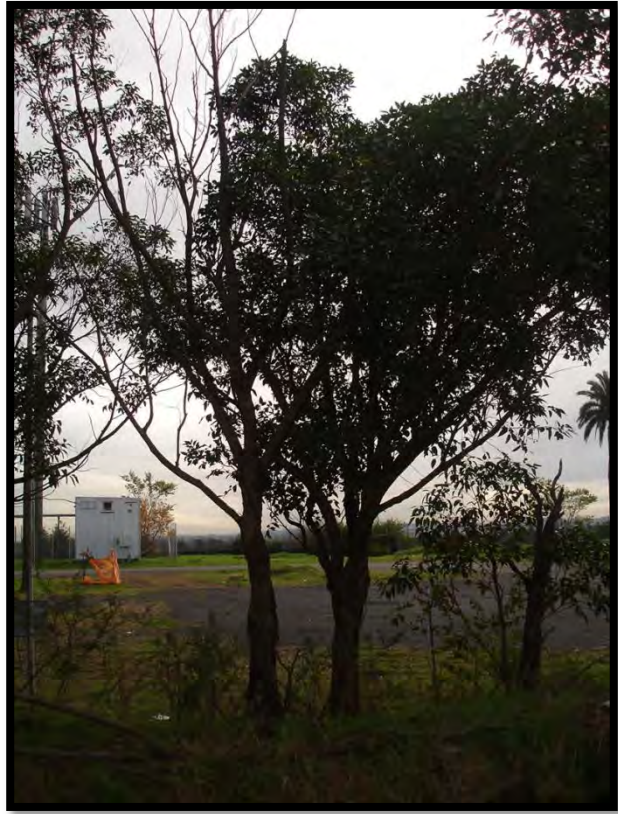
Trees 10 & 11 (left to right).

Tree Identification	Description		Health	Structure	U.L.E. (Useful Life Expectancy)
<b>Tree 10</b> <b>Botanical Name</b> <i>Eucalyptus robusta</i>	<u>Age:</u>	Early Mature	The tree has died, and swelling of the trunk is present at 1.4 metres high. This indicates fungal activity may be present in the stem.	The structural strength of the tree is suspect due to the dead stems.	The tree has been given a ULE of 4A due to its condition.
	<u>CBH</u>	940mm (at 1 metre high)			
	<u>DBH</u>	299mm (at 1 metre high)			
<b>Common Name</b> Swamp Mahogany	<u>Height:</u>	11 metres			
	<u>Canopy Spread:</u>	5m X 5m			
<b>Tree 11</b> <b>Botanical Name</b> <i>Eucalyptus robusta</i>	<u>Age:</u>	Early Mature	The tree is in poor health, having a leaf density of 60% coverage from epicormic growth. Moderate deadwood to 100mm diameter is present. A dead branch measuring approximately 3 metres long x 100mm diameter is present at 3 metres high. An occlusion measuring 400mm long is present at 2 metres high. Some swelling is present around this area.	The tree has a poor structure having 3 dominant stems from 1.7 metres high. A moderate amount of epicormic growth measuring 5 metres long x 70mm diameter is present.	The tree has been given a ULE of 3B due to the poor condition.

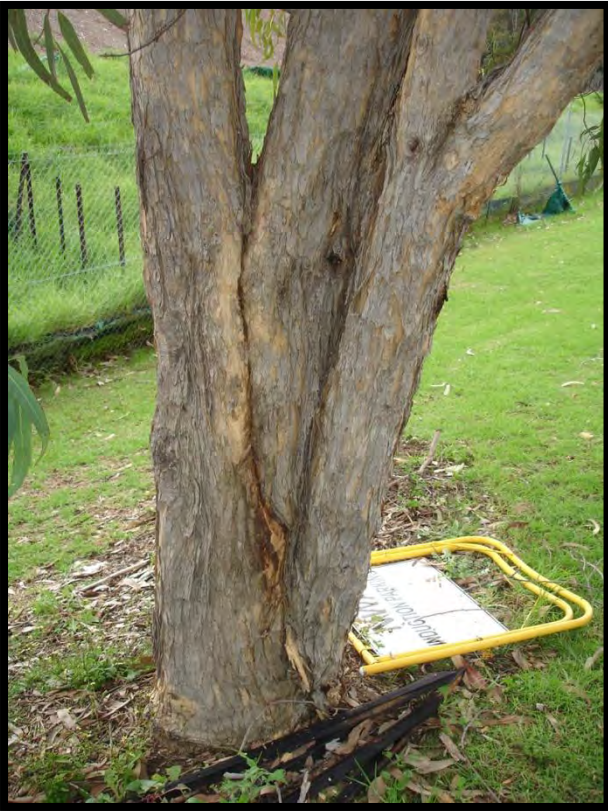
The base of Tree 25.

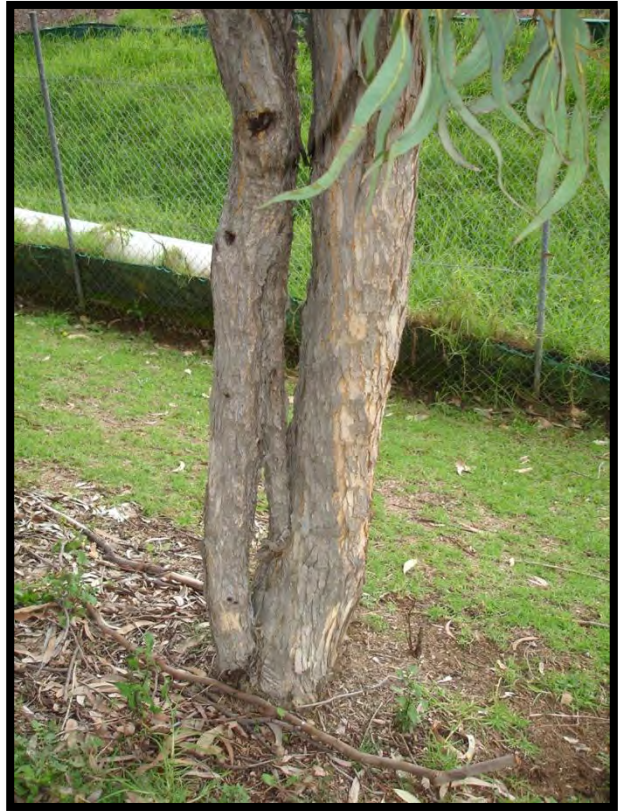
The base of Tree 26.

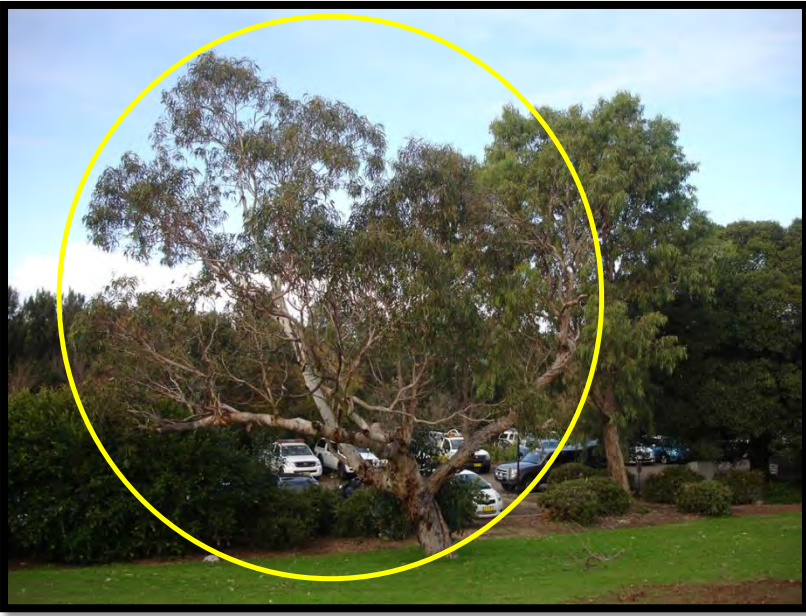
Tree 32 (outlined).

<u>CBH</u>	1340mm			
	<u>DBH</u>	426mm			
	<u>Height:</u>	11 metres			
<b>Common Name</b> Swamp Mahogany	<u>Canopy Spread:</u>	10m X 11m			
<b>Tree 32</b> <b>Botanical Name</b> <i>Eucalyptus globulus</i>	<u>Age:</u>	Mature	The tree is in poor health, having a leaf density of 40% coverage. Severe deadwood to 250mm diameter is present. Some decay is present in the east scaffold. Severe bark dieback is present around 50% of the trunk. Some trunk swelling is present at 1.1 metres. Some past borer activity present. No live specimens observed.	The tree has a poor structure, the main leader having broken off. A moderate amount of epicormic growth measuring 5 metres long x 80mm diameter is present. Some trunk twist is present, and a specimen of <i>Ficus</i> sp. measuring 3 metres long x 80mm diameter is present is growing from a crack in the trunk	The tree has been given a ULE of 3B due to the poor structure.

Trees 30 – 33 are of a similar condition to the previously mentioned trees, with Tree 32 being an exceptionally poor specimen.

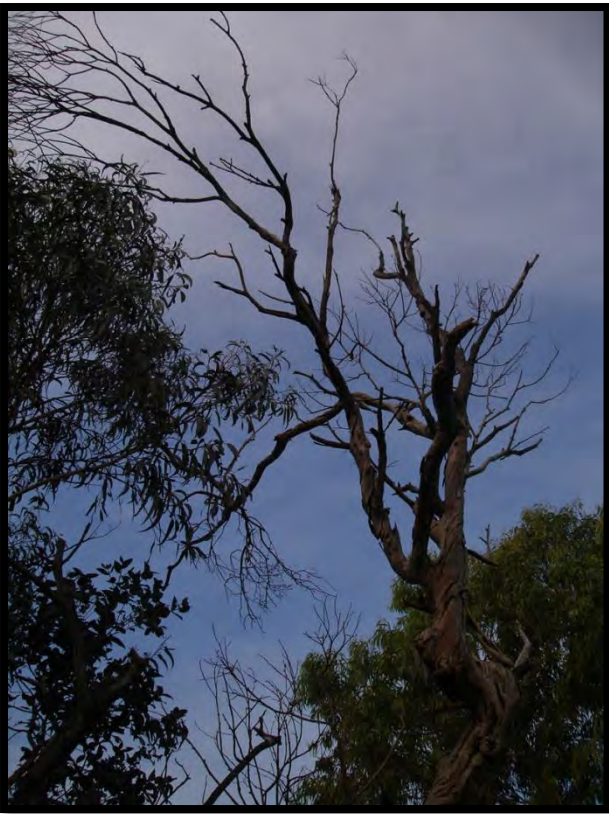
Deadwood in Tree 32.

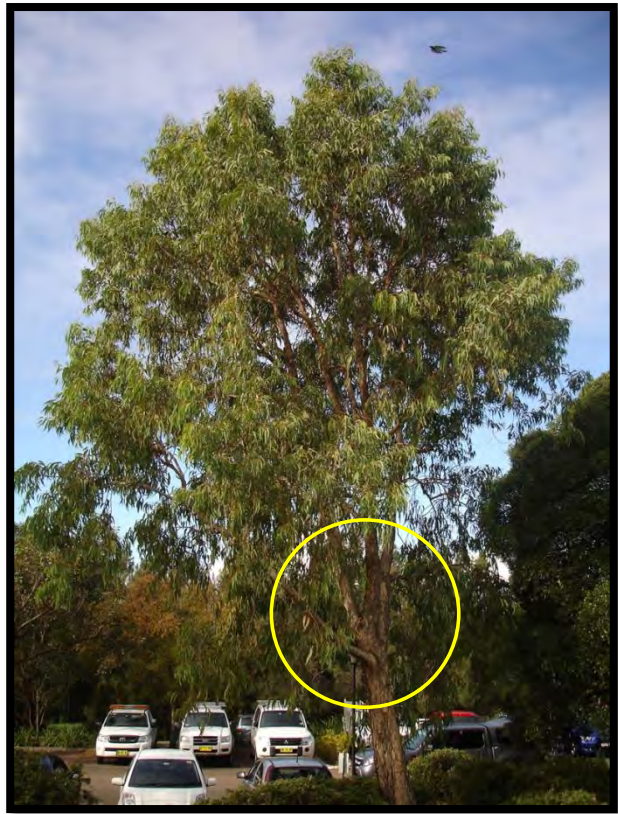
Tree Identification	Description		Health	Structure	U.L.E. (Useful Life Expectancy)
<b>Tree 33</b> <b>Botanical Name</b> <i>Corymbia eximia</i>	<u>Age:</u>	Mature	The tree is in good health.	The tree has a fair structure having 3 dominant stems from 3 metres high. Slight trunk twist is present, as well as a natural lean of 10° to the north east.	The tree has been given a ULE of 3B due to the structural defects.
	<u>CBH</u>	1540mm			
	<u>DBH</u>	490mm			
	<u>Height:</u>	12 metres			
<b>Common Name</b> Yellow Bloodwood	<u>Canopy Spread:</u>	10m X 9m	The tree is in good health, having a leaf density of 80% coverage.	The tree has a fair structure having scaffold branches from 1.3 metres high. A branch has broken off from a scaffold at 1.7 metres high, and some small epicormic shoots measuring 1 metre long x 50mm diameter are present. Some included bark is present between the scaffolds at 1.5 metres high.	The tree has been given a ULE of 3B due to the structural defects.

Tree 33. The 3 stem union is circled.

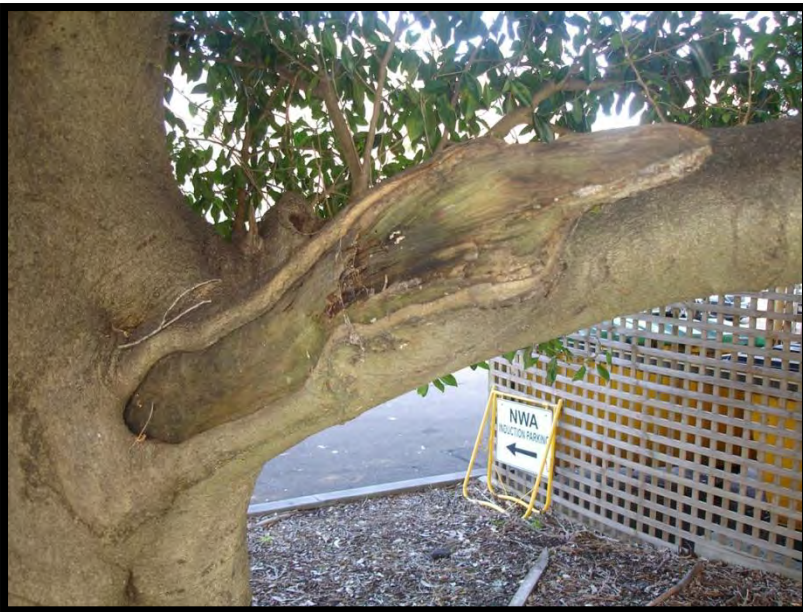
Trees 34 & 35 are in generally good health, but do have some structural defects. As they cannot be adequately protected [during and after construction as required by AS 4970 (2009)], their removal (destruction or relocation) should be based on economic viability.

Area of broken branch on scaffold Tree 34.

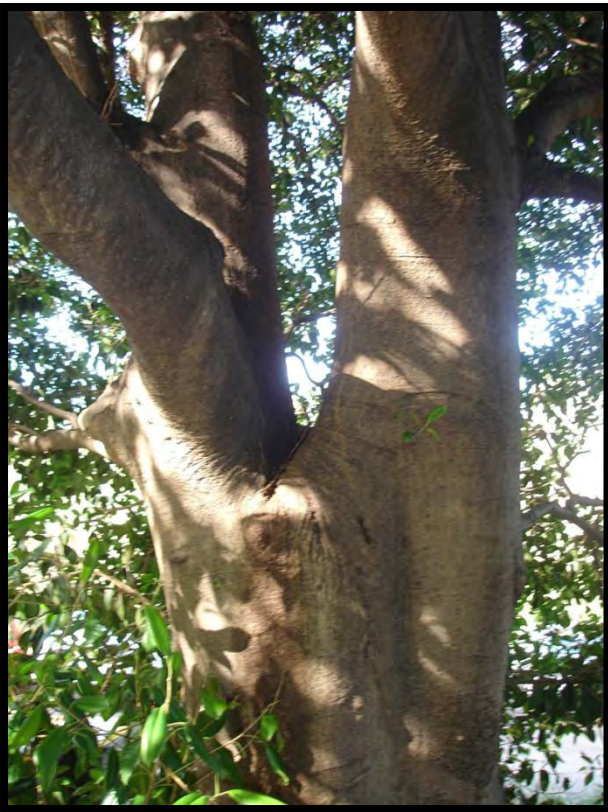
Tree Identification	Description		Health	Structure	U.L.E. (Useful Life Expectancy)
<b>Tree 35</b> <b>Botanical Name</b> <i>Ficus obliqua</i>	<u>Age:</u>	Mature	The tree is in fair health, having a leaf density of 80% coverage. Slight deadwood to 60mm diameter is present.  A partial occlusion measuring 1.4 metres long x 50mm wide is present on a buttress root north side.	The tree has a fair structure having co - dominant stems from 2 metres high. Scaffold branches are present from 1 metre high. Some epicormic growth measuring 4 metres long x 70mm diameter are present around old pruning cuts.	The tree has been given a ULE of 3B due to the fair condition.
	<u>CBH</u>	2650mm (at 900mm high)			
	<u>DBH</u>	843mm (at 900mm hi)			
<b>Common Name</b>  Small Leaved Fig	<u>Height:</u>	11 metres			
	<u>Canopy Spread:</u>	13m X 14m			
<b>Tree 36</b> <b>Botanical Name</b> <i>Magnolia grandiflora</i>	<u>Age:</u>	Early Mature	The tree is in good health, having a leaf density of 90% coverage. Slight deadwood twigs are present.	The tree has a good structure.	The tree has been given a ULE of 2B due to the good condition.

Tree 35 stem union.

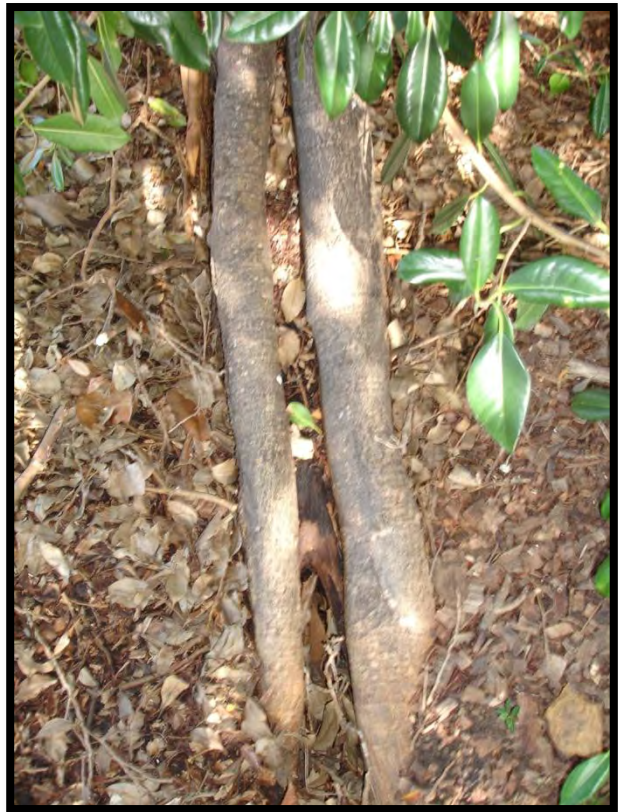
Partial occlusion in buttress of Tree 35.

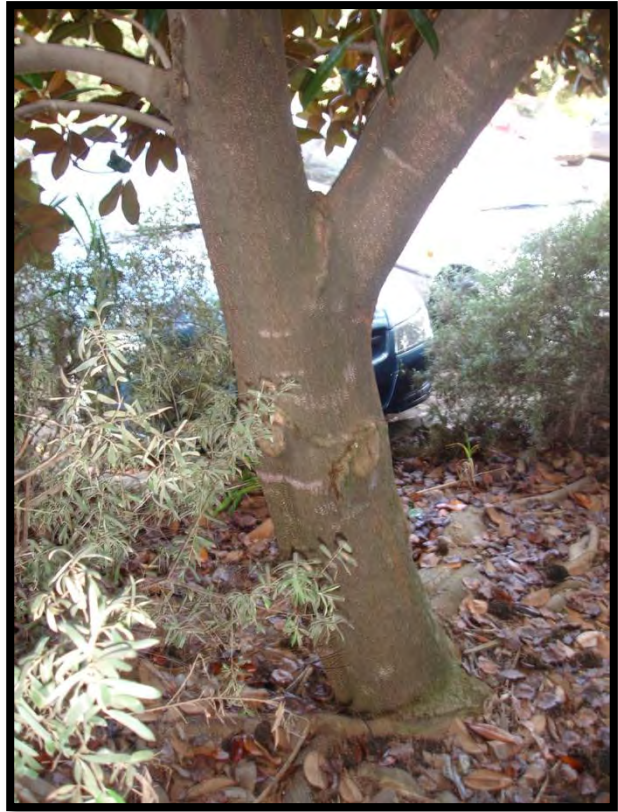
Tree Identification	Description		Health	Structure	U.L.E. (Useful Life Expectancy)
<b>Tree 38</b> <b>Botanical Name</b> <i>Magnolia grandiflora</i>	<u>Age:</u>	Early Mature	The tree is in good health, having a leaf density of 90% coverage. Slight deadwood twigs are present.	The tree has a fair structure having co - dominant stems from 1.3 metres high, and a natural lean of 15° to the east.	The tree has been given a ULE of 2B due to the good condition.
	<u>CBH</u>	850mm (at 1 metre high)			
	<u>DBH</u>	270mm (at 1 metre high)			
<b>Common Name</b> Evergreen Magnolia	<u>Height:</u>	8 metres			
	<u>Canopy Spread:</u>	7m X 7m			
<b>Tree 39</b> <b>Botanical Name</b> <i>Sapium sebiferum</i>	<u>Age:</u>	Early Mature	The tree is in good health, however, slight swelling is present around some old pruning cuts at 1 metre high.	The tree has a fair structure having 3 dominant stems from 3.5 metres high. Some epicormic growth measuring 4 metres long x 60mm diameter is present.	The tree has been given a ULE of 3B due to the structural defects.

Trunk lean & stem union of Tree 38.

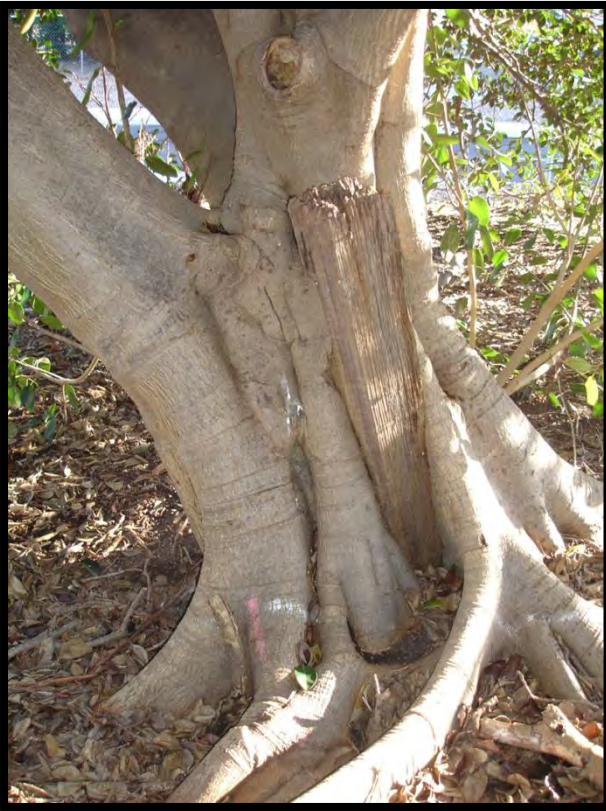
Tree 50 is in generally good health, but has some structural defects common in old Figs (as in Trees 34 & 35). The presence of the fence post (the trunk is growing around it) and the poor pruning suggest this tree has also not been treated correctly in the past.

Trunk growing around post on Tree 50.

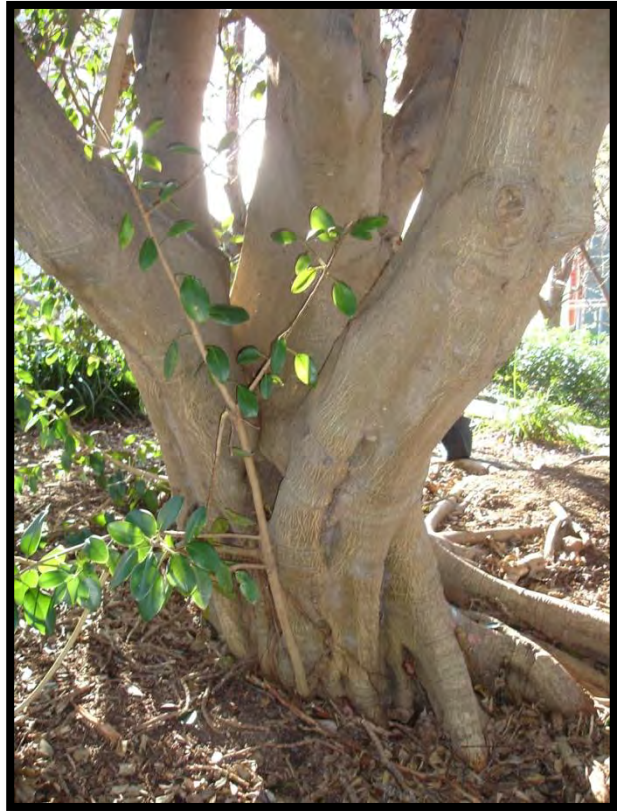
Tree Identification	Description		Health	Structure	U.L.E. (Useful Life Expectancy)
<b>Tree 50</b> <b>Botanical Name</b> <i>Ficus rubiginosa</i>	<u>Age:</u>	Mature	The tree is in fair health, having a leaf density of 80 - 90% coverage. Slight deadwood to 60mm diameter is present. Some deadwood stubs to 300mm long x 70mm diameter are present.	The tree has a poor structure having 3 dominant stems from 900mm high. An old fence post is embedded in the trunk on the north east side. Some poor pruning has been carried out at 2 metres high, and the branch ends are moderately decayed. Some small epicormic shoots measuring to 2 metre long x 50mm diameter are present. Some included bark is present around the stem union. Some bark damage has occurred to some of the surface roots.	The tree has been given a ULE of 3B due to the poor structure.
	<u>CBH</u>	2500mm (at 800 mm high)			
	<u>DBH</u>	796mm (at 800 mm high)

Opposite view of the base of Tree 50.
