Hazardous Building Materials Assessment SYDES2 (Engineering Store) 297 King Street Mascot NSW 2020

Qantas Facility ID: SYDES2

Job No: 51241-004: Client No: J0013

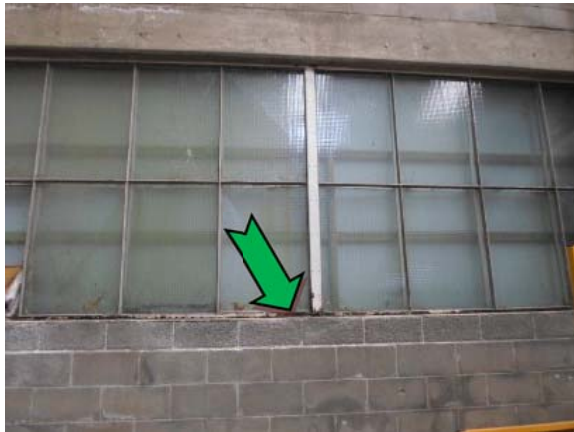
Photo 1. Ground level, perimeter wall, window frames – non asbestos-containing mastic sealant

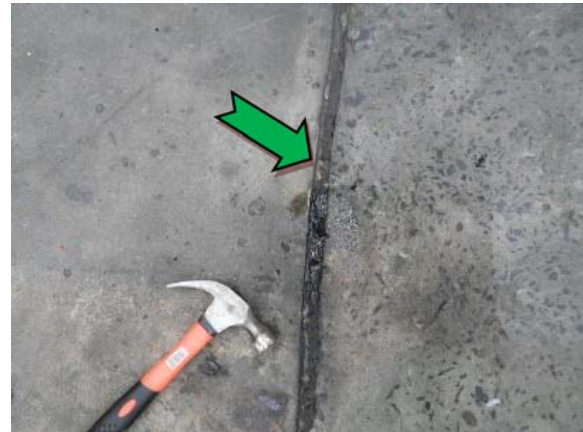
Photo 2. Ground level, on ground, expansion joint – non asbestos-containing mastic sealant

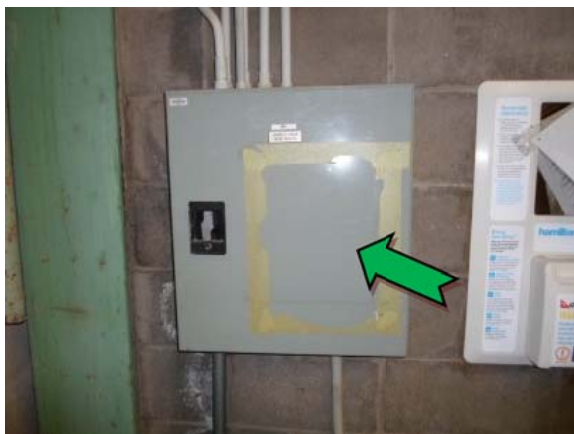
Photo 3. Ground level, south east corner, switchboard – suspected non asbestos-containing bituminous backing board

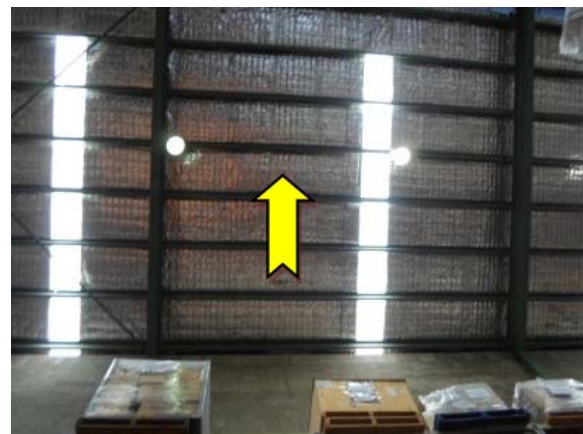
- SMF in the form of sarking insulation was suspected to be present throughout the roof space.

Ground level	Roof space	Throughout	Sarking insulation	SMF	-	Positive	Bonded	Low	Good	Low	~800m ²	Maintain in current condition if to remain in-situ. Remove under controlled SMF conditions as per Code of Practice for the Safe Use of Synthetic Mineral Fibres [NOHSC: 2006 (1990)].	-	-	4
Throughout	All areas	-	-	PCBs	-	-	-	-	-	-	-	No PCBs identified or suspected at the time of the assessment.			-
Exterior	Walls - east façade	Walls	Grey (light) - upper coloured paint system	Lead Paint - Swab	-	Negative	-	-	-	-	-	<1% lead content, not lead containing paint as described in AS 4361.2:1998 Guide to lead paint management	-	-	5
Exterior	Roller door, crash barrier (east façade) - corner crash panel	Infill panels	Yellow - upper coloured paint system	Lead Paint - Swab	-	Negative	-	-	-	-	-	<1% lead content, not lead containing paint as described in AS 4361.2:1998 Guide to lead paint management	-	-	6
Exterior	Exterior steel - north façade	Infill panels	Grey (light) - upper coloured paint system	Lead Paint - Swab	-	Negative	-	-	-	-	-	<1% lead content, not lead containing paint as described in AS 4361.2:1998 Guide to lead paint management	-	-	-

Photo 4. Ground level, throughout roof space – SMF sarking insulation

- SMF materials that are likely to be disturbed during any proposed demolition/refurbishment works should be handled in accordance with the *Code of Practice for the Safe Use of Synthetic Mineral Fibres* [NOHSC:2006(1990)].
- Please refer to the HMMP for this site for overarching recommendations for SMFs at this site.

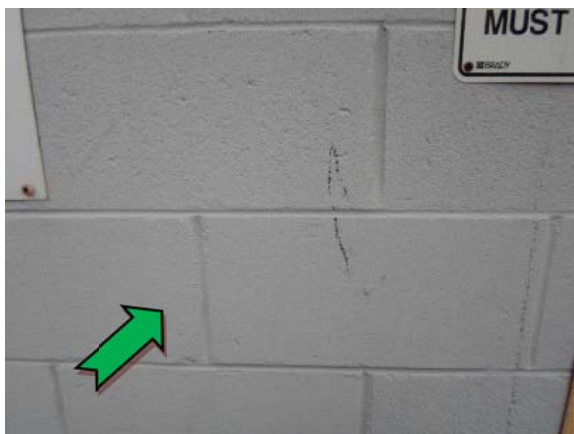
Photo 5. Exterior, walls, east façade, walls – non lead-containing light grey upper coloured paint system

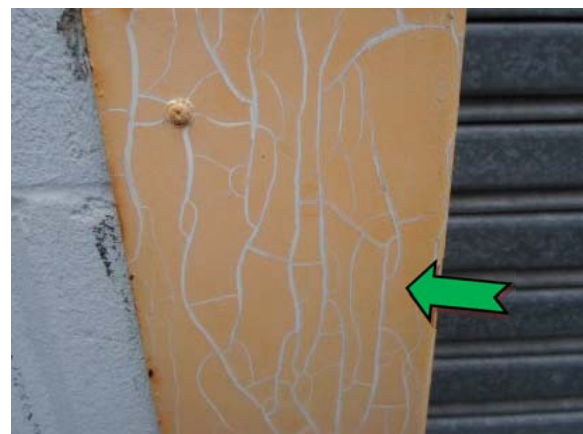
Photo 6. Exterior, roller door, crash barrier (east façade), corner crash infill panel – non lead-containing yellow upper coloured paint system

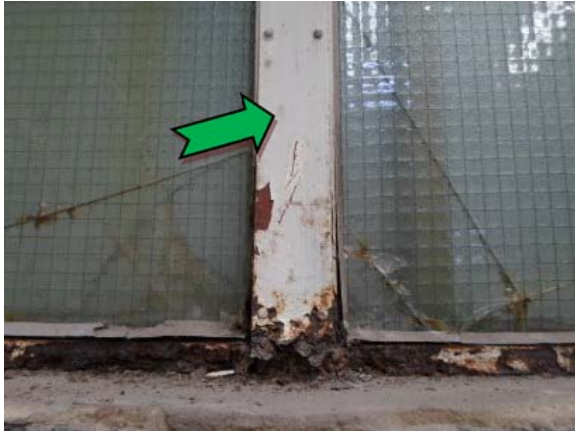
Photo 7. Ground level, throughout, window frames – non lead-containing white upper coloured paint system

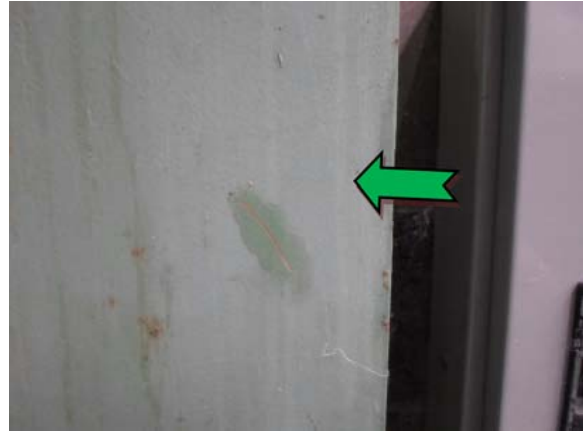
Photo 8. Ground level, main room, structural steel – non lead-containing green upper coloured paint system
