Hazardous Building Materials Assessment Guardhouse King Street Nth (SYDGKN) Jet Base Mascot NSW 2020

Jones Lang LaSalle

November 2014

Qantas Facility ID: SYDGKN

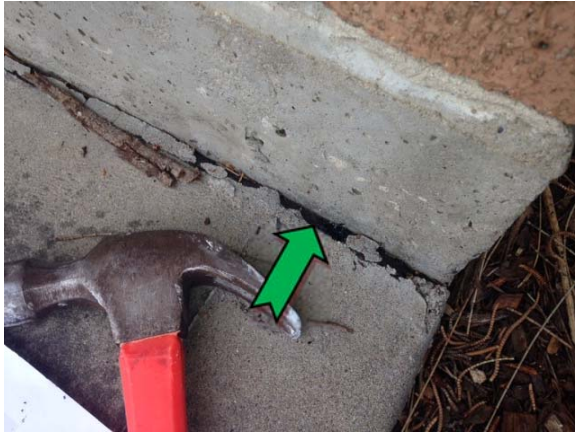
Photo 1. Exterior, western façade, base of building, expansion joint – non asbestos-containing mastic sealant

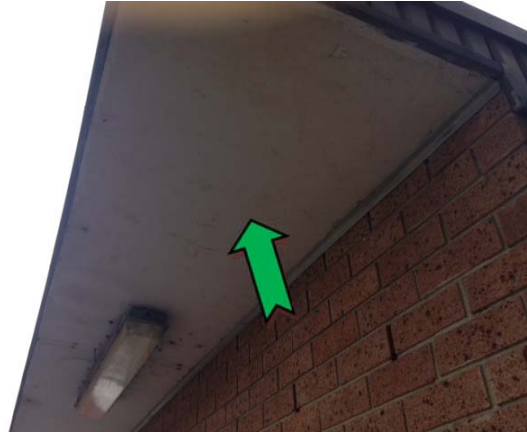
Photo 2. Exterior, western side, roof, eave – non asbestos-containing fibre cement sheeting

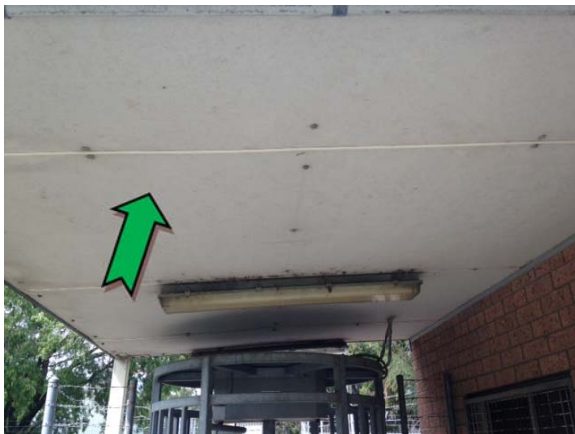
Photo 3. Exterior, eastern façade, awning, infill panels – assumed non asbestos-containing fibre cement sheeting

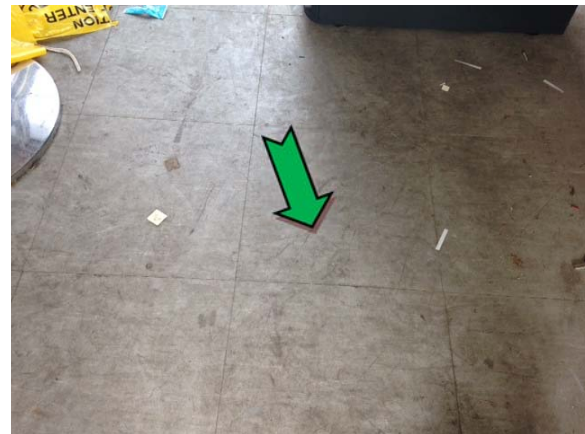
Photo 4. Ground level, throughout, lower floor layer, grey floor coverings – non asbestos-containing vinyl floor tiles

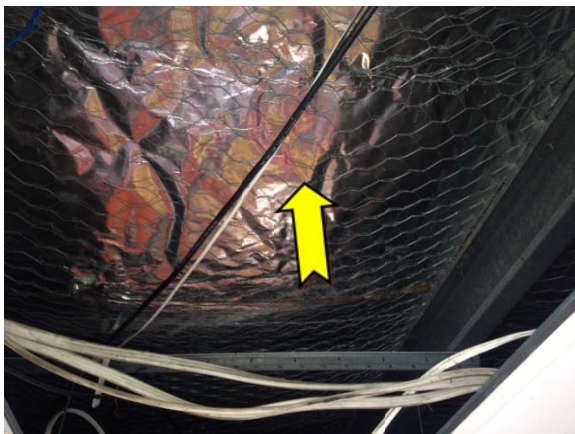
- SMF sarking insulation was present throughout the roof space of the site.

Photo 5. Ground level, throughout roof space – SMF sarking insulation

- SMF materials that are likely to be disturbed during any proposed demolition/refurbishment works should be handled in accordance with the *Code of Practice for the Safe Use of Synthetic Mineral Fibres* [NOHSC:2006(1990)].
- Please refer to the HMMP for this site for overarching recommendations for SMFs at this site.
