DEMOLITION/REFURBISHMENT HAZARDOUS MATERIAL RISK ASSESSMENT

DATE: FEBRUARY 2020

OUR REFERENCE:
C107662 : J162866

JDH ARCHITECTS
BANKSTOWN NORTH PUBLIC SCHOOL
322 HUME HIGHWAY, BANKSTOWN NSW 2200

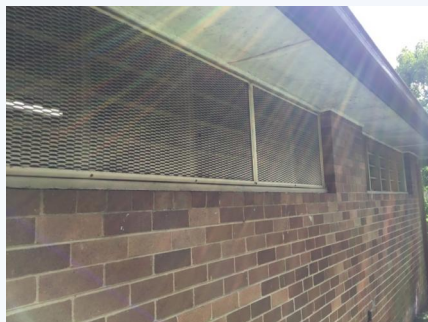
ITEM NO.: 4
 PHOTO NO.: J162866-1124-PHOTO003
 RESULT: LEAD (PAINT) - POSITIVE (0.54 % W/W) LEAD
 BUILDING/LEVEL: BLOCK C - PUPIL FACILITIES (B00C) - GROUND LEVEL
 ROOM/LOCATION: EXTERIOR - THROUGHOUT
 FEATURE/MATERIAL: WINDOW FRAME - PAINT SYSTEM/S
 SAMPLE NO.: J162866-1124-LP-002

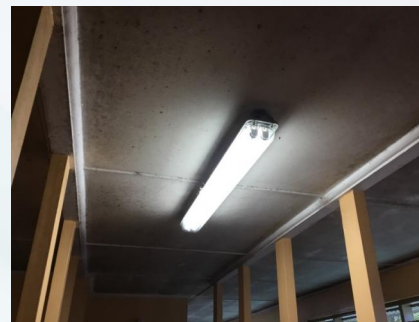
ITEM NO.: 7
 PHOTO NO.: J162866-1124-PHOTO065
 RESULT: LEAD (PAINT) - POSITIVE (0.13 % W/W) LEAD
 BUILDING/LEVEL: BLOCK C - PUPIL FACILITIES (B00C) - GROUND LEVEL
 ROOM/LOCATION: ALL ROOMS - THROUGHOUT
 FEATURE/MATERIAL: CEILING - PAINT SYSTEM/S
 SAMPLE NO.: J162866-1124-LP-017

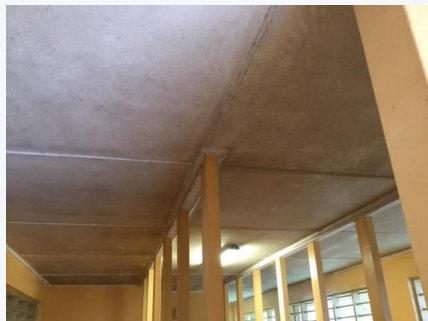
10	CR0003 Girls Toilet Fluorescent Light Fitting - Capacitor	PCB		Presumed Positive	J162866-1124-Photo 069	15 Unit/s	Good							Remove by an appropriately experienced contractor under controlled conditions and using correct PPE if this item will be impacted by refurbishment/ demolition works.

ITEM NO.: 10
 PHOTO NO.: J162866-1124-PHOTO069
 RESULT: PCB - PRESUMED POSITIVE
 BUILDING/LEVEL: BLOCK C - PUPIL FACILITIES (B00C) - GROUND LEVEL
 ROOM/LOCATION: CR0003 GIRLS TOILET
 FEATURE/MATERIAL: FLUORESCENT LIGHT FITTING - CAPACITOR
 SAMPLE NO.: -

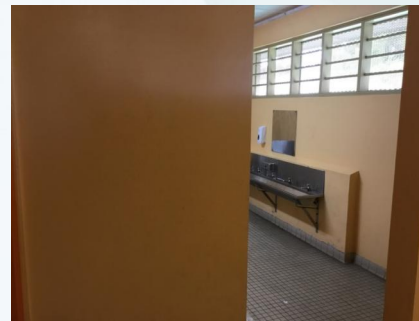
ITEM NO.: 11
 PHOTO NO.: J162866-1124-PHOTO066
 RESULT: LEAD (PAINT) - PRESUMED POSITIVE (0.12 % W/W) LEAD
 BUILDING/LEVEL: BLOCK C - PUPIL FACILITIES (B00C) - GROUND LEVEL
 ROOM/LOCATION: CR0003 GIRLS TOILET - THROUGHOUT
 FEATURE/MATERIAL: WALL - PAINT SYSTEM/S
 SAMPLE NO.: SIMILAR TO: J162866-1124-LP-016

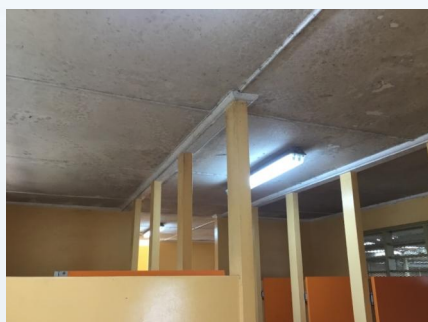
ITEM NO.: 12
 PHOTO NO.: J162866-1124-PHOTO106
 RESULT: PCB - PRESUMED POSITIVE
 BUILDING/LEVEL: BLOCK C - PUPIL FACILITIES (B00C) - GROUND LEVEL
 ROOM/LOCATION: CR0007 BOYS TOILET
 FEATURE/MATERIAL: FLUORESCENT LIGHT FITTING - CAPACITOR
 SAMPLE NO.: -

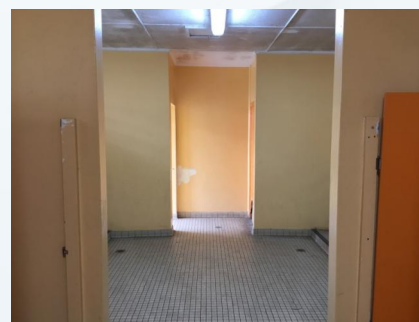
ITEM NO.: 15
 PHOTO NO.: J162866-1124-PHOTO063
 RESULT: LEAD (PAINT) - POSITIVE (0.12 % W/W) LEAD
 BUILDING/LEVEL: BLOCK C - PUPIL FACILITIES (B00C) - GROUND LEVEL
 ROOM/LOCATION: CR0007 BOYS TOILET - THROUGHOUT
 FEATURE/MATERIAL: WALL - PAINT SYSTEM/S
 SAMPLE NO.: J162866-1124-LP-016

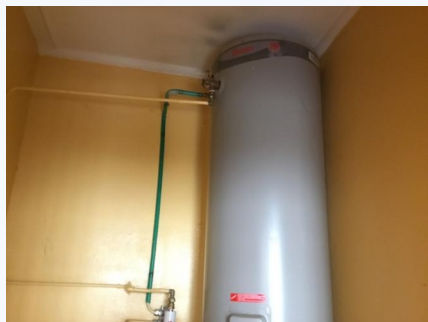
ITEM NO.: 16
 PHOTO NO.: J162866-1124-PHOTO062
 RESULT: SMF - PRESUMED POSITIVE
 BUILDING/LEVEL: BLOCK C - PUPIL FACILITIES (B00C) - GROUND LEVEL
 ROOM/LOCATION: CR0007 BOYS TOILET - CLEANER'S ROOM - EAST
 FEATURE/MATERIAL: HOT WATER HEATER - INSULATION MATERIAL
 SAMPLE NO.: -

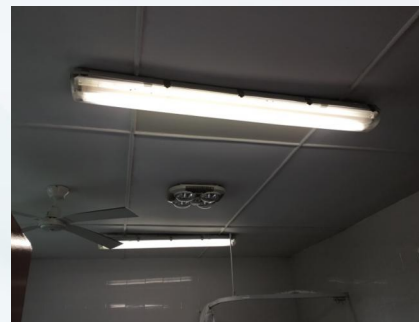
17	CR0009 Shower Toilet - Throughout Fluorescent Light Fitting - Capacitor	PCB		Presumed Positive	J162866-1124-Photo 068	15 Unit/s	Good							Remove by an appropriately experienced contractor under controlled conditions and using correct PPE if this item will be impacted by refurbishment/ demolition works.

ITEM NO.: 17
 PHOTO NO.: J162866-1124-PHOTO068
 RESULT: PCB - PRESUMED POSITIVE
 BUILDING/LEVEL: BLOCK C - PUPIL FACILITIES (B00C) - GROUND LEVEL
 ROOM/LOCATION: CR0009 SHOWER TOILET - THROUGHOUT
 FEATURE/MATERIAL: FLUORESCENT LIGHT FITTING - CAPACITOR
 SAMPLE NO.: -

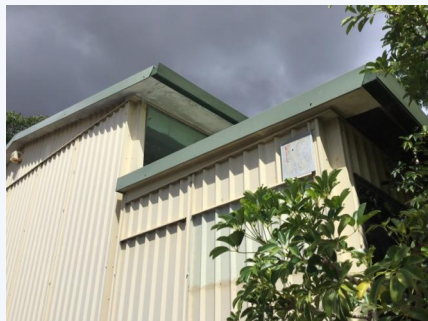
ITEM NO.: 29
 PHOTO NO.: J162866-1124-PHOTO157
 RESULT: ASBESTOS - PRESUMED POSITIVE
 BUILDING/LEVEL: BLOCK K - OTHER - REGIONAL USE (B00K) - GROUND LEVEL
 ROOM/LOCATION: EXTERIOR
 FEATURE/MATERIAL: EAVES - FIBRE CEMENT SHEETING
 SAMPLE NO.: NOT SAMPLED HEIGHT RESTRICTED

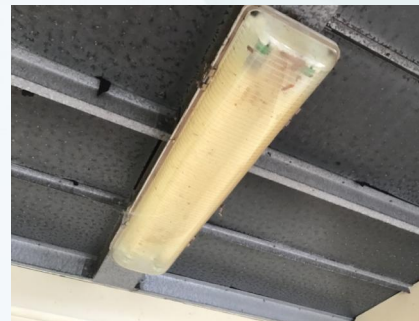
ITEM NO.: 30
 PHOTO NO.: J162866-1124-PHOTO159
 RESULT: PCB - PRESUMED POSITIVE
 BUILDING/LEVEL: BLOCK K - OTHER - REGIONAL USE (B00K) - GROUND LEVEL
 ROOM/LOCATION: EXTERIOR
 FEATURE/MATERIAL: FLUORESCENT LIGHT FITTING - CAPACITOR
 SAMPLE NO.: -

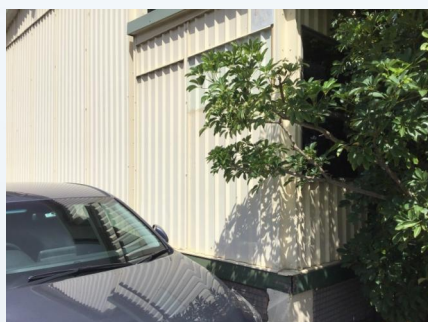
ITEM NO.: 31
 PHOTO NO.: J162866-1124-PHOTO156
 RESULT: LEAD (PAINT) - POSITIVE (0.15 % W/W) LEAD
 BUILDING/LEVEL: BLOCK K - OTHER - REGIONAL USE (B00K) - GROUND LEVEL
 ROOM/LOCATION: EXTERIOR - THROUGHOUT
 FEATURE/MATERIAL: WALL - PAINT SYSTEM/S
 SAMPLE NO.: J162866-1124-LP-030

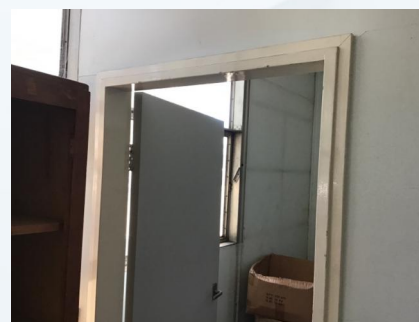
ITEM NO.: 34
 PHOTO NO.: J162866-1124-PHOTO146
 RESULT: LEAD (PAINT) - POSITIVE (0.14 % W/W) LEAD
 BUILDING/LEVEL: BLOCK K - OTHER - REGIONAL USE (B00K) - GROUND LEVEL
 ROOM/LOCATION: ALL ROOMS
 FEATURE/MATERIAL: DOOR FRAME - PAINT SYSTEM/S
 SAMPLE NO.: J162866-1124-LP-028

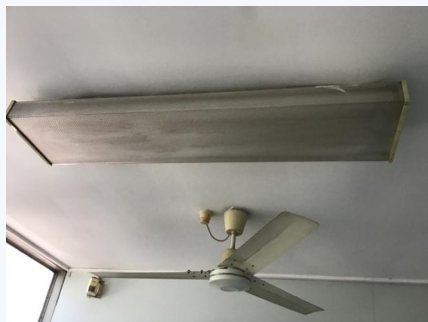
ITEM NO.: 36
 PHOTO NO.: J162866-1124-PHOTO159
 RESULT: PCB - PRESUMED POSITIVE
 BUILDING/LEVEL: BLOCK K - OTHER - REGIONAL USE (B00K) - GROUND LEVEL
 ROOM/LOCATION: ALL ROOMS
 FEATURE/MATERIAL: FLUORESCENT LIGHT FITTING - CAPACITOR
 SAMPLE NO.: -

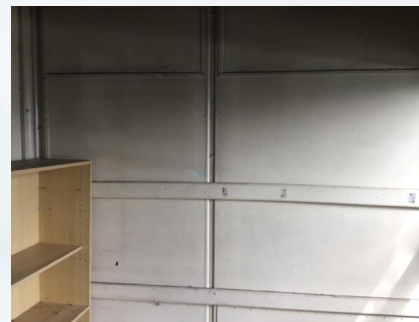
ITEM NO.: 40
 PHOTO NO.: J162866-1124-PHOTO135
 RESULT: LEAD (PAINT) - POSITIVE (0.13 % W/W) LEAD
 BUILDING/LEVEL: BLOCK K - OTHER - REGIONAL USE (B00K) - GROUND LEVEL
 ROOM/LOCATION: ALL ROOMS - THROUGHOUT
 FEATURE/MATERIAL: WALL - PAINT SYSTEM/S
 SAMPLE NO.: J162866-1124-LP-025

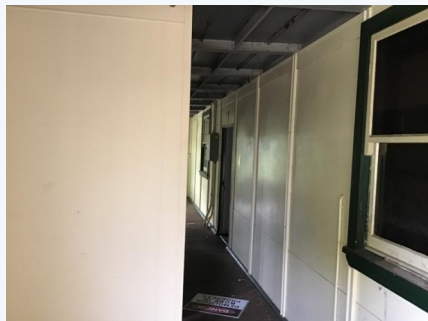
ITEM NO.: 40
 PHOTO NO.: J162866-1124-PHOTO136
 RESULT: LEAD (PAINT) - POSITIVE (0.13 % W/W) LEAD
 BUILDING/LEVEL: BLOCK K - OTHER - REGIONAL USE (B00K) - GROUND LEVEL
 ROOM/LOCATION: ALL ROOMS - THROUGHOUT
 FEATURE/MATERIAL: WALL - PAINT SYSTEM/S
 SAMPLE NO.: J162866-1124-LP-025

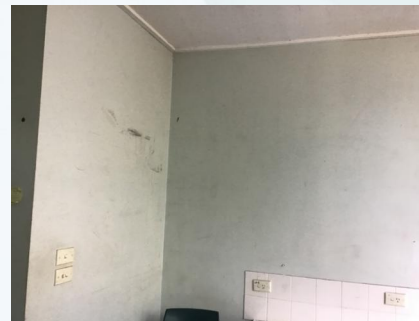
ITEM NO.: 41
 PHOTO NO.: J162866-1124-PHOTO143
 RESULT: LEAD (PAINT) - POSITIVE (0.27 % W/W) LEAD
 BUILDING/LEVEL: BLOCK K - OTHER - REGIONAL USE (B00K) - GROUND LEVEL
 ROOM/LOCATION: ALL ROOMS - THROUGHOUT
 FEATURE/MATERIAL: WALL - PAINT SYSTEM/S
 SAMPLE NO.: J162866-1124-LP-027

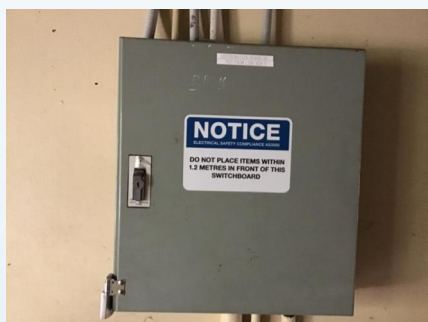
ITEM NO.: 43
 PHOTO NO.: J162866-1124-PHOTO133
 RESULT: ASBESTOS - PRESUMED POSITIVE
 BUILDING/LEVEL: BLOCK K - OTHER - REGIONAL USE (B00K) - GROUND LEVEL
 ROOM/LOCATION: KR0001 DET-REGION - CENTRAL
 FEATURE/MATERIAL: ELECTRICAL DISTRIBUTION BOARD - ELECTRICAL COMPONENTS
 SAMPLE NO.: NOT SAMPLED LIVE ELECTRICAL HAZARD

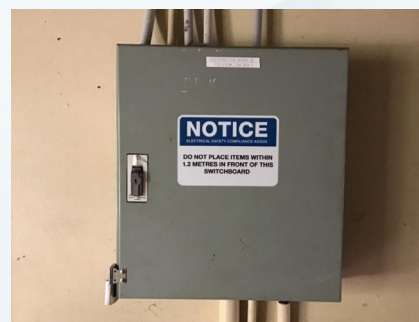
ITEM NO.: 44
 PHOTO NO.: J162866-1124-PHOTO132
 RESULT: ASBESTOS - PRESUMED POSITIVE
 BUILDING/LEVEL: BLOCK K - OTHER - REGIONAL USE (B00K) - GROUND LEVEL
 ROOM/LOCATION: KR0001 DET-REGION - CENTRAL
 FEATURE/MATERIAL: ELECTRICAL DISTRIBUTION BOARD - COMPRESSED BITUMINOUS ELECTRICAL PANEL
 SAMPLE NO.: NOT SAMPLED LIVE ELECTRICAL HAZARD

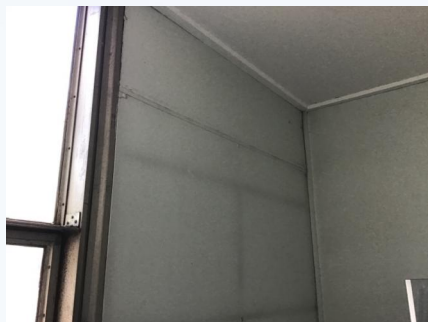
ITEM NO.: 51
 PHOTO NO.: J162866-1124-PHOTO144
 RESULT: **ASBESTOS - POSITIVE**
 BUILDING/LEVEL: **BLOCK K - OTHER - REGIONAL USE (B00K) - GROUND LEVEL**
 ROOM/LOCATION: **KR0008 DET-REGION - THROUGHOUT**
 FEATURE/MATERIAL: **WALL LINING - FIBRE CEMENT SHEETING**
 SAMPLE NO.: **J162866-1124-038**

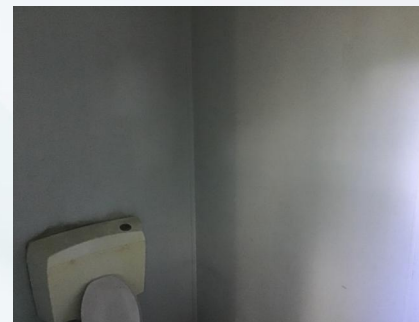
ITEM NO.: 52
 PHOTO NO.: J162866-1124-PHOTO145
 RESULT: **ASBESTOS - PRESUMED POSITIVE**
 BUILDING/LEVEL: **BLOCK K - OTHER - REGIONAL USE (B00K) - GROUND LEVEL**
 ROOM/LOCATION: **KR0009 DET-REGION - THROUGHOUT**
 FEATURE/MATERIAL: **WALL LINING - FIBRE CEMENT SHEETING**
 SAMPLE NO.: **SIMILAR TO: J162866-1124-038**

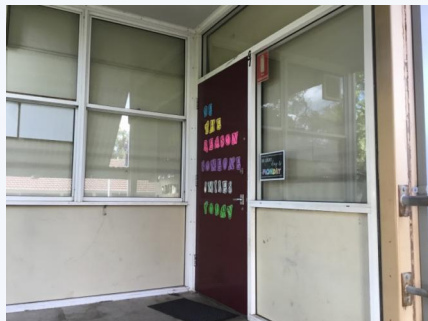
ITEM NO.: 63
 PHOTO NO.: J162866-1124-PHOTO016
 RESULT: **LEAD (PAINT) - PRESUMED POSITIVE (0.17 % W/W) LEAD**
 BUILDING/LEVEL: **D11072 - GROUND LEVEL**
 ROOM/LOCATION: **NORTHEAST ENTRANCE - WEST**
 FEATURE/MATERIAL: **DOOR - PAINT SYSTEM/S**
 SAMPLE NO.: **SIMILAR TO: J162866-1124-LP-006**

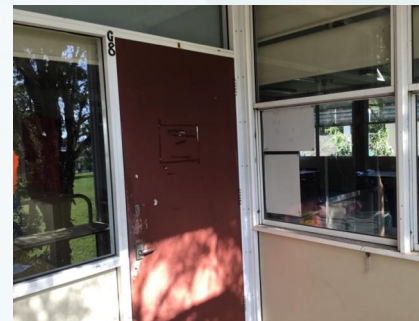
ITEM NO.: 64
 PHOTO NO.: J162866-1124-PHOTO017
 RESULT: **LEAD (PAINT) - POSITIVE (0.17 % W/W) LEAD**
 BUILDING/LEVEL: **D11072 - GROUND LEVEL**
 ROOM/LOCATION: **NORTHWEST ENTRANCE - EAST**
 FEATURE/MATERIAL: **DOOR - PAINT SYSTEM/S**
 SAMPLE NO.: **J162866-1124-LP-006**

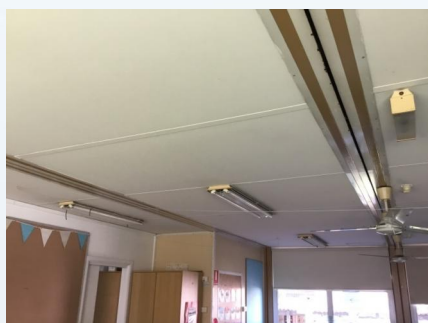
ITEM NO.: 67
 PHOTO NO.: J162866-1124-PHOTO086
 RESULT: **ASBESTOS - PRESUMED POSITIVE**
 BUILDING/LEVEL: **D11072 - GROUND LEVEL**
 ROOM/LOCATION: **EASTERN CLASSROOM - THROUGHOUT**
 FEATURE/MATERIAL: **CEILING LINING - FIBRE CEMENT SHEETING**
 SAMPLE NO.: **SIMILAR TO: J162866-1124-026**

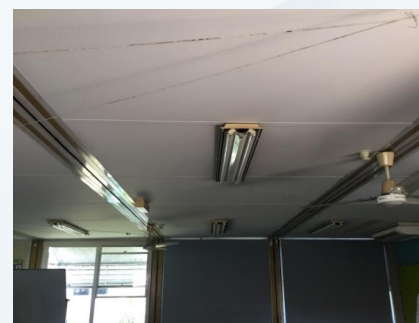
ITEM NO.: 68
 PHOTO NO.: J162866-1124-PHOTO159
 RESULT: **PCB - PRESUMED POSITIVE**
 BUILDING/LEVEL: **D11072 - GROUND LEVEL**
 ROOM/LOCATION: **EASTERN CLASSROOM - VARIOUS THROUGHOUT**
 FEATURE/MATERIAL: **FLUORESCENT LIGHT FITTING - CAPACITOR**
 SAMPLE NO.: -

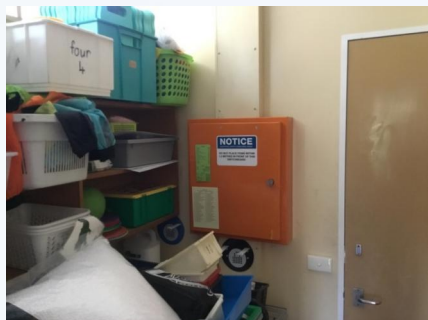
ITEM NO.: 69
 PHOTO NO.: J162866-1124-PHOTO085
 RESULT: **ASBESTOS - PRESUMED POSITIVE**
 BUILDING/LEVEL: D11072 - GROUND LEVEL
 ROOM/LOCATION: **STORAGE ROOM - NORTHEAST**
 FEATURE/MATERIAL: **ELECTRICAL DISTRIBUTION BOARD - ELECTRICAL COMPONENTS**
 SAMPLE NO.: **NOT SAMPLED RESTRICTED ACCESS**

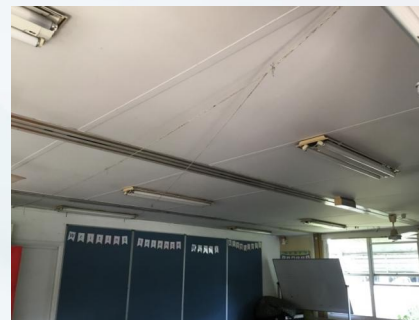
ITEM NO.: 71
 PHOTO NO.: J162866-1124-PHOTO083
 RESULT: **ASBESTOS - POSITIVE**
 BUILDING/LEVEL: D11072 - GROUND LEVEL
 ROOM/LOCATION: **WESTERN CLASSROOM - THROUGHOUT**
 FEATURE/MATERIAL: **CEILING LINING - FIBRE CEMENT SHEETING**
 SAMPLE NO.: J162866-1124-026

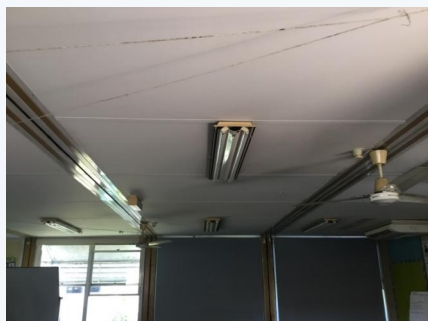
ITEM NO.: 72
 PHOTO NO.: J162866-1124-PHOTO084
 RESULT: **PCB - PRESUMED POSITIVE**
 BUILDING/LEVEL: D11072 - GROUND LEVEL
 ROOM/LOCATION: **WESTERN CLASSROOM - VARIOUS THROUGHOUT**
 FEATURE/MATERIAL: **FLUORESCENT LIGHT FITTING - CAPACITOR**
 SAMPLE NO.: -

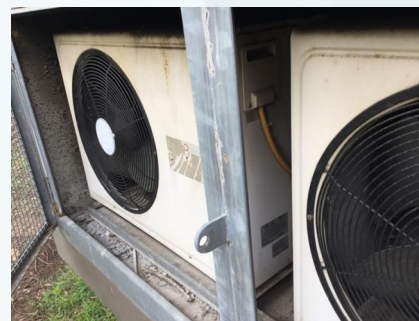
ITEM NO.: 74
 PHOTO NO.: J162866-1124-PHOTO052
 RESULT: **ODS - PRESUMED POSITIVE**
 BUILDING/LEVEL: D11377 - GROUND LEVEL
 ROOM/LOCATION: **EXTERIOR - SOUTHWEST - AIR CONDITION UNIT BOX**
 FEATURE/MATERIAL: **A/C UNIT - UNABLE TO DETERMINE**
 SAMPLE NO.: -

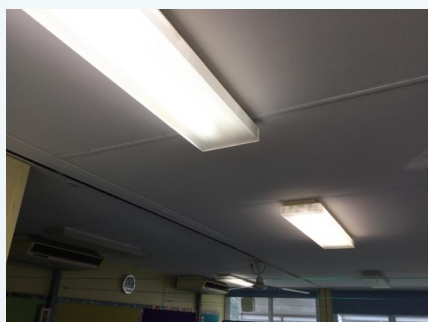
ITEM NO.: 79
 PHOTO NO.: J162866-1124-PHOTO049
 RESULT: **PCB - PRESUMED POSITIVE**
 BUILDING/LEVEL: D11377 - GROUND LEVEL
 ROOM/LOCATION: **ALL ROOMS**
 FEATURE/MATERIAL: **FLUORESCENT LIGHT FITTING - CAPACITOR**
 SAMPLE NO.: -

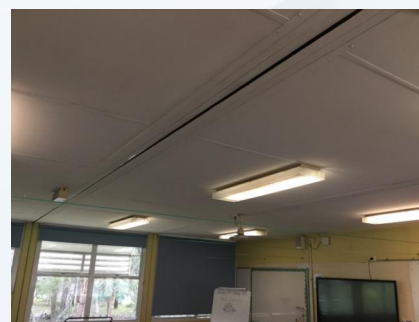
ITEM NO.: 80
 PHOTO NO.: J162866-1124-PHOTO048
 RESULT: **ASBESTOS - POSITIVE**
 BUILDING/LEVEL: D11377 - GROUND LEVEL
 ROOM/LOCATION: **ALL ROOMS - THROUGHOUT**
 FEATURE/MATERIAL: **CEILING LINING - FIBRE CEMENT SHEETING**
 SAMPLE NO.: J162866-1124-027

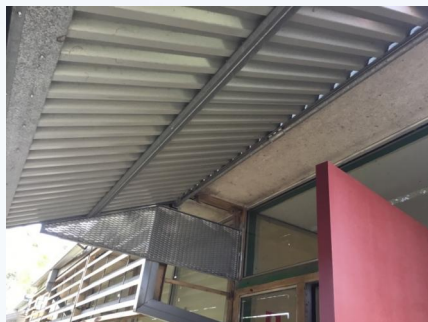
ITEM NO.: 86
 PHOTO NO.: J162866-1124-PHOTO029
 RESULT: **ASBESTOS - POSITIVE**
 BUILDING/LEVEL: D11532 - GROUND LEVEL
 ROOM/LOCATION: EXTERIOR - NORTH & SOUTH
 FEATURE/MATERIAL: **EAVES - FIBRE CEMENT SHEETING**
 SAMPLE NO.: J162866-1124-008

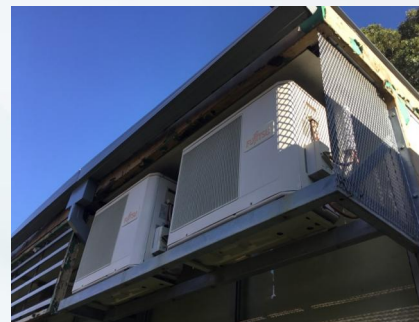
ITEM NO.: 87
 PHOTO NO.: J162866-1124-PHOTO033
 RESULT: **ODS - PRESUMED POSITIVE**
 BUILDING/LEVEL: D11532 - GROUND LEVEL
 ROOM/LOCATION: EXTERIOR - NORTHWEST
 FEATURE/MATERIAL: **A/C UNIT - UNABLE TO DETERMINE**
 SAMPLE NO.: -

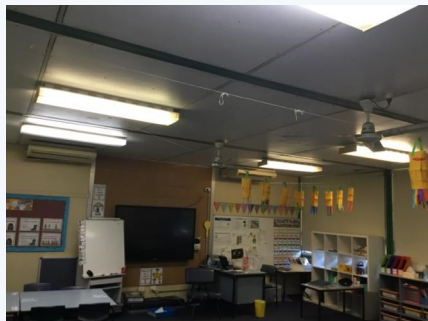
ITEM NO.: 89
 PHOTO NO.: J162866-1124-PHOTO037
 RESULT: **PCB - PRESUMED POSITIVE**
 BUILDING/LEVEL: D11532 - GROUND LEVEL
 ROOM/LOCATION: ALL ROOMS
 FEATURE/MATERIAL: **FLUORESCENT LIGHT FITTING - CAPACITOR**
 SAMPLE NO.: -

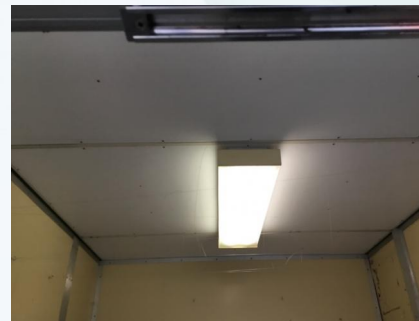
ITEM NO.: 90
 PHOTO NO.: J162866-1124-PHOTO038
 RESULT: **ASBESTOS - POSITIVE**
 BUILDING/LEVEL: D11532 - GROUND LEVEL
 ROOM/LOCATION: ALL ROOMS - THROUGHOUT
 FEATURE/MATERIAL: **CEILING LINING - FIBRE CEMENT SHEETING**
 SAMPLE NO.: J162866-1124-012

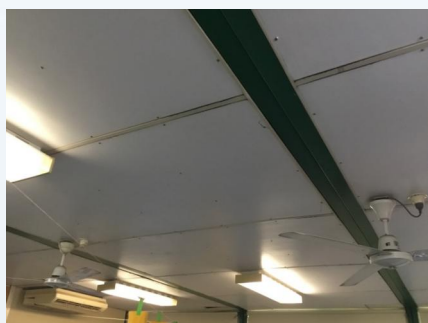
ITEM NO.: 90
 PHOTO NO.: J162866-1124-PHOTO039
 RESULT: **ASBESTOS - POSITIVE**
 BUILDING/LEVEL: D11532 - GROUND LEVEL
 ROOM/LOCATION: ALL ROOMS - THROUGHOUT
 FEATURE/MATERIAL: **CEILING LINING - FIBRE CEMENT SHEETING**
 SAMPLE NO.: J162866-1124-012

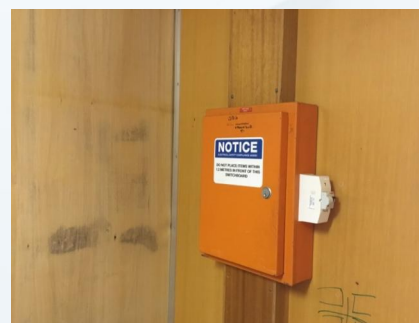
ITEM NO.: 94
 PHOTO NO.: J162866-1124-PHOTO034
 RESULT: **ASBESTOS - PRESUMED POSITIVE**
 BUILDING/LEVEL: D11532 - GROUND LEVEL
 ROOM/LOCATION: STORAGE ROOM - SOUTH
 FEATURE/MATERIAL: **SWITCHBOARD - ELECTRICAL COMPONENTS**
 SAMPLE NO.: NOT SAMPLED LIVE ELECTRICAL HAZARD

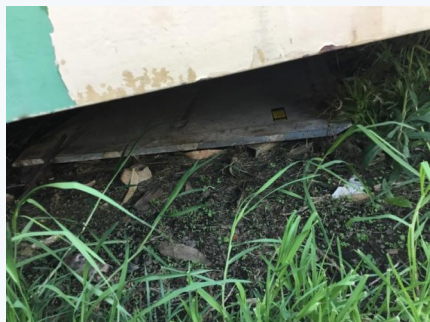
ITEM NO.: 96
 PHOTO NO.: J162866-1124-PHOTO032
 RESULT: **ASBESTOS - POSITIVE**
 BUILDING/LEVEL: D11532 - SUB-FLOOR
 ROOM/LOCATION: ON GROUND - EAST
 FEATURE/MATERIAL: **STORED PANELS - COMPRESSED CEMENT SHEETING**
 SAMPLE NO.: J162866-1124-009

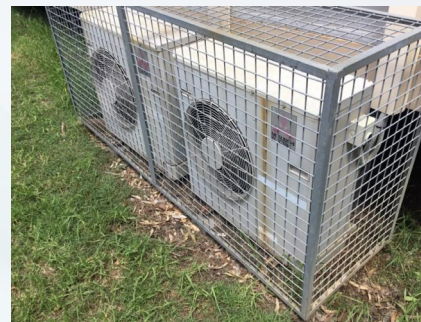
ITEM NO.: 98
 PHOTO NO.: J162866-1124-PHOTO074
 RESULT: **ODS - PRESUMED POSITIVE**
 BUILDING/LEVEL: D13994 - GROUND LEVEL
 ROOM/LOCATION: EXTERIOR - NORTHWEST
 FEATURE/MATERIAL: **A/C UNIT - UNABLE TO DETERMINE**
 SAMPLE NO.: -

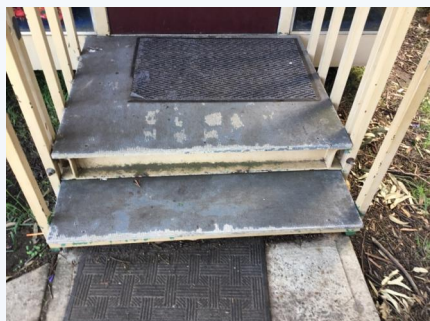
ITEM NO.: 100
 PHOTO NO.: J162866-1124-PHOTO071
 RESULT: **ASBESTOS - POSITIVE**
 BUILDING/LEVEL: D13994 - GROUND LEVEL
 ROOM/LOCATION: SOUTHEAST ENTRANCE - THROUGHOUT
 FEATURE/MATERIAL: **FLOOR COVERING - COMPRESSED CEMENT SHEETING**
 SAMPLE NO.: J162866-1124-022

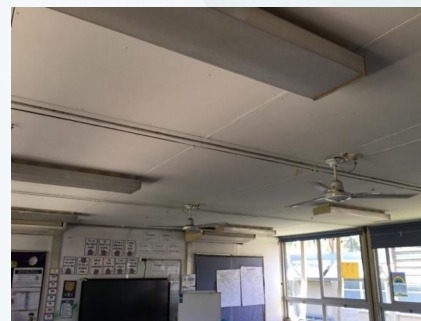
ITEM NO.: 101
 PHOTO NO.: J162866-1124-PHOTO077
 RESULT: **PCB - PRESUMED POSITIVE**
 BUILDING/LEVEL: D13994 - GROUND LEVEL
 ROOM/LOCATION: ALL ROOMS
 FEATURE/MATERIAL: **FLUORESCENT LIGHT FITTING - CAPACITOR**
 SAMPLE NO.: -

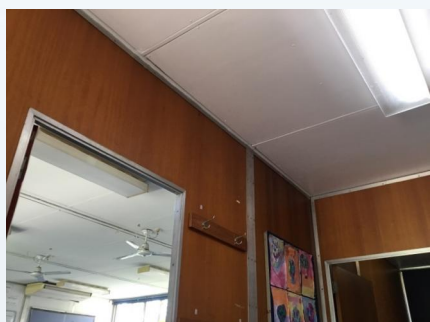
ITEM NO.: 102
 PHOTO NO.: J162866-1124-PHOTO076
 RESULT: **ASBESTOS - POSITIVE**
 BUILDING/LEVEL: D13994 - GROUND LEVEL
 ROOM/LOCATION: ALL ROOMS - THROUGHOUT
 FEATURE/MATERIAL: **CEILING LINING - FIBRE CEMENT SHEETING**
 SAMPLE NO.: J162866-1124-023

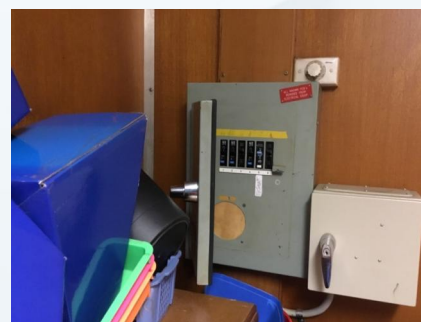
ITEM NO.: 104
 PHOTO NO.: J162866-1124-PHOTO075
 RESULT: **ASBESTOS - PRESUMED POSITIVE**
 BUILDING/LEVEL: D13994 - GROUND LEVEL
 ROOM/LOCATION: SOUTHWEST ENTRANCE - NORTH
 FEATURE/MATERIAL: **ELECTRICAL DISTRIBUTION BOARD - ELECTRICAL COMPONENTS**
 SAMPLE NO.: NOT SAMPLED LIVE ELECTRICAL HAZARD

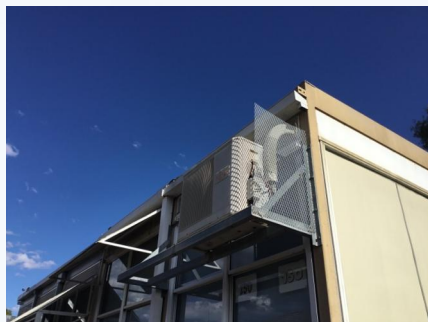
ITEM NO.: 106
 PHOTO NO.: J162866-1124-PHOTO023
 RESULT: ODS - PRESUMED POSITIVE
 BUILDING/LEVEL: D15125 - GROUND LEVEL
 ROOM/LOCATION: EXTERIOR - NORTHWEST
 FEATURE/MATERIAL: A/C UNIT - UNABLE TO DETERMINE
 SAMPLE NO.: -

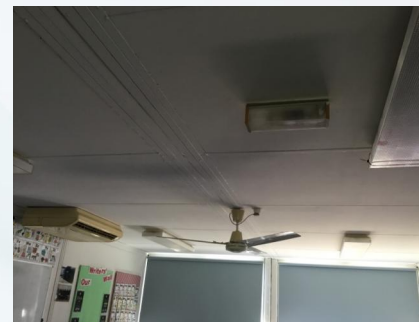
ITEM NO.: 110
 PHOTO NO.: J162866-1124-PHOTO088
 RESULT: ASBESTOS - PRESUMED POSITIVE
 BUILDING/LEVEL: D15125 - GROUND LEVEL
 ROOM/LOCATION: ALL ROOMS - THROUGHOUT
 FEATURE/MATERIAL: CEILING LINING - FIBRE CEMENT SHEETING
 SAMPLE NO.: SIMILAR TO: J162866-1124-012

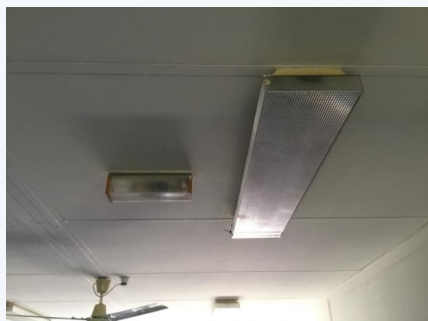
ITEM NO.: 111
 PHOTO NO.: J162866-1124-PHOTO089
 RESULT: PCB - PRESUMED POSITIVE
 BUILDING/LEVEL: D15125 - GROUND LEVEL
 ROOM/LOCATION: ALL ROOMS - THROUGHOUT
 FEATURE/MATERIAL: FLUORESCENT LIGHT FITTING - CAPACITOR
 SAMPLE NO.: -

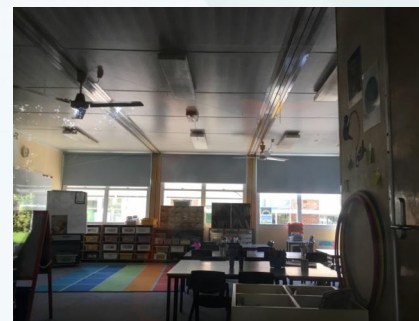
ITEM NO.: 116
 PHOTO NO.: J162866-1124-PHOTO092
 RESULT: PCB - PRESUMED POSITIVE
 BUILDING/LEVEL: D15243 - GROUND LEVEL
 ROOM/LOCATION: ALL ROOMS
 FEATURE/MATERIAL: FLUORESCENT LIGHT FITTING - CAPACITOR
 SAMPLE NO.: -

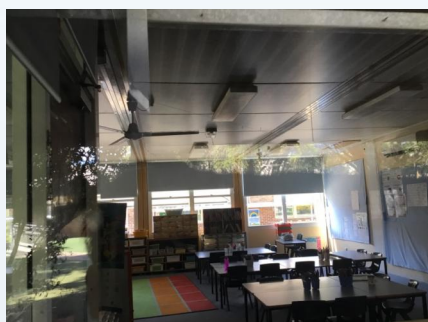
ITEM NO.: 117
 PHOTO NO.: J162866-1124-PHOTO091
 RESULT: ASBESTOS - PRESUMED POSITIVE
 BUILDING/LEVEL: D15243 - GROUND LEVEL
 ROOM/LOCATION: ALL ROOMS - THROUGHOUT
 FEATURE/MATERIAL: CEILING LINING - FIBRE CEMENT SHEETING
 SAMPLE NO.: SIMILAR TO: J162866-1124-012

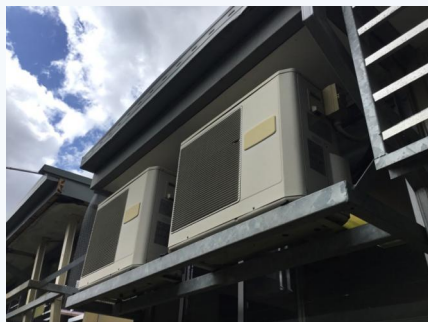
ITEM NO.: 118
 PHOTO NO.: J162866-1124-PHOTO058
 RESULT: ODS - POSITIVE
 BUILDING/LEVEL: D15583 - GROUND LEVEL
 ROOM/LOCATION:
 FEATURE/MATERIAL: A/C UNIT - R22 - CHLORODIFLUOROMETHANE
 SAMPLE NO.: -
