Moriah War Memorial College Association

Moriah War Memorial College Existing Conditions Road Safety Audit

August 2019

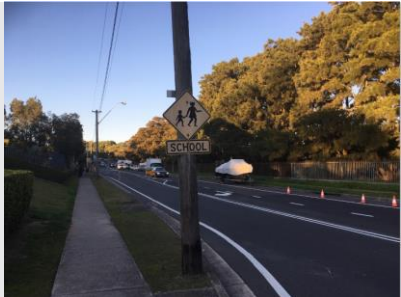
Location	Finding	Photo
York Road – eastern kerb	Non reflective material on sign

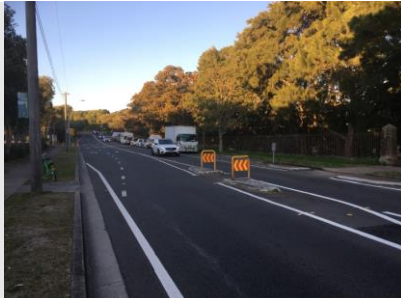
York Road – eastern and western kerb	No advance warning sign of pedestrian refuge

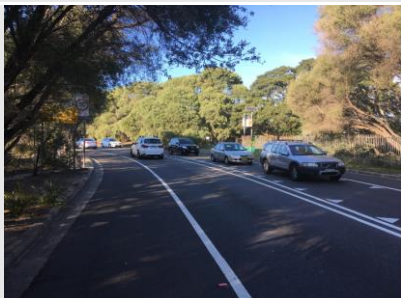
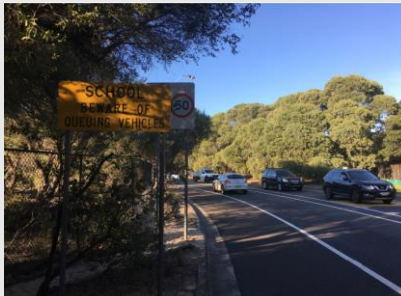
York Road – eastern kerb	Signs obstructed by vegetation. “School Beware of Queuing Vehicles” sign not place in advance of the potential end of queue.

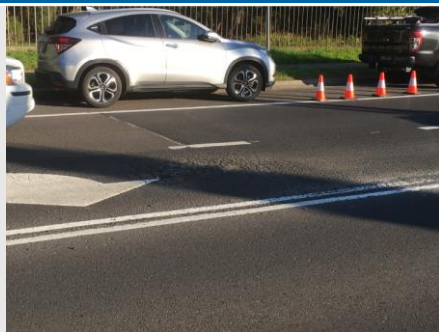
Location	Finding	Photo
York Road – Right turn lane into Queens Park Road	Road pavement degradation

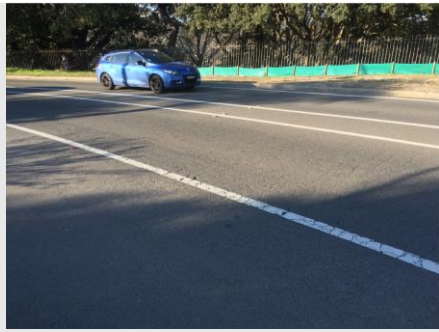
York Road – Southbound on curve	Road pavement degradation

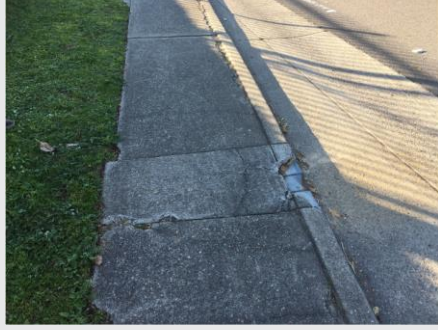
York Road – Southbound within School drop off pick up area (Gate 4A)	Footpath pavement degradation

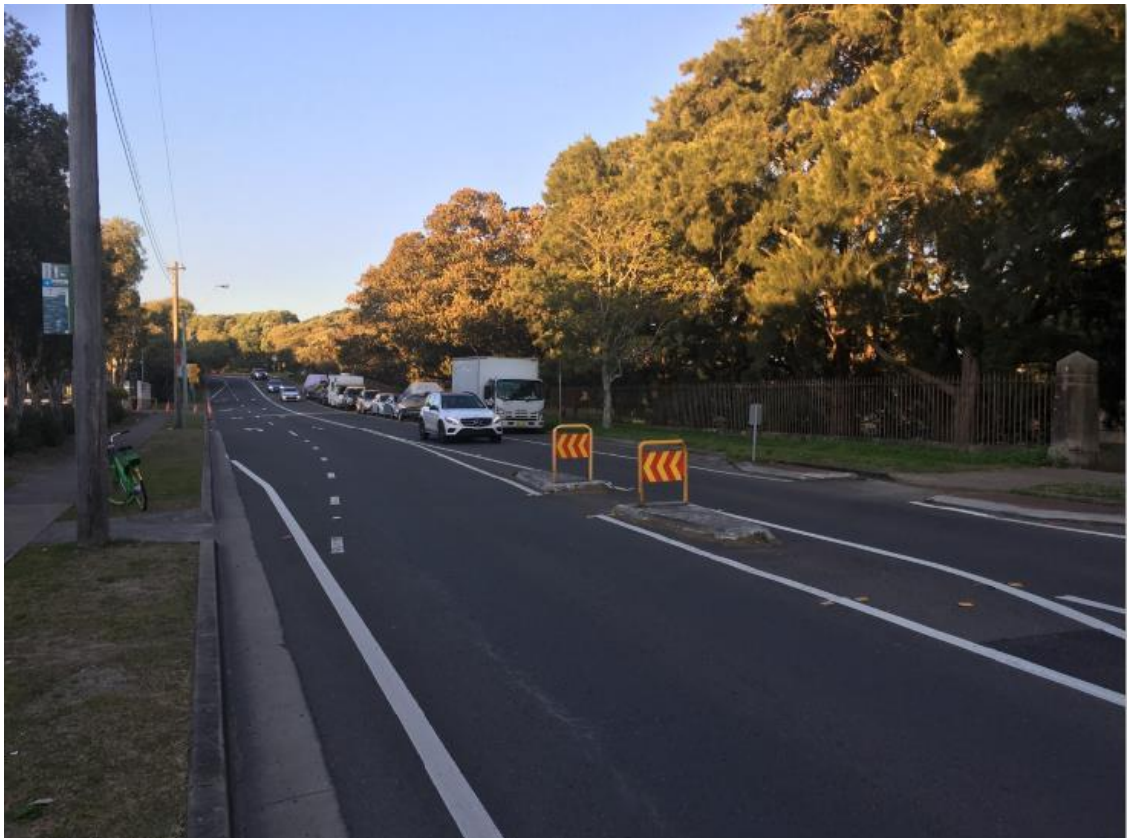
Figure 3-1 York Road Pedestrian refuge

Risk Rating	
Severity	Serious
Frequency	Occasional
Risk	High

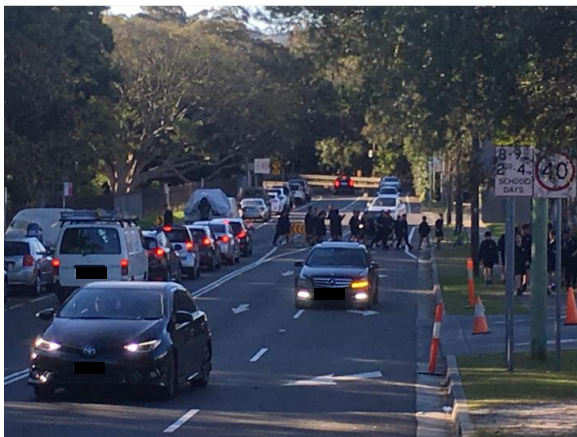
Figure 3-2 York Road pedestrian refuge – Alternate operation

The site inspection identified that a large volume of students were required to cross at the pedestrian refuge to travel between the school and Centennial Parklands (refer to Figure 3-2). Due to the number of students, it was observed that a single teacher would stop traffic to allow students to cross York Road in groups.

- The teacher is not wearing high visibly clothing and is controlling traffic movement through the area. There is risk drivers may not observe the teacher, resulting in pedestrian / vehicle conflict.

Risk Rating	
Severity	Catastrophic
Frequency	Occasional
Risk	Intolerable

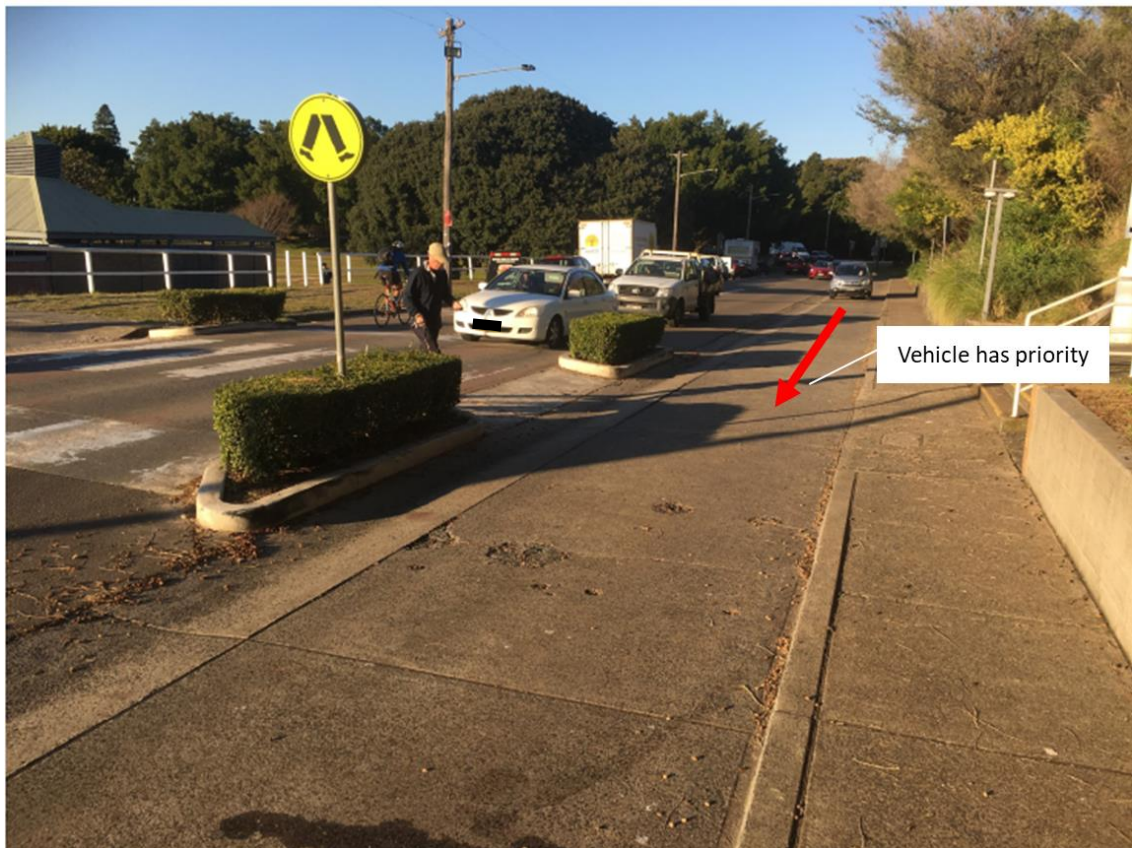
Figure 3-3 Baronga Avenue pedestrian crossing – Change in priority

Risk Rating	
Severity	Serious
Frequency	Occasional
Risk	High

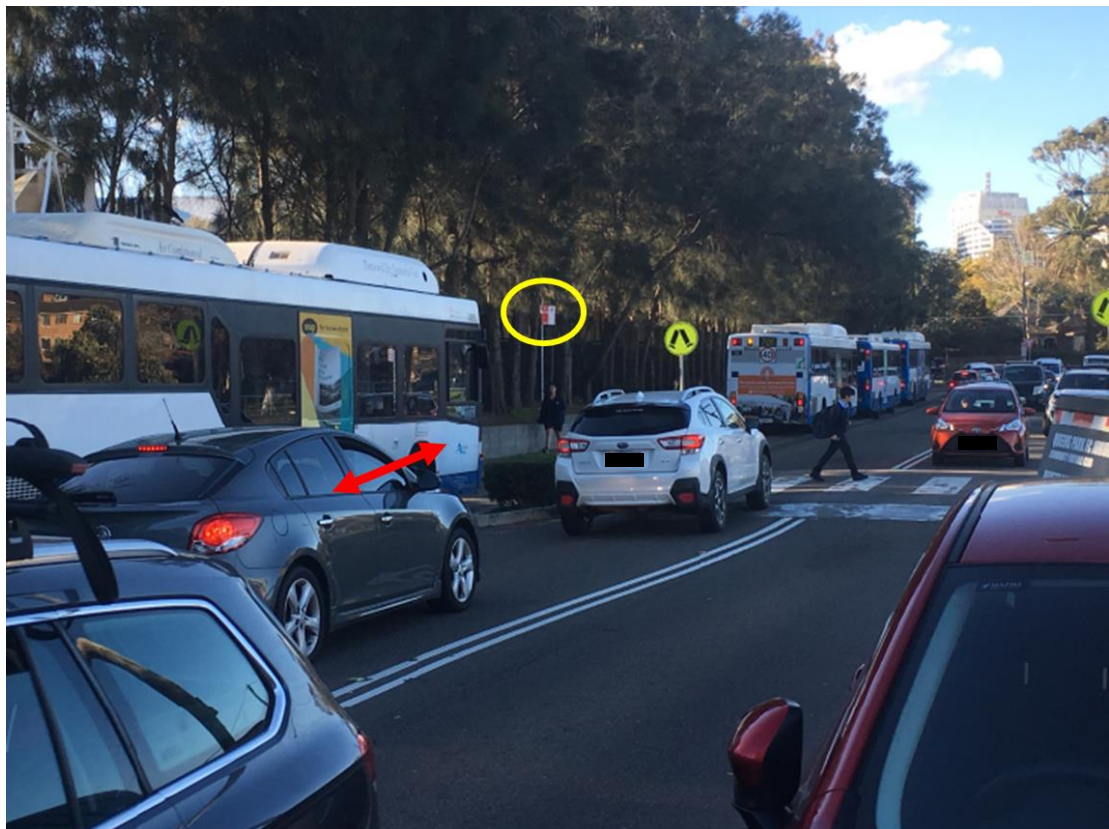
Figure 3-4 Baronga Avenue – Visibility obstruction to pedestrians

Notwithstanding the findings outlined in section 3.5.1, it was observed however, that typically vehicles (notably busses) travelling through the layby, would stop to give way to pedestrians crossing the layby and Baronga Avenue carriageway or stop in immediate approach to the crossing area crossing (i.e. within the pedestrian crossing “No Stopping” restriction), while waiting in queue to collect children north of the pedestrian (refer to Figure 3-4).

The position of the vehicle (notably buses) within the layby would restrict visibility between pedestrians and drivers of northbound through travelling vehicles on approach to the pedestrian crossing. There is risk that through travelling drivers along Baronga Avenue carriageway may not clearly identify a pedestrian approaching the pedestrian crossing (and visa-versa), due to the stop vehicles adjacent, resulting in pedestrian/vehicle conflict.

Risk Rating		Special Road User Infrastructure	
Severity	Serious	Pedestrian Infrastructure	
Frequency	Occasional		
Risk	High

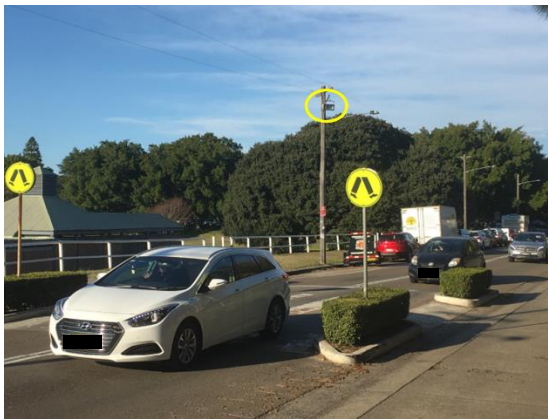
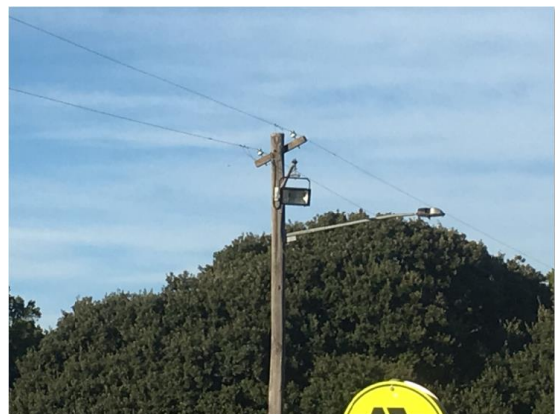
Figure 3-5 Baronga Avenue – Lighting

The site inspection was only carried out during the daylight period during the school peak AM and PM peak pick up and drop off times, therefore current operation of the lighting was not able to be observed. However, it was identified at the pedestrian zebra crossing on Baronga Avenue had lighting for crossing on angle that may create artificial glare to southbound vehicles on approach to the pedestrian zebra crossing (refer to Figure 3-5). Such glare may affect the visibility of opposing approaching vehicles or pedestrians on the pedestrian zebra crossing resulting in potential pedestrian/vehicles impact or head on crash of approaching vehicles.

Risk Rating	
Severity	Serious
Frequency	Occasional
Risk	High

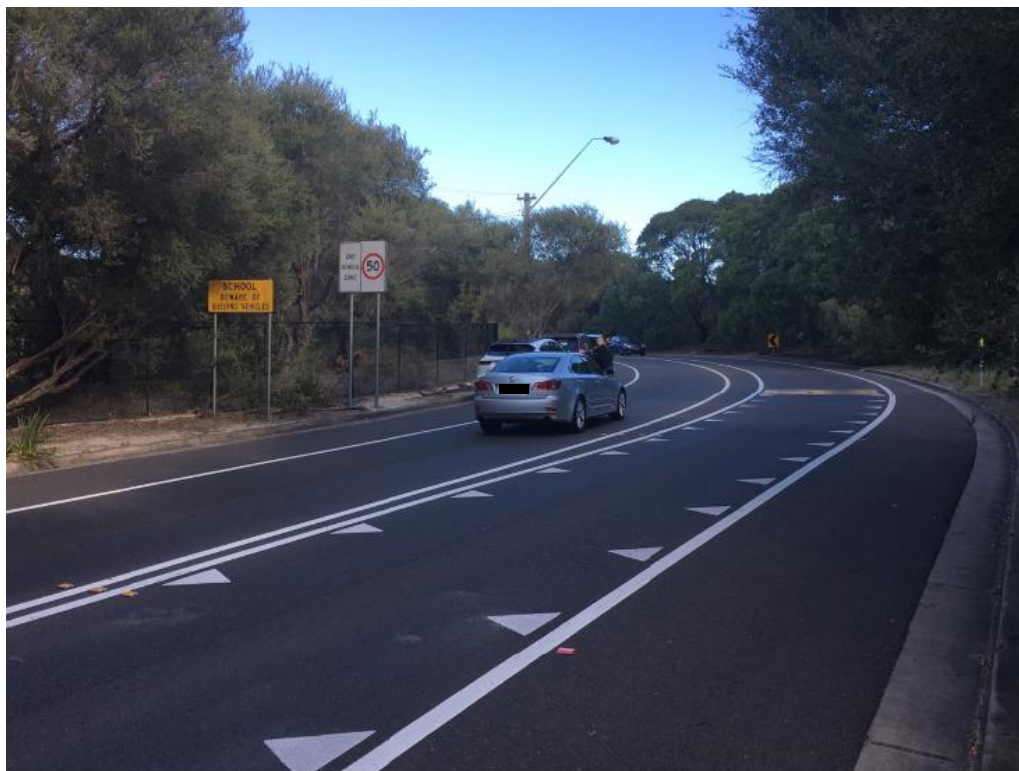
Figure 3-6 Gate 4A vehicle queue – Vehicle queue reaching the queue advance warning sign

It was observed at the site inspection, that vehicles were in queue from 2:40 pm to pick up students from gate 4A on York Road, with pick up operations commencing at 3:15 pm. This resulted in:

- An extended period of time for the queuing of vehicles prior to the release of school students.
- The vehicle queue was in advance of the “School Beware of Queuing Vehicles” advanced warning sign located on the southbound travel lane on York Road and therefore did not provide advance warning of the queue to approaching traffic (refer to Figure 3-6).
- It was also observed at the site visit that vehicles within the queue did not always position close to the rear of vehicle in front. This resulted in:
- A longer than necessary queue of vehicles.
- Vehicles attempting to “jump the queue”, causing the rear of the vehicle to be within the through traffic lane (refer to Figure 3-7).

Risk Rating	
Severity	Minor
Frequency	Occasional
Risk	Medium

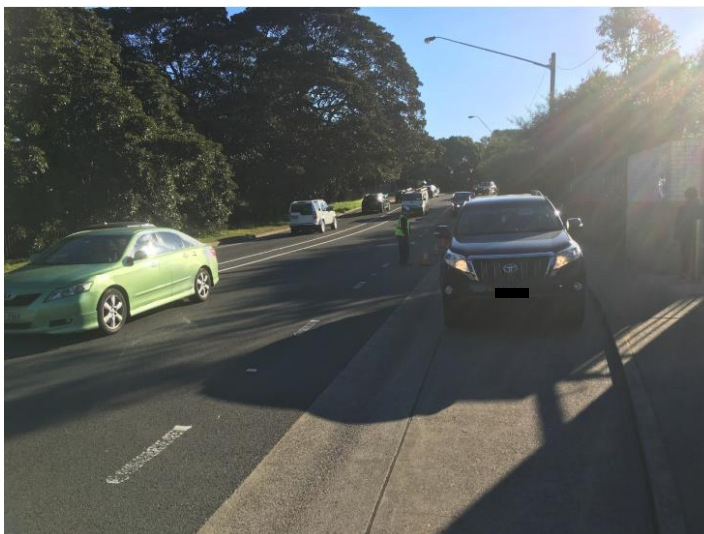
Figure 3-8 Gate 4A vehicle queue – Traffic controller safety

It was observed at the site inspection a traffic controller was positioned to assist in the egress of vehicles from the pickup facility at Gate 4A to merge into the through travel lane. The traffic controller, while wearing high visibility clothing, was positioned between the pickup vehicles and the through traffic (to manoeuvre traffic cones). Refer to Figure 3-8. This position of the traffic controller adjacent to through traffic flow will have restricted emergency egress path in the event of an errant vehicle. Additionally there is no advance warning to approaching traffic that a traffic controller is within the road area.

Risk Rating	
Severity	Serious
Frequency	Occasional
Risk	High

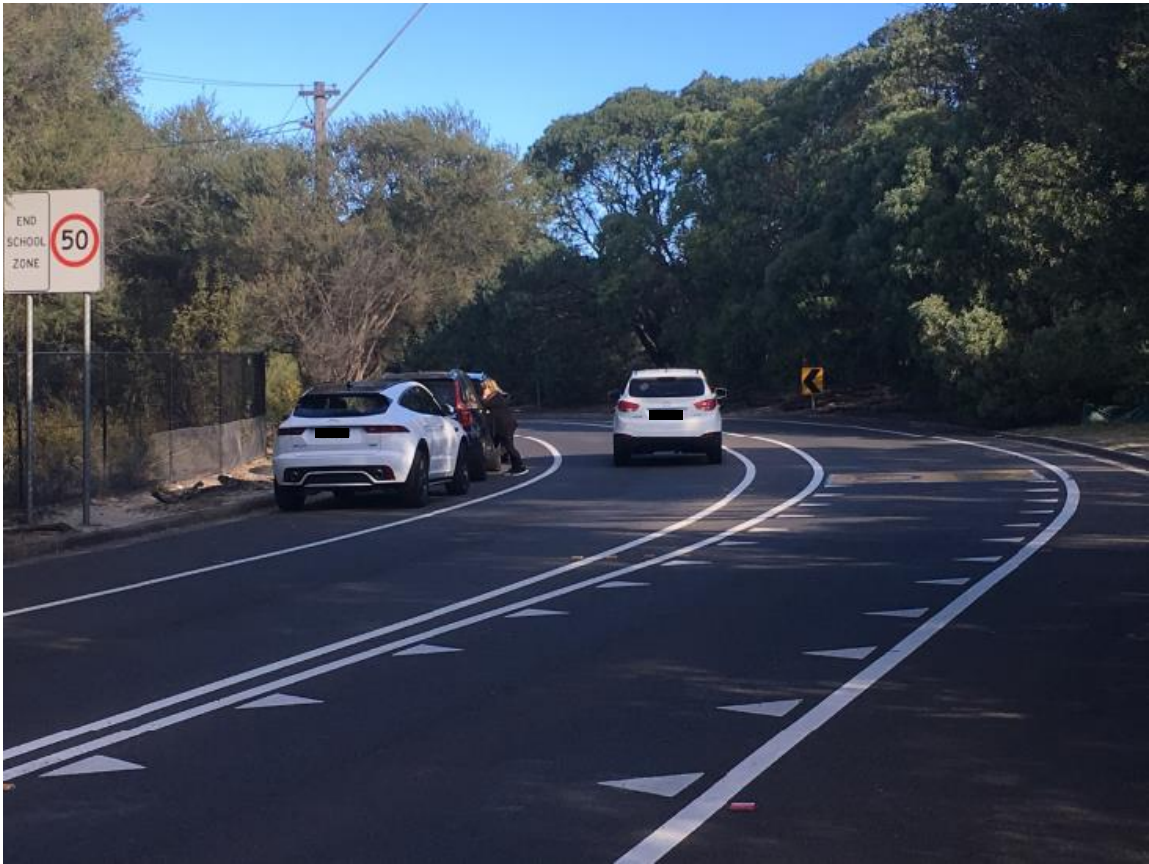
Figure 3-9 Gate 4A vehicle queue – Waiting people safety

It was observed at the site inspection, that as a result of drivers arriving prior to the released of students, time was available for drivers to alight from their vehicle to talk to other drivers while waiting. Conversations occurred adjacent to the through traffic lane (refer to Figure 3-9).

There is risk, especially on the curve, that through travelling vehicles may collide with people adjacent to the queued vehicles and there is no means of emergency egress path in the event of an errant vehicle.

Risk Rating		Special Road User Infrastructure	
Severity	Serious	Traffic Management and Operation	
Frequency	Occasional		
Risk	High

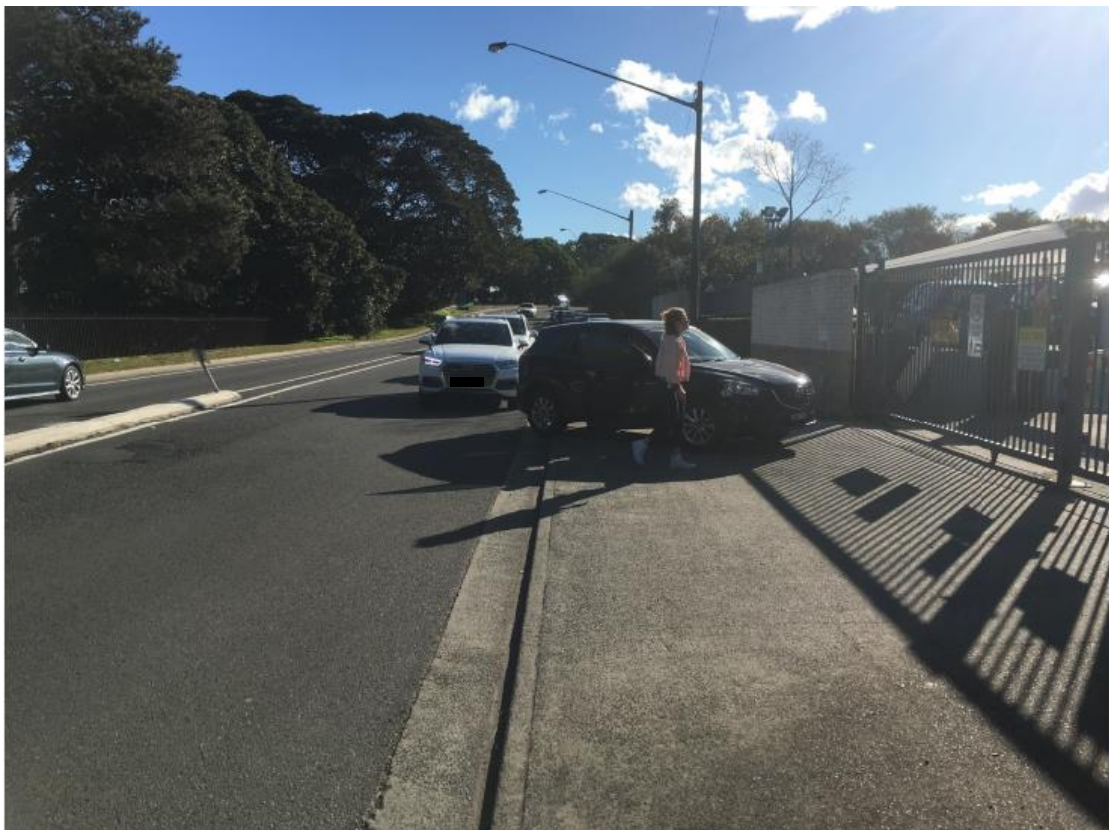
Figure 3-10 Gate 4 vehicle queue

It was observed at the site inspection, that to gain vehicle access through Gate 4, drivers were required to alight from their vehicles in order to insert a pin number to open the gate. Such operation created delays, with other vehicles waiting to access through Gate 4 required to queue within the through travel lane on York Road (refer to Figure 3-10).

There is risk of a rear end type crash to vehicles within the queue.

Risk Rating		Special Road User Infrastructure	
Severity	Serious	Traffic Management and Operation	
Frequency	Improbable		
Risk	Medium

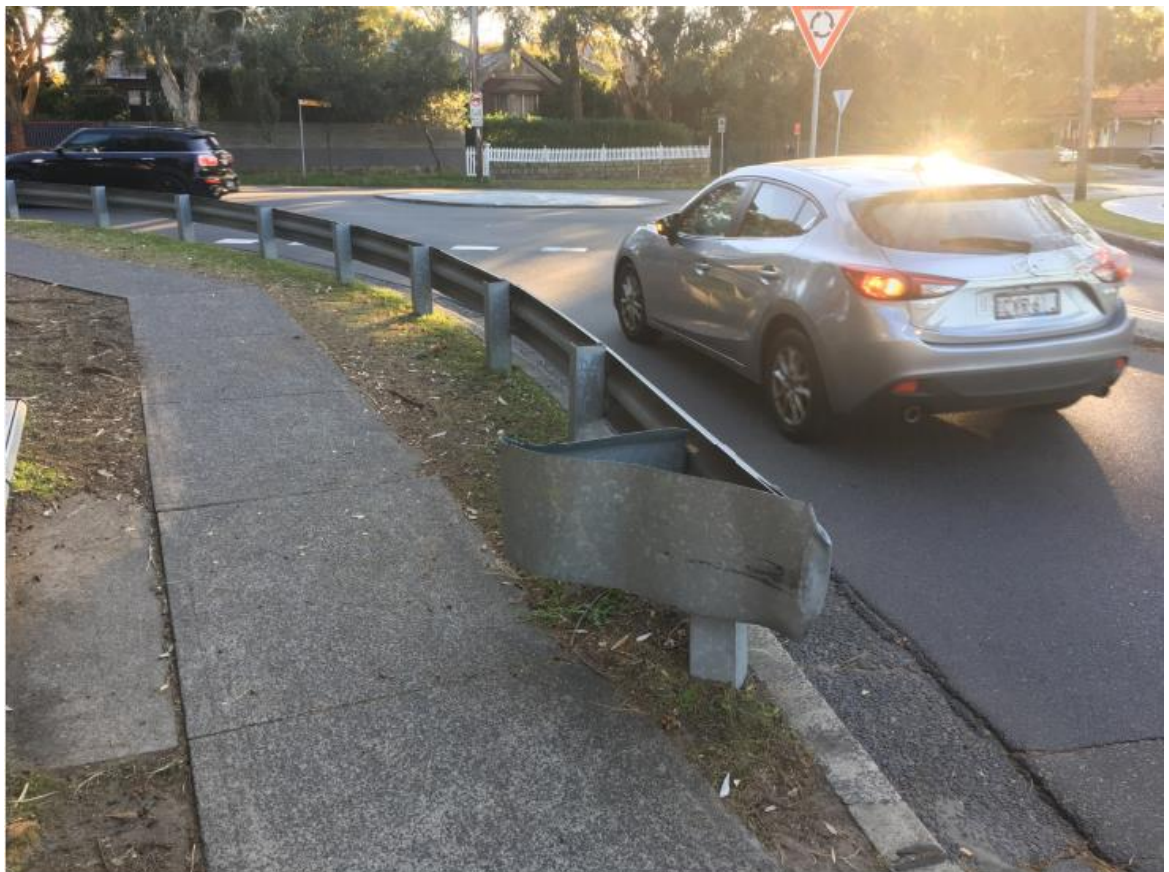
Figure 3-11 Baronga Avenue – Barrier end treatment

It was observed at the site visit, the existing barrier end treatment on Baronga Avenue at the intersection with Queens Park Road was damaged (refer to Figure 3-11).

There is risk the current condition of the barrier end treat may not operate as intended during impact, resulting in injury to the occupants within the vehicles.

Risk Rating	
Severity	Serious
Frequency	Improbable
Risk	Medium

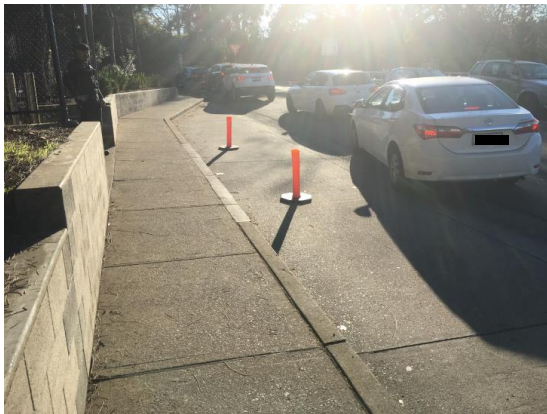
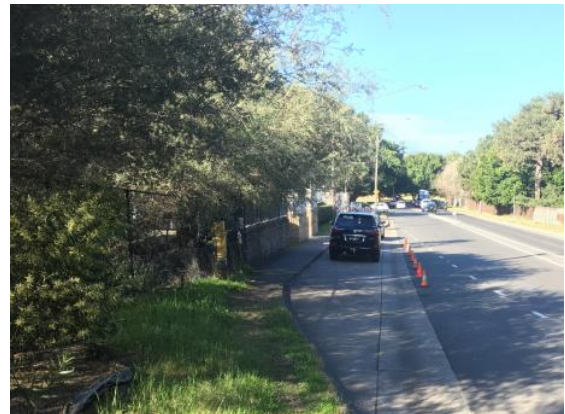
Figure 3-12 Temporary traffic control devices

It was observed at the site inspection that temporary traffic control devices (i.e. cones and bollards) were utilised on the public road to manage temporary pick up and drop off operations or to prevent parking in areas (i.e. as in front of school gates). Some of the devices utilised were not in line with current standards for temporary traffic control devices. Such items include:

Utilising temporary traffic control equipment not to the current standard may not be visible to drivers and therefore be impacted and become a hazard.

This was observed on one occasion on site at Gate 3A where a driver exiting from the lay-by did not see the bollard in front of the vehicle and run directly over it, moving it closer to the traffic lane.

Risk Rating	
Severity	Limited
Frequency	Occasional
Risk	Low
