# **Hazardous Materials Refurbishment & Demolition Survey, Buildings A, B, C, D, E And J, Moriah War Memorial College, Queens Park.**

9<sup>th</sup> August, 2019

Prepared for:  
**Aver Pty Limited, on behalf of:  
Moriah War Memorial College,  
3 Queens Park Road,  
Queens Park. NSW. 2022.**

Prepared by:  
**Banksia EOHS Pty Limited.**

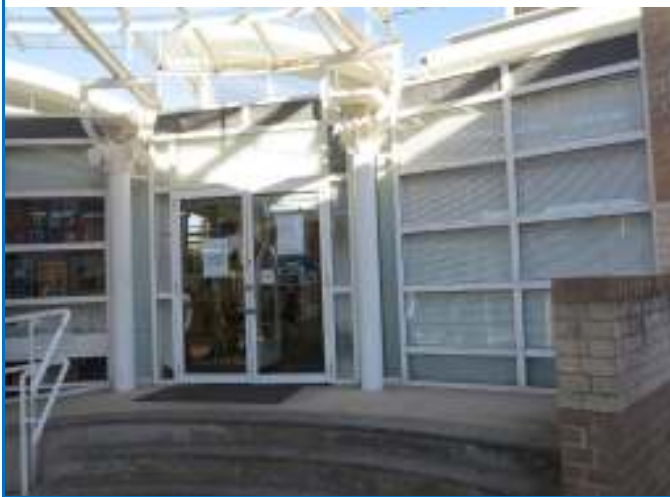
**Photo 1: Main Entry To Building A – The School Library.**

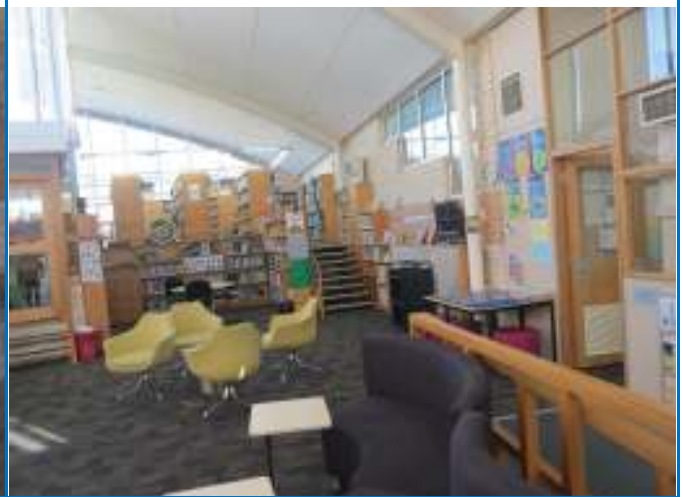
**Photo 2: Interior Of Building A - Library Building. No Asbestos Detected.**

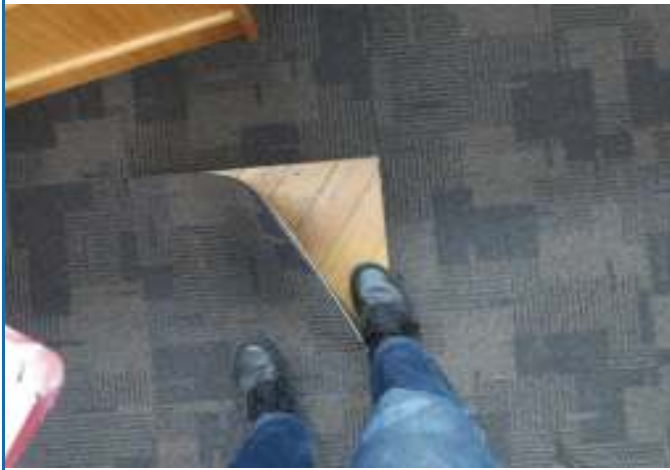
**Photo 3: Building A. Wooden Floorboards Under Carpet Squares. No Asbestos Present.**

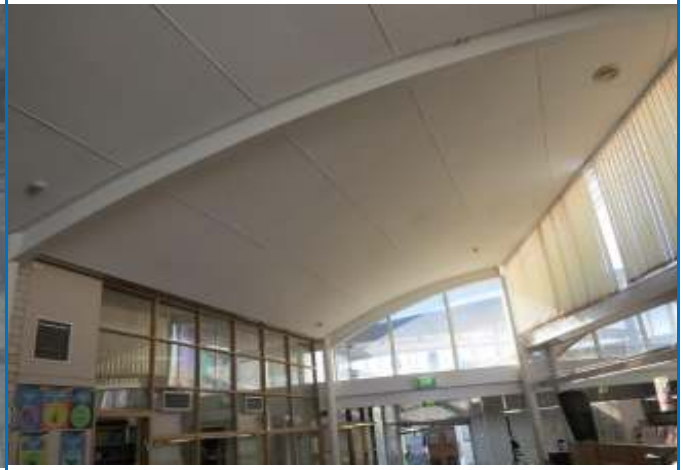
**Photo 4: Building A. Building Ceiling. No Asbestos Detected.**

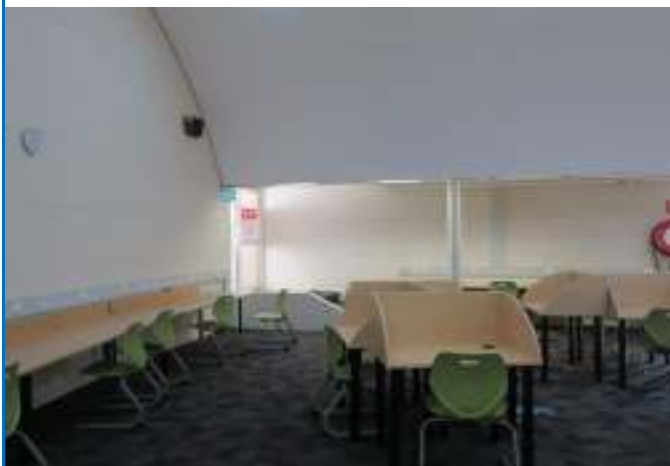
**Photo 5: Building A. Reading Room. No Asbestos Detected.**

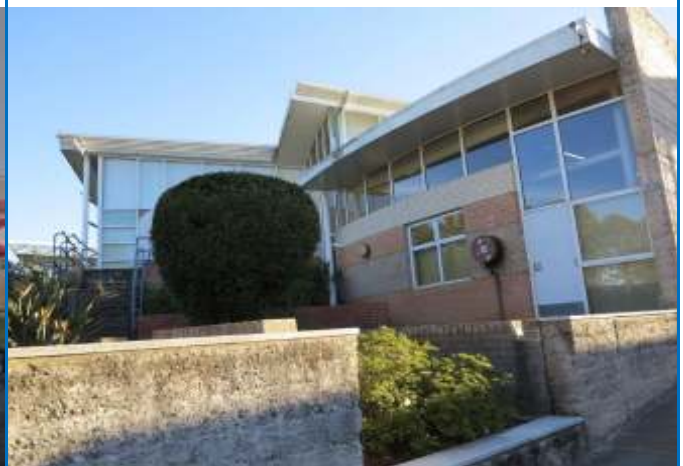
**Photo 6: Building A. External Eaves Lined With Fibre Cement. No Asbestos Detected.**

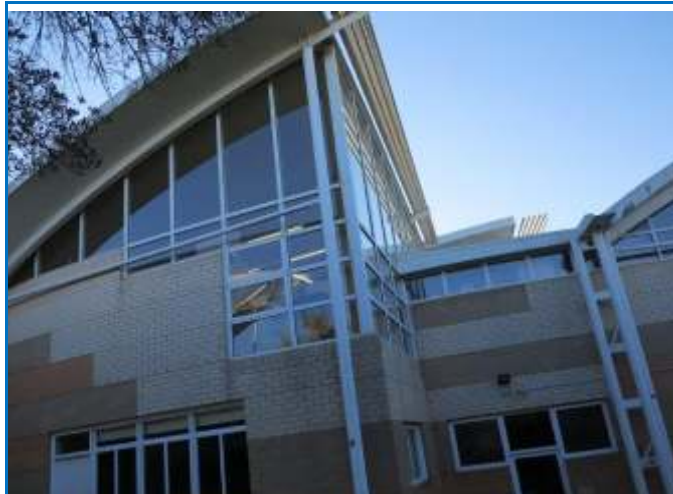
**Photo 7: Building A. Roofline Of Building. No Asbestos Detected.**

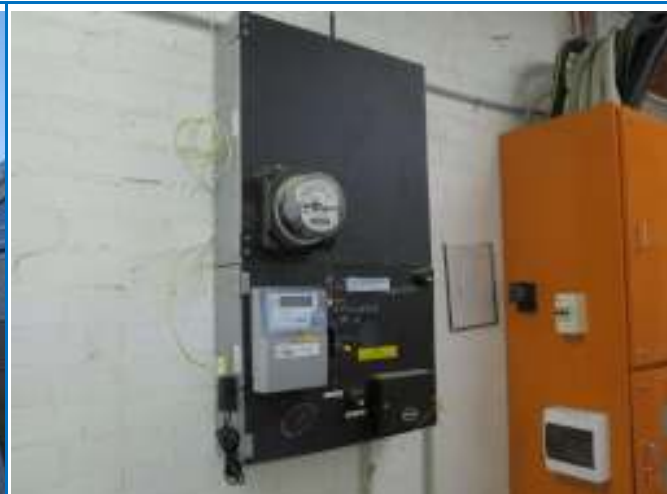
**Photo 8: Building A. Meter/Fuse Board. Deemed No Asbestos Present.**

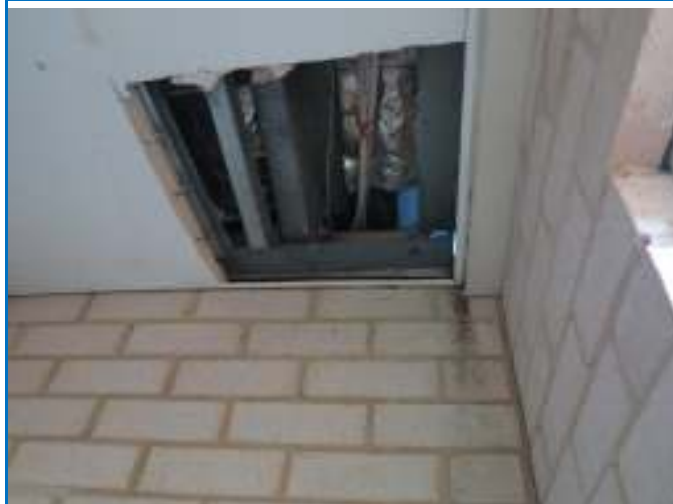
**Photo 9: Building A. SMF Detected In The Ceiling Cavity A. No Asbestos Detected.**

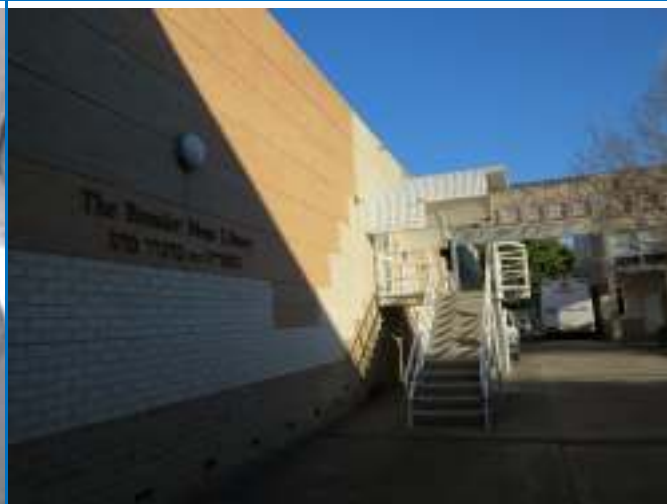
**Photo 10: Building A. Awning Over Rear Entry To Library Lined With Fibre Cement. No Asbestos Detected.**

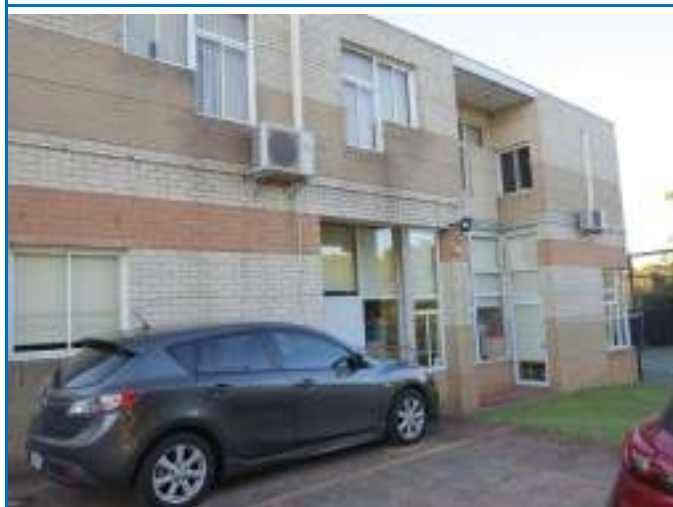
**Photo 11: Building B. No Asbestos Detected.**

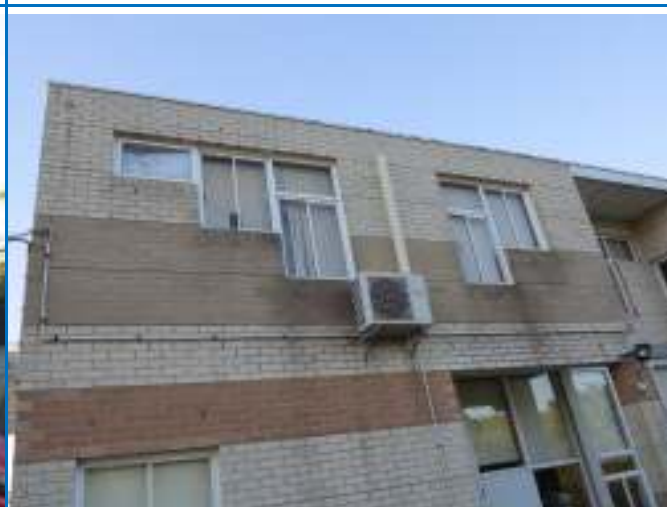
**Photo 12: Building B. No Eaves. No Asbestos Detected.**

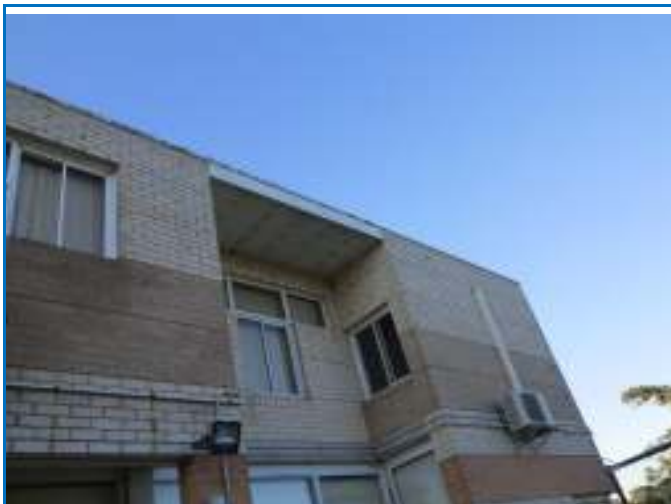
**Photo 13: Building B Fibre Cement Awning, Upper Level. No Asbestos Detected.**

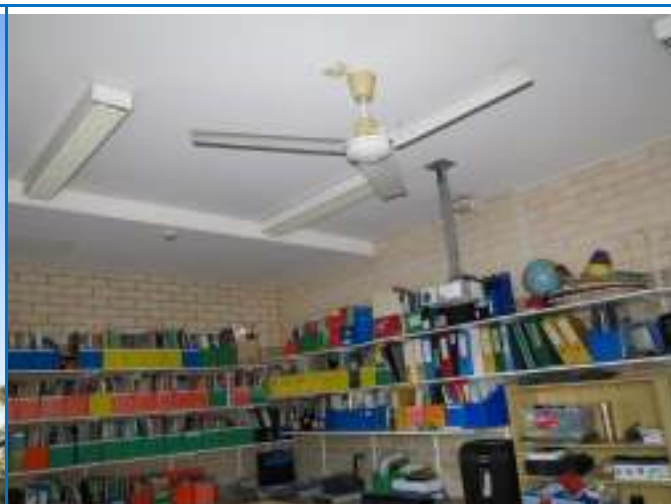
**Photo 14: Building B Interior, Ceilings Concrete & Plaster. No Asbestos Detected.**

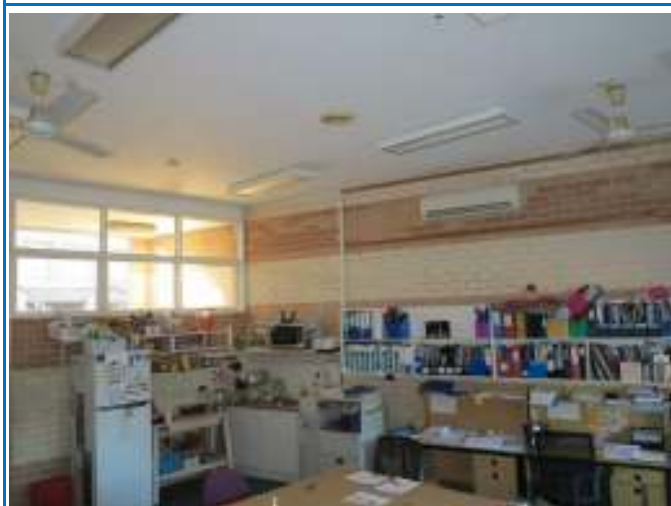
**Photo 15: Building B Interior, Ceilings Concrete & Plaster. No Asbestos Detected.**

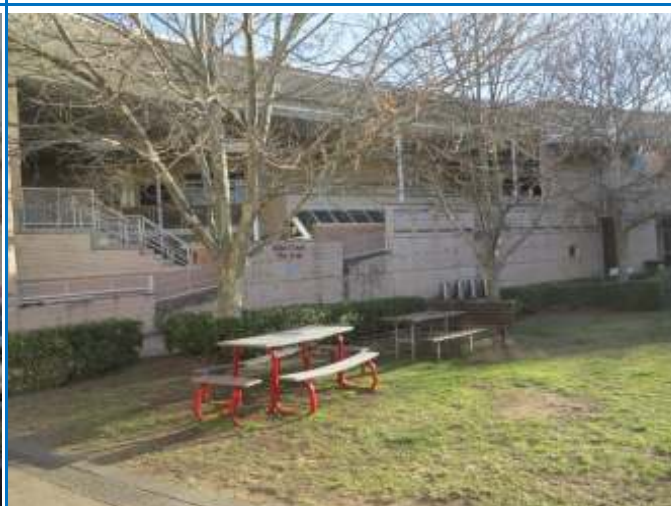
**Photo 16: Building C. No Asbestos Detected.**

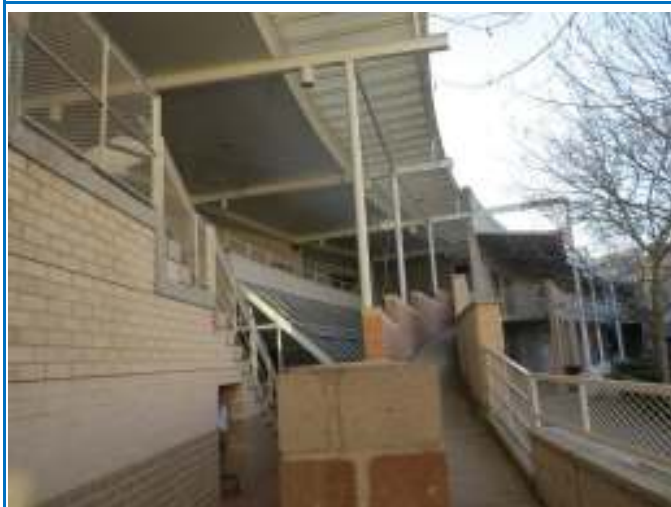
**Photo 17: Building C. Concrete and Brick Construction With Metal Roof. No Asbestos Detected.**

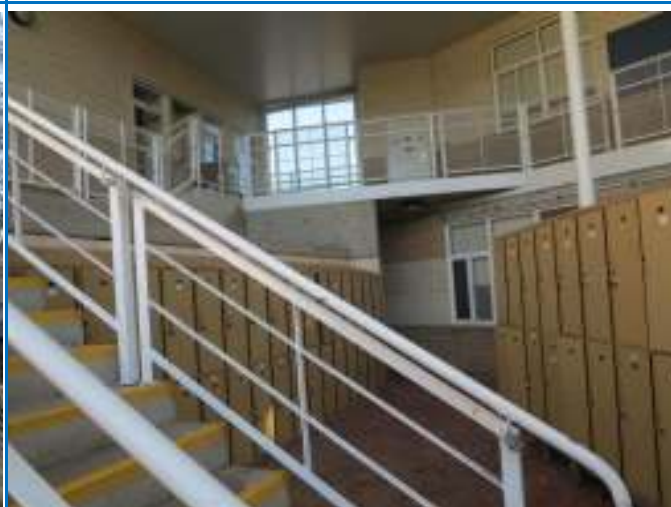
**Photo 18: Building C Locker Area, Ground Floor. No Asbestos Detected.**

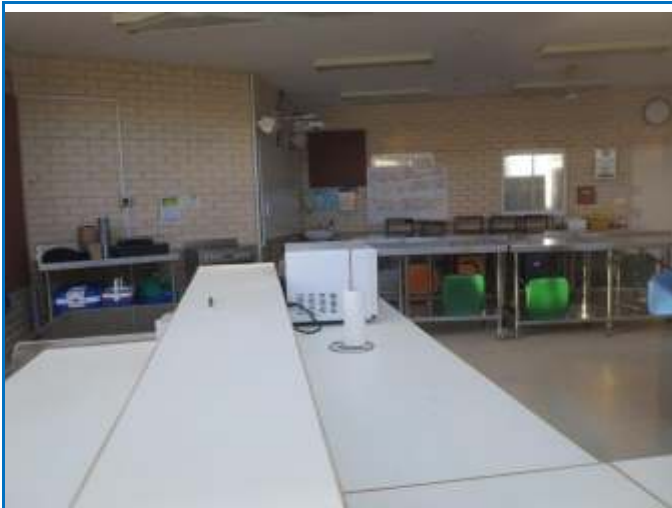
**Photo 19: Building C Trades Area. No Asbestos Detected.**

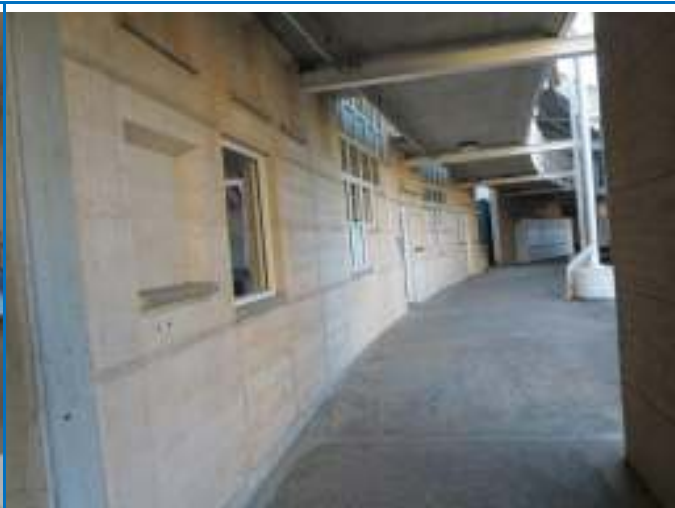
**Photo 20: Building C. Concrete & Brick Construction. No Asbestos Detected.**

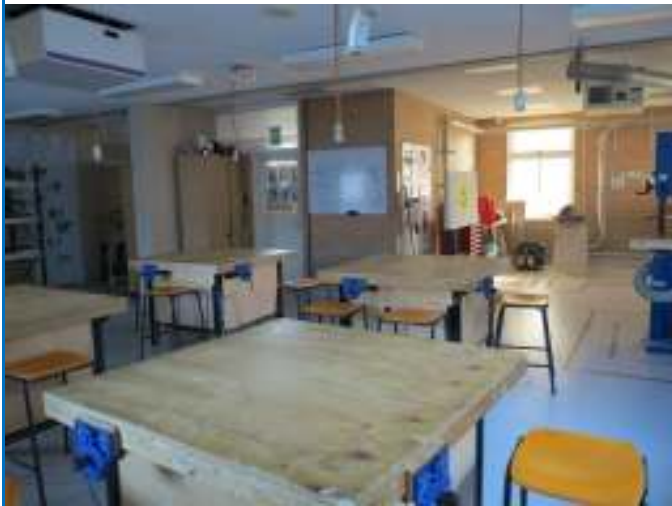
**Photo 21: Building C Trades Area. No Asbestos Detected.**

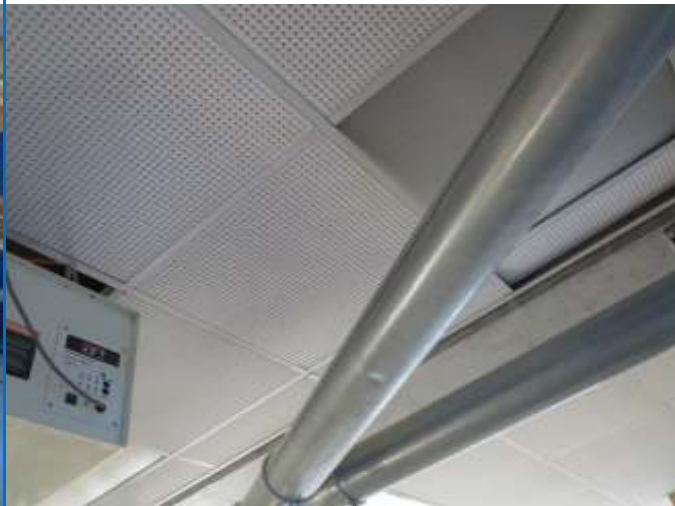
**Photo 22: Building C Trades Area Ceiling Tiles. No Asbestos Detected.**

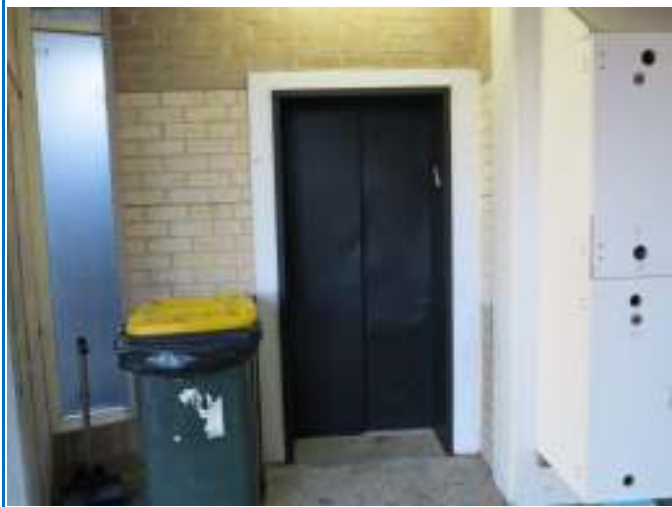
**Photo 23: Building C Hydraulic Lift. No Asbestos Detected.**

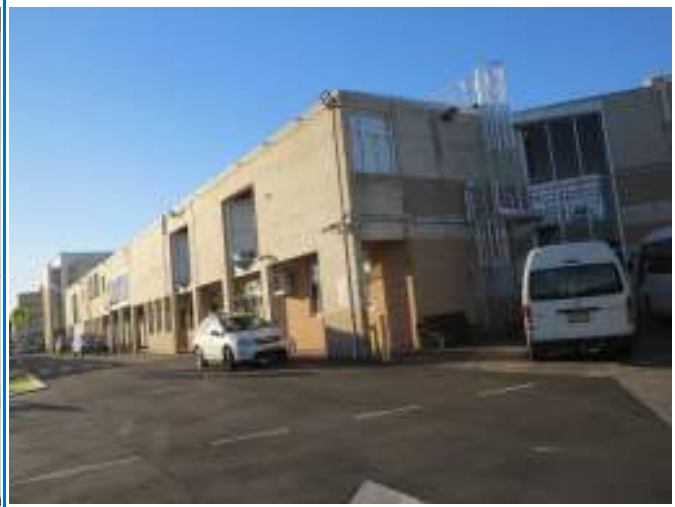
**Photo 24: Building C Rear. No Asbestos Detected.**

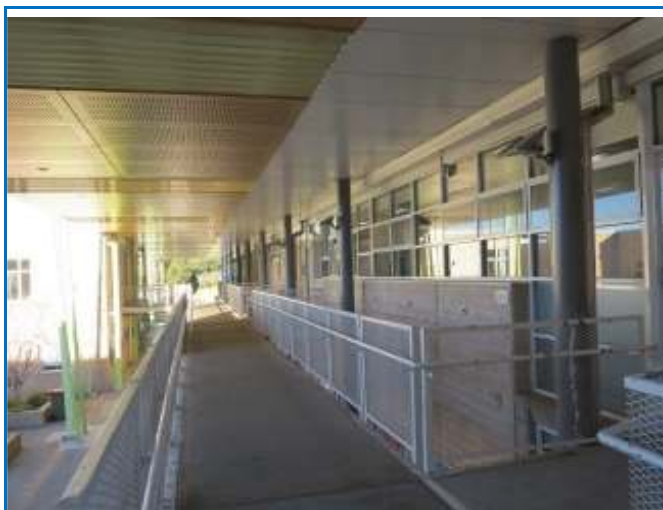
**Photo 25: Building D. No Asbestos Detected.**

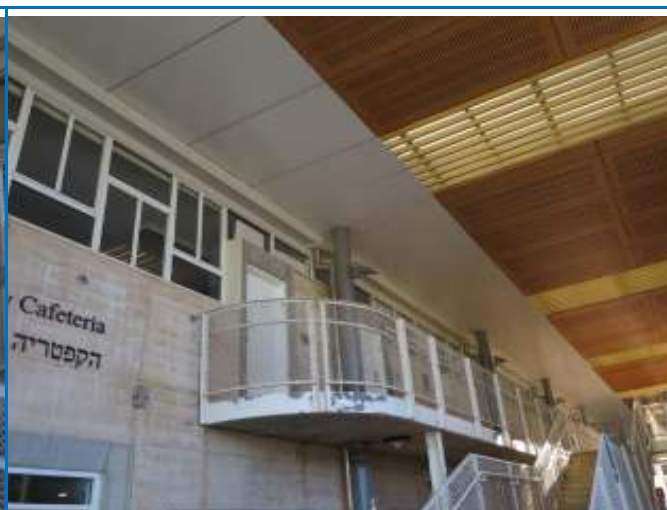
**Photo 26: Building D. Fibre Cement & Wood Panel Ceiling. No Asbestos Detected.**

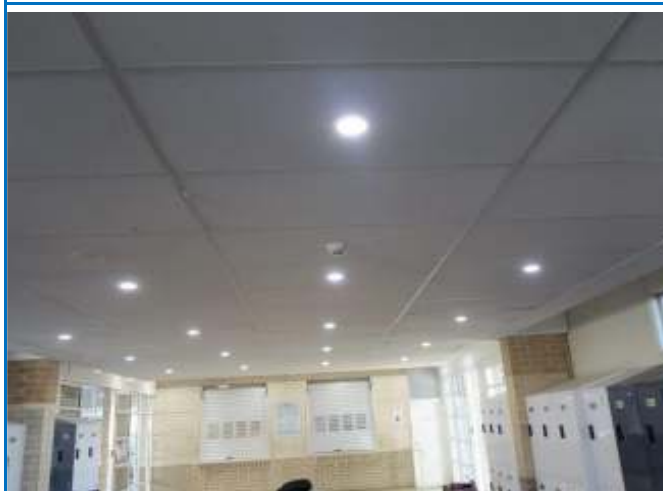
**Photo 27: Building D. Canteen Area. Composite Ceiling Tiles. No Asbestos Detected.**

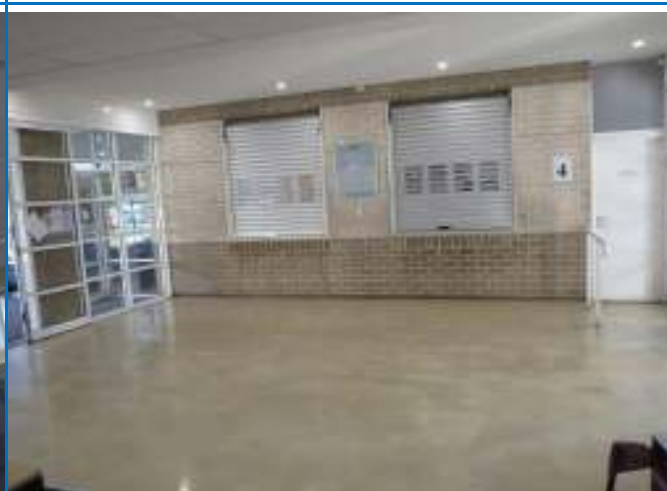
**Photo 28: Building D. Canteen. No Asbestos Detected.**

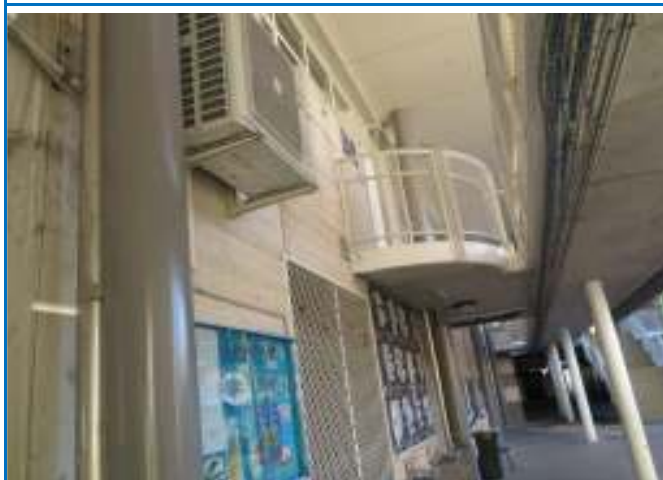
**Photo 29: Building D. Concrete Panel Construction. No Asbestos Detected.**

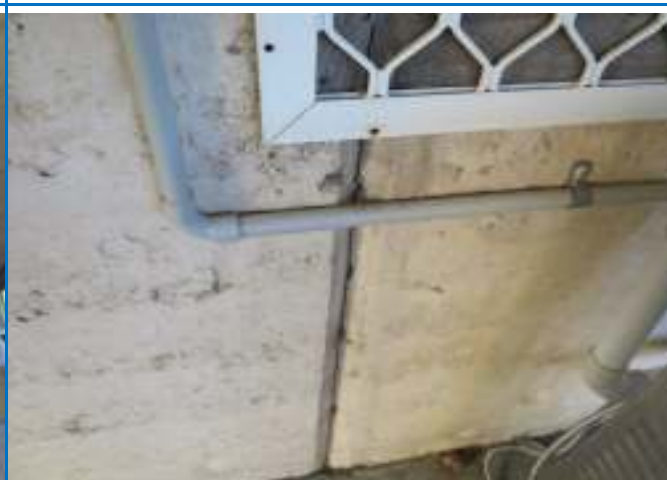
**Photo 30: Building D. Concrete Panels. No Mastic Sealant. No Asbestos Detected.**

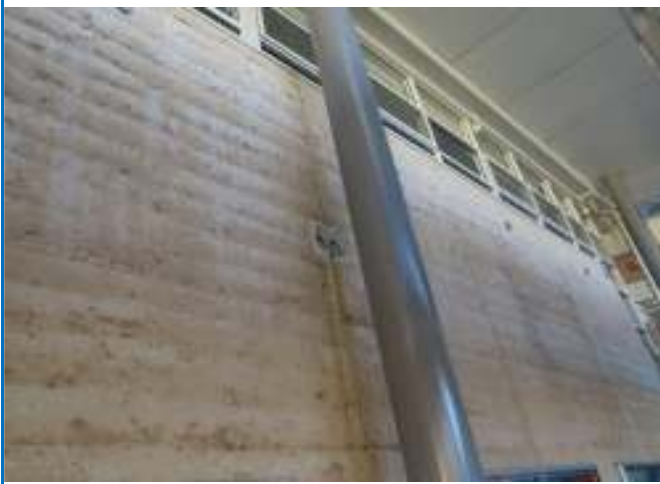
**Photo 31: Building D. Spandrel Bracket. No Asbestos Detected.**

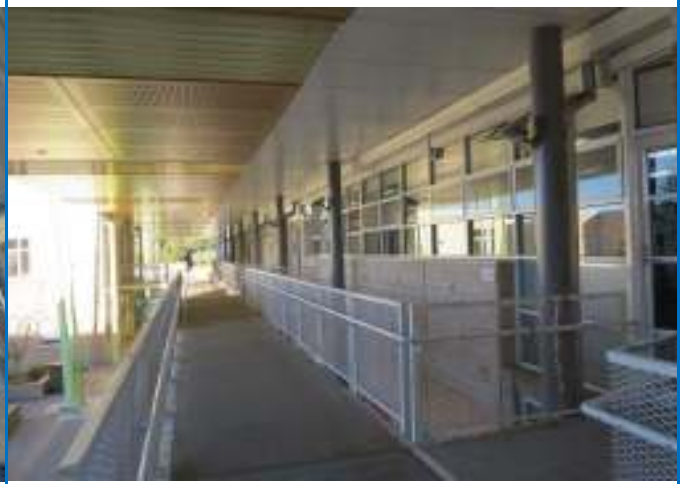
**Photo 32: Building D. Upper Level. Awning Fibre Cement & Wood Panel. No Asbestos Detected.**

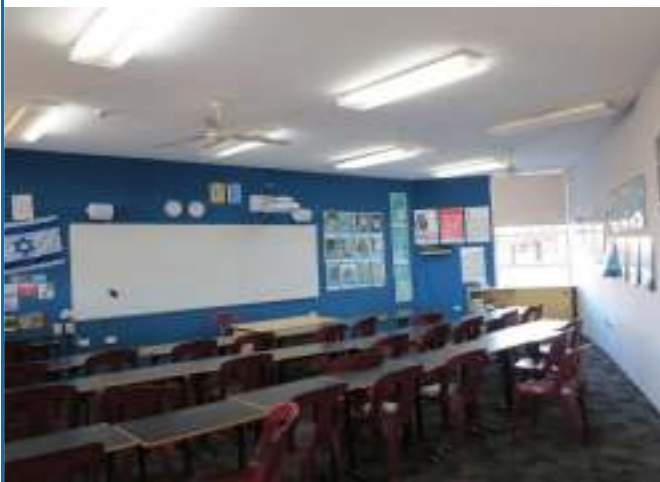
**Photo 33: Building D. Classroom. Ceiling Plaster. No Asbestos Detected.**

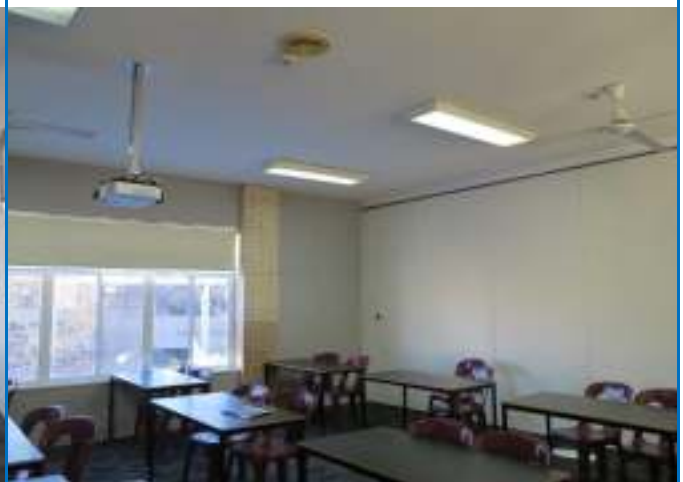
**Photo 34: Building D. Classroom. Ceiling Plaster. No Asbestos Detected.**

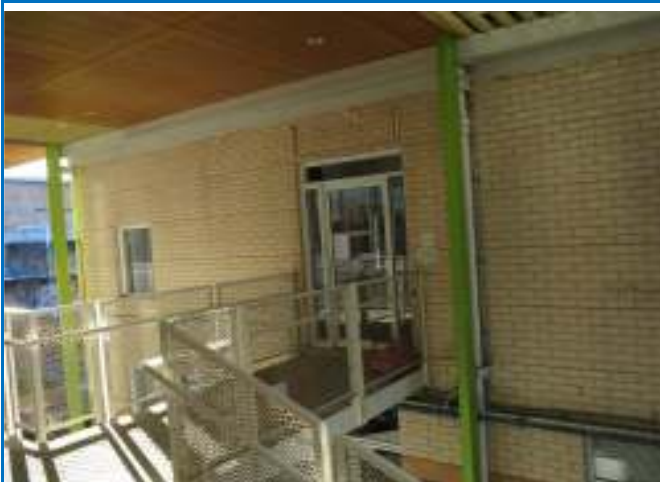
**Photo 35: Building D. Wood Panel Awning. No Asbestos Detected.**

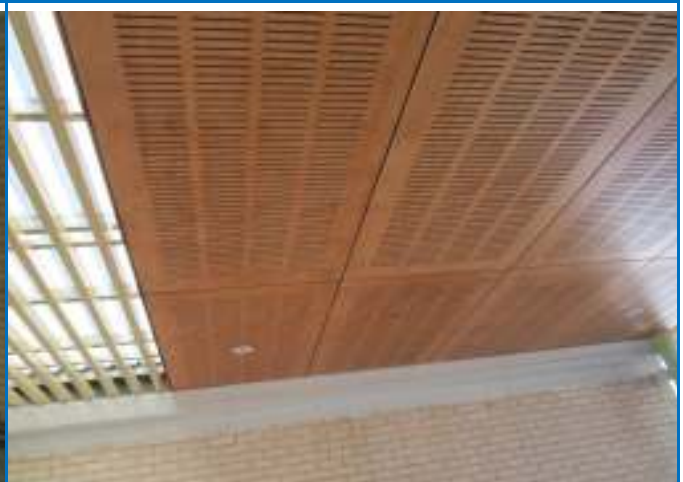
**Photo 36: Building D. Wood Panel Awning. No Asbestos Detected.**

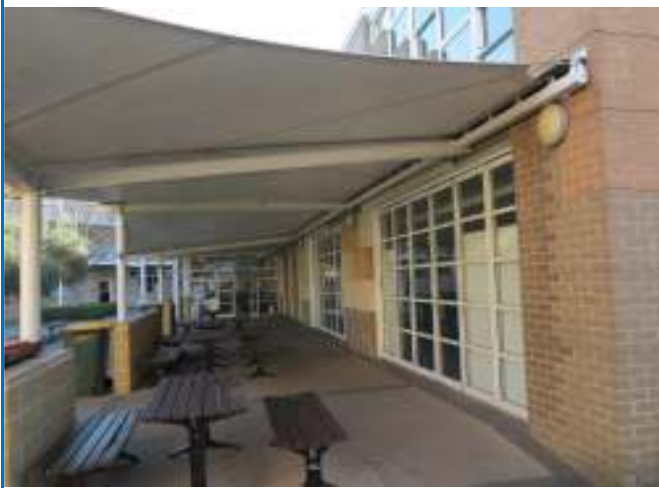
**Photo 37: Building D. Canteen Outdoor Area. No Asbestos Detected.**

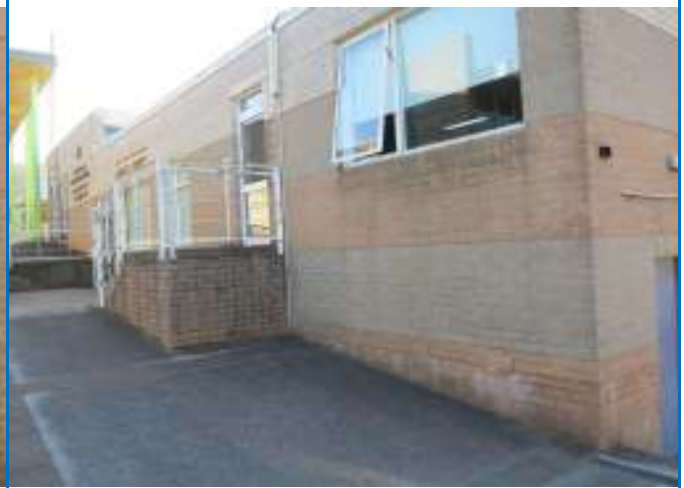
**Photo 38: Building E. No Asbestos Detected.**

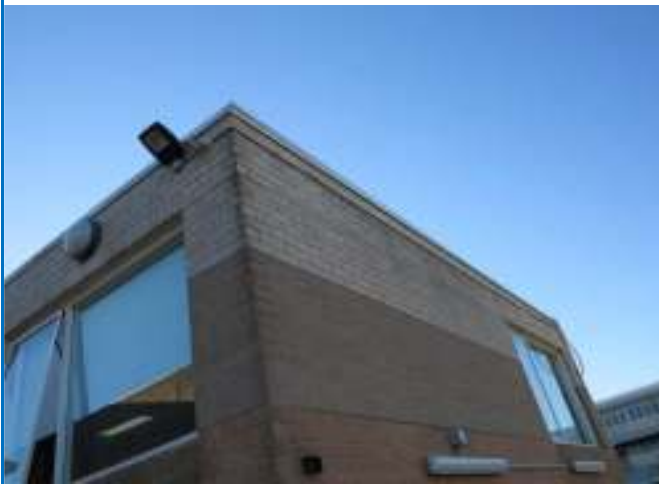
**Photo 39: Building E. No Eaves. No Asbestos Detected.**

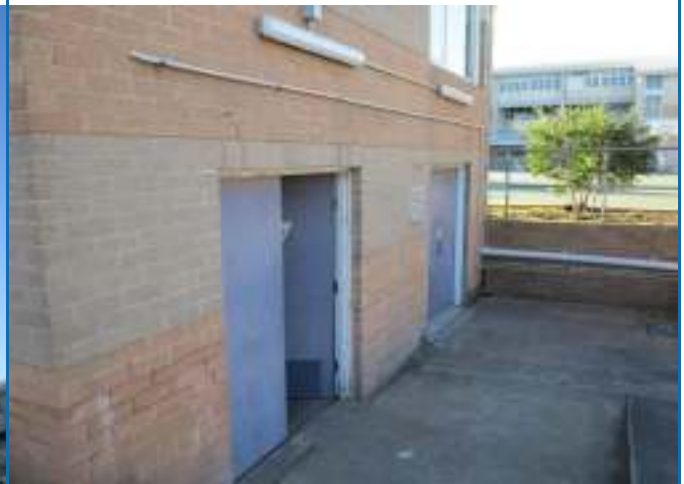
**Photo 40: Building E. Lower Level Cleaners Room. No Asbestos Detected.**

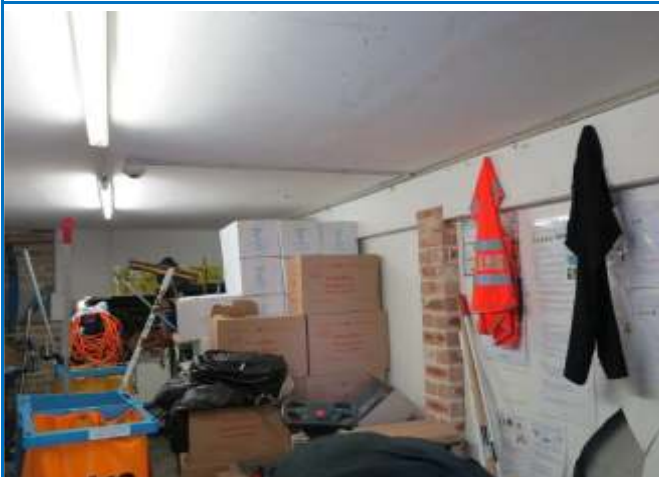
**Photo 41: Building E. Lower Level Fibre Cement Wall. No Asbestos Detected.**

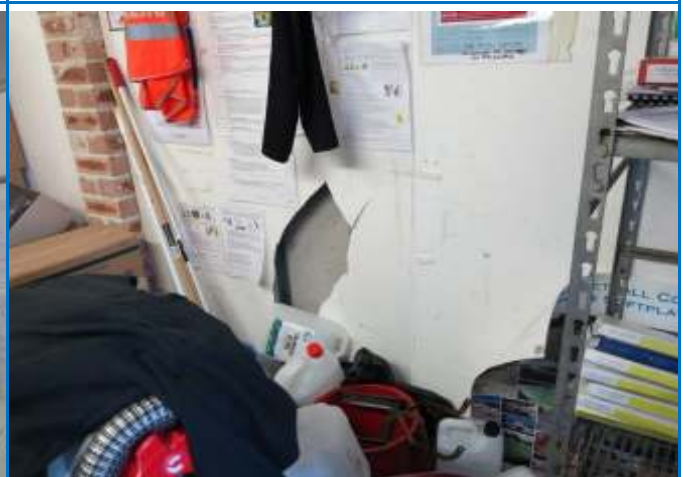
On the lower level of the building (Photograph 40), there are workshops (Photograph 41). A panel of the fibre cement wall (Photograph 42) has been broken. This material contains no asbestos (Sample 3).

**Photo 42: Building E Damaged Fibre Cement Wall Lower Level. No Asbestos Detected.**

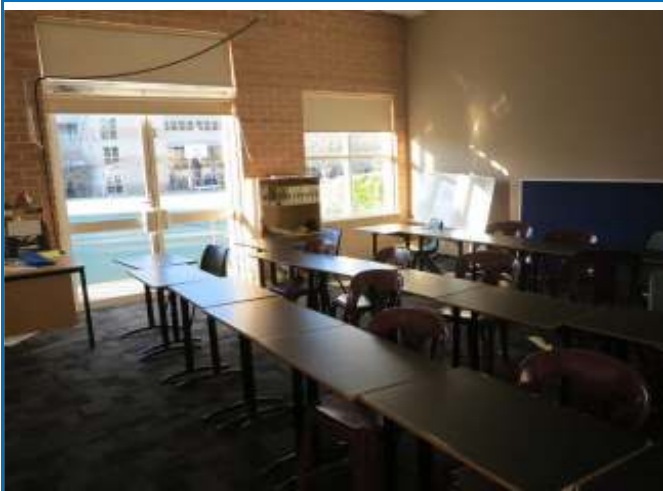
**Photo 43: Building E Classroom. No Asbestos Detected.**

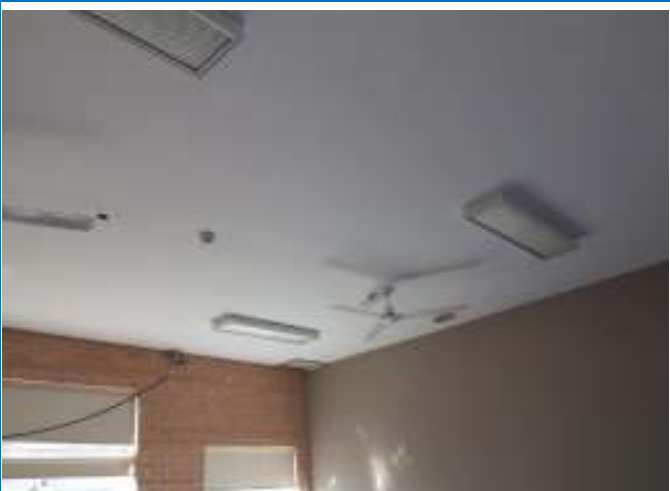
**Photo 44: Building E Classroom. Plasterboard Ceiling. No Asbestos Detected.**

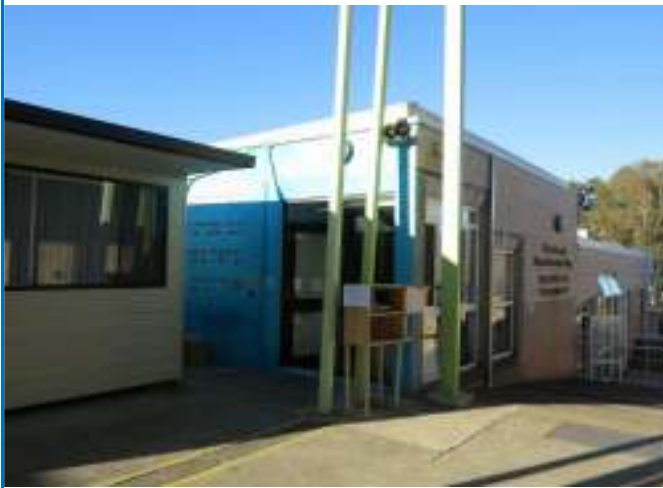
**Photo 45: Building E. Seniors Room. No Asbestos Detected.**

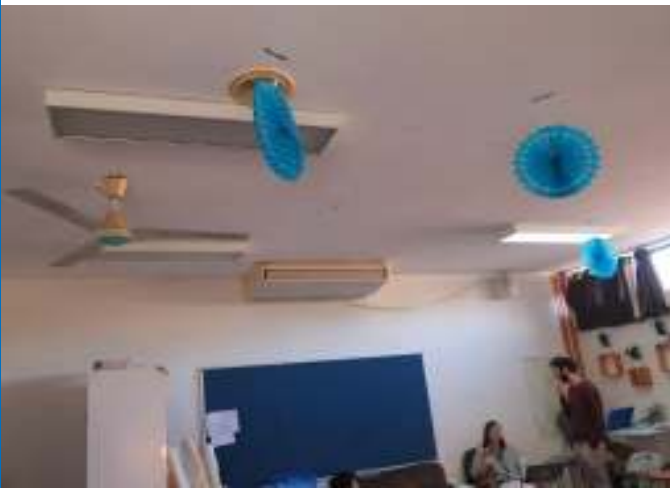
**Photo 46: Building E. Seniors Room. No Asbestos Detected.**

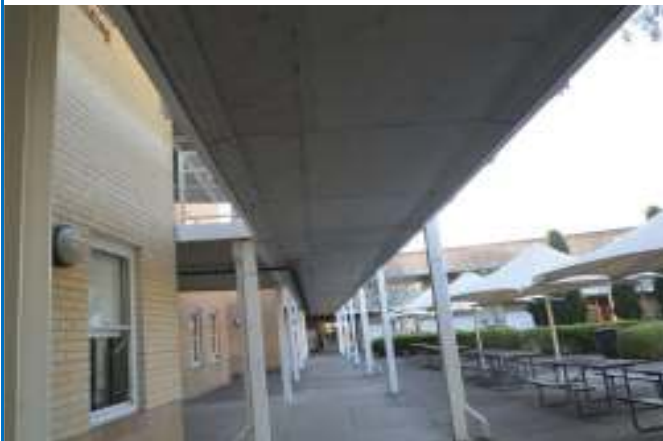
**Photo 47: Building J. Concrete & Brick Construction. No Asbestos Detected.**

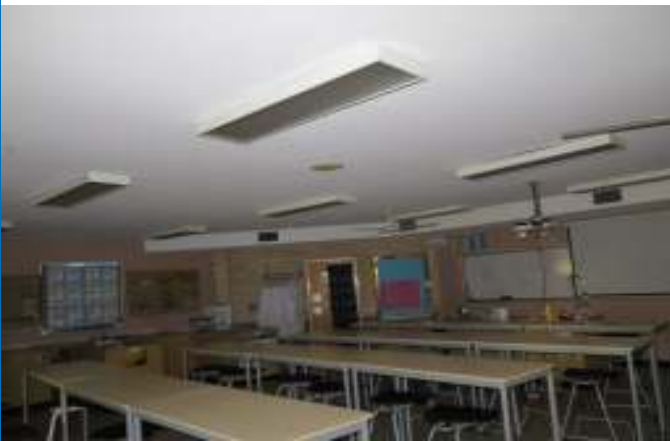
**Photo 48: Building J Classroom. Plaster Ceiling. No Asbestos Detected.**

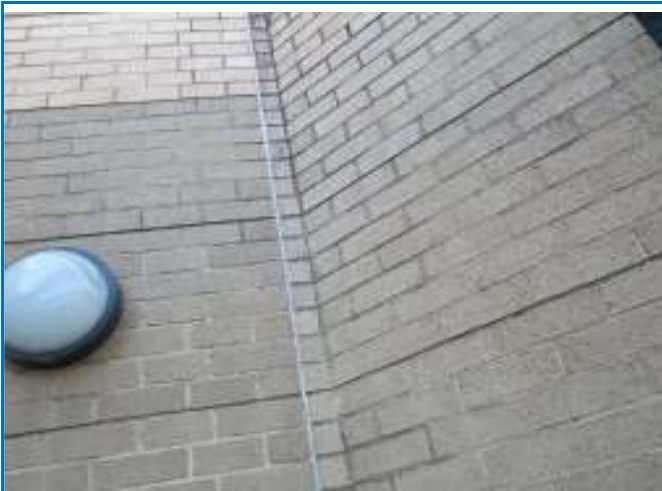
***Photo 49: Building J. Mastic Waterproofing. No Asbestos Detected.***

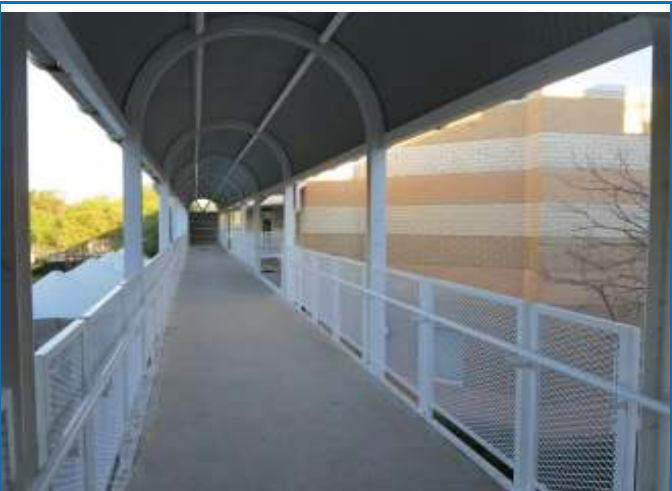
***Photo 50: Building J. Metal Covered Walkway. No Asbestos Detected.***

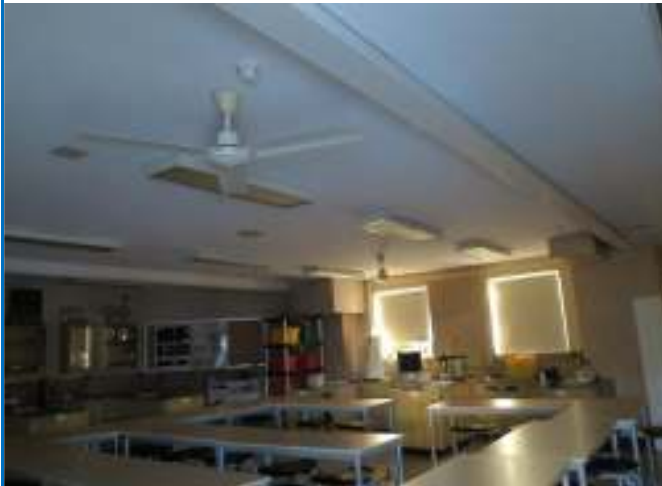
***Photo 51: Building J Classroom. Plaster Ceiling. No Asbestos Detected.***

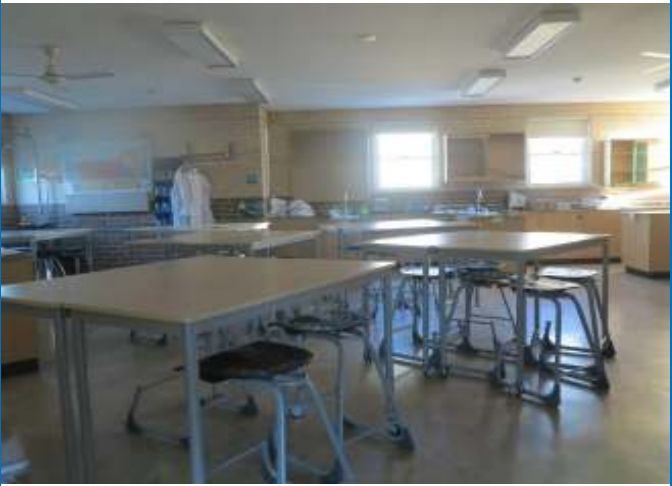
***Photo 52: Building J Classroom. Plaster Ceiling. No Asbestos Detected.***

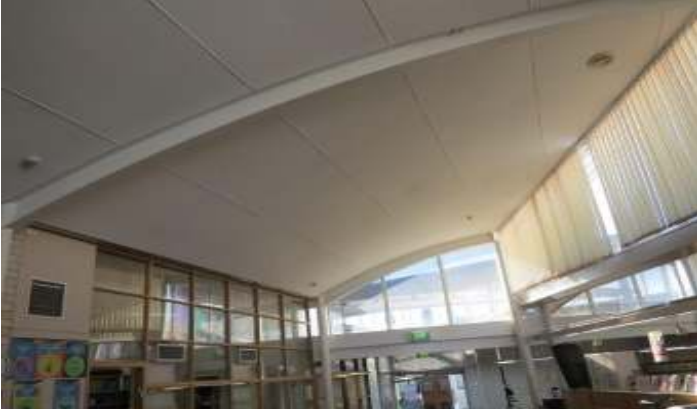
Moriah College Health Risk Assessment		Location: Building A Ceiling,		No Asbestos Detected

Item: Flat Fibre Cement  Extent (Approx. m²): 750m²  Lab. Sample Number: E68279  Banksia Sample Number: 1  Friability: Non Friable	Health Risk Assessment Product Type: 1 Surface Treatment: 0 Extent Of Damage: 0 Asbestos Type: 0  Score: 1 Algorithm Guideline:					
				10-12 High			
				7-9 Medium			
				5-6 Low			
				1-4 Very Low			
		Recommendation: No Action Necessary. Notes: No Reinspection Required.		Potential To Release Fibres:	No Potential For Fibre Release

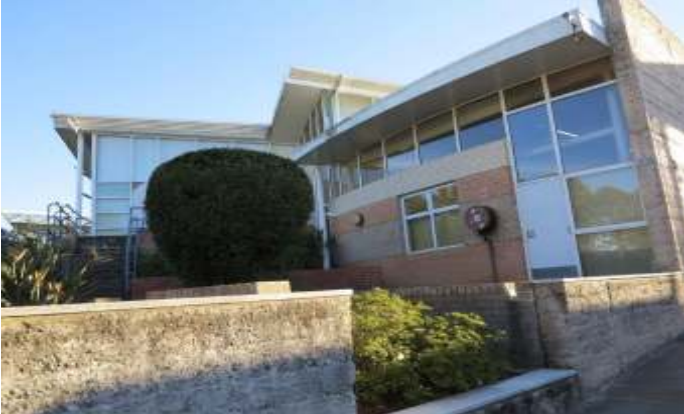
Moriah College Health Risk Assessment		Location: Building A Eaves		No Asbestos Detected

Item: Flat Fibre Cement  Extent (Approx. m²): 170m²  Lab. Sample Number: E68280  Banksia Sample Number: 2  Friability: Non Friable	Health Risk Assessment Product Type: 1 Surface Treatment: 0 Extent Of Damage: 0 Asbestos Type: 0  Score: 1 Algorithm Guideline:					
				10-12 High			
				7-9 Medium			
				5-6 Low			
				1-4 Very Low			
		Recommendation: No Action Necessary. Notes: No Reinspection Required.		Potential To Release Fibres:	No Potential For Fibre Release

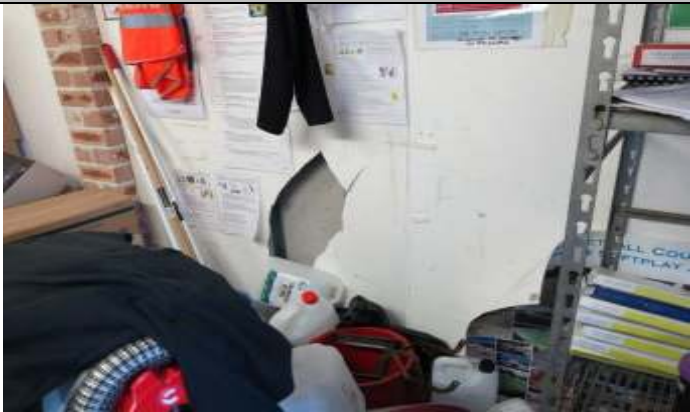
Moriah College Health Risk Assessment		Location: Building E Basement,		No Asbestos Detected

Item: Flat Fibre Cement		Health Risk Assessment			
		Extent (Approx. m²): 45m²		Product Type: 1			
		Lab. Sample Number: E68281		Surface Treatment: 0			
		Banksia Sample Number: 3		Extent Of Damage: 0			
		Friability: Non Friable		Asbestos Type: 0			
		Recommendation: No Action Necessary. Notes: No Reinspection Required.		Potential To Release Fibres:		Score: 1	
				No Potential For Fibre Release		Algorithm Guideline:	
				10-12 High			
				7-9 Medium			
				5-6 Low			
				1-4 Very Low

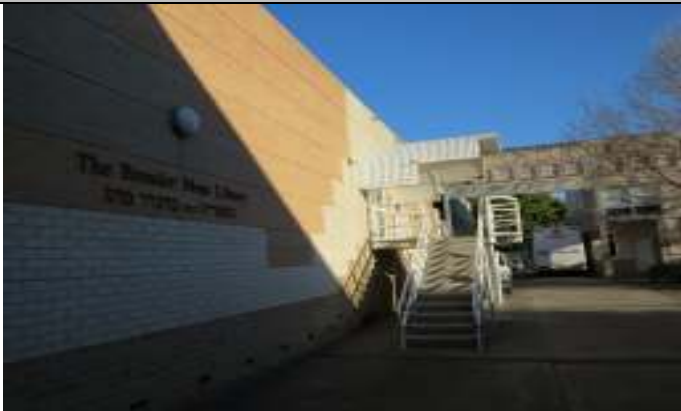
Moriah College Health Risk Assessment		Location: Rear Entry To Building A		No Asbestos Detected

Item: Flat Fibre Cement		Health Risk Assessment			
		Extent (Approx. m²): 10m²		Product Type: 1			
		Lab. Sample Number: E68282		Surface Treatment: 0			
		Banksia Sample Number: 4		Extent Of Damage: 0			
		Friability: Non Friable		Asbestos Type: 0			
		Recommendation: No Action Necessary. Notes: No Reinspection Required.		Potential To Release Fibres:		Score: 1	
				No Potential For Fibre Release		Algorithm Guideline:	
				10-12 High			
				7-9 Medium			
				5-6 Low			
				1-4 Very Low

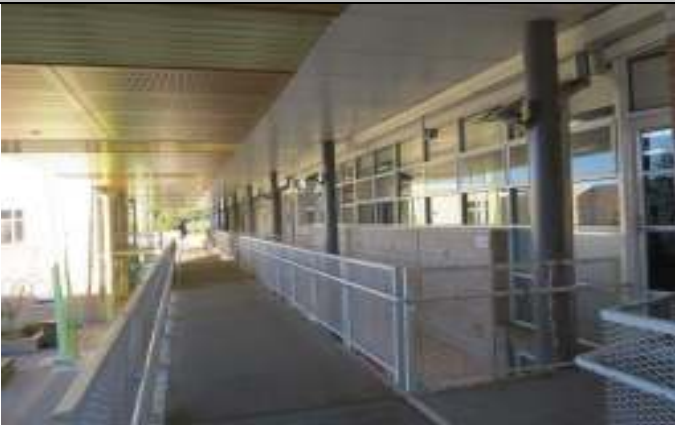
Moriah College Health Risk Assessment		Location: Building D Awning,		No Asbestos Detected

Item: Flat Fibre Cement		Health Risk Assessment	
		Extent (Approx. m²): 450m²		Product Type: 1	
		Lab. Sample Number: E68283		Surface Treatment: 0	
		Banksia Sample Number: 5		Extent Of Damage: 0	
		Friability: Non Friable		Asbestos Type: 0	
		Score: 1		Algorithm Guideline:	
		10-12 High			
		7-9 Medium			
		5-6 Low			
		1-4 Very Low			
Recommendation: No Action Necessary. Notes: No Reinspection Required.		Potential To Release Fibres:	No Potential For Fibre Release

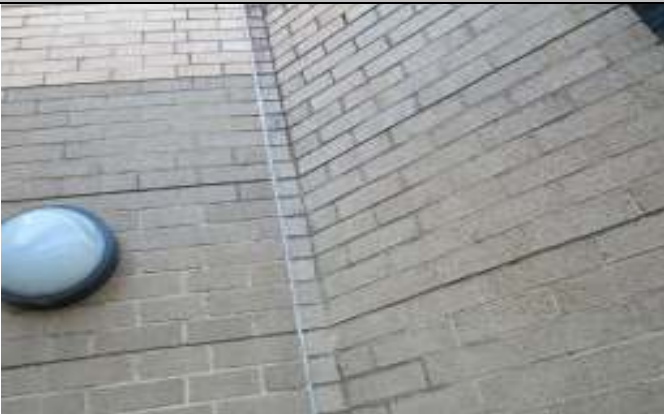
Moriah College Health Risk Assessment		Location: Building J Mastic		No Asbestos Detected

Item: Mastic		Health Risk Assessment	
		Extent (Approx. m²): 10m²		Product Type: 1	
		Lab. Sample Number: E68284		Surface Treatment: 0	
		Banksia Sample Number: 6		Extent Of Damage: 0	
		Friability: Non Friable		Asbestos Type: 0	
		Score: 1		Algorithm Guideline:	
		10-12 High			
		7-9 Medium			
		5-6 Low			
		1-4 Very Low			
Recommendation: No Action Necessary. Notes: No Reinspection Required.		Potential To Release Fibres:	No Potential For Fibre Release
