Preliminary Arboricultural Report

Tweed Valley Hospital Project

17 October 2018

Preliminary Arboricultural Report relating to four (4) individual trees and 150+ hedgerow trees located at 771 Cudgen Road Kingscliff NSW

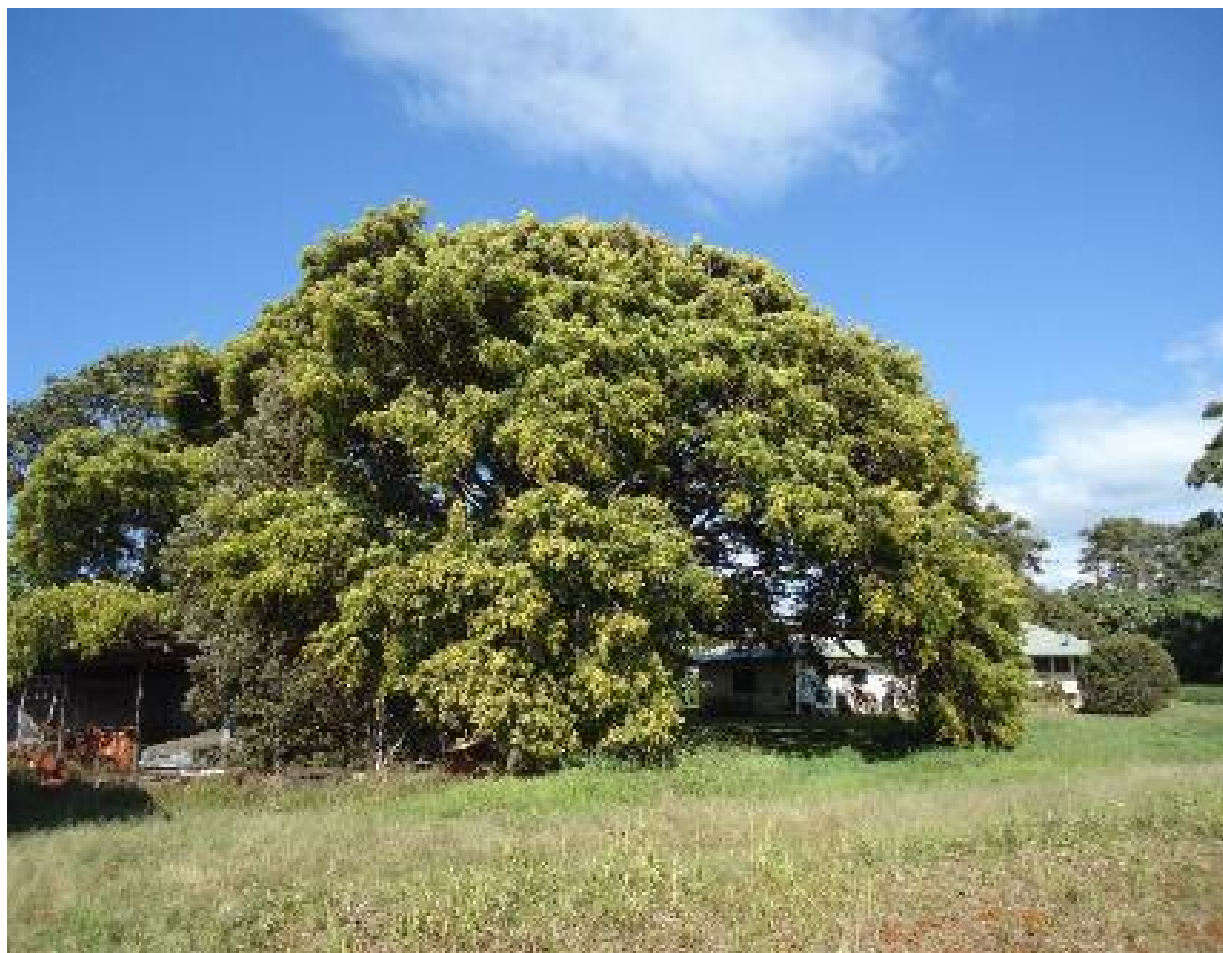
- 5.2.3 Tree 4 was a *Ficus benjamina* (Weeping Fig). The tree was located adjacent to Cudgen road, immediately east of the existing house structure. The tree was large and well established for its species and formed a significant feature within the landscape (see Figure 6).
- 5.2.4 Tree 4 was of good health and fair structure and had an estimated life expectancy of greater than 25 years (25–50 years). The lower trunk structure was a mass of competing stems typical of the species (see Figure 7).
- 5.2.5 The TPZ for Tree 4 is 15m, and the SRZ is 3.9m, measured at a radial distance from the centre of the trunk.

Figure 6. View to south of Tree 4 *Ficus benjamina* (Weeping Fig) in its growing environment. Source: Andrew Clark, 20 July 2018

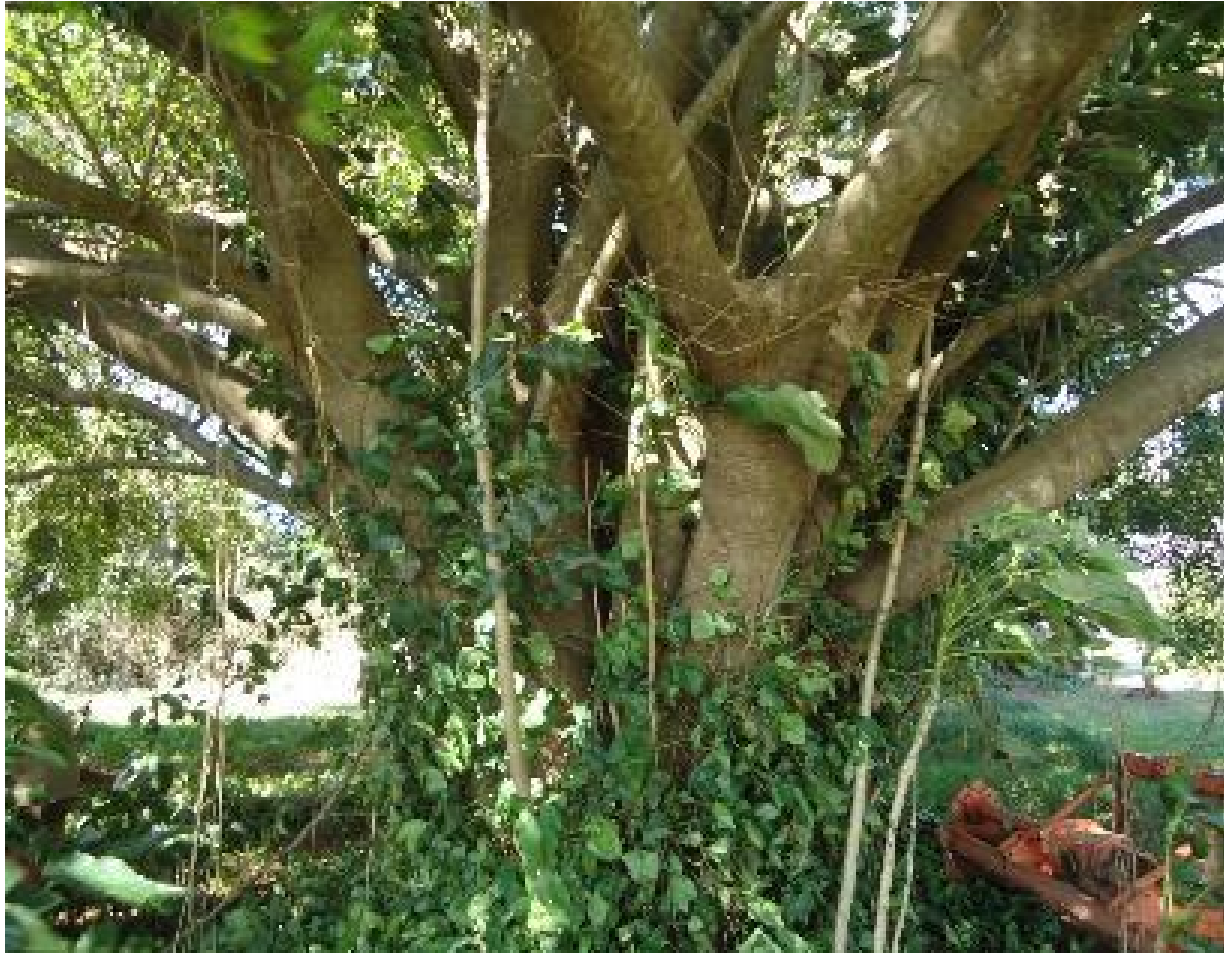
Figure 7. View of the lower trunk structure of Tree 4 *Ficus benjamina* (Weeping Fig). Source: Andrew Clark, 20 July 2018

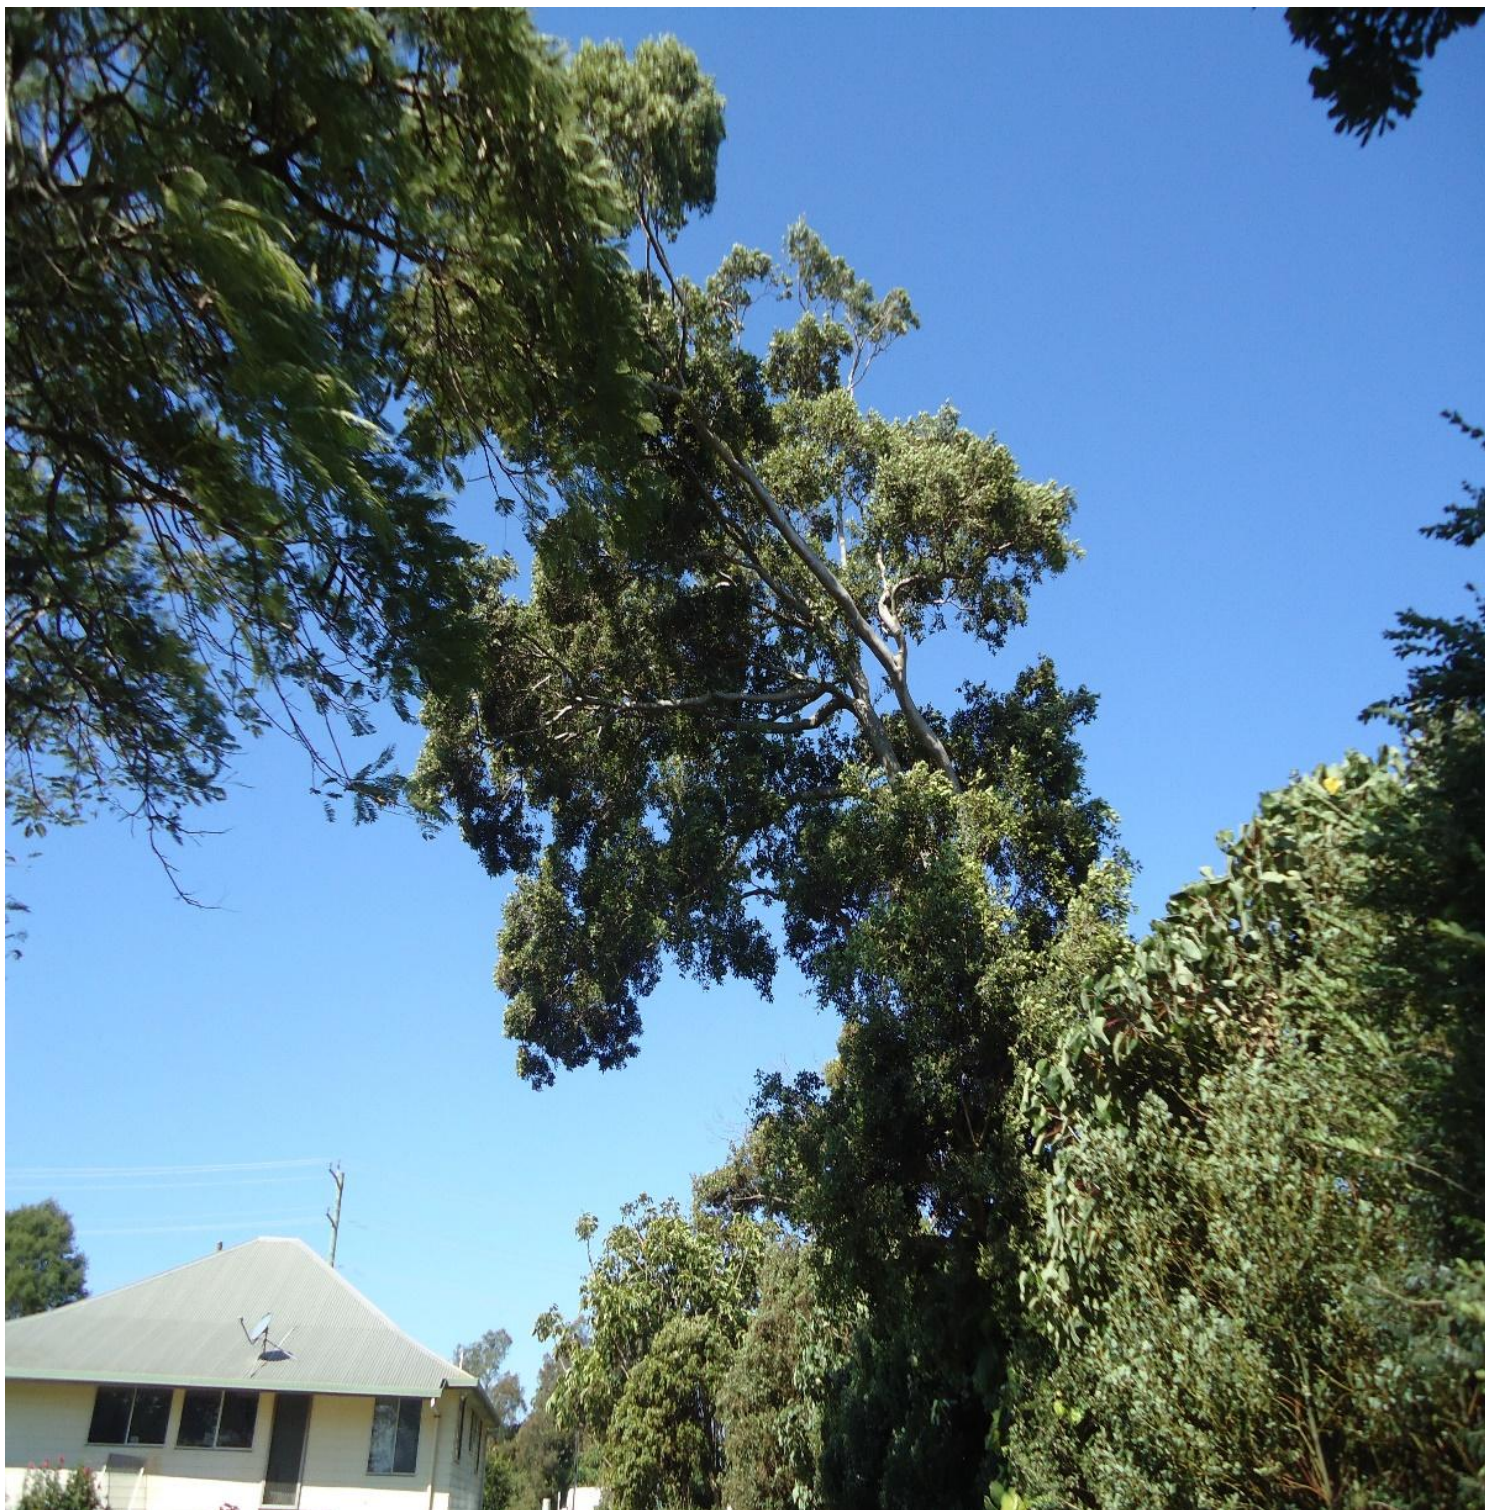
- 5.3.3 Tree 1 was a *Ficus obliqua* (Small Leafed Fig). The tree was considered to be in good health with a fair structure. The tree canopy had a significantly crown bias to the east, attributed to suppression from an adjacent, previously removed tree, which detracted from its overall visual / aesthetic appearance (see Figure 9).
- 5.3.4 The tree had established over and around a decaying stump, from the previously removed tree, causing cavities and uneven growth with the basal area and structural roots. Overall structural stability was not considered to be compromised, at the time of inspection, and root growth of this kind was considered typical of the species. A large European bees' nest was observed within the basal hollows of the tree.
- 5.3.5 The TPZ for Tree 1 is 12m, and the SRZ is 4.4m, measured at a radial distance from the centre of the trunk.

Figure 9. View to south of Tree 1 *Ficus obliqua* (Small Leafed Fig) in its growing environment. Source: Andrew Clark, 20 July 2018

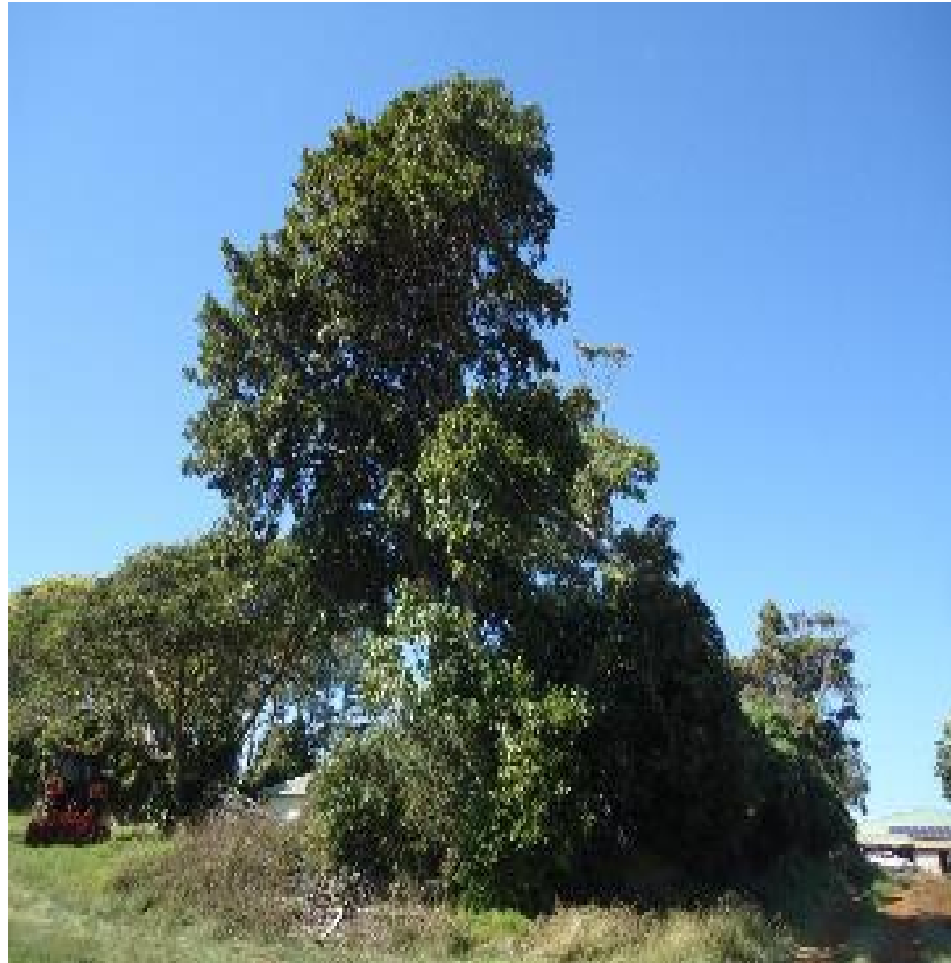
- 5.3.6 Tree 2 was a *Cupaniopsis anacardioides* (Tuckeroo). The tree was of a large size for the species and considered in good health with a fair structure. The tree canopy had a significantly crown bias to the north east, attributed to suppression from an adjacent previously removed tree, which detracted from its overall visual / aesthetic appearance (see Figures 10 and 11). Several wounds from previous lateral branch failures were observed within the crown.
- 5.3.7 The TPZ for Tree 2 is 7.2m, and the SRZ is 2.8m, measured at a radial distance from the centre of the trunk.

Figure 10. View to south of Tree 2 *Cupaniopsis anacardioides* (Tuckeroo) in its growing environment. Source: Andrew Clark, 20 July 2018

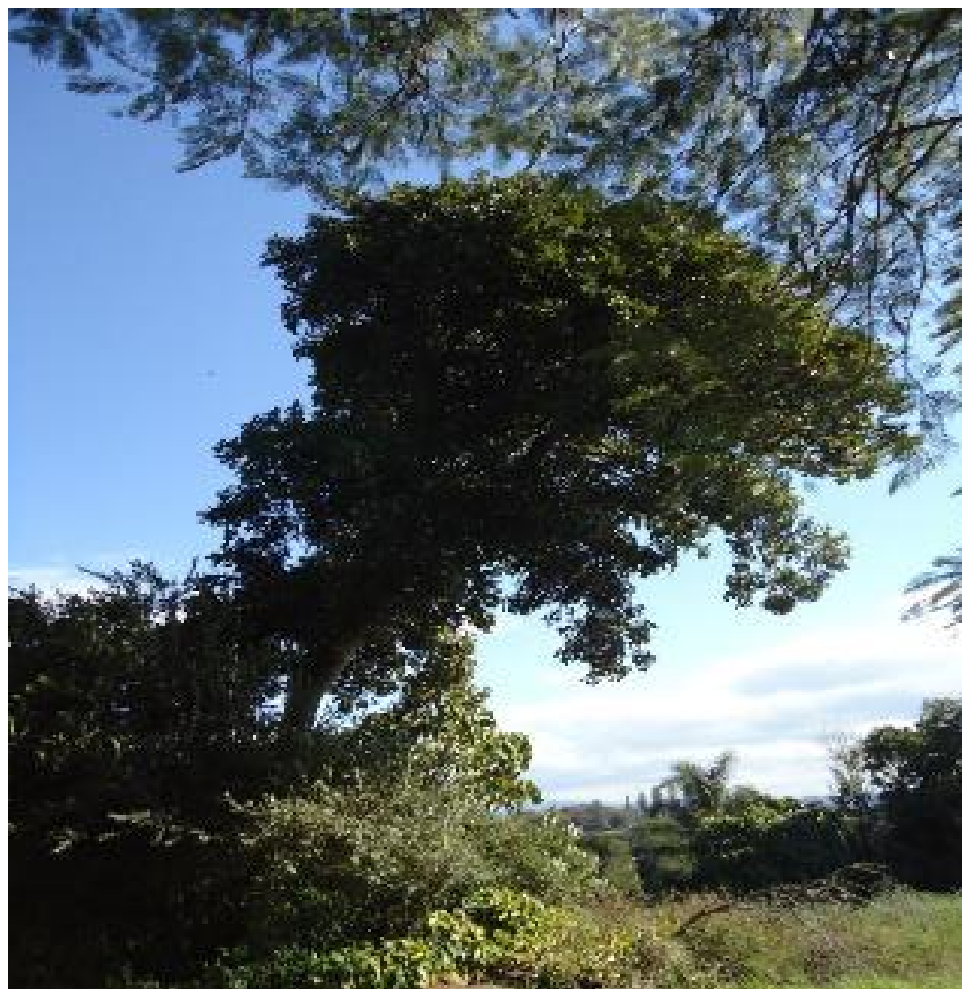
Figure 11. View to west of Tree 2 *Cupaniopsis anacardioides* (Tuckeroo) in its growing environment. Source: Andrew Clark, 20 July 2018

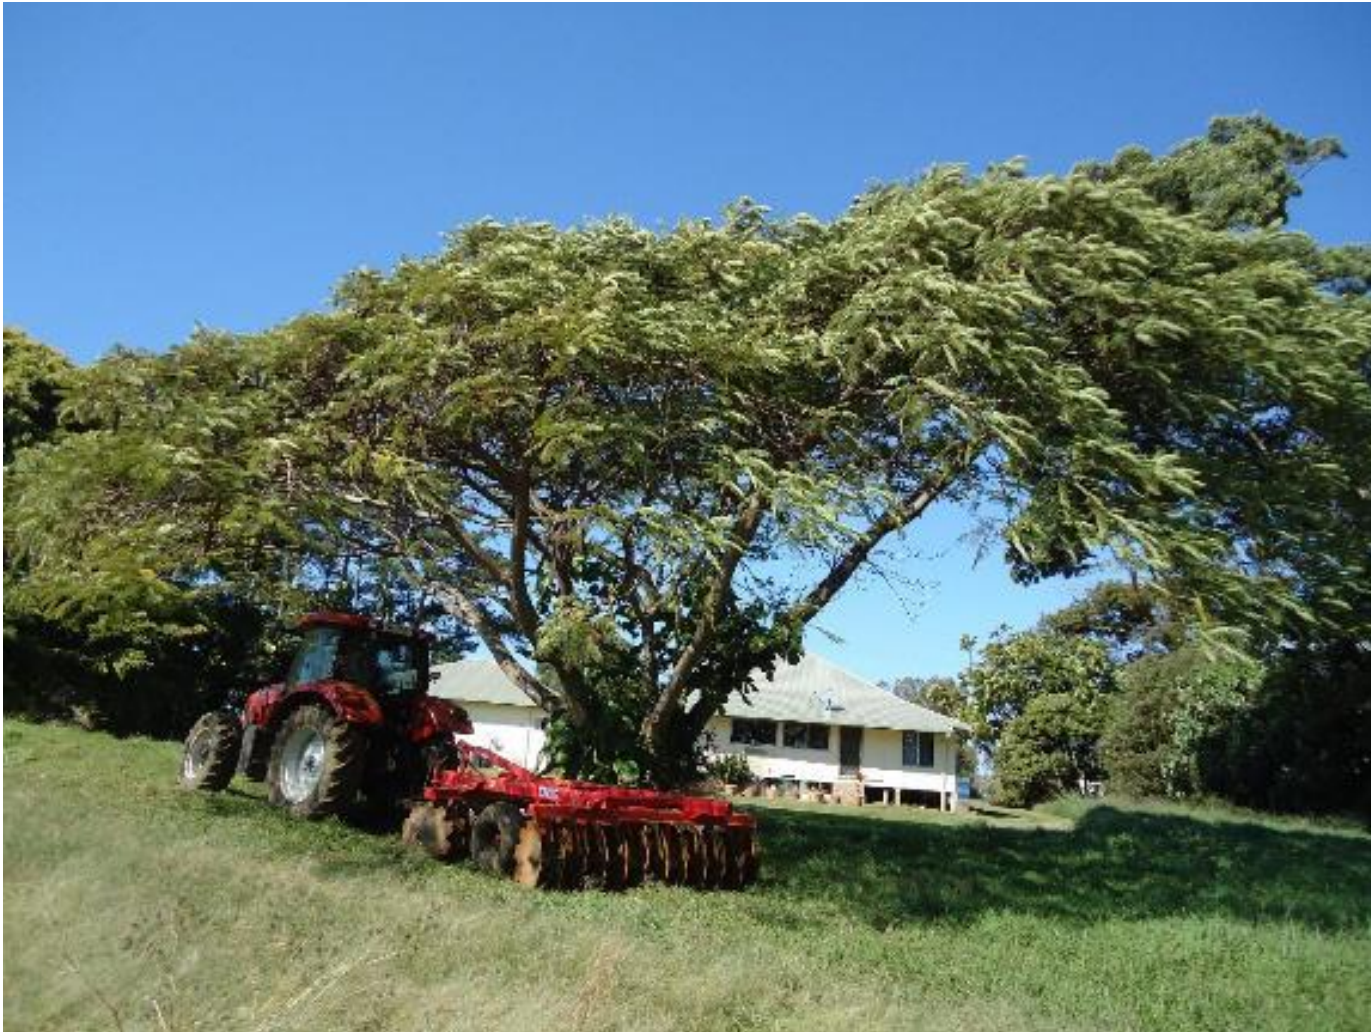
- 5.3.8 Tree 3 was a *Delonix regia* (Poinciana). The tree was of a moderate height for the species and was in good health with a fair structure. Several included unions between co-dominant stems were observed. Although these unions were considered stable at the time of assessment they could detract from the tree's long-term structural stability.
- 5.3.9 The TPZ for Tree 3 is 9.4m, and the SRZ is 3.4m, measured at a radial distance from the centre of the trunk.

Figure 12. View to west of Tree 3, *Delonix regia* (Poinciana) in its growing environment. Source: Andrew Clark, 20 July 2018

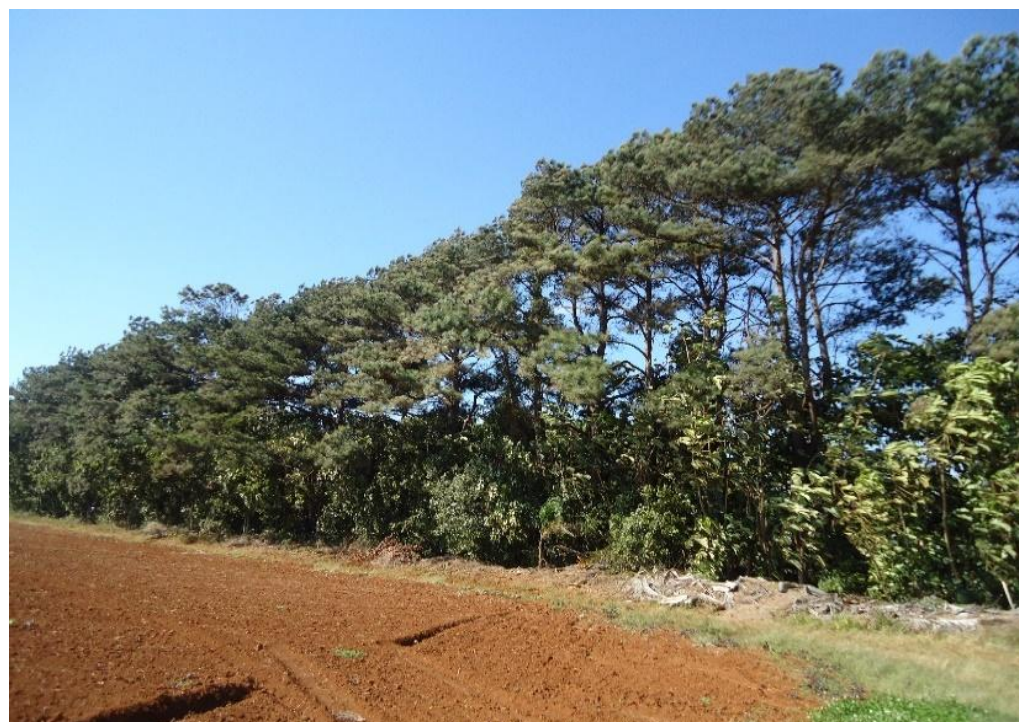
- 5.4.3 The line of wind break trees on the boundary of Cudgen Road were identified as *Pinus elliottii* (Slash Pine), of which there were over 150 individual trees (estimated), planted at 3-4m spacings. The DBH of the larger trees was observed to be approximately 40cm (at 1.4m above ground level) with estimated heights of between 15–20m.
- 5.4.4 *Pinus elliottii* (Slash Pine) is regarded as an environmental weed in Queensland and New South Wales (BCC website – 2018) with a variety of control recommendations.
- 5.4.5 The trees provide some screen value between the site and neighbouring properties, however ease of growth (possible weedy tendencies), limited ULE and species type resulted in a classification of Low Retention Value.
- 5.4.6 The average TPZ for the *Pinus elliottii* (Slash Pine) was 4.8m, measured at a radial distance from the centre trunk.

Figure 14. View to the east of the line of *Pinus elliottii* (Slash Pine), and the regenerating trees under the canopy. Source: Andrew Clark, 20 July 2018

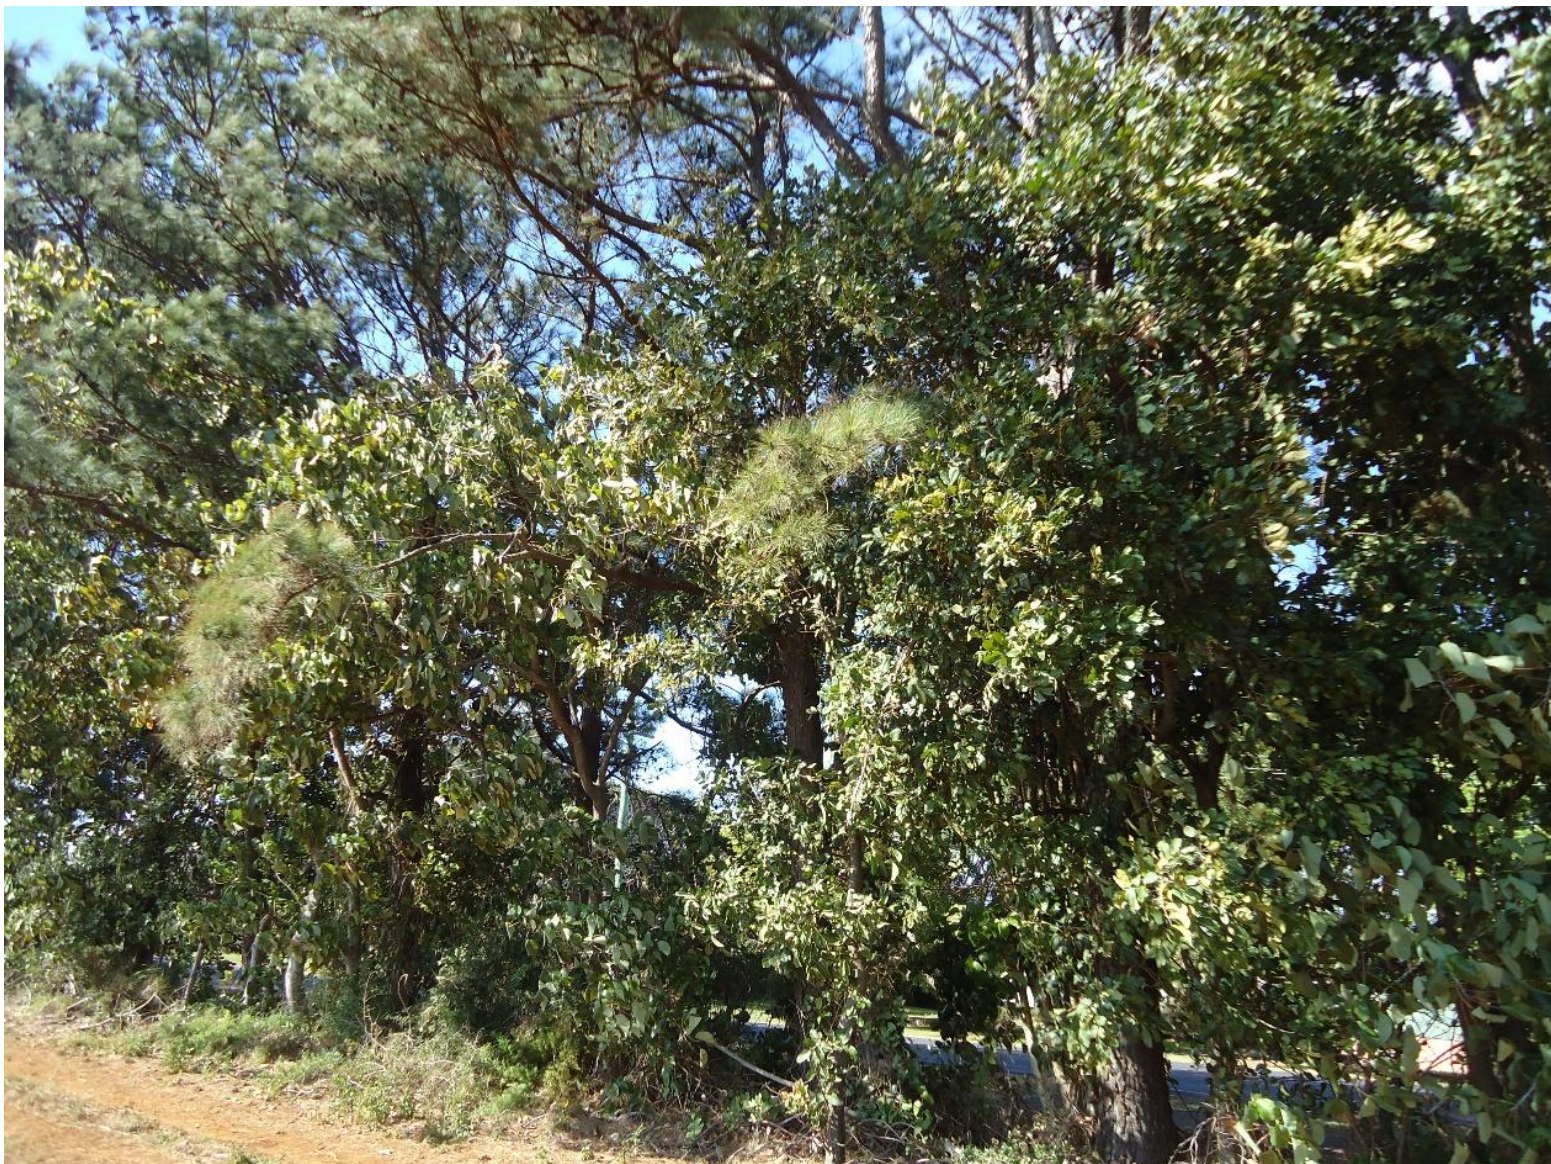
- 5.4.7 The naturally regenerating understory trees consisted mainly of three native species, namely *Cupaniopsis anacardioides* (Tuckeroo), *Macaranga tanarius* (Macaranga) and *Schefflera actinophylla* (Umbrella Tree). The trees were typically suppressed, semi-mature specimens, with a DBH in the range of 10–20cm and tree heights of between 5–10m.

- 5.4.11 The trees provided some screen value between the site and neighbouring properties, however age, size, health and structure, ease of growth and species type resulted in a Low Retention Value.

Figure 15. A closer view of the line of regenerating trees growing under the *Pinus elliottii* (Slash Pine). Source: Andrew Clark, 20 July 2018
