Due Diligence Report

Sutherland Entertainment Centre

Prepared for NBR Architecture / 22 November 2019

182011

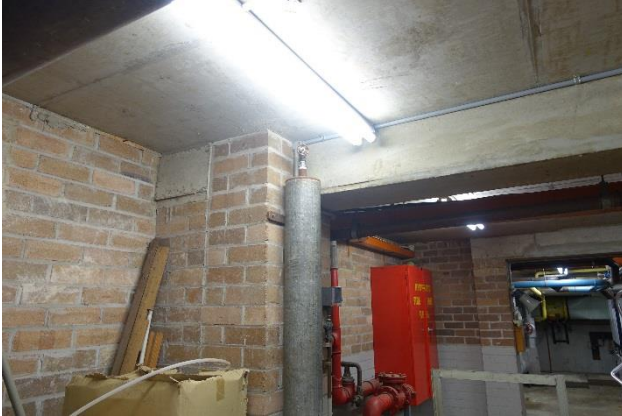
Photo 1 – Load bearing brickwork walls and piers

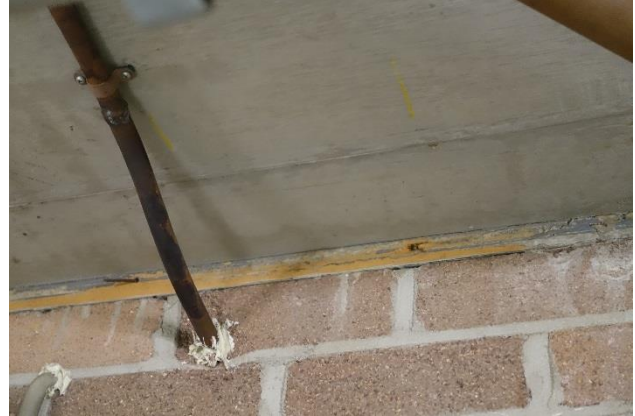
Photo 2 – Typical brickwork damp-proof courses

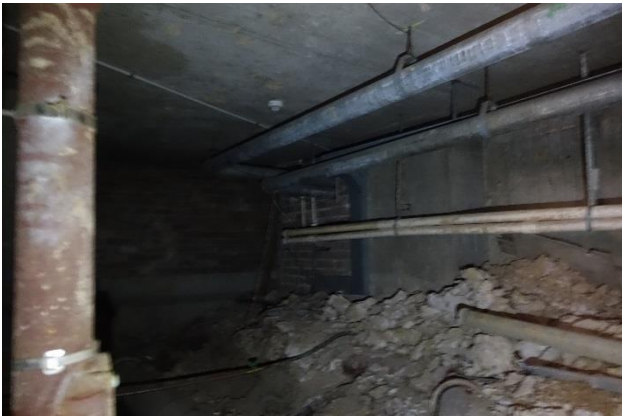
Photo 3 – Shoring wall under auditorium perimeter

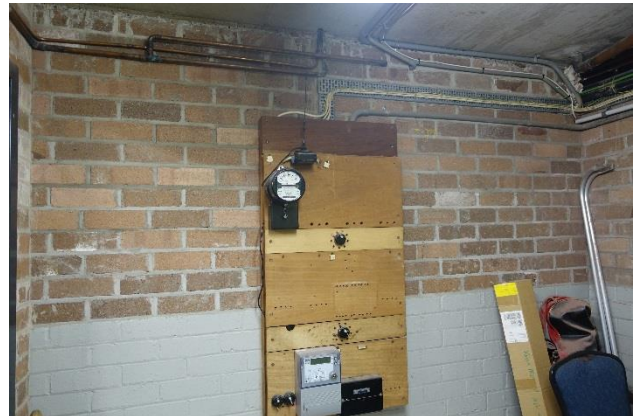
Photo 4 – Proposed location for new shear wall

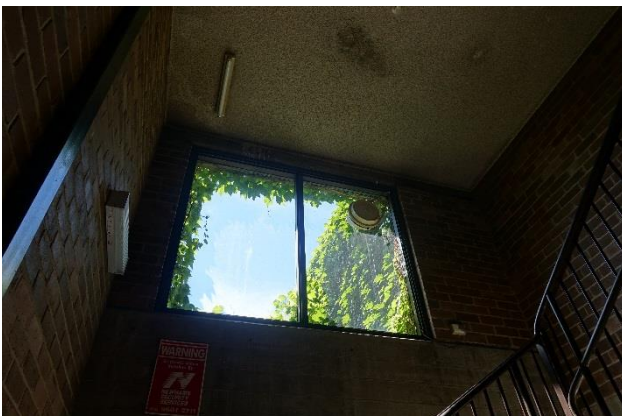
Photo 1 – Brickwork piers on either side of window

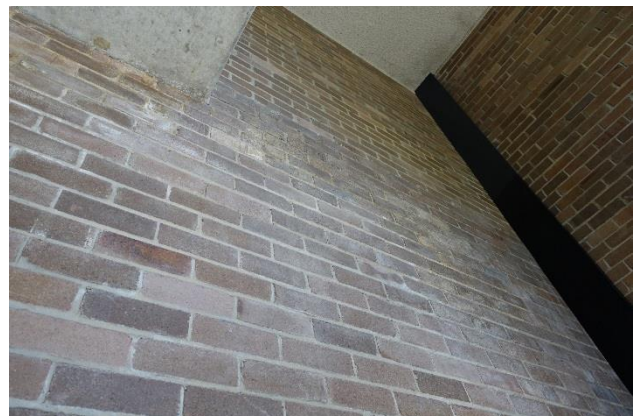
Photo 2 – Load bearing brickwork walls

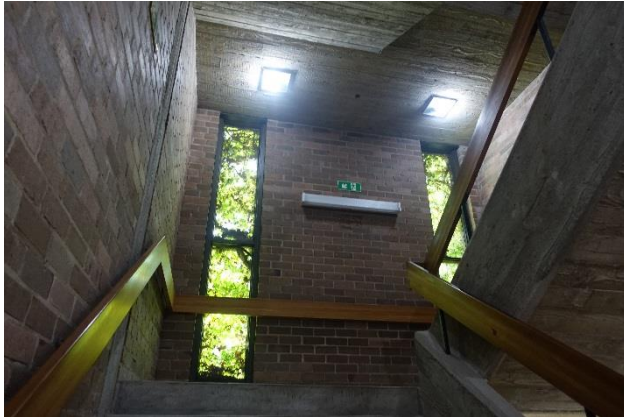
Photo 1 – Load bearing brickwork walls

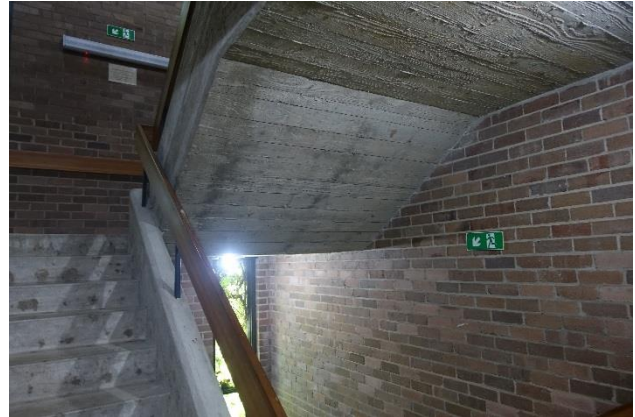
Photo 2 – RC flight and landing slabs

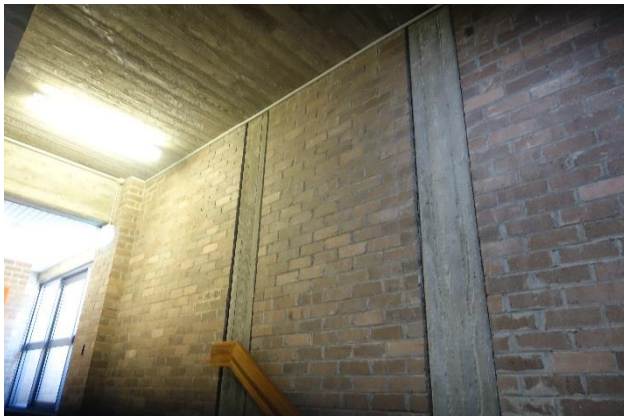
Photo 1 – Load bearing brickwork wall [1]

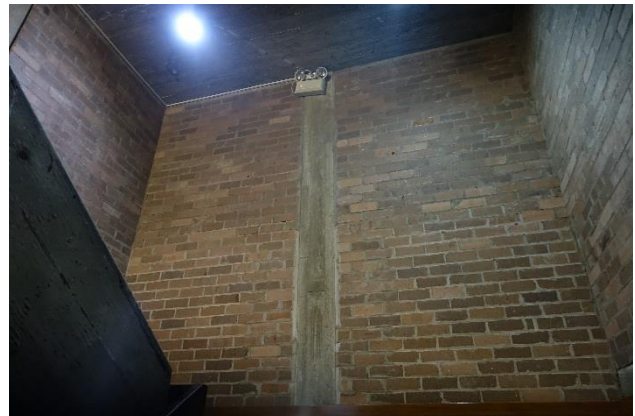
Photo 2 – Load bearing brickwork wall [2]

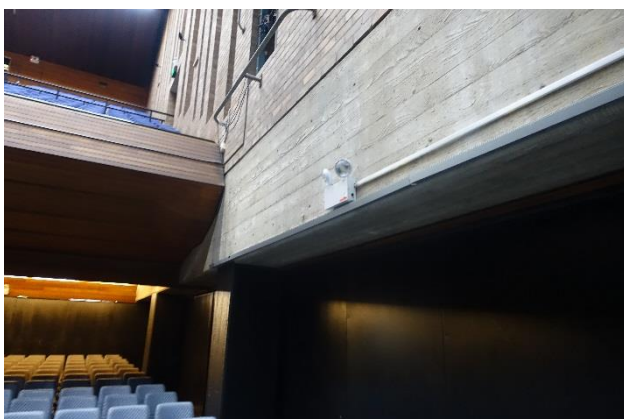
Photo 1 – RC perimeter beam and concrete encased steel columns

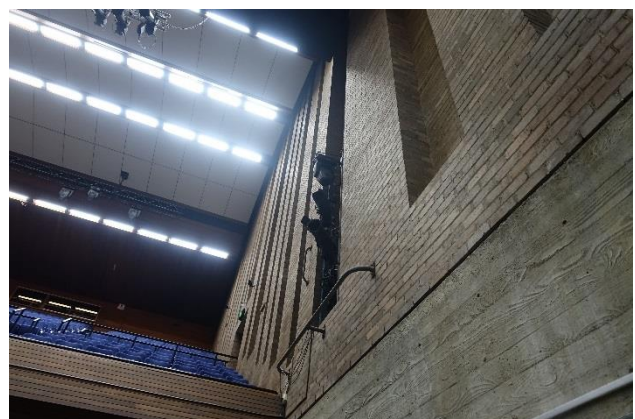
Photo 2 – Brickwork perimeter wall and brickwork encased steel columns

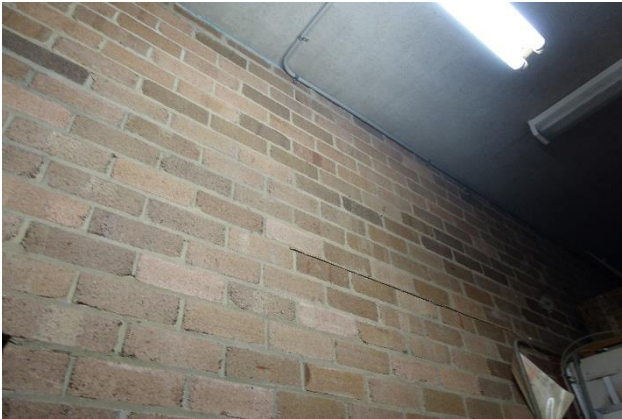
Photo 1 – Typical load bearing brickwork wall

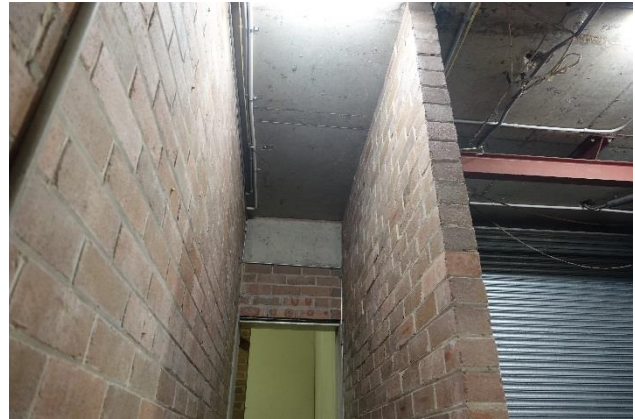
Photo 2 – Typical non-load bearing brickwork wall

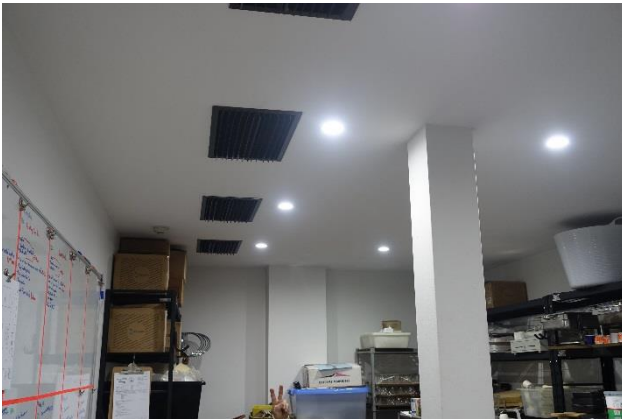
Photo 3 – Typical steel column (covered)

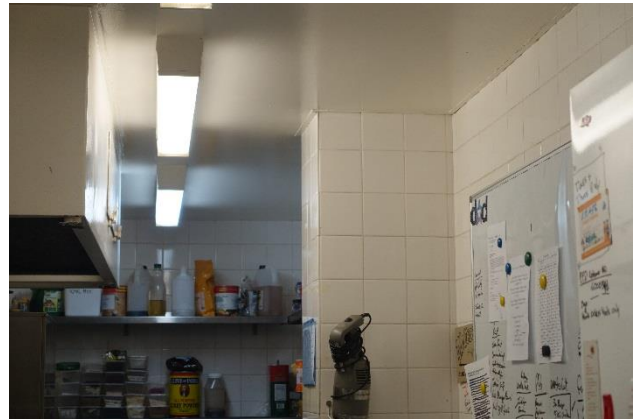
Photo 4 – Typical brickwork pier (covered)

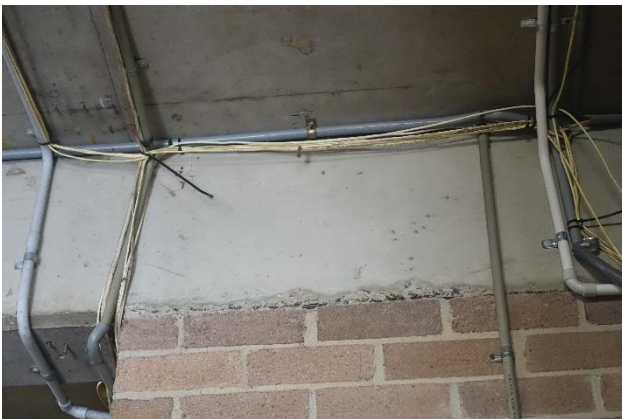
Photo 5 – Typical beam on wall bearing (rectification might be required if reinforcing bars being exposed)

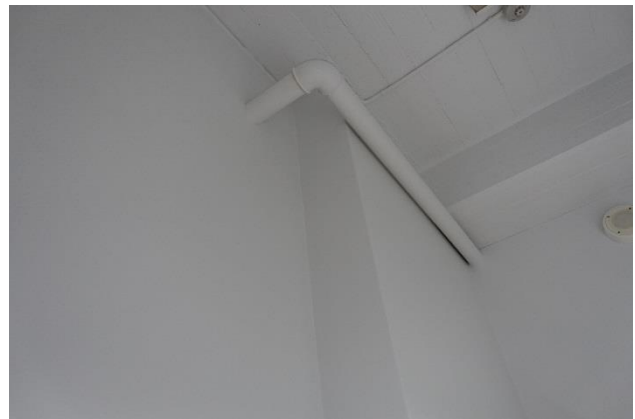
Photo 6 – Blade brickwork pier (covered)

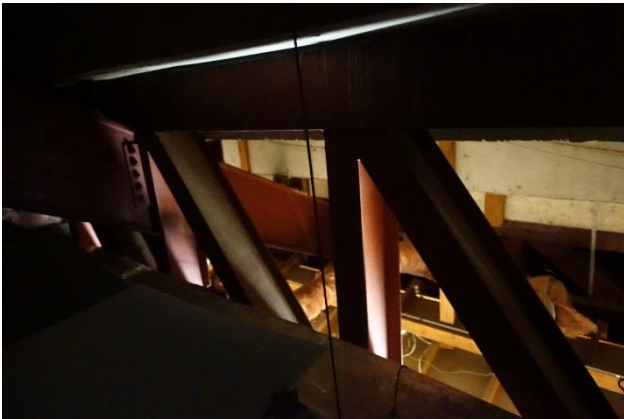
Photo 3 – BT1 truss

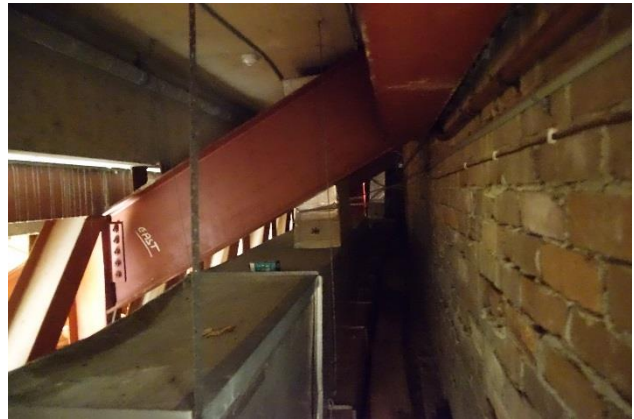
It appears that the existing steel raker beams are not fire-rated at the time of the inspection. These structural elements are supporting the upper seating stalls and, therefore, need to be assessed for fire resistance.

Photo 4 – BT1 truss to raker beam connection

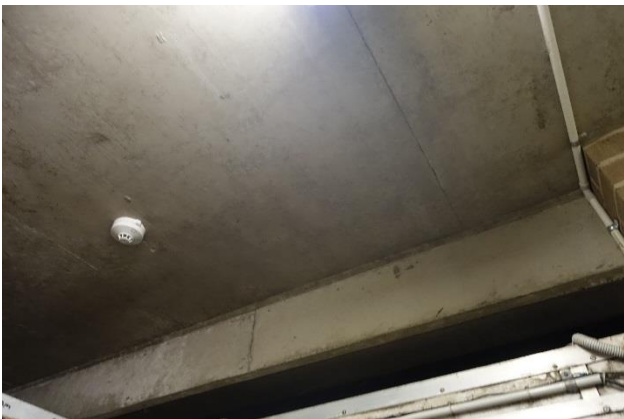
Photo 5 – Green Room terrace RC floor framing

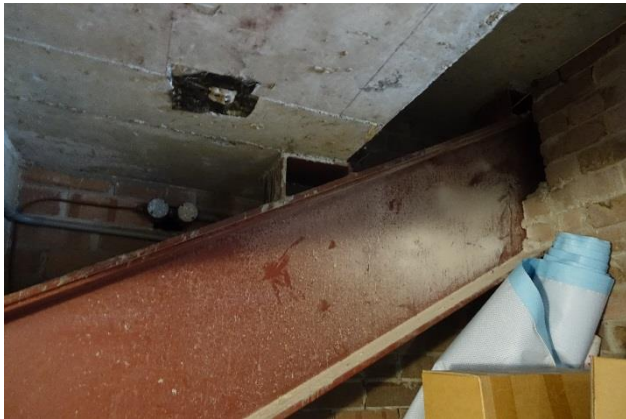
Photo 3 – Raker beam end connection (covered)

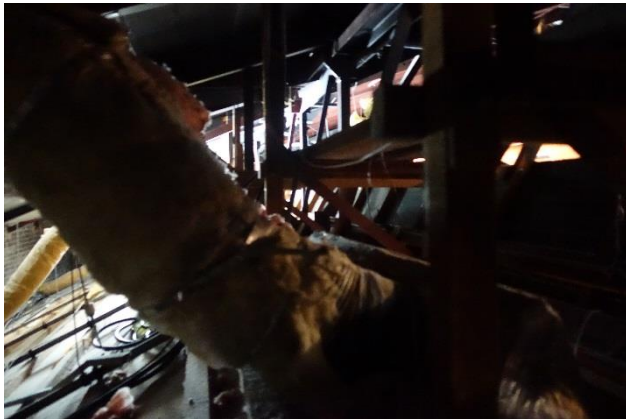
Photo 1 – Roof truss

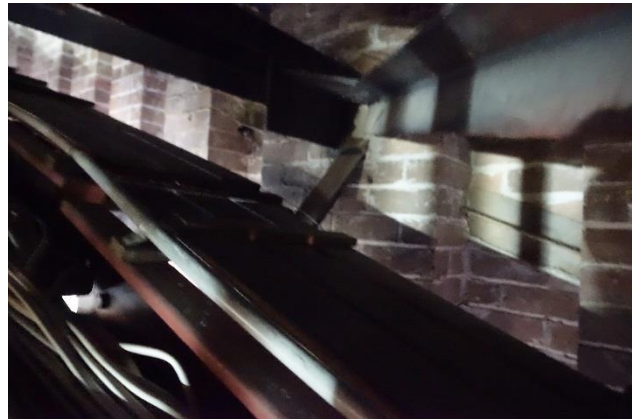
Photo 2 – Roof truss to column connection (covered)

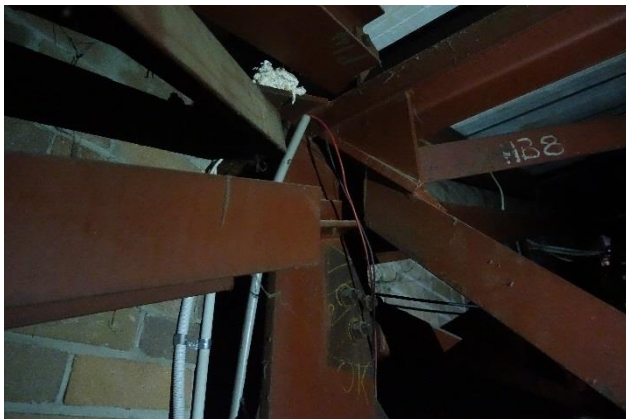
Photo 3 – Roof truss to column top connection

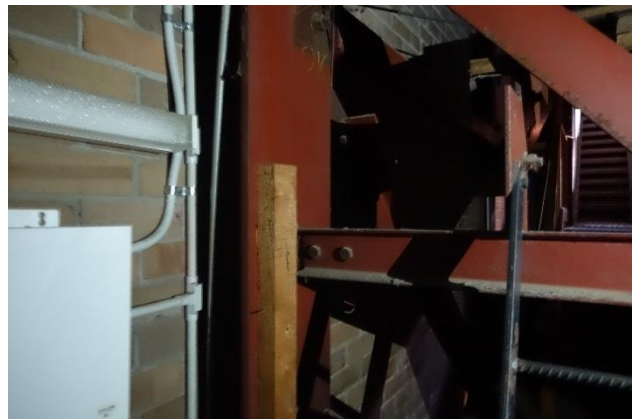
Photo 4 – Roof truss to column bottom connection

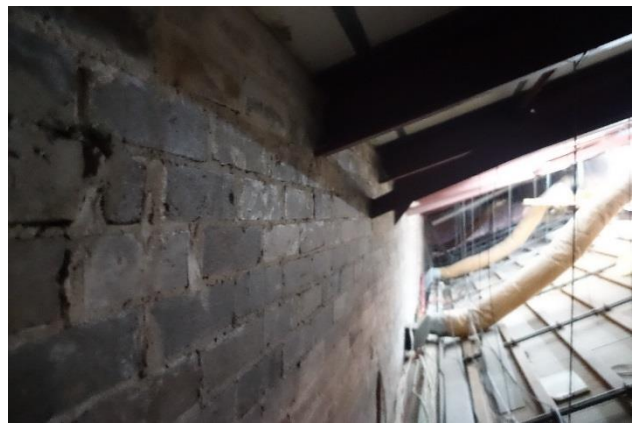
Photo 8 – Roof beam end connection (covered)

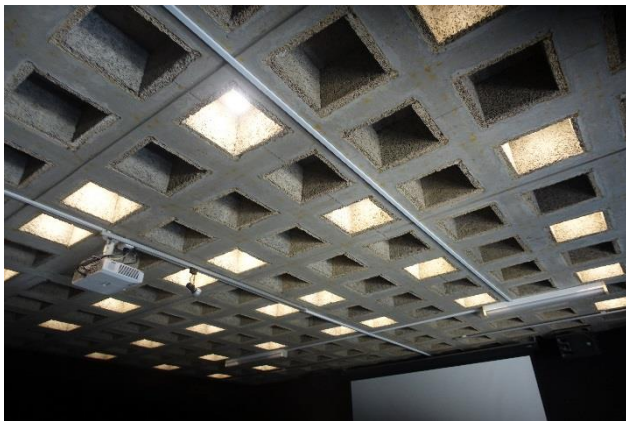
Photo 1 – Level 1 RC waffle slab

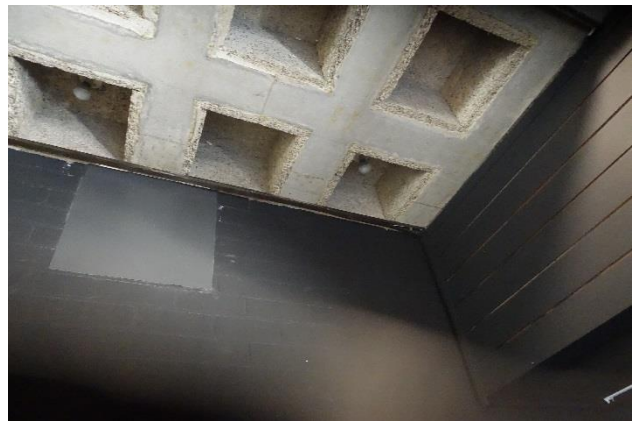
Photo 2 – RC waffle slab on brickwork wall bearing

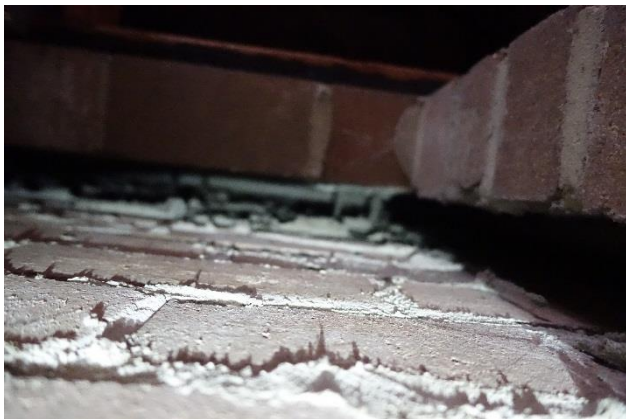
Photo 3 – Brickwork ties in cavity wall [1]

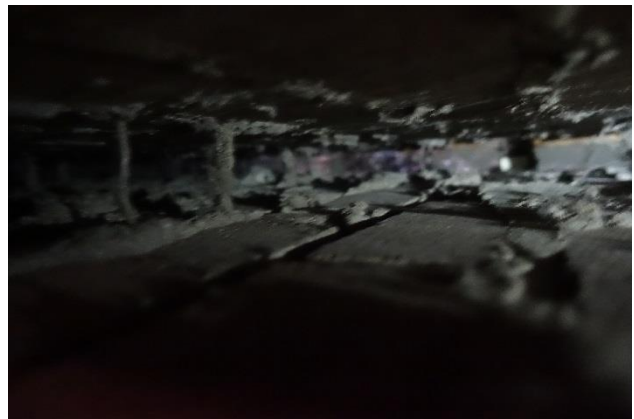
Photo 4 – Brickwork ties in cavity wall [2]

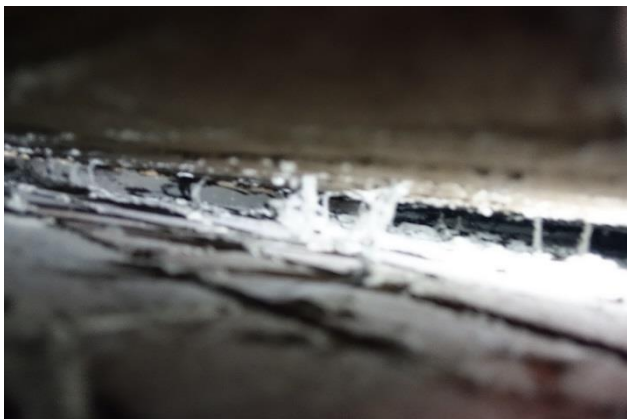
Photo 5 – Brickwork ties in cavity wall [3]

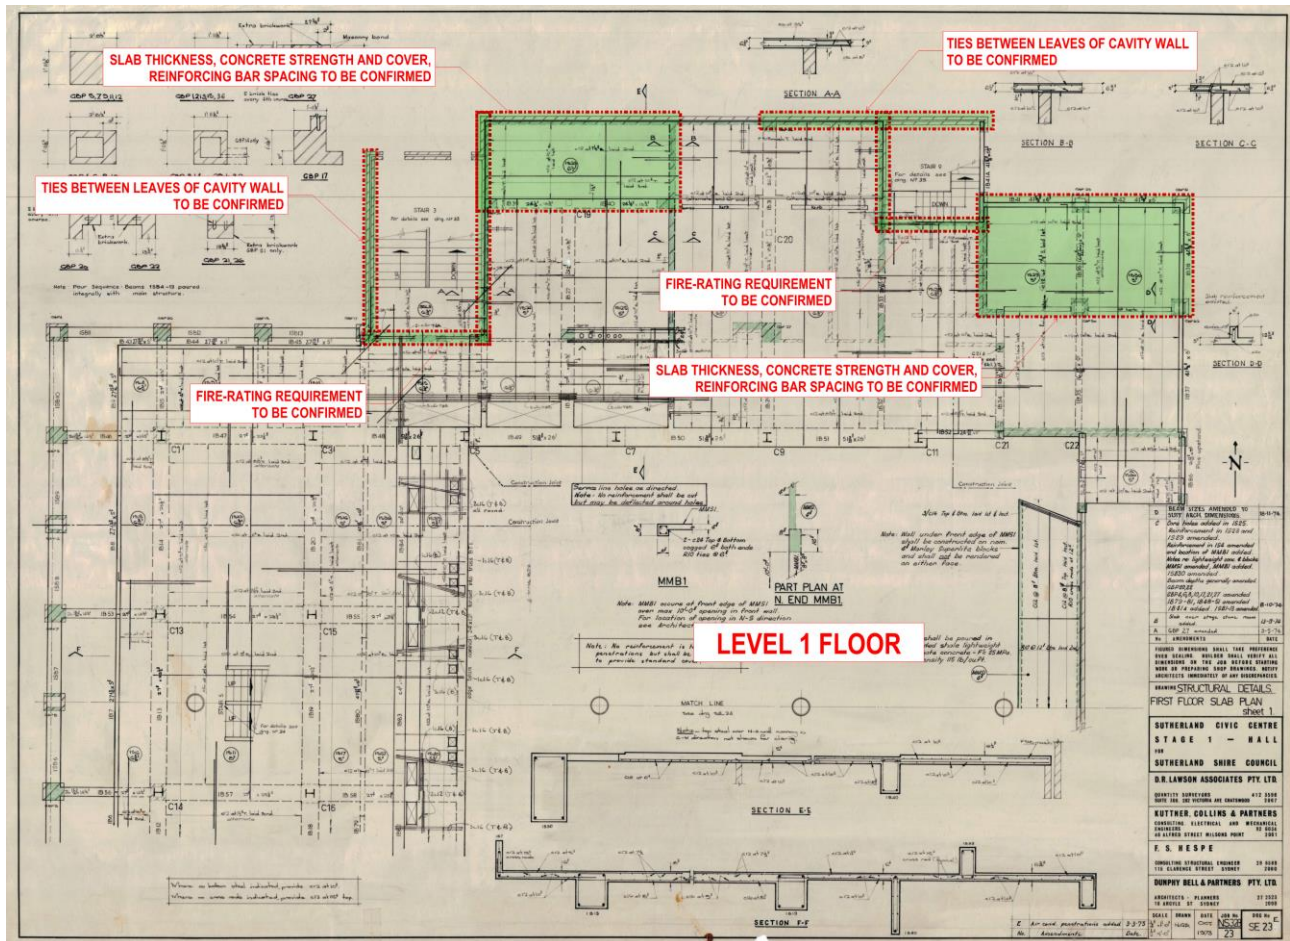
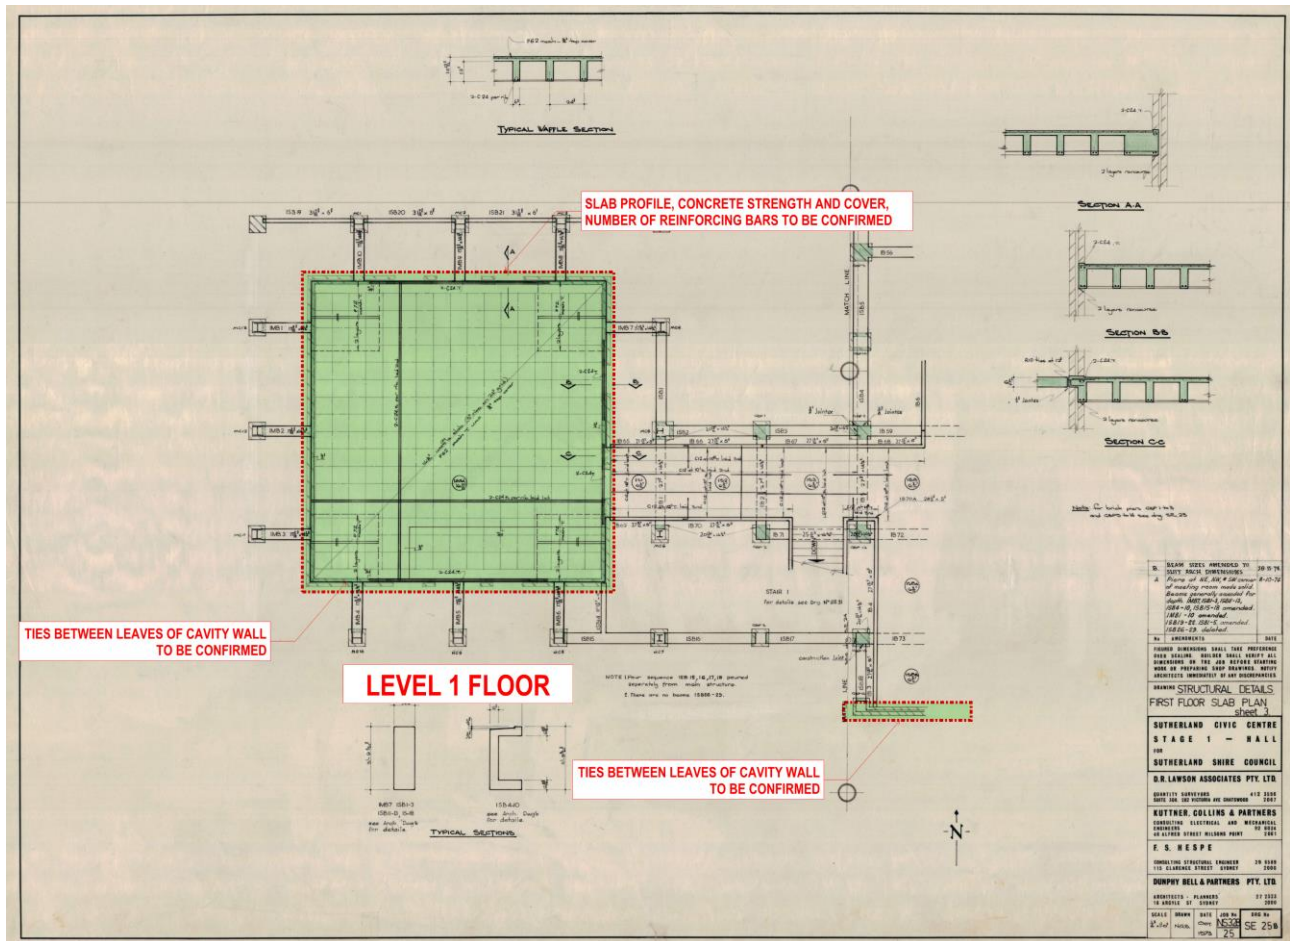
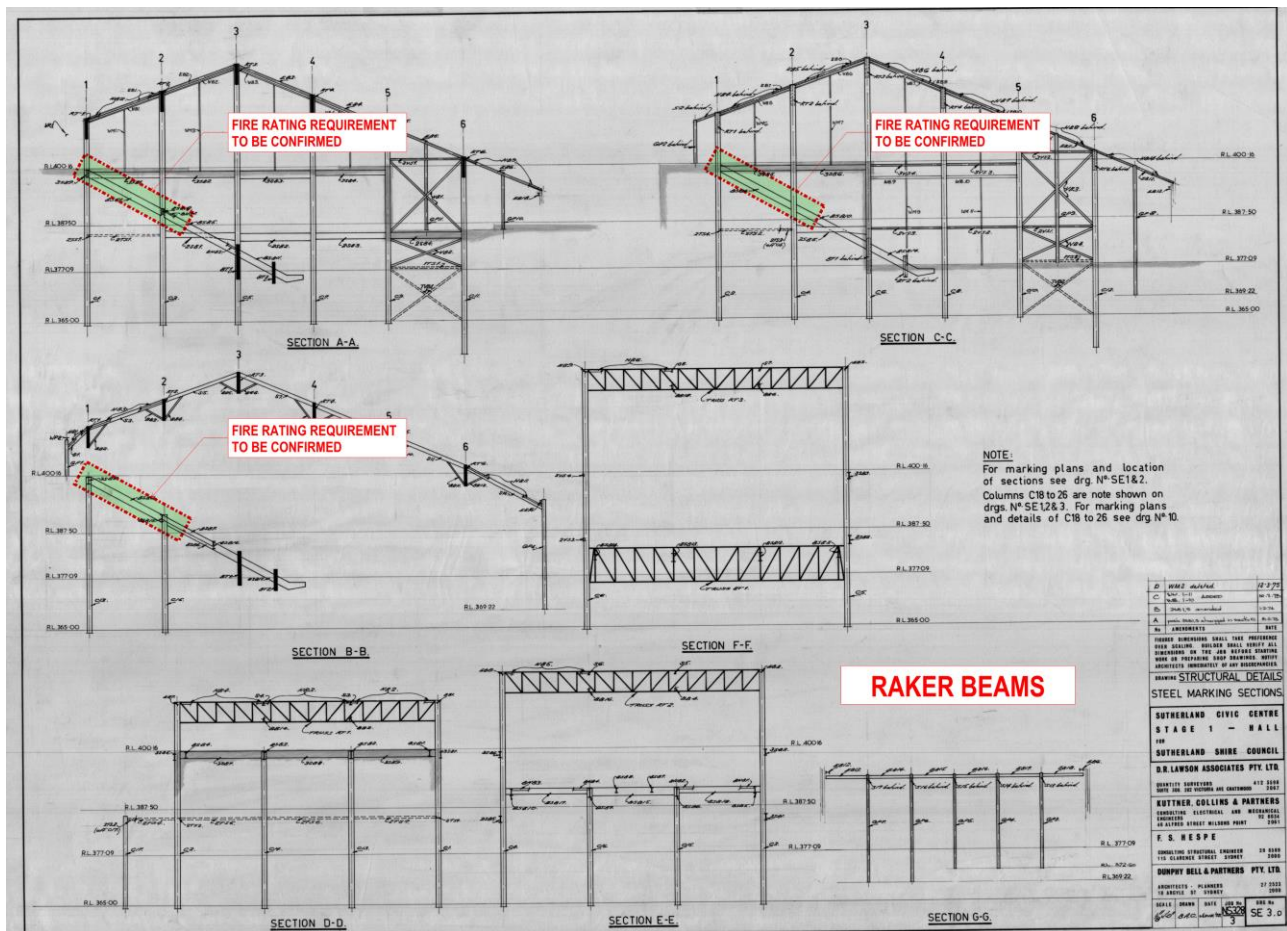
Critical Structural Areas

Refer to Appendix C for the critical structural areas where the structural conditions need to be confirmed by the detailed building condition inspection for the purpose of de-risking the project.
