# **HAZARDOUS MATERIALS REINSPECTION REPORT, CATHERINE MCAULEY HIGH SCHOOL WESTMEAD.**

**20<sup>th</sup> March 2016**

Prepared for:  
**Catholic Education Diocese of Parramatta,  
Locked Bag 4,  
North Parramatta. NSW. 1750.**

Prepared by:  
**Banksia EOHS Pty Limited.**

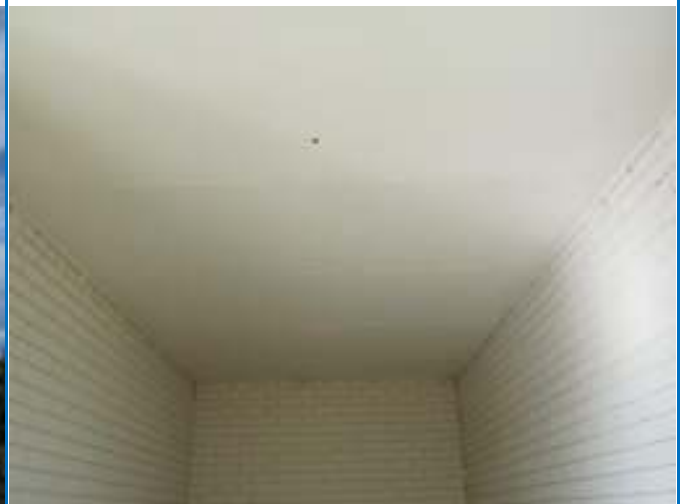
**Photo 4: Block A Ceiling Above Stairs Lined With Fibre Cement. Deemed Asbestos Present.**

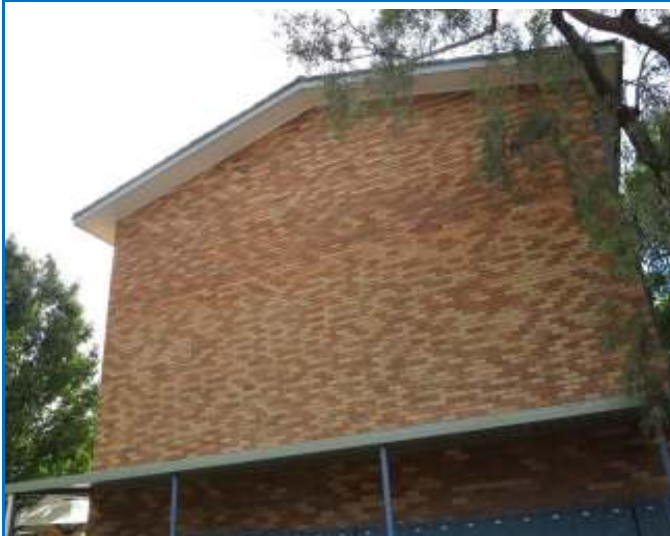
**Photo 5: Block B Eaves Lined With Fibre Cement. Deemed Asbestos Present.**

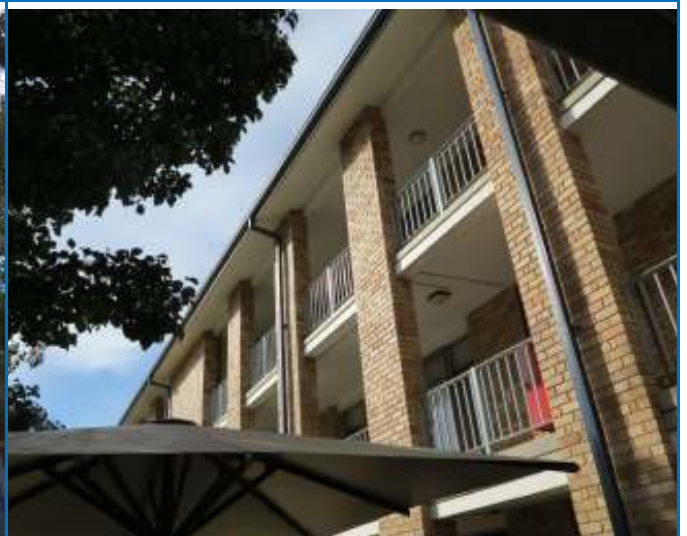
**Photo 6: Block B Awning & Classroom Ceilings Lined With Fibre Cement. Deemed Asbestos Present.**

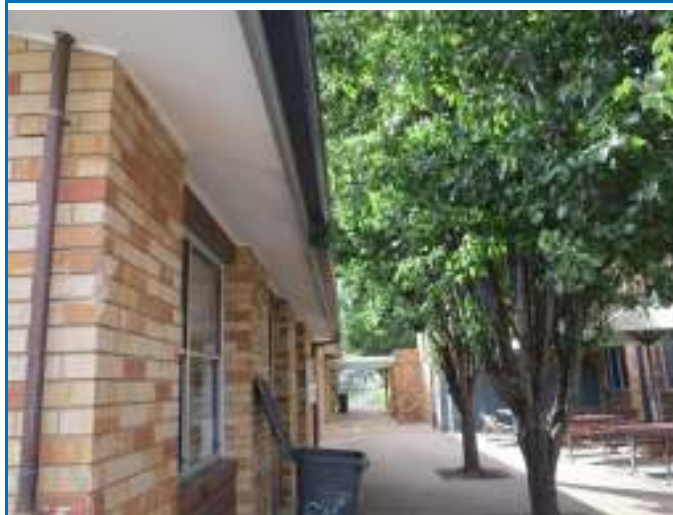
***Photo 9: Block G Eaves Lined With Fibre Cement.  
Deemed Asbestos Present.***

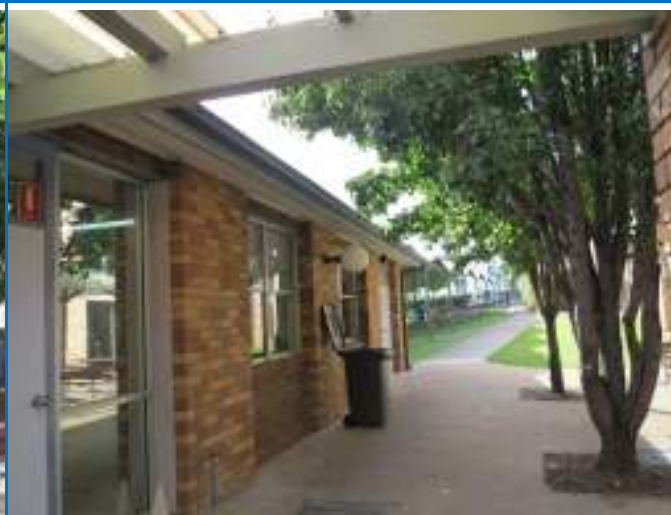
***Photo 10: Block G Eaves Lined With Fibre Cement.  
Deemed Asbestos Present.***

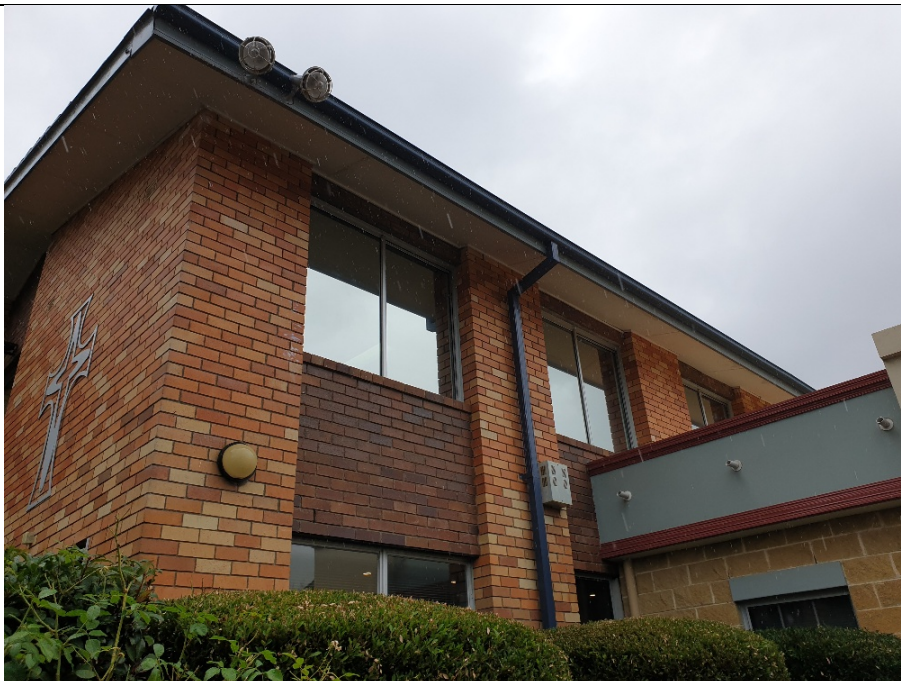
***Photo 1 – Block A, Fibre Cement Eave Linings to Perimeter – Deemed Asbestos Present***

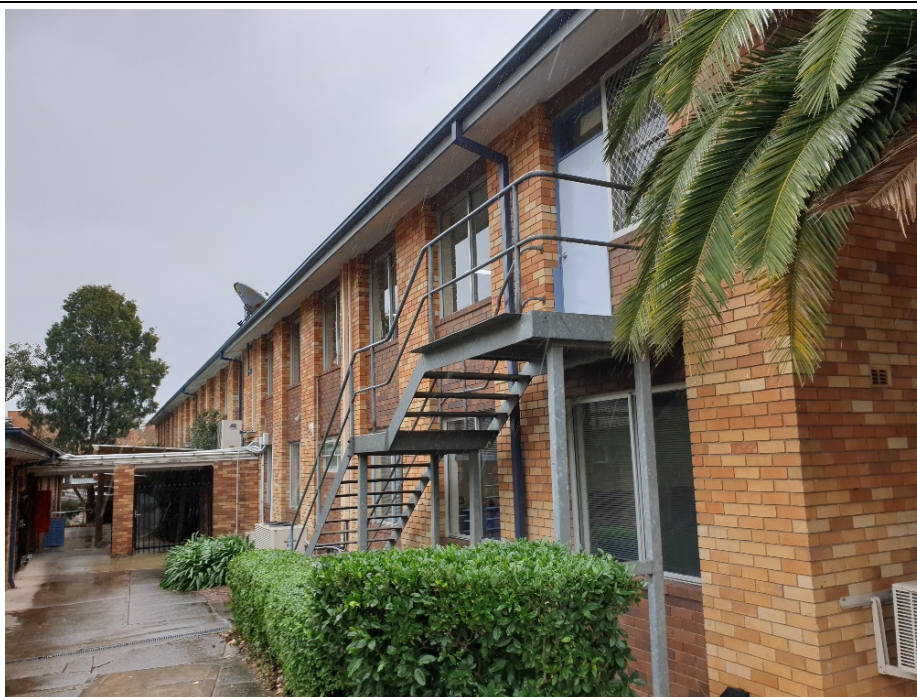
***Photo 2 – Block A, Fibre Cement Eave Linings to Perimeter – Deemed Asbestos Present***

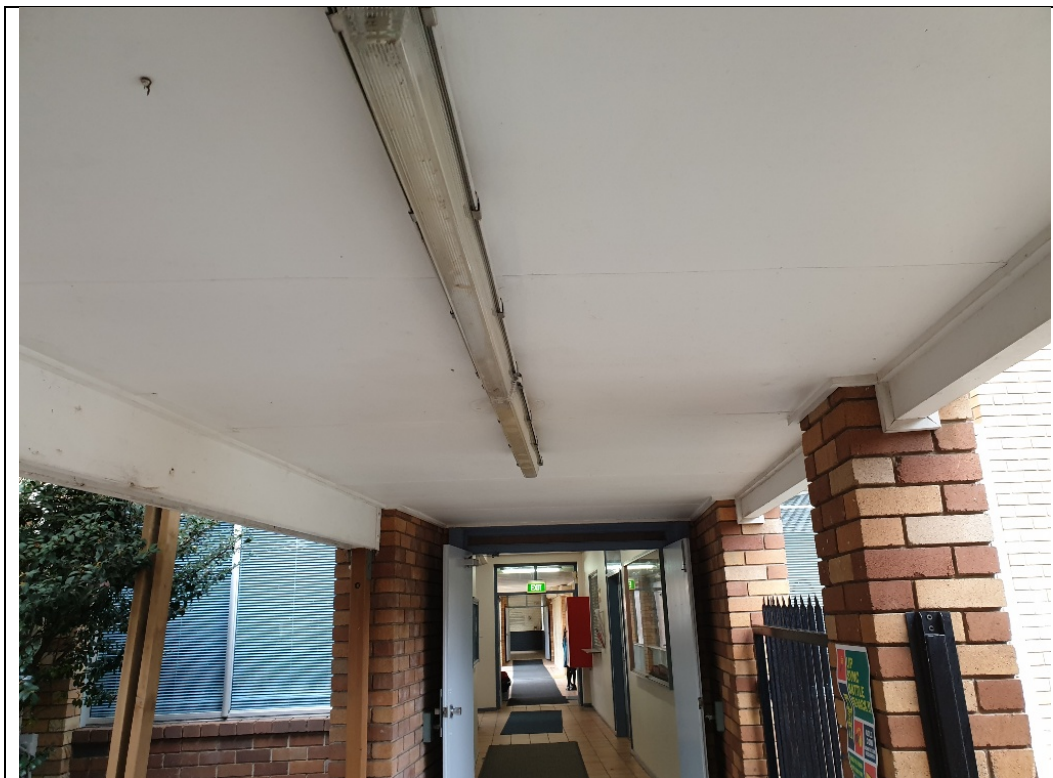
**Photo 3 – Block A, Fibre Cement Lining to Awning (Connecting to Block G) – Deemed Asbestos Present**

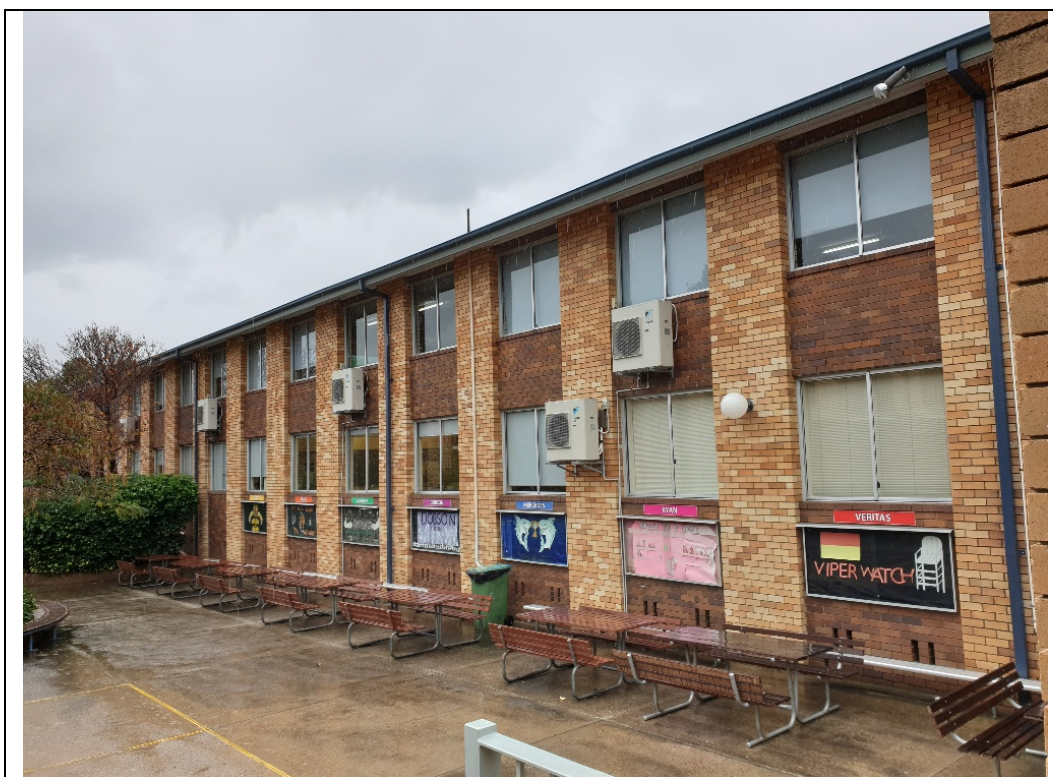
**Photo 4 – Block B, Fibre Cement Eave Linings to Perimeter – Deemed Asbestos Present**

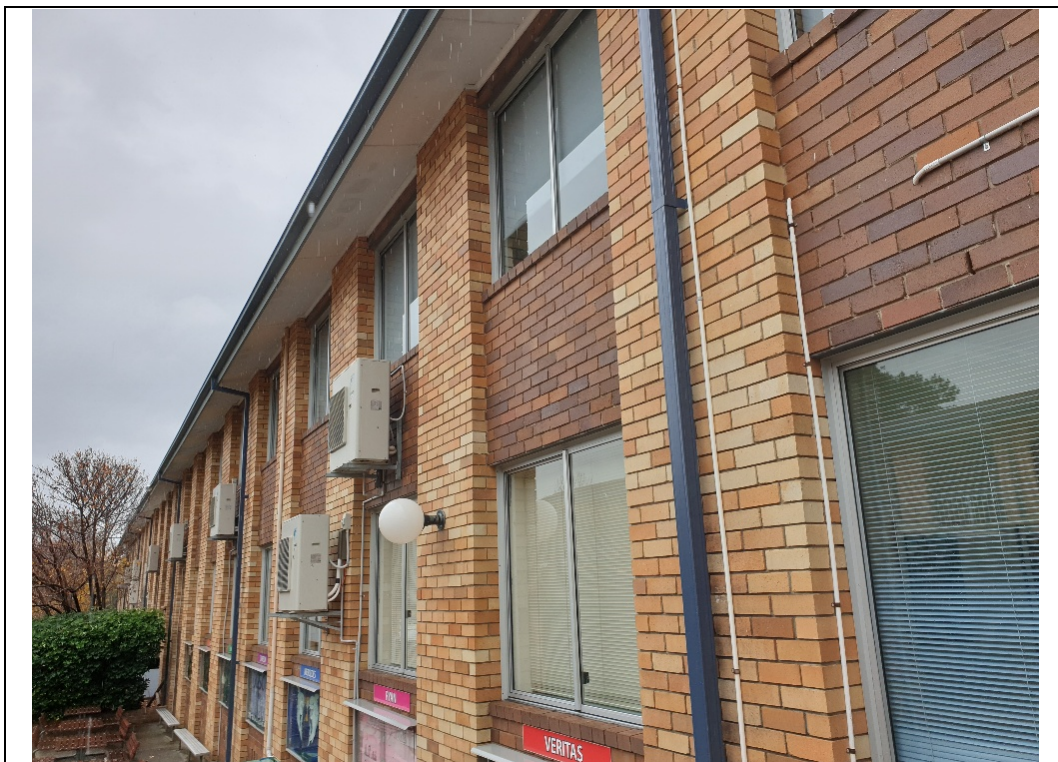
***Photo 5 – Block B, Fibre Cement Eave Linings to Perimeter – Deemed Asbestos Present***

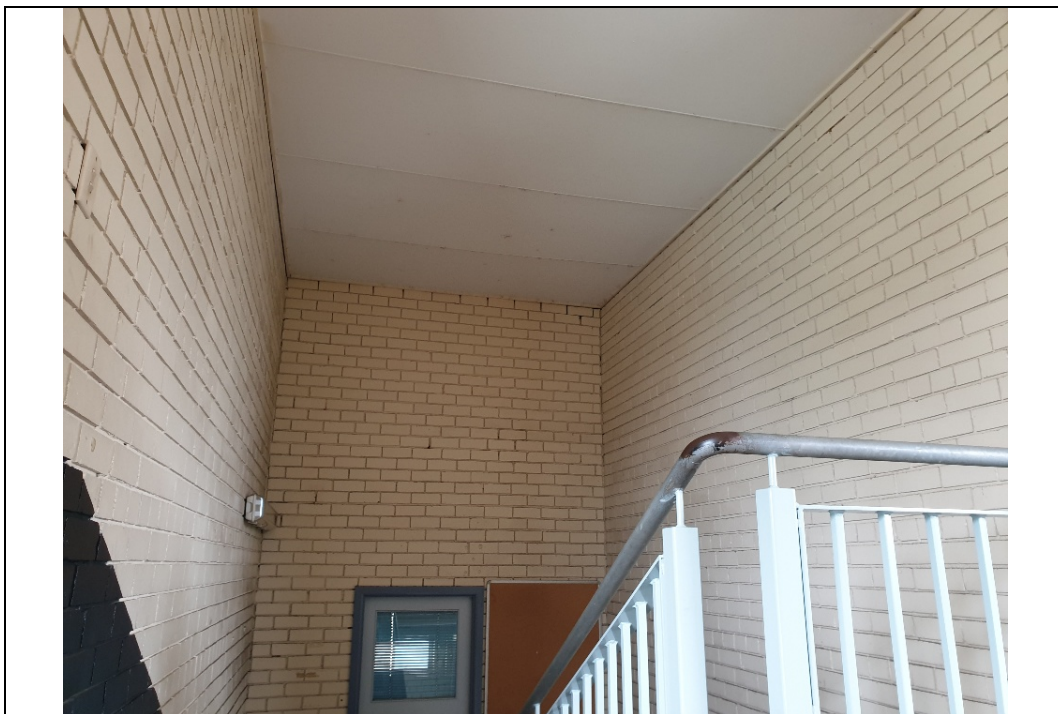
***Photo 6 – Block B, Fibre Cement Lining to Upper Level Walkway Inc. Stair Well – Deemed Asbestos Present***

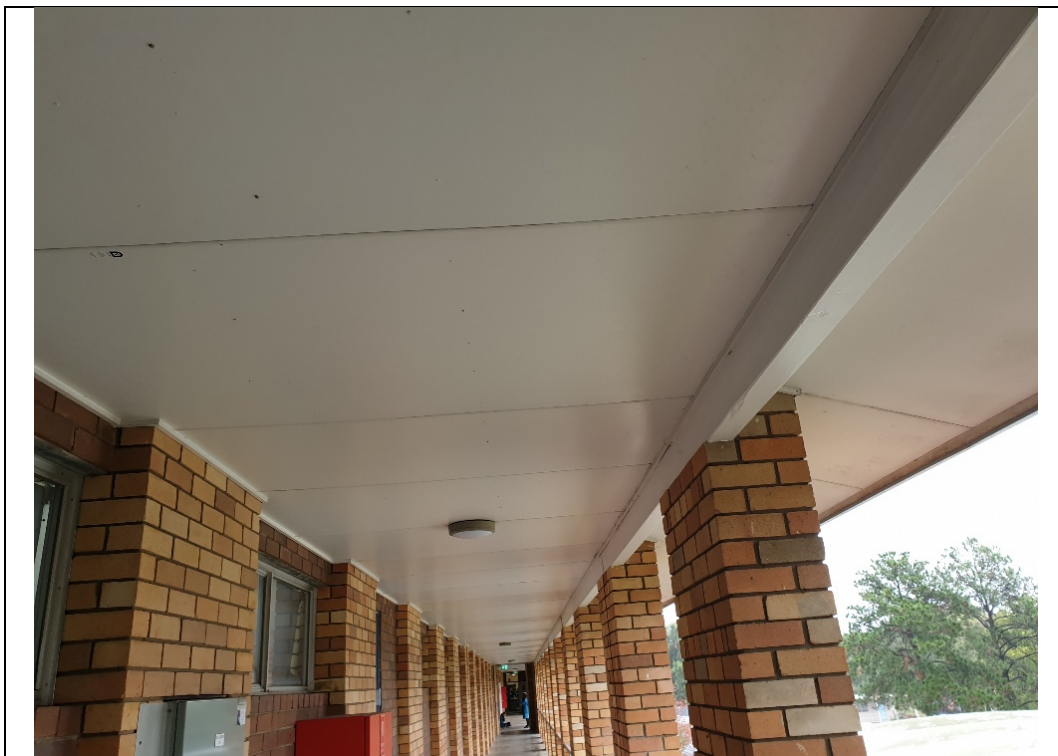
***Photo 7 – Block B, Fibre Cement to Upper Level Walkway Awning & Eave Linings – Deemed Asbestos Present***

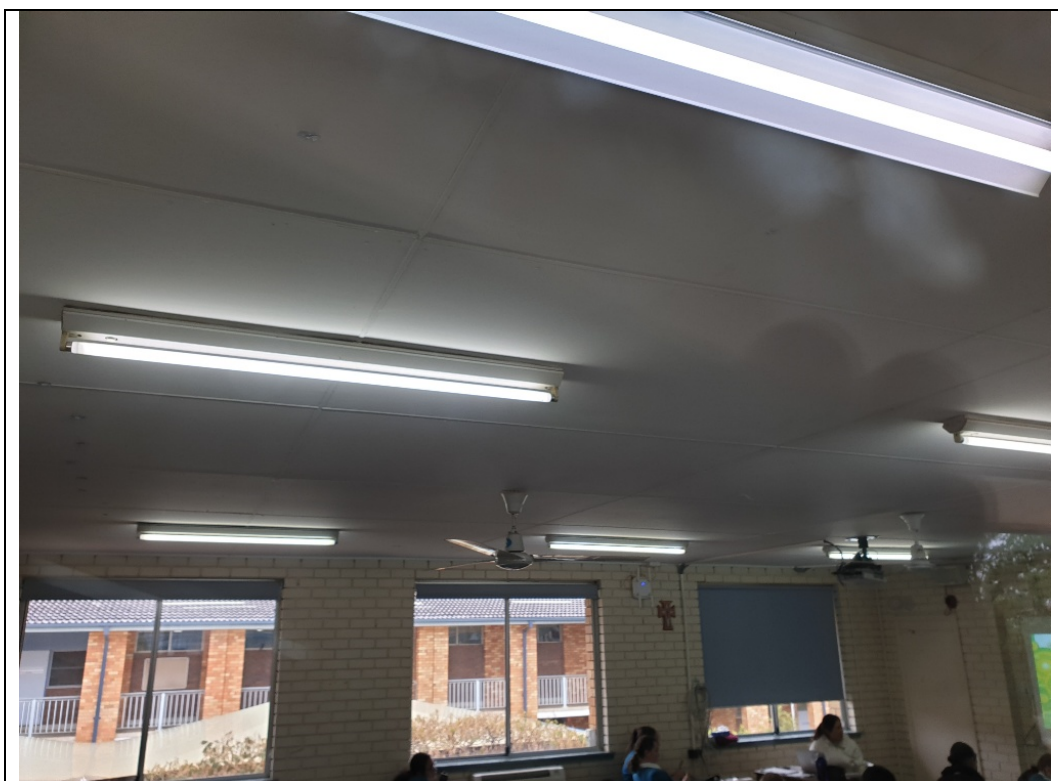
***Photo 8 – Block B, Fibre Cement Linings to Classroom Ceilings – Deemed Asbestos Present***

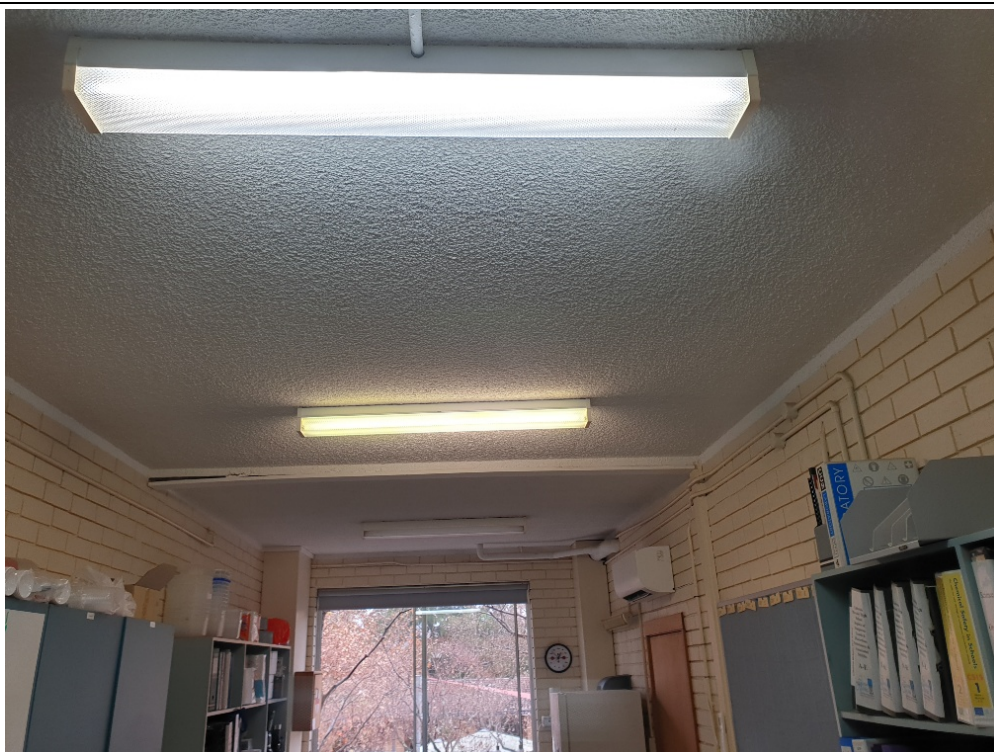
***Photo 9 – Block B, Vermiculite Plaster to Ceilings – Deemed Asbestos Present as a Precaution***

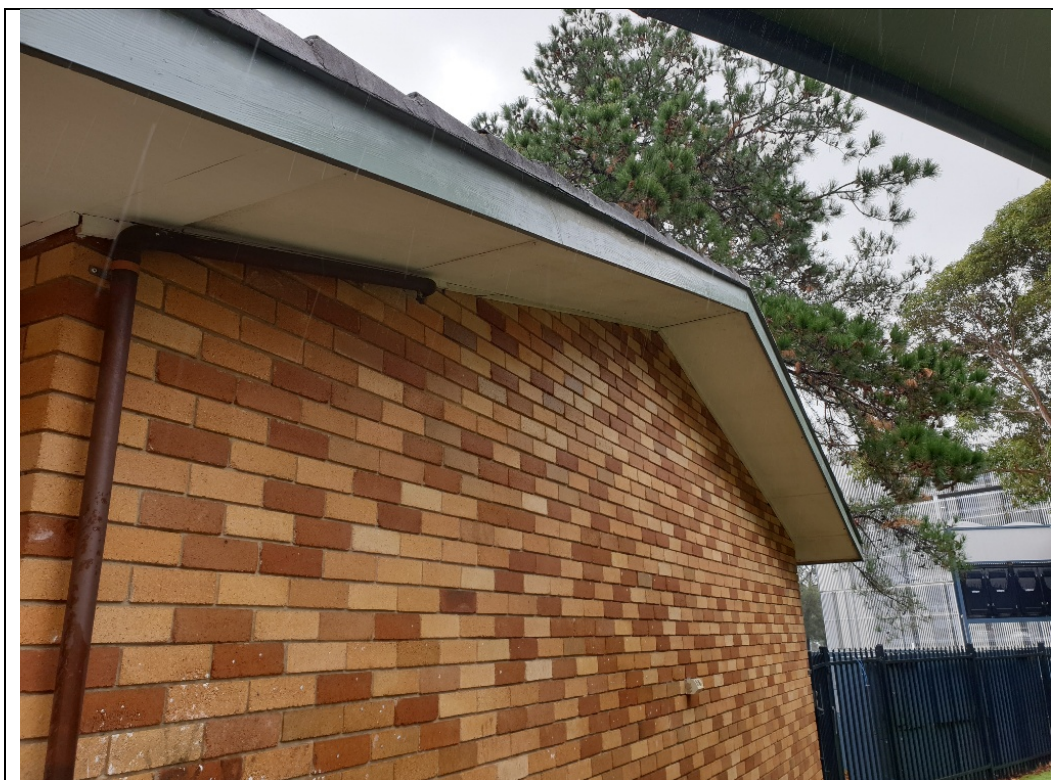
***Photo 11 – Block C, Fibre Cement Eave Linings to Perimeter – Deemed Asbestos Present***

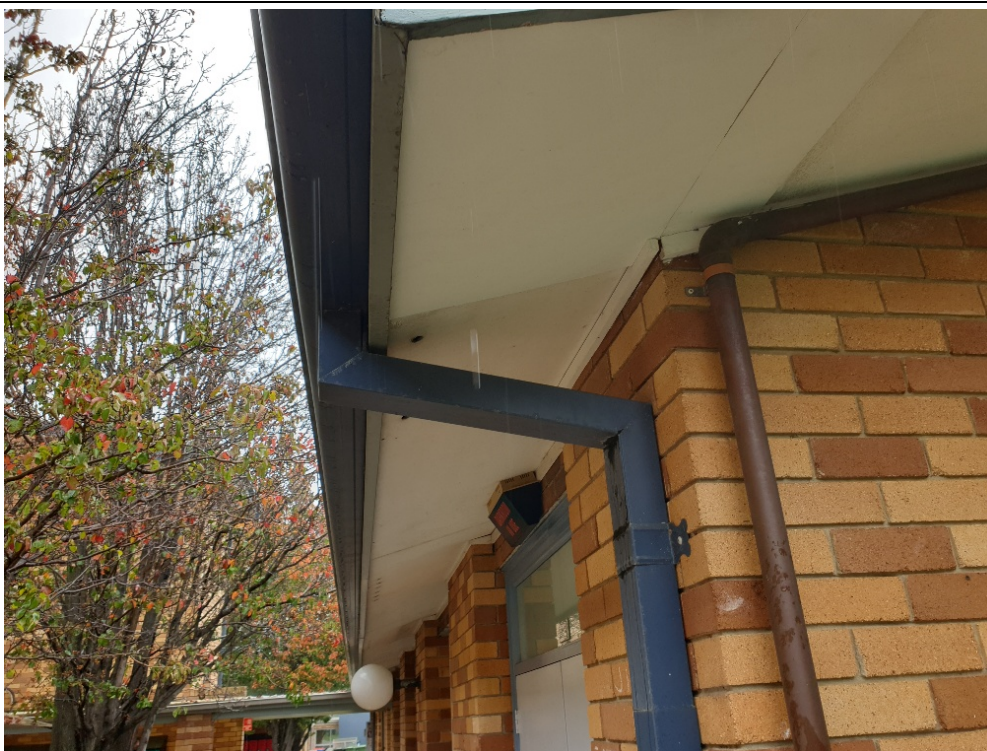
***Photo 12 – Block C, Fibre Cement Eave Linings to Perimeter – Deemed Asbestos Present***

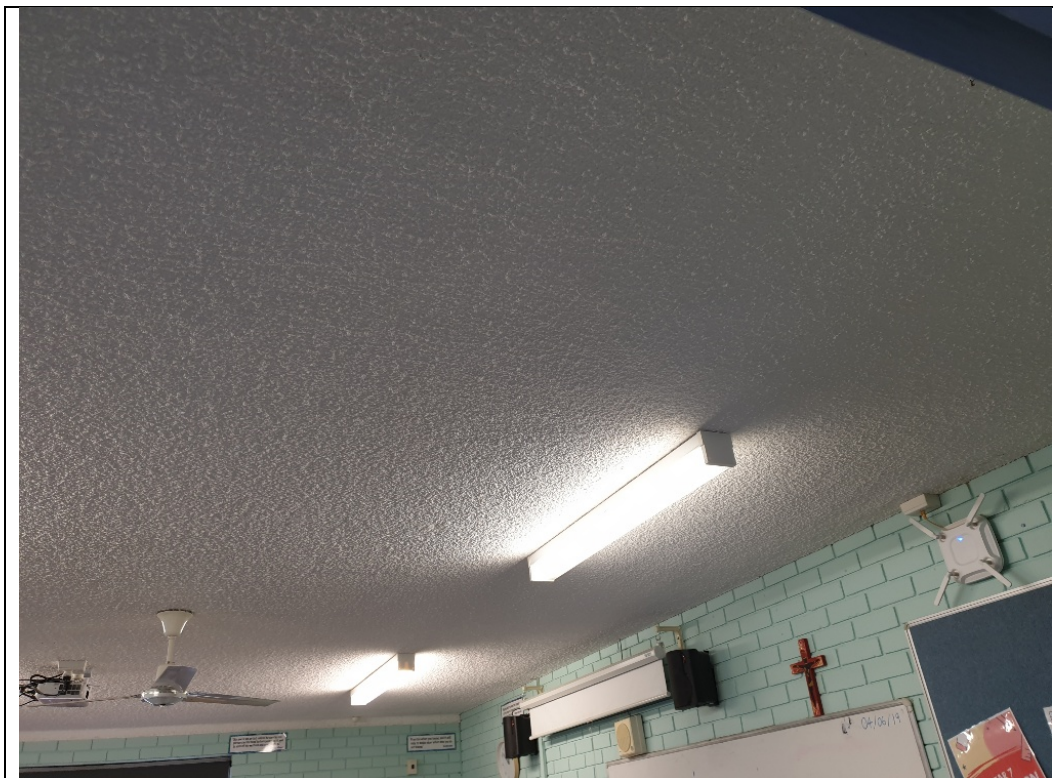
***Photo 13 – Block C, Vermiculite Plaster to Ceilings – Deemed Asbestos Present as a Precaution***

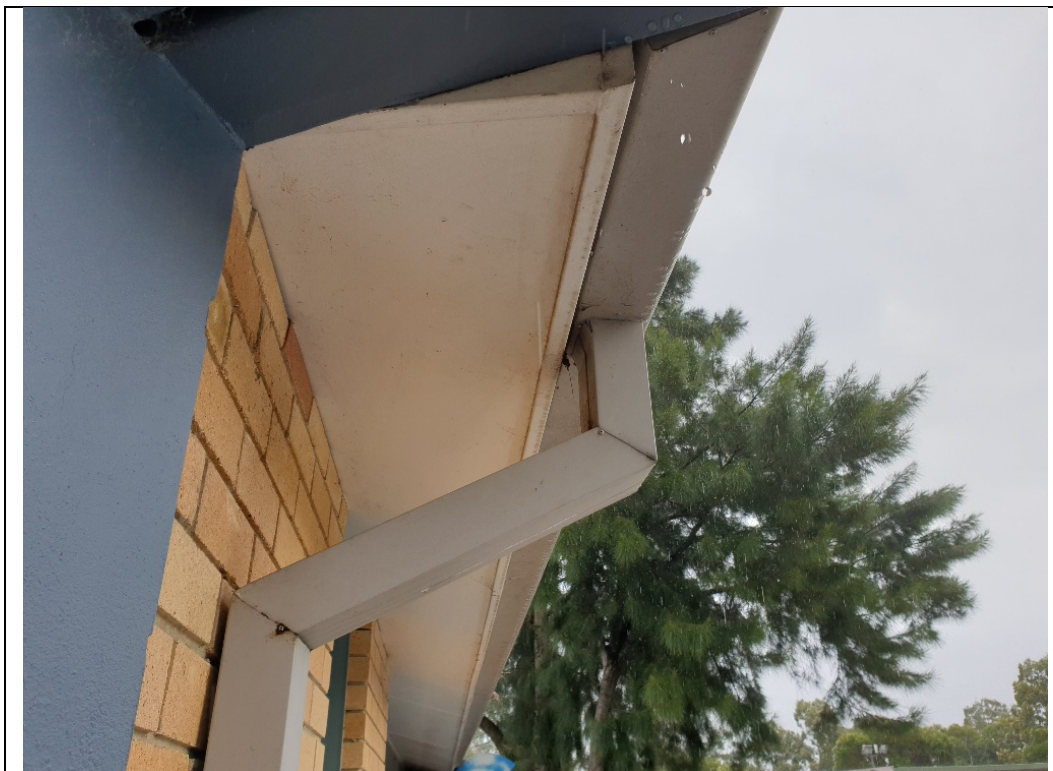
***Photo 15 – Block D, Fibre Cement Eave Linings to Perimeter – Deemed Asbestos Present***

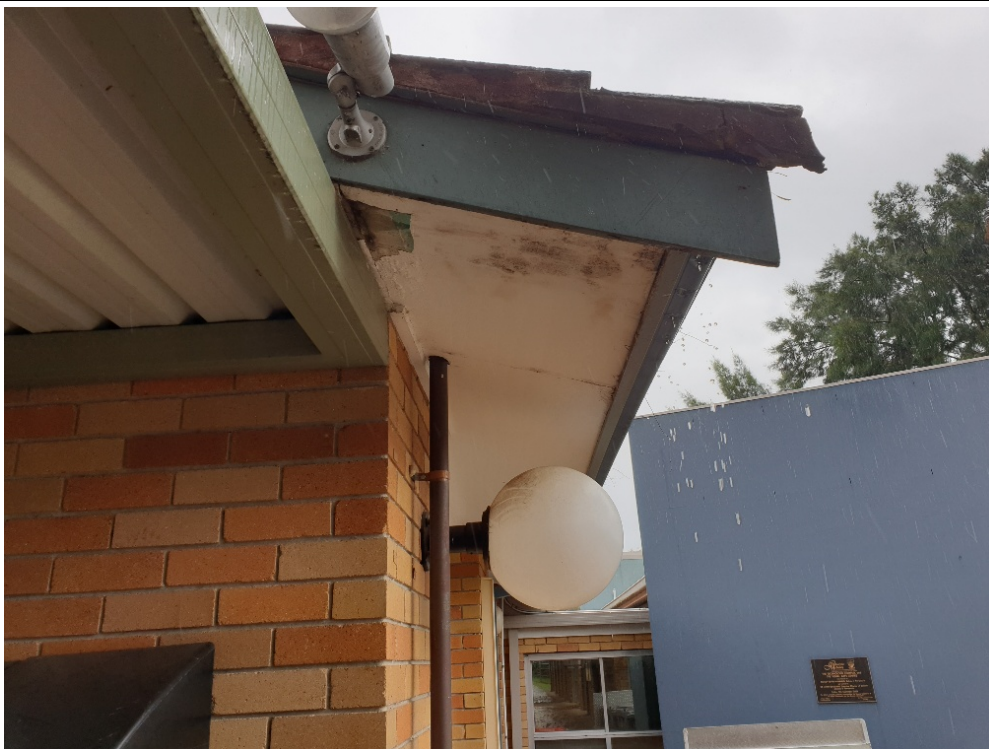
***Photo 17 – Block E, Fibre Cement Eave Linings to Perimeter – Deemed Asbestos Present***

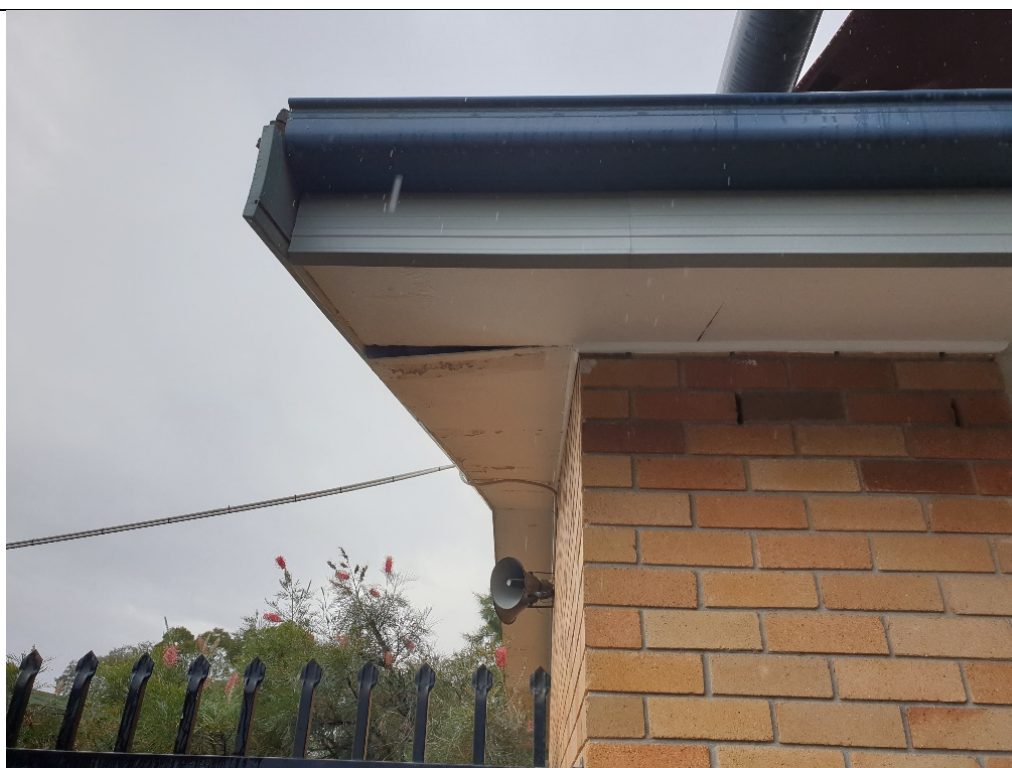
***Photo 18 – Block E, Fibre Cement Eave Linings to Perimeter – Deemed Asbestos Present***

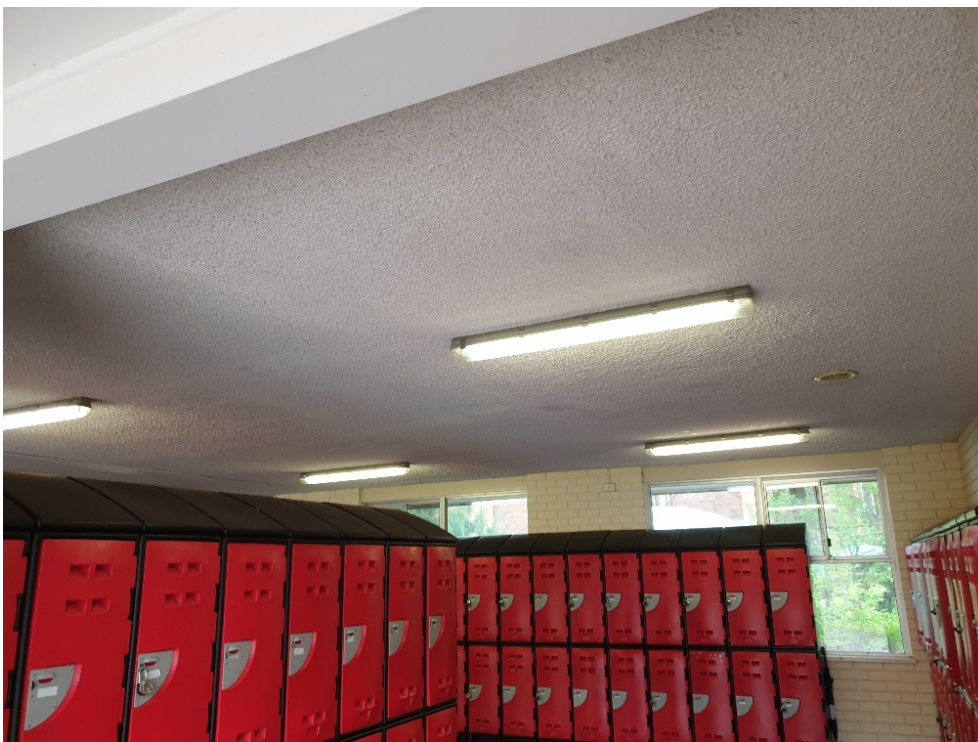
***Photo 20 – Block F, Vermiculite Plaster to Ceilings – Deemed Asbestos Present as a Precaution***

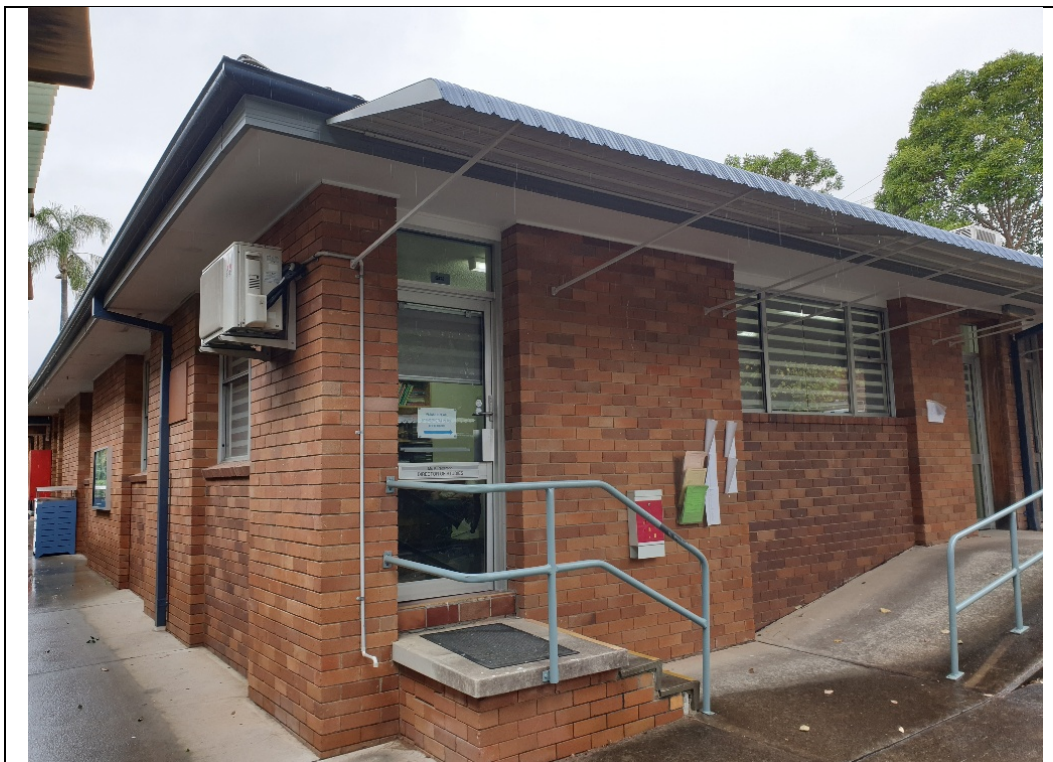
***Photo 21 – Block G, Fibre Cement Eave Linings to Perimeter – Deemed Asbestos Present***

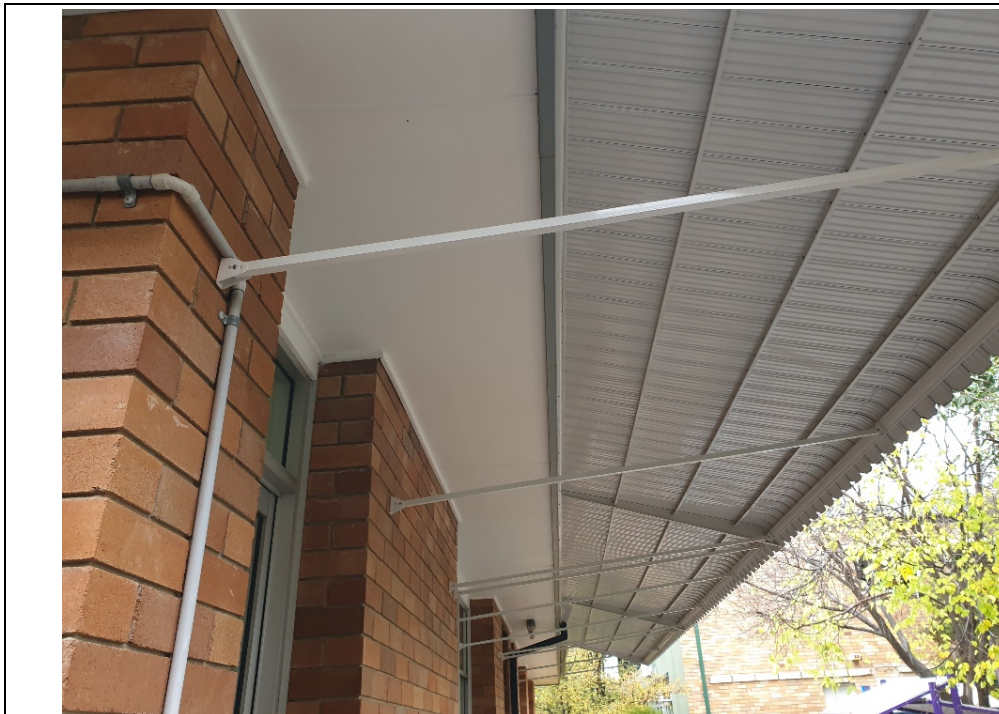
***Photo 22 – Block G, Fibre Cement Eave Linings to Perimeter – Deemed Asbestos Present***

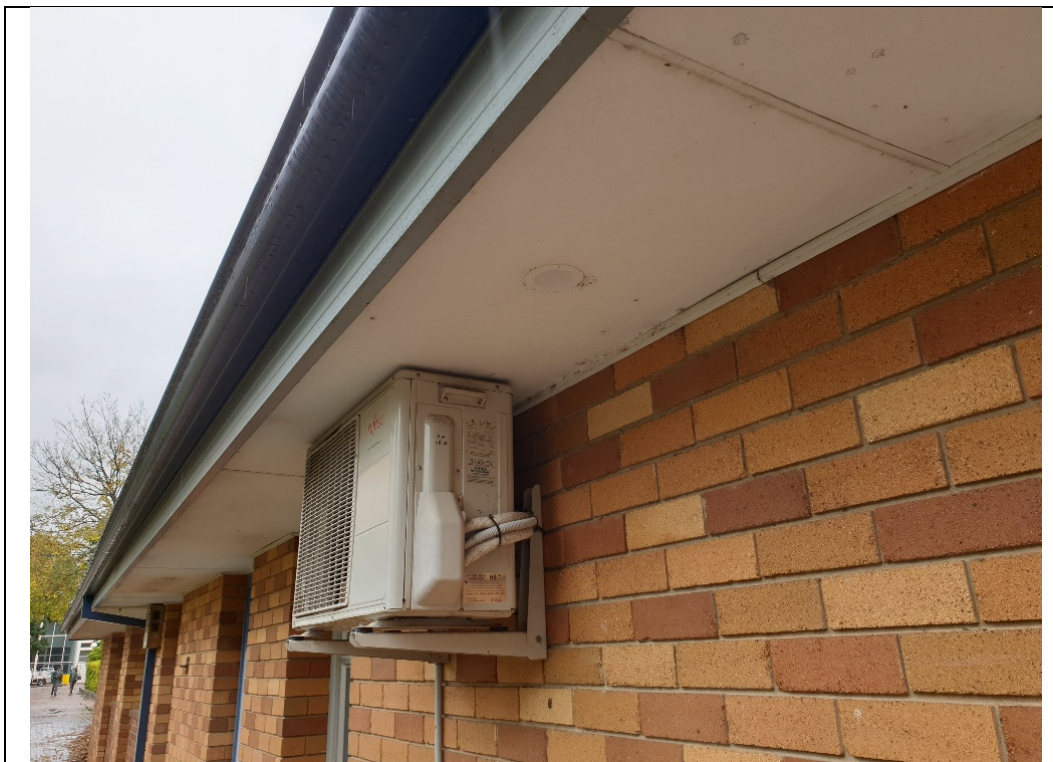
***Photo 23 – Block G, Fibre Cement Eave Linings to Perimeter – Deemed Asbestos Present***

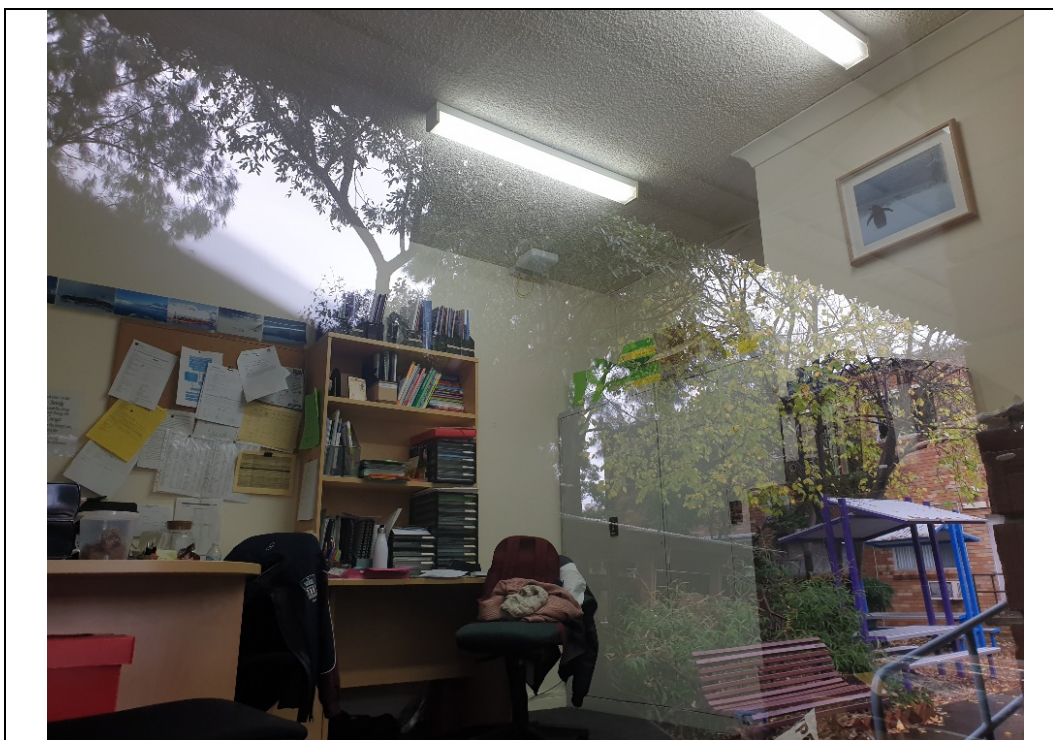
***Photo 24 – Block G, Vermiculite Plaster to Ceilings – Deemed Asbestos Present as a Precaution***

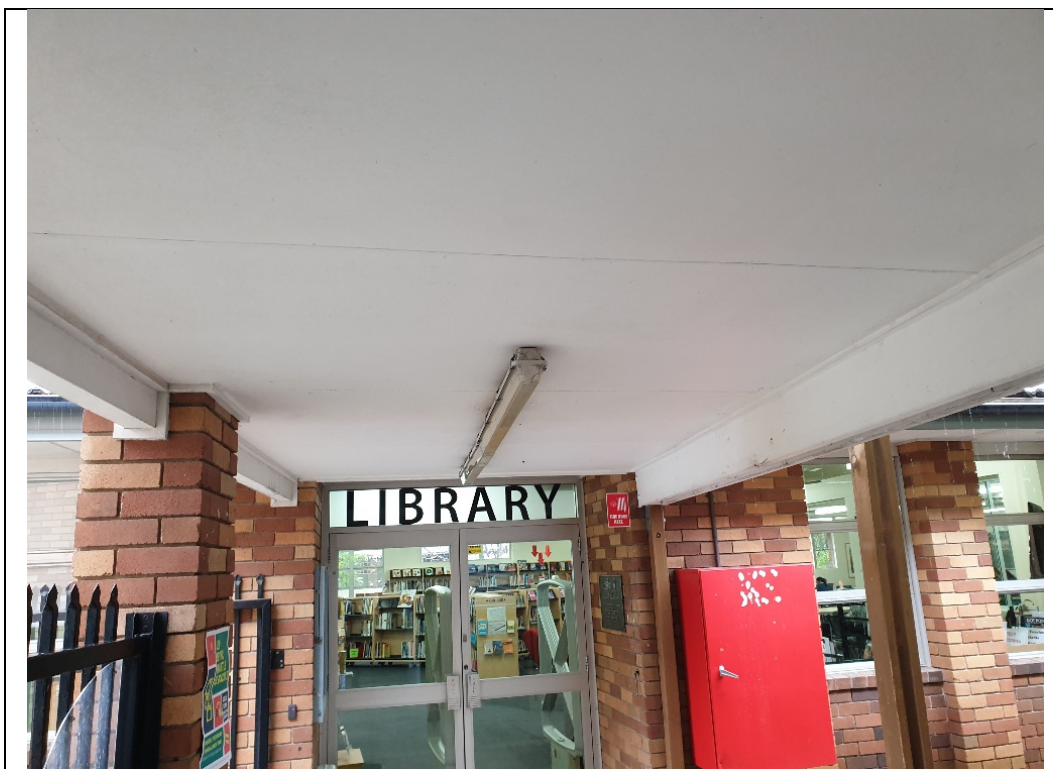
***Photo 25 – Block G, Fibre Cement Lining to Awning (Connecting to Block A) – Deemed Asbestos Present***

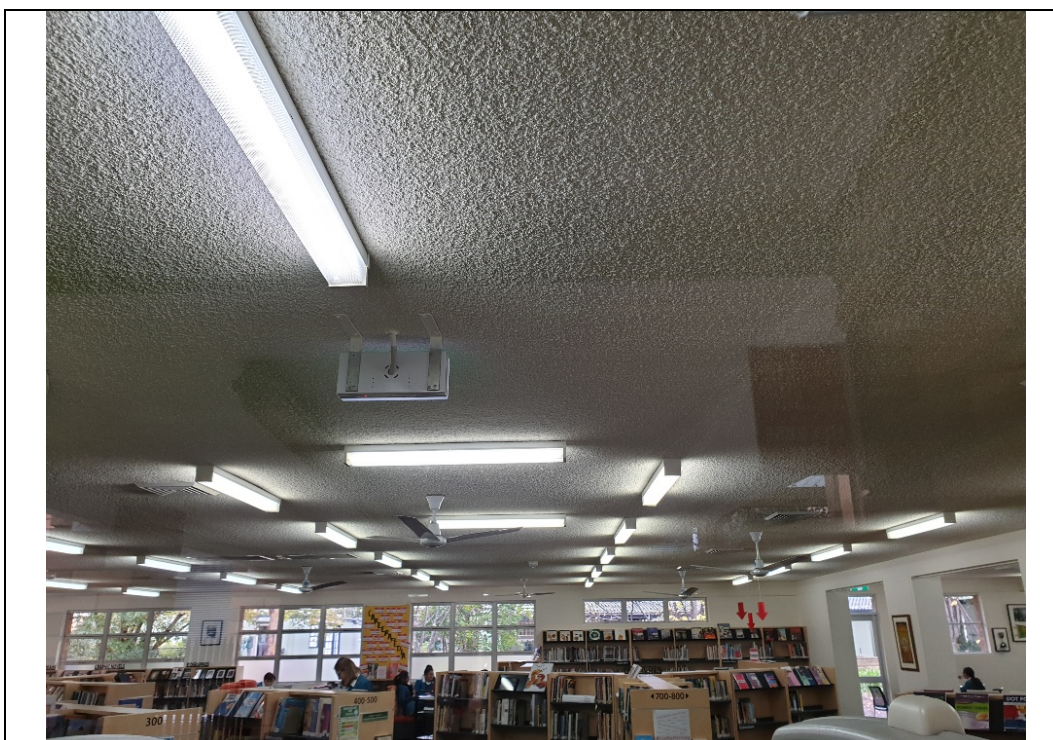
***Photo 26 – Block G (Library), Vermiculite Plaster to Library Ceiling – Deemed Asbestos Present as a Precaution***

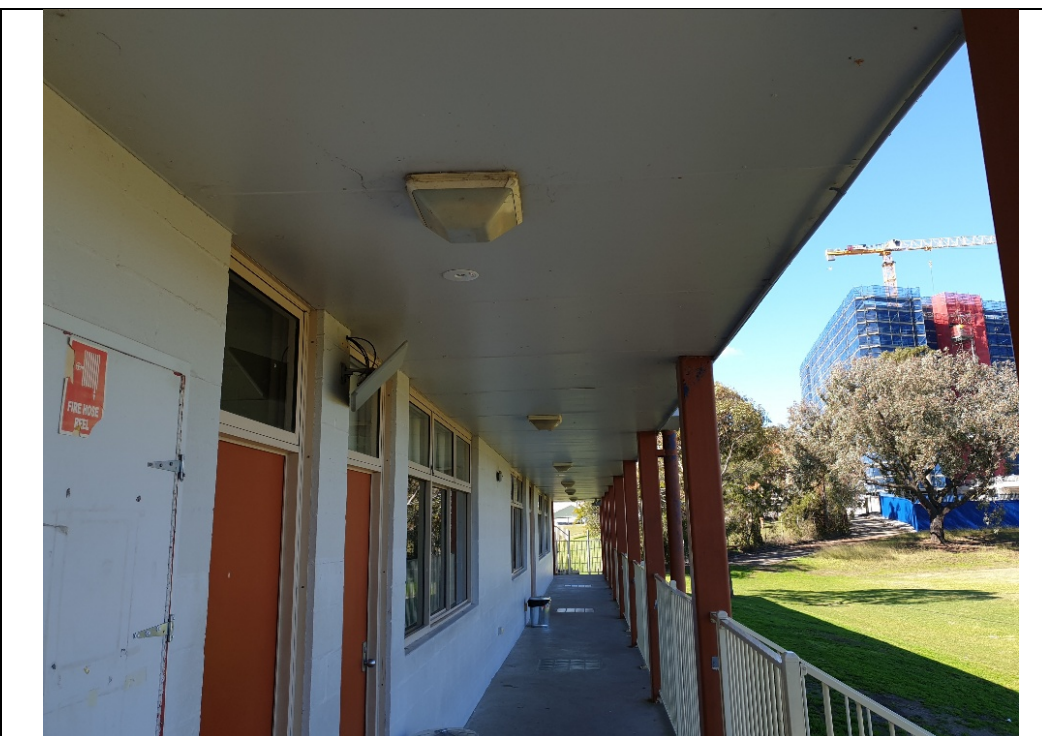
***Photo 2 – Block K, Fibre Cement Walkway Awning Lining (to Rear) –  
Deemed Asbestos Present***

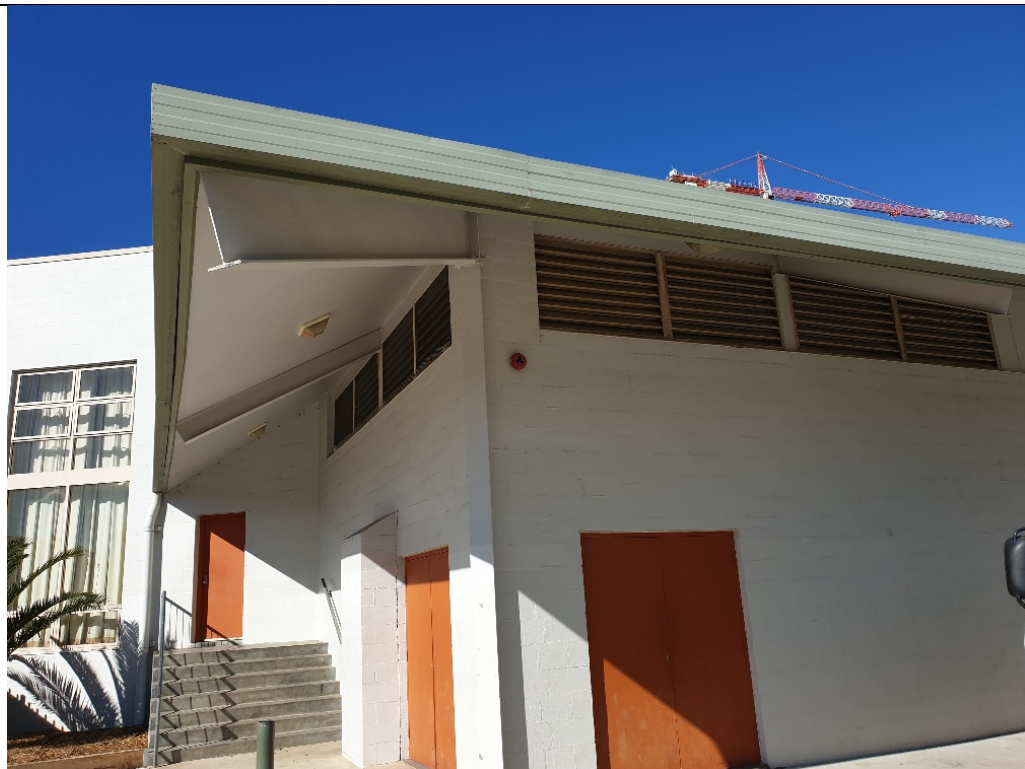
***Photo 3 – Block K, Fibre Cement Walkway Awning Lining (to Front) –  
Deemed Asbestos Present***

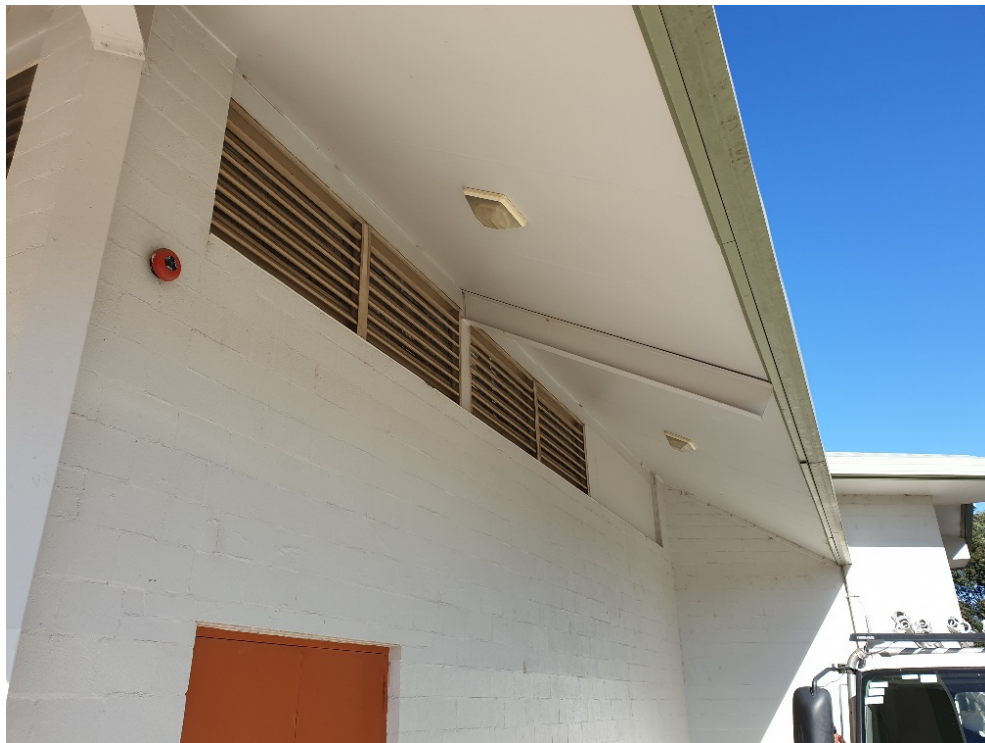
***Photo 4 – Block K, Fibre Cement Walkway Awning Lining (to Front) –  
Deemed Asbestos Present***

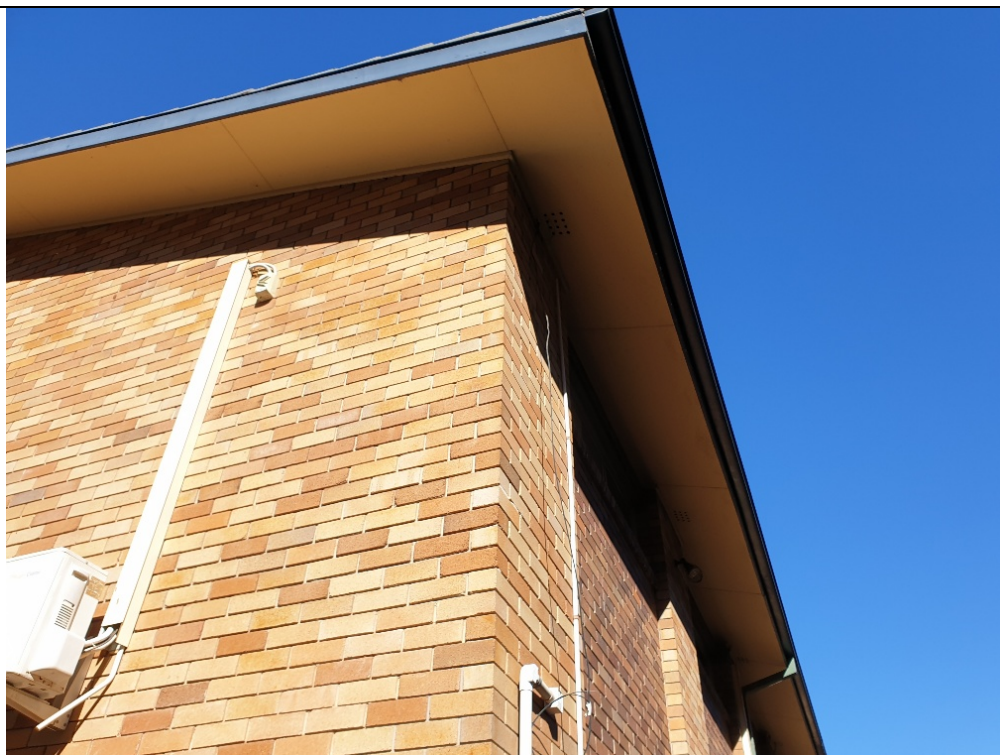
***Photo 6 – Block H, Fibre Cement Eave Linings to Perimeter – Deemed Asbestos Present***
