# **HAZARDOUS MATERIALS REINSPECTION REPORT, CATHERINE MCAULEY HIGH SCHOOL WESTMEAD.**

**20<sup>th</sup> March 2016**

Prepared for:  
**Catholic Education Diocese of Parramatta,  
Locked Bag 4,  
North Parramatta. NSW. 1750.**

Prepared by:  
**Banksia EOHS Pty Limited.**

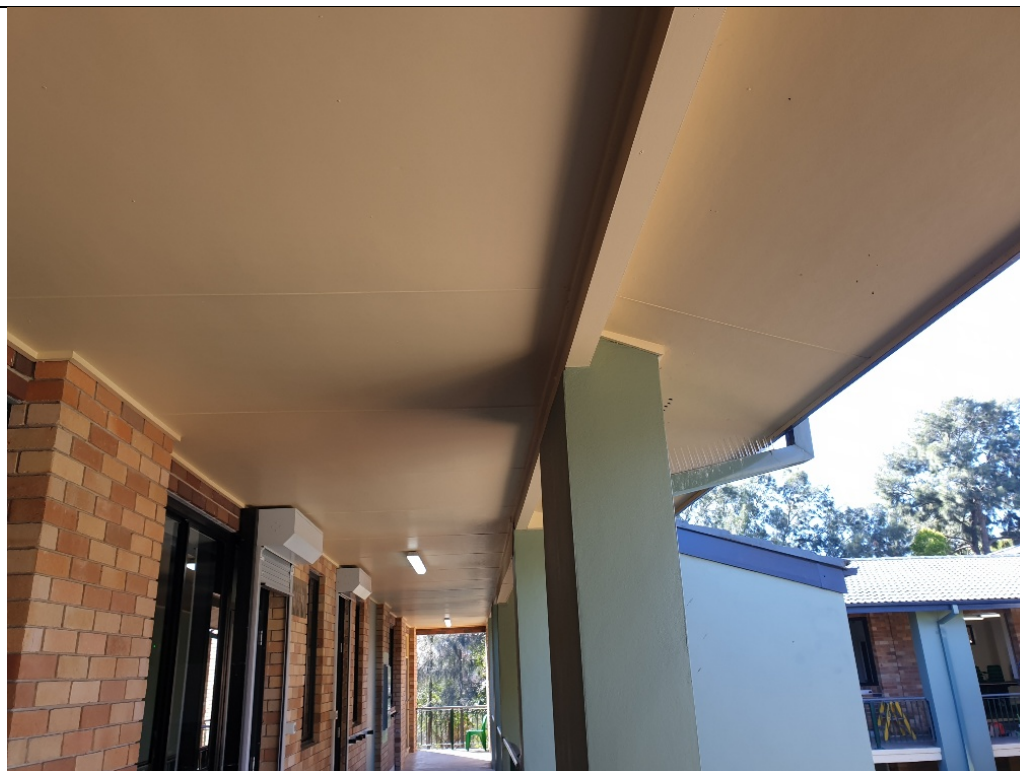
***Photo 7 – Block H, Fibre Cement Lining to Upper Level Walkway Ceiling & Eaves – Deemed Asbestos Present***

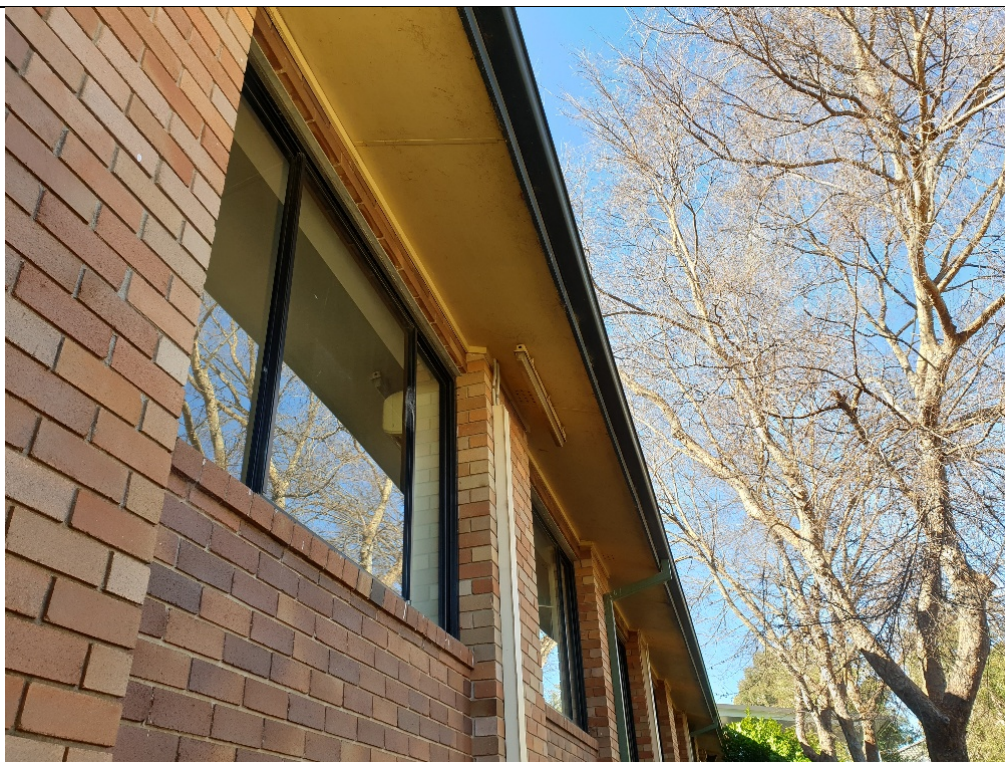
***Photo 9 – Block G, Fibre Cement Eave Linings to Perimeter – Deemed Asbestos Present***

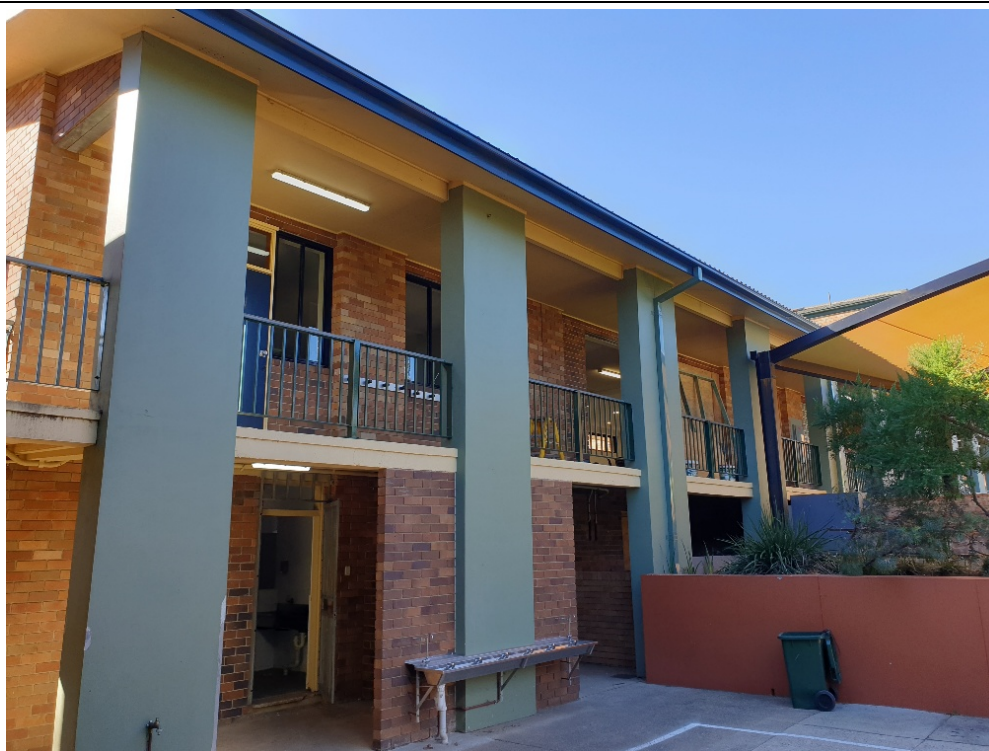
***Photo 10 – Block J, Fibre Cement Upper Level Walkway Ceiling – Deemed Asbestos Present***

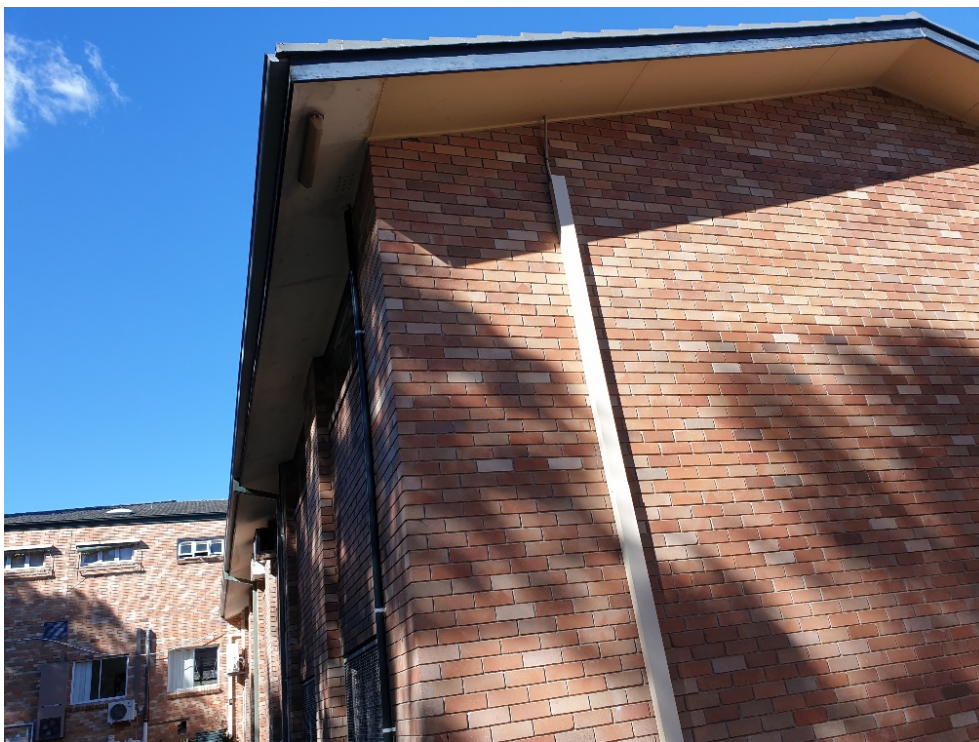
***Photo 11 – Block J, Fibre Cement Eave Linings to Perimeter – Deemed Asbestos Present***

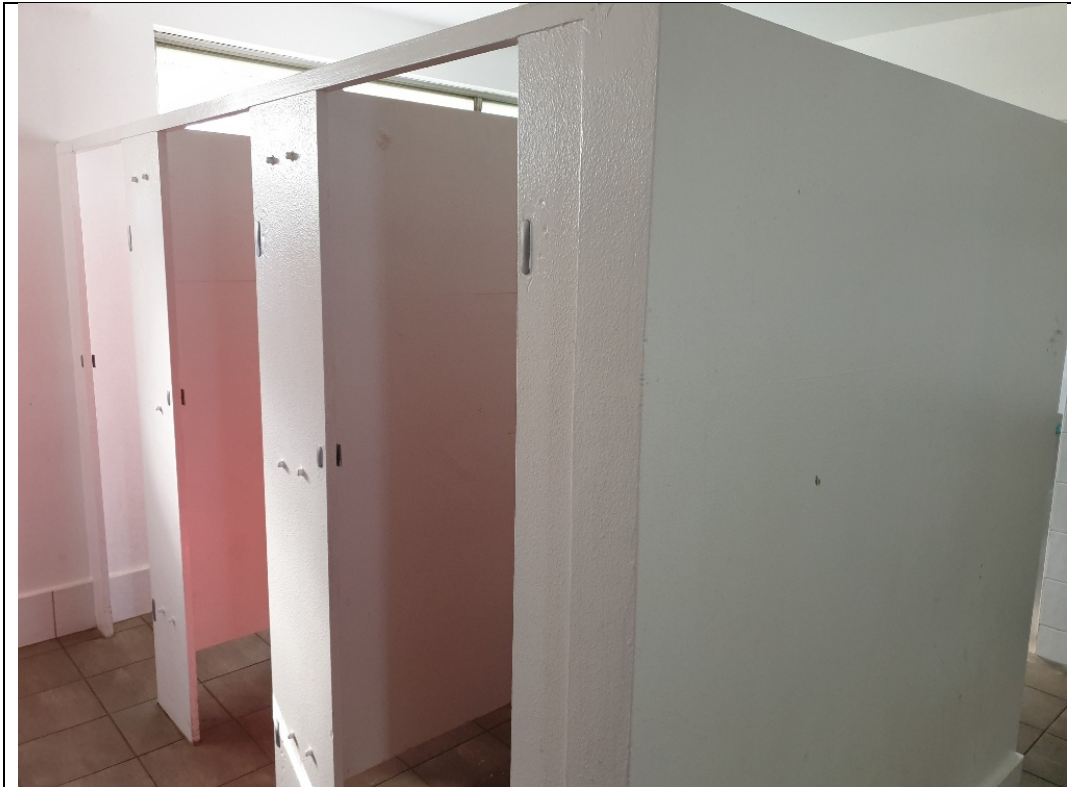
***Photo 13 – Block J, Student Toilet Facilities, Thick Compressed Fibre Cement Partitions – Deemed Asbestos Present***

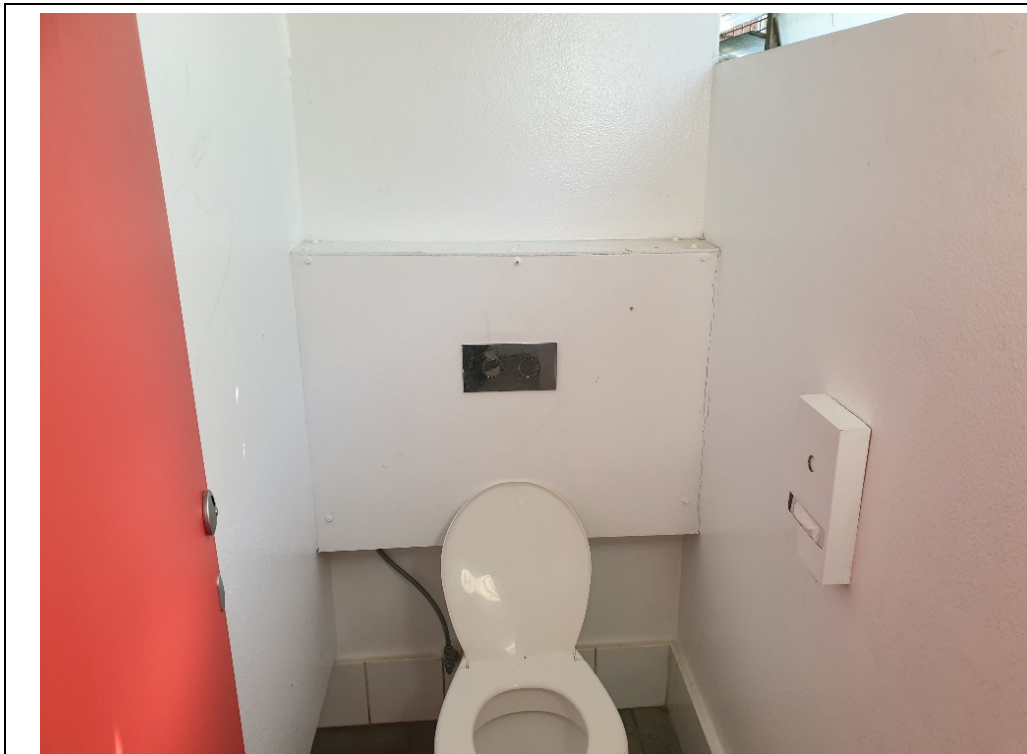
***Photo 14 – Block J, Student Toilet Facilities, Fibre Cement Cistern Enclosure – Deemed No Asbestos Present***

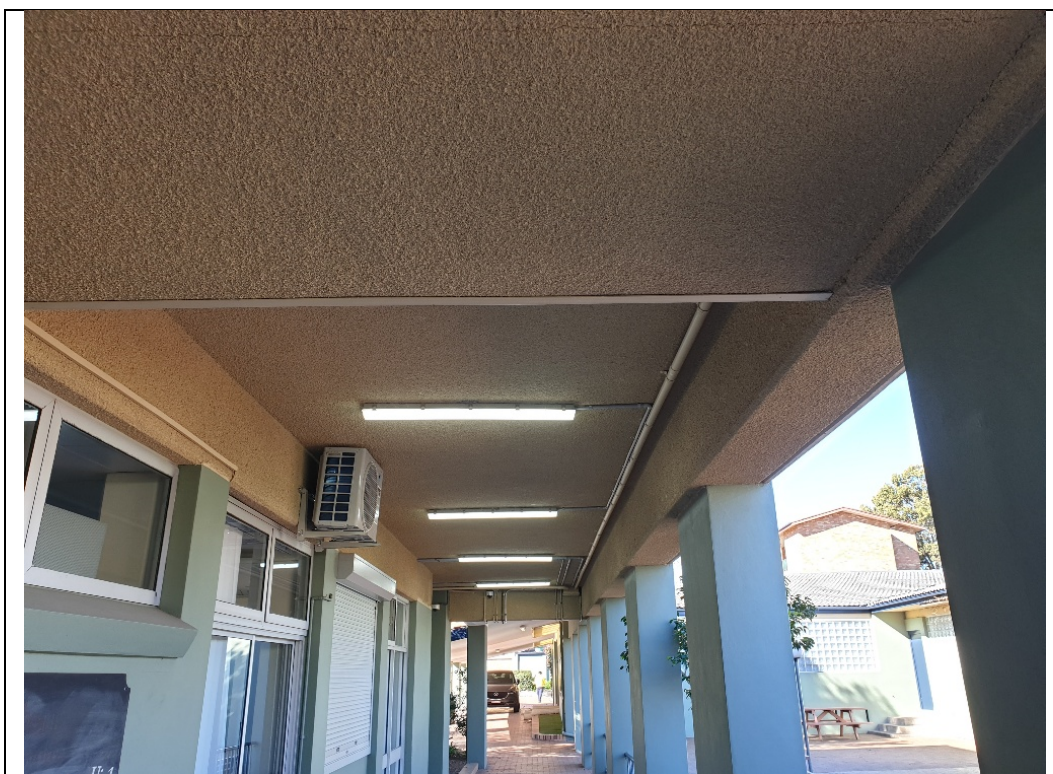
***Photo 16 – Block I, Vermiculite Plaster to Lower Level Walkway Ceiling – Deemed Asbestos Present as a Precaution***

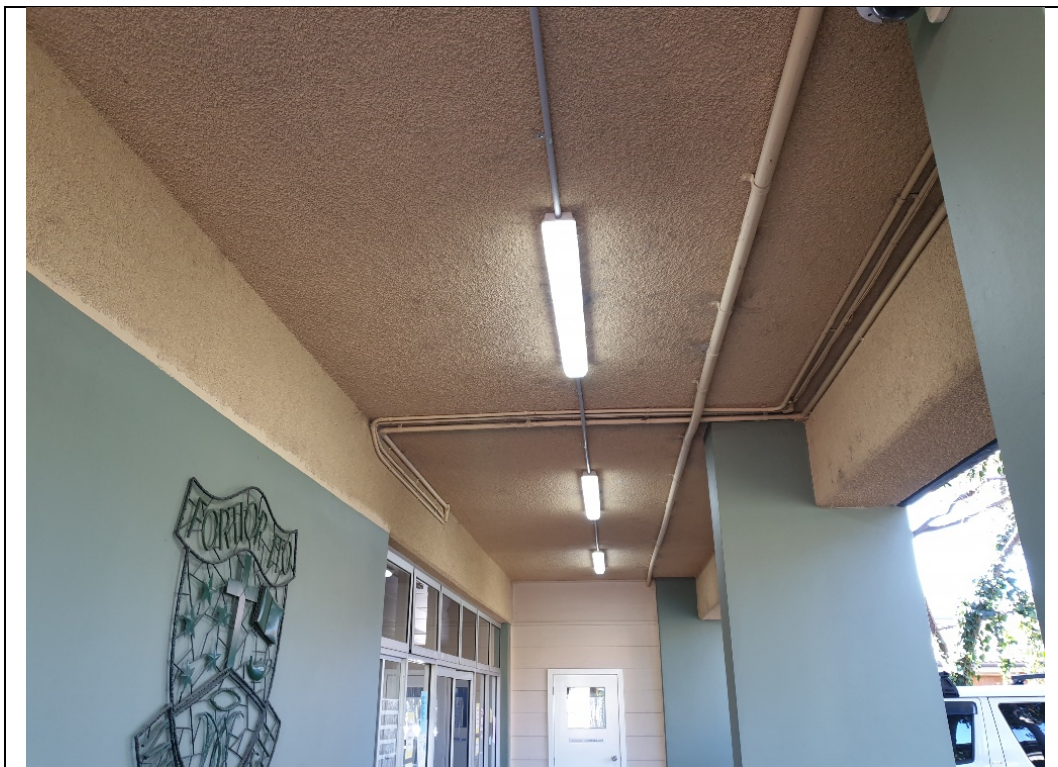
**Photo 17 – Block I, Vermiculite Plaster to Lower Level Walkway Ceiling – Deemed Asbestos Present as a Precaution**

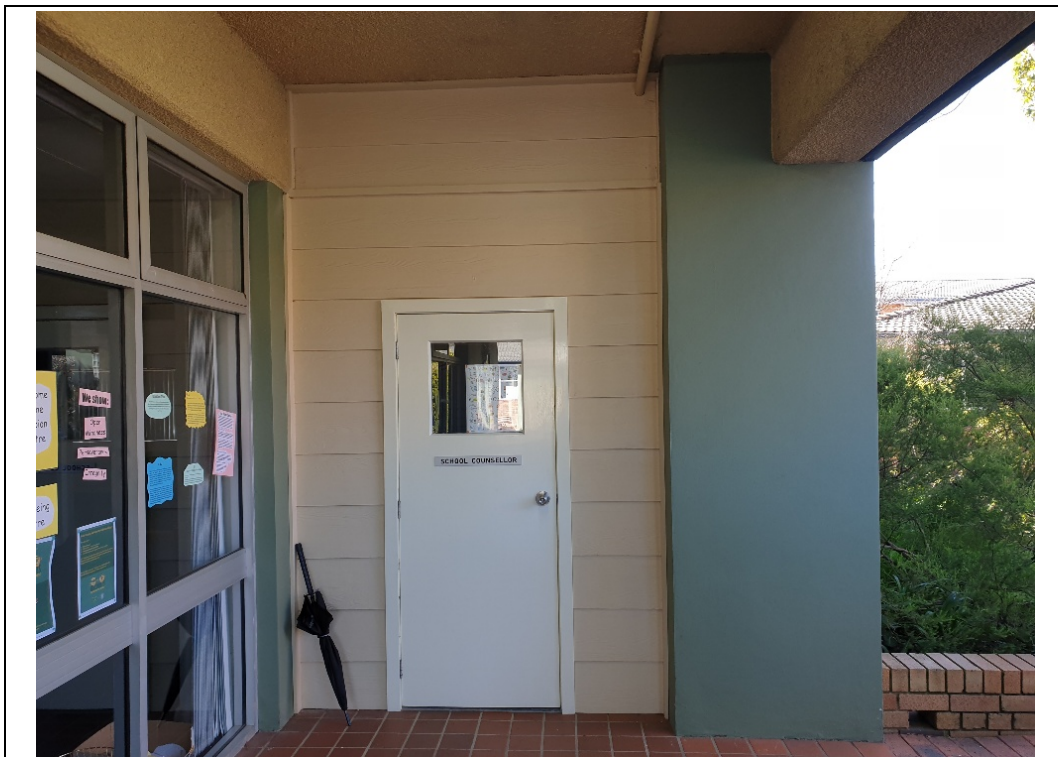
**Photo 18 – Block I, Fibre Cement Weather Boards to “School Counsellor” Doorway/Entrance – Deemed Asbestos Present**

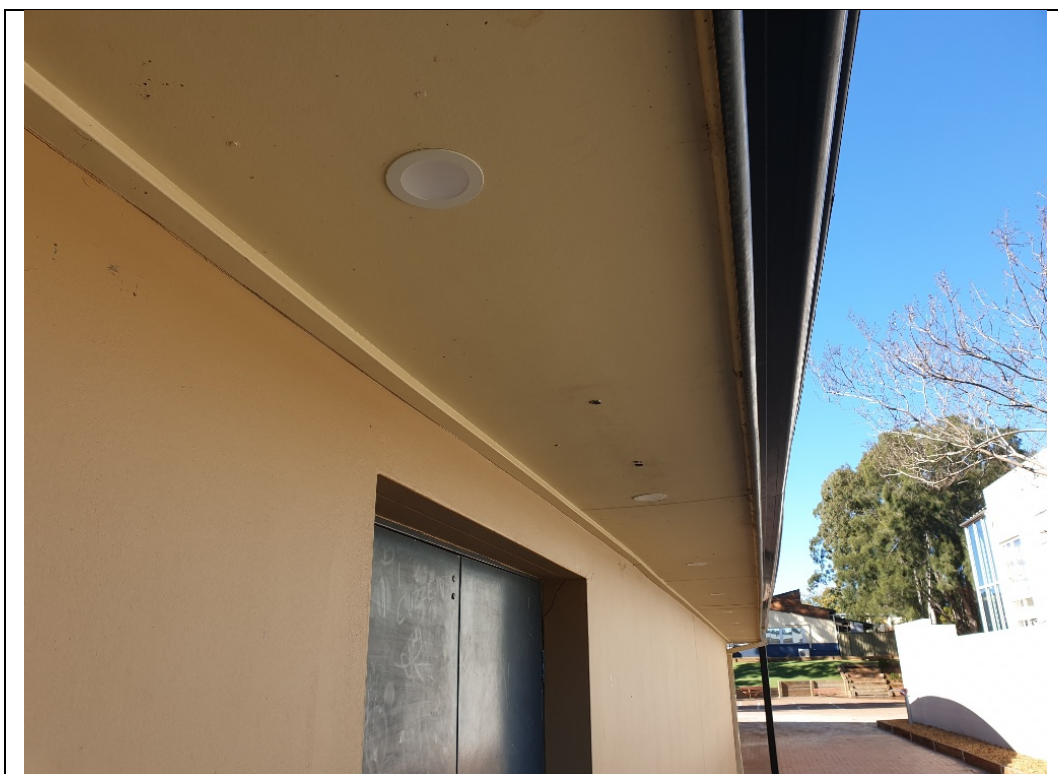
***Photo 20 – Block F, Fibre Cement Eave Linings to Perimeter – Deemed Asbestos Present***

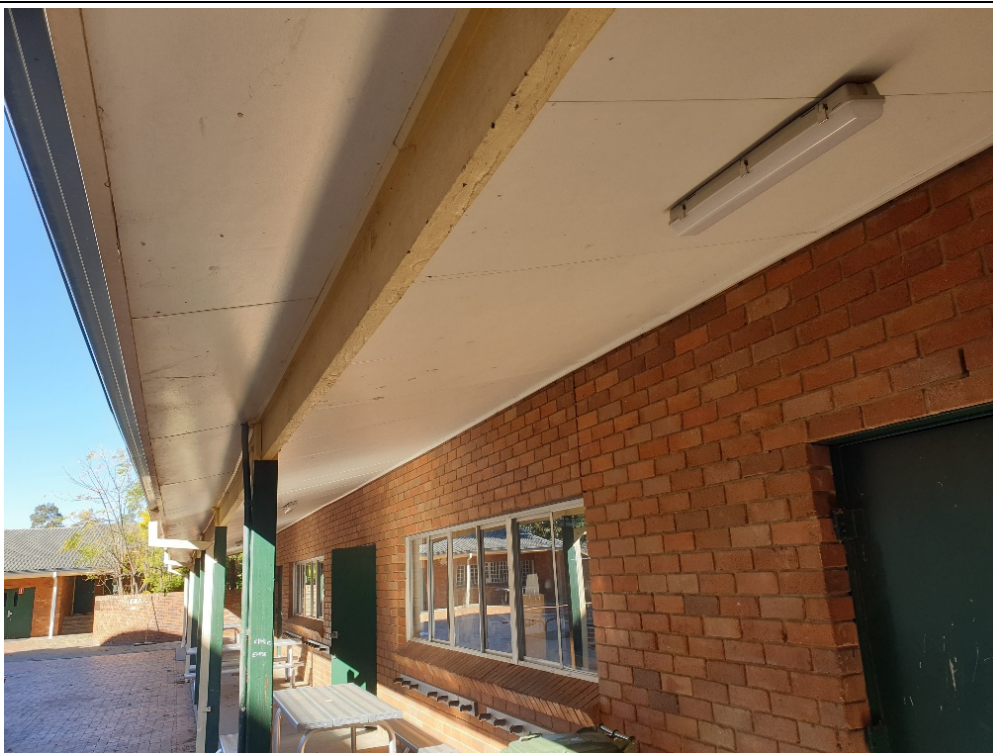
***Photo 22 – Block E, Fibre Cement Awning Lining & Eave Linings to Perimeter – Deemed Asbestos Present***

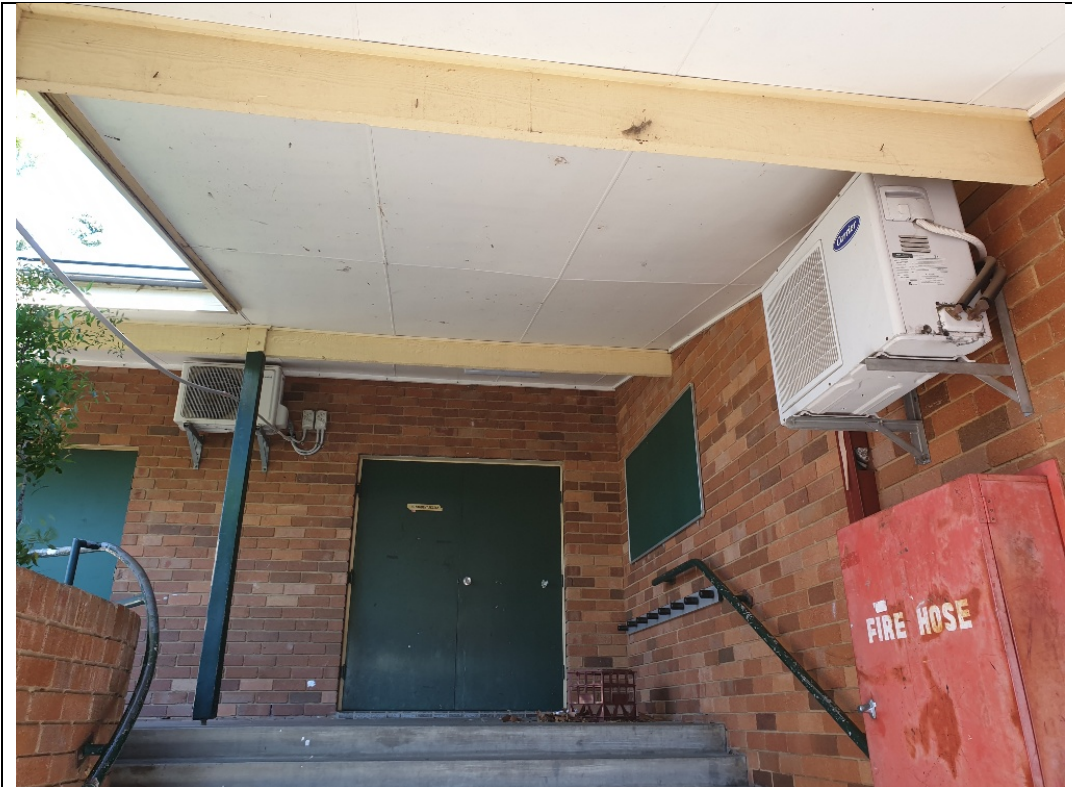
***Photo 23 – Block E, Fibre Cement Awning Linings – Deemed Asbestos Present***

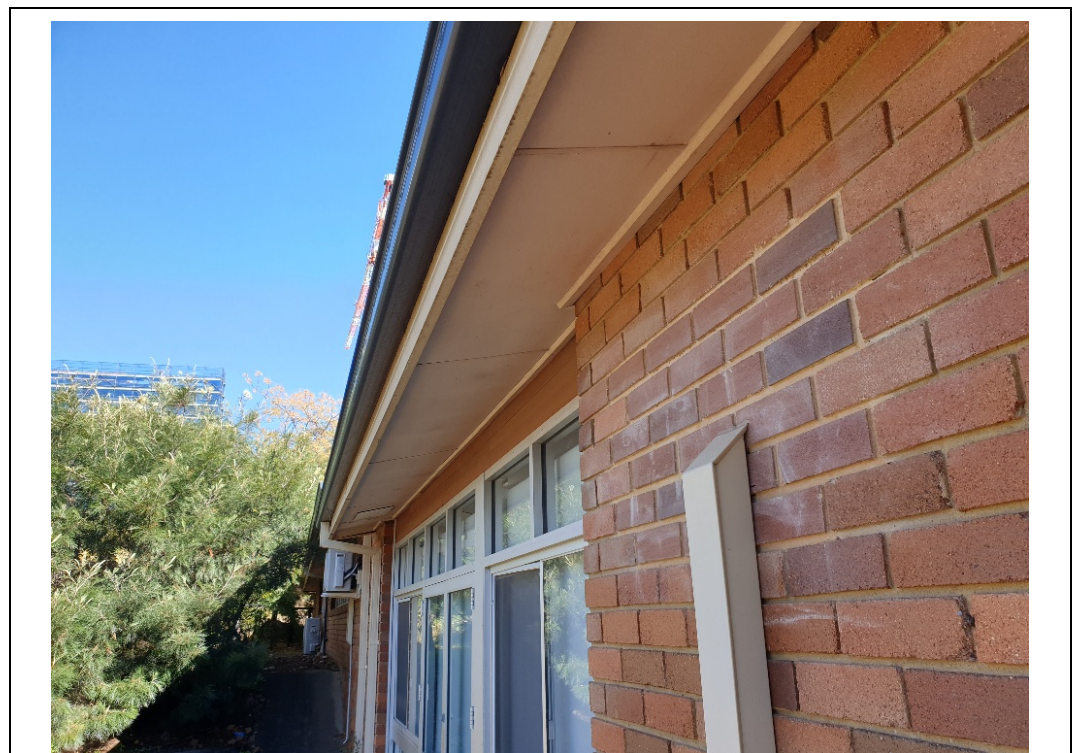
***Photo 24 – Block E, Fibre Cement Eave Linings to Perimeter – Deemed Asbestos Present***

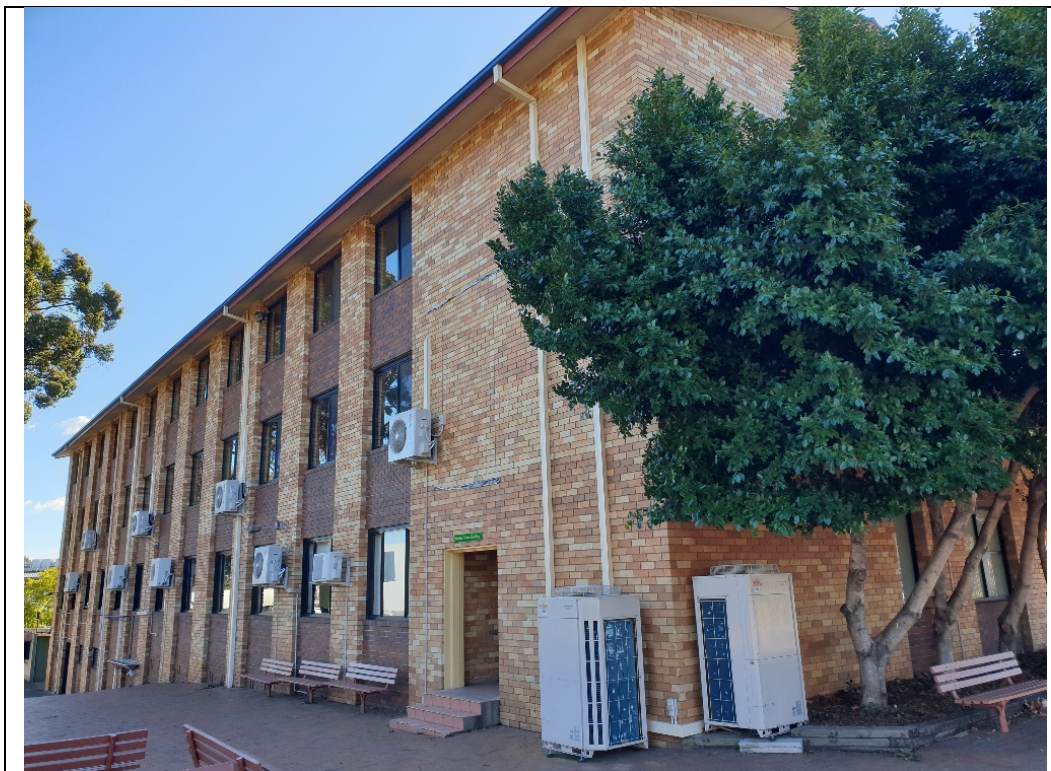
***Photo 25 – Block D, Fibre Cement Eave Linings to Perimeter -Deemed Asbestos Present***

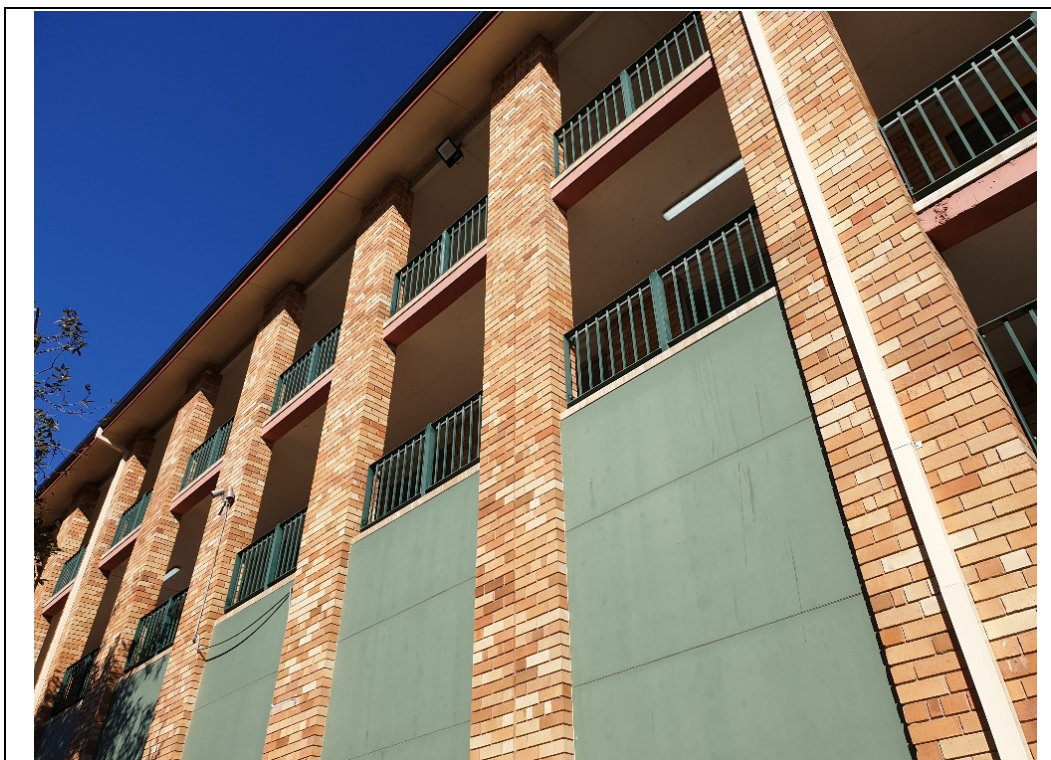
***Photo 26 – Block D, Fibre Cement Lining to Upper Level Walkway – Deemed Asbestos Present***

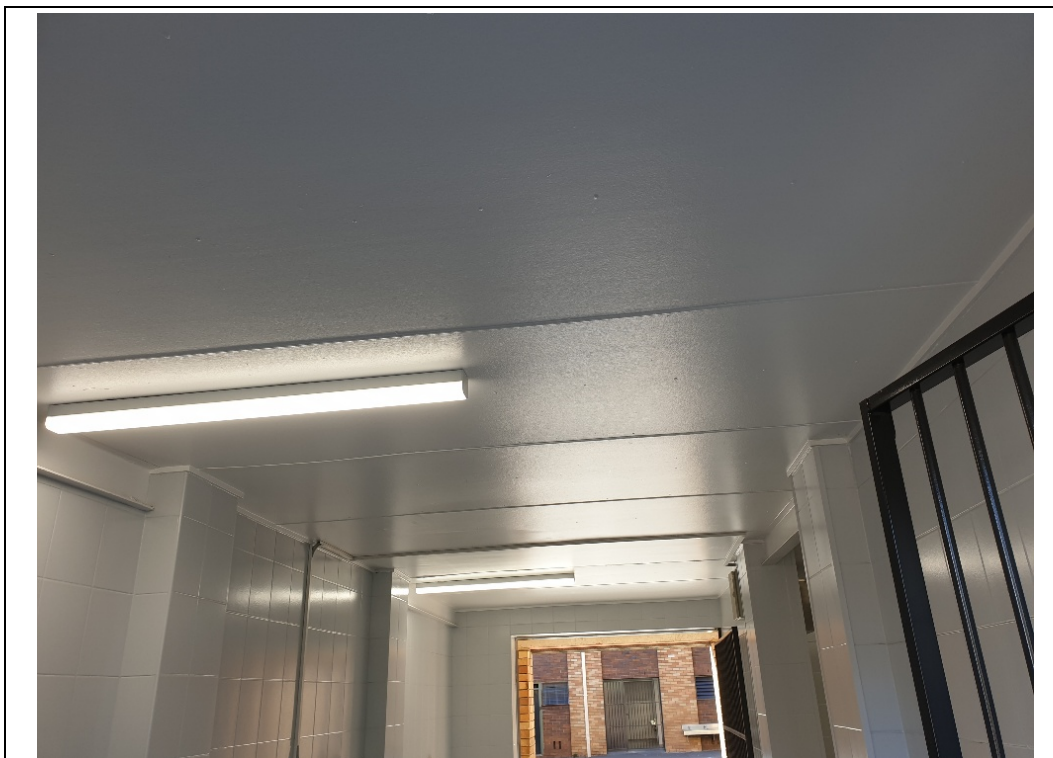
***Photo 28 – Block D, Student Toilet Facilities, Fibre Cement Ceiling Lining to Access Corridor – Deemed Asbestos Present***

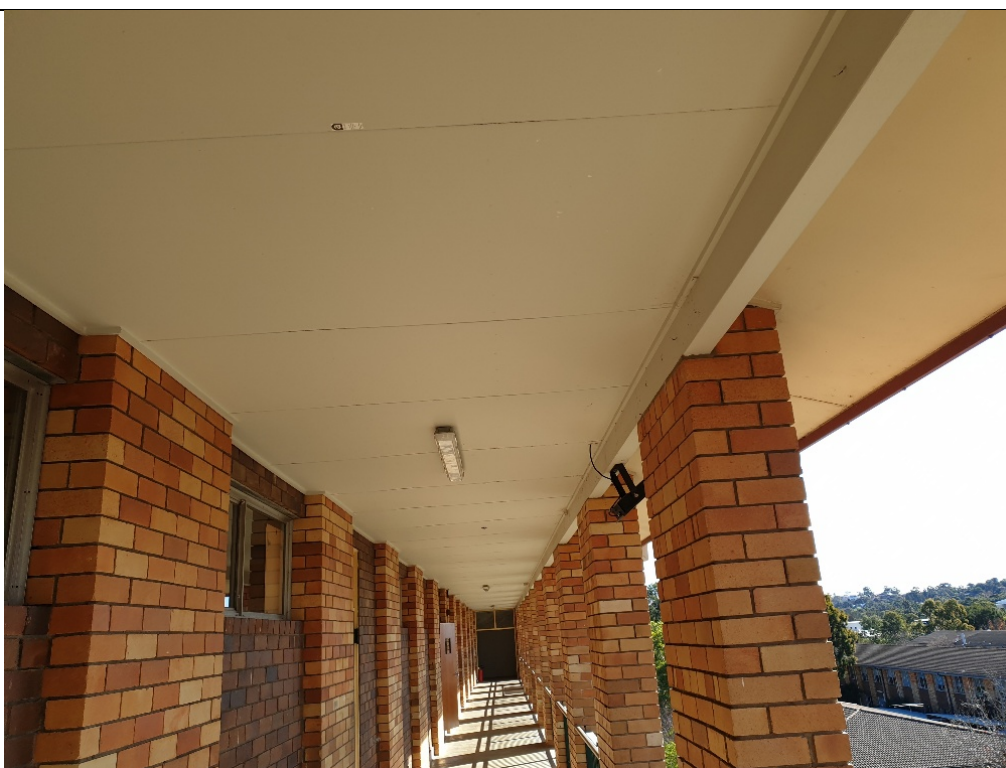
***Photo 30 – Block C, Fibre Cement Lining to Upper Level Walkway & Eave Linings – Deemed Asbestos Present***

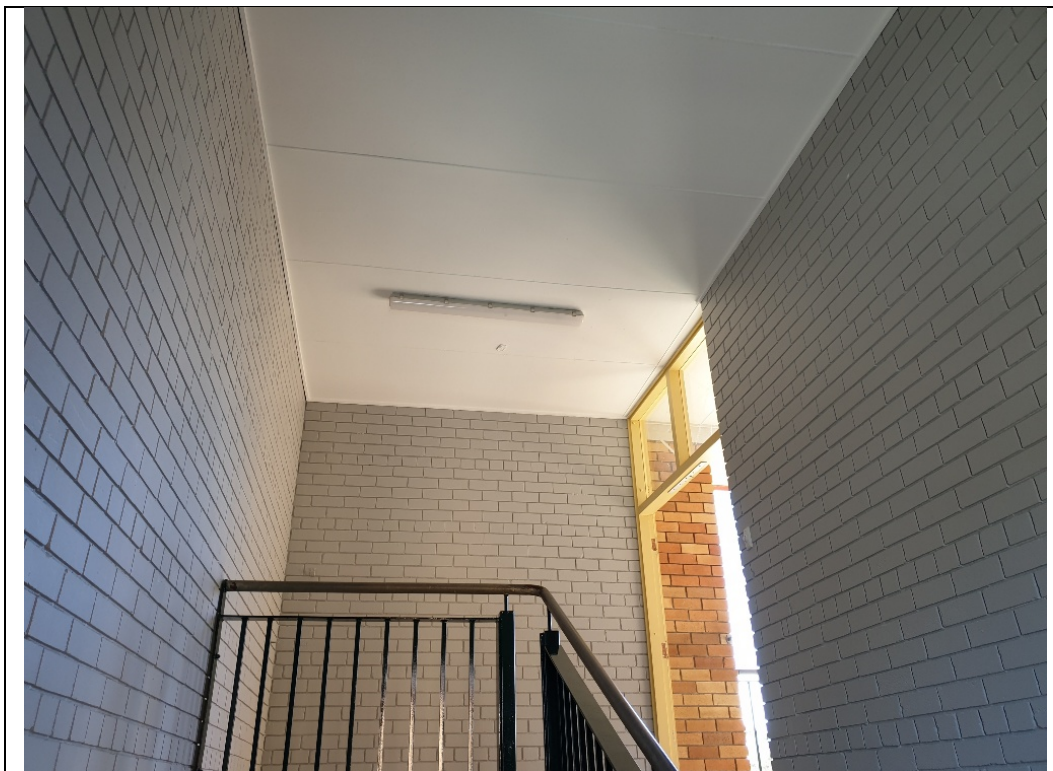
***Photo 31 – Block C, Fibre Cement Lining to (Upper Level) Stair Wells – Deemed Asbestos Present***

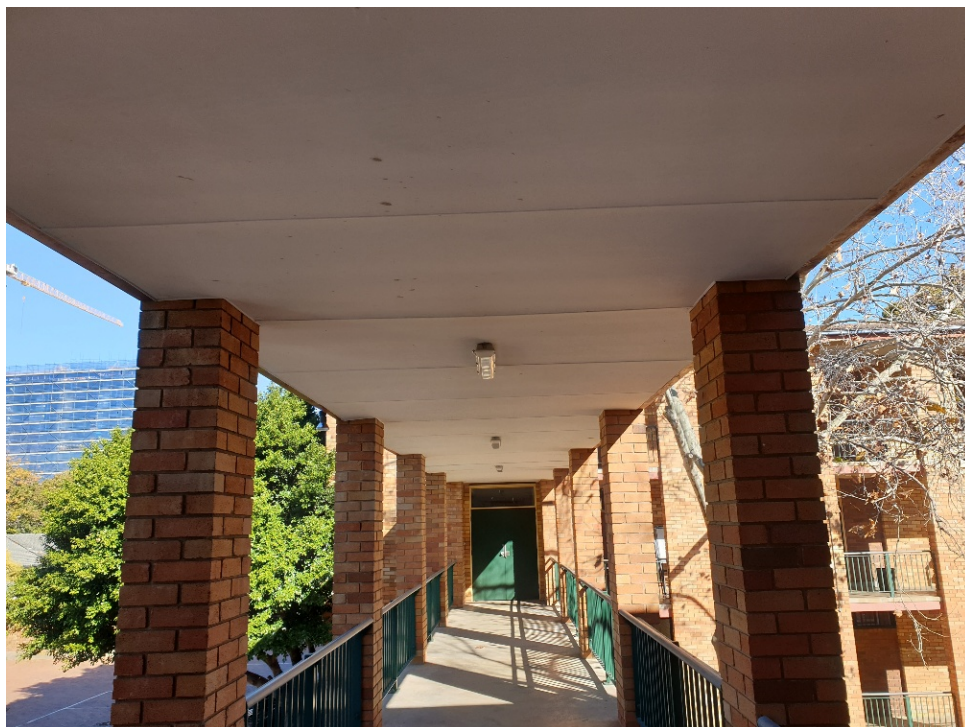
***Photo 32 – Fibre Cement Lining to Covered Walkway from Block C to Block D – Deemed Asbestos Present***
