# Hazardous Materials Survey Report and Register

Liverpool Hospital,  
Liverpool NSW

South Western Sydney  
LHD

Contract Number: C19 8144  
Report Number: EMS19 6723

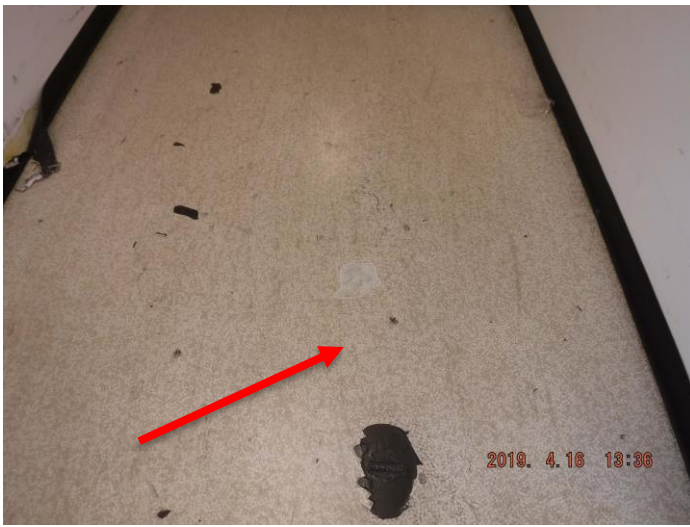
Photograph 1:

Alex Grimson, Identical throughout  
Basement level

Asbestos backed brown vinyl sheeting

**Note: Damage to the floor with  
asbestos backing visible beneath tile.  
Damaged sections of flooring should  
be sealed and/or covered as soon as  
possible to prevent potential fibre  
release**

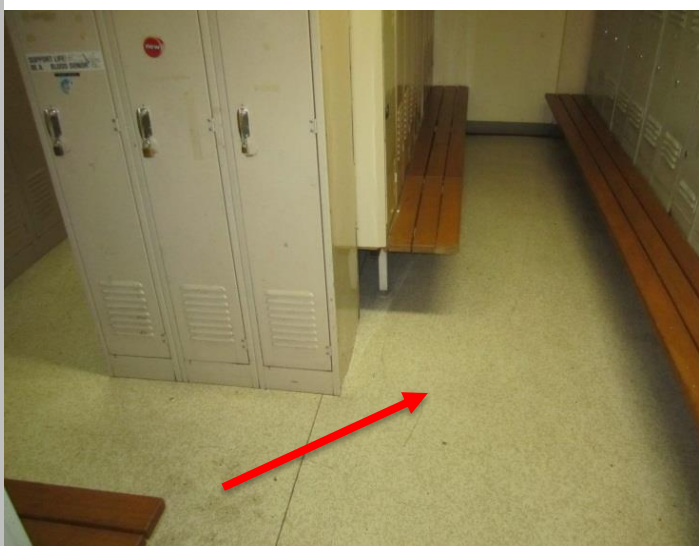
Photograph 2:

Alex Grimson – Basement Locker  
Rooms / Amenities

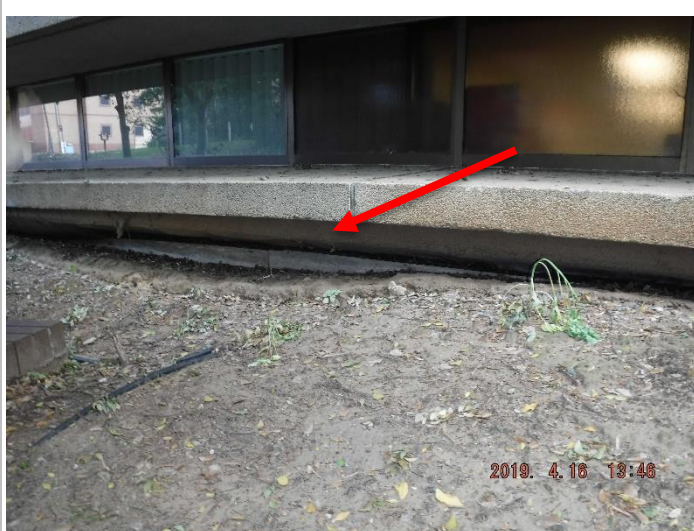
Photograph 5:

Alex Grimson, External to Pathology in  
basement  
Fibre cement sheeting between soil and  
wall of building is presumed to contain  
asbestos

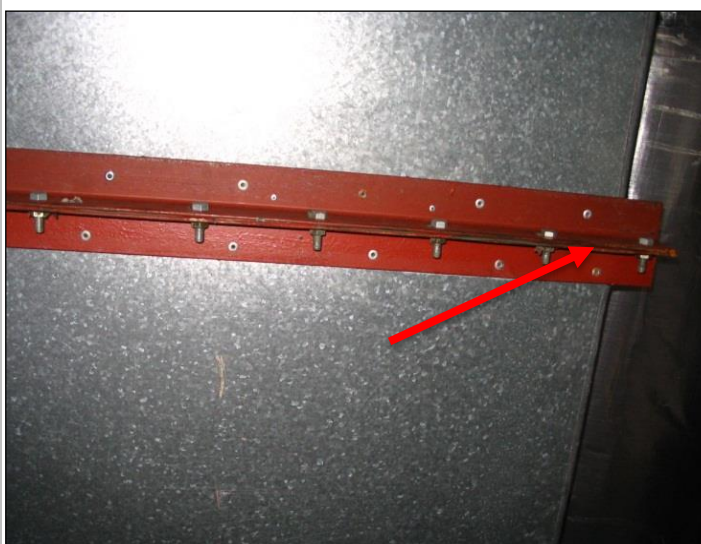
Photograph 6:

Alex Grimson - Ground Floor East Ceiling  
cavity  
Asbestos containing air conditioning duct  
mastic sealant

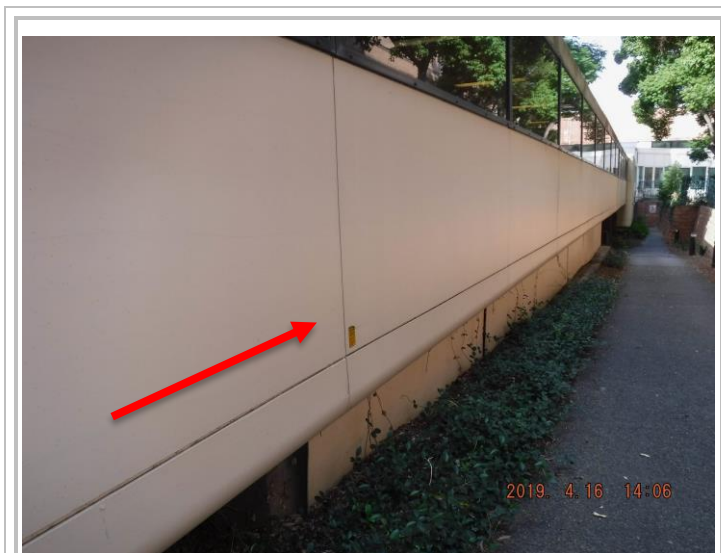
Photograph 7:

Alex Grimson Ground Floor walkway to  
Mental Health Building – Internal and  
external walls  
Asbestos cement sheeting

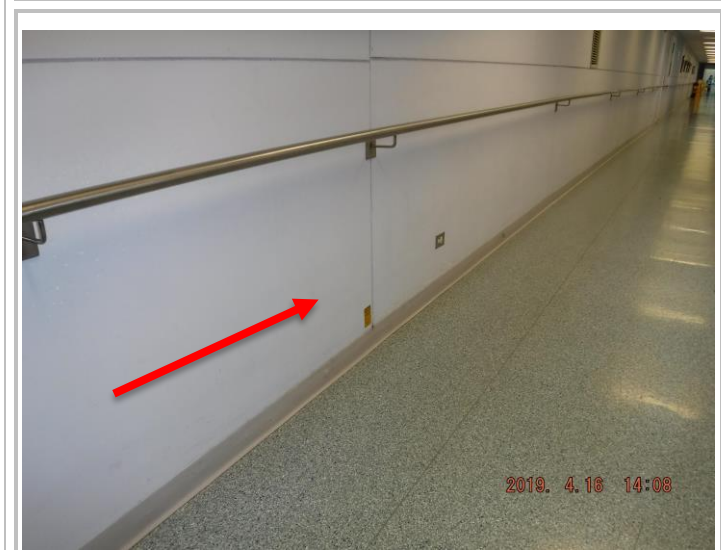
Photograph 8:

Alex Grimson Ground Floor walkway to  
Mental Health Building – Internal and  
external walls  
Asbestos cement sheeting

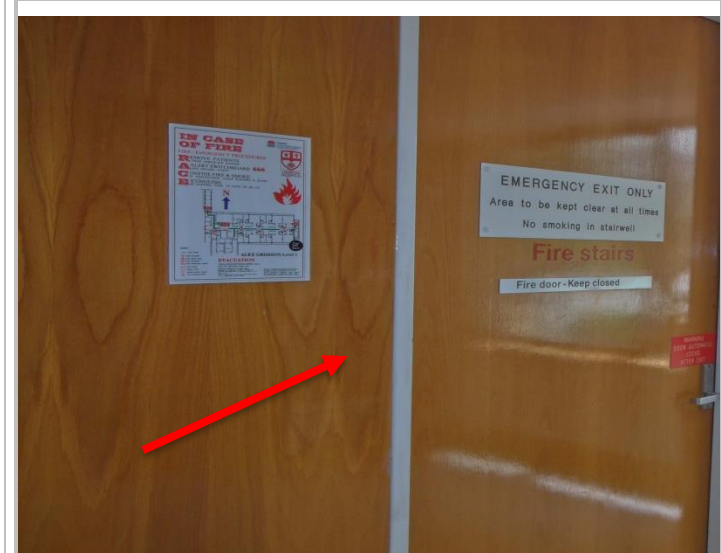
Photograph 9:

Alex Grimson Ground Floor – Original  
Wood Veneered Fire Doors throughout  
Asbestos core within

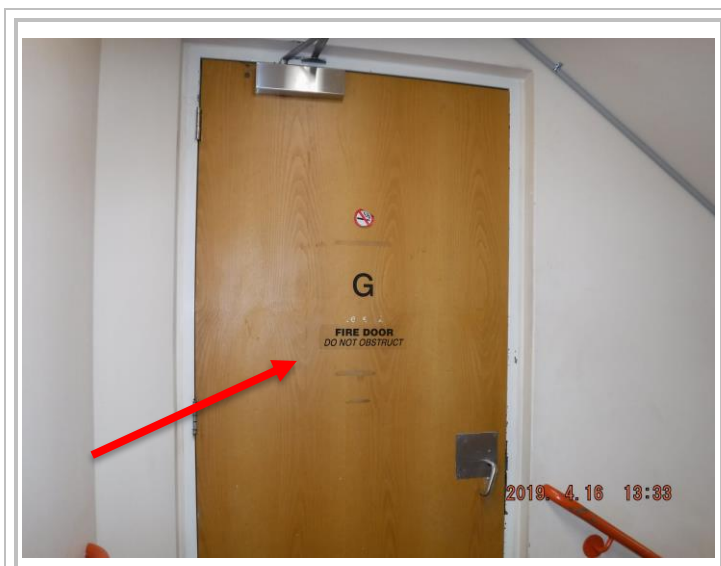
Photograph 10:

Alex Grimson Ground Floor– Original Wood Veneered Fire Doors throughout  
Asbestos core within

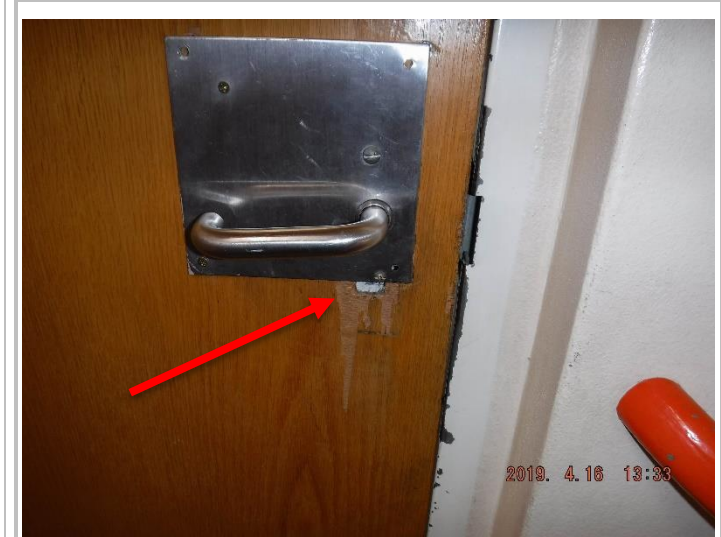
Photograph 11:

See S7687	Internal fibrous core insulation	Fire doors between wards and fire stairs, wood veneered original	Friable	Some doors damaged	Several	No	April 2019	Yes		9-11

Alex Grimson Ground Floor– Original Wood Veneered Fire Doors throughout  
Asbestos core within

**Note: Damage to door with asbestos core visible. Damaged section of door should be sealed as soon as possible to prevent potential fibre release**

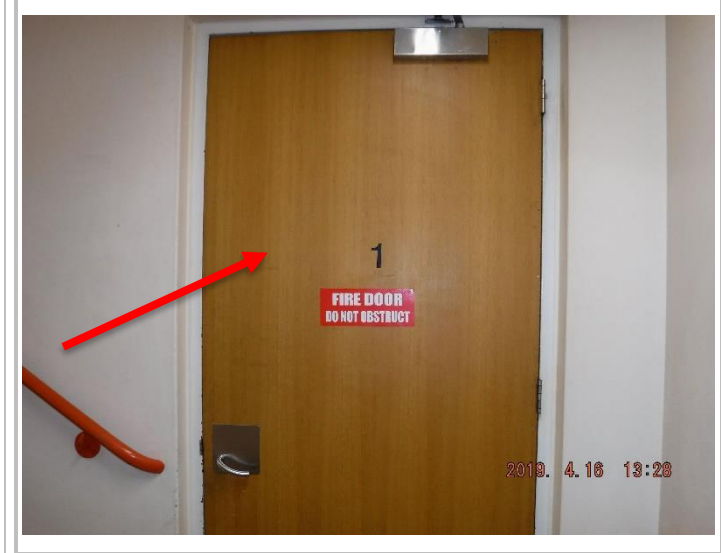
Photograph 12:

Alex Grimson First Floor– Original Wood Veneered Fire Doors throughout  
Asbestos core within

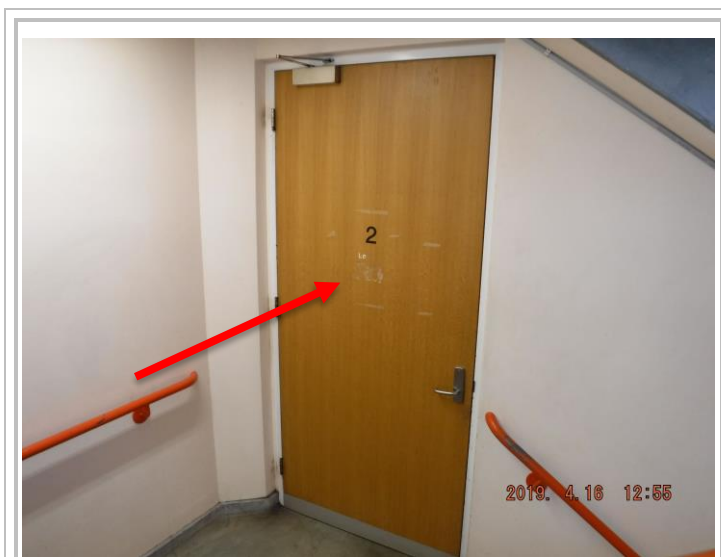
Photograph 13:

Alex Grimson Second Floor – Original Wood Veneered Fire Doors throughout Asbestos core within

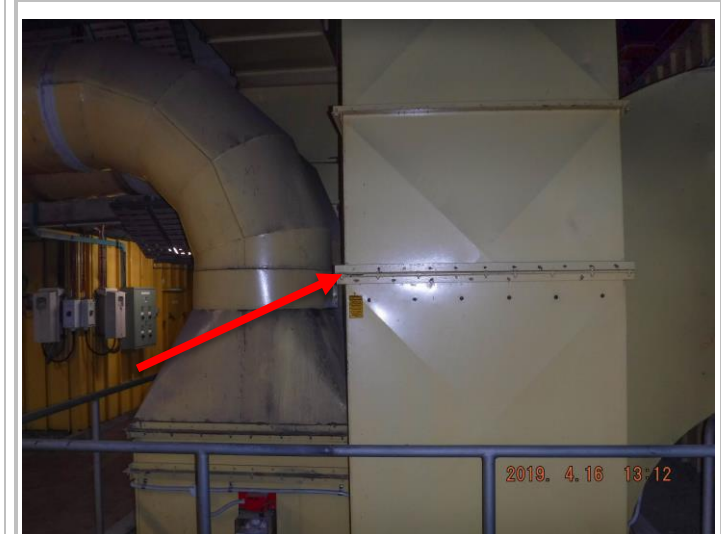
Photograph 14:

Alex Grimson, Plant Room – Mastic Sealant to Air Conditioning Ductwork

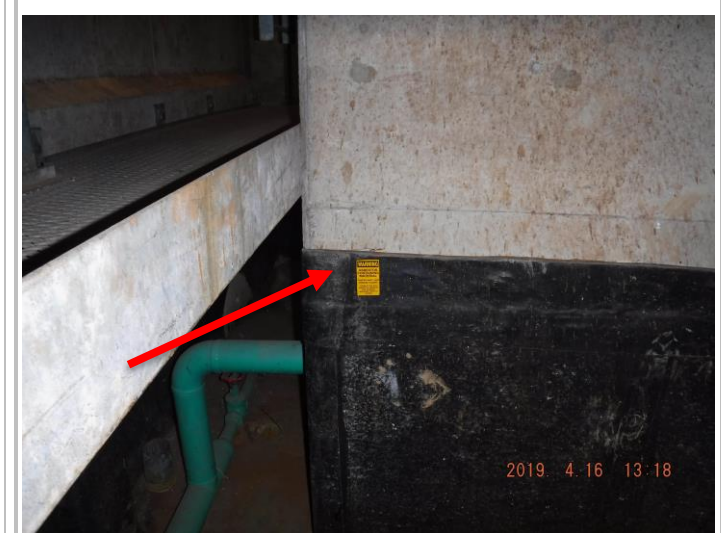
Photograph 15:

Alex Grimson - Plant Room  
Bituminous membrane, bunded, to the south western corner of the large water tank all the way to the floor

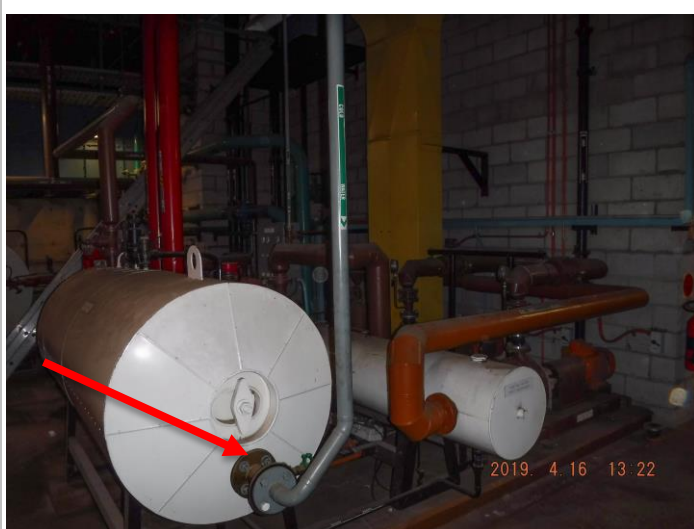
Photograph 17:

Alex Grimson - Plant Room

Calorifier flange gaskets should be presumed to contain asbestos and checked prior to disposal

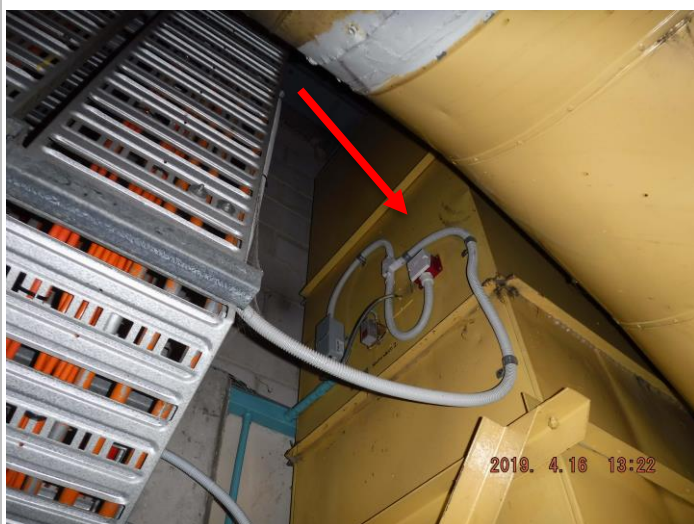
Photograph 18:

Alex Grimson - Plant Room

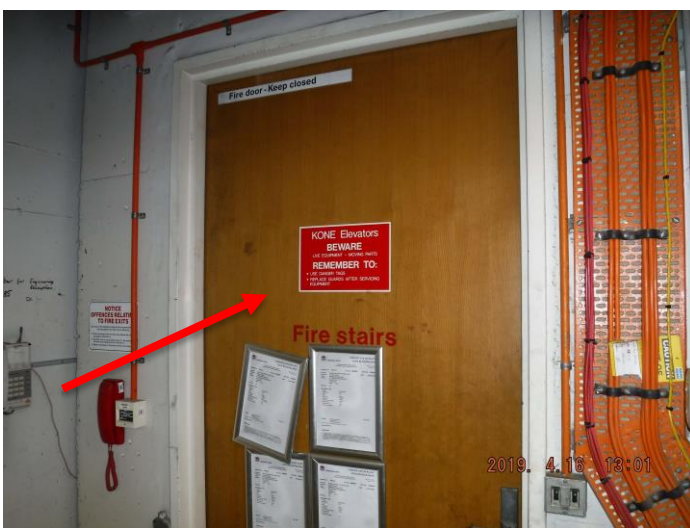
Photograph 20:

Alex Grimson Lift Motor Room – Original Wood Veneered Fire Doors throughout  
Asbestos core within

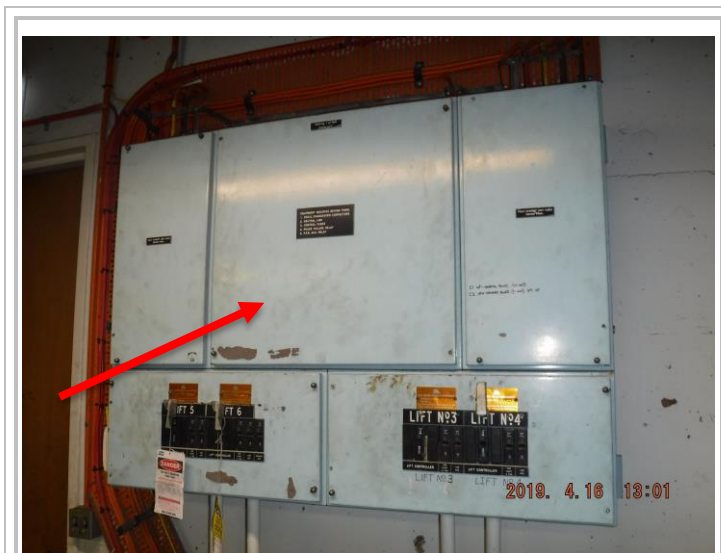
Photograph 22:

Alex Grimson, Lift Motor Room  
Assumed asbestos backing board within  
electrical cabinet

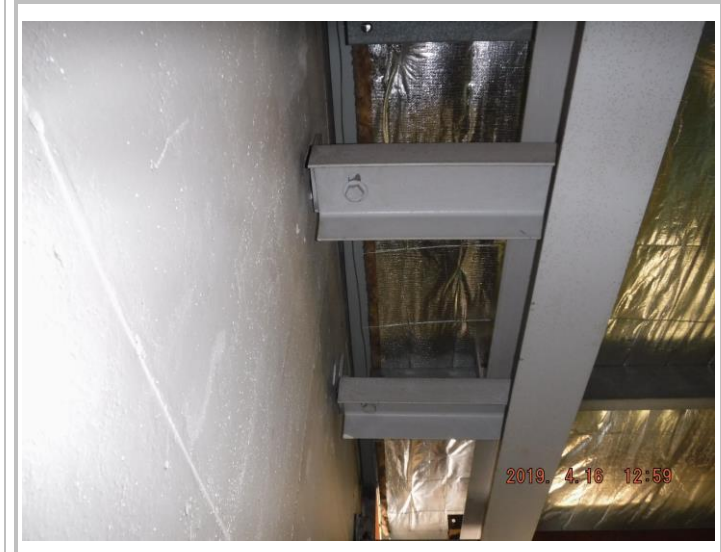
Photograph 23:

Alex Grimson, Lift Motor Room  
Rooftop sheeting lined with foil backed  
synthetic mineral fibre insulation

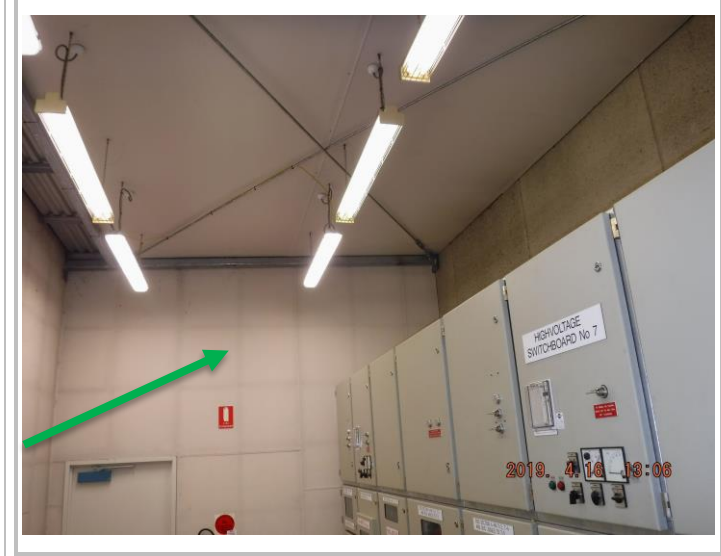
Photograph 24:

Alex Grimson, High Voltage Switch Room,  
Fibre cement wall and ceiling sheeting is  
free of asbestos

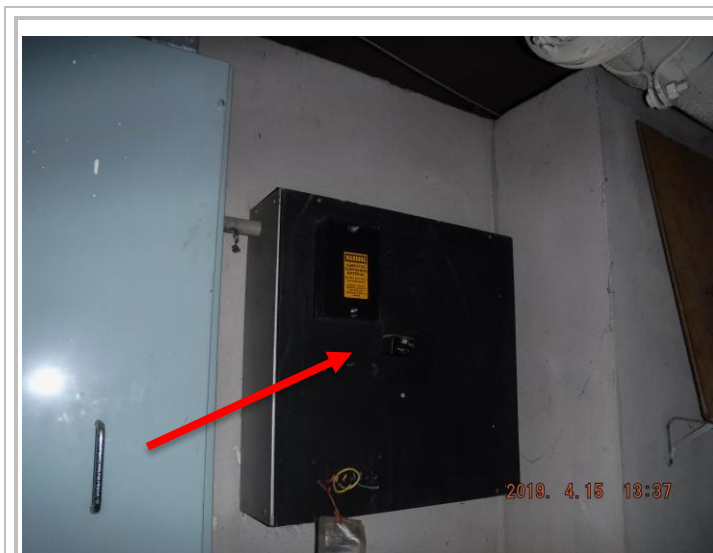
Photograph 25:

Don Everett Building – Basement  
ECB on wall adjacent to the lift foyer

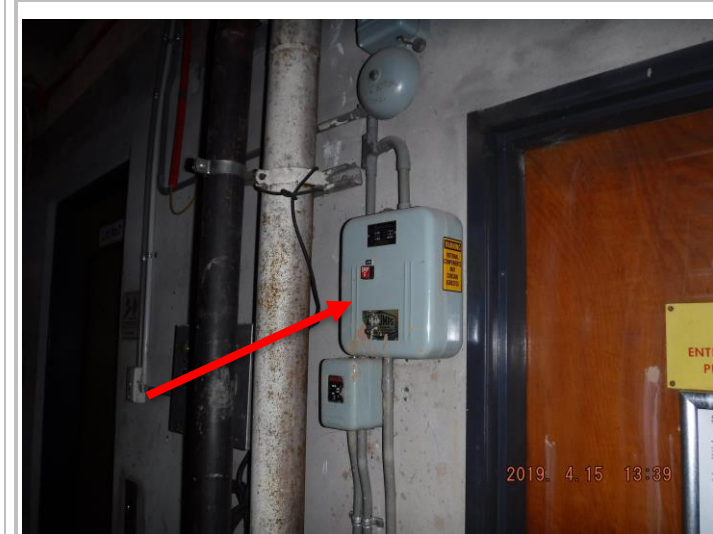
Photograph 26:

Don Everett Building – Basement  
Lift foyer electrical cabinets are presumed  
to contain asbestos materials internally

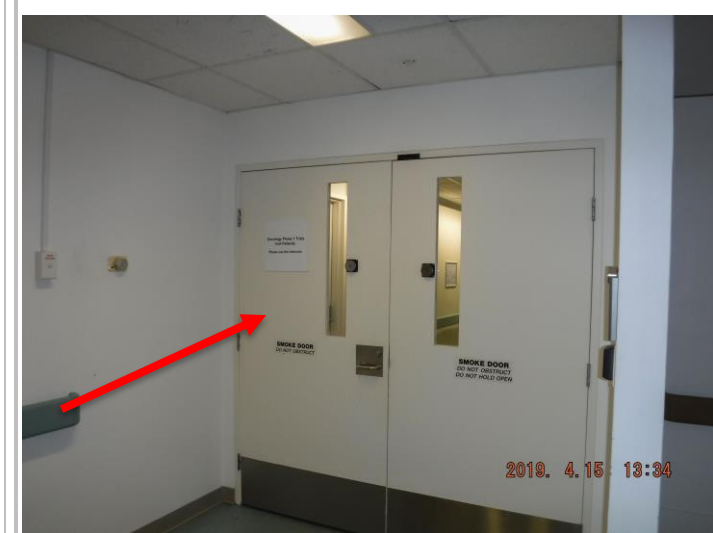
Photograph 27:

Don Everett Ground Floor – Fire Doors  
Asbestos cement core insulation

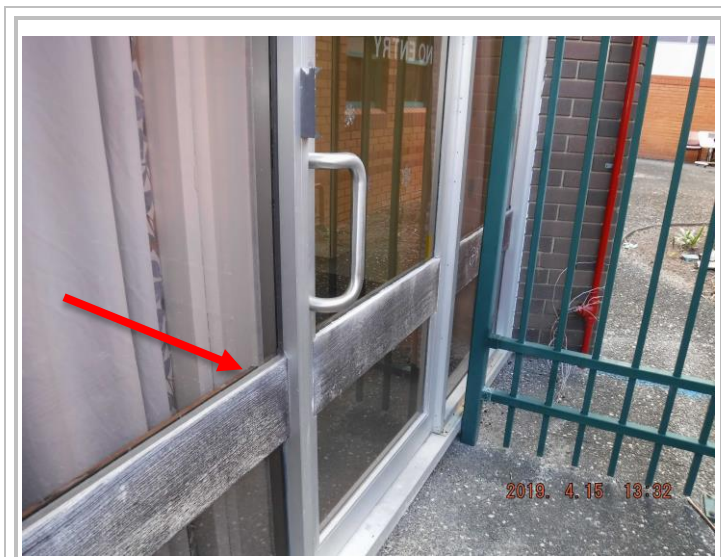
Photograph 28:

Don Everett Ground Floor Exit  
Asbestos door/window panel putty sealant

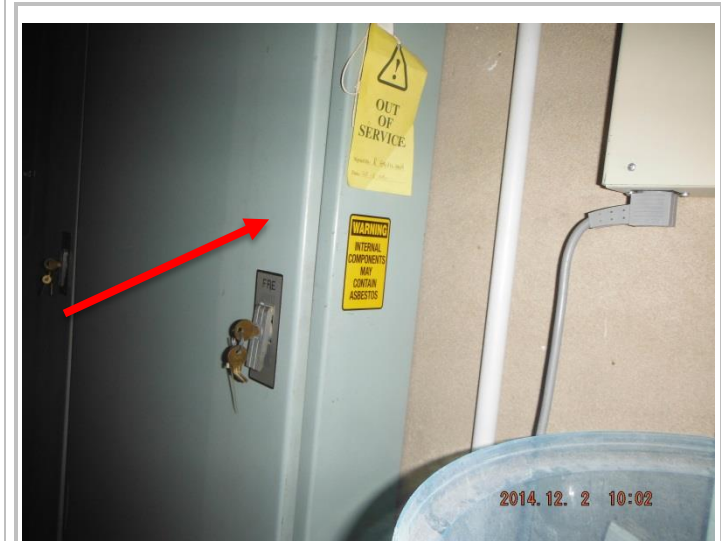
Photograph 29:

Don Everett Ground Floor  
Eastern wing adjacent main nurses office.  
Assumed EBB within

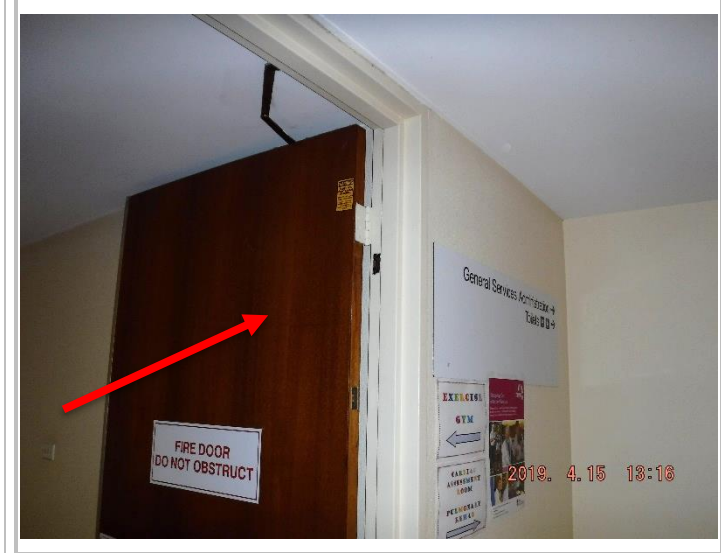
Photograph 30:

Don Everett First Floor – Wood veneered  
double fire Doors  
Asbestos cement core insulation

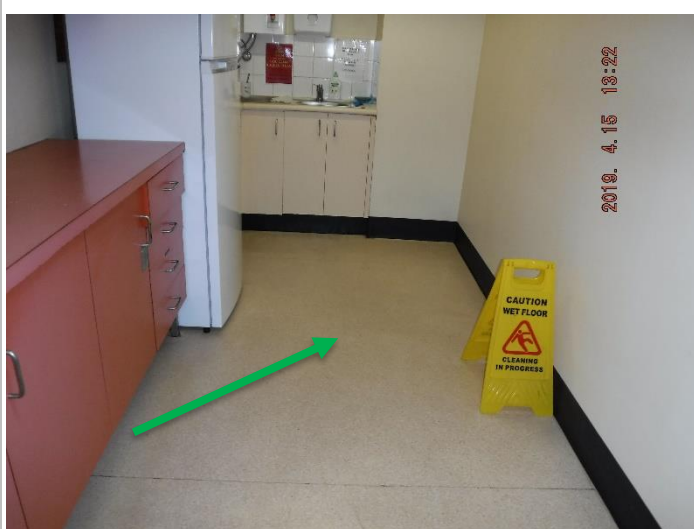
Photograph 32:

Don Everett Building First Floor  
Yellow vinyl floor sheeting within eastern  
Physiotherapist kitchen is free of asbestos

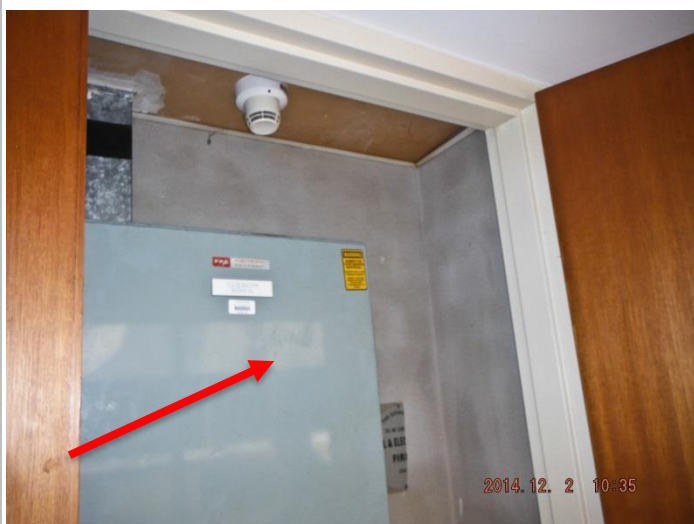
Photograph 33:

Don Everett First Floor Eastern Wing In  
corridor adjacent to central courtyard  
EBB presumed to contain asbestos

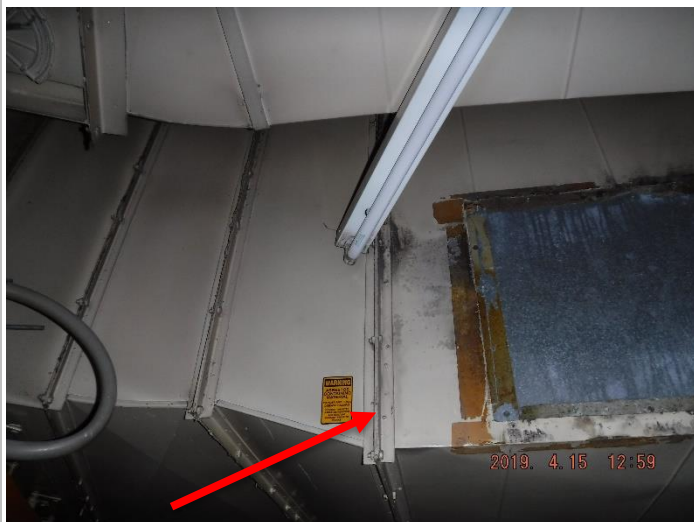
Photograph 34:

Don Everett, Plant Room – Air  
conditioning duct work  
Asbestos containing mastic sealant

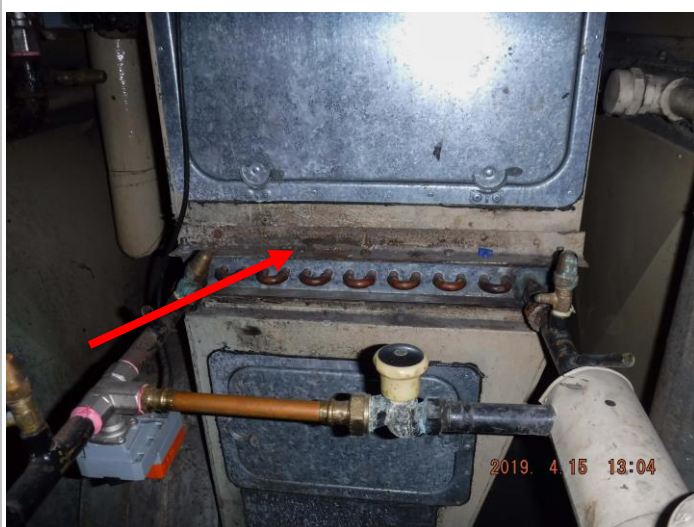
Photograph 35:

Don Everett, Plant Room – Air  
conditioning duct work  
Heater coils may contain asbestos  
insulation internally. Should be checked  
prior to disposal

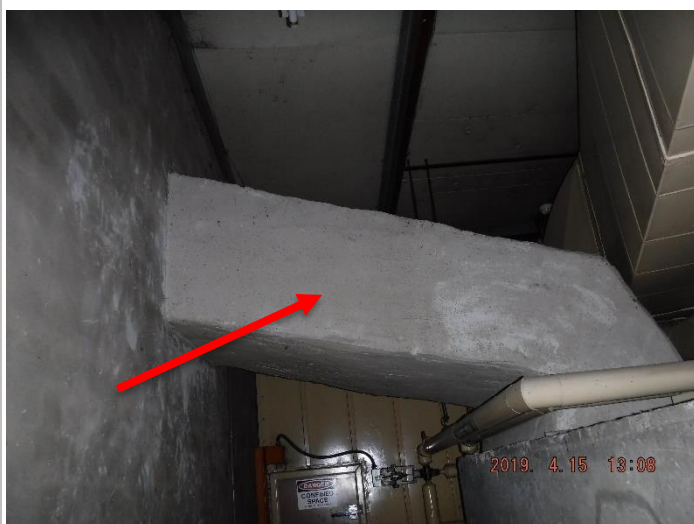
Photograph 36:

Don Everett, Roof top Plant Room south  
west area – Exhaust type duct work  
Asbestos insulation material

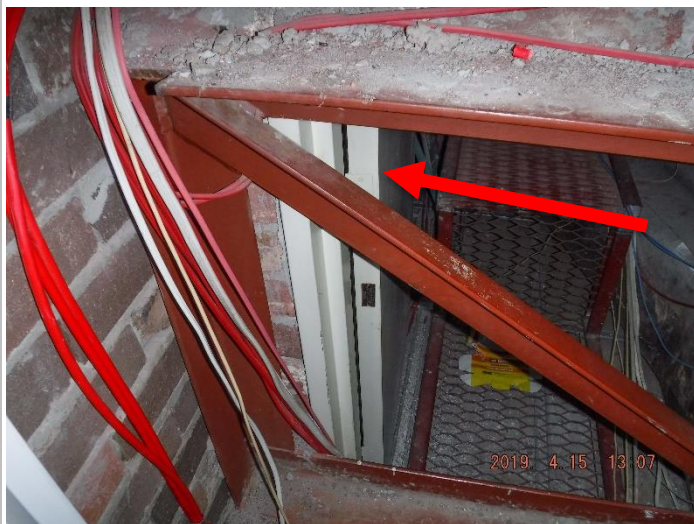
Photograph 37:

Don Everett, Roof top Plant Room  
Small original fire doors between  
compartments in roof cavity area above  
consulting rooms  
Presumed asbestos core within

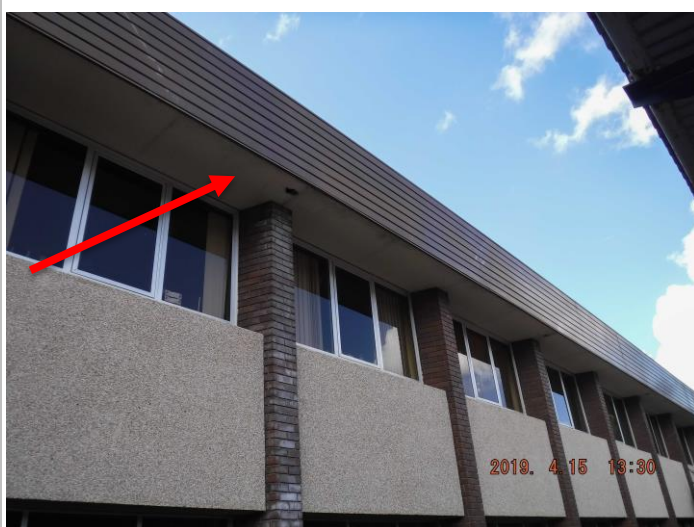
Photograph 38:

Don Everett, External eaves lining  
Assumed asbestos cement sheeting

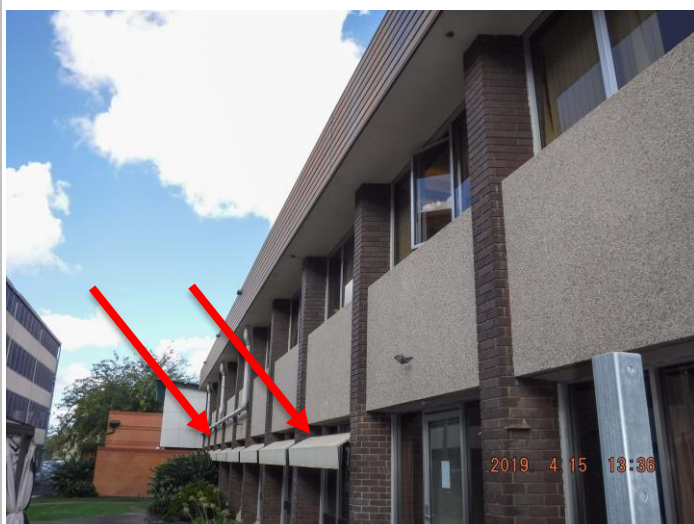
Photograph 39:

Don Everett, Exterior North face awnings  
Asbestos cement panelling

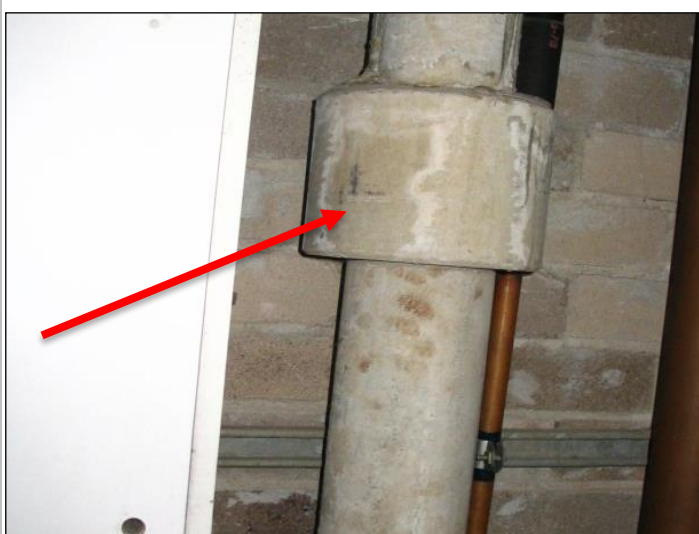
Photograph 41:

Ron Dunbier, units – Toiler riser  
Asbestos cement pipework

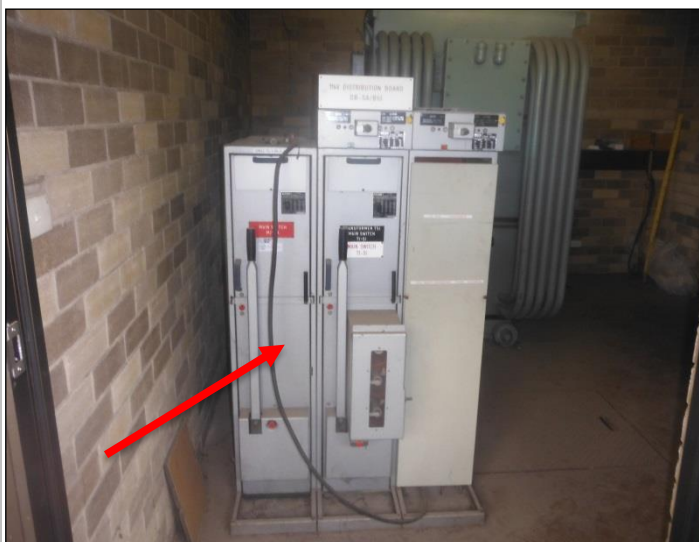
Photograph 42:

Ron Dunbier – Transformer rooms throughout  
Electrical distribution panelling

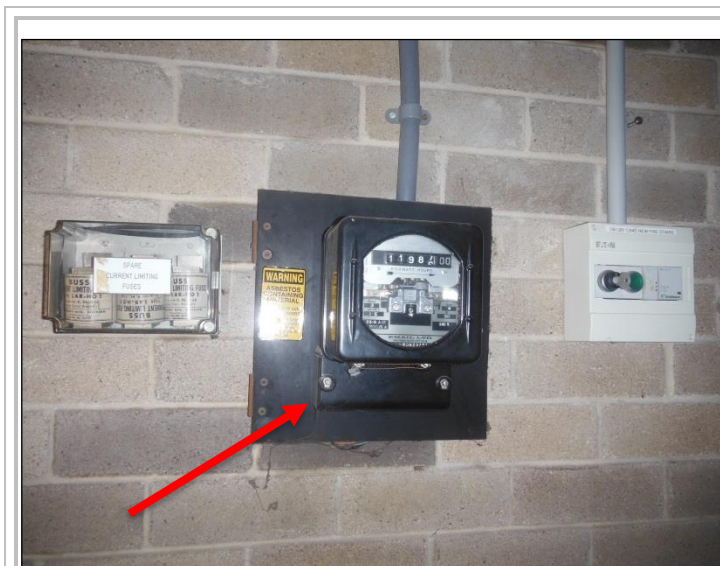
Photograph 43:

Ron Dunbier Ground Floor – Transformer room  
Wall mounted electrical backing board panel

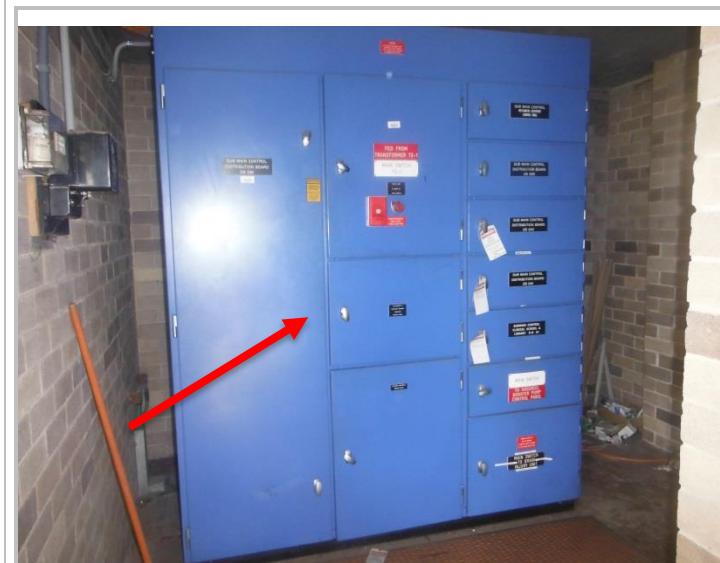
Photograph 44:

Ron Dunbier – Transformer rooms throughout  
Electrical distribution panelling

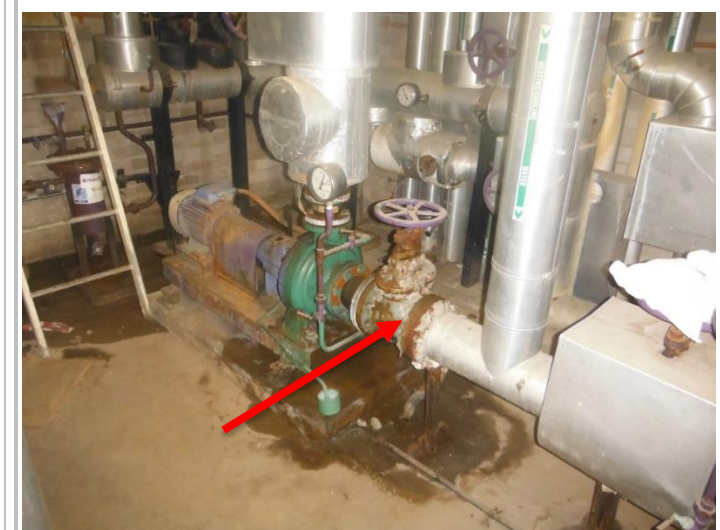
Photograph 45:

Ron Dunbier – Plant Room Upper Floor  
Original gaskets assumed to contain asbestos

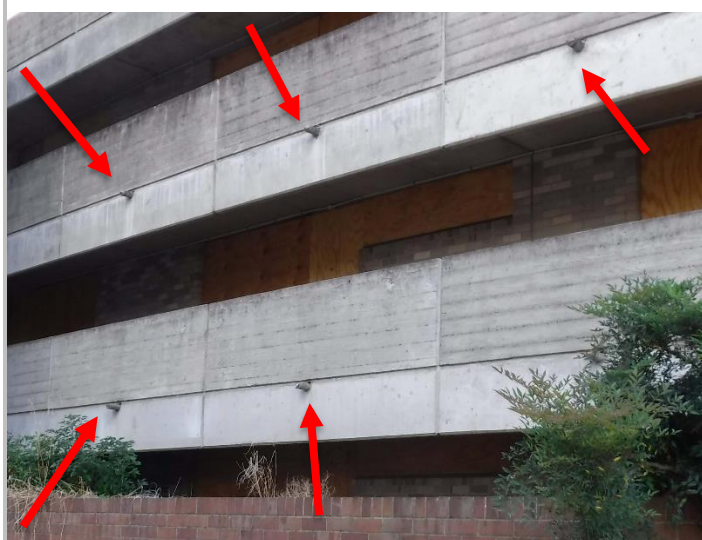
Photograph 46:

Ron Dunbier External walkway & walls  
Asbestos drainage half pipes

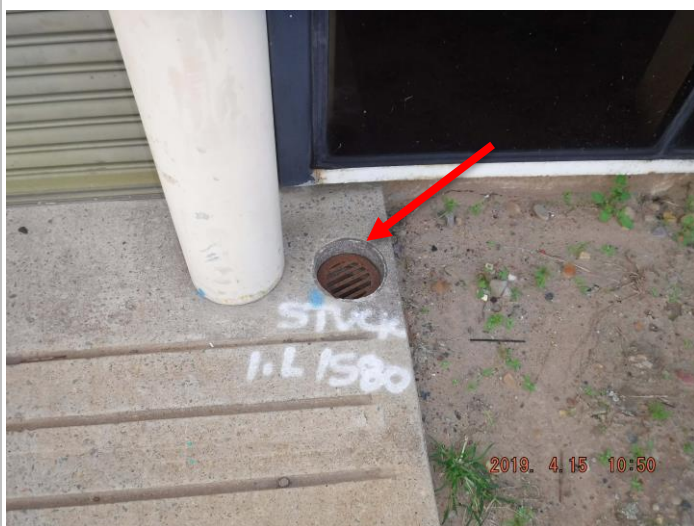
Photograph 48:

Central Energy – Exterior drainage pipe  
Asbestos cement pipe in ground

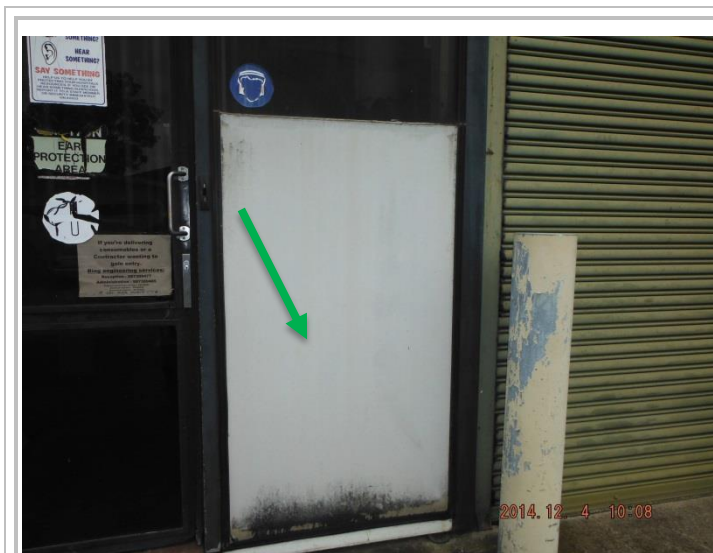
Photograph 49:

Central Energy – Adjacent front entrance and roller door

Cement sheet panel is free of asbestos

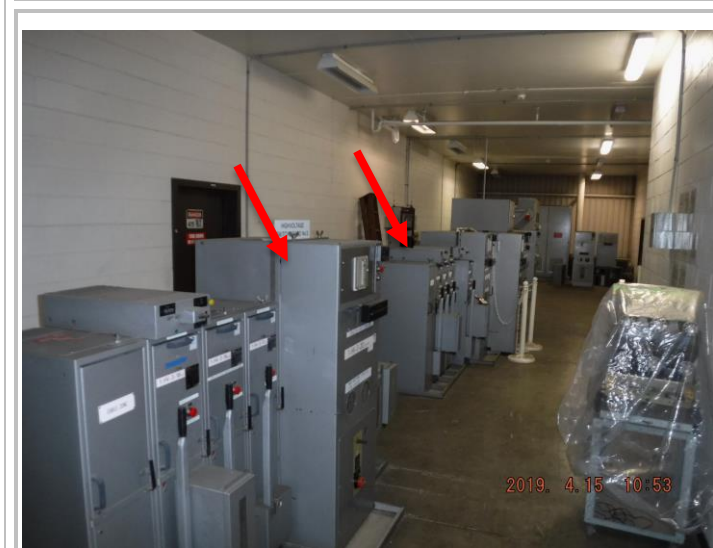
Photograph 50:

Ground floor, ground floor, south area, main switch room, EBBs presumed to be present internally within equipment

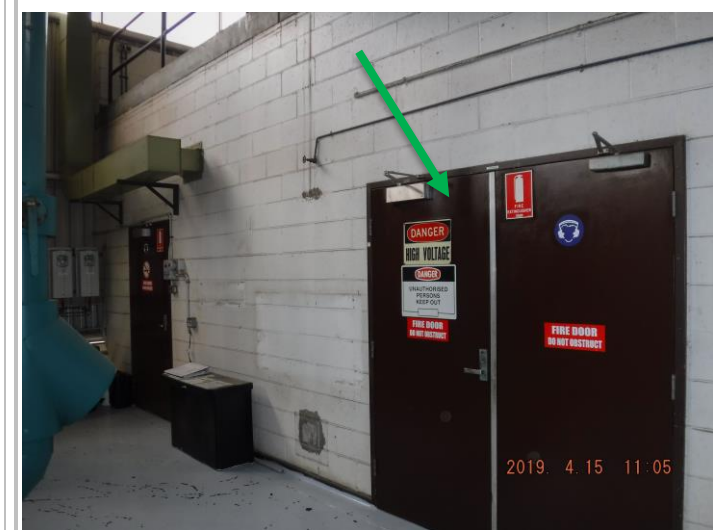
Photograph 51:

Central Energy, ground floor, south eastern area, Chiller Water Room door core is free of asbestos

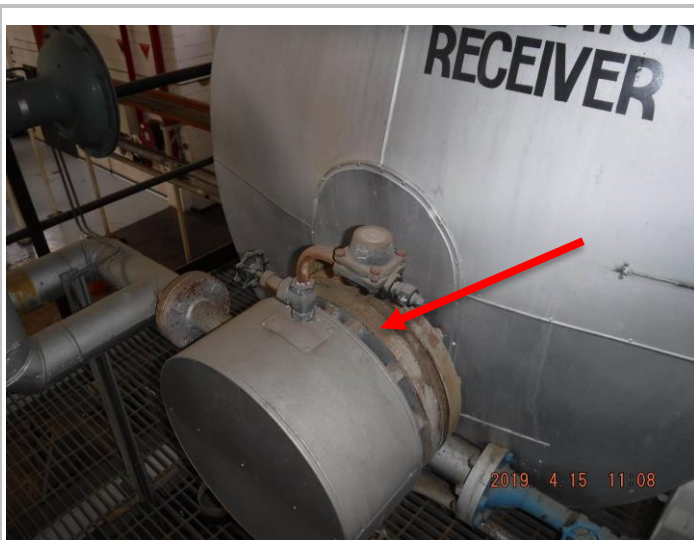
Photograph 53:

Central energy, level one, south western area, deaerator receiver, gaskets to pipework on flanges presumed to contain asbestos

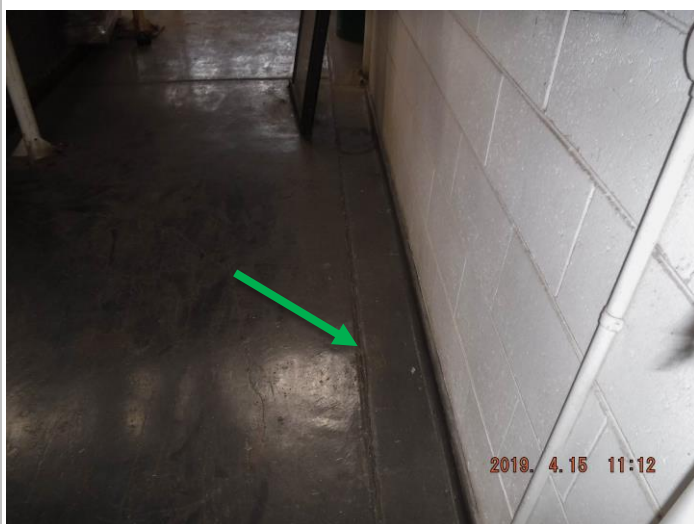
Photograph 54:

Central Energy, ground floor, south western area, joints between floor slab free of asbestos

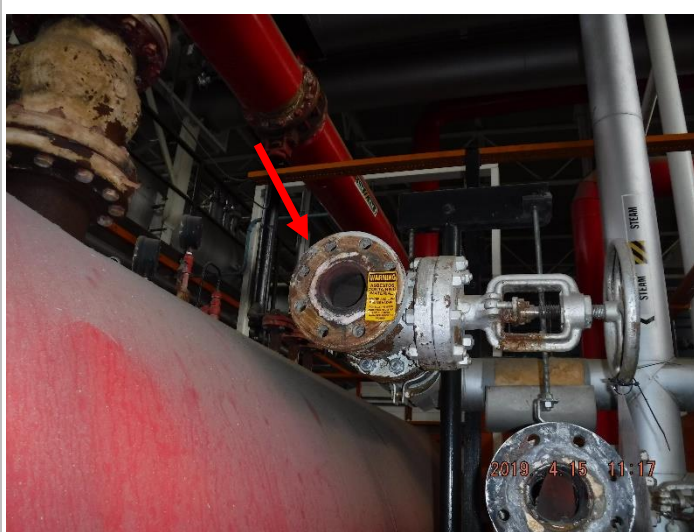
Photograph 56:

Central Energy, ground floor, above north eastern MTW heating vessel no. 2.  
Asbestos debris to disused pipe / exposed flange

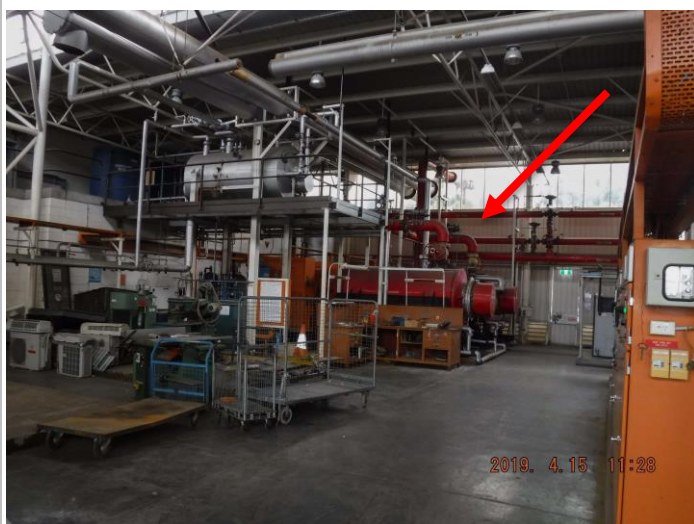
Photograph 57:

Central Energy, ground floor, south western corner of main plant room,  
Gaskets to original pipework

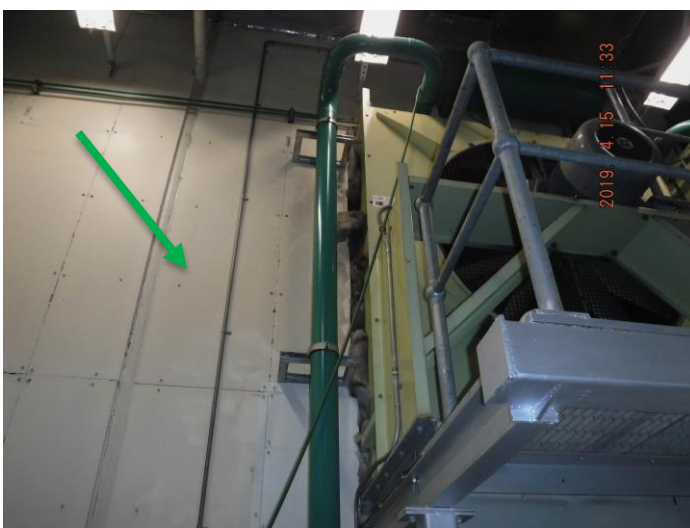
Photograph 59:

Central Energy, ground floor, southern side, backup generator room  
Fibre cement sheeting is free of asbestos

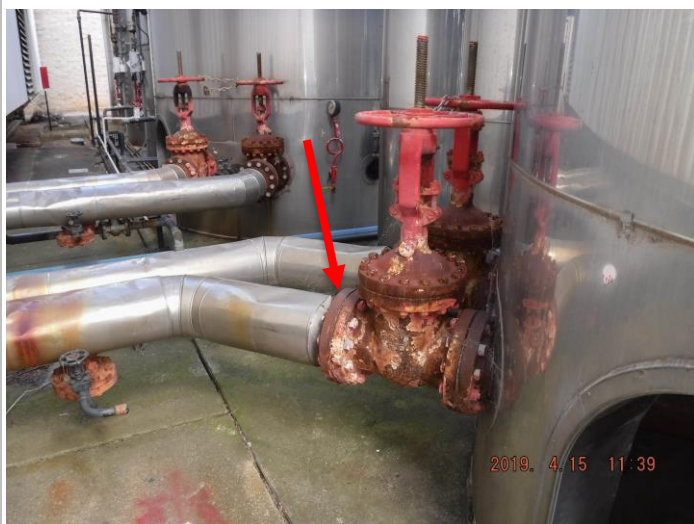
Photograph 61:

Central Energy, external south western side, gaskets to pipework flanges presumed to contain asbestos

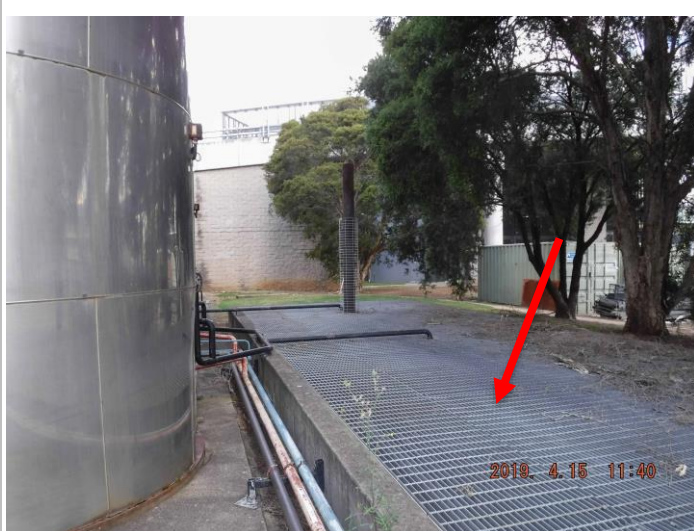
Photograph 62:

Central Energy – External south western side  
Assumed asbestos materials within large diesel tank

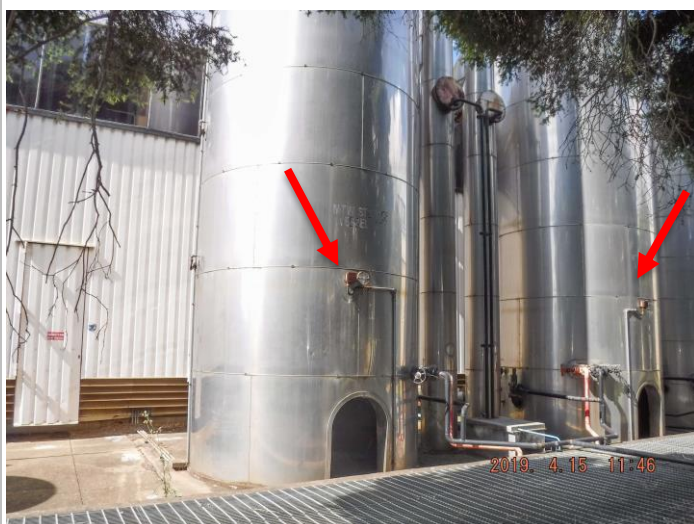
Photograph 63:

Central Energy – External south western side  
Electrical control boxes may contain asbestos materials internally

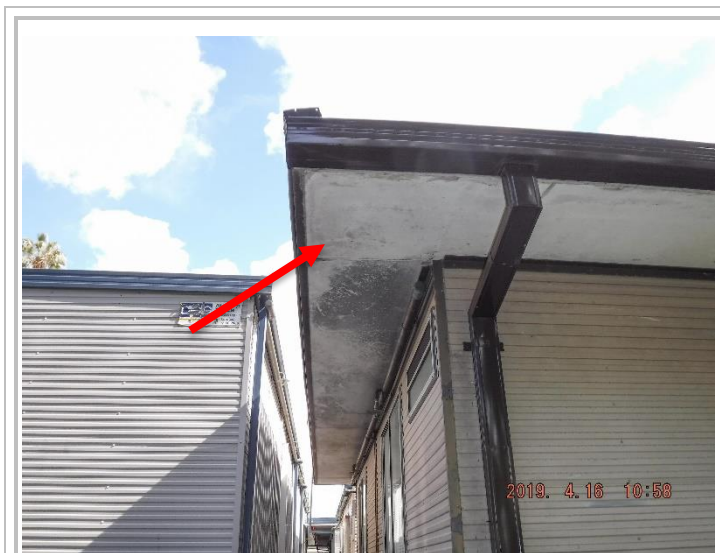
Photograph 64:

C Core Building, Merit, BIU Admin, Supply  
Department, C Core Buildings Group of  
Demountables

Asbestos cement eaves linings

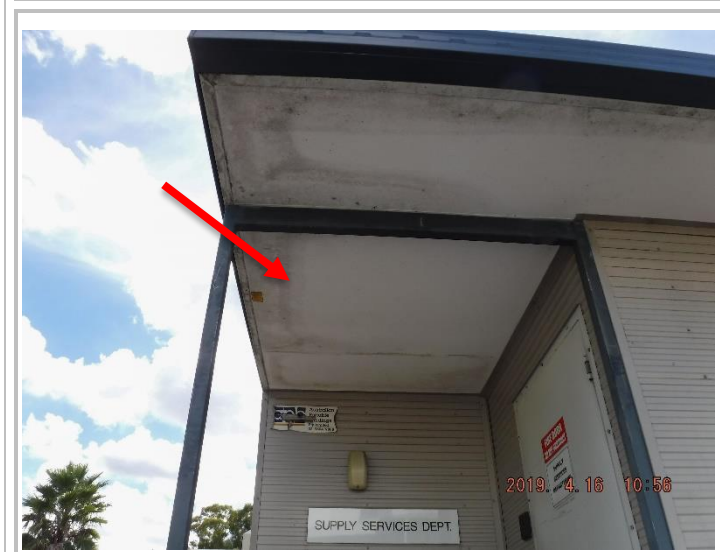
Photograph 65:

C Core Building, Merit, BIU Admin, Supply  
Department, C Core Buildings Group of  
Demountables

Asbestos cement eaves linings

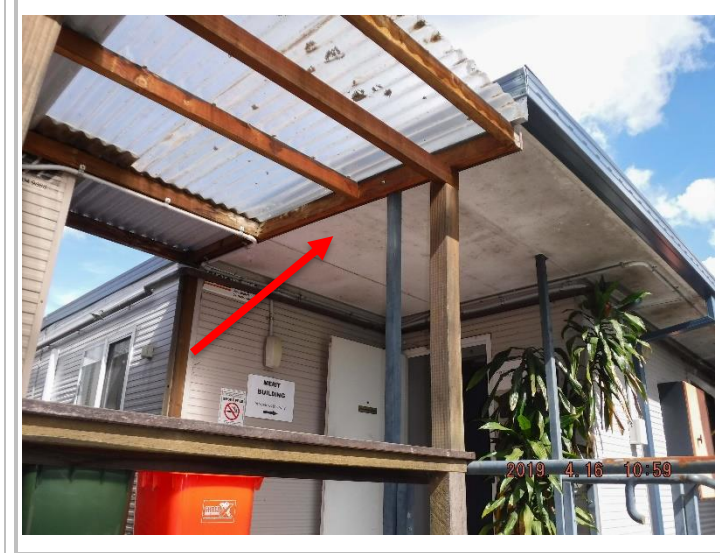
Photograph 66:

C Core Building, Merit, BIU Admin, Supply  
Department, C Core Buildings Group of  
Demountables

Asbestos cement eaves linings

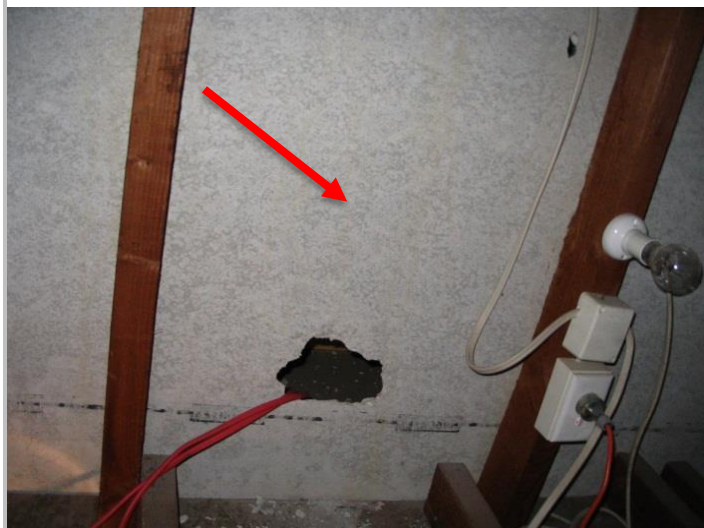
Photograph 67:

C Core Demountable – Roof space  
Asbestos cement wall sheeting
