# Hazardous Materials Survey Report and Register

Liverpool Hospital,  
Liverpool NSW

South Western Sydney  
LHD

Contract Number: C19 8144  
Report Number: EMS19 6723

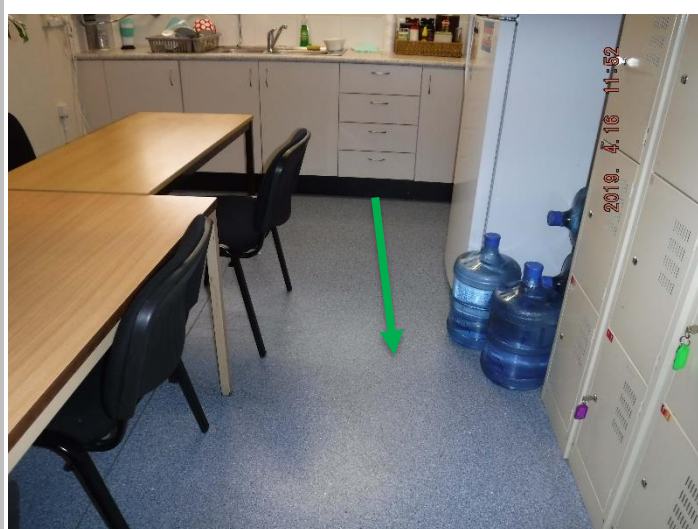
Photograph 68:

Bigge Park Centre  
Kitchen – Floor  
Asbestos cement floor tiles previously  
located within kitchen.

These are assumed to have been removed  
and not simply covered, but care should  
be taken if current flooring is removed.

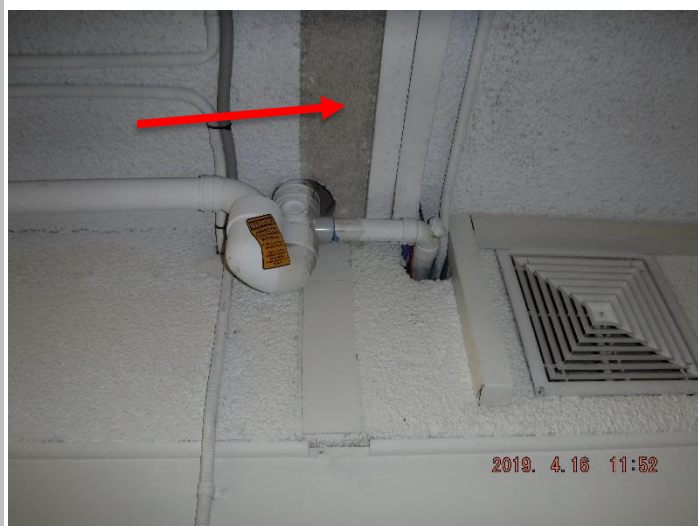
Photograph 69:

Bigge Park Centre - Kitchen  
Asbestos cement sheeting to duct  
work/bulkheads  
Non asbestos vermiculite throughout

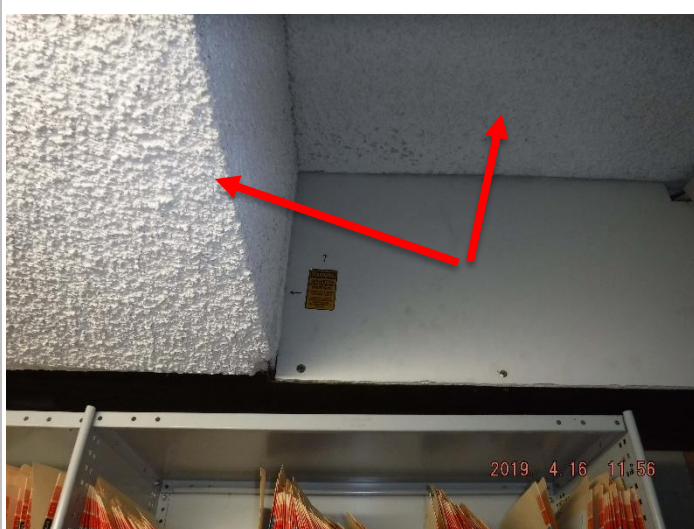
Photograph 71:

Bigge Park Centre – File Room  
Asbestos cement ceiling lining  
Non asbestos vermiculite throughout

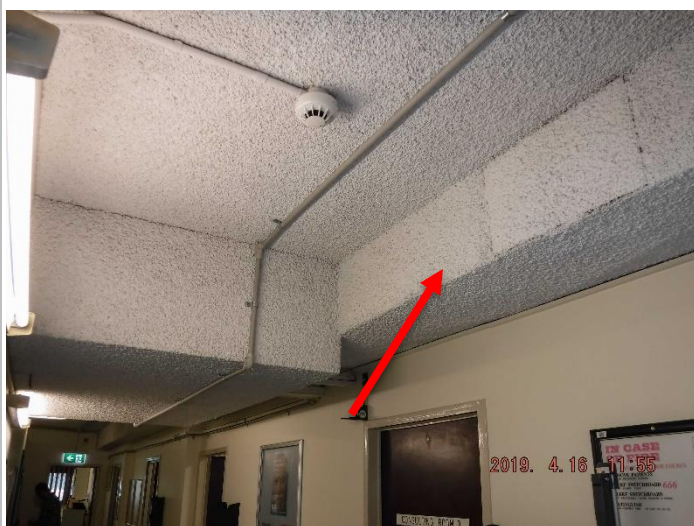
Photograph 72:

Bigge Park Centre - Hallway  
Asbestos cement to duct work/bulkheads  
Non asbestos vermiculite throughout

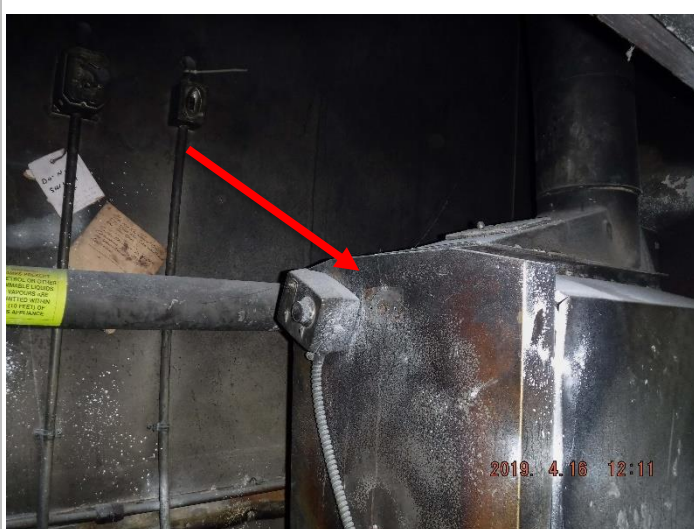
Photograph 74:

Bigge Park Centre – beneath stairwell  
Original disused oil heater may contain asbestos materials within

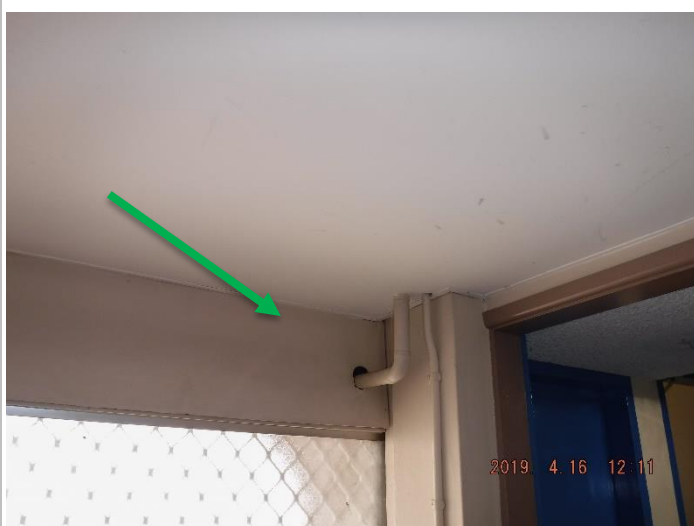
Photograph 75:

Bigge Park Centre - Toilet  
Wall sheet panelling above windows constructed from modern non-asbestos materials

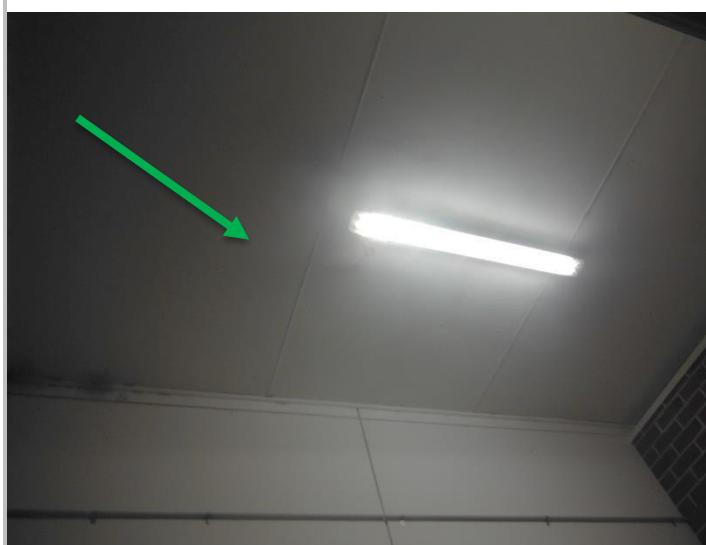
Photograph 76:

ISD Building – Adjacent Loading Dock  
Fibre cement sheet ceiling to Loading Dock is newer material and will be free of asbestos

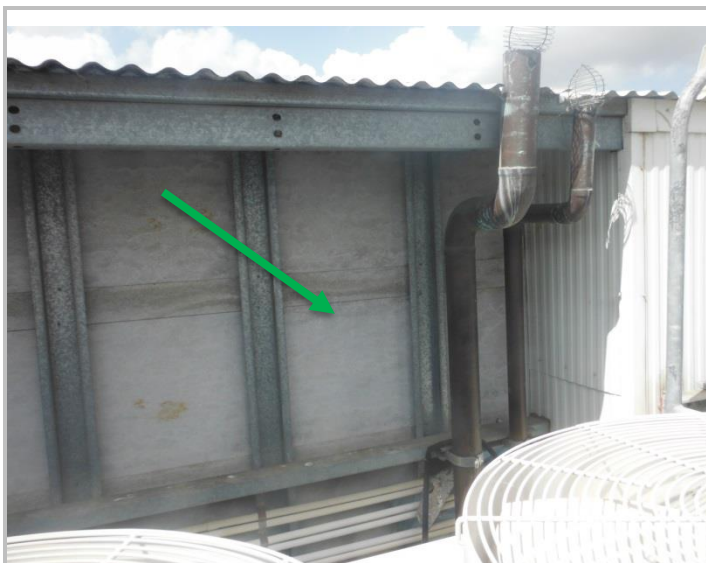
Photograph 77:

ISD Building – Rooftop Plant Area  
Fibre cement sheet to external walls is newer material and will be free of asbestos

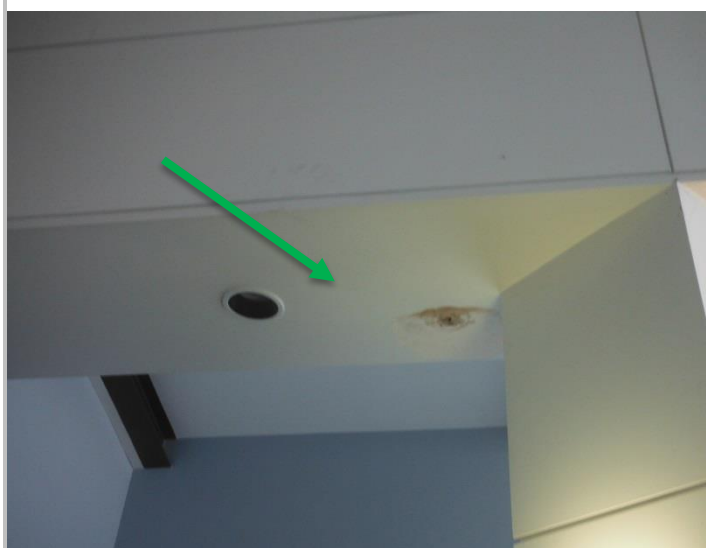
Photograph 78:

ISD Building – Throughout  
Plasterboard panels throughout on walls  
No asbestos sighted

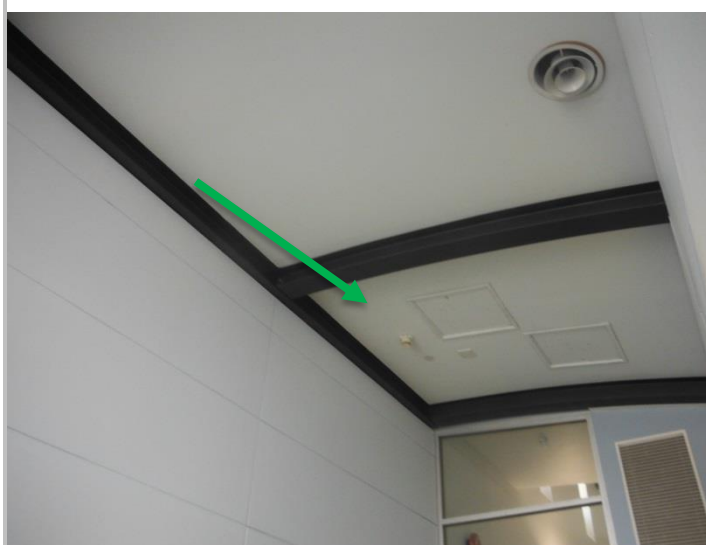
Photograph 79:

ISD Building – Throughout  
Plasterboard ceilings onto metal structural  
beams  
No asbestos sighted

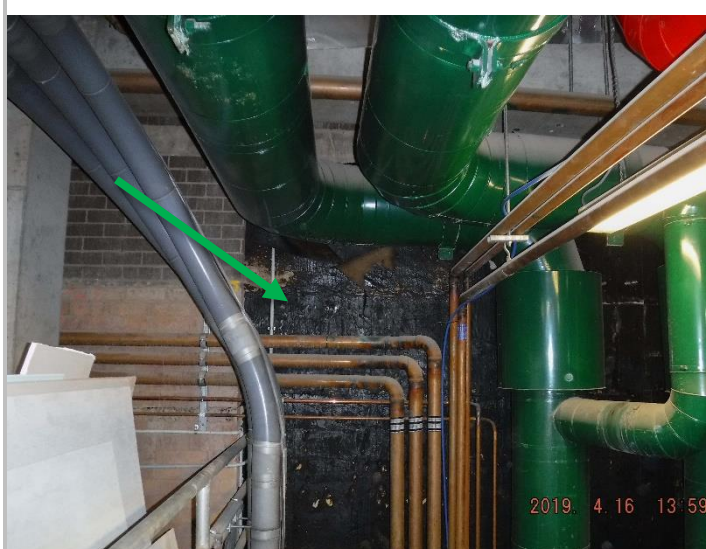
Photograph 80:

Caroline Chisholm – Basement  
Bituminous membrane on wall above  
tunnel entry is free of asbestos

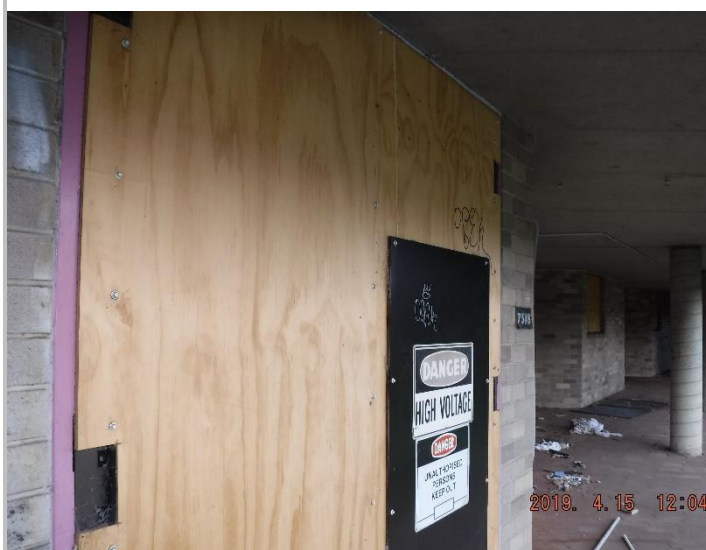
Photograph 81:

Ron Dunbier Building –  
Access restricted due to building being  
boarded up. It is assumed all the original  
asbestos remains, as per previous  
Asbestos inspections.
