Sydney Grammar School  
c/-Jattca Property Solutions  
Hazardous Materials Survey

Proposed SGS Weigall Sports Complex  
Neild Avenue, Paddington NSW

11 August 2020

58554/128597(Rev 0)

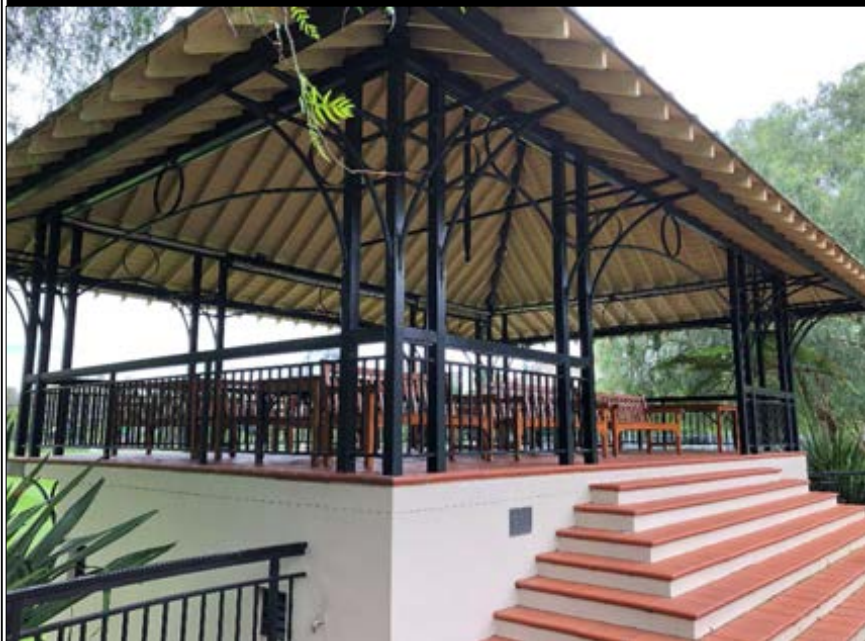
**PHOTOGRAPH 1 – PAVILION TOP FLOOR VIEW FACING NORTH EAST**

-	Barry Pavilion: Top floor/External black metal poles	Metal poles	1 to 4	Yes	-	XRF: 0.00 mg/cm <sup>2</sup>	Good	15 m <sup>2</sup>	No further action required	30/03/2020 JBS&G MN	-

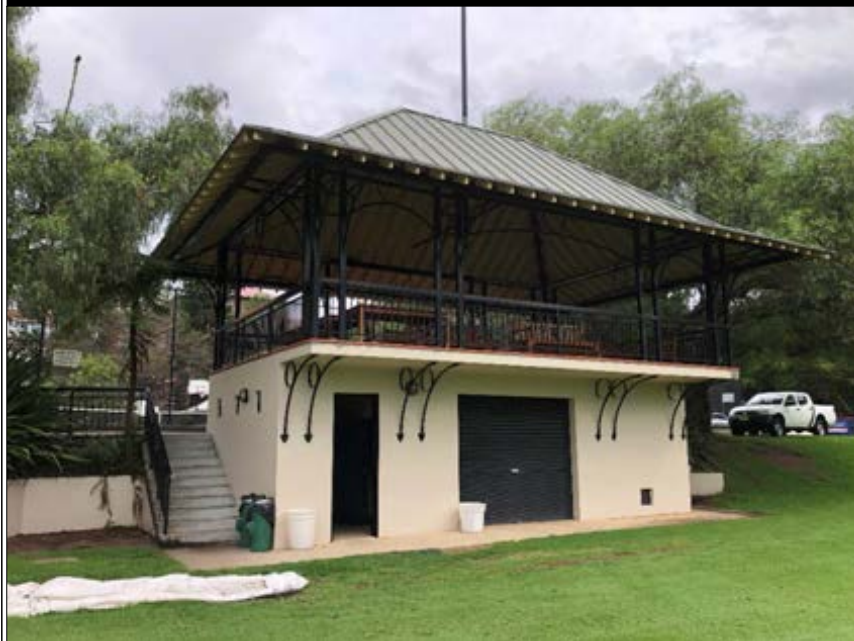
**PHOTOGRAPH 2 – PAVILION VIEW FACING SOUTH EAST**

-	Barry Pavilion: Ground floor/External cream walls	Concrete	2	Yes	-	XRF: 0.00 mg/cm <sup>2</sup>	Good	100 m <sup>2</sup>	No further action required	30/03/2020 JBS&G MN	-

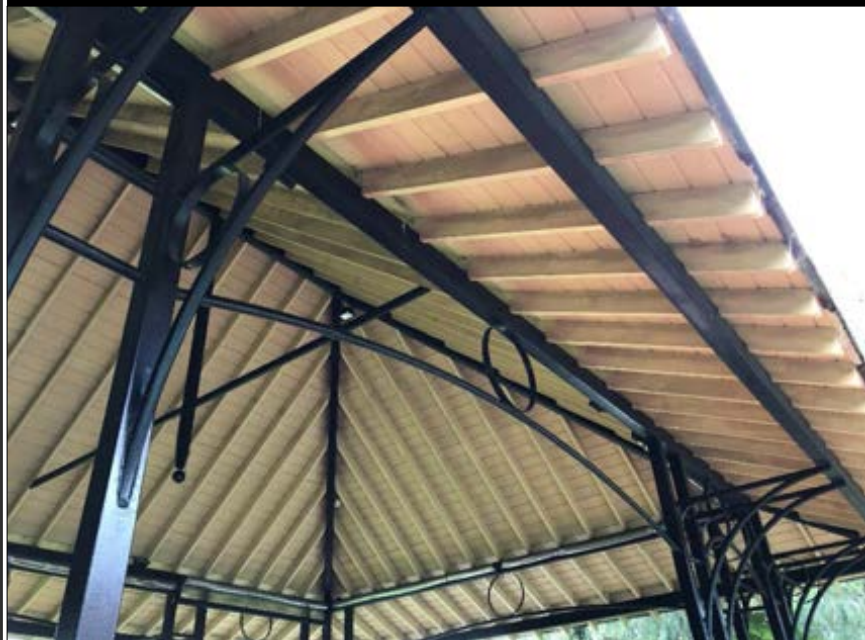
**PHOTOGRAPH 3 – PAVILION ROOF VIEW**

-	Barry Pavilion: Top floor/Cream roof timber	Timber	3 and 4	Yes	-	XRF: 0.00 mg/cm <sup>2</sup>	Good	20 m <sup>2</sup>	No further action required	30/03/2020 JBS&G MN	-

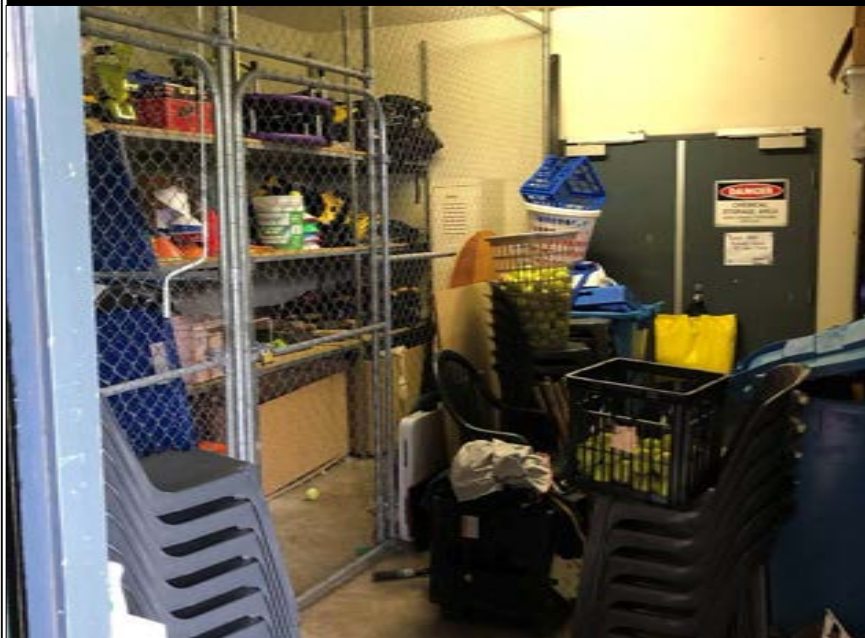
**PHOTOGRAPH 5 – PAVILION GROUND FLOOR – STORAGE ROOM**

-	Barry Pavilion: Ground floor/Internal cream walls	Concrete	5,6,7 and 9 to 12	Yes	-	XRF: 0.00 mg/cm <sup>2</sup>	Good	50 m <sup>2</sup>	No further action required	30/03/2020 JBS&G MN	-

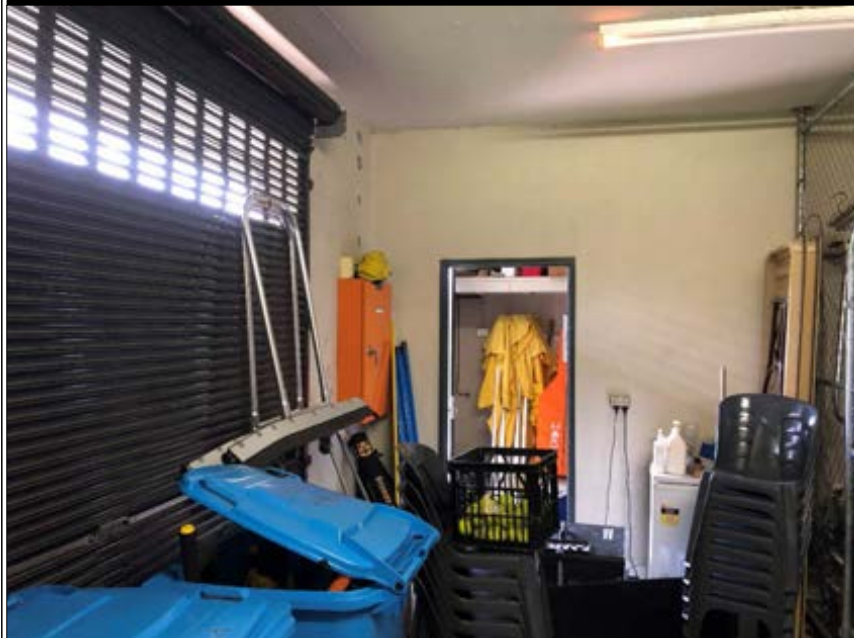
**PHOTOGRAPH 6 – PAVILION GROUND FLOOR – STORAGE ROOM**

-	Barry Pavilion: Ground floor/Internal white ceiling walls	Concrete	6,11 and 12	Yes	-	XRF: 0.00 mg/cm <sup>2</sup>	Good	50 m <sup>2</sup>	No further action required	30/03/2020 JBS&G MN	-

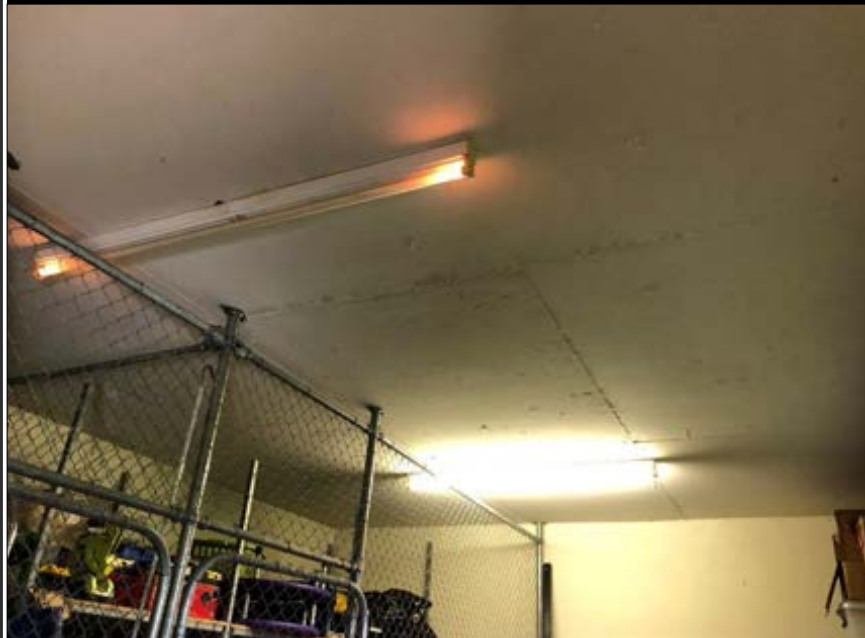
**PHOTOGRAPH 7 – PAVILION GROUND FLOOR – STORAGE ROOM CEILING AND LIGHTS**

Fluorescent lights were identified throughout the internal areas of the Barry Pavilion ground floor and were suspected to contain PCB capacitors.

All old fluorescent light fittings throughout the site are to be treated as containing PCB capacitors unless further investigation confirms otherwise.

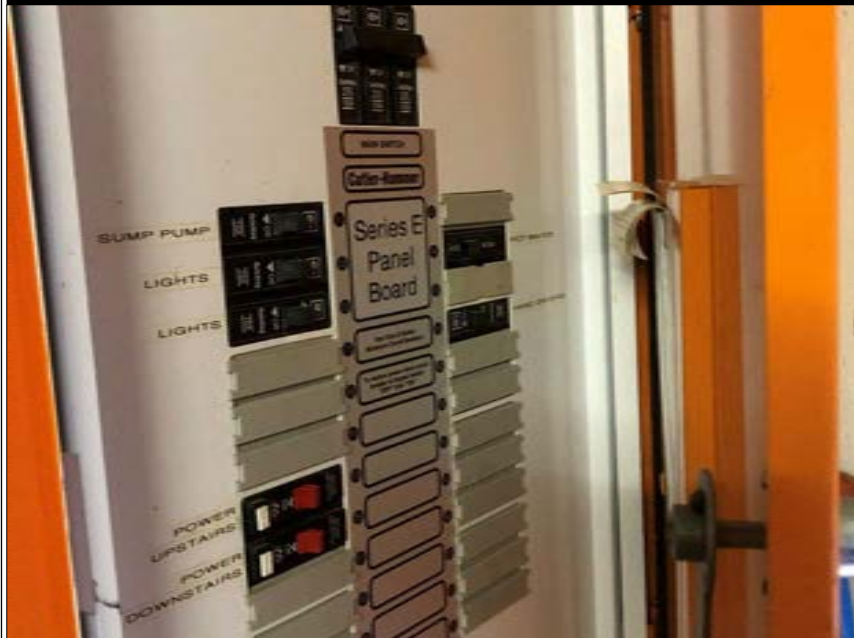
**PHOTOGRAPH 8 – PAVILION GROUND FLOOR – STORAGE ROOM ELECTRIC POWER BOARD**

- Non-lead based dark blue paint was identified to the internal doors and frames of the Barry Pavilion;
- An electric power board (EPB) was identified in the storage room of the Barry Pavilion, and was not suspected to contain hazardous material;

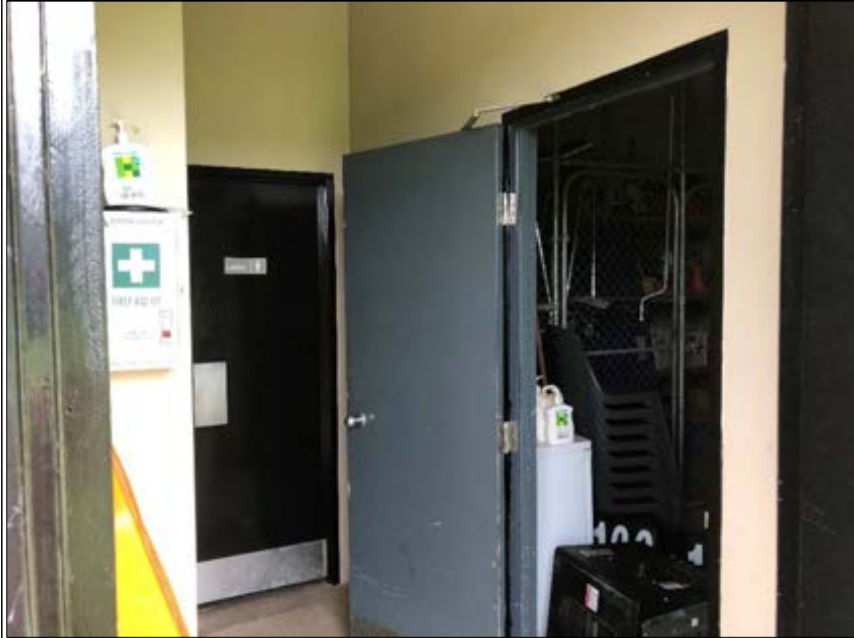
**PHOTOGRAPH 10 – PAVILION GROUND FLOOR – INTERNAL DOORS**

-	Barry Pavilion: Ground floor/Internal doors	Wood	10	Yes	-	XRF: 0.00 mg/cm <sup>2</sup>	Good	10 m <sup>2</sup>	No further action required	30/03/2020 JBS&G MN	-

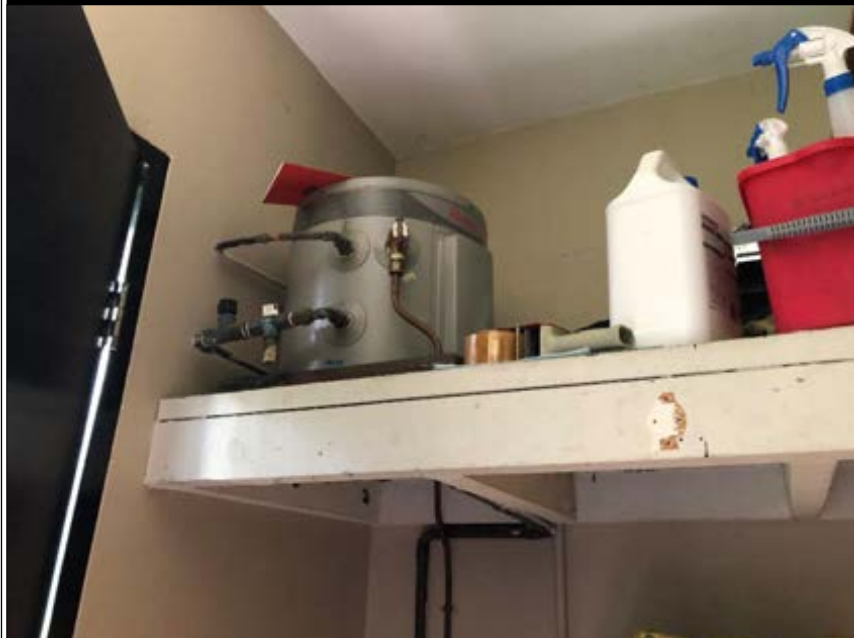
**PHOTOGRAPH 12 – PAVILION GROUND FLOOR HOT WATER SYSTEM**

SMF was suspected to be present within the hot water system identified at the time of inspection.

-	Ground floor	Internal insulation		No	-	<b>Assumed SMF</b>	Good	1 m <sup>2</sup>	Remove in accordance with NOHSC:2006 (1990)	30/03/2020 JBS&G MN	-
<b>Inaccessible Areas</b>											
All areas were accessible at the time of the inspection

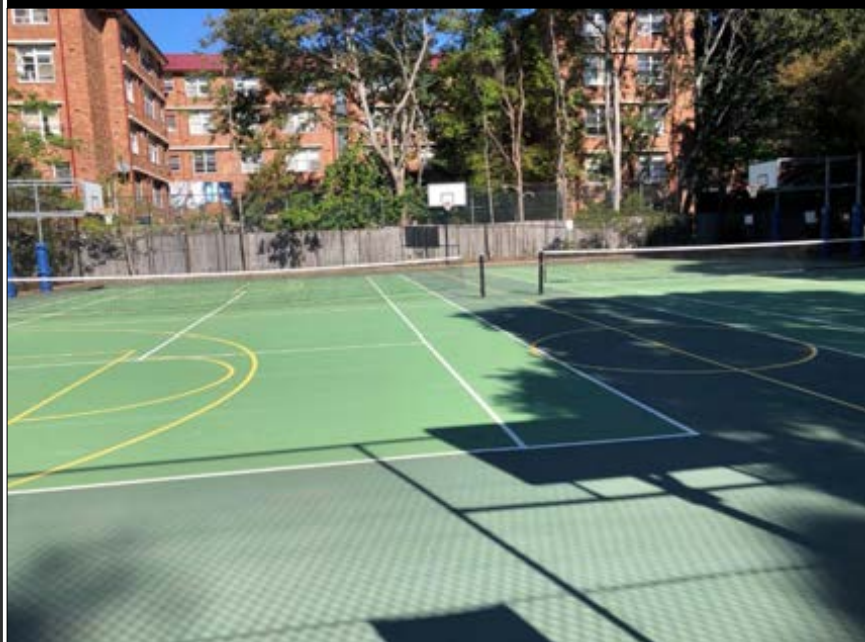
**PHOTOGRAPH 15 – TENNIS/BASKETBALL COURTS**

-	Tennis/Basketball Courts and Cricket Nets: Black metal poles and chain linked fence	Metal	15,18,19 and 20	Yes	-	XRF: 0.00 mg/cm <sup>2</sup>	Good	3000 m <sup>2</sup>	No further action required	28/05/2020 JBS&G MN

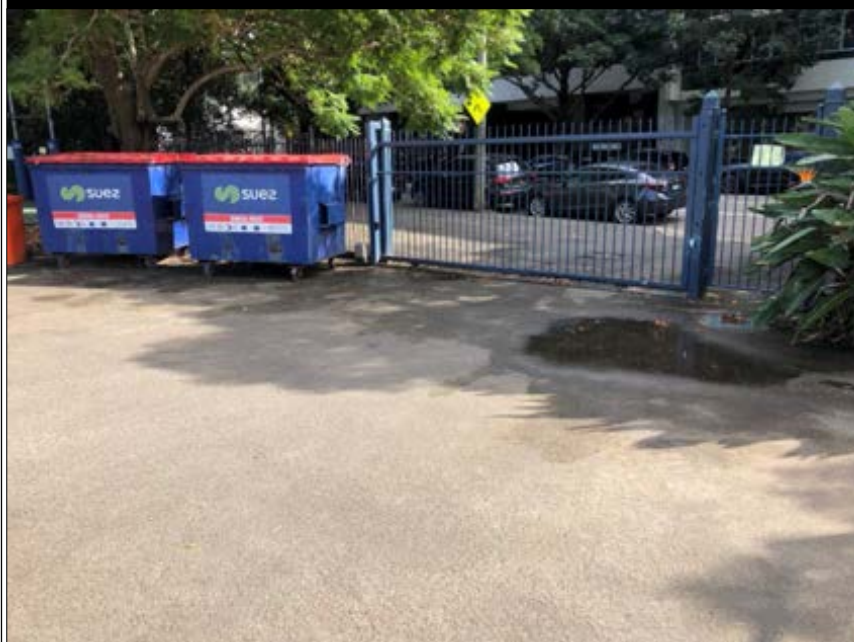
**PHOTOGRAPH 16 – ENTRY GATE VIA NEILD AVENUE**

-	Entry Gate/Fence: Blue Gate/Fence	Metal	16	Yes	-	XRF: 0.00 mg/cm <sup>2</sup>	Good	15 m <sup>2</sup>	No further action required	28/05/2020 JBS&G MN	
-	Tennis/Basketball Courts: Green Painted Floor	Asphalt	15,18,19 and 20	Yes	-	XRF: 0.00 mg/cm <sup>2</sup>	Good	3000 m <sup>2</sup>	No further action required	28/05/2020 JBS&G MN	
<b>Polychlorinated Biphenyls (PCBs)</b>											
Detailed inspection of light fittings could not be undertaken due to active electricity supply. All light fittings should be assumed to contain PCBs.									Undertake detailed inspection following isolation of electricity supply, <u>OR</u> Handle in accordance with ANZECC 1997	30/03/2020 JBS&G MN	-
<b>Synthetic Mineral Fibres (SMF)</b>
