**1-15 AND 2-12 CONFERTA AVENUE,
ROUSE HILL NSW 2155
TALLAWONG STATION PRECINCT SOUTH
PRE-DILAPIDATION REPORT**

**DEICORP PROJECTS
(TALLAWONG STATION) PTY LTD**

Job No. 191294.0
24/03/2020

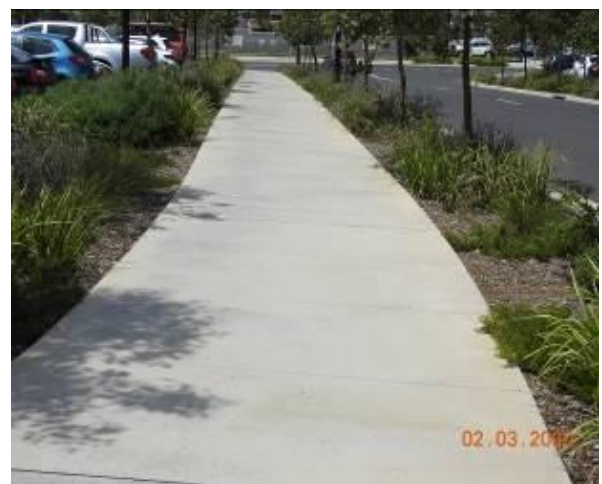
Figure 11 – General Condition of footpath pavement

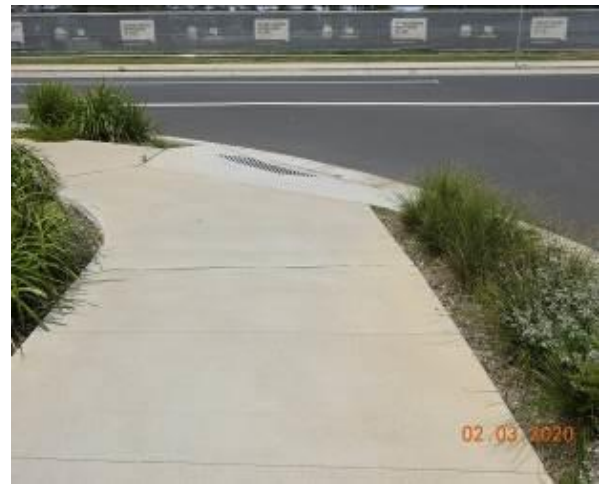
Figure 15 – General Condition of footpath pavement

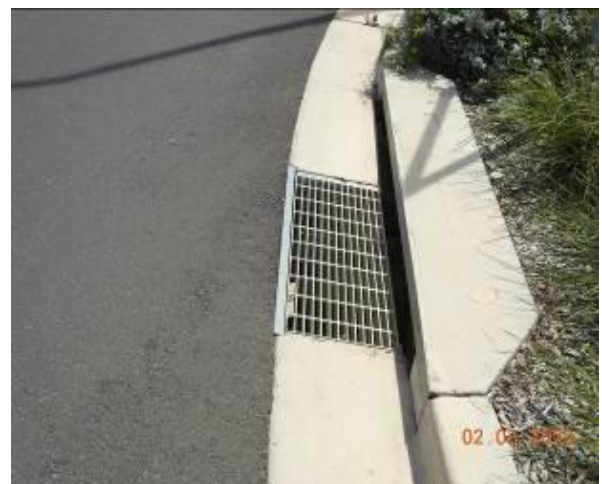
Figure 17 – General Condition of kerb and gutter

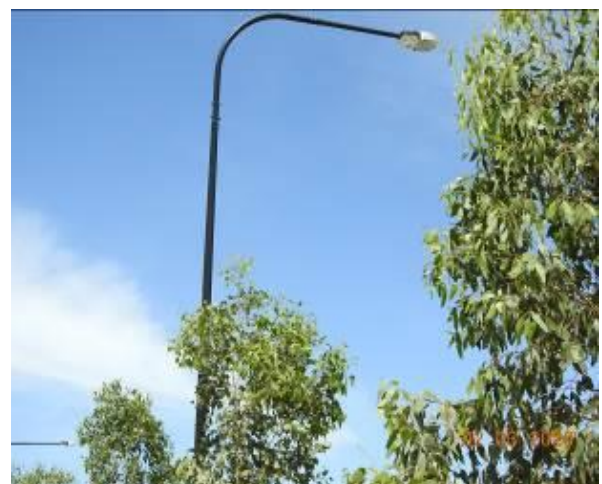
Figure 77 – General Condition of lamp post
Identification No.922702

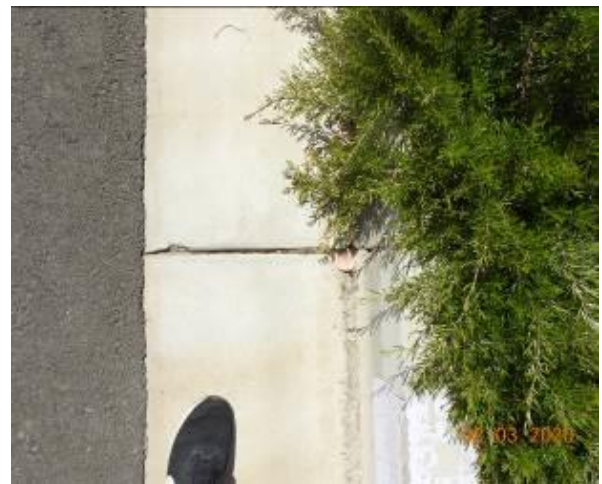
Figure 321 – General Condition of kerb and gutter

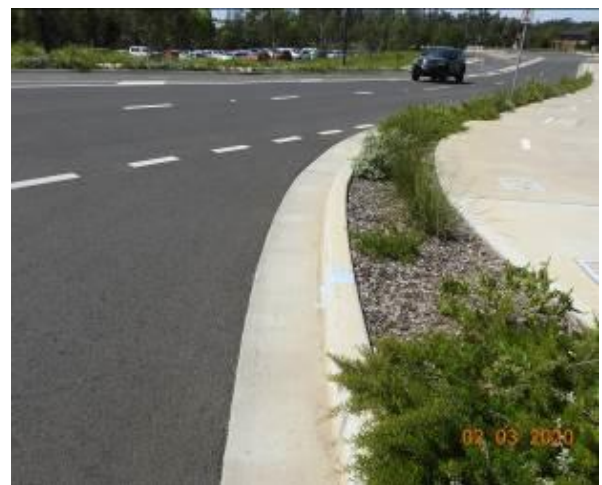
Figure 495 – Crack propagation through kerb and gutter

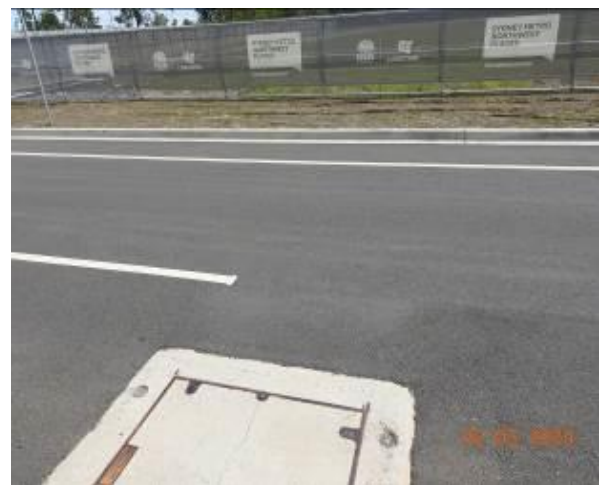
Figure 603 – Loss of material through service pit

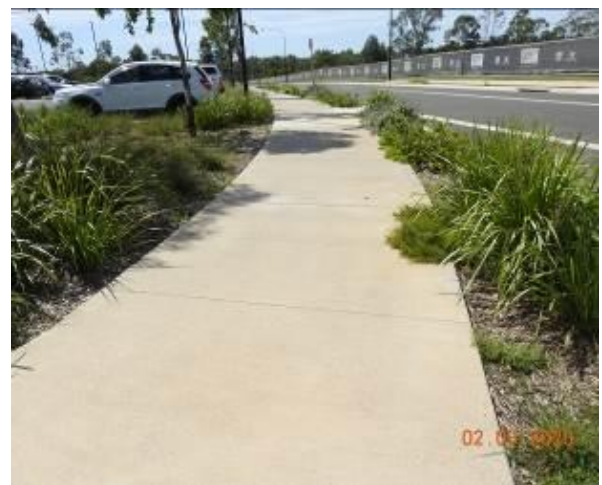
Figure 855 – Crack propagation through footpath pavement

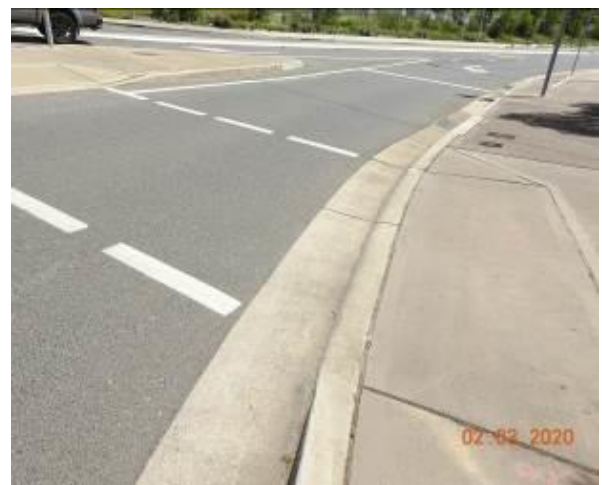
Figure 1506 – Loss of material through kerb

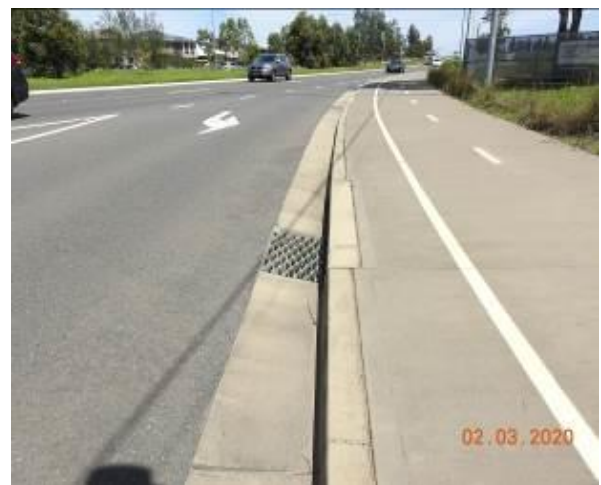
Figure 1566 – Loss of material through kerb

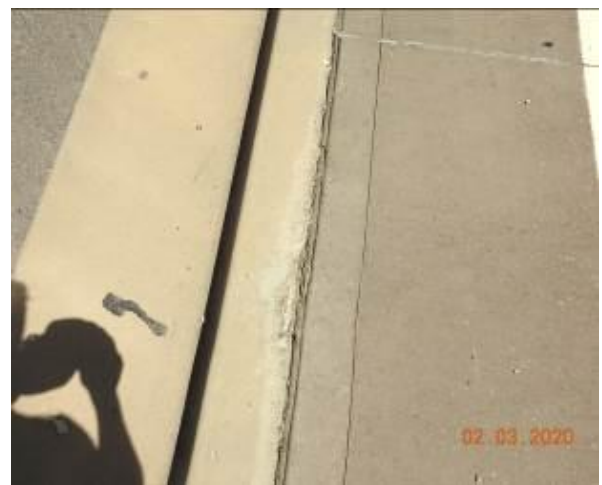
Figure 1638 – Crack propagation through kerb

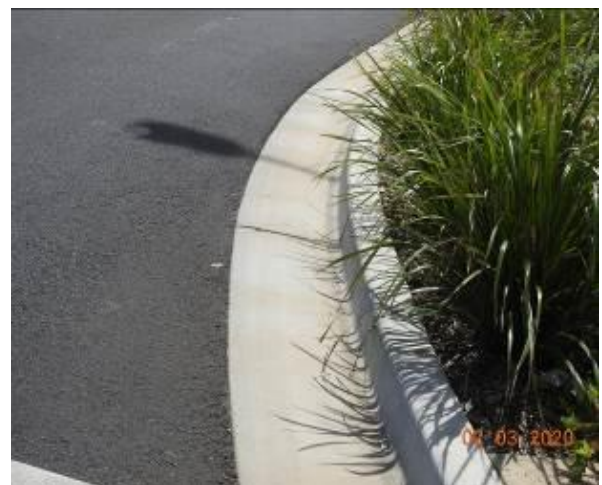
Figure 1951 – Crack propagation through kerb and gutter

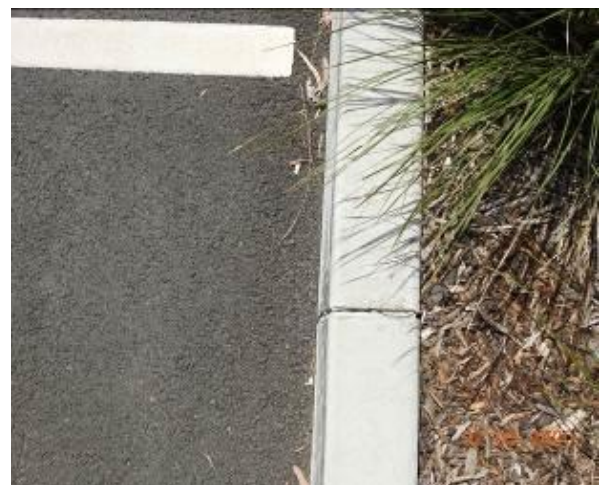
Figure 2065 – Crack propagation through kerb

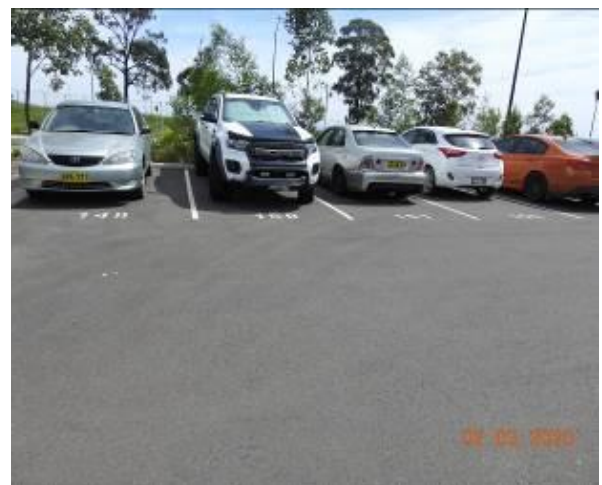
Figure 2620 – Crack propagation through carpark pavement

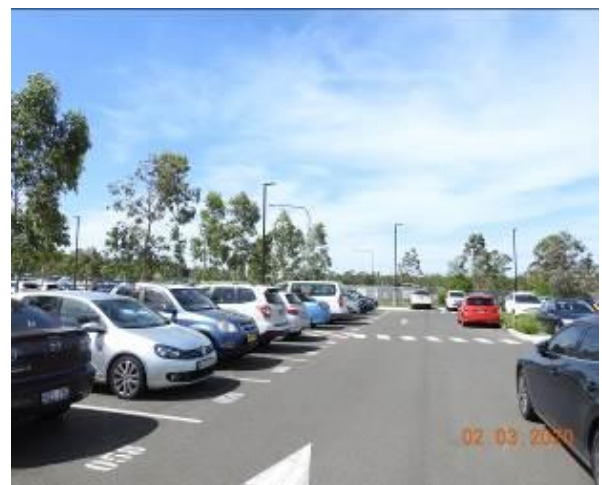
Figure 2996 – Loss of material through carpark pavement
