PROVISION OF CONSULTING ENGINEERING SERVICES

**81 GOW STREET,
PADSTOW NSW 2211
STORMWATER PIPE CONDITION & ADEQUACY**

Prepared for: Gow Street Recycling Centre
81 Gow St,
Padstow NSW 2211

26 APRIL 2021

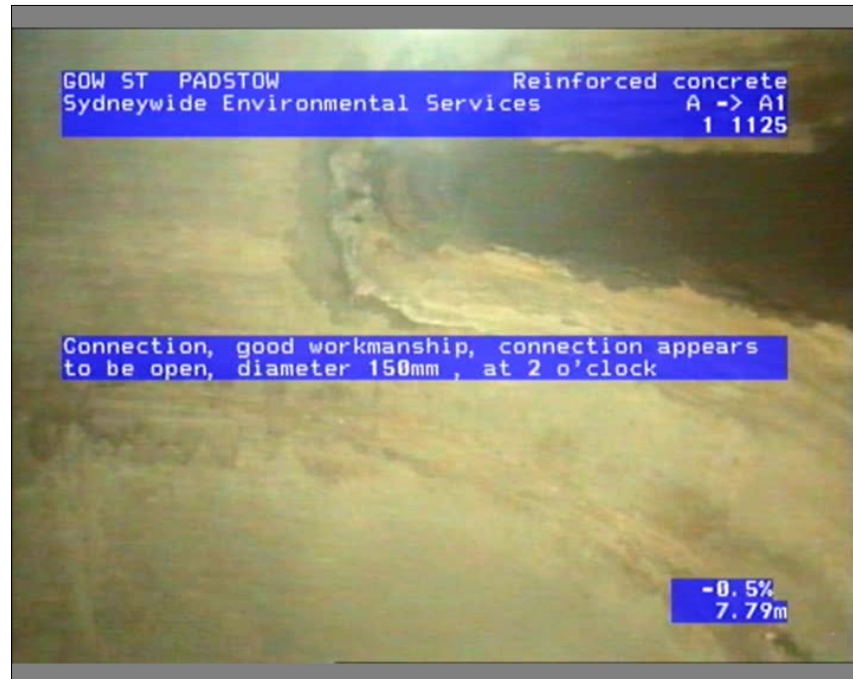
A number of smaller pipe connections can be observed in the CCTV report, of which 'Sydney Wide Environmental Services' state as good workmanship with the connection appearing open.

Photo: 082244_14042021_A.JPG, Media No.: TRIAXIAL CON_0, 00:03:02
7.79m, Connection, good workmanship, connection appears to be open, diameter 150mm , at 2 o'clock

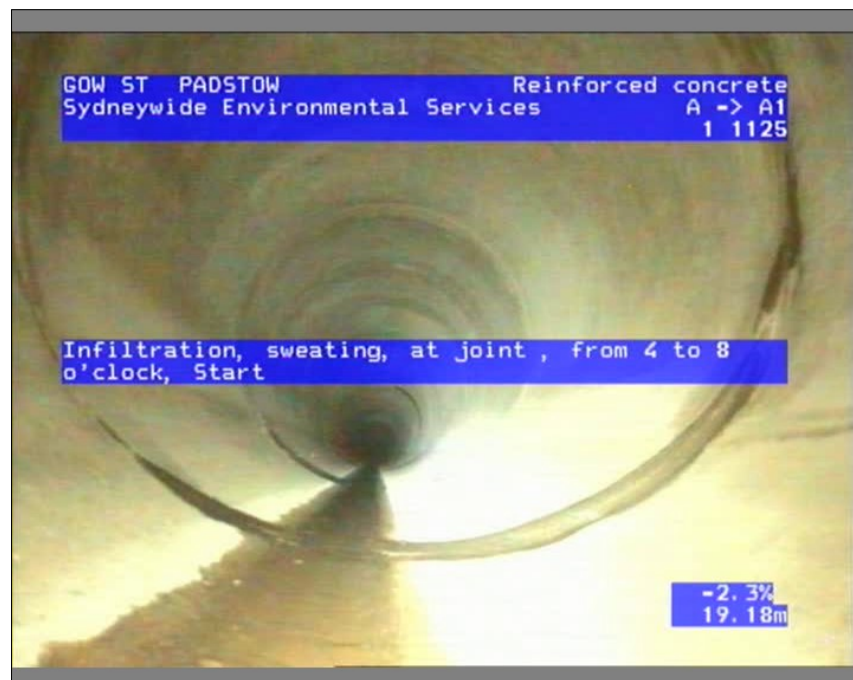
For pipe section 1 at chainage 19.18, Sydney Wide Environmental Services identify infiltration and sweating at a joint.

Photo: 082334_14042021_A.JPG, Media No.: TRIAXIAL CON_0, 00:03:45
19.18m, Infiltration, sweating, at joint , from 4 to 8 o'clock, Start

Subject to the above investigations, we recommend these areas are regularly monitored after repair to ensure the problem does not redevelop,

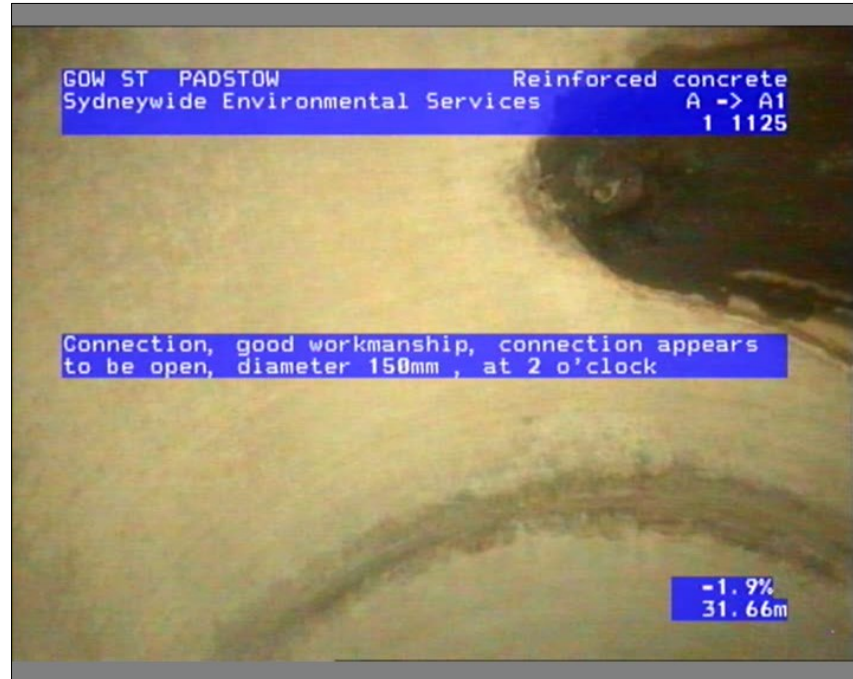
Photo: 082440_14042021_A.JPG, Media No.: TRIAXIAL CON_0, 00:04:41
31.66m, Connection, good workmanship, connection appears to be open, diameter 150mm , at 2 o'clock

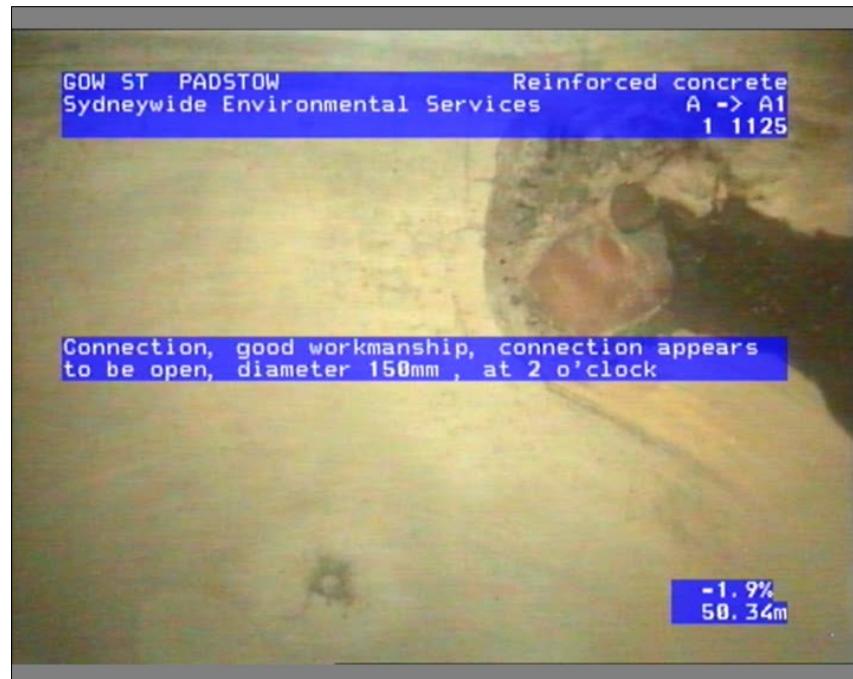
Photo: 083125_14042021_A.JPG, Media No.: TRIAXIAL CON_0, 00:09:36
50.34m, Connection, good workmanship, connection appears to be open, diameter 150mm , at 2 o'clock

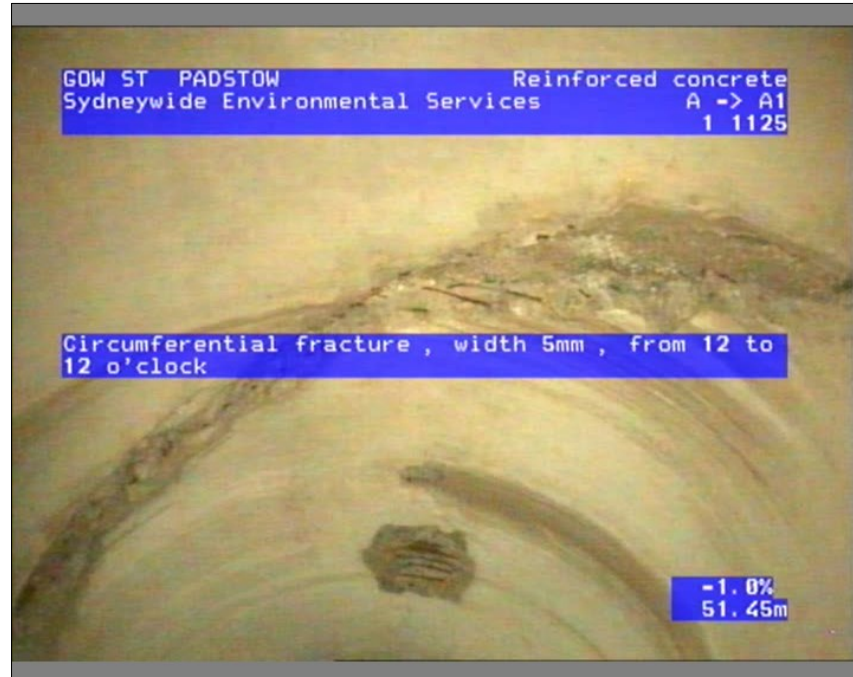
For pipe section 1 at chainage 51.45, Sydney Wide Environmental Services identify a 'circumferential fracture of approximately 5mm at the crown of the pipe.

Photo: 083354_14042021_A.JPG, Media No.: TRIAXIAL CON_0, 00:10:04
51.45m, Circumferential fracture , width 5mm , from 12 to 12 o'clock

Where a circumferential fracture was identified, we again recommend the area is further investigated to determine if there is a clear crack through the pipe wall, or if the deterioration is only to the inside of the pipe wall. Pending this, Triaxial can provide details for strengthening of the pipe section or patch repair. It should be noted that most of the ground settlement leading to circumferential cracking would be from initial loading. Since there is no planned increase in the magnitude of loading, we do not expect there to be significant additional ground settlements that could worsen the circumferential cracking.

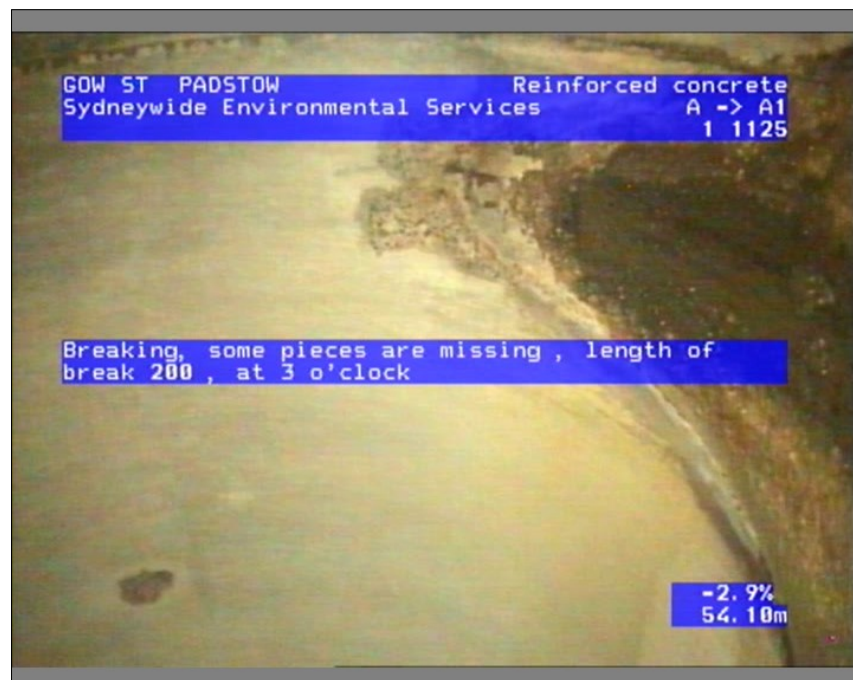
For pipe section 1 at chainage 54.1 and pipe section 2 at chainage 38.35, the report identifies breaking out of the inside of the concrete pipe, with some pieces missing.

Photo: 083418_14042021_A.JPG, Media No.: TRIAXIAL CON_0, 00:10:22
54.1m, Breaking, some pieces are missing , length of break 200 , at 3 o'clock

In the areas where Sydney Wide Environmental Services identified breaking out of concrete inside the stormwater pipe, we recommend further investigation to determine the extent of damage, particularly if there is any corrosion to the reinforcement. It is expected that the areas will require a patch fixing in order to improve the pipe's durability. Triaxial can provide remedial details if required.

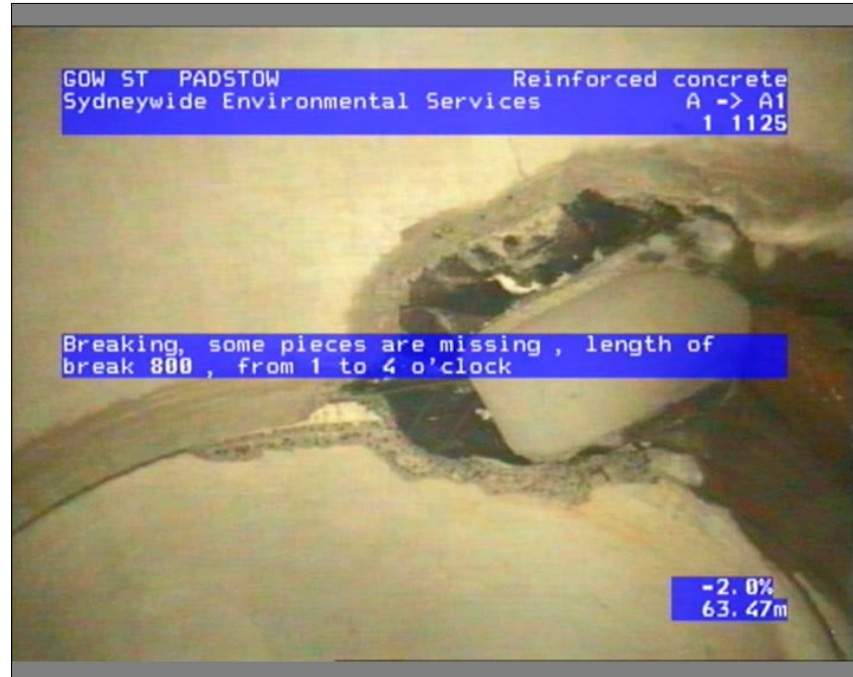
Photo: 083516_14042021_A.JPG, Media No.: TRIAXIAL CON_0, 00:11:07
 63.47m, Breaking, some pieces are missing , length of break 800 , from 1 to 4 o'clock

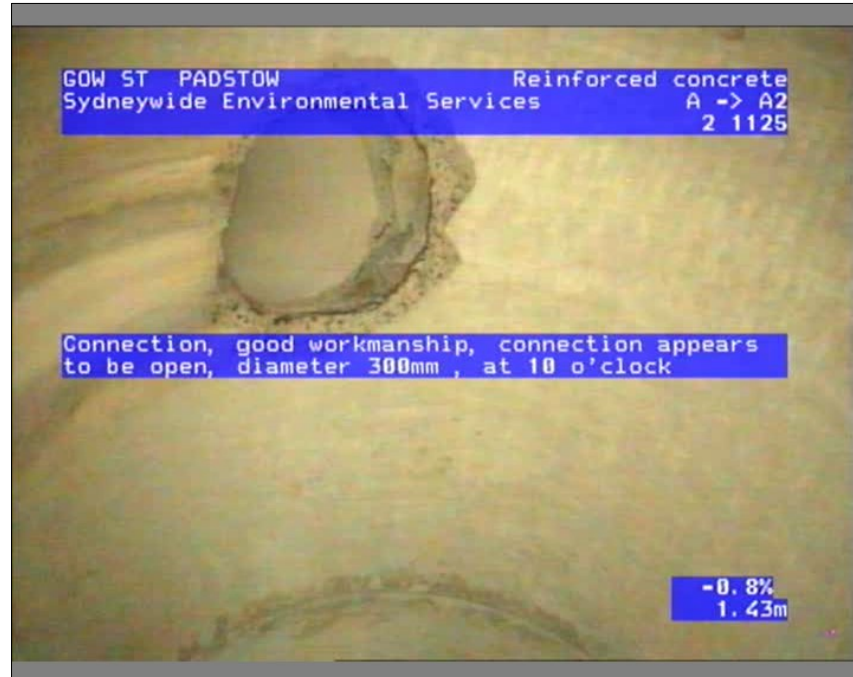
Photo: 084917_14042021_A.JPG, Media No.: TRIAXIAL CON_0, 00:00:30
1.43m, Connection, good workmanship, connection appears to be open, diameter 300mm , at 10 o'clock

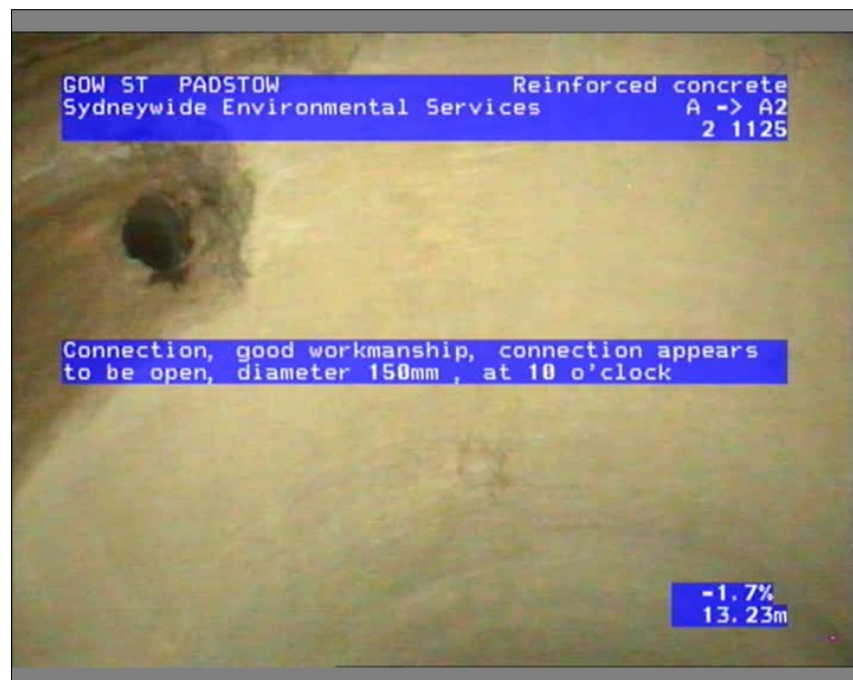
Photo: 084957_14042021_A.JPG, Media No.: TRIAXIAL CON_0, 00:01:03
13.23m, Connection, good workmanship, connection appears to be open, diameter 150mm , at 10 o'clock

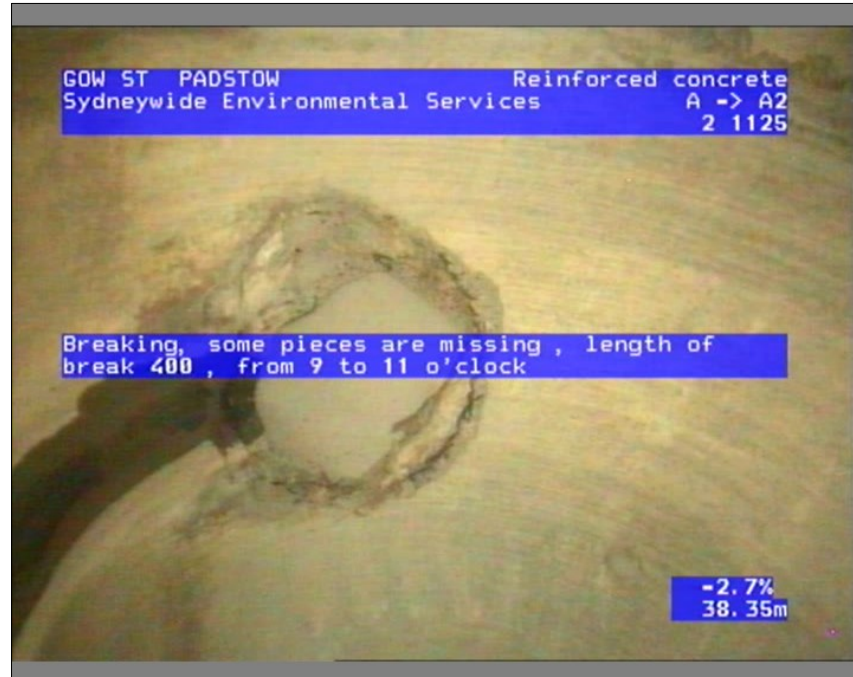
Photo: 085116_14042021_A.JPG, Media No.: TRIAXIAL CON_0, 00:02:07
38.35m, Breaking, some pieces are missing, length of break 400, from 9 to 11 o'clock

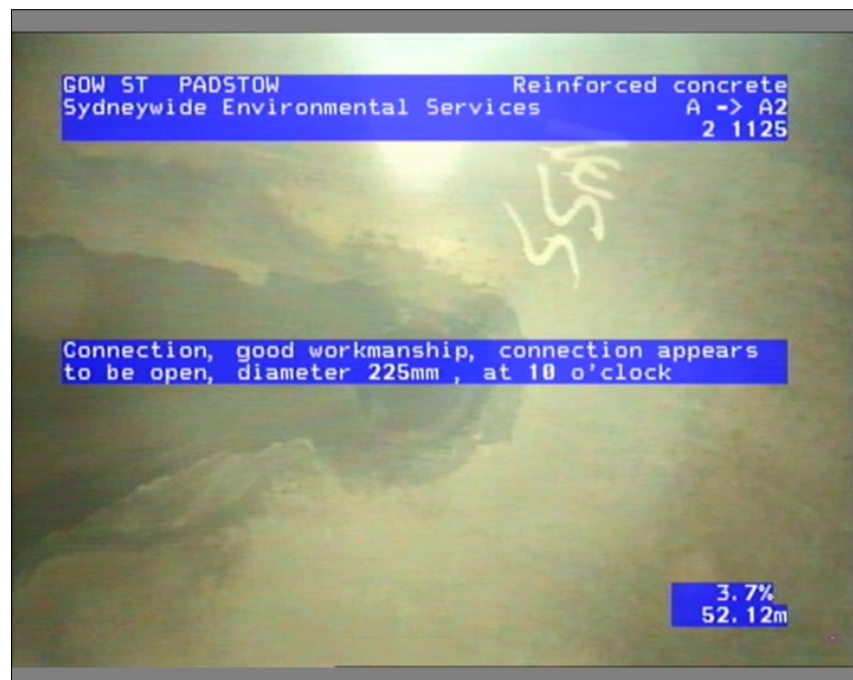
Photo: 085207_14042021_A.JPG, Media No.: TRIAXIAL CON_0, 00:02:44
52.12m, Connection, good workmanship, connection appears to be open, diameter 225mm, at 10 o'clock

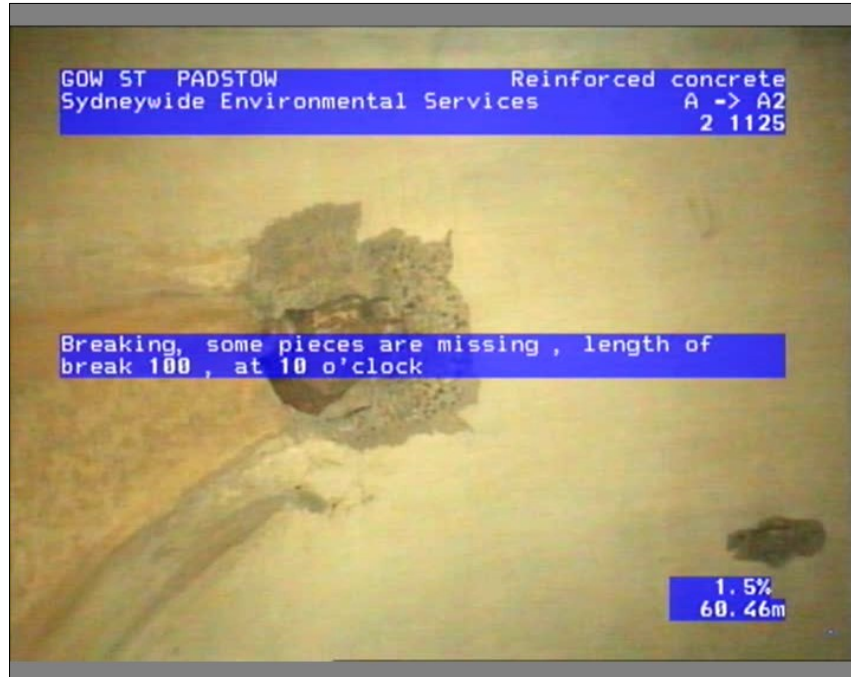
Photo: 085253_14042021_A.JPG, Media No.: TRIAXIAL CON_0, 00:03:24
 60.46m, Breaking, some pieces are missing , length of break 100 , at 10 o'clock
