ARBORICULTURAL IMPACT ASSESSMENT

Prepared for: Matthew Spooner (Senior Project Manager) Taronga Conservation Society Australia

Site: Bradleys Head Road, Mosman NSW 2088

Project Name	Taronga Zoo Upper Australia Project
Project Number	SYD-ARBOR-2133
Project Manager	Garry Neilsen
Produced by	Mathew Phillips
Reviewed by	Greg Thallon
Approved by	Mathew Phillips
Status	Final
Version Number	V4
Last saved on	6 th December 2021

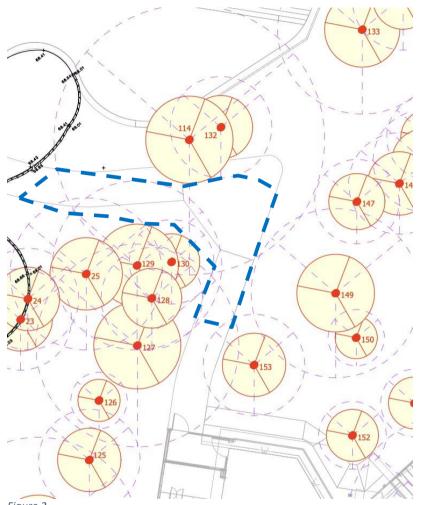
- The proposed path within the SRZ of tree 114 as shown in Figure 2 (Not the blue hashed line), is recommended to be shifted outside the SRZ of tree 114 given this tree is a high priority for retention. This has potential to adversely impact tree 130 and potentially tree 129.
- The blue hatched line is where the proposed path is recommended to be installed.
- This new proposed location will require a grade change and cut into the TPZ of tree 129 and 130 and may require significant root removal from both trees.
- Tree 130 has a substantial lean over the proposed path and may also require removal once excavation and levels have been confirmed through the installation of the path.
- 5.1.8 Tree 156 Eucalyptus botryiodes (Bangalay)

- 6.4.2 Conduct non-destructive root exploration in the proposed cut locations to assess for tree roots.
- 6.4.3 Have flexibility within the placement of the path with possible path movement where structural roots are found.

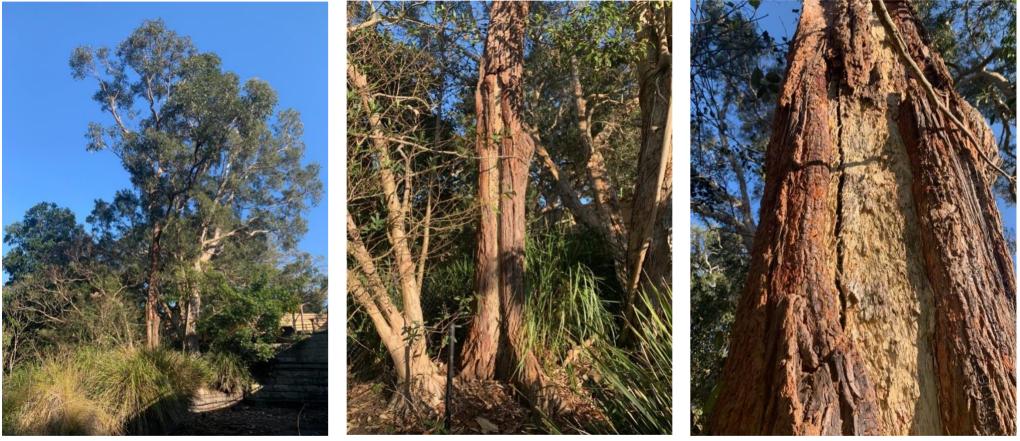
9.5 APPENDIX 5: Tree 20 Defect Images

- Significant basal wound on the northern side of trunk extending from ground level to 4m in height.
- Significant basal wound on the southern side of trunk extending from ground level to 4m in height, opposing the adjacent defect.
- Internal vertical crack within heartwood.
- Internal white rot decay.

The part assessed to fail at defect 1, basal wound with internal decay and vertical crack, over the development site and within fall distance to children's play area, resulted in a Risk of Harm (ROH) **1/400K**. This risk is Unacceptable, this risk will not ordinarily be tolerated with an action response to control the risk. A reasonable response to the risk is mitigation through whole tree removal. There are no Arboricultural practices to save this tree through other mitigation measures.

Figure 3 Shows Tree 20.

Figure 4 Shows the basal defect.

Figure 5 Shows the vertical crack within the defect and heartwood.

- 6.1 The removal of tree **20** is supported as risk mitigation to potential tree failure impacting targets within the development site working below the tree and guests to the zoo within fall distance of the tree.

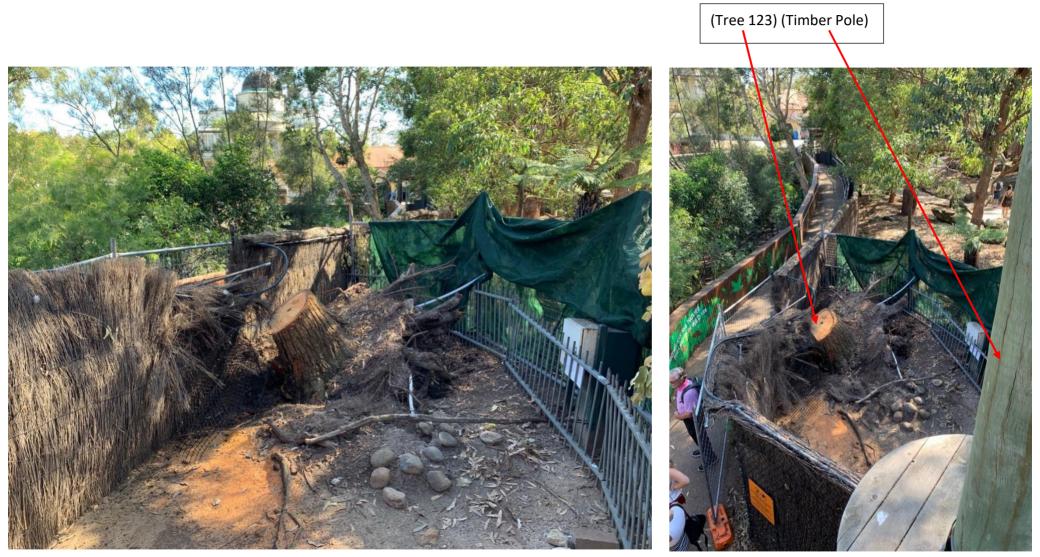
9.6 APPENDIX 6: Tree 123 Failure Images

The subject tree was removed due to failure on the 18th of February 2020 by Sydney Arbor Trees. The subject tree failed during an extreme weather event. Appendix 6 shows the subject tree failure and plan image showing tree location.

Figure 6 Shows tree 123 root plate failure.

Figure 7 Shows tree 123 failure from above the ropes course building.
