Mosman Public School – Update to Asbestos and Hazardous Materials Report

**Limited Asbestos and Hazardous
Materials Pre-Demolition Survey R02**

Mosman High School
769 Military Road
Mosman NSW 2088

13 May 2020

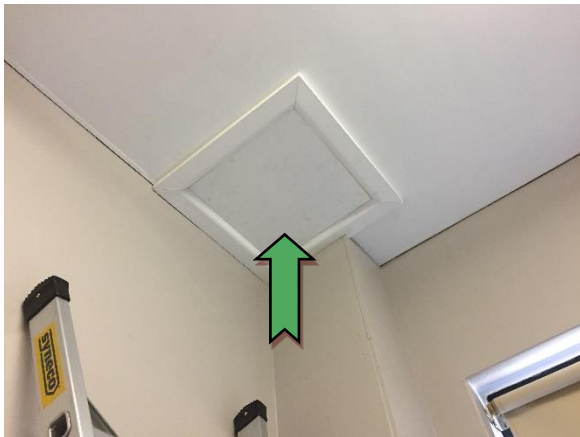
Photo 1 Interior: ground level, administration lunch room, man hole – non asbestos containing fibre cement sheet.

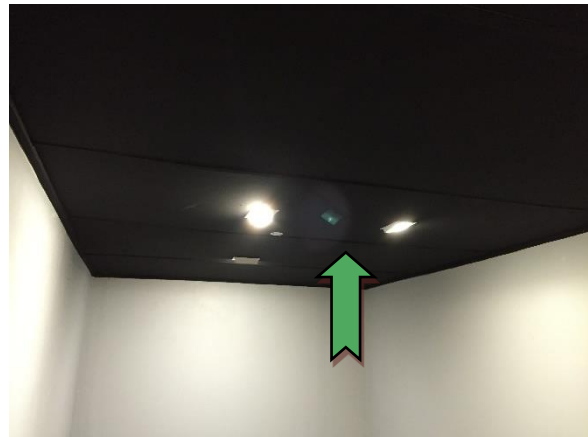
Photo 2 Interior: level 1, stairwell to counselors' office, ceiling – non asbestos containing fibre cement sheet.

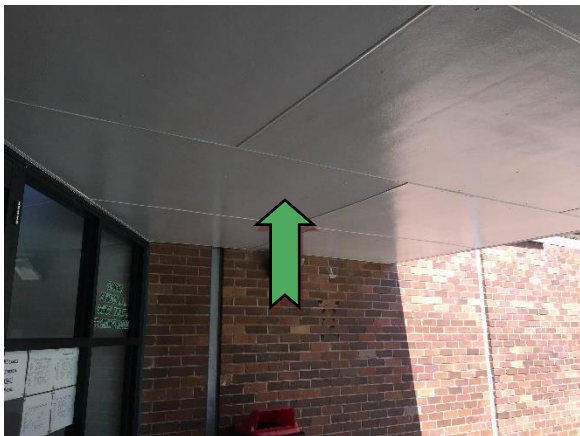
Photo 3 Exterior: ground level, entrance adjacent hall, ceiling – non asbestos containing fibre cement sheet.

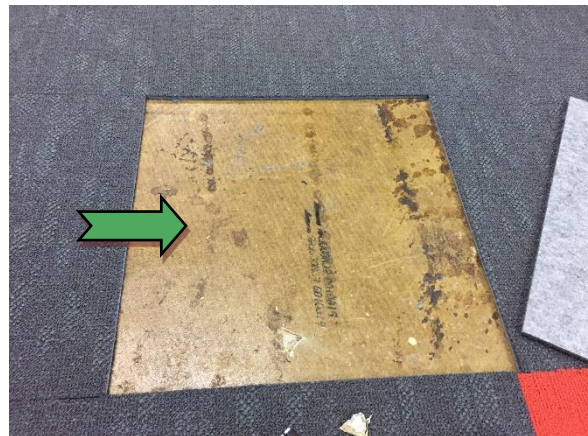
Photo 4 Interior: level 1, throughout library under carpet – non asbestos containing yellow vinyl floor tiles.

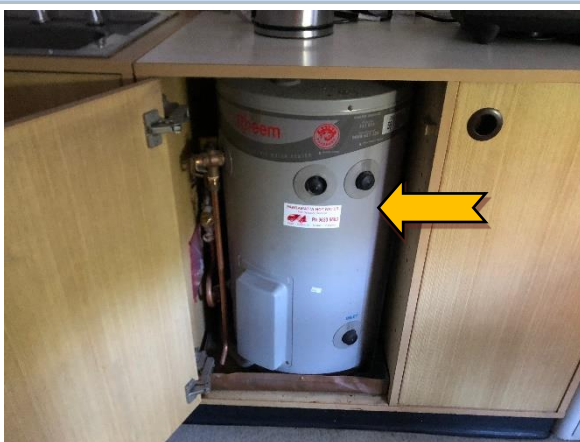
Photo 5 Interior: ground level, administration lunch room, hot water heater – suspected SMF containing internal insulation.

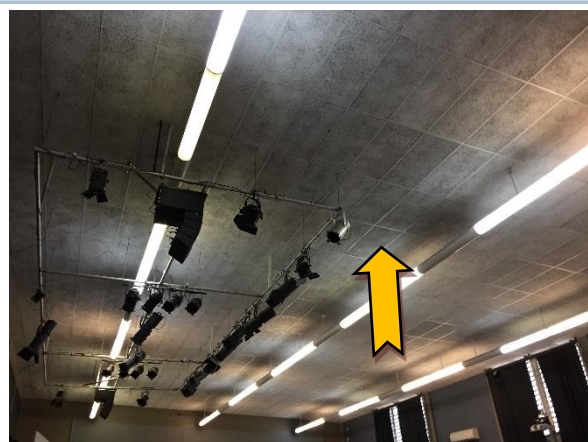
Photo 6 Interior: ground level, hall, ceiling – suspected SMF containing compressed ceiling tiles.

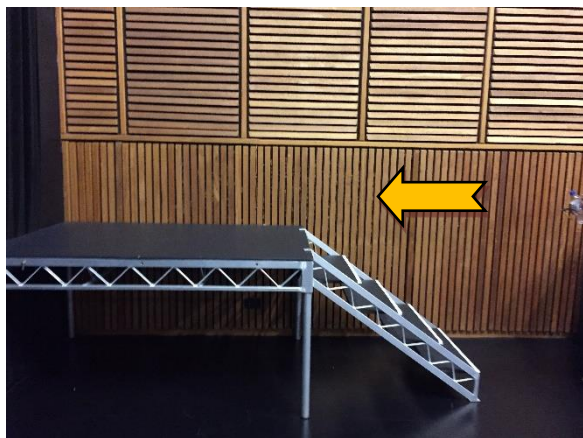
Photo 7 Interior: ground level, theatre behind wooden walls – suspected SMF containing insulation material.

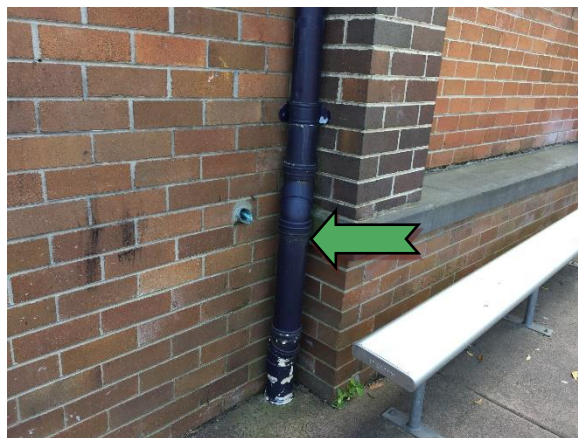
Photo 8 Exterior: Throughout, doors and pipes – non lead based purple paint.

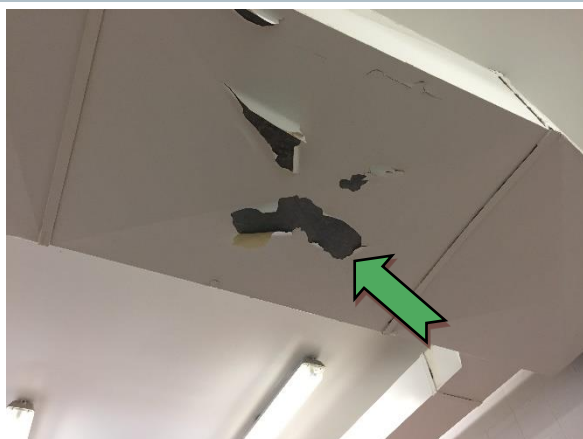
Photo 9 Interior: ground level, male and female toilets, air conditioning ductwork – non lead based white paint.

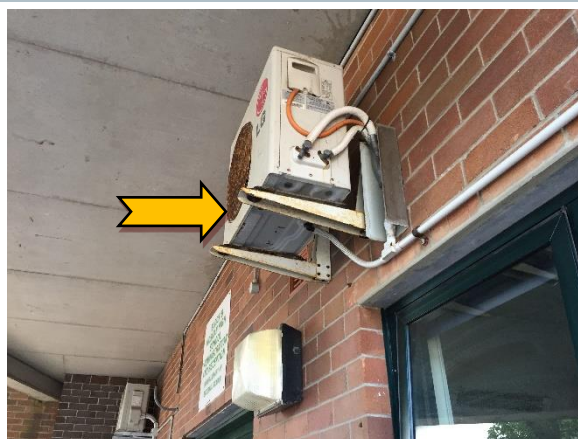
- Exterior: ground level, adjacent entrance to reception, air conditioning unit – suspected ODS containing refrigerant.

Photo 10 Exterior: ground level, adjacent entrance to reception, air conditioning unit – suspected ODS containing refrigerant.

Removal should to be undertaken prior to any future demolition, partial demolition, renovation or refurbishment, where ODS's are likely to be disturbed. A licensed contractor who will recycle and reuse the refrigerant should decommission CFC and HCFC based equipment that is being disposed of in accordance with Association of Fluorocarbon Consumers and Manufacturers, The Australian Refrigeration and Air Conditioning Code of Good Practice – 1992 and the Australian Commonwealth Government Ozone Protection Act – 1989.

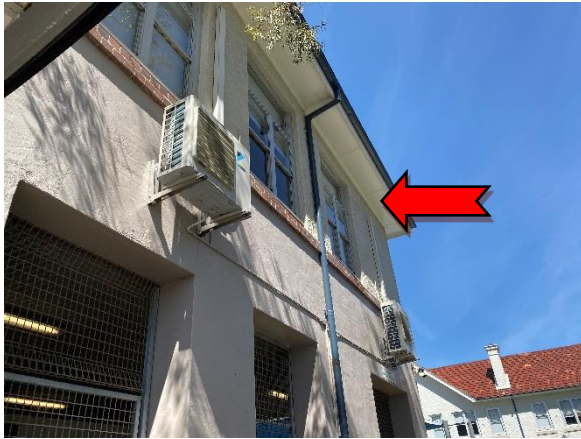
Photo 11 Exterior: all levels, throughout, eaves, and beading to eaves – asbestos containing fibre cement sheet and moulded fibre cement.

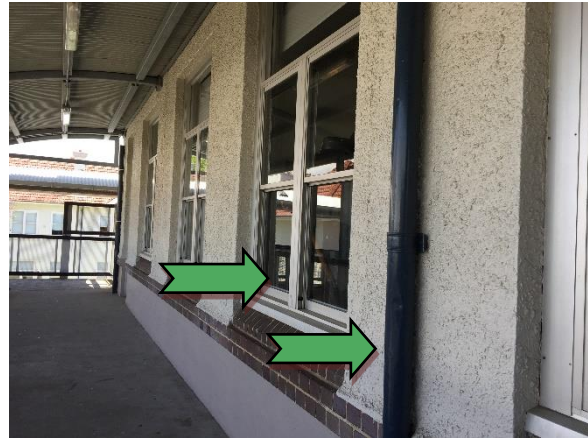
Photo 12 Exterior: throughout, walls and windows – non asbestos containing textured coating, and window mastic.

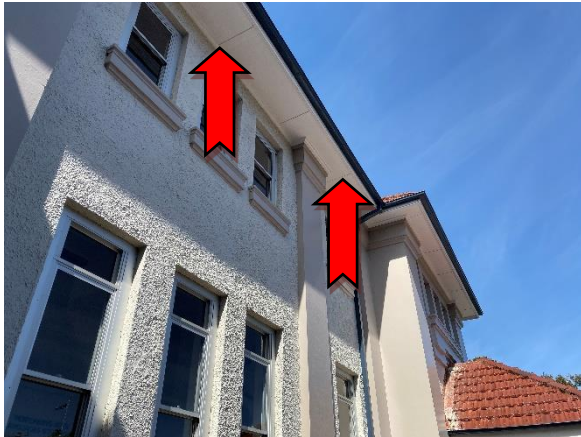
Photo 13 Exterior: all levels, throughout, eaves and beading to eaves – asbestos containing fibre cement sheeting and moulded fibre cement.

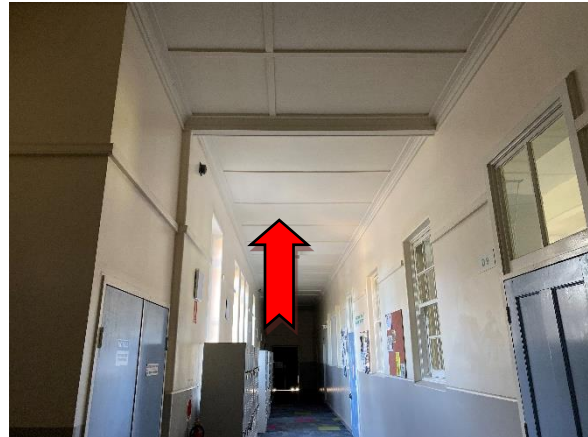
Photo 14 Interior: all levels, throughout, ceiling – asbestos containing fibre cement sheeting.

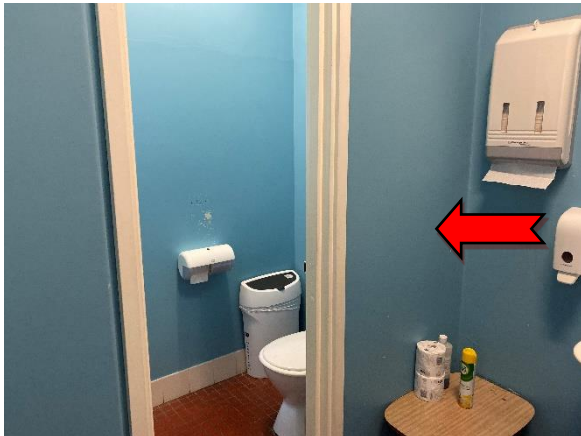
Photo 15 Interior: level 1, print room, staff toilets, walls – asbestos containing fibre cement sheet.

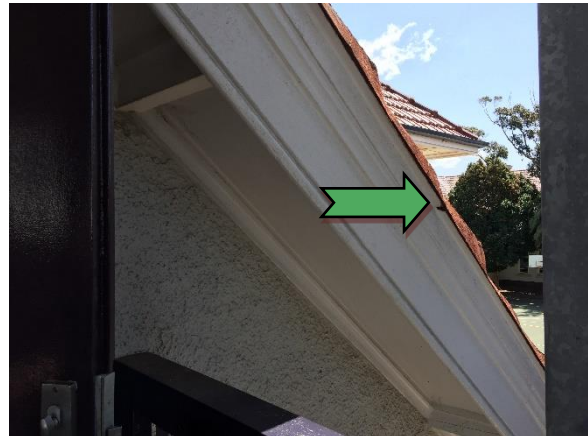
Photo 16 Exterior: level 1, throughout, roof, verge lining – non asbestos containing fibre cement sheet.

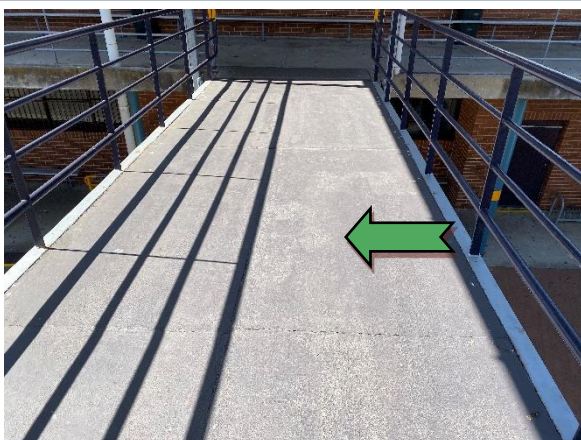
Photo 17 Exterior: level 1, walkway between Block E and D, floor – non asbestos containing fibre cement sheet.

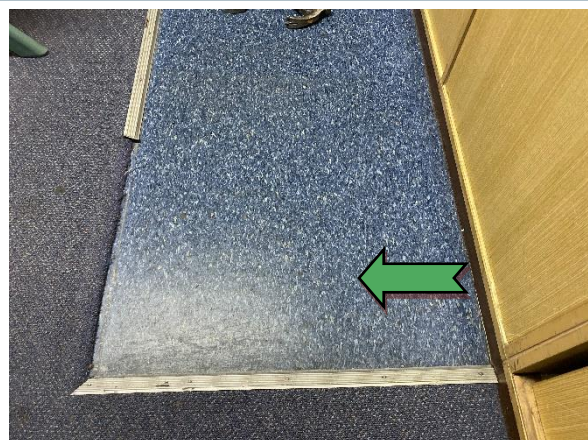
Photo 18 Interior: throughout classrooms, in front of sinks – non asbestos containing blue vinyl sheet.

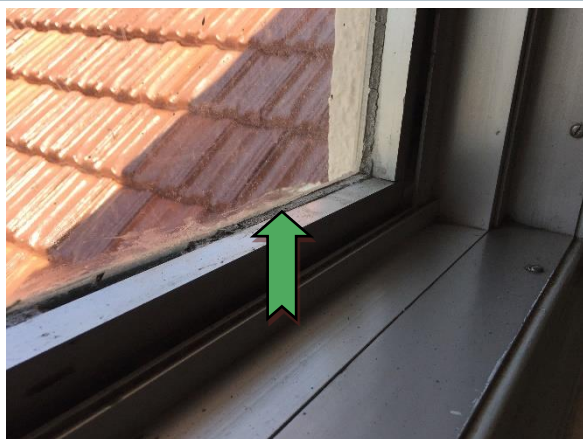
Photo 19 Interior: throughout, windows to exterior – non asbestos containing window mastic.

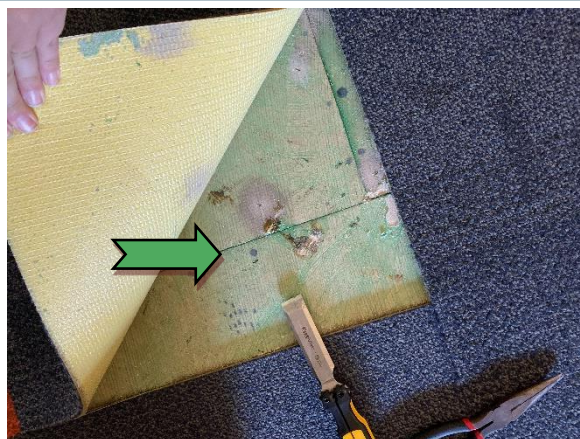
Photo 20 Interior: ground level, throughout, under carpet, floor – non asbestos containing paper backing.

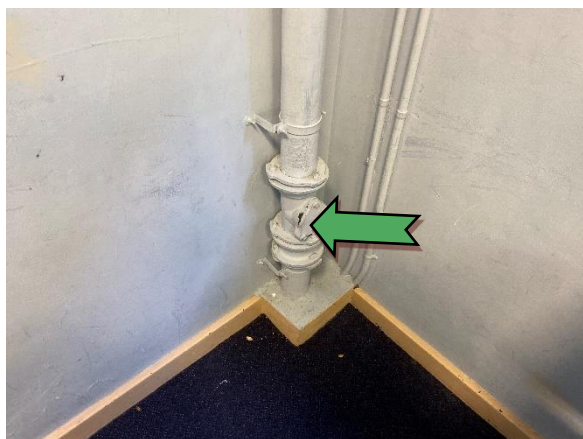
Photo 21 Interior: ground level, D1A classroom, pipe work – non asbestos containing gasket.

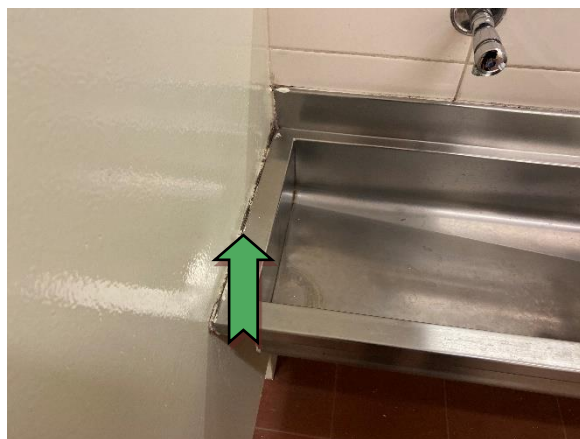
Photo 22 Interior: ground level girls toilets, sink – non asbestos containing mastic sealant.

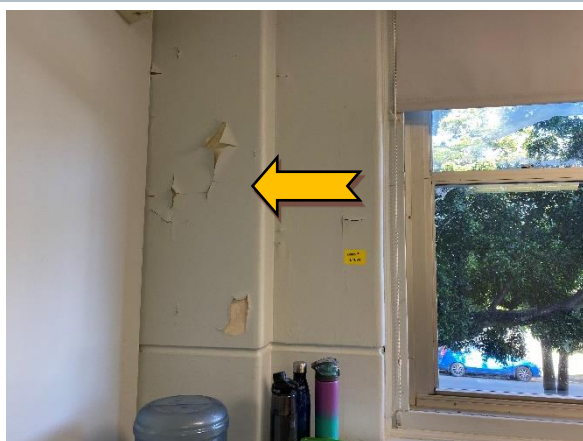
Photo 23 Interior: all levels, throughout, walls – 0.19% lead based light-blue paint.

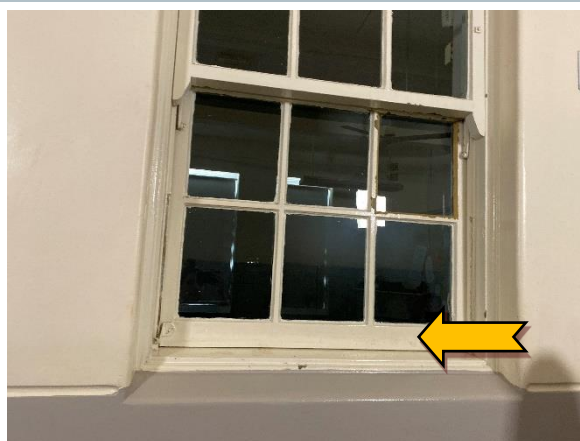
Photo 24 Interior: all levels, throughout, window frames – 0.28% w/w lead containing white paint.

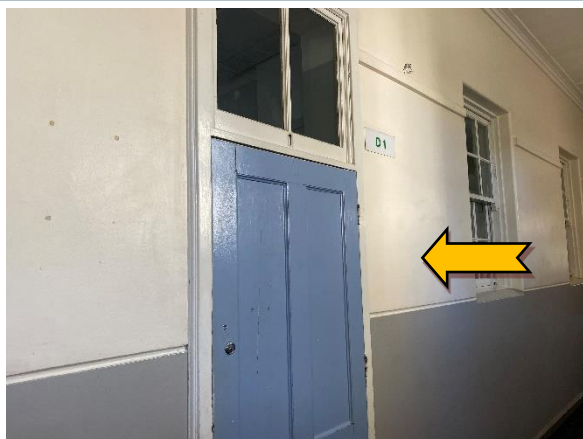
Photo 25 Interior: all levels, throughout, walls – 0.15% w/w lead containing white paint.

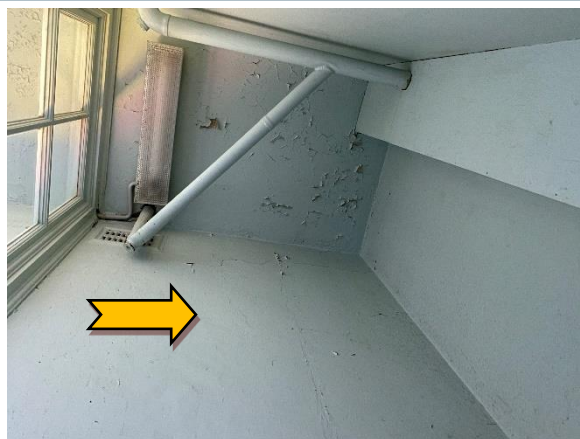
Photo 26 Interior: ground level, toilet within D2A, walls and ceiling – 0.21% w/w lead containing light-blue paint.

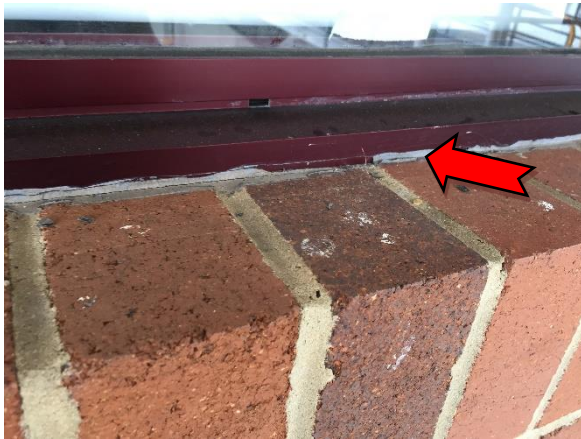
Photo 27 Exterior: throughout, window frames – asbestos containing window mastic.

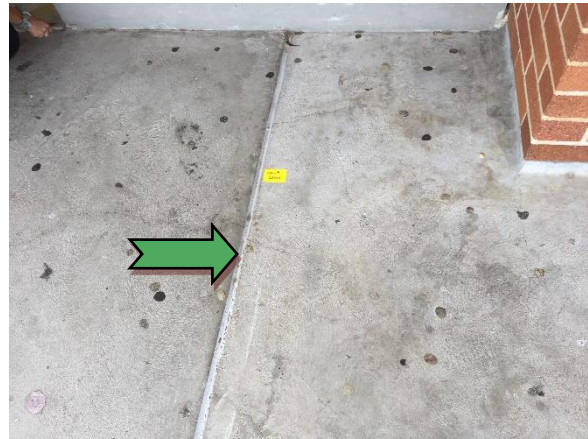
Photo 28 Exterior: level 1, throughout, floor – non asbestos containing expansion joint.

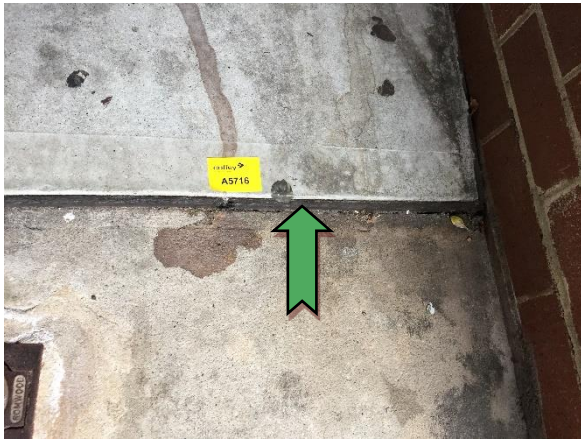
Photo 29 Exterior: ground level, throughout – non asbestos containing expansion joint.

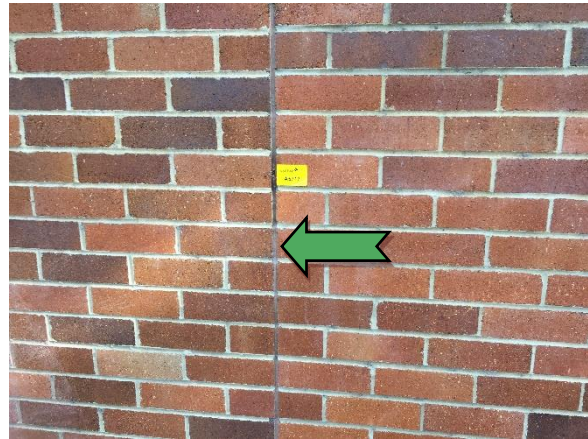
Photo 30 Exterior: ground level, throughout, walls – non asbestos containing expansion joint.

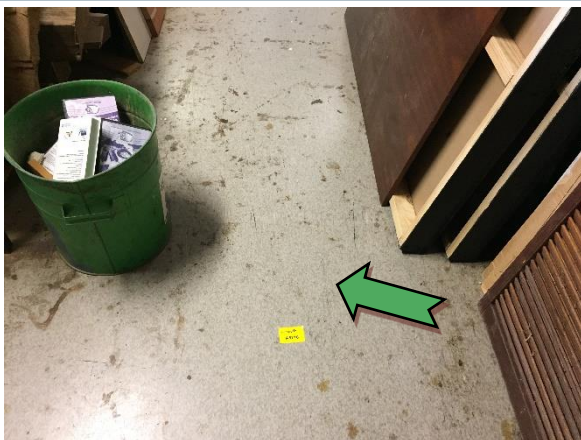
Photo 31 Interior: ground level, major project area, floor – non asbestos containing grey vinyl sheet.

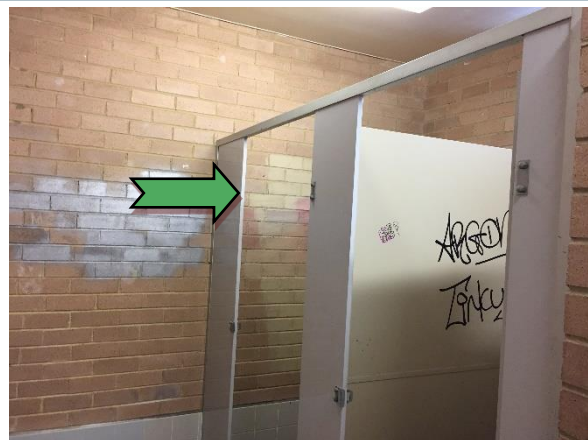
Photo 32 Interior: level 1, female toilets, partition walls – non asbestos containing fibre cement sheet.

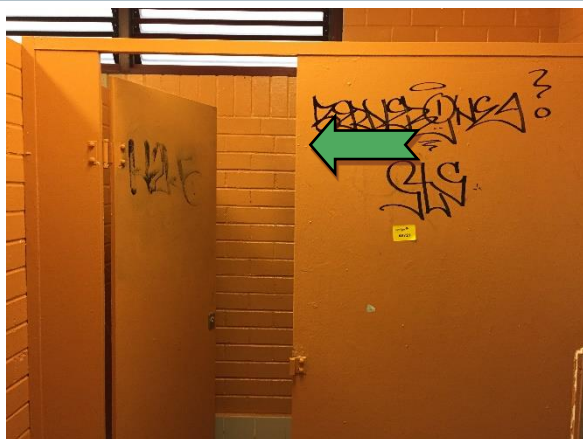
Photo 33 Interior: level 1, male toilets, partition walls – non asbestos containing fibre cement sheet.

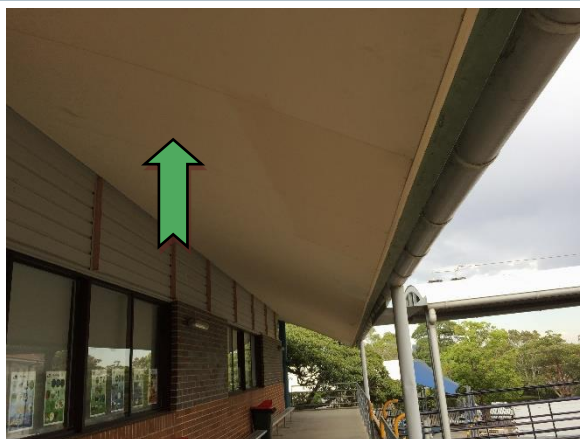
Photo 34 Interior: level 1, throughout, awning – non asbestos containing fibre cement sheet.

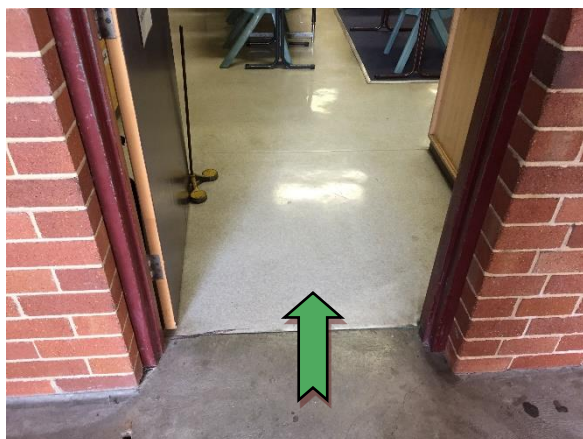
Photo 35 Interior: level 1, lab 4, floor coverings – non asbestos containing grey vinyl sheet.

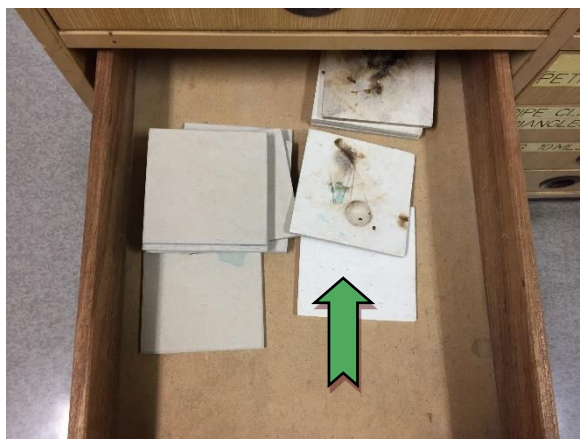
Photo 36 Interior: level 1, science prep area, heat mats – non asbestos containing fibre cement sheet.

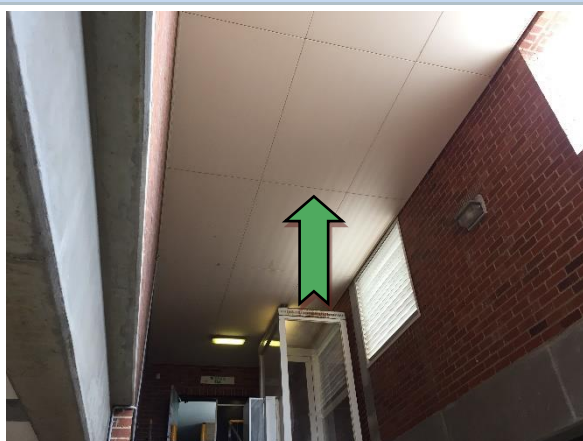
Photo 37 Exterior: adjacent science staff room, and above stairs, ceiling – non asbestos containing fibre cement sheet.

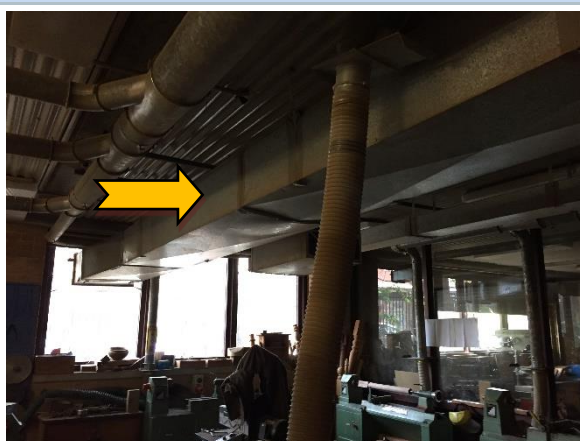
- Interior: all levels, throughout, air conditioning ductwork – suspected SMF containing internal insulation material;
- Interior: all levels, throughout ceiling space – suspected SMF containing sarking insulation; and
- Interior: ground level, throughout ceiling space – suspected SMF containing insulation.

Photo 38 Interior: all levels, throughout, air conditioning ductwork – suspected SMF containing internal insulation material.

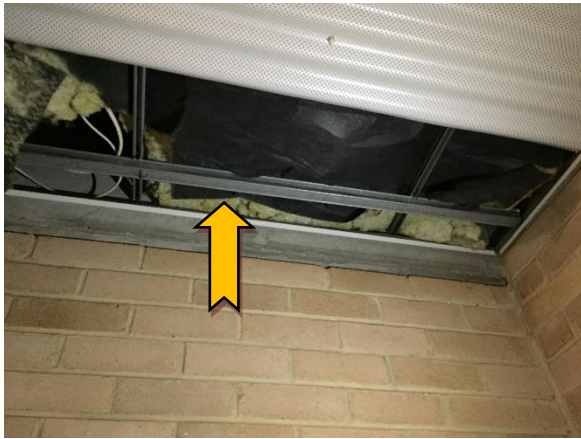
Photo 39 Interior: ground level, throughout ceiling space – suspected SMF containing insulation batts.

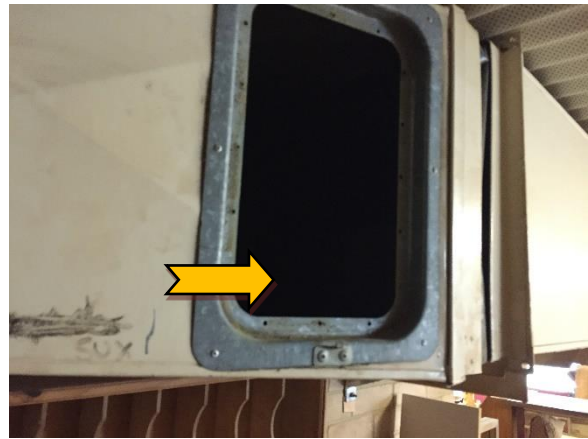
- Interior: ground level, major projects room, within air conditioning ductwork – 1000mg/kg lead containing dust;
- Interior: ground level, major projects room, surfaces below air conditioning ductwork – 120mg/kg lead containing dust;
- Interior: ground level, major projects room, metal store, floor – 240mg/kg lead containing dust;
- Interior: level 1, lab 3 within riser under white board – 200mg/kg lead containing dust;
- Interior: level 2, ceiling space – 200mg/kg lead containing dust;
- Interior: throughout, ceiling space – suspected lead containing dust; and
- Interior: throughout, air conditioning ductwork – suspected lead containing dust.

Photo 40 Interior: ground level, major projects room, within air conditioning ductwork – 1000mg/kg lead containing dust.

Confirmed lead-containing dust within the ceiling spaces should be removed prior to refurbishment works in accordance with Australian Standard (AS4361.2), Guide to Hazardous Paint Management – 2017 Part 2: Lead in Paint in Residential, Public and commercial buildings.

Lead-containing dust removal works should include the use of High Efficiency Particulate Air (HEPA) filtered vacuum cleaners and wet wiping techniques by a licensed contractor under controlled lead-containing dust conditions.

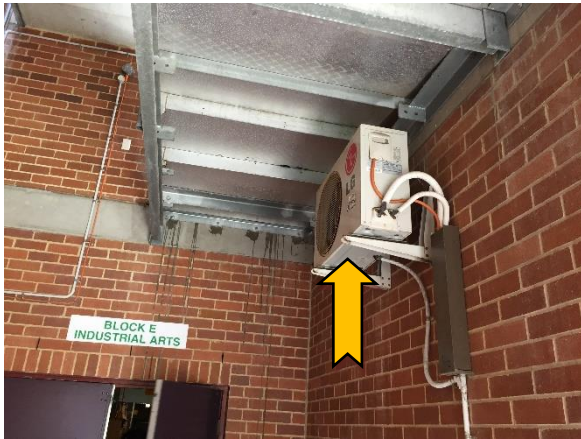
- Exterior: ground level, adjacent entrance to industrial arts, air conditioning unit – R22 ODS containing refrigerant.

Photo 41 Exterior: ground level, adjacent entrance to industrial arts, air conditioning unit – R22 ODS containing refrigerant.

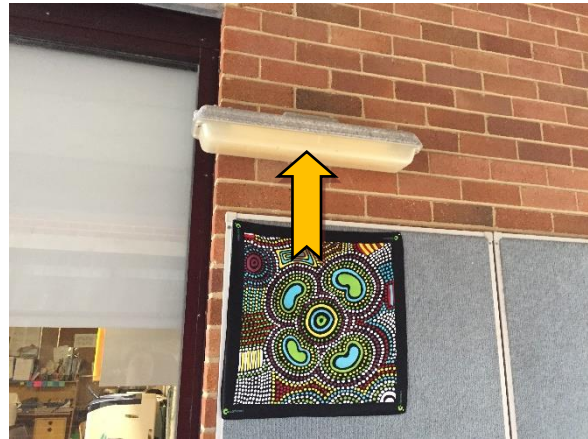
Photo 42 Exterior: throughout, light fittings – suspected PCB containing capacitors.

PCB is a potential environmental hazard and must be handled in accordance with Work Safe Guidance Notes. Post removal, provision should be made for appropriate storage/disposal of PCB-containing capacitors.
