STORMWATER CHANNEL

HASLAM'S CREEK

Internal Concrete Floor & Walls

Photo ID **HC-SWC-1.1**
To
Photo ID **HC-SWC-1.73**
(INCLUSIVE)

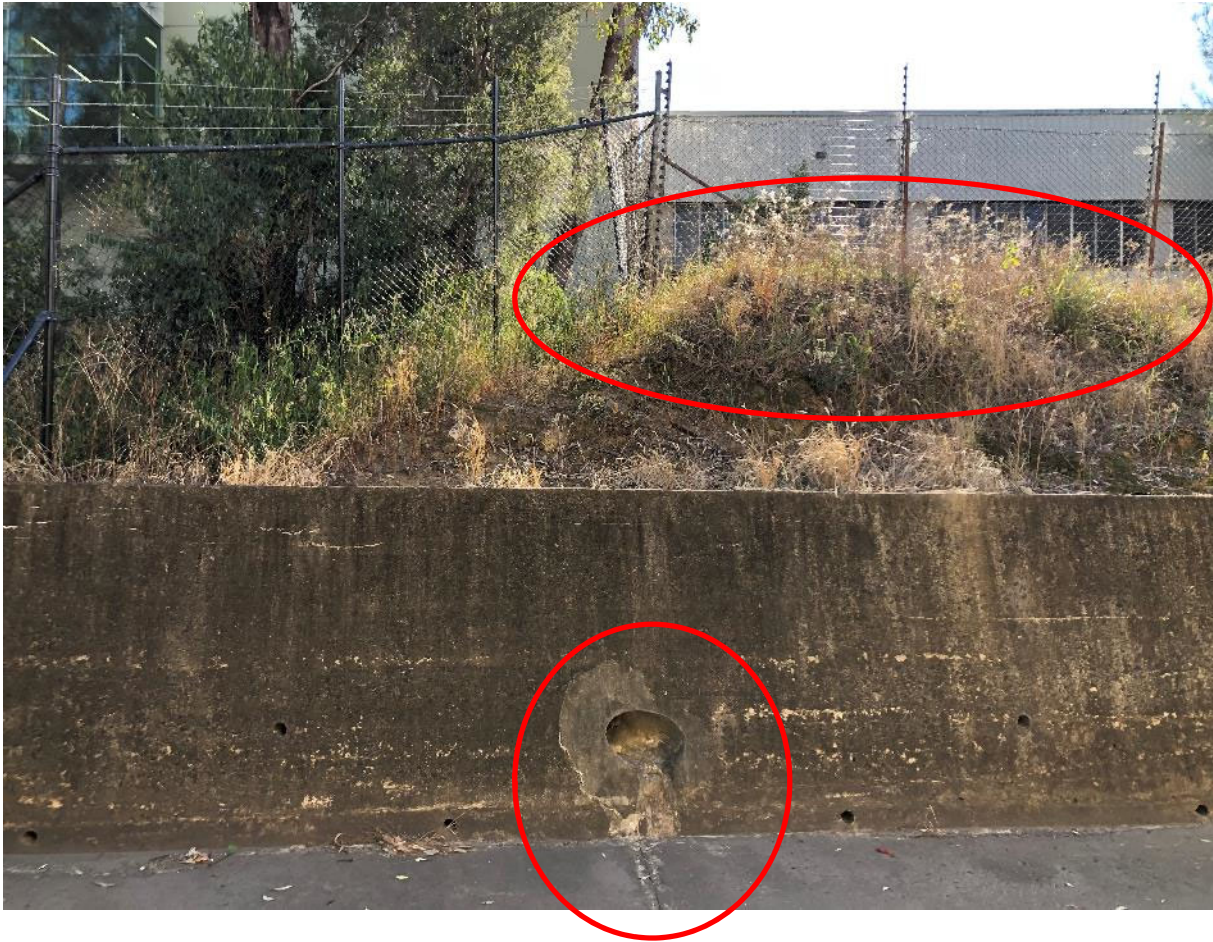
LOCATION: HASLAM'S CREEK STORMWATER CHANNEL – Internal Concrete Floor & Walls		
PHOTO ID	PHOTO	DESCRIPTION/CONDITION
HC-SWC-1.1

<p>Floors & Walls within Haslam's Creek Stormwater Channel (including Stormwater Discharge Outlets) outside South-Eastern Boundary of Site.</p> <ul style="list-style-type: none">• Visible sediment to bottom of Drainage Outlet.• Overgrown Vegetation in Drainage Channel and on each side of Canal Walls. Trees leaning over canal.• Surface Cracking & pitting to concrete base/floor• Surface Cracking to concrete Walls. Visible evident of movement/misalignment• Graffiti/Vandalism• Grass/vegetation & trees poorly maintained. Waste/Litter <p><u>Condition:</u> POOR/DAMAGED</p>

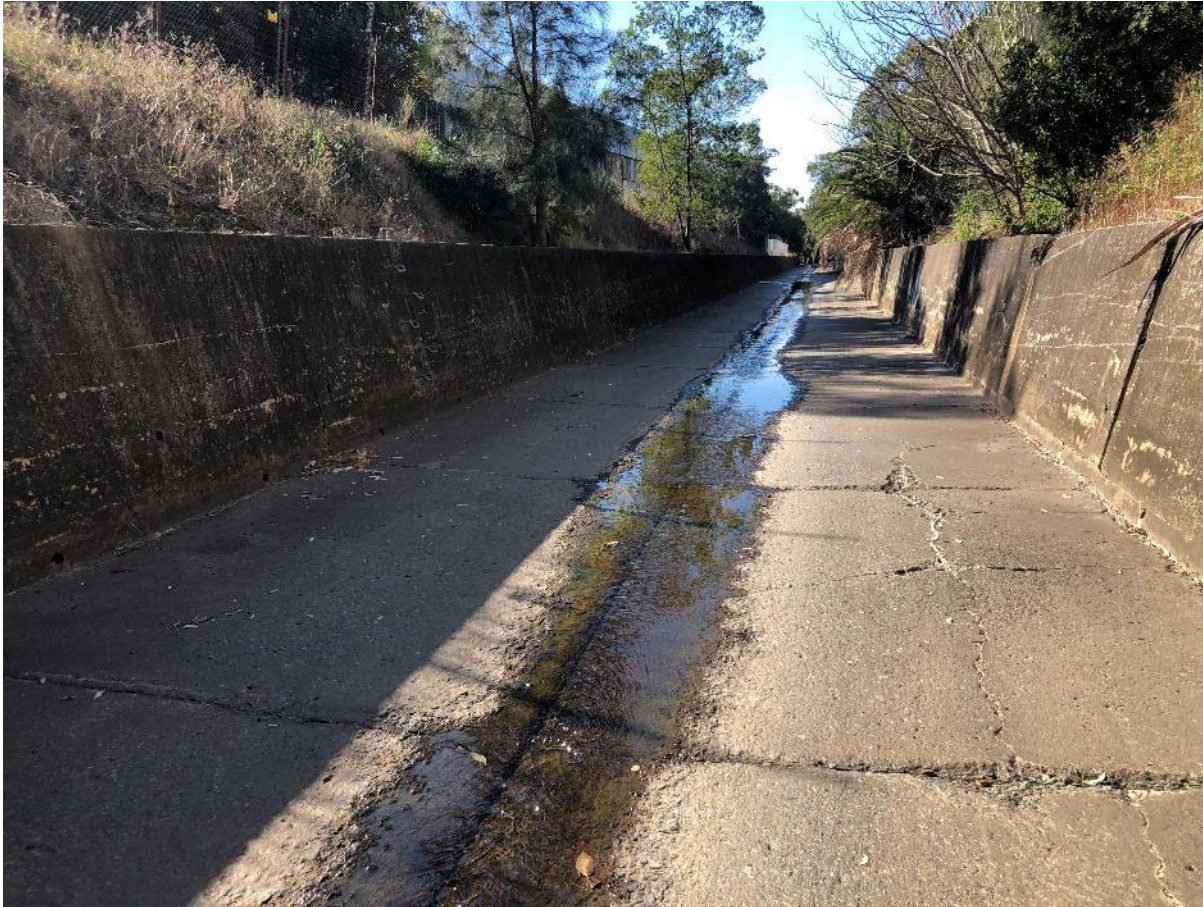
PHOTO ID	PHOTO	DESCRIPTION/CONDITION
HC-SWC-1.4

<p>Floors & Walls within Haslam's Creek Stormwater Channel (including Stormwater Discharge Outlets) outside South-Eastern Boundary of Site.</p> <ul style="list-style-type: none"> • Visible sediment to bottom of Drainage Outlet. • Overgrown Vegetation in Drainage Channel and on each side of Canal Walls. Trees leaning over canal. • Surface Cracking & pitting to concrete base/floor • Surface Cracking to concrete Walls. Visible evident of movement/misalignment • Graffiti/Vandalism • Grass/vegetation & trees poorly maintained. Waste/Litter <p><u>Condition:</u> POOR/DAMAGED</p>

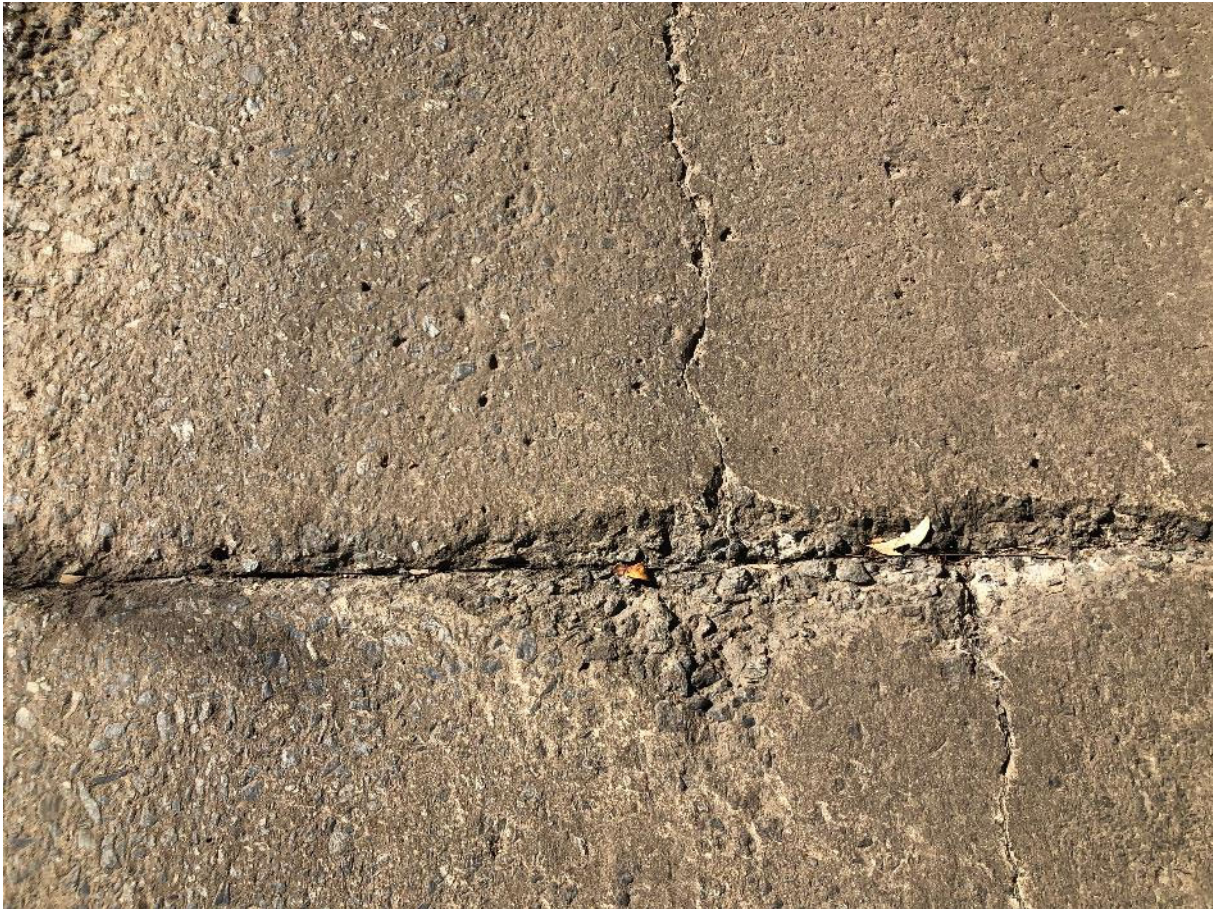
LOCATION: HASLAM'S CREEK STORMWATER CHANNEL – Internal Concrete Floor & Walls		
PHOTO ID	PHOTO	DESCRIPTION/CONDITION
HC-SWC-1.5

<p>Floors & Walls within Haslams Creek Stormwater Channel (including Stormwater Discharge Outlets) outside South-Eastern Boundary of Site.</p> <ul style="list-style-type: none">• Visible sediment to bottom of Drainage Outlet.• Overgrown Vegetation in Drainage Channel and on each side of Canal Walls. Trees leaning over canal.• Surface Cracking & pitting to concrete base/floor• Surface Cracking to concrete Walls. Visible evident of movement/misalignment• Graffiti/Vandalism• Grass/vegetation & trees poorly maintained. Waste/Litter <p><u>Condition:</u> POOR/DAMAGED</p>

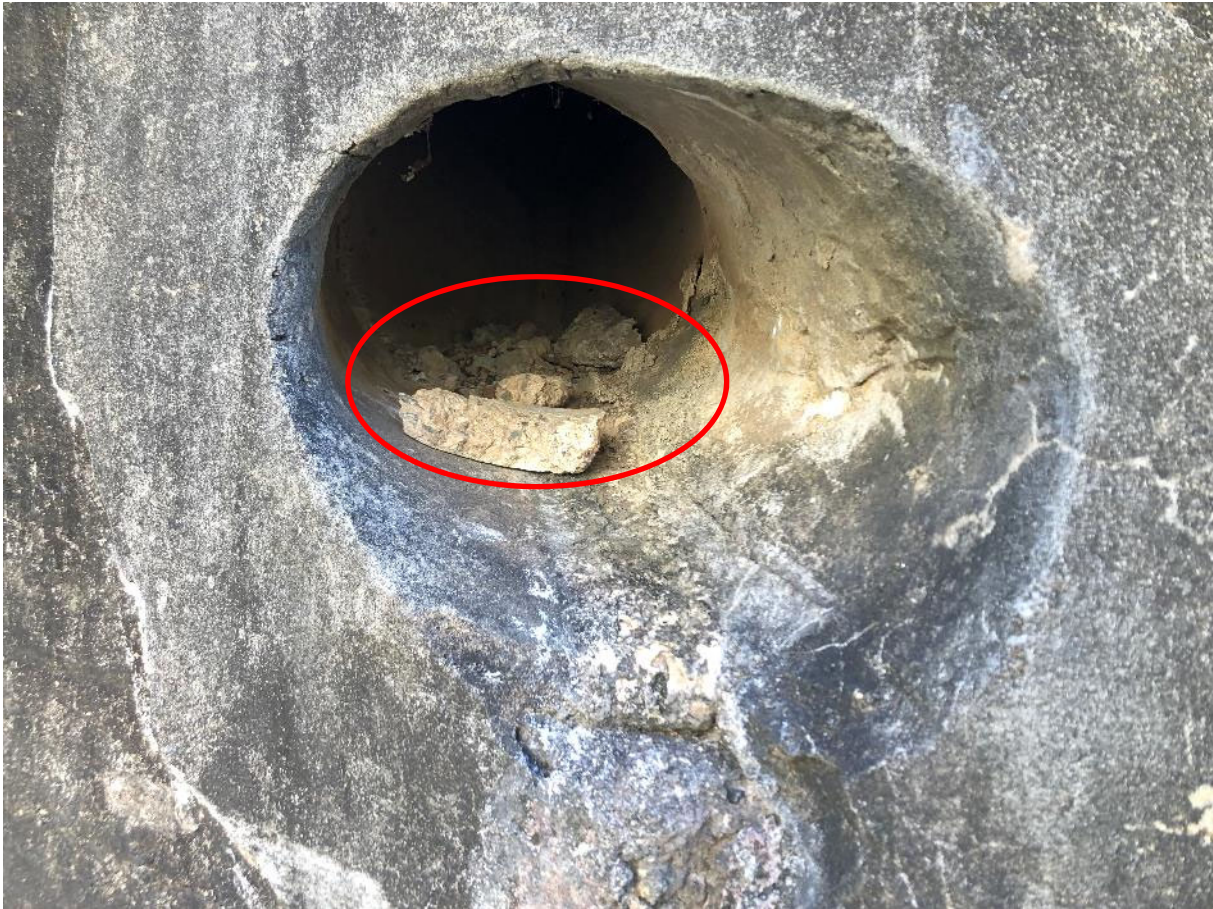
LOCATION: HASLAM'S CREEK STORMWATER CHANNEL – Internal Concrete Floor & Walls		
PHOTO ID	PHOTO	DESCRIPTION/CONDITION
HC-SWC-1.6

<p>Floors & Walls within Haslams Creek Stormwater Channel (including Stormwater Discharge Outlets) outside South-Eastern Boundary of Site.</p> <ul style="list-style-type: none">• Visible sediment to bottom of Drainage Outlet.• Overgrown Vegetation in Drainage Channel and on each side of Canal Walls. Trees leaning over canal.• Surface Cracking & pitting to concrete base/floor• Surface Cracking to concrete Walls. Visible evident of movement/misalignment• Graffiti/Vandalism• Grass/vegetation & trees poorly maintained. Waste/Litter <p><u>Condition:</u> POOR/DAMAGED</p>

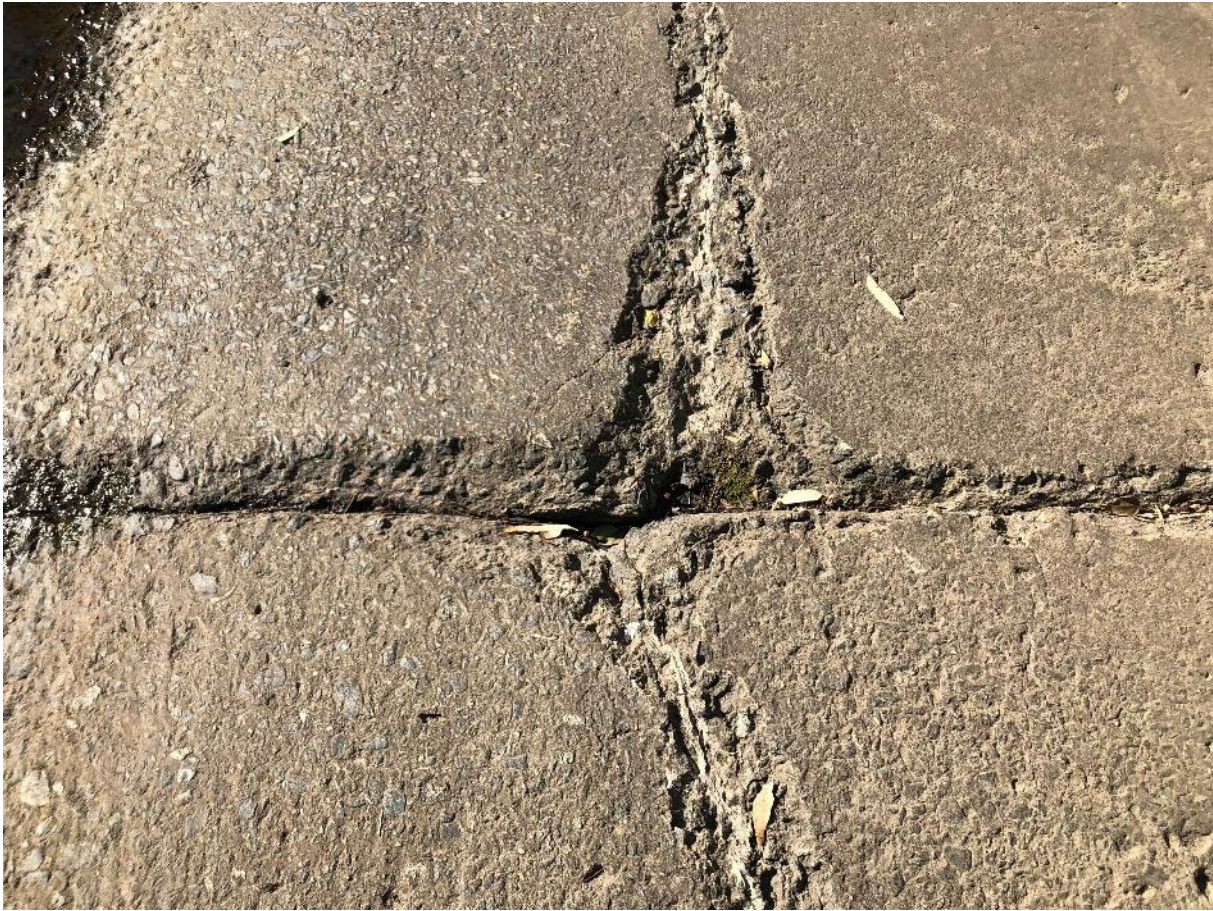
LOCATION: HASLAM'S CREEK STORMWATER CHANNEL – Internal Concrete Floor & Walls		
PHOTO ID	PHOTO	DESCRIPTION/CONDITION
HC-SWC-1.8

<p>Floors & Walls within Haslam's Creek Stormwater Channel (including Stormwater Discharge Outlets) outside South-Eastern Boundary of Site.</p> <ul style="list-style-type: none">• Visible sediment to bottom of Drainage Outlet.• Overgrown Vegetation in Drainage Channel and on each side of Canal Walls. Trees leaning over canal.• Surface Cracking & pitting to concrete base/floor• Surface Cracking to concrete Walls. Visible evident of movement/misalignment• Graffiti/Vandalism• Grass/vegetation & trees poorly maintained. Waste/Litter <p><u>Condition:</u> POOR/DAMAGED</p>

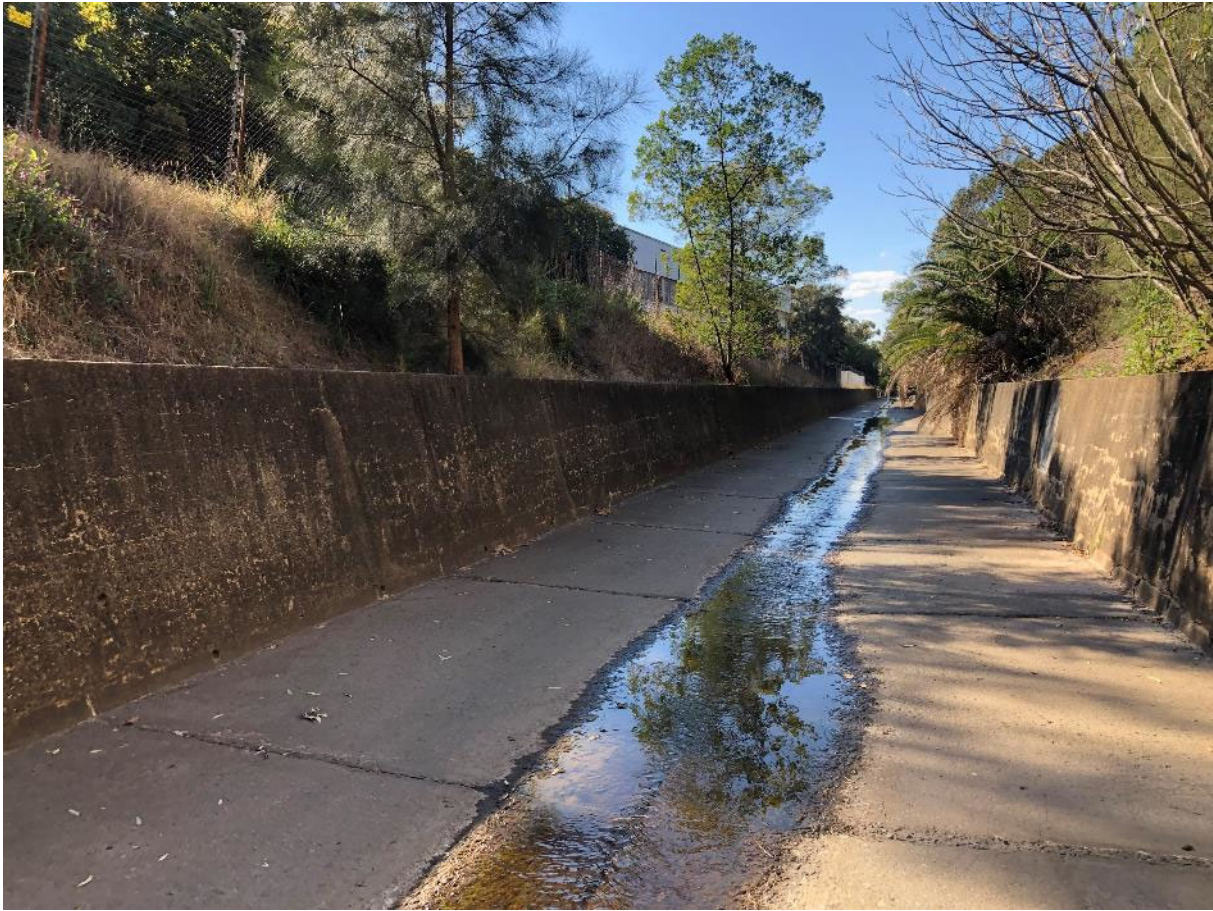
LOCATION: HASLAM'S CREEK STORMWATER CHANNEL – Internal Concrete Floor & Walls		
PHOTO ID	PHOTO	DESCRIPTION/CONDITION
HC-SWC-1.9

<p>Floors & Walls within Haslam's Creek Stormwater Channel (including Stormwater Discharge Outlets) outside South-Eastern Boundary of Site.</p> <ul style="list-style-type: none">• Visible sediment to bottom of Drainage Outlet.• Overgrown Vegetation in Drainage Channel and on each side of Canal Walls. Trees leaning over canal.• Surface Cracking & pitting to concrete base/floor• Surface Cracking to concrete Walls. Visible evident of movement/misalignment• Graffiti/Vandalism• Grass/vegetation & trees poorly maintained. Waste/Litter <p><u>Condition:</u> POOR/DAMAGED</p>

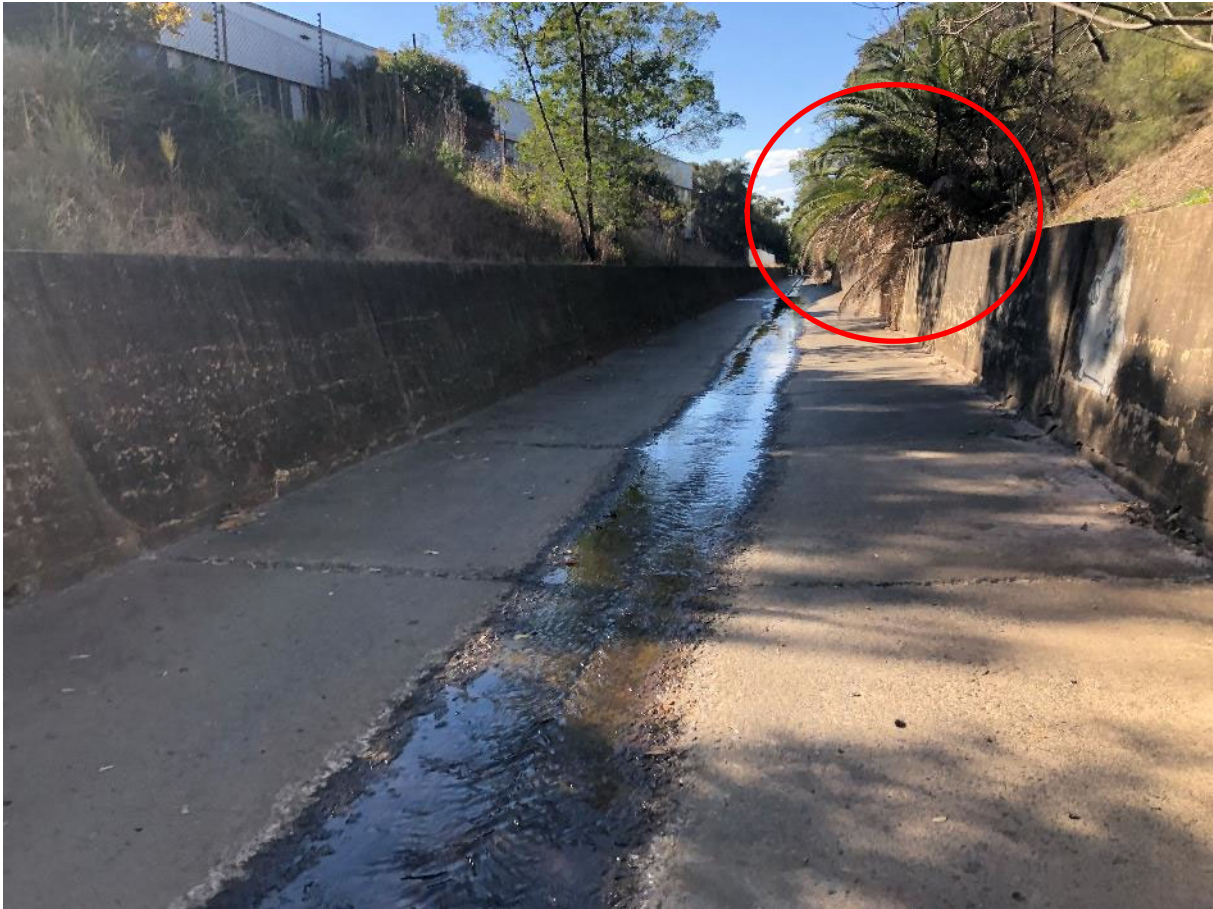
LOCATION: HASLAM'S CREEK STORMWATER CHANNEL – Internal Concrete Floor & Walls		
PHOTO ID	PHOTO	DESCRIPTION/CONDITION
HC-SWC-1.10

<p>Floors & Walls within Haslam's Creek Stormwater Channel (including Stormwater Discharge Outlets) outside South-Eastern Boundary of Site.</p> <ul style="list-style-type: none">• Visible sediment to bottom of Drainage Outlet.• Overgrown Vegetation in Drainage Channel and on each side of Canal Walls. Trees leaning over canal.• Surface Cracking & pitting to concrete base/floor• Surface Cracking to concrete Walls. Visible evident of movement/misalignment• Graffiti/Vandalism• Grass/vegetation & trees poorly maintained. Waste/Litter <p><u>Condition:</u> POOR/DAMAGED</p>

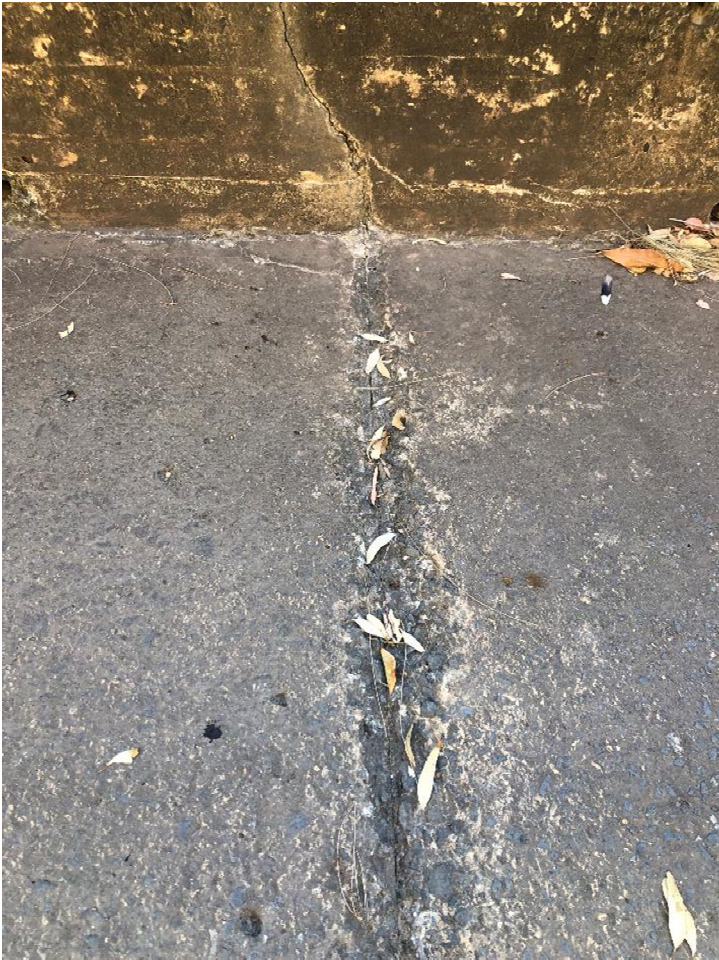
LOCATION: HASLAM'S CREEK STORMWATER CHANNEL – Internal Concrete Floor & Walls		
PHOTO ID	PHOTO	DESCRIPTION/CONDITION
HC-SWC-1.11

<p>Floors & Walls within Haslam's Creek Stormwater Channel (including Stormwater Discharge Outlets) outside South-Eastern Boundary of Site.</p> <ul style="list-style-type: none">• Visible sediment to bottom of Drainage Outlet.• Overgrown Vegetation in Drainage Channel and on each side of Canal Walls. Trees leaning over canal.• Surface Cracking & pitting to concrete base/floor• Surface Cracking to concrete Walls. Visible evident of movement/misalignment• Graffiti/Vandalism• Grass/vegetation & trees poorly maintained. Waste/Litter <p><u>Condition:</u> POOR/DAMAGED</p>

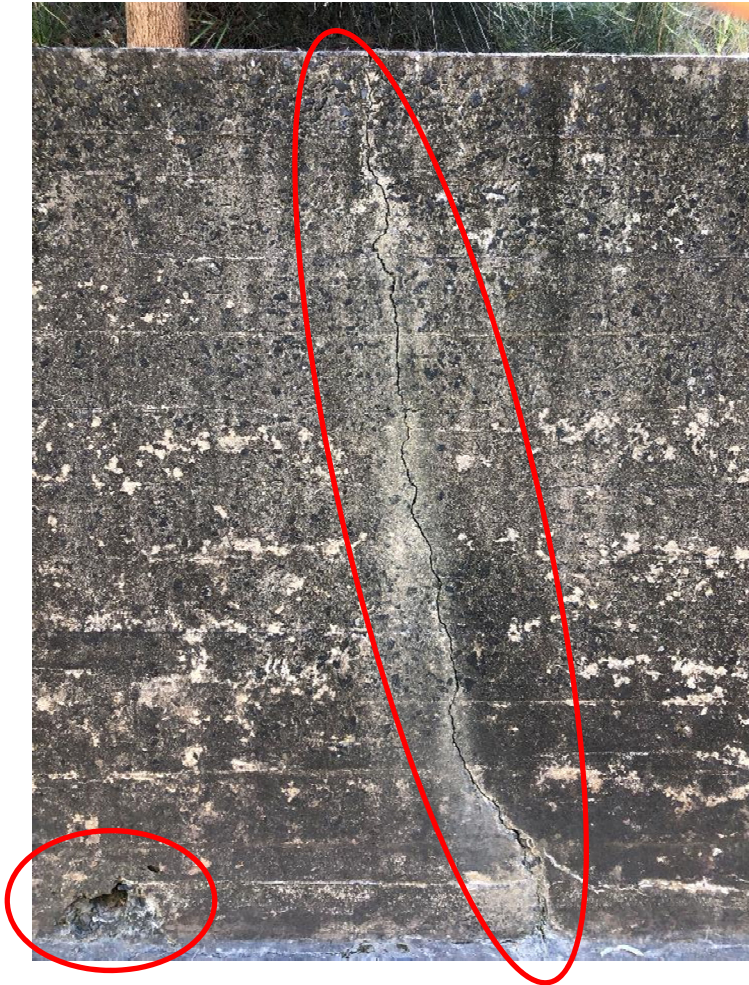
LOCATION: HASLAM'S CREEK STORMWATER CHANNEL – Internal Concrete Floor & Walls		
PHOTO ID	PHOTO	DESCRIPTION/CONDITION
HC-SWC-1.12

<p>Floors & Walls within Haslam's Creek Stormwater Channel (including Stormwater Discharge Outlets) outside South-Eastern Boundary of Site.</p> <ul style="list-style-type: none">• Visible sediment to bottom of Drainage Outlet.• Overgrown Vegetation in Drainage Channel and on each side of Canal Walls. Trees leaning over canal.• Surface Cracking & pitting to concrete base/floor• Surface Cracking to concrete Walls. Visible evident of movement/misalignment• Graffiti/Vandalism• Grass/vegetation & trees poorly maintained. Waste/Litter <p><u>Condition:</u> POOR/DAMAGED</p>

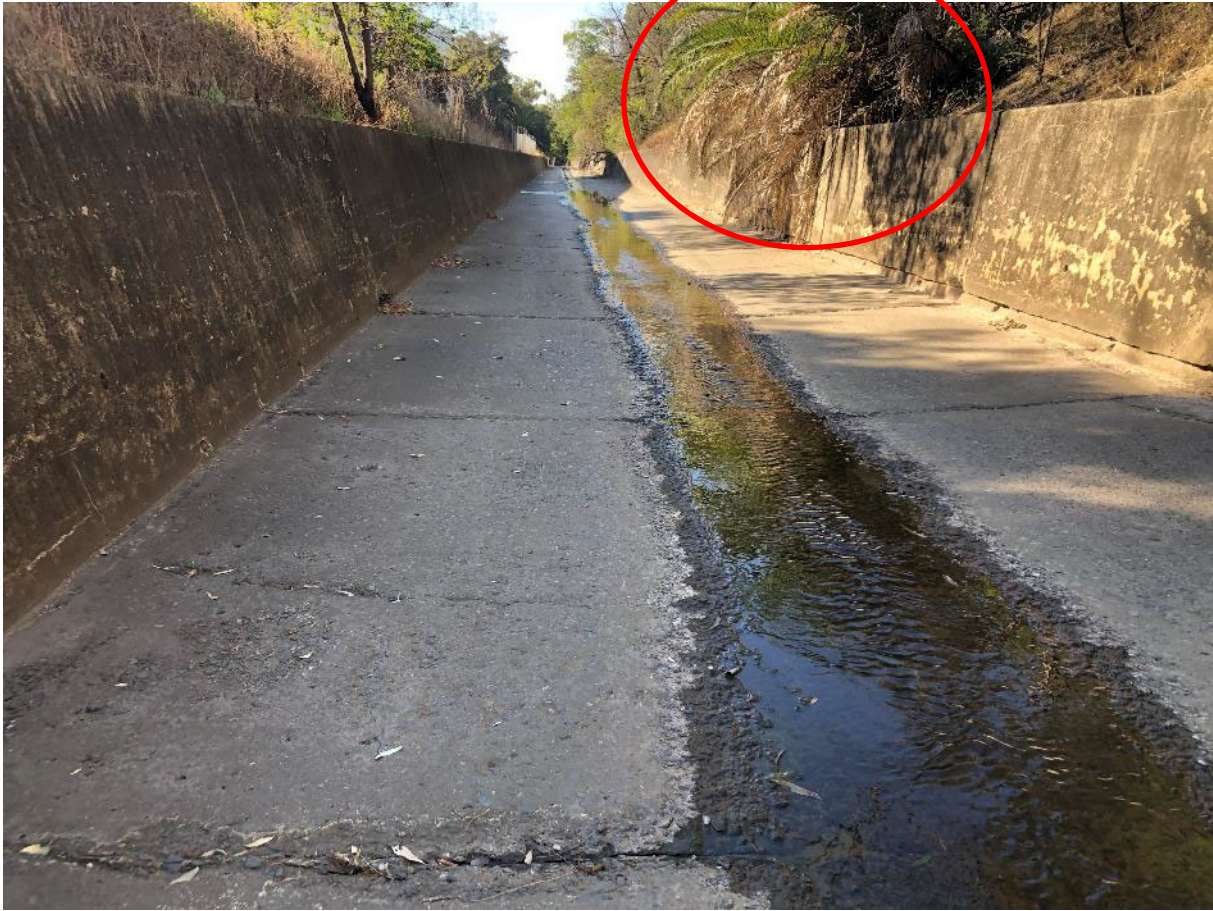
LOCATION: HASLAM'S CREEK STORMWATER CHANNEL – Internal Concrete Floor & Walls		
PHOTO ID	PHOTO	DESCRIPTION/CONDITION
HC-SWC-1.13

<p>Floors & Walls within Haslam's Creek Stormwater Channel (including Stormwater Discharge Outlets) outside South-Eastern Boundary of Site.</p> <ul style="list-style-type: none">• Visible sediment to bottom of Drainage Outlet.• Overgrown Vegetation in Drainage Channel and on each side of Canal Walls. Trees leaning over canal.• Surface Cracking & pitting to concrete base/floor• Surface Cracking to concrete Walls. Visible evident of movement/misalignment• Graffiti/Vandalism• Grass/vegetation & trees poorly maintained. Waste/Litter <p><u>Condition:</u> POOR/DAMAGED</p>

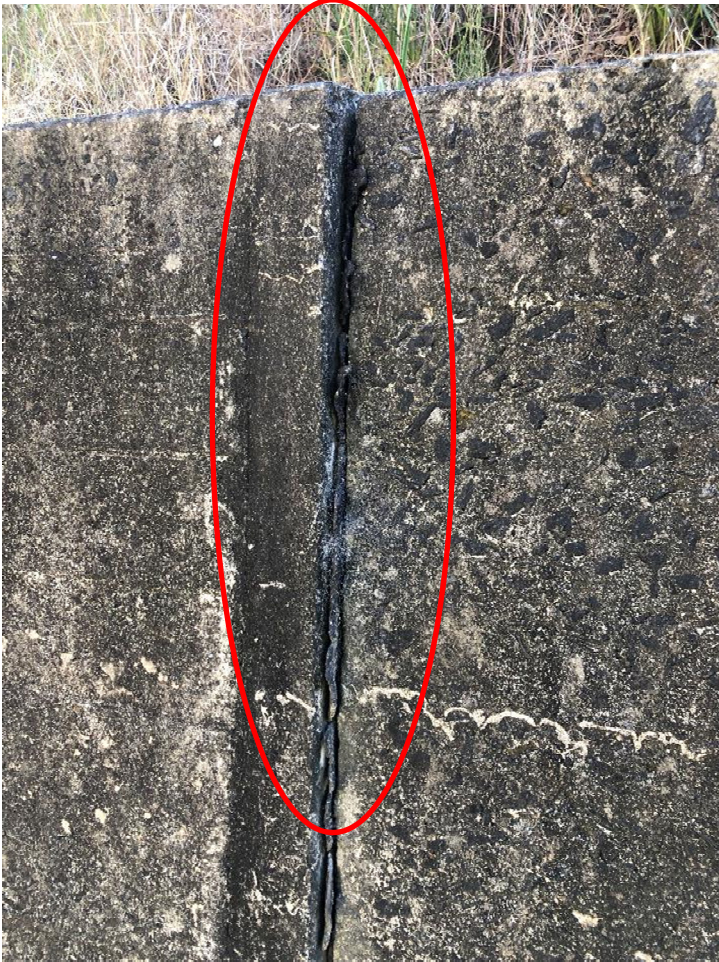
LOCATION: HASLAM'S CREEK STORMWATER CHANNEL – Internal Concrete Floor & Walls		
PHOTO ID	PHOTO	DESCRIPTION/CONDITION
HC-SWC-1.14

<p>Floors & Walls within Haslam's Creek Stormwater Channel (including Stormwater Discharge Outlets) outside South-Eastern Boundary of Site.</p> <ul style="list-style-type: none">• Visible sediment to bottom of Drainage Outlet.• Overgrown Vegetation in Drainage Channel and on each side of Canal Walls. Trees leaning over canal.• Surface Cracking & pitting to concrete base/floor• Surface Cracking to concrete Walls. Visible evident of movement/misalignment• Graffiti/Vandalism• Grass/vegetation & trees poorly maintained. Waste/Litter <p><u>Condition:</u> POOR/DAMAGED</p>

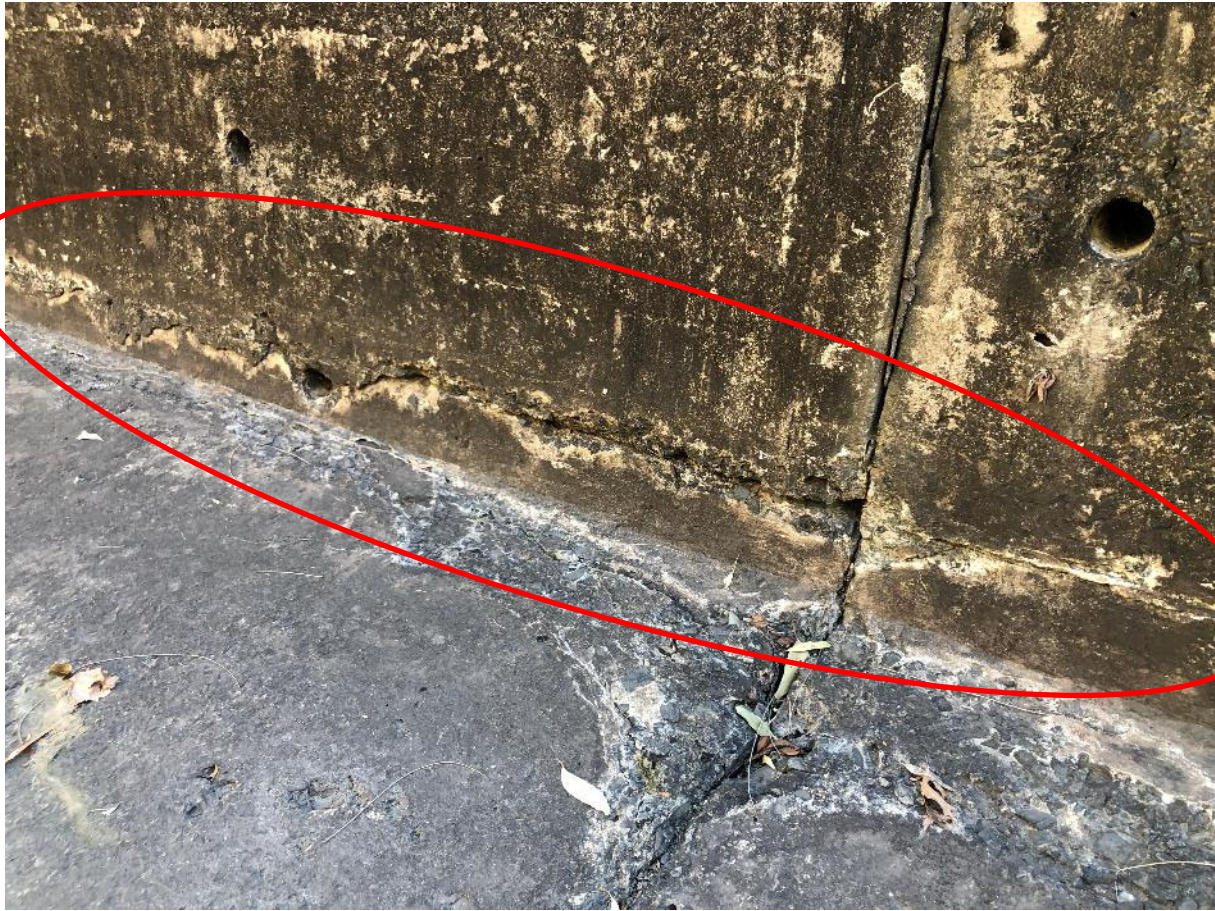
LOCATION: HASLAM'S CREEK STORMWATER CHANNEL – Internal Concrete Floor & Walls		
PHOTO ID	PHOTO	DESCRIPTION/CONDITION
HC-SWC-1.15

<p>Floors & Walls within Haslam's Creek Stormwater Channel (including Stormwater Discharge Outlets) outside South-Eastern Boundary of Site.</p> <ul style="list-style-type: none">• Visible sediment to bottom of Drainage Outlet.• Overgrown Vegetation in Drainage Channel and on each side of Canal Walls. Trees leaning over canal.• Surface Cracking & pitting to concrete base/floor• Surface Cracking to concrete Walls. Visible evident of movement/misalignment• Graffiti/Vandalism• Grass/vegetation & trees poorly maintained. Waste/Litter <p><u>Condition:</u> POOR/DAMAGED</p>

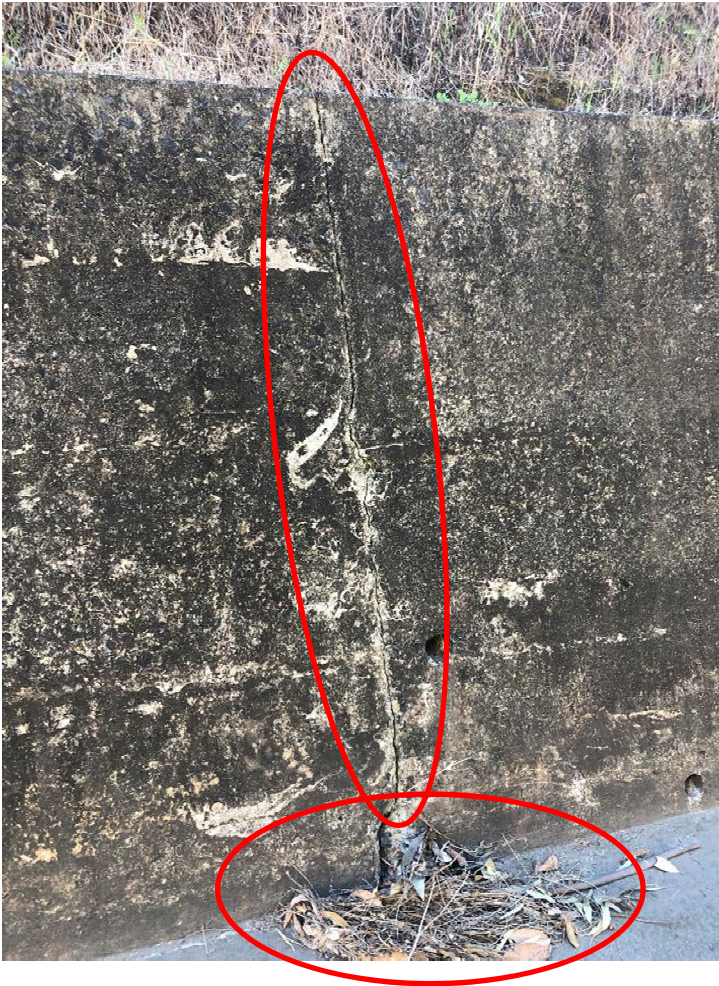
LOCATION: HASLAM'S CREEK STORMWATER CHANNEL – Internal Concrete Floor & Walls		
PHOTO ID	PHOTO	DESCRIPTION/CONDITION
HC-SWC-1.17

<p>Floors & Walls within Haslam's Creek Stormwater Channel (including Stormwater Discharge Outlets) outside South-Eastern Boundary of Site.</p> <ul style="list-style-type: none">• Visible sediment to bottom of Drainage Outlet.• Overgrown Vegetation in Drainage Channel and on each side of Canal Walls. Trees leaning over canal.• Surface Cracking & pitting to concrete base/floor• Surface Cracking to concrete Walls. Visible evident of movement/misalignment• Graffiti/Vandalism• Grass/vegetation & trees poorly maintained. Waste/Litter <p><u>Condition:</u> POOR/DAMAGED</p>

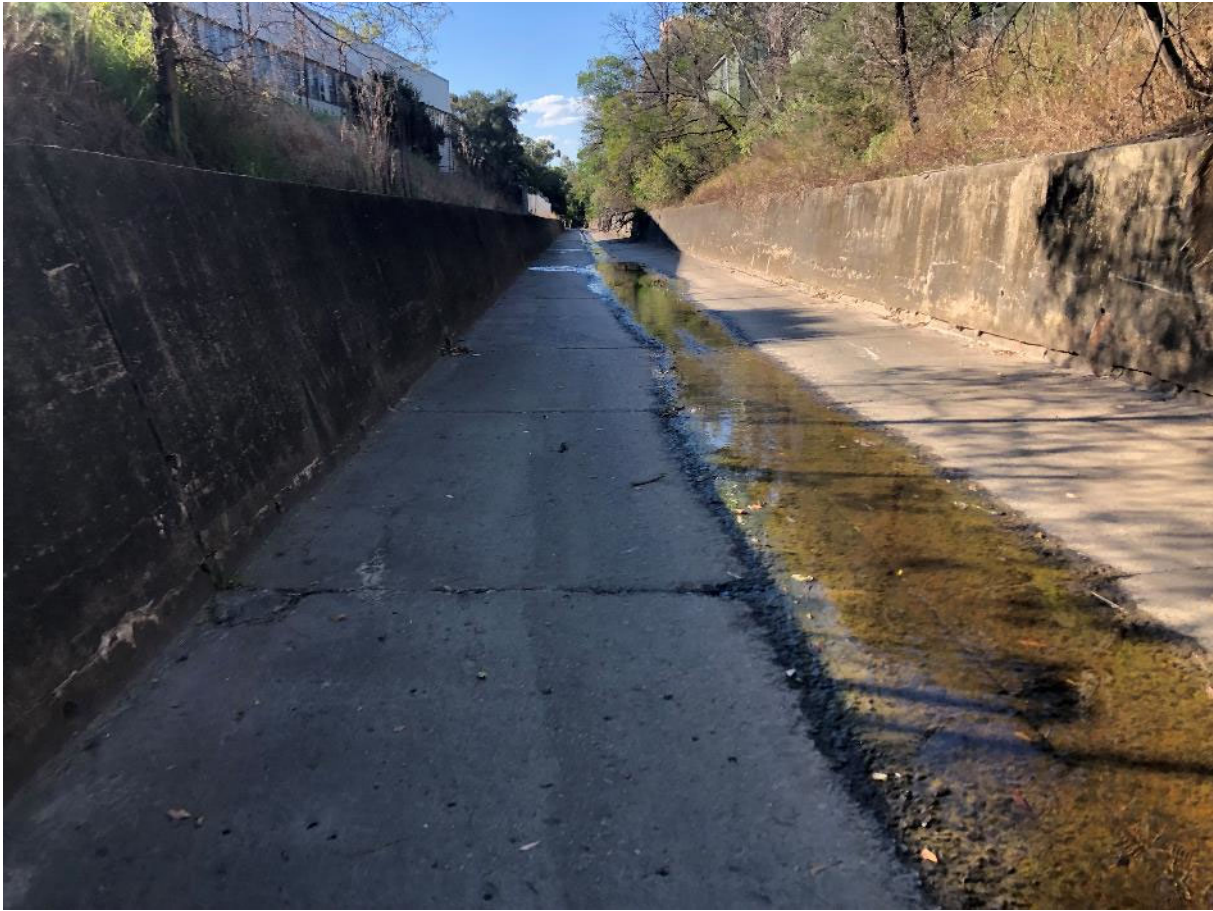
LOCATION: HASLAM'S CREEK STORMWATER CHANNEL – Internal Concrete Floor & Walls		
PHOTO ID	PHOTO	DESCRIPTION/CONDITION
HC-SWC-1.18

<p>Floors & Walls within Haslam's Creek Stormwater Channel (including Stormwater Discharge Outlets) outside South-Eastern Boundary of Site.</p> <ul style="list-style-type: none">• Visible sediment to bottom of Drainage Outlet.• Overgrown Vegetation in Drainage Channel and on each side of Canal Walls. Trees leaning over canal.• Surface Cracking & pitting to concrete base/floor• Surface Cracking to concrete Walls. Visible evident of movement/misalignment• Graffiti/Vandalism• Grass/vegetation & trees poorly maintained. Waste/Litter <p><u>Condition:</u> POOR/DAMAGED</p>

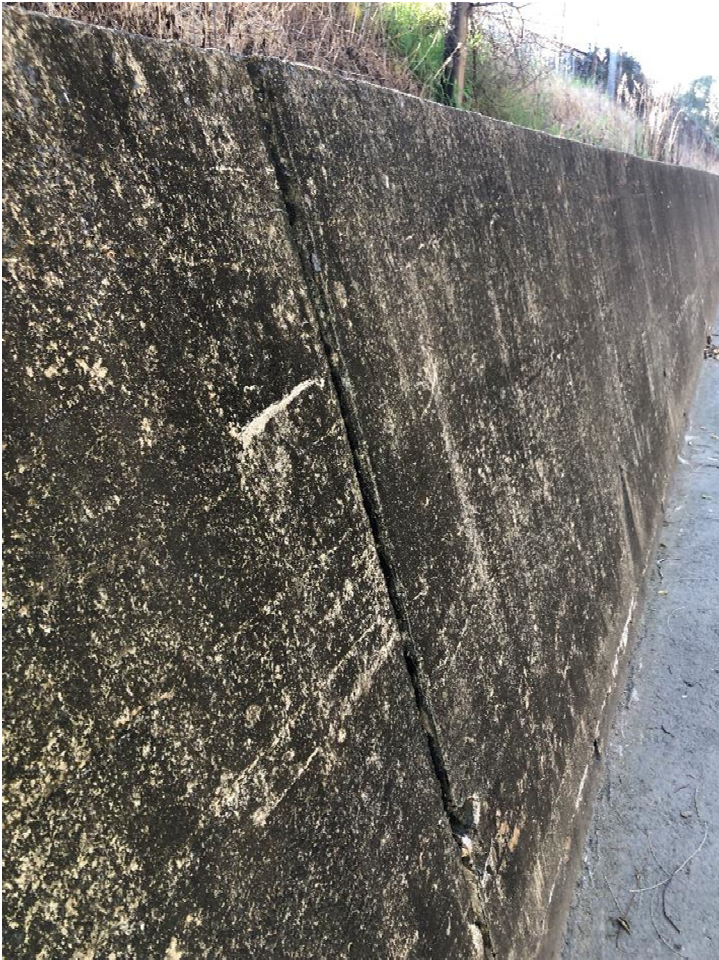
LOCATION: HASLAM'S CREEK STORMWATER CHANNEL – Internal Concrete Floor & Walls		
PHOTO ID	PHOTO	DESCRIPTION/CONDITION
HC-SWC-1.19

<p>Floors & Walls within Haslam's Creek Stormwater Channel (including Stormwater Discharge Outlets) outside South-Eastern Boundary of Site.</p> <ul style="list-style-type: none">• Visible sediment to bottom of Drainage Outlet.• Overgrown Vegetation in Drainage Channel and on each side of Canal Walls. Trees leaning over canal.• Surface Cracking & pitting to concrete base/floor• Surface Cracking to concrete Walls. Visible evident of movement/misalignment• Graffiti/Vandalism• Grass/vegetation & trees poorly maintained. Waste/Litter <p><u>Condition:</u> POOR/DAMAGED</p>

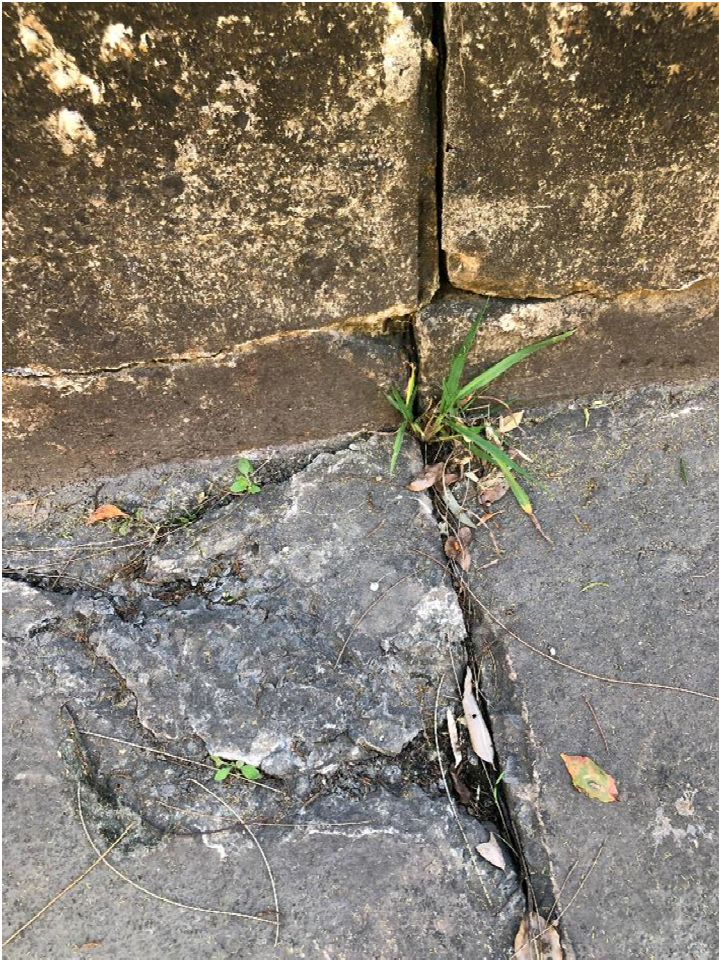
LOCATION: HASLAM'S CREEK STORMWATER CHANNEL – Internal Concrete Floor & Walls		
PHOTO ID	PHOTO	DESCRIPTION/CONDITION
HC-SWC-1.20

<p>Floors & Walls within Haslams Creek Stormwater Channel (including Stormwater Discharge Outlets) outside South-Eastern Boundary of Site.</p> <ul style="list-style-type: none">• Visible sediment to bottom of Drainage Outlet.• Overgrown Vegetation in Drainage Channel and on each side of Canal Walls. Trees leaning over canal.• Surface Cracking & pitting to concrete base/floor• Surface Cracking to concrete Walls. Visible evident of movement/misalignment• Graffiti/Vandalism• Grass/vegetation & trees poorly maintained. Waste/Litter <p><u>Condition:</u> POOR/DAMAGED</p>

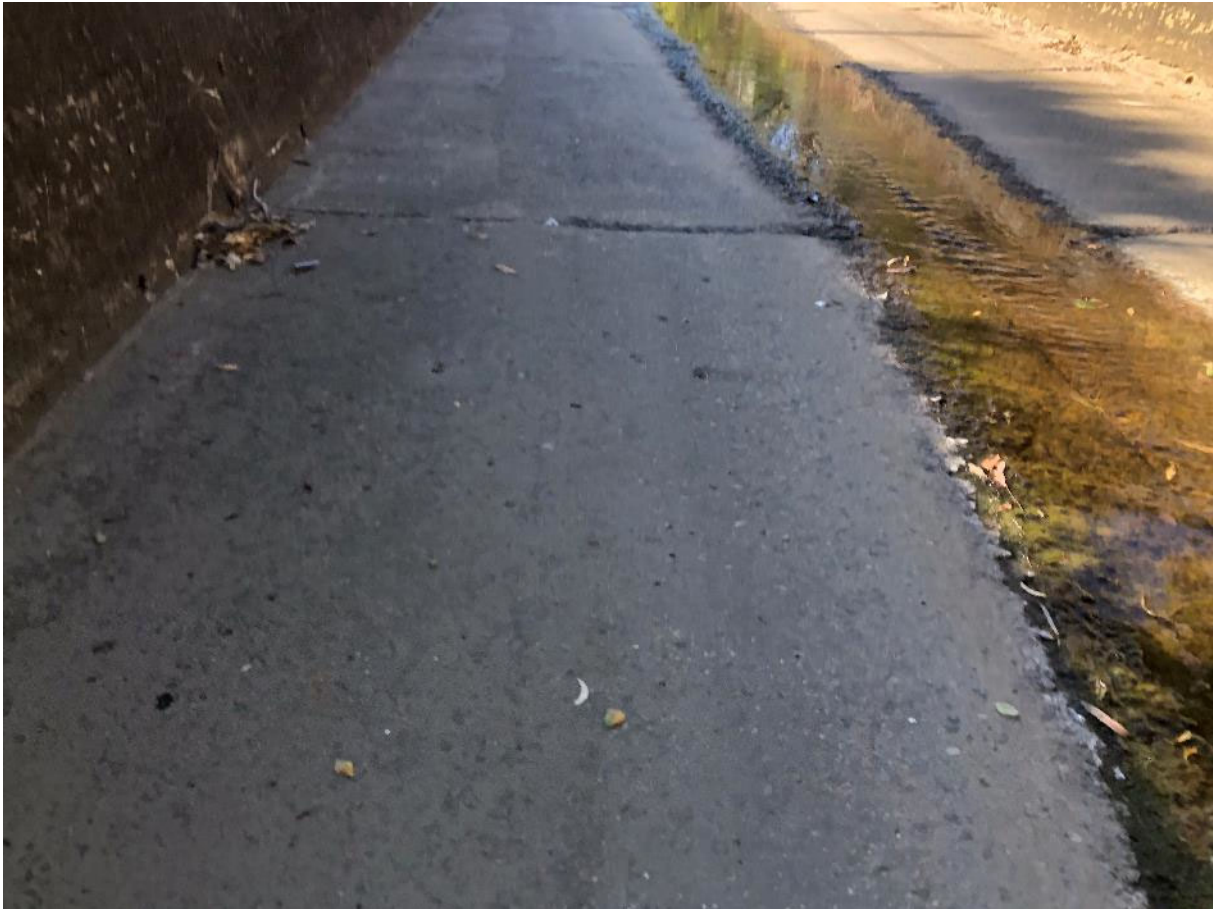
LOCATION: HASLAM'S CREEK STORMWATER CHANNEL – Internal Concrete Floor & Walls		
PHOTO ID	PHOTO	DESCRIPTION/CONDITION
HC-SWC-1.21

<p>Floors & Walls within Haslam's Creek Stormwater Channel (including Stormwater Discharge Outlets) outside South-Eastern Boundary of Site.</p> <ul style="list-style-type: none">• Visible sediment to bottom of Drainage Outlet.• Overgrown Vegetation in Drainage Channel and on each side of Canal Walls. Trees leaning over canal.• Surface Cracking & pitting to concrete base/floor• Surface Cracking to concrete Walls. Visible evident of movement/misalignment• Graffiti/Vandalism• Grass/vegetation & trees poorly maintained. Waste/Litter <p><u>Condition:</u> POOR/DAMAGED</p>

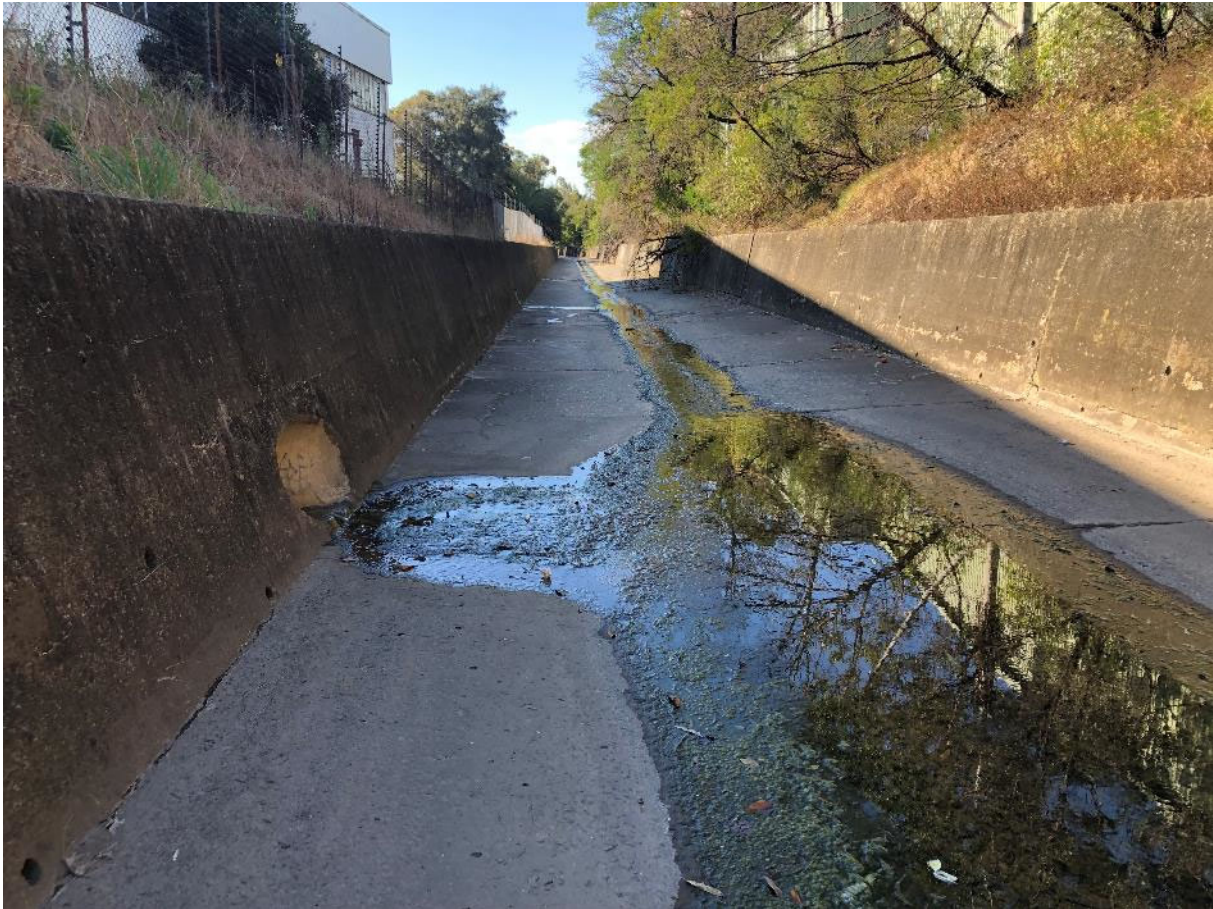
LOCATION: HASLAM'S CREEK STORMWATER CHANNEL – Internal Concrete Floor & Walls		
PHOTO ID	PHOTO	DESCRIPTION/CONDITION
HC-SWC-1.23

<p>Floors & Walls within Haslam's Creek Stormwater Channel (including Stormwater Discharge Outlets) outside South-Eastern Boundary of Site.</p> <ul style="list-style-type: none">• Visible sediment to bottom of Drainage Outlet.• Overgrown Vegetation in Drainage Channel and on each side of Canal Walls. Trees leaning over canal.• Surface Cracking & pitting to concrete base/floor• Surface Cracking to concrete Walls. Visible evident of movement/misalignment• Graffiti/Vandalism• Grass/vegetation & trees poorly maintained. Waste/Litter <p><u>Condition:</u> POOR/DAMAGED</p>

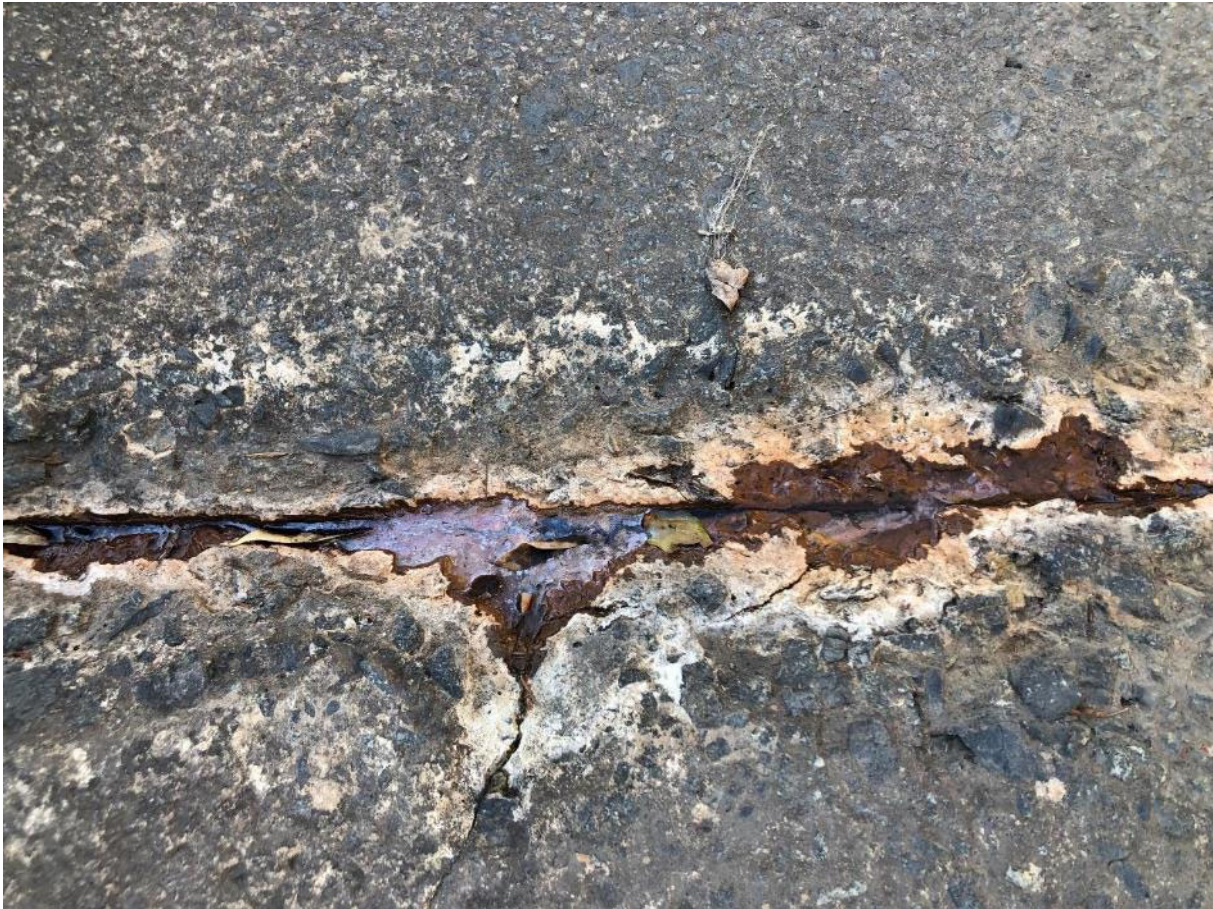
LOCATION: HASLAM'S CREEK STORMWATER CHANNEL – Internal Concrete Floor & Walls		
PHOTO ID	PHOTO	DESCRIPTION/CONDITION
HC-SWC-1.26

<p>Floors & Walls within Haslam's Creek Stormwater Channel (including Stormwater Discharge Outlets) outside South-Eastern Boundary of Site.</p> <ul style="list-style-type: none">• Visible sediment to bottom of Drainage Outlet.• Overgrown Vegetation in Drainage Channel and on each side of Canal Walls. Trees leaning over canal.• Surface Cracking & pitting to concrete base/floor• Surface Cracking to concrete Walls. Visible evident of movement/misalignment• Graffiti/Vandalism• Grass/vegetation & trees poorly maintained. Waste/Litter <p><u>Condition:</u> POOR/DAMAGED</p>
