STORMWATER CHANNEL

HASLAM'S CREEK

Internal Concrete Floor & Walls

Photo ID **HC-SWC-1.1**
To
Photo ID **HC-SWC-1.73**
(INCLUSIVE)

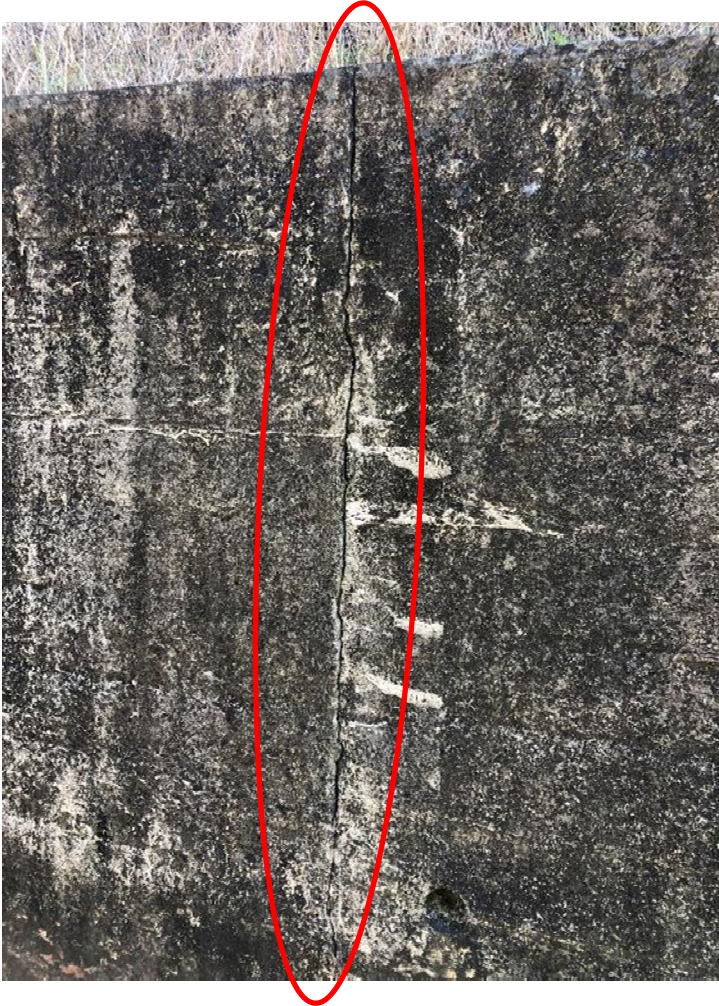
LOCATION: HASLAM'S CREEK STORMWATER CHANNEL – Internal Concrete Floor & Walls		
PHOTO ID	PHOTO	DESCRIPTION/CONDITION
HC-SWC-1.27

<p>Floors & Walls within Haslam's Creek Stormwater Channel (including Stormwater Discharge Outlets) outside South-Eastern Boundary of Site.</p> <ul style="list-style-type: none">• Visible sediment to bottom of Drainage Outlet.• Overgrown Vegetation in Drainage Channel and on each side of Canal Walls. Trees leaning over canal.• Surface Cracking & pitting to concrete base/floor• Surface Cracking to concrete Walls. Visible evident of movement/misalignment• Graffiti/Vandalism• Grass/vegetation & trees poorly maintained. Waste/Litter <p><u>Condition:</u> POOR/DAMAGED</p>

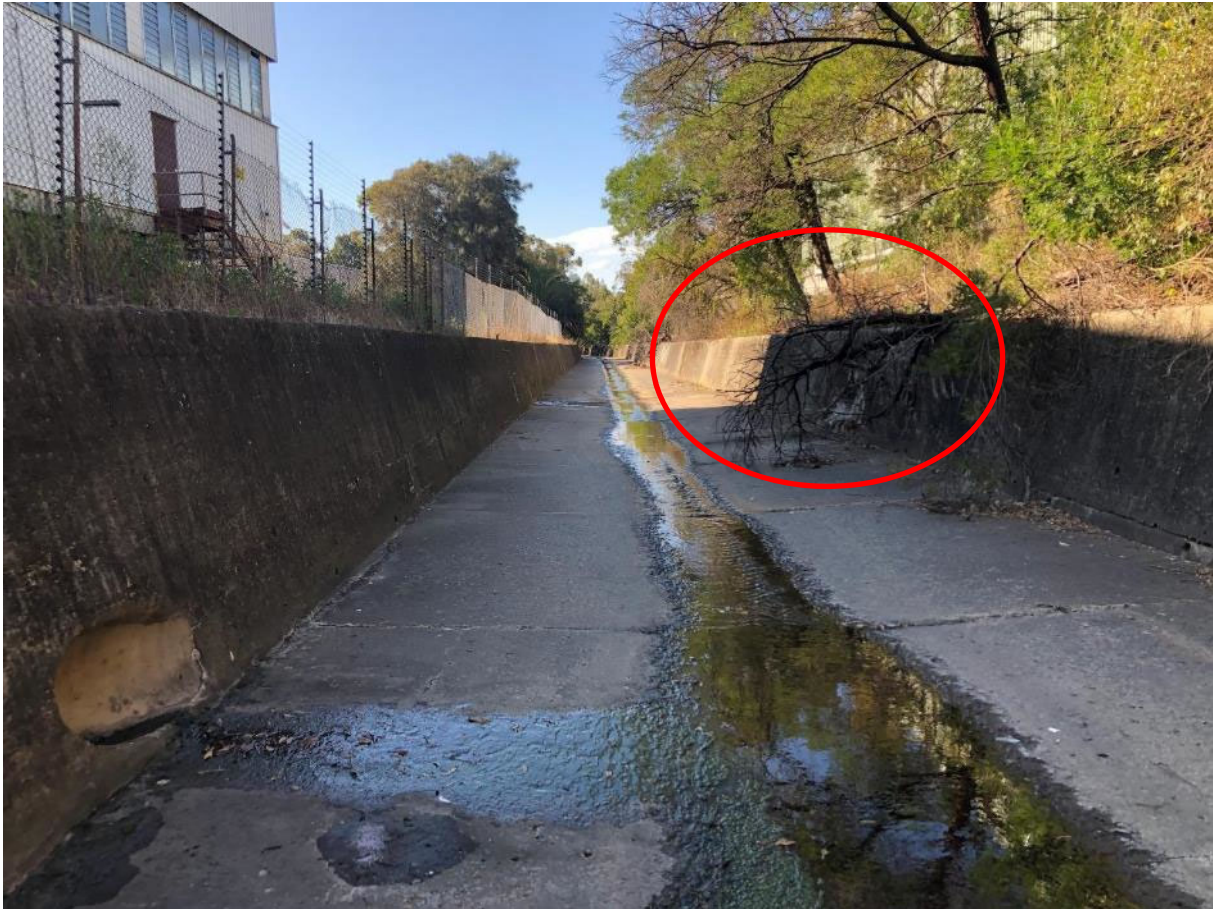
LOCATION: HASLAM'S CREEK STORMWATER CHANNEL – Internal Concrete Floor & Walls		
PHOTO ID	PHOTO	DESCRIPTION/CONDITION
HC-SWC-1.28

<p>Floors & Walls within Haslam's Creek Stormwater Channel (including Stormwater Discharge Outlets) outside South-Eastern Boundary of Site.</p> <ul style="list-style-type: none">• Visible sediment to bottom of Drainage Outlet.• Overgrown Vegetation in Drainage Channel and on each side of Canal Walls. Trees leaning over canal.• Surface Cracking & pitting to concrete base/floor• Surface Cracking to concrete Walls. Visible evident of movement/misalignment• Graffiti/Vandalism• Grass/vegetation & trees poorly maintained. Waste/Litter <p><u>Condition:</u> POOR/DAMAGED</p>

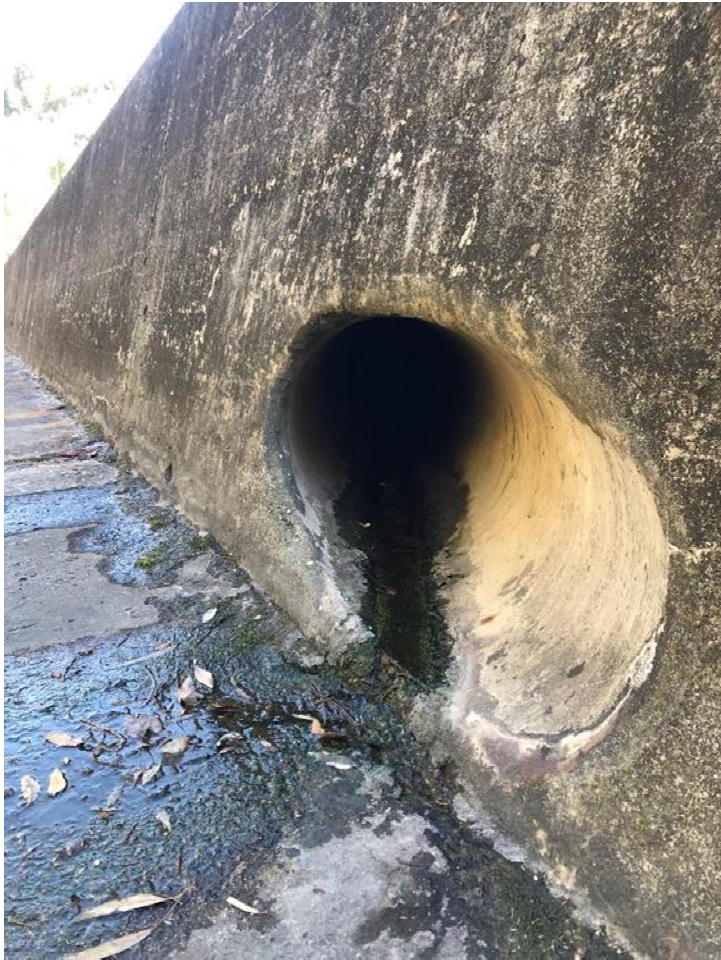
LOCATION: HASLAM'S CREEK STORMWATER CHANNEL – Internal Concrete Floor & Walls		
PHOTO ID	PHOTO	DESCRIPTION/CONDITION
HC-SWC-1.29

<p>Floors & Walls within Haslam's Creek Stormwater Channel (including Stormwater Discharge Outlets) outside South-Eastern Boundary of Site.</p> <ul style="list-style-type: none">• Visible sediment to bottom of Drainage Outlet.• Overgrown Vegetation in Drainage Channel and on each side of Canal Walls. Trees leaning over canal.• Surface Cracking & pitting to concrete base/floor• Surface Cracking to concrete Walls. Visible evident of movement/misalignment• Graffiti/Vandalism• Grass/vegetation & trees poorly maintained. Waste/Litter <p><u>Condition:</u> POOR/DAMAGED</p>

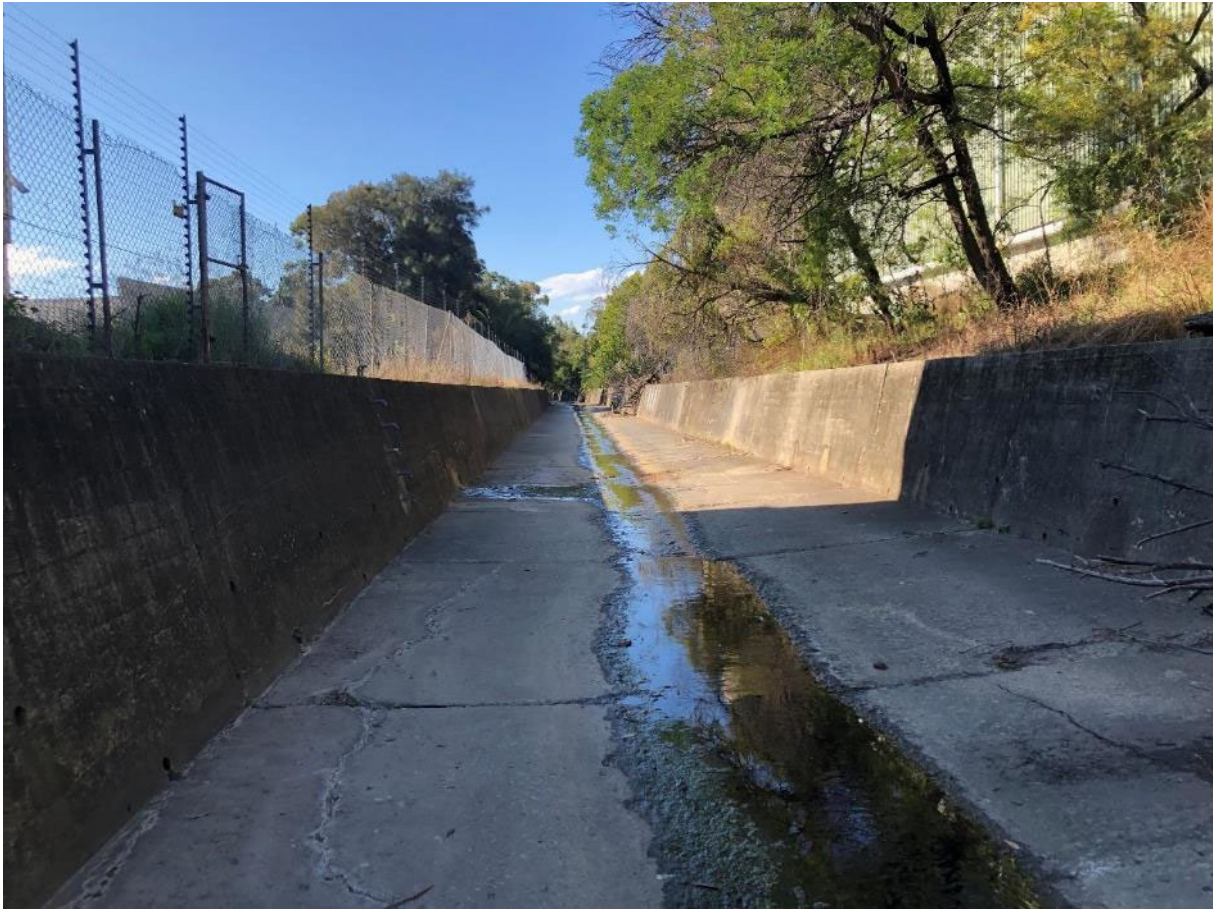
LOCATION: HASLAM'S CREEK STORMWATER CHANNEL – Internal Concrete Floor & Walls		
PHOTO ID	PHOTO	DESCRIPTION/CONDITION
HC-SWC-1.30

<p>Floors & Walls within Haslam's Creek Stormwater Channel (including Stormwater Discharge Outlets) outside South-Eastern Boundary of Site.</p> <ul style="list-style-type: none">• Visible sediment to bottom of Drainage Outlet.• Overgrown Vegetation in Drainage Channel and on each side of Canal Walls. Trees leaning over canal.• Surface Cracking & pitting to concrete base/floor• Surface Cracking to concrete Walls. Visible evident of movement/misalignment• Graffiti/Vandalism• Grass/vegetation & trees poorly maintained. Waste/Litter <p><u>Condition:</u> POOR/DAMAGED</p>

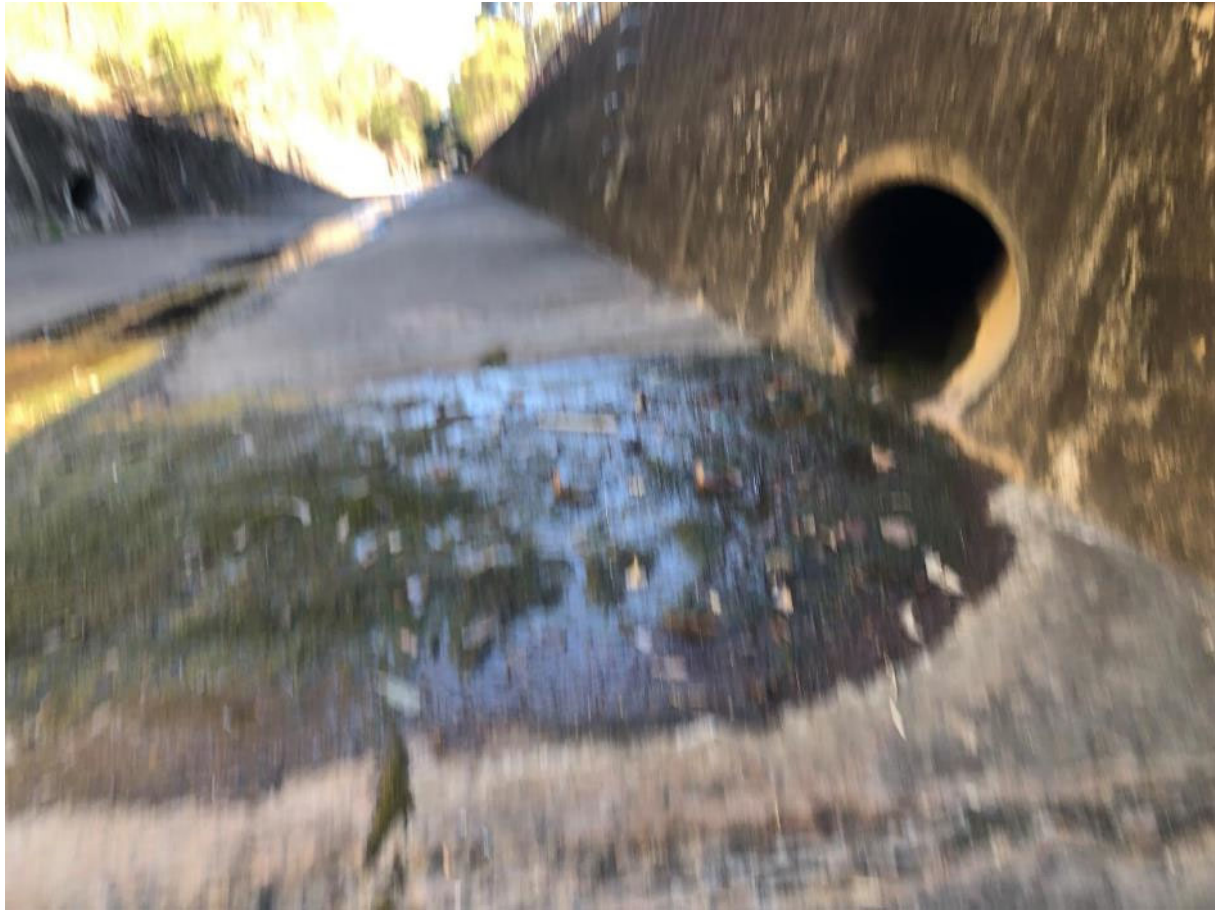
LOCATION: HASLAM'S CREEK STORMWATER CHANNEL – Internal Concrete Floor & Walls		
PHOTO ID	PHOTO	DESCRIPTION/CONDITION
HC-SWC-1.32

<p>Floors & Walls within Haslam's Creek Stormwater Channel (including Stormwater Discharge Outlets) outside South-Eastern Boundary of Site.</p> <ul style="list-style-type: none">• Visible sediment to bottom of Drainage Outlet.• Overgrown Vegetation in Drainage Channel and on each side of Canal Walls. Trees leaning over canal.• Surface Cracking & pitting to concrete base/floor• Surface Cracking to concrete Walls. Visible evident of movement/misalignment• Graffiti/Vandalism• Grass/vegetation & trees poorly maintained. Waste/Litter <p><u>Condition:</u> POOR/DAMAGED</p>

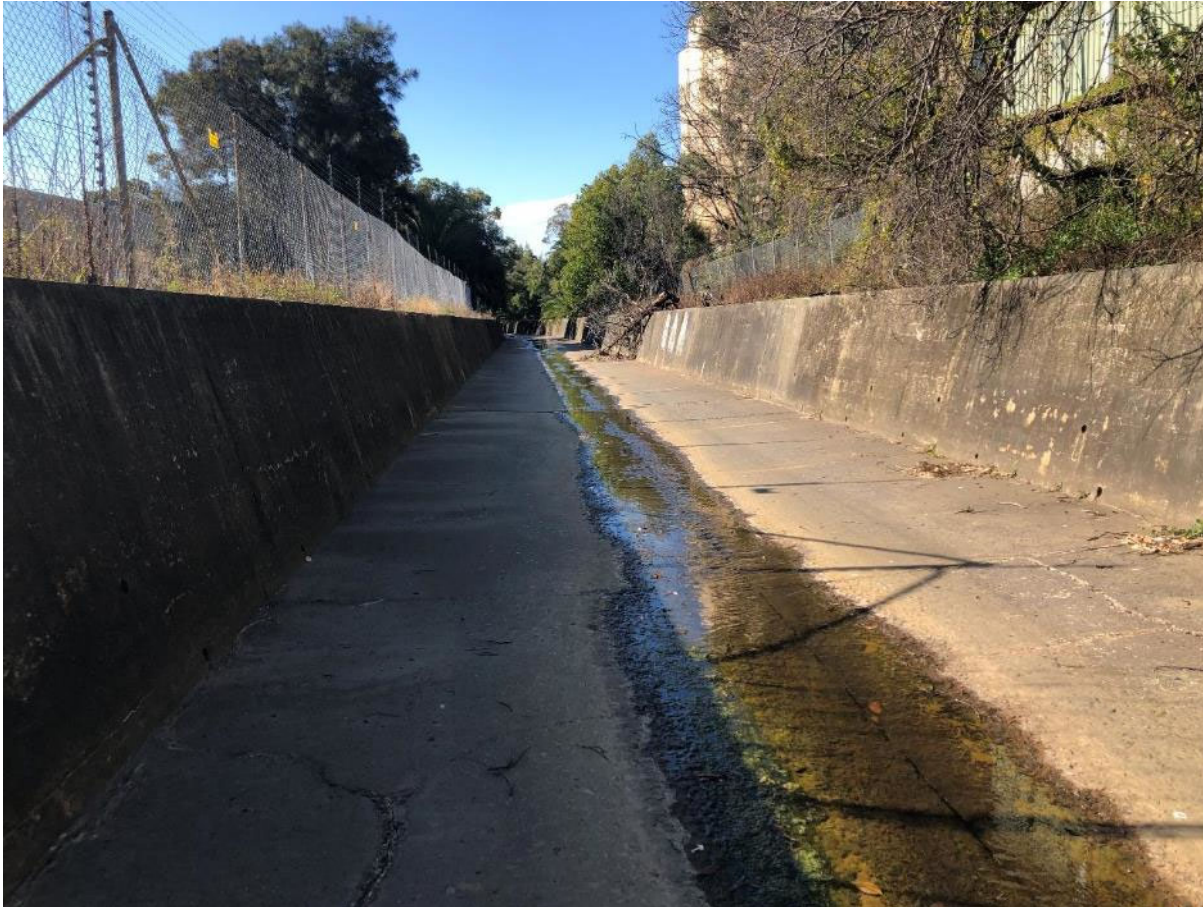
PHOTO ID	PHOTO	DESCRIPTION/CONDITION
HC-SWC-1.33

<p>Floors & Walls within Haslam's Creek Stormwater Channel (including Stormwater Discharge Outlets) outside South-Eastern Boundary of Site.</p> <ul style="list-style-type: none"> • Visible sediment to bottom of Drainage Outlet. • Overgrown Vegetation in Drainage Channel and on each side of Canal Walls. Trees leaning over canal. • Surface Cracking & pitting to concrete base/floor • Surface Cracking to concrete Walls. Visible evident of movement/misalignment • Graffiti/Vandalism • Grass/vegetation & trees poorly maintained. Waste/Litter <p><u>Condition:</u> POOR/DAMAGED</p>

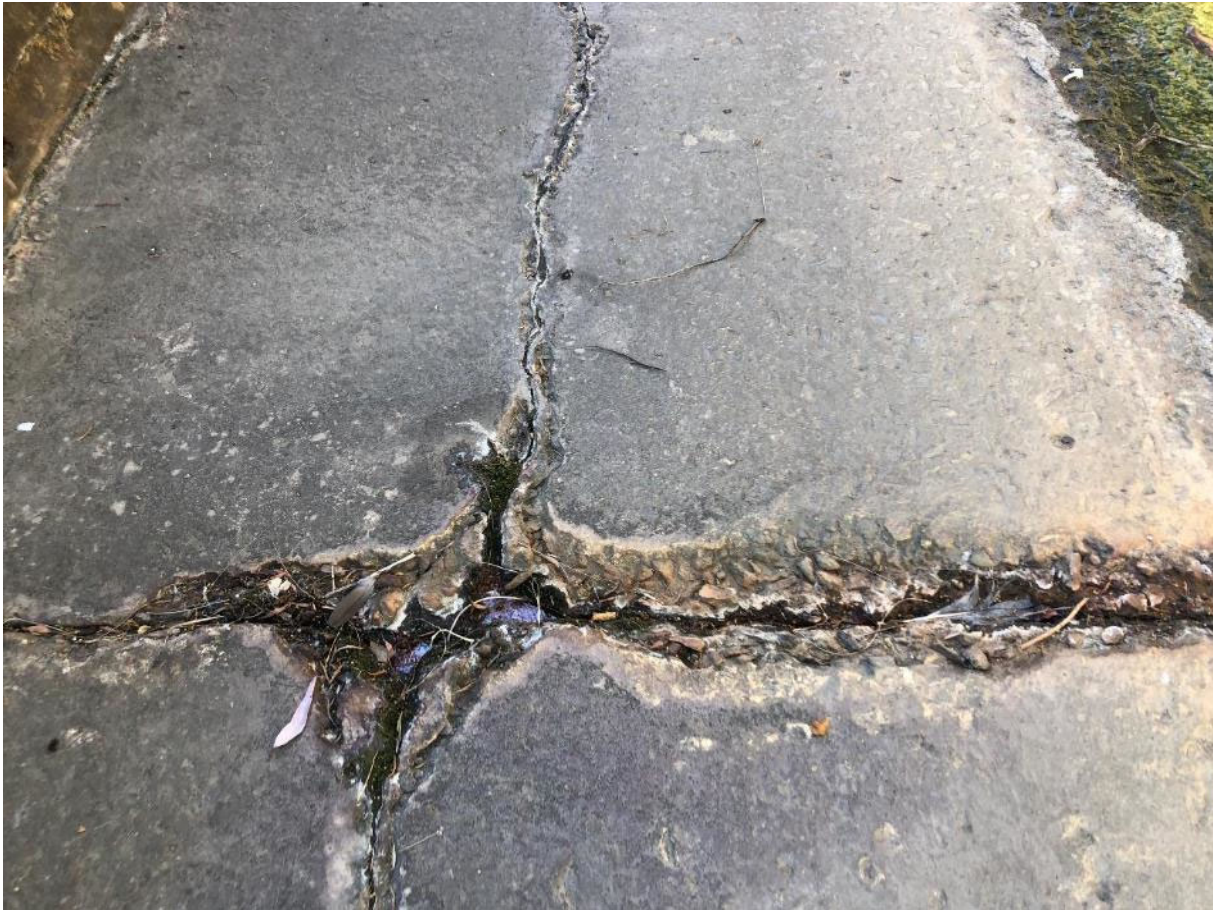
LOCATION: HASLAM'S CREEK STORMWATER CHANNEL – Internal Concrete Floor & Walls		
PHOTO ID	PHOTO	DESCRIPTION/CONDITION
HC-SWC-1.34

<p>Floors & Walls within Haslam's Creek Stormwater Channel (including Stormwater Discharge Outlets) outside South-Eastern Boundary of Site.</p> <ul style="list-style-type: none">• Visible sediment to bottom of Drainage Outlet.• Overgrown Vegetation in Drainage Channel and on each side of Canal Walls. Trees leaning over canal.• Surface Cracking & pitting to concrete base/floor• Surface Cracking to concrete Walls. Visible evident of movement/misalignment• Graffiti/Vandalism• Grass/vegetation & trees poorly maintained. Waste/Litter <p><u>Condition:</u> POOR/DAMAGED</p>

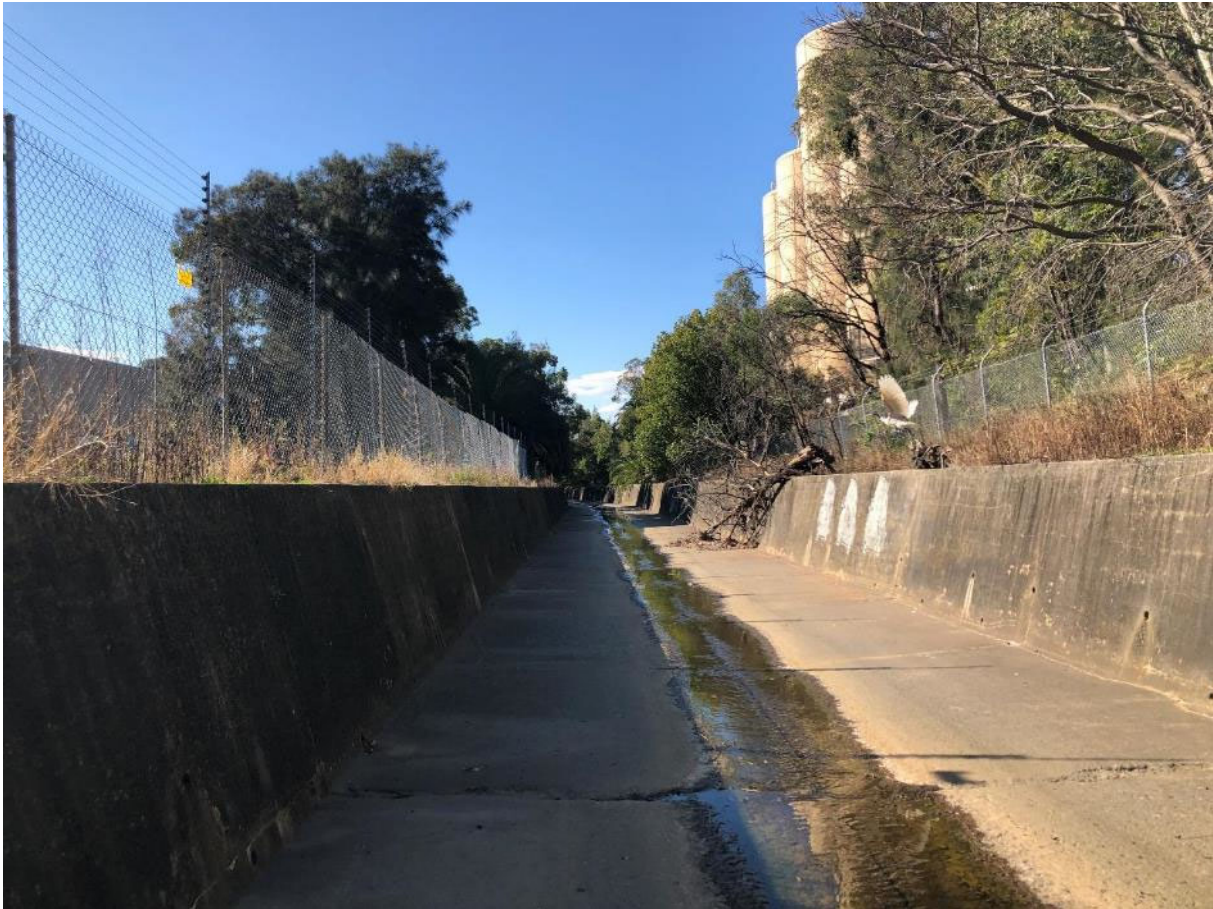
LOCATION: HASLAM'S CREEK STORMWATER CHANNEL – Internal Concrete Floor & Walls		
PHOTO ID	PHOTO	DESCRIPTION/CONDITION
HC-SWC-1.35

<p>Floors & Walls within Haslam's Creek Stormwater Channel (including Stormwater Discharge Outlets) outside South-Eastern Boundary of Site.</p> <ul style="list-style-type: none">• Visible sediment to bottom of Drainage Outlet.• Overgrown Vegetation in Drainage Channel and on each side of Canal Walls. Trees leaning over canal.• Surface Cracking & pitting to concrete base/floor• Surface Cracking to concrete Walls. Visible evident of movement/misalignment• Graffiti/Vandalism• Grass/vegetation & trees poorly maintained. Waste/Litter <p><u>Condition:</u> POOR/DAMAGED</p>

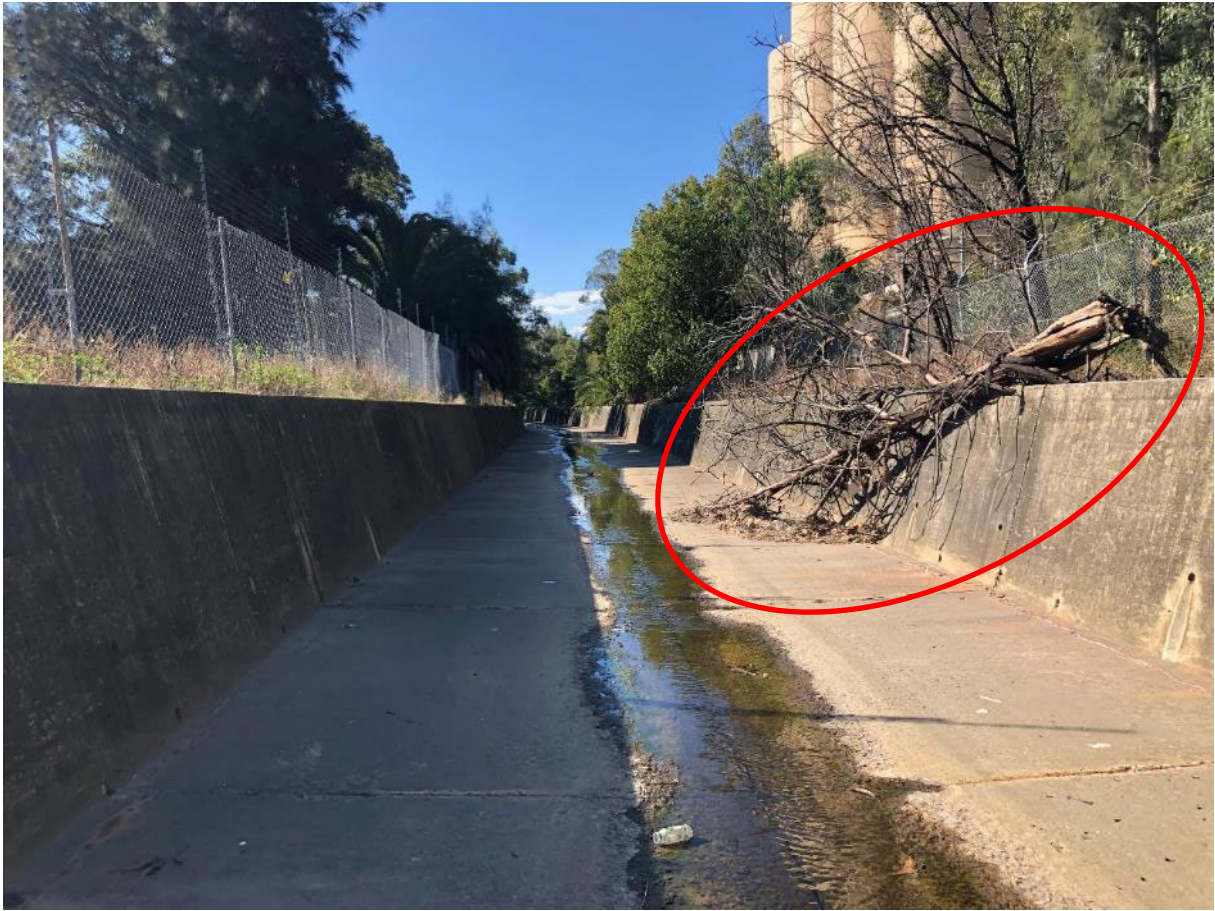
LOCATION: HASLAM'S CREEK STORMWATER CHANNEL – Internal Concrete Floor & Walls		
PHOTO ID	PHOTO	DESCRIPTION/CONDITION
HC-SWC-1.36

<p>Floors & Walls within Haslams Creek Stormwater Channel (including Stormwater Discharge Outlets) outside South-Eastern Boundary of Site.</p> <ul style="list-style-type: none">• Visible sediment to bottom of Drainage Outlet.• Overgrown Vegetation in Drainage Channel and on each side of Canal Walls. Trees leaning over canal.• Surface Cracking & pitting to concrete base/floor• Surface Cracking to concrete Walls. Visible evident of movement/misalignment• Graffiti/Vandalism• Grass/vegetation & trees poorly maintained. Waste/Litter <p><u>Condition:</u> POOR/DAMAGED</p>

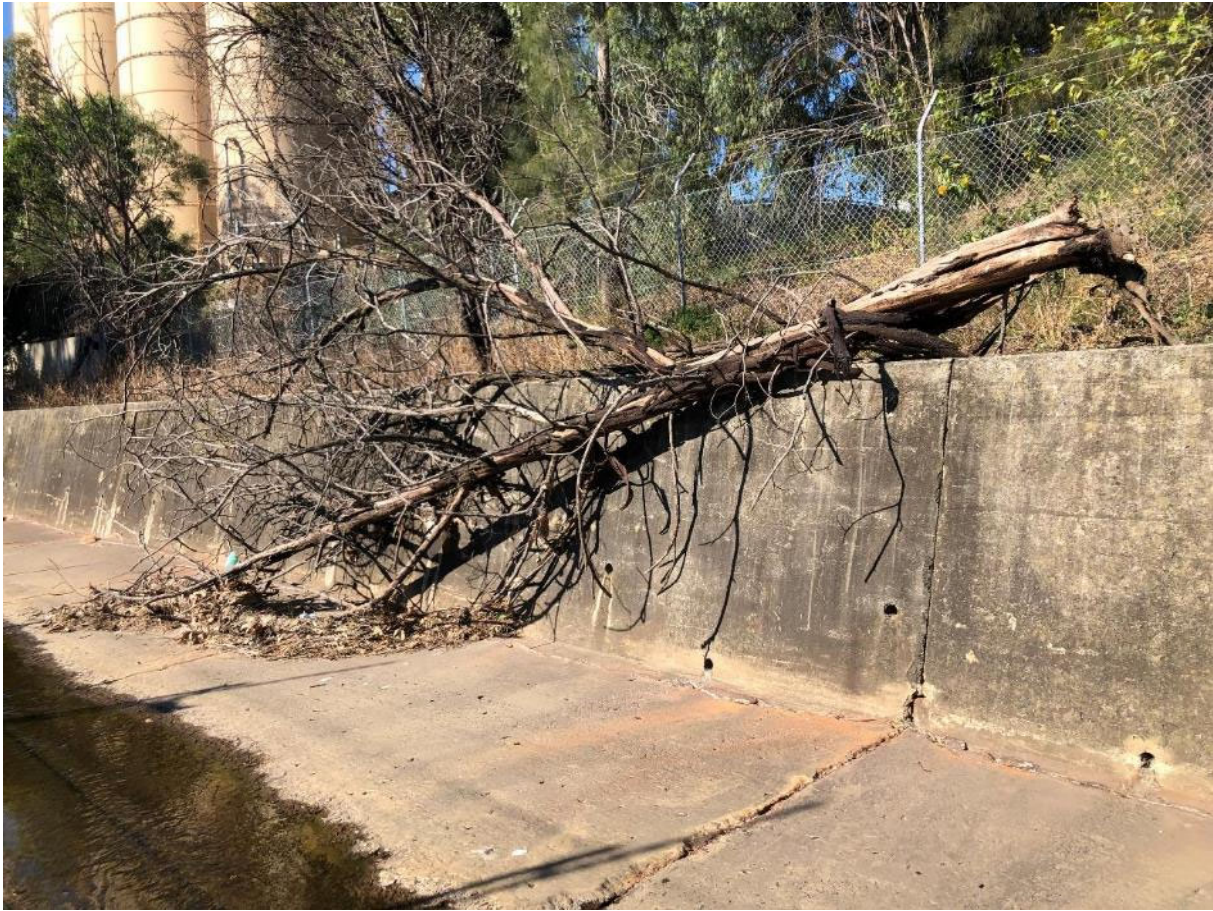
LOCATION: HASLAM'S CREEK STORMWATER CHANNEL – Internal Concrete Floor & Walls		
PHOTO ID	PHOTO	DESCRIPTION/CONDITION
HC-SWC-1.37

<p>Floors & Walls within Haslam's Creek Stormwater Channel (including Stormwater Discharge Outlets) outside South-Eastern Boundary of Site.</p> <ul style="list-style-type: none">• Visible sediment to bottom of Drainage Outlet.• Overgrown Vegetation in Drainage Channel and on each side of Canal Walls. Trees leaning over canal.• Surface Cracking & pitting to concrete base/floor• Surface Cracking to concrete Walls. Visible evident of movement/misalignment• Graffiti/Vandalism• Grass/vegetation & trees poorly maintained. Waste/Litter <p><u>Condition:</u> POOR/DAMAGED</p>

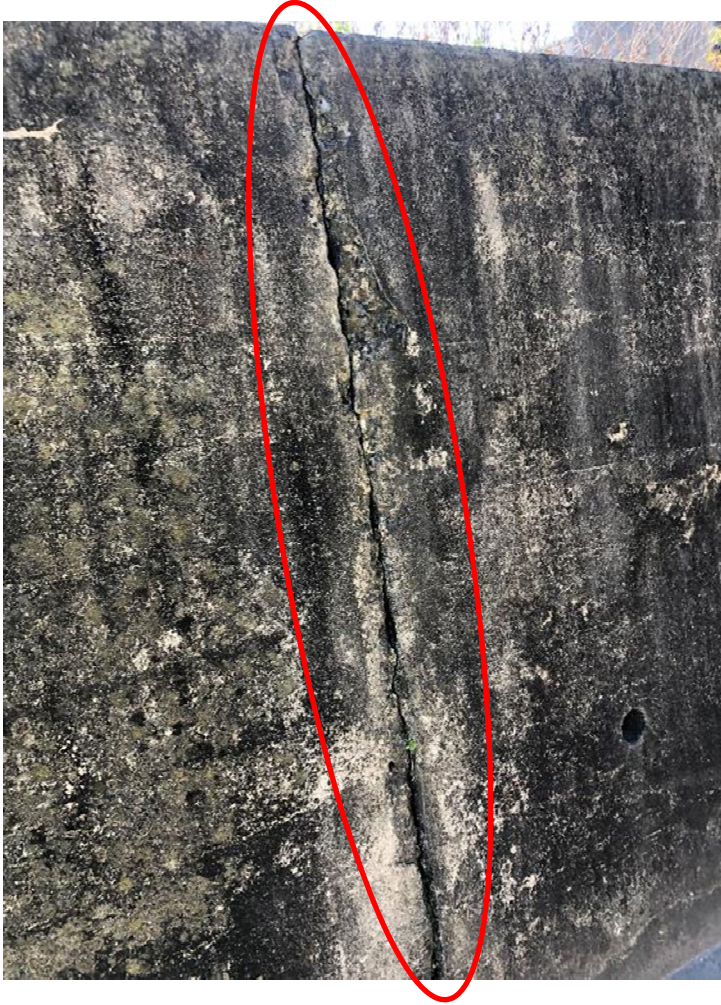
LOCATION: HASLAM'S CREEK STORMWATER CHANNEL – Internal Concrete Floor & Walls		
PHOTO ID	PHOTO	DESCRIPTION/CONDITION
HC-SWC-1.38

<p>Floors & Walls within Haslam's Creek Stormwater Channel (including Stormwater Discharge Outlets) outside South-Eastern Boundary of Site.</p> <ul style="list-style-type: none">• Visible sediment to bottom of Drainage Outlet.• Overgrown Vegetation in Drainage Channel and on each side of Canal Walls. Trees leaning over canal.• Surface Cracking & pitting to concrete base/floor• Surface Cracking to concrete Walls. Visible evident of movement/misalignment• Graffiti/Vandalism• Grass/vegetation & trees poorly maintained. Waste/Litter <p><u>Condition:</u> POOR/DAMAGED</p>

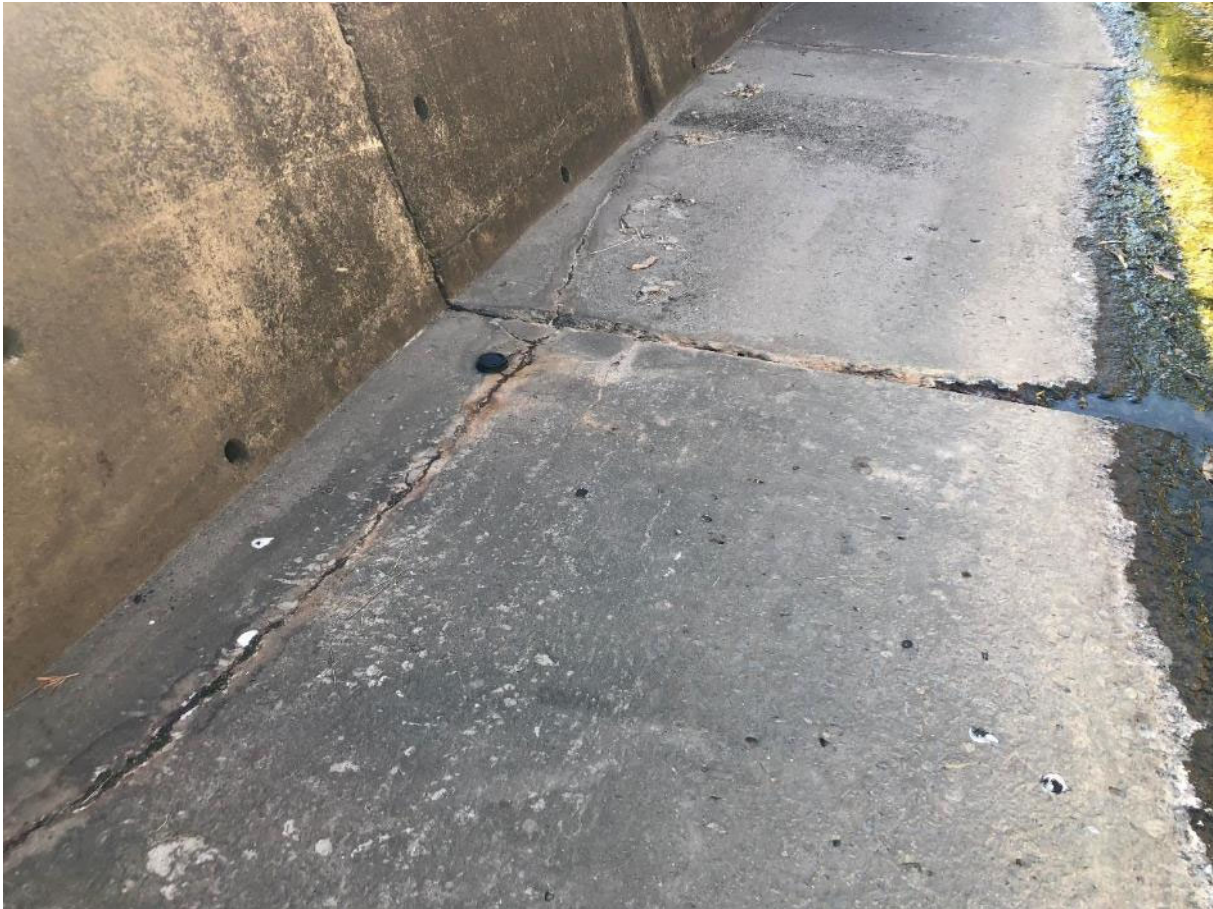
LOCATION: HASLAM'S CREEK STORMWATER CHANNEL – Internal Concrete Floor & Walls		
PHOTO ID	PHOTO	DESCRIPTION/CONDITION
HC-SWC-1.40

<p>Floors & Walls within Haslam's Creek Stormwater Channel (including Stormwater Discharge Outlets) outside South-Eastern Boundary of Site.</p> <ul style="list-style-type: none">• Visible sediment to bottom of Drainage Outlet.• Overgrown Vegetation in Drainage Channel and on each side of Canal Walls. Trees leaning over canal.• Surface Cracking & pitting to concrete base/floor• Surface Cracking to concrete Walls. Visible evident of movement/misalignment• Graffiti/Vandalism• Grass/vegetation & trees poorly maintained. Waste/Litter <p><u>Condition:</u> POOR/DAMAGED</p>

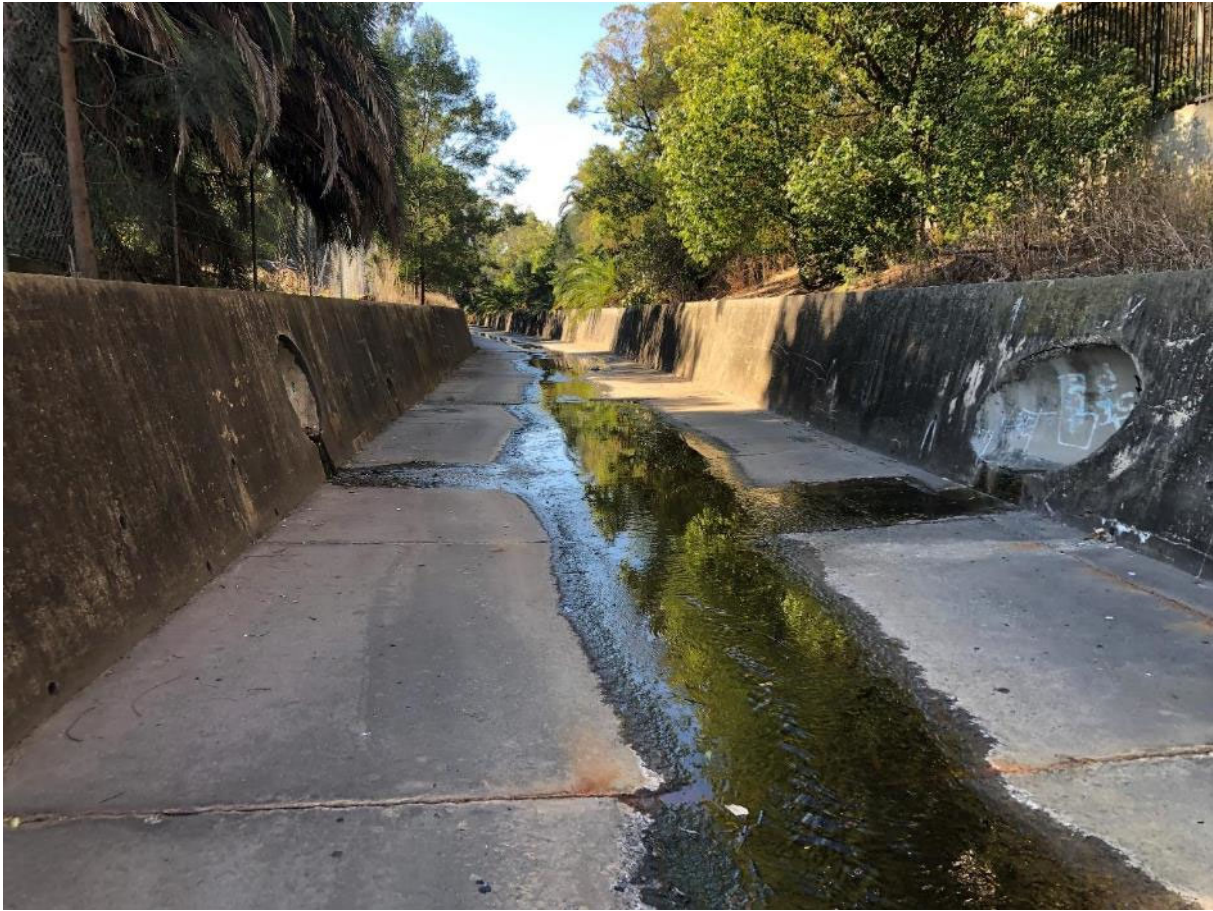
LOCATION: HASLAM'S CREEK STORMWATER CHANNEL – Internal Concrete Floor & Walls		
PHOTO ID	PHOTO	DESCRIPTION/CONDITION
HC-SWC-1.41

<p>Floors & Walls within Haslam's Creek Stormwater Channel (including Stormwater Discharge Outlets) outside South-Eastern Boundary of Site.</p> <ul style="list-style-type: none">• Visible sediment to bottom of Drainage Outlet.• Overgrown Vegetation in Drainage Channel and on each side of Canal Walls. Trees leaning over canal.• Surface Cracking & pitting to concrete base/floor• Surface Cracking to concrete Walls. Visible evident of movement/misalignment• Graffiti/Vandalism• Grass/vegetation & trees poorly maintained. Waste/Litter <p><u>Condition:</u> POOR/DAMAGED</p>

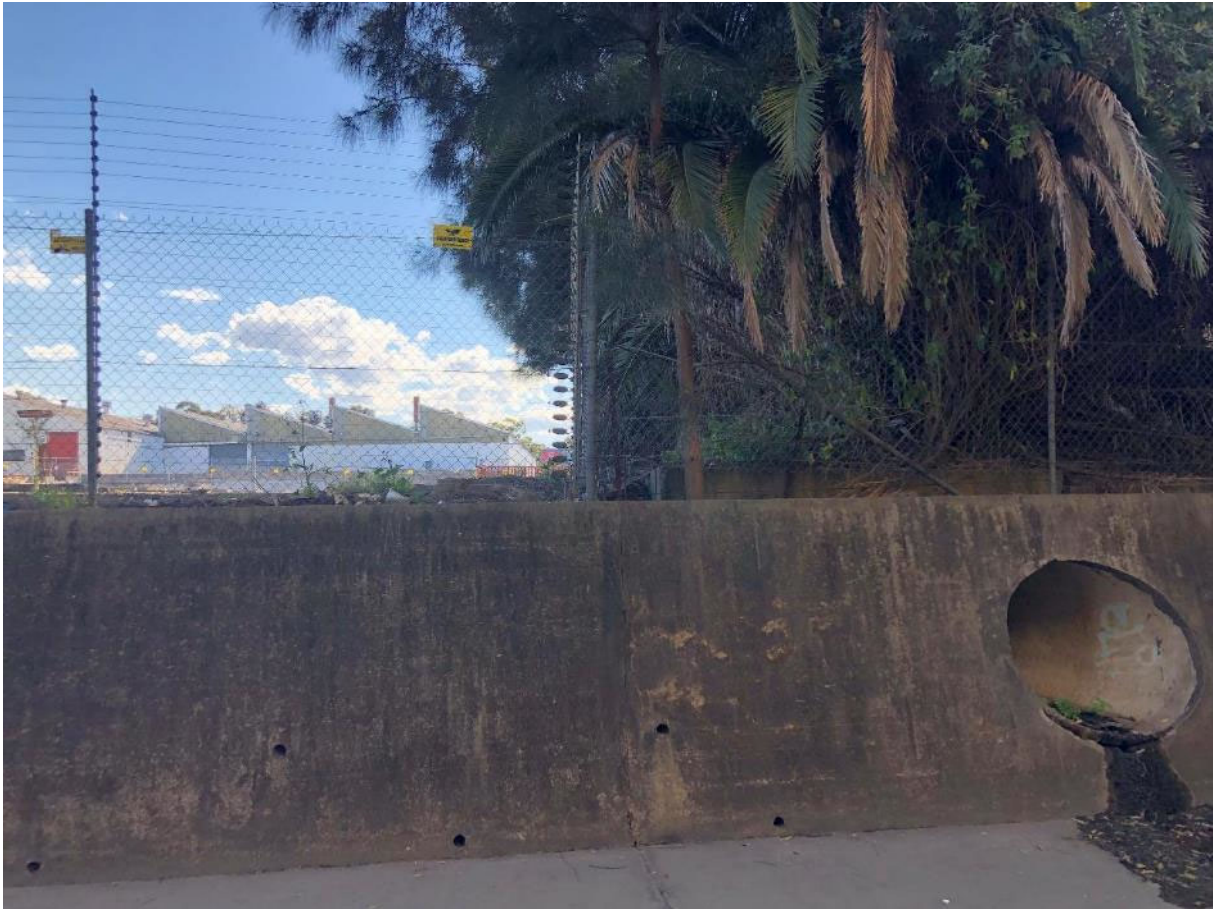
LOCATION: HASLAM'S CREEK STORMWATER CHANNEL – Internal Concrete Floor & Walls		
PHOTO ID	PHOTO	DESCRIPTION/CONDITION
HC-SWC-1.42

<p>Floors & Walls within Haslam's Creek Stormwater Channel (including Stormwater Discharge Outlets) outside South-Eastern Boundary of Site.</p> <ul style="list-style-type: none">• Visible sediment to bottom of Drainage Outlet.• Overgrown Vegetation in Drainage Channel and on each side of Canal Walls. Trees leaning over canal.• Surface Cracking & pitting to concrete base/floor• Surface Cracking to concrete Walls. Visible evident of movement/misalignment• Graffiti/Vandalism• Grass/vegetation & trees poorly maintained. Waste/Litter <p><u>Condition:</u> POOR/DAMAGED</p>

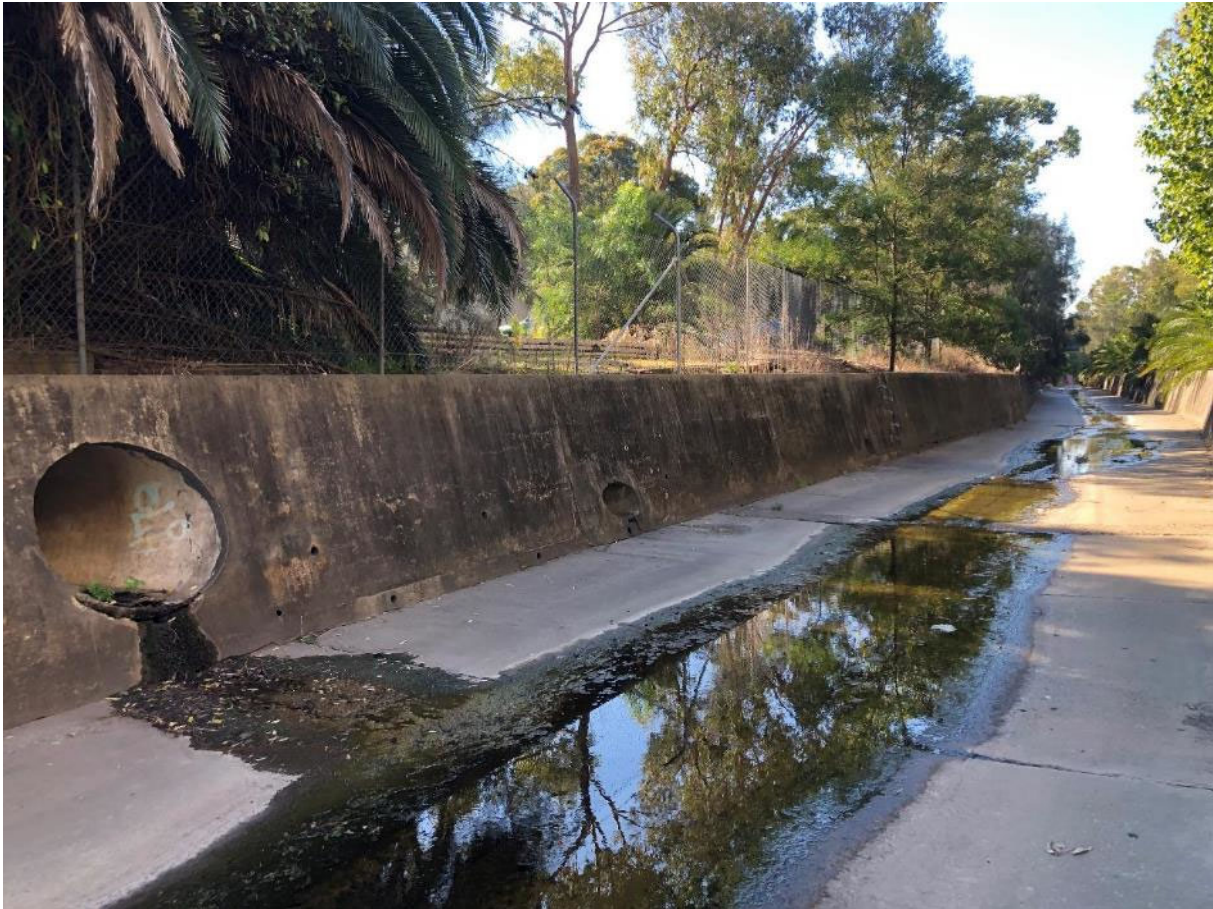
LOCATION: HASLAM'S CREEK STORMWATER CHANNEL – Internal Concrete Floor & Walls		
PHOTO ID	PHOTO	DESCRIPTION/CONDITION
HC-SWC-1.43

<p>Floors & Walls within Haslam's Creek Stormwater Channel (including Stormwater Discharge Outlets) outside South-Eastern Boundary of Site.</p> <ul style="list-style-type: none">• Visible sediment to bottom of Drainage Outlet.• Overgrown Vegetation in Drainage Channel and on each side of Canal Walls. Trees leaning over canal.• Surface Cracking & pitting to concrete base/floor• Surface Cracking to concrete Walls. Visible evident of movement/misalignment• Graffiti/Vandalism• Grass/vegetation & trees poorly maintained. Waste/Litter <p><u>Condition:</u> POOR/DAMAGED</p>

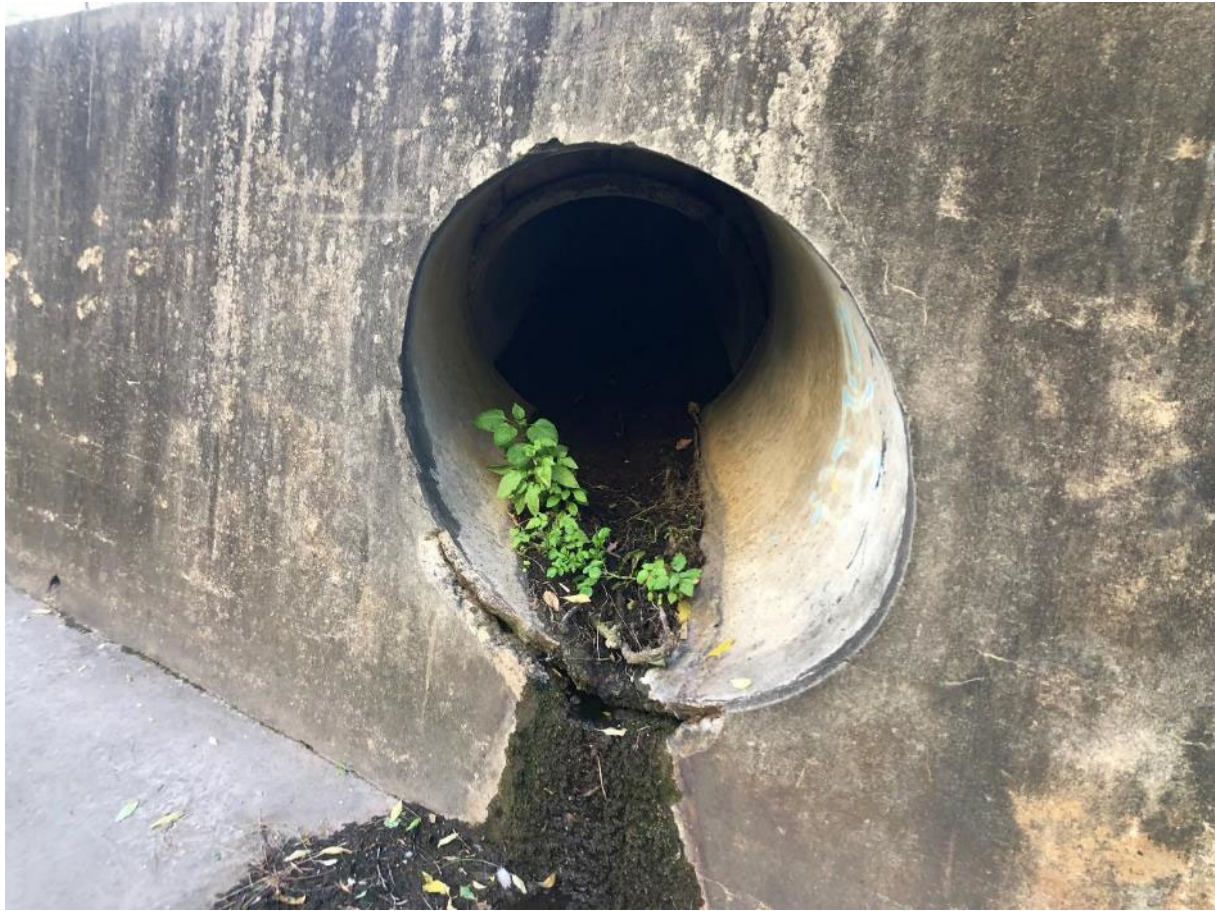
LOCATION: HASLAM'S CREEK STORMWATER CHANNEL – Internal Concrete Floor & Walls		
PHOTO ID	PHOTO	DESCRIPTION/CONDITION
HC-SWC-1.44

<p>Floors & Walls within Haslams Creek Stormwater Channel (including Stormwater Discharge Outlets) outside South-Eastern Boundary of Site.</p> <ul style="list-style-type: none">• Visible sediment to bottom of Drainage Outlet.• Overgrown Vegetation in Drainage Channel and on each side of Canal Walls. Trees leaning over canal.• Surface Cracking & pitting to concrete base/floor• Surface Cracking to concrete Walls. Visible evident of movement/misalignment• Graffiti/Vandalism• Grass/vegetation & trees poorly maintained. Waste/Litter <p><u>Condition:</u> POOR/DAMAGED</p>

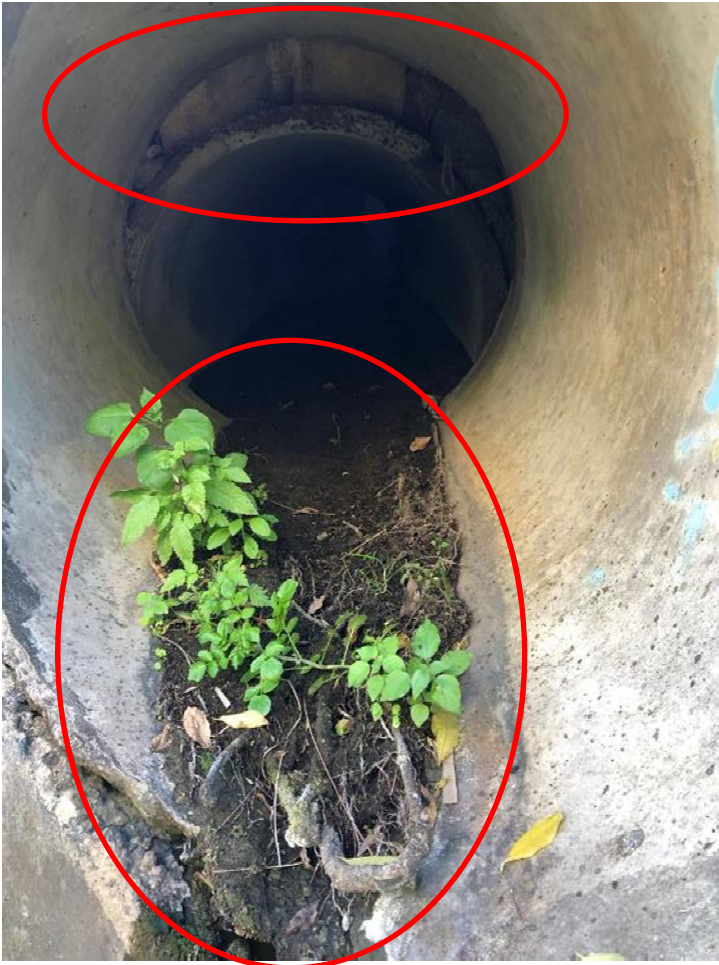
LOCATION: HASLAM'S CREEK STORMWATER CHANNEL – Internal Concrete Floor & Walls		
PHOTO ID	PHOTO	DESCRIPTION/CONDITION
HC-SWC-1.45

<p>Floors & Walls within Haslam's Creek Stormwater Channel (including Stormwater Discharge Outlets) outside South-Eastern Boundary of Site.</p> <ul style="list-style-type: none">• Visible sediment to bottom of Drainage Outlet.• Overgrown Vegetation in Drainage Channel and on each side of Canal Walls. Trees leaning over canal.• Surface Cracking & pitting to concrete base/floor• Surface Cracking to concrete Walls. Visible evident of movement/misalignment• Graffiti/Vandalism• Grass/vegetation & trees poorly maintained. Waste/Litter <p><u>Condition:</u> POOR/DAMAGED</p>

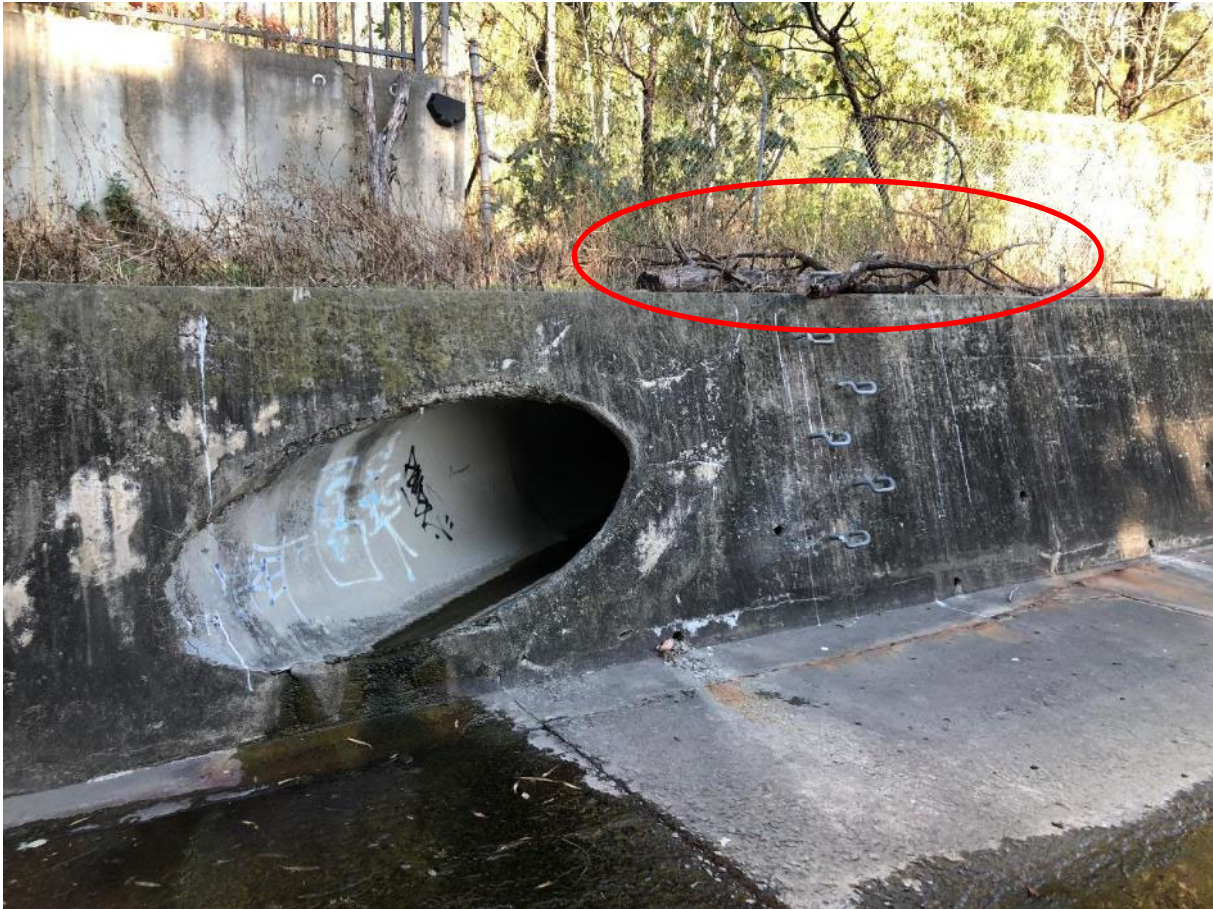
LOCATION: HASLAM'S CREEK STORMWATER CHANNEL – Internal Concrete Floor & Walls		
PHOTO ID	PHOTO	DESCRIPTION/CONDITION
HC-SWC-1.48

<p>Floors & Walls within Haslam's Creek Stormwater Channel (including Stormwater Discharge Outlets) outside South-Eastern Boundary of Site.</p> <ul style="list-style-type: none">• Visible sediment to bottom of Drainage Outlet.• Overgrown Vegetation in Drainage Channel and on each side of Canal Walls. Trees leaning over canal.• Surface Cracking & pitting to concrete base/floor• Surface Cracking to concrete Walls. Visible evident of movement/misalignment• Graffiti/Vandalism• Grass/vegetation & trees poorly maintained. Waste/Litter <p><u>Condition:</u> POOR/DAMAGED</p>
