STORMWATER CHANNEL

HASLAM'S CREEK

Internal Concrete Floor & Walls

Photo ID **HC-SWC-1.1**
To
Photo ID **HC-SWC-1.73**
(INCLUSIVE)

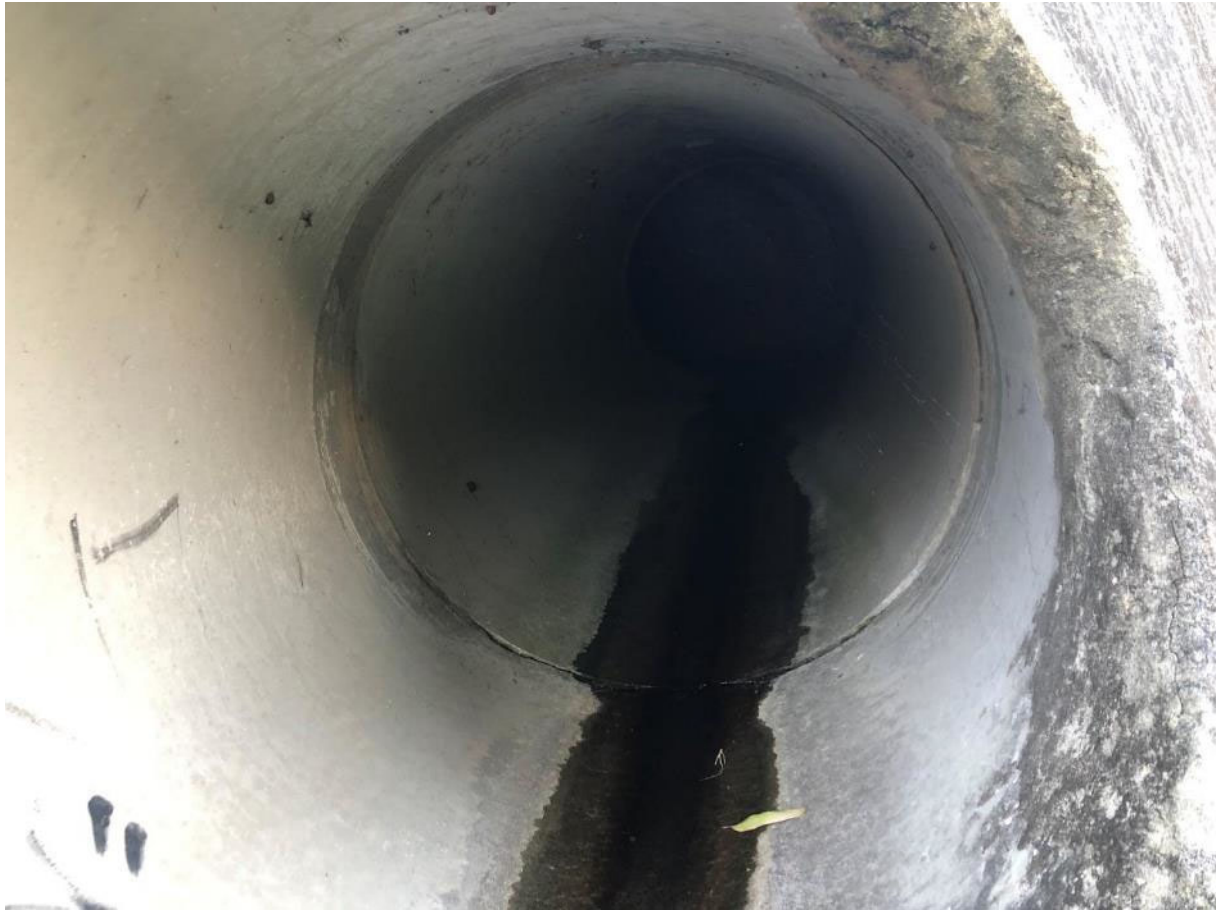
LOCATION: HASLAM'S CREEK STORMWATER CHANNEL – Internal Concrete Floor & Walls		
PHOTO ID	PHOTO	DESCRIPTION/CONDITION
HC-SWC-1.49

<p>Floors & Walls within Haslam's Creek Stormwater Channel (including Stormwater Discharge Outlets) outside South-Eastern Boundary of Site.</p> <ul style="list-style-type: none">• Visible sediment to bottom of Drainage Outlet.• Overgrown Vegetation in Drainage Channel and on each side of Canal Walls. Trees leaning over canal.• Surface Cracking & pitting to concrete base/floor• Surface Cracking to concrete Walls. Visible evident of movement/misalignment• Graffiti/Vandalism• Grass/vegetation & trees poorly maintained. Waste/Litter <p><u>Condition:</u> POOR/DAMAGED</p>

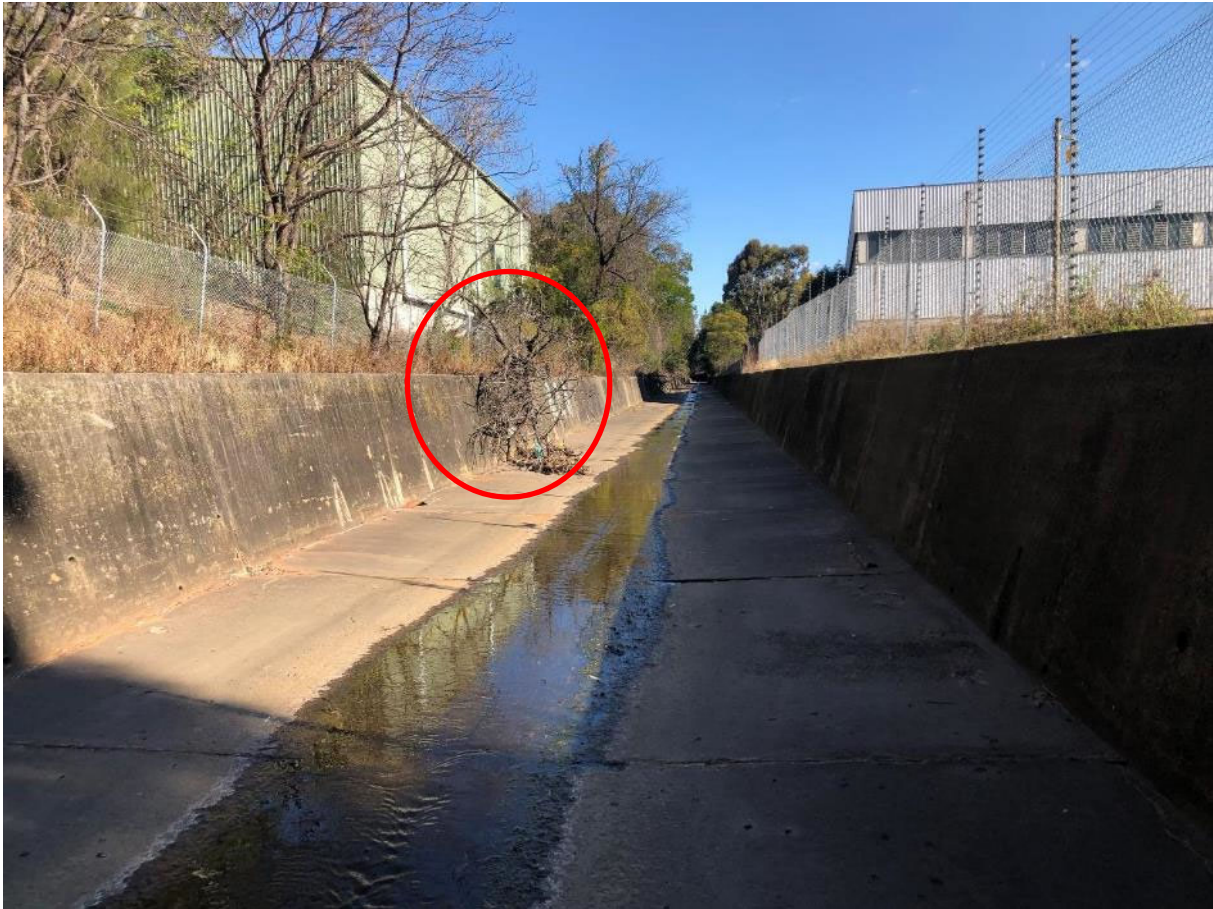
LOCATION: HASLAM'S CREEK STORMWATER CHANNEL – Internal Concrete Floor & Walls		
PHOTO ID	PHOTO	DESCRIPTION/CONDITION
HC-SWC-1.50

<p>Floors & Walls within Haslam's Creek Stormwater Channel (including Stormwater Discharge Outlets) outside South-Eastern Boundary of Site.</p> <ul style="list-style-type: none">• Visible sediment to bottom of Drainage Outlet.• Overgrown Vegetation in Drainage Channel and on each side of Canal Walls. Trees leaning over canal.• Surface Cracking & pitting to concrete base/floor• Surface Cracking to concrete Walls. Visible evident of movement/misalignment• Graffiti/Vandalism• Grass/vegetation & trees poorly maintained. Waste/Litter <p><u>Condition:</u> POOR/DAMAGED</p>

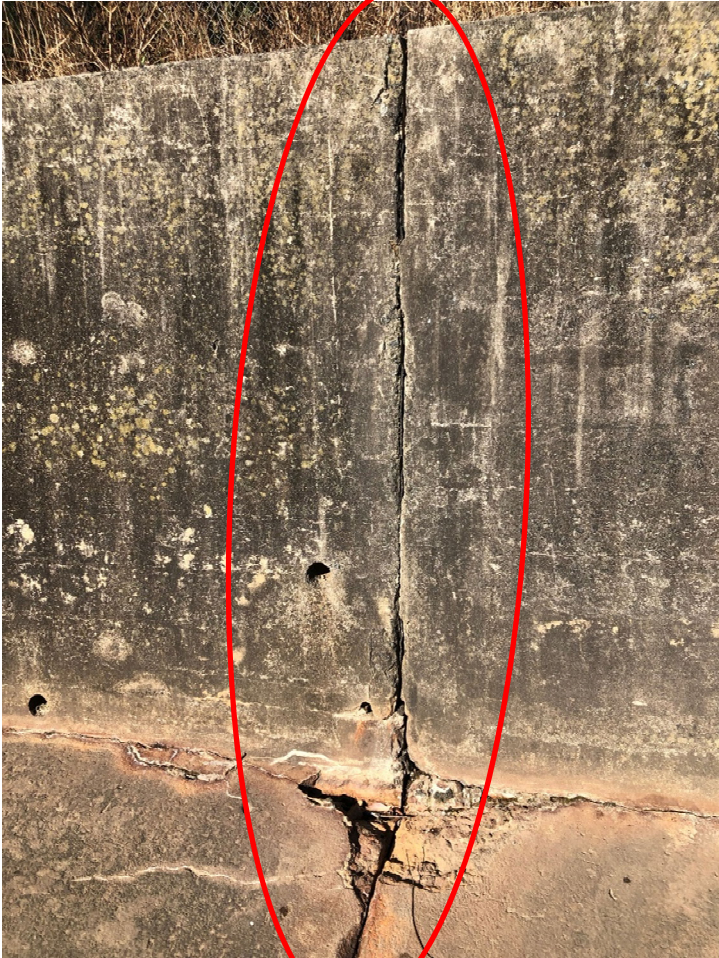
LOCATION: HASLAM'S CREEK STORMWATER CHANNEL – Internal Concrete Floor & Walls		
PHOTO ID	PHOTO	DESCRIPTION/CONDITION
HC-SWC-1.51

<p>Floors & Walls within Haslam's Creek Stormwater Channel (including Stormwater Discharge Outlets) outside South-Eastern Boundary of Site.</p> <ul style="list-style-type: none">• Visible sediment to bottom of Drainage Outlet.• Overgrown Vegetation in Drainage Channel and on each side of Canal Walls. Trees leaning over canal.• Surface Cracking & pitting to concrete base/floor• Surface Cracking to concrete Walls. Visible evident of movement/misalignment• Graffiti/Vandalism• Grass/vegetation & trees poorly maintained. Waste/Litter <p><u>Condition:</u> POOR/DAMAGED</p>

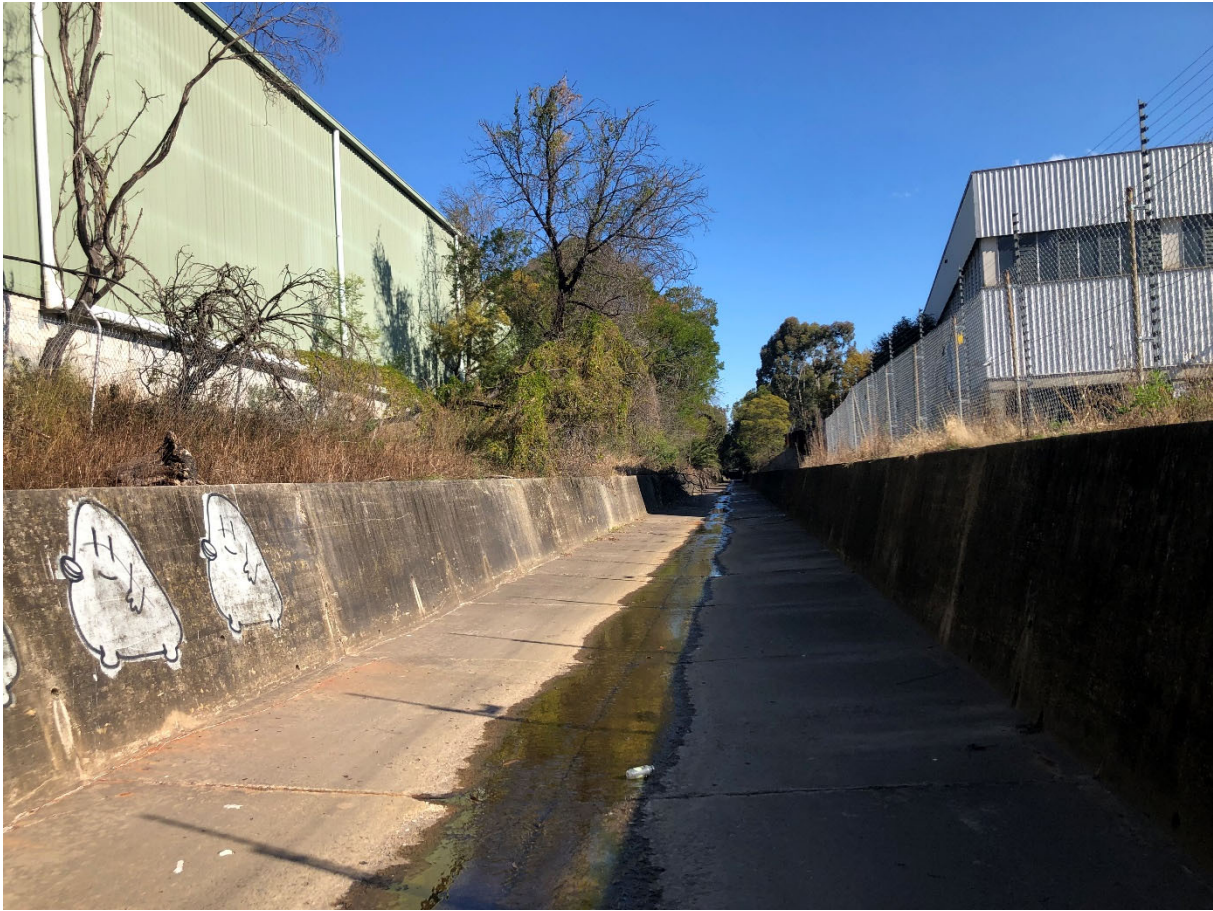
LOCATION: HASLAM'S CREEK STORMWATER CHANNEL – Internal Concrete Floor & Walls		
PHOTO ID	PHOTO	DESCRIPTION/CONDITION
HC-SWC-1.52

<p>Floors & Walls within Haslam's Creek Stormwater Channel (including Stormwater Discharge Outlets) outside South-Eastern Boundary of Site.</p> <ul style="list-style-type: none">• Visible sediment to bottom of Drainage Outlet.• Overgrown Vegetation in Drainage Channel and on each side of Canal Walls. Trees leaning over canal.• Surface Cracking & pitting to concrete base/floor• Surface Cracking to concrete Walls. Visible evident of movement/misalignment• Graffiti/Vandalism• Grass/vegetation & trees poorly maintained. Waste/Litter <p><u>Condition:</u> POOR/DAMAGED</p>

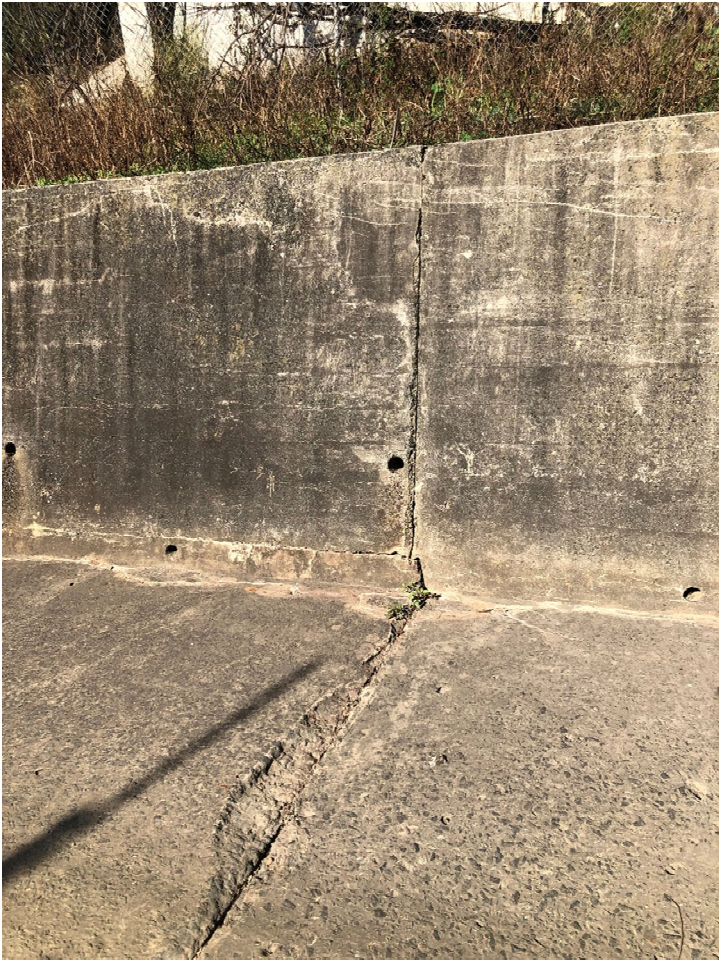
LOCATION: HASLAM'S CREEK STORMWATER CHANNEL – Internal Concrete Floor & Walls		
PHOTO ID	PHOTO	DESCRIPTION/CONDITION
HC-SWC-1.53

<p>Floors & Walls within Haslam's Creek Stormwater Channel (including Stormwater Discharge Outlets) outside South-Eastern Boundary of Site.</p> <ul style="list-style-type: none">• Visible sediment to bottom of Drainage Outlet.• Overgrown Vegetation in Drainage Channel and on each side of Canal Walls. Trees leaning over canal.• Surface Cracking & pitting to concrete base/floor• Surface Cracking to concrete Walls. Visible evident of movement/misalignment• Graffiti/Vandalism• Grass/vegetation & trees poorly maintained. Waste/Litter <p><u>Condition:</u> POOR/DAMAGED</p>

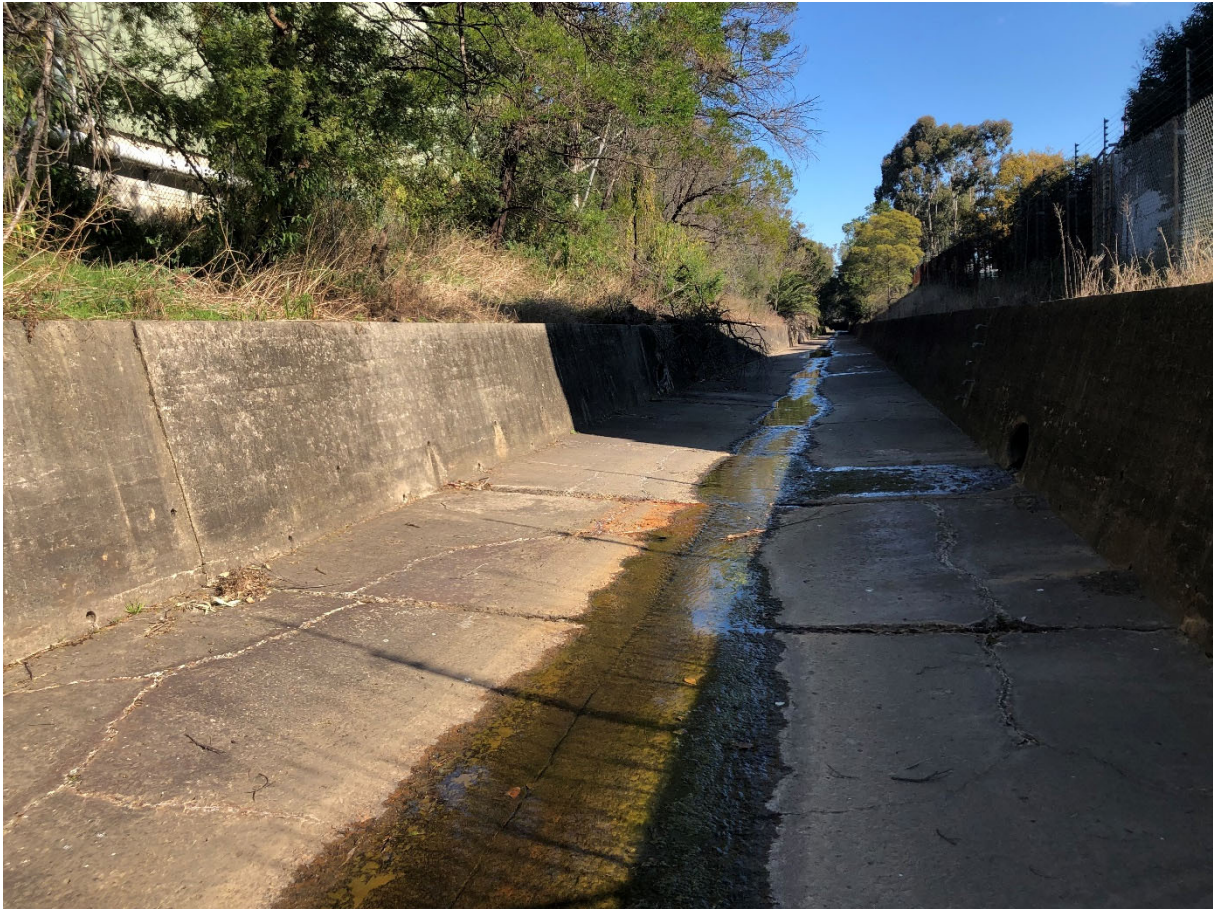
LOCATION: HASLAM'S CREEK STORMWATER CHANNEL – Internal Concrete Floor & Walls		
PHOTO ID	PHOTO	DESCRIPTION/CONDITION
HC-SWC-1.54

<p>Floors & Walls within Haslam's Creek Stormwater Channel (including Stormwater Discharge Outlets) outside South-Eastern Boundary of Site.</p> <ul style="list-style-type: none">• Visible sediment to bottom of Drainage Outlet.• Overgrown Vegetation in Drainage Channel and on each side of Canal Walls. Trees leaning over canal.• Surface Cracking & pitting to concrete base/floor• Surface Cracking to concrete Walls. Visible evident of movement/misalignment• Graffiti/Vandalism• Grass/vegetation & trees poorly maintained. Waste/Litter <p><u>Condition:</u> POOR/DAMAGED</p>

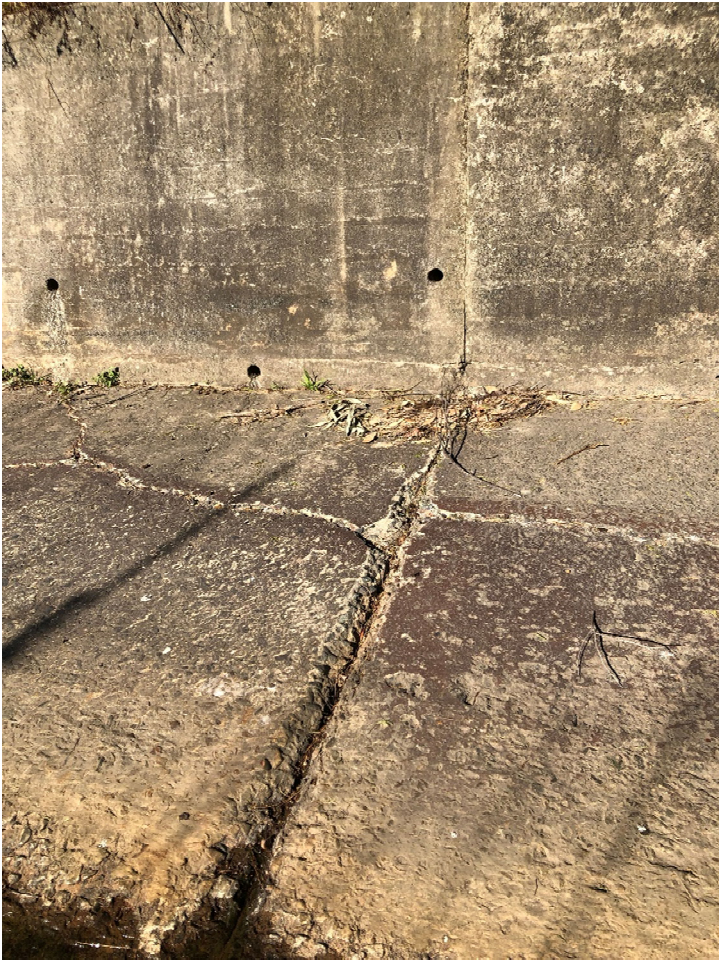
LOCATION: HASLAM'S CREEK STORMWATER CHANNEL – Internal Concrete Floor & Walls		
PHOTO ID	PHOTO	DESCRIPTION/CONDITION
HC-SWC-1.55

<p>Floors & Walls within Haslam's Creek Stormwater Channel (including Stormwater Discharge Outlets) outside South-Eastern Boundary of Site.</p> <ul style="list-style-type: none">• Visible sediment to bottom of Drainage Outlet.• Overgrown Vegetation in Drainage Channel and on each side of Canal Walls. Trees leaning over canal.• Surface Cracking & pitting to concrete base/floor• Surface Cracking to concrete Walls. Visible evident of movement/misalignment• Graffiti/Vandalism• Grass/vegetation & trees poorly maintained. Waste/Litter <p><u>Condition:</u> POOR/DAMAGED</p>

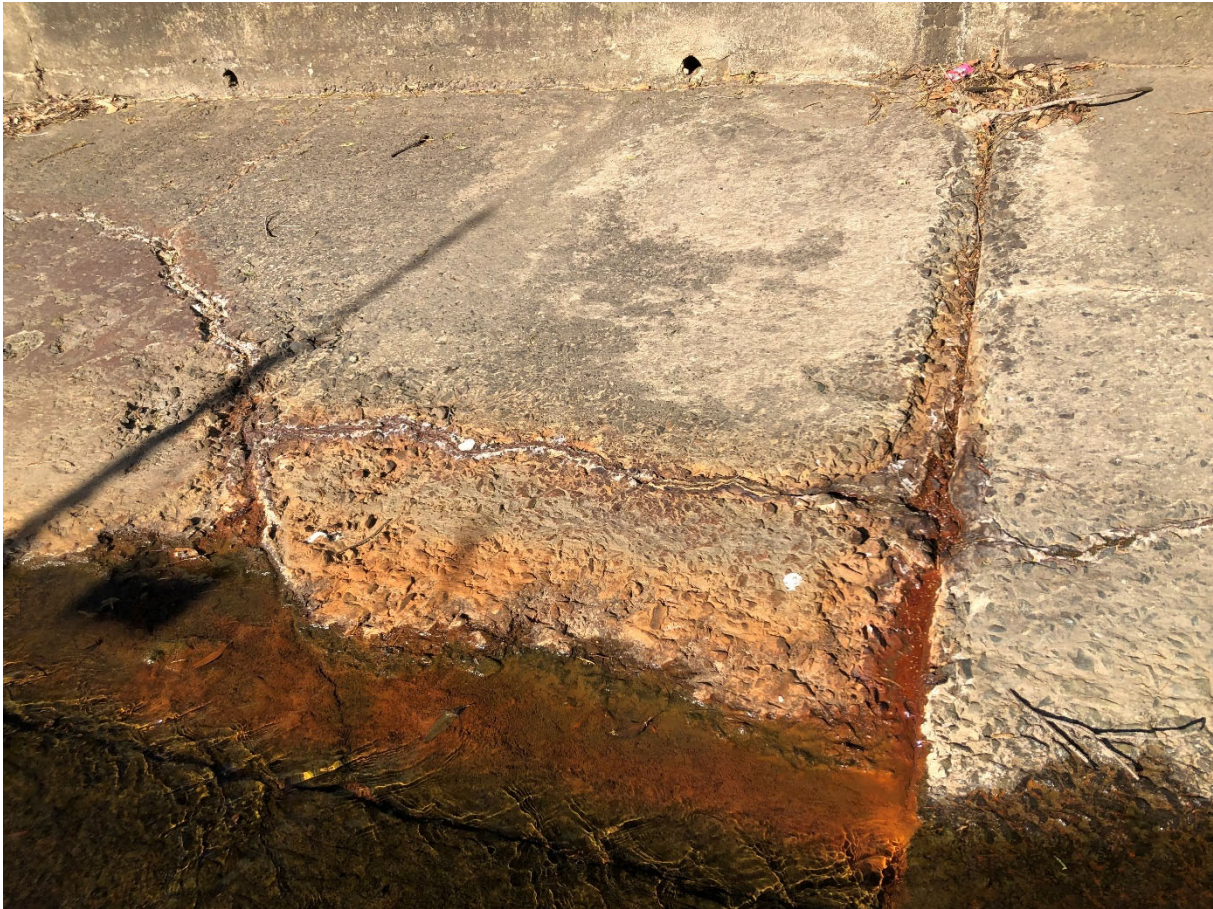
LOCATION: HASLAM'S CREEK STORMWATER CHANNEL – Internal Concrete Floor & Walls		
PHOTO ID	PHOTO	DESCRIPTION/CONDITION
HC-SWC-1.56

<p>Floors & Walls within Haslam's Creek Stormwater Channel (including Stormwater Discharge Outlets) outside South-Eastern Boundary of Site.</p> <ul style="list-style-type: none">• Visible sediment to bottom of Drainage Outlet.• Overgrown Vegetation in Drainage Channel and on each side of Canal Walls. Trees leaning over canal.• Surface Cracking & pitting to concrete base/floor• Surface Cracking to concrete Walls. Visible evident of movement/misalignment• Graffiti/Vandalism• Grass/vegetation & trees poorly maintained. Waste/Litter <p><u>Condition:</u> POOR/DAMAGED</p>

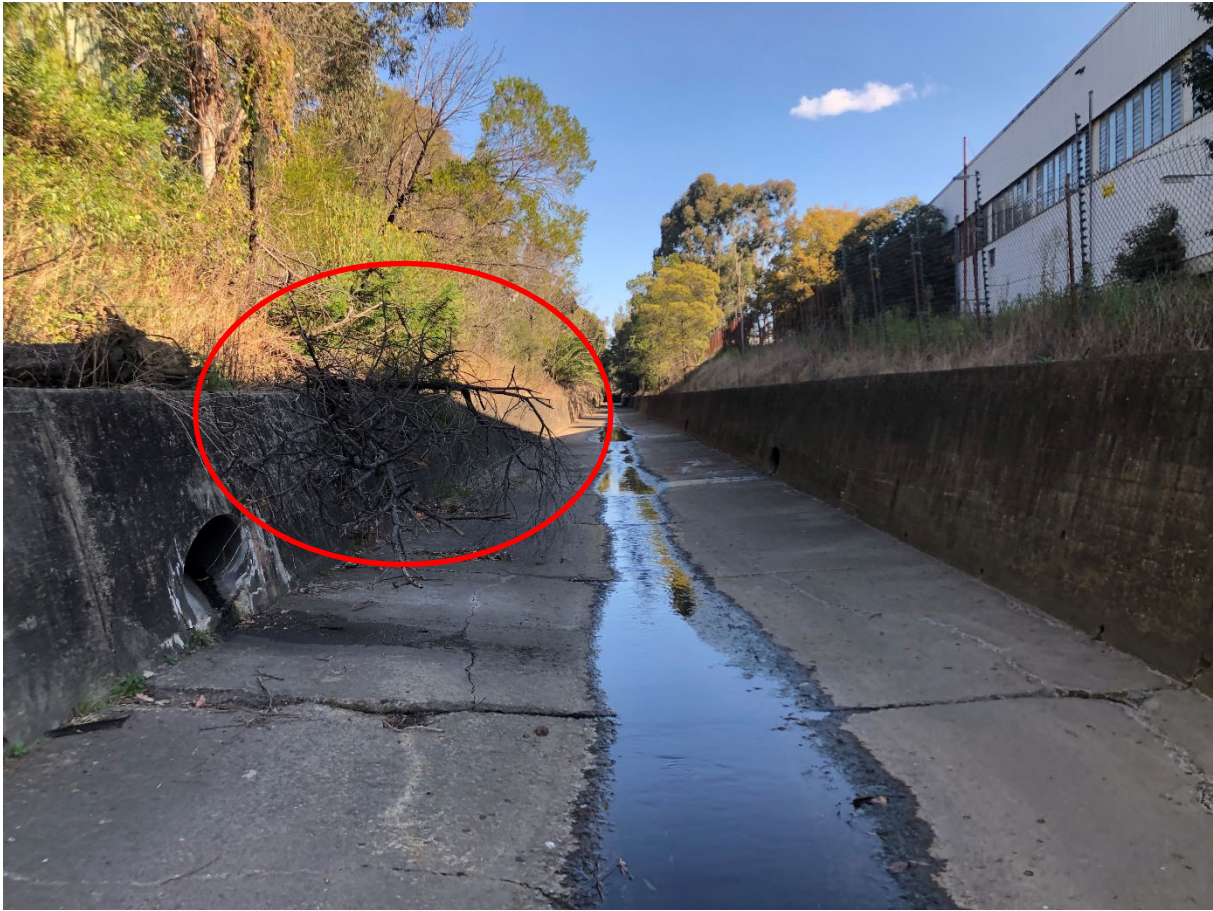
LOCATION: HASLAM'S CREEK STORMWATER CHANNEL – Internal Concrete Floor & Walls		
PHOTO ID	PHOTO	DESCRIPTION/CONDITION
HC-SWC-1.57

<p>Floors & Walls within Haslam's Creek Stormwater Channel (including Stormwater Discharge Outlets) outside South-Eastern Boundary of Site.</p> <ul style="list-style-type: none">• Visible sediment to bottom of Drainage Outlet.• Overgrown Vegetation in Drainage Channel and on each side of Canal Walls. Trees leaning over canal.• Surface Cracking & pitting to concrete base/floor• Surface Cracking to concrete Walls. Visible evident of movement/misalignment• Graffiti/Vandalism• Grass/vegetation & trees poorly maintained. Waste/Litter <p><u>Condition:</u> POOR/DAMAGED</p>

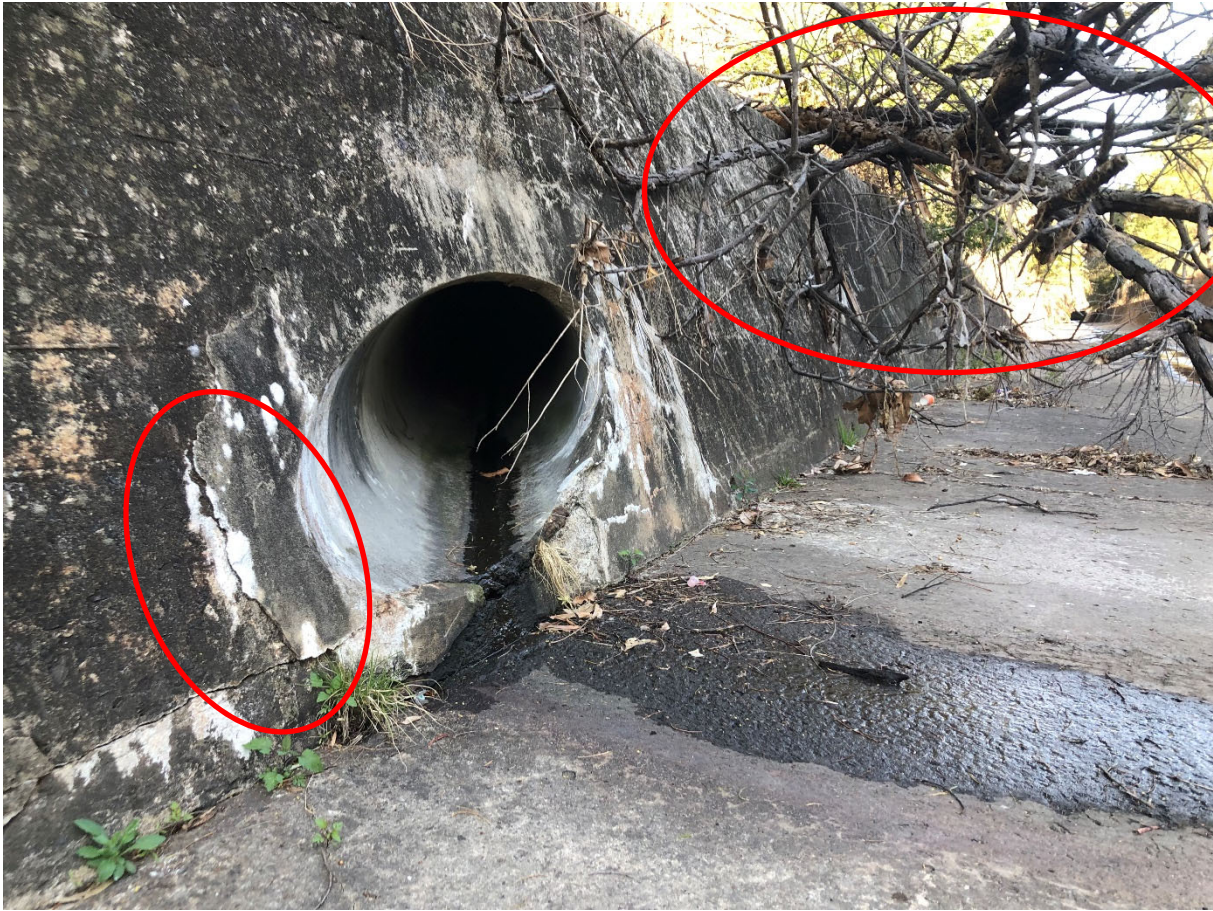
LOCATION: HASLAM'S CREEK STORMWATER CHANNEL – Internal Concrete Floor & Walls		
PHOTO ID	PHOTO	DESCRIPTION/CONDITION
HC-SWC-1.58

<p>Floors & Walls within Haslam's Creek Stormwater Channel (including Stormwater Discharge Outlets) outside South-Eastern Boundary of Site.</p> <ul style="list-style-type: none">• Visible sediment to bottom of Drainage Outlet.• Overgrown Vegetation in Drainage Channel and on each side of Canal Walls. Trees leaning over canal.• Surface Cracking & pitting to concrete base/floor• Surface Cracking to concrete Walls. Visible evident of movement/misalignment• Graffiti/Vandalism• Grass/vegetation & trees poorly maintained. Waste/Litter <p><u>Condition:</u> POOR/DAMAGED</p>

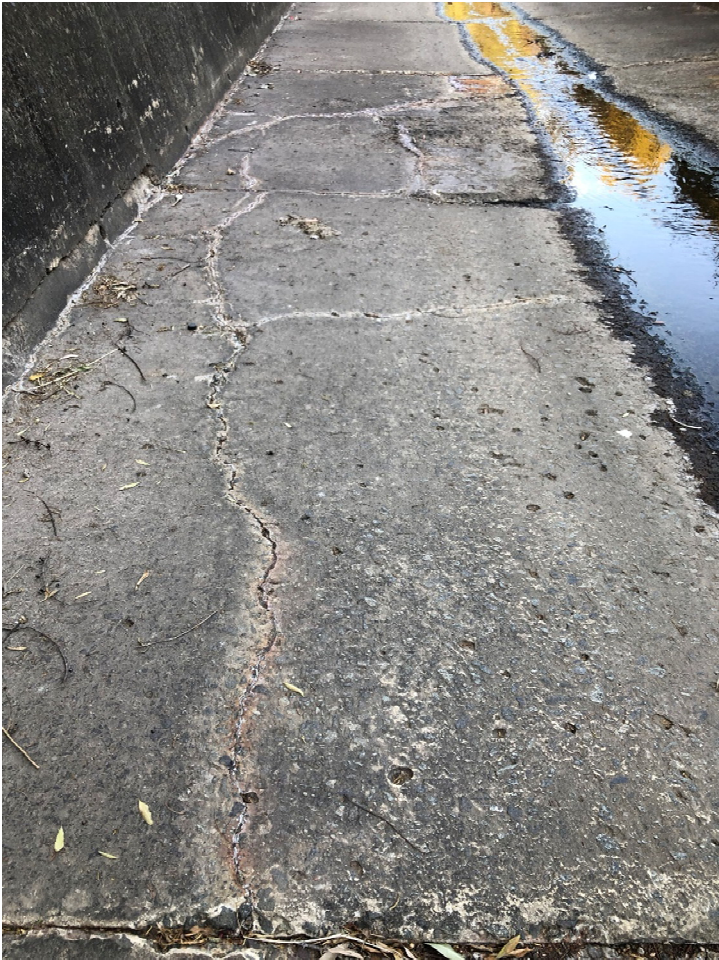
LOCATION: HASLAM'S CREEK STORMWATER CHANNEL – Internal Concrete Floor & Walls		
PHOTO ID	PHOTO	DESCRIPTION/CONDITION
HC-SWC-1.61

<p>Floors & Walls within Haslam's Creek Stormwater Channel (including Stormwater Discharge Outlets) outside South-Eastern Boundary of Site.</p> <ul style="list-style-type: none">• Visible sediment to bottom of Drainage Outlet.• Overgrown Vegetation in Drainage Channel and on each side of Canal Walls. Trees leaning over canal.• Surface Cracking & pitting to concrete base/floor• Surface Cracking to concrete Walls. Visible evident of movement/misalignment• Graffiti/Vandalism• Grass/vegetation & trees poorly maintained. Waste/Litter <p><u>Condition:</u> POOR/DAMAGED</p>

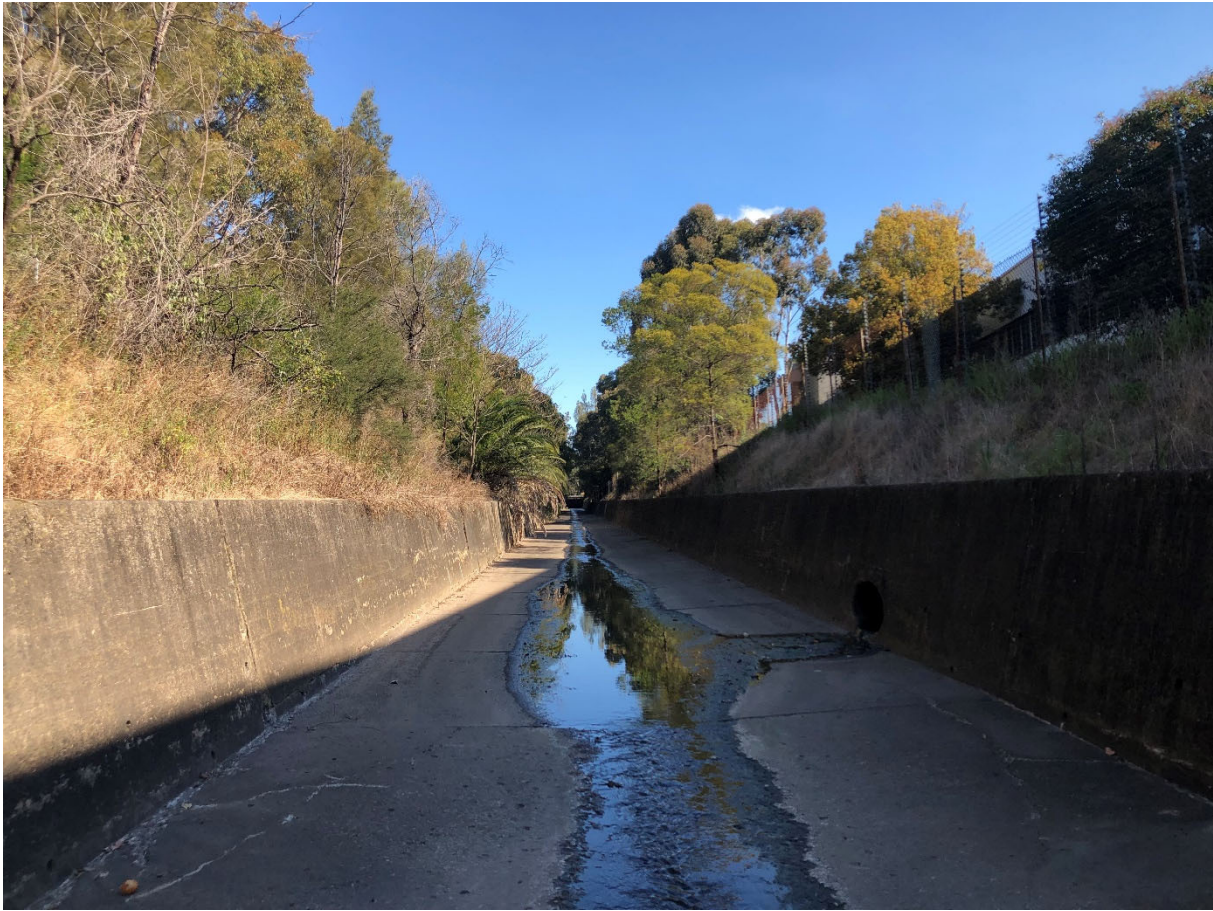
<p>Floors & Walls within Haslam's Creek Stormwater Channel (including Stormwater Discharge Outlets) outside South-Eastern Boundary of Site.</p> <ul style="list-style-type: none">• Visible sediment to bottom of Drainage Outlet.• Overgrown Vegetation in Drainage Channel and on each side of Canal Walls. Trees leaning over canal.• Surface Cracking & pitting to concrete base/floor• Surface Cracking to concrete Walls. Visible evident of movement/misalignment• Graffiti/Vandalism• Grass/vegetation & trees poorly maintained. Waste/Litter <p><u>Condition:</u> POOR/DAMAGED</p>

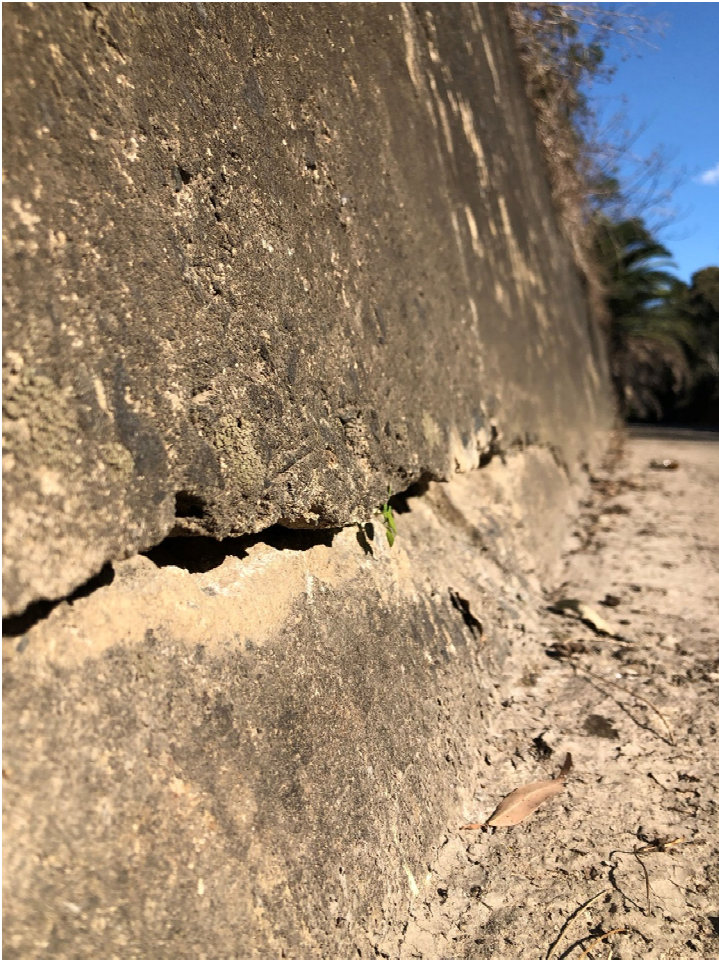
<p>Floors & Walls within Haslam's Creek Stormwater Channel (including Stormwater Discharge Outlets) outside South-Eastern Boundary of Site.</p> <ul style="list-style-type: none">• Visible sediment to bottom of Drainage Outlet.• Overgrown Vegetation in Drainage Channel and on each side of Canal Walls. Trees leaning over canal.• Surface Cracking & pitting to concrete base/floor• Surface Cracking to concrete Walls. Visible evident of movement/misalignment• Graffiti/Vandalism• Grass/vegetation & trees poorly maintained. Waste/Litter <p><u>Condition:</u> POOR/DAMAGED</p>

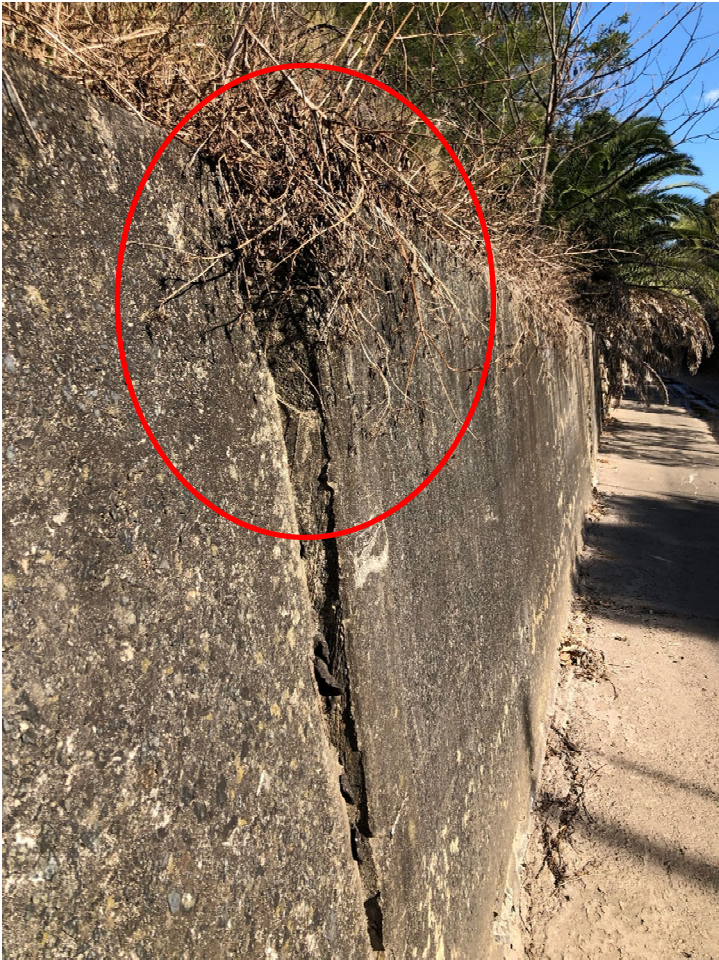
<p>Floors & Walls within Haslam's Creek Stormwater Channel (including Stormwater Discharge Outlets) outside South-Eastern Boundary of Site.</p> <ul style="list-style-type: none">• Visible sediment to bottom of Drainage Outlet.• Overgrown Vegetation in Drainage Channel and on each side of Canal Walls. Trees leaning over canal.• Surface Cracking & pitting to concrete base/floor• Surface Cracking to concrete Walls. Visible evident of movement/misalignment• Graffiti/Vandalism• Grass/vegetation & trees poorly maintained. Waste/Litter <p><u>Condition:</u> POOR/DAMAGED</p>
