18 August 2021
Ref: E33177Plet-ADDrev1

ADDENDUM TO PRELIMINARY AND DETAILED SITE INVESTIGATION REPORTS
PROPOSED NEW PRIMARY SCHOOL IN MULGOA RISE
1-23 FORESTWOOD DRIVE, GLENMORE PARK, NSW

1 INTRODUCTION

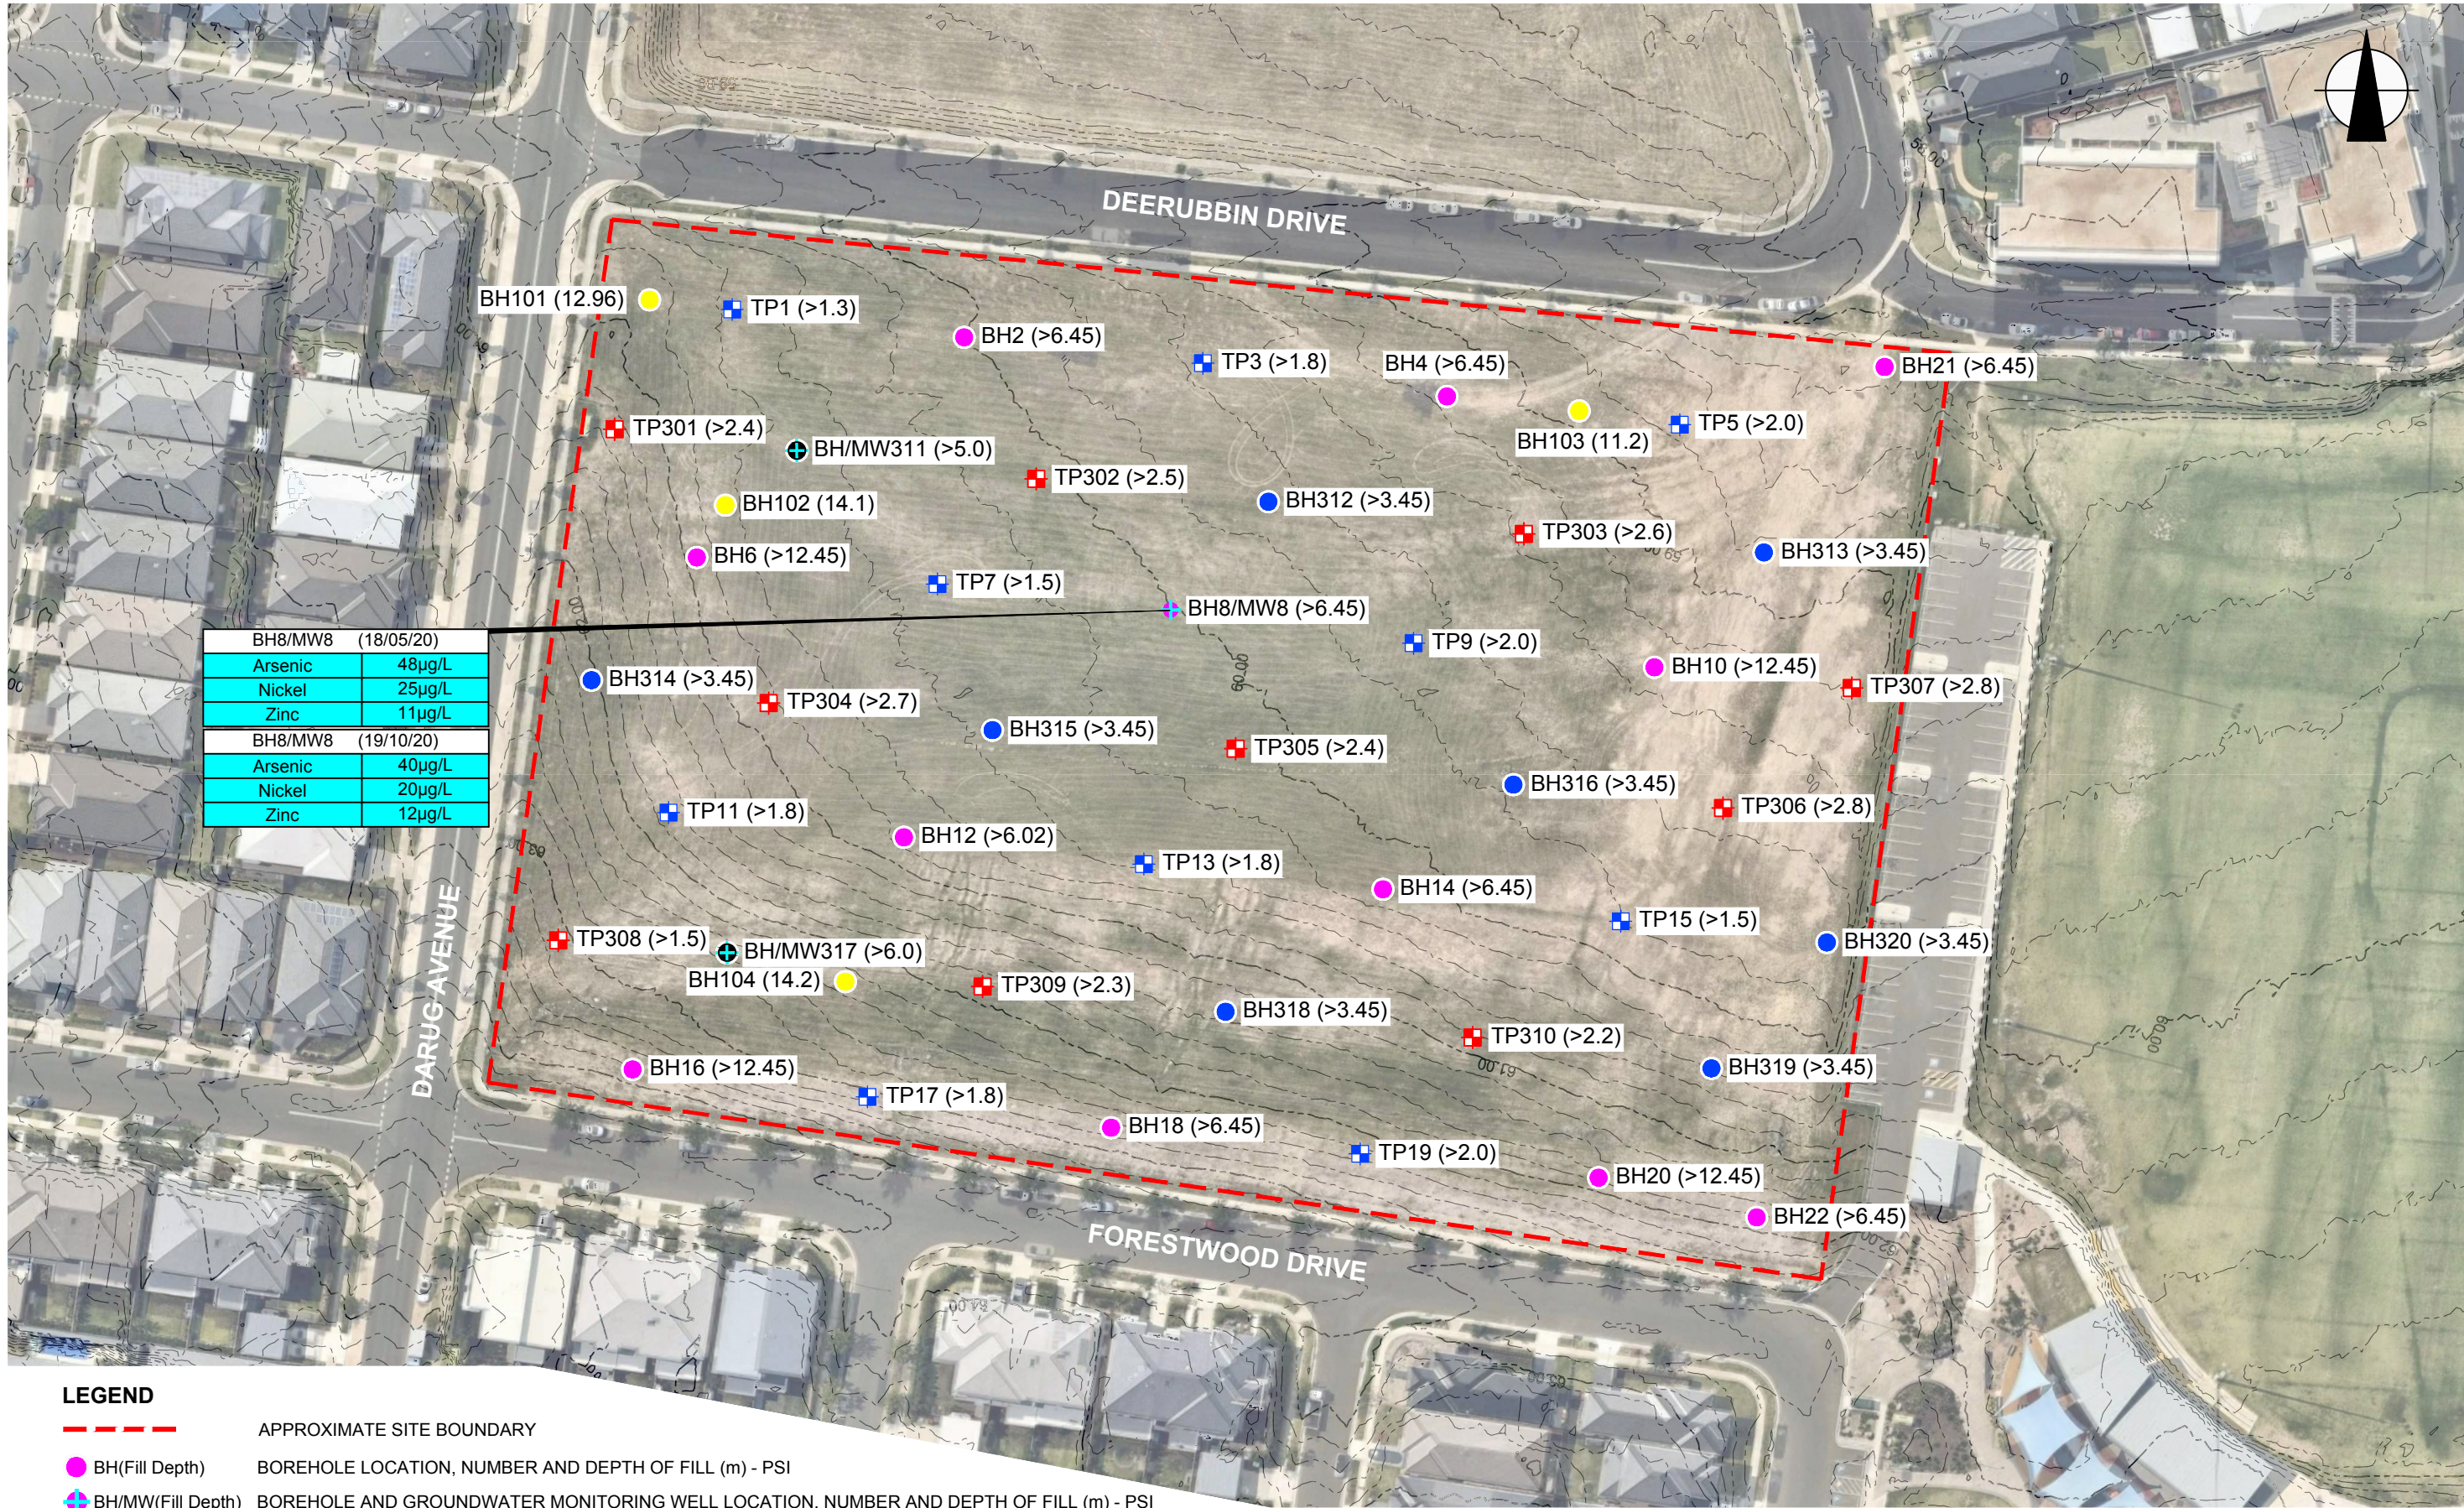
The laboratory analysis detected concentrations of arsenic, cadmium, copper, nickel and zinc within the groundwater beneath the site. With the exception of arsenic, nickel and zinc within the samples collected from MW8, all of the detected concentrations were below the respective human-health and ecological-based SAC. The concentrations of arsenic, nickel and zinc detected in the groundwater collected from MW8 exceeded the ecological-based SAC and were relatively consistent with the results obtained during the PSI. Overall, the minor elevations of these heavy metals in groundwater were assessed not to pose an unacceptable risk under the proposed land use scenario.

BH8/MW8 (18/05/20)	
Arsenic	48µg/L
Nickel	25µg/L
Zinc	11µg/L
BH8/MW8 (19/10/20)	
Arsenic	40µg/L
Nickel	20µg/L
Zinc	12µg/L

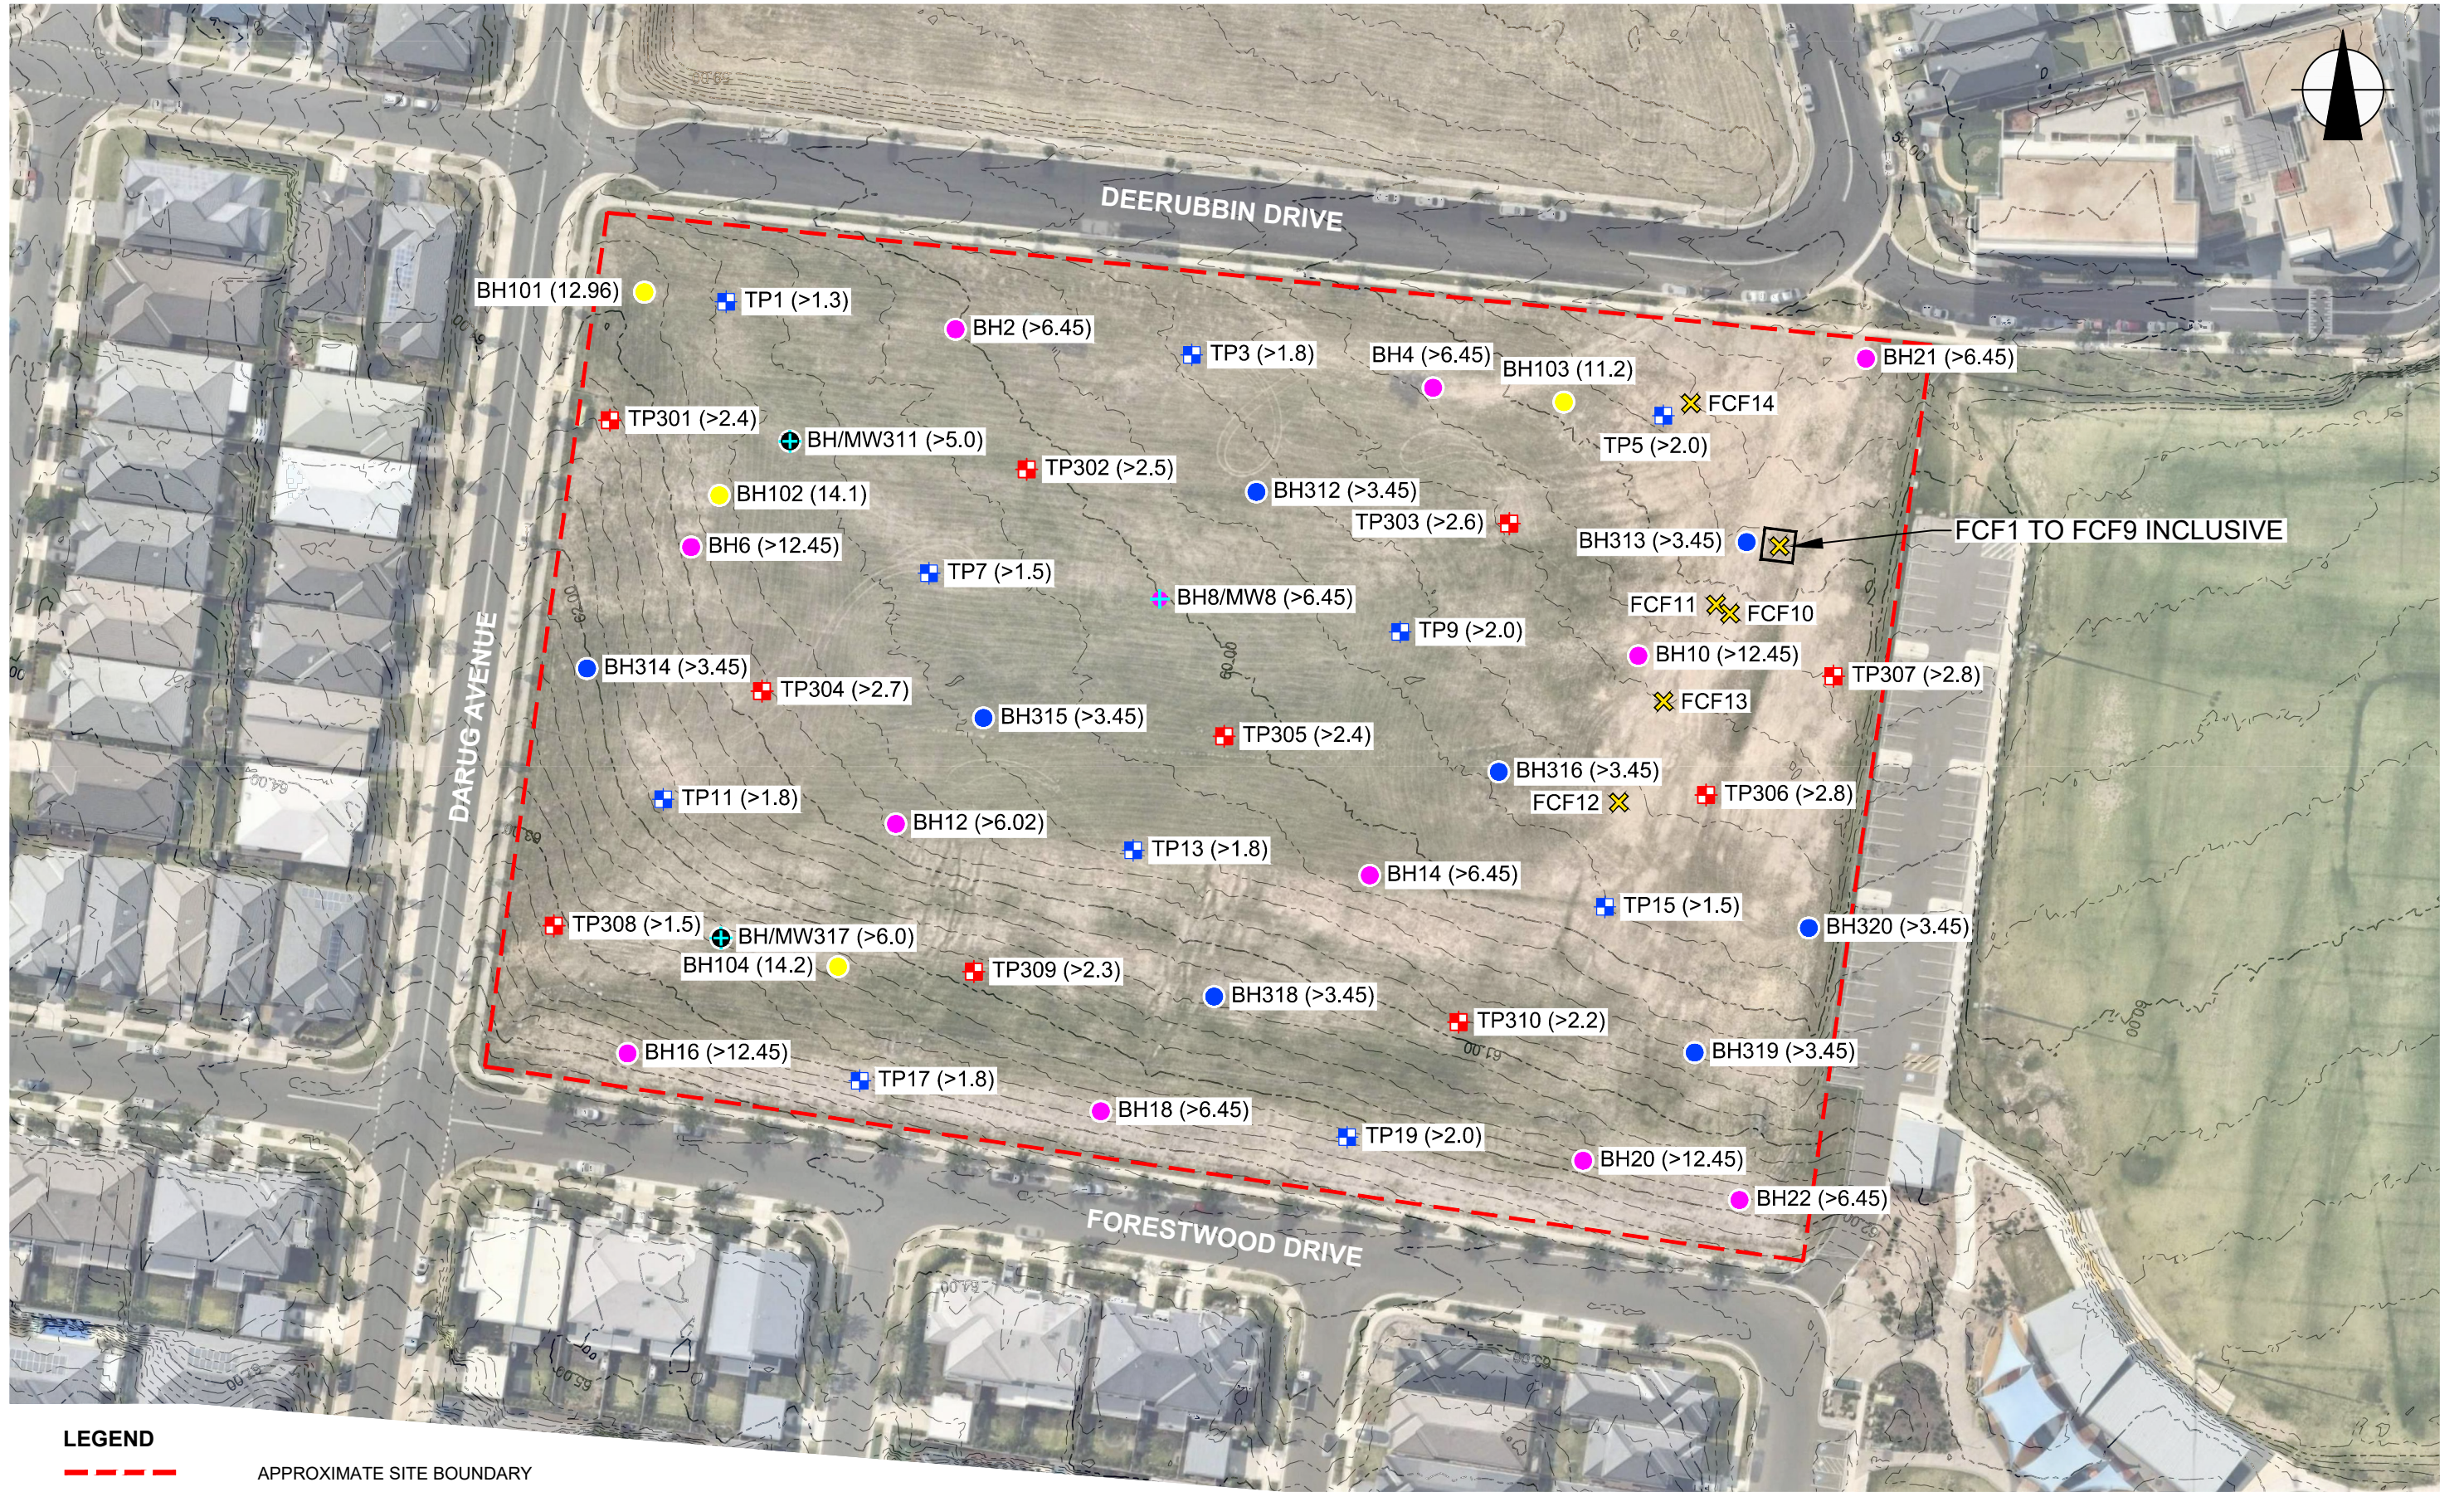
Title: ADDITIONAL SAMPLE LOCATION PLAN	
Location: 1-23 FORESTWOOD DRIVE, GLENMORE PARK, NSW	
Project No: E33177P	Figure No: 4
JKEnvironments

- There appeared to be increased vehicular traffic over the north-eastern/eastern based on the presence of vehicle tracks and wheel ruts in the soil;
- Scattered fragments of fibre cement (suspected of containing asbestos) were observed in the north-eastern/eastern section of the site. The fragments were generally embedded into the soil surface. Nine of these fragments were in a closely-spaced cluster over an area of approximately 5m by 5m;

The occurrence of scattered fragments of fibre cement at the ground surface was inconsistent with previous site observations during the PSI and DSI. Consequently, the observed fragments were collected, placed in zip-lock bags and each was assigned a sample identification number (FCF1 to FCF14 inclusive). The approximate locations of the fibre cement fragment samples are shown on Figure 4 in Appendix A.

The samples were submitted to a National Association of Testing Authorities, Australia (NATA) accredited laboratory for asbestos analysis. Analysis was scheduled on three representative samples, including FCF2, FCF10 and FCF14. All samples were found to contain asbestos. Two of the samples contained chrysotile and amosite asbestos, whilst one of the samples only contained chrysotile asbestos.

All fragments identified and collected by JKE were in good condition and could not be crushed, easily broken or pulverised using hand pressure. On this basis, the fibre cement/asbestos containing material (ACM) was deemed to be non-friable (i.e. bonded).

- The site is to be secured by appropriate fencing to eliminate unauthorised access;
- A suitably qualified contractor/consultant is to undertake an 'emu pick' to remove any visible fragments of ACM/fibre cement from the ground surface in the north-eastern/eastern areas of the site (in accordance with the relevant codes of practice). Any fragments must be double bagged and disposed of lawfully as asbestos waste. A waste disposal docket is to be provided to the client to demonstrate compliance;

- Following the pick, a suitably qualified environmental consultant (e.g. a Licensed Asbestos Assessor) is to carry out a surface inspection and provide an asbestos clearance certificate;

- Subsequently, asbestos quantification sampling is to occur to verify the removal of the ACM and to confirm that impacts do not extend beneath the surface. This is to involve bulk sampling/screening utilising the same field methods as documented in the DSI. We recommend that sampling occurs on a 12m grid spacing and that samples be collected from the surface (0-0.05m depth interval) and from the subsurface at depths of approximately 0.5m and 1m, whilst ensuring that all district fill profiles down to the termination depth of the investigation are sampled/screened. These details should be outlined in a Sampling, Analysis and Quality Plan (SAQP) prior to the commencement of the investigation and the SAQP should be approved by the site auditor; and

- A Supplementary Asbestos Investigation Report is to be prepared presenting the results of the investigation, along with a discussion/assessment of risk and any recommendations.

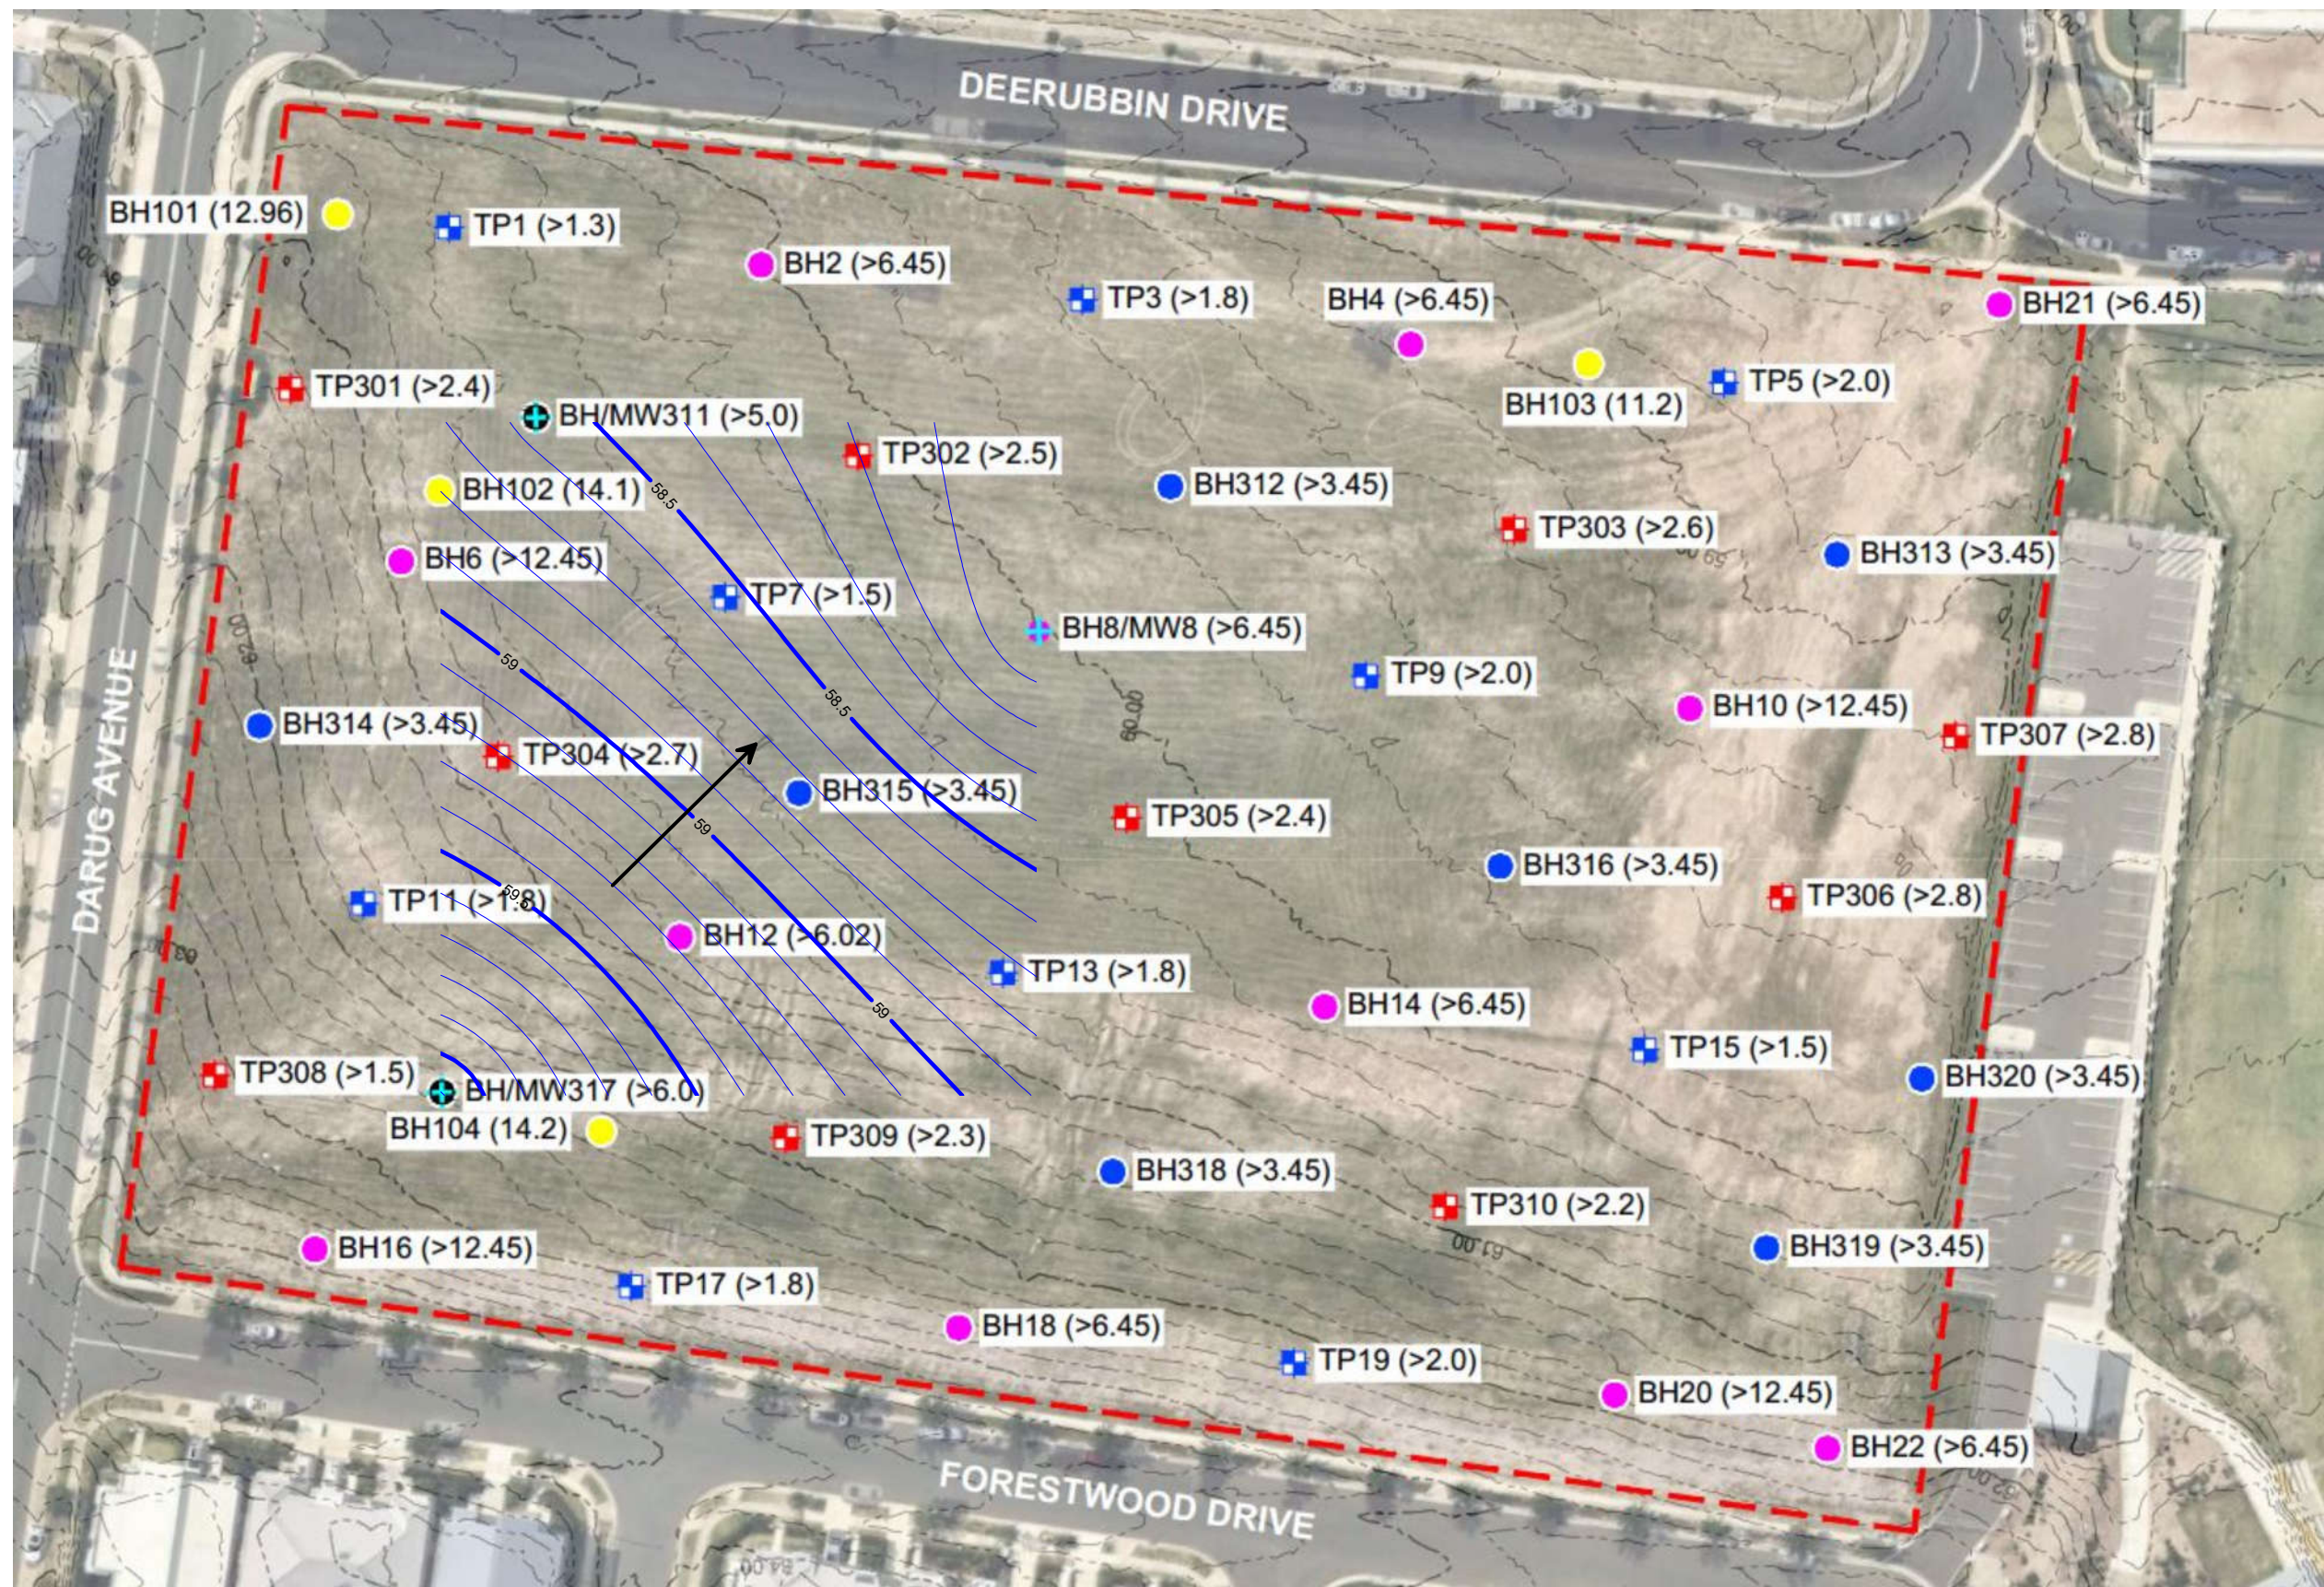
Ground surface levels at the monitoring well locations have now been interpolated based on the survey/contour information presented on Figure 2 in Appendix A. These levels were used to generate a groundwater contour plan using Surfer v8.08 (Surface Mapping Program), presented as Figure 5 in Appendix A of this addendum. The data input into the contour model was as follows:

The contour plan indicates that the groundwater flow direction is towards the north-east. This is in sympathy with the topography and generally aligned with expectations based on what was reported in the DSI.
