# Asbestos and Hazardous Materials Limited Pre-Demolition Assessment

Prepared for  
CBRE on Behalf of Health Infrastructure

19 June 2020

754-SYDEN273910

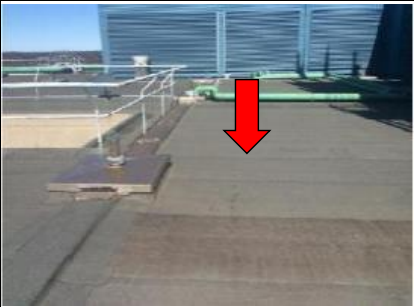
Surveyors: Matt Hemingway and Jake Iskenderian									Assessment Type: HAZMAT Audit		Date: 26-05-2020 to 28-05-2020	
Site Contact: Steph Rossi									Site / Location: Kingsway & Kareena Rd, Caringbah NSW 2		Review Date: May 2025	
Primary Location	Secondary Location	Description	Sample Number	Sample Results	Approx. Quantity	Friability	Condition	Accessibility	Action Rating	Photograph	Recommendations	
<b>Asbestos-containing Materials</b>												
Exterior: level 5	Roof area, TSHARF04, throughout, roof covering	Bituminous membrane	Refer to 85241-A-01	Chrysotile Asbestos Detected	~10m <sup>2</sup>	N	G	L	Very Low	-	Label as containing asbestos and maintain in current condition if to remain in-situ. Remove under controlled non-friable asbestos removal conditions prior to refurbishment or demolition works by a Class B (non-friable) licensed asbestos removal contractor.	
Exterior: level 5	Roof area, TSHARF06, lining	Bituminous membrane	Refer to 85241-A-01	Chrysotile Asbestos Detected	~2000m <sup>2</sup>	N	G	L	Very Low

Label as containing asbestos and maintain in current condition if to remain in-situ. Remove under controlled non-friable asbestos removal conditions prior to refurbishment or demolition works by a Class B (non-friable) licensed asbestos removal contractor.

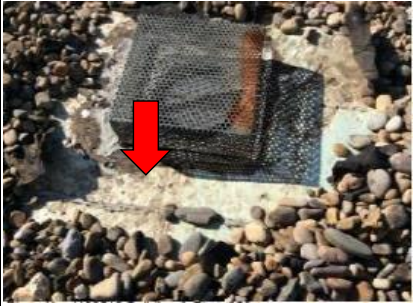
Exterior: level 4	Platform, throughout, waterproof membrane	Bituminous membrane	Refer to 85241-A-24	Chrysotile Asbestos Detected	~200m <sup>2</sup>	N	G	L	Very Low

Label as containing asbestos and maintain in current condition if to remain in-situ. Remove under controlled non-friable asbestos removal conditions prior to refurbishment or demolition works by a Class B (non-friable) licensed asbestos removal contractor.
