# WOLLONGONG COAL LTD

## Russell Vale Colliery

### Bellambi Creek Diversion Pipeline Assessment

**December 2017**

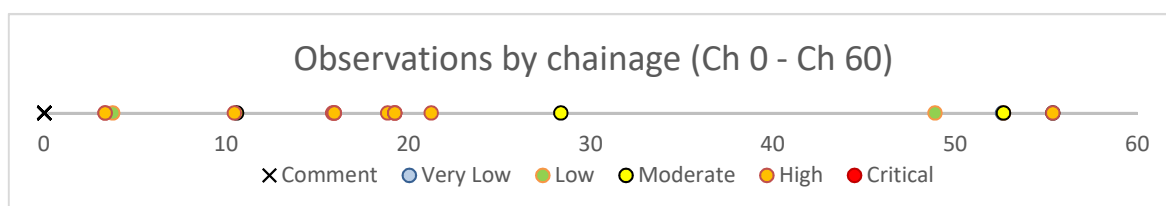
Figure 1 - Identified defects MH B to MH A

A total of 29 defects or observations were made on the Bellambi pipeline between Manhole B to Manhole A. Most of the defects occur between chainages 3 – 56 m, with an isolated observation of a wooden obstruction at Chainage 166.70 m. The risk ranking for the defects range from Very Low to High.

Structural damage to the pipeline has been identified between chainages 3 – 16 m, as indicated by exposed reinforcement and cracking. This suggests that the serviceability limit state for the pipeline has locally been exceeded, likely from an external surface loading.

Chainage (m) and Number of Defects	Action	Timeframe
3 – 16 (7 defects – structural)	Re-line pipe (i.e. installing CMP / Polypipe pipe and cement pressure grouting the annulus or installing an insitu reinforced concrete pipe (e.g. Tunneline system). Note the pipe invert appears to have a concrete floor. This may need to be demolished prior to relining.	1 – 6 months
16 – 22 (7 defects – external penetrations)	The source of the external connections needs to be investigated, only clean water sources are to be directed to the pipeline. Repair the external connections by either epoxy pressure grouting the annulus between the RCP and the penetration or remove the penetration, and reinstate RCP wall by scrubbing/cleaning the concrete surface, applying a bonding agent (e.g. Epirez 133) and repair with non-shrink cement mortar repair.	1 – 6 months
28 – 56 (7 defects – suspected deteriorated seals causing infiltration. Encrustation/scale present)	For infiltration and deteriorated jointing mechanisms Remediate defects by cement pressure grouting annulus behind CMP / replace band connection, or seal band / CMP gap with expanding sealant.  Within the 28 m length of pipe, there are 4 pipe jointing mechanisms that are failing, some in multiple places with varying risk categories at each failure point. In total the risk ratings of the defects in the area are 1 x High, 3 x Moderate and 2 x Low. Due to the similar nature of the repairs in this area, the defects have been grouped together for remediation.	1-6 months  An opportunity exists to only remediate the defects identified as presenting a High or Moderate risk. The remaining defects could be assessed through the ongoing monitoring program.

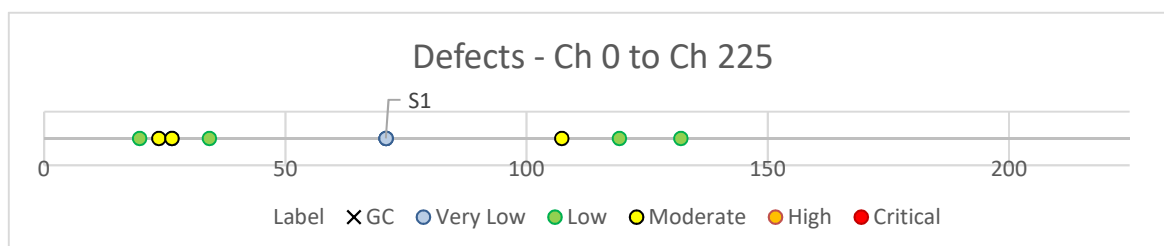
Figure 2 - Identified defects MH B to MHC, part 1

A total of 47 defects or observations were made on the Bellambi Gully pipeline between Manhole B to Manhole C. The risk ranking for the defects range from Very Low to Moderate. The majority of the moderate risk defects were recorded between chainages 320 – 395 m.

The moderate risk observations generally pertain to suspected infiltration, vertical deformations of the pipeline – likely from a dynamic surface loading, or longitudinal wall cracks, again suggesting structural damage to the pipeline.

Chainage (m) and Number of Defects	Action	Timeframe
<p>0 - 307</p> <p>(17 defects: 5 moderate; 8 low; 4 very low)</p>	<p>Localised repairs and pipe cleaning required. Refer to detailed observations and suggested remediation works in Appendix B. Further investigation of some defects is required, refer to Appendix B. Suggest an ongoing pipeline monitoring program be initiated to assess the lower risk category defects.</p> <p>For infiltration and deteriorated jointing mechanisms Remediate defects by cement pressure grouting annulus behind CMP / replace band connection, or seal band / CMP gap with expanding sealant.</p> <p>Remove blockages, defective connections and clean pipe as required.</p> <p>Bulging of the pipe wall and bellies in the line identified. Where safe to do so, install bolted strengthening plate/ring. Cement pressure grout outside CMP to fill any voids.</p> <p>Within the 307 m length of pipe, there are 17 recorded defects. In total the risk ratings of the defects in the area are 5 x Moderate, 8 x Low and 4 x Very Low. It is anticipated that only the Moderate risk defects will be initially remediated, however an opportunity exists to group some of the remediation of the lower risk defects due to the similar nature of the repairs.</p> <p>The moderate defects in general consist of deteriorated pipe joint seals, or bulges/bellies in the corrugated metal pipe wall/floor.</p>	<p>6 to 18 months</p> <p>(As per identified risk profile for each hazard. Ranging from 6-18 months for 'Moderate' risk defects, or as identified by ongoing pipeline monitoring program.</p>

<p>70.84, 349.96, 375 – 386, 416.35</p> <p>(10 defects, 7 moderate, 3 very low)</p>	<p>Re-line pipe (i.e. installing CMP / Polypipe pipe and cement pressure grouting the annulus or installing an insitu reinforced concrete pipe (e.g. Tunneline system). Note the pipe invert appears to have a concrete floor. This may need to be demolished prior to relining.</p>	<p>6-18 months</p>

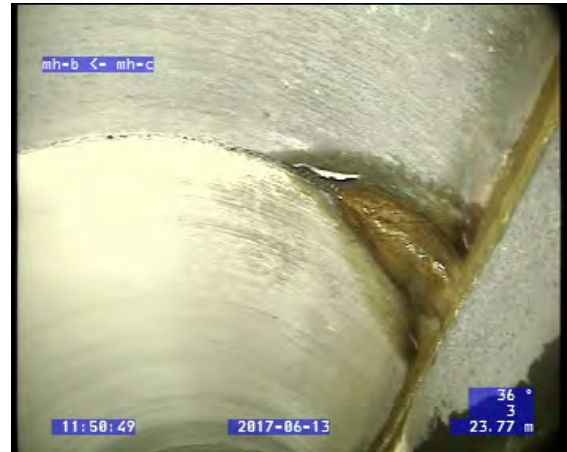
Photo: SW001 (Section 3)\_MH B\_MH  
C\_20062017\_110739\_A.jpg  
23.77m, Wall Staining is present on the surface of the conduit, at joint, General Comments Possible infiltration is present, at 4 o'clock

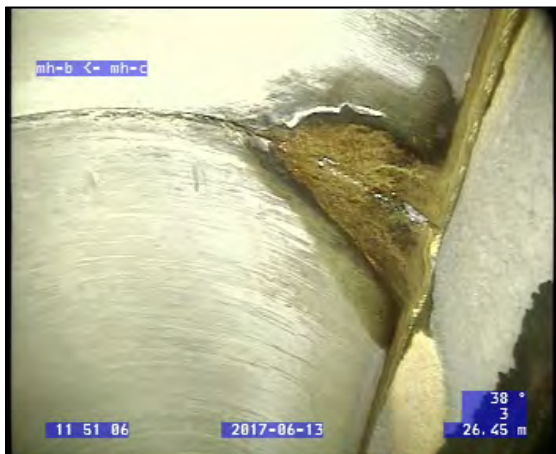
Photo: SW001 (Section 3)\_MH B\_MH  
C\_20062017\_111022\_A.jpg  
26.45m, Infiltration, running, at joint, General Comments Wall staining also present, at 4 o'clock

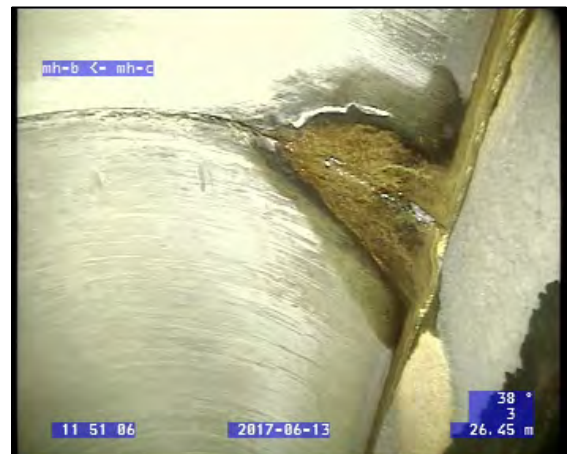
Photo: SW001 (Section 3)\_MH B\_MH  
C\_20062017\_111019\_A.jpg  
26.45m, Encrustation/Scale is attached to the wall above the water line, at joint, Obstruction: <5%, General Comments from infiltration , at 4 o'clock

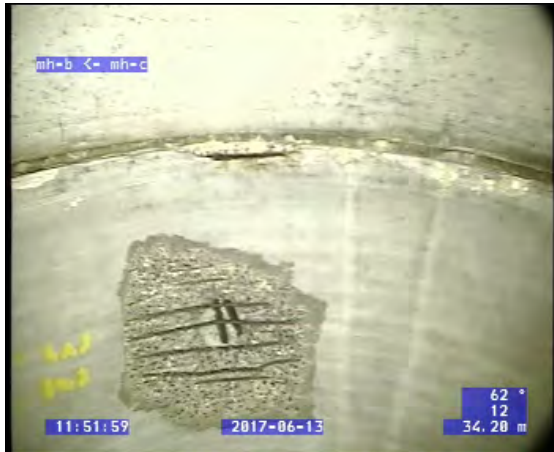
Photo: SW001 (Section 3)\_MH B\_MH  
C\_20062017\_111118\_A.jpg  
34.2m, Steel reinforcement is visible with little or no corrosion evident , at 12 o'clock

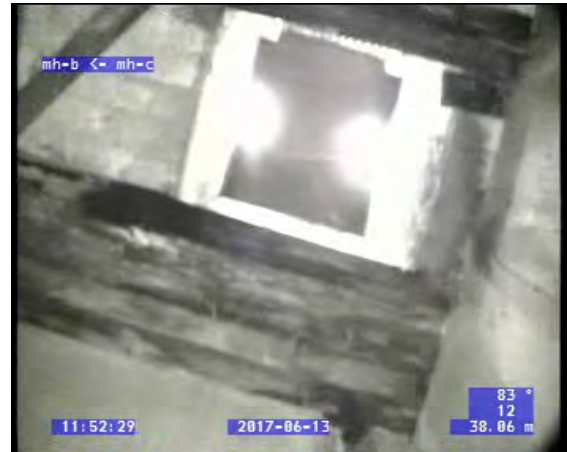
Photo: SW001 (Section 3)\_MH B\_MH  
C\_20062017\_111243\_A.jpg  
38.06m, General Comments Unknown Pit found

38.06, 306.27 (2 defects: To be determined if potential for groundwater ingress exists at the pits)	Unknown pits identified. Confirm if pit is still required. If not, construct reinforced concrete plug, dowelled in to RCP / Manhole.	As identified by ongoing pipeline monitoring program.

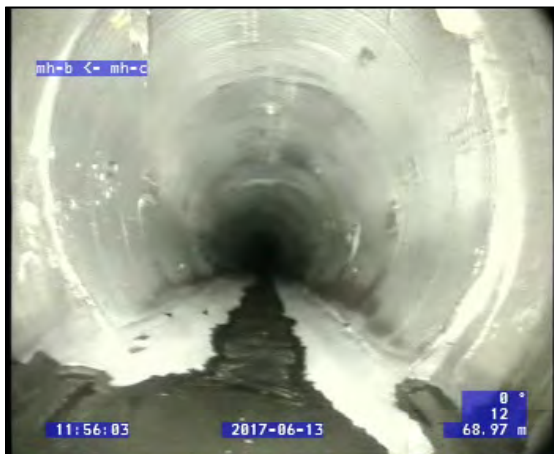
Photo: SW001 (Section 3)\_MH B\_MH  
C\_20062017\_111620\_A.jpg  
70.84m, New material, Corrugated Iron , General Comments Reduces diameter of pipe

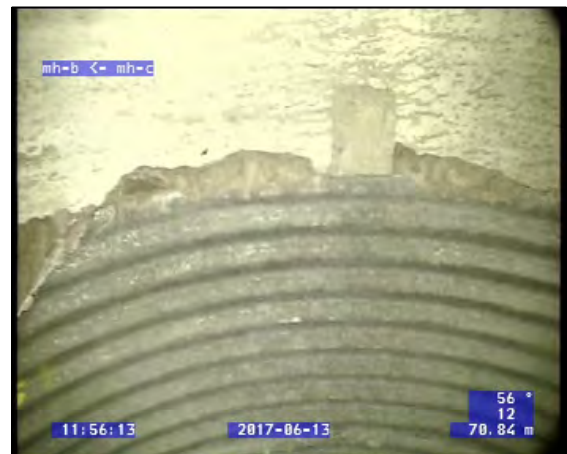
Photo: SW001 (Section 3)\_MH B\_MH  
C\_20062017\_111631\_B.jpg  
70.84m, New material, Corrugated Iron , General Comments Reduces diameter of pipe

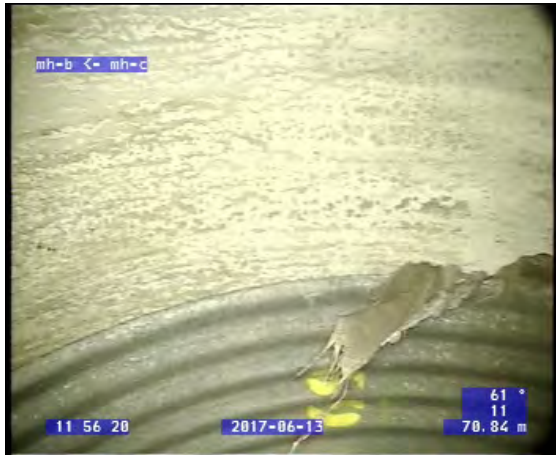
Photo: SW001 (Section 3)\_MH B\_MH  
C\_20062017\_111827\_A.jpg  
70.84m, Defective repair, major or irregular gaps or both in the pipe wall , General Comments Packer is hanging loose

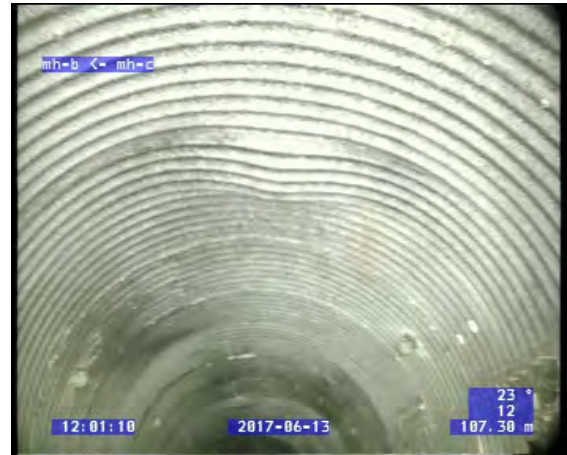
Photo: SW001 (Section 3)\_MH B\_MH  
C\_20062017\_112122\_A.jpg  
107.3m, Defective repair, bellies in the line , General Comments dropping of corrugated iron

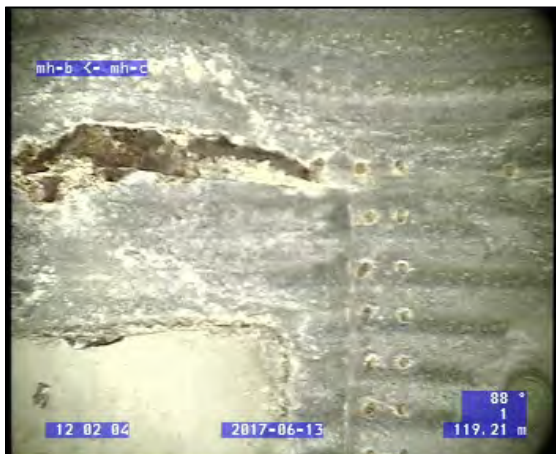
Photo: SW001 (Section 3)\_MH B\_MH  
C\_20062017\_112234\_A.jpg  
119.21m, Other Deposits on the wall, Rusting , Obstruction: <5% , at 1 o'clock

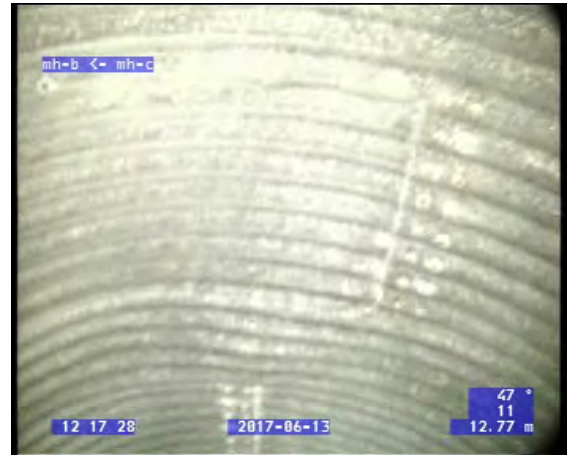
Photo: SW001 (Section 3A)\_MH B\_MH  
C\_20062017\_112849\_A.jpg  
12.77m, Defective repair, bellies in the line , General Comments  
Drooping of corrugated iron

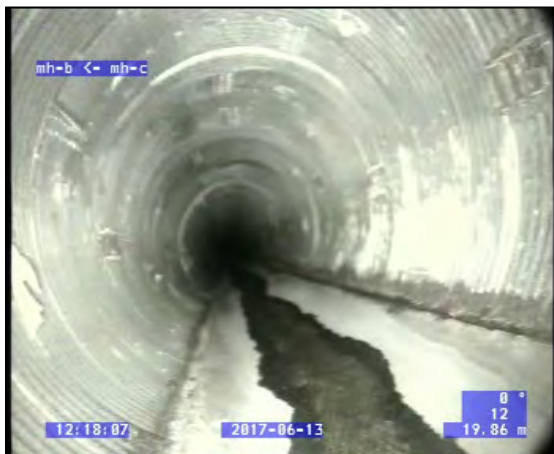
Photo: SW001 (Section 3A)\_MH B\_MH  
C\_20062017\_113011\_A.jpg  
19.86m, General Comments Multiple joining mechanisms on  
pipe wall to hold corrugated iron in place; rusting present

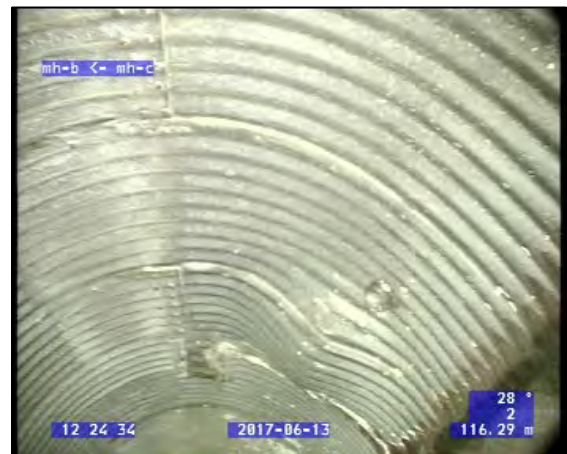
Photo: SW001 (Section 3A)\_MH B\_MH  
C\_20062017\_113837\_A.jpg  
116.29m, Defective repair , other defects: Bulging of pipe wall  
@ 3 o'clock

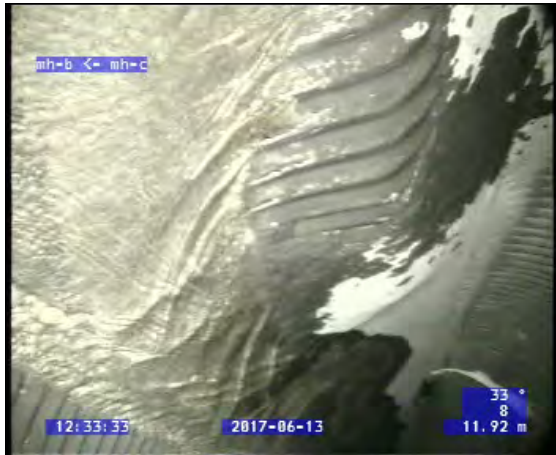
Photo: SW001 (Section 3B)\_MH B\_MH  
C\_20062017\_120205\_A.jpg  
11.92m, Defective repair , other defects: Bulging of corrugated iron in invert

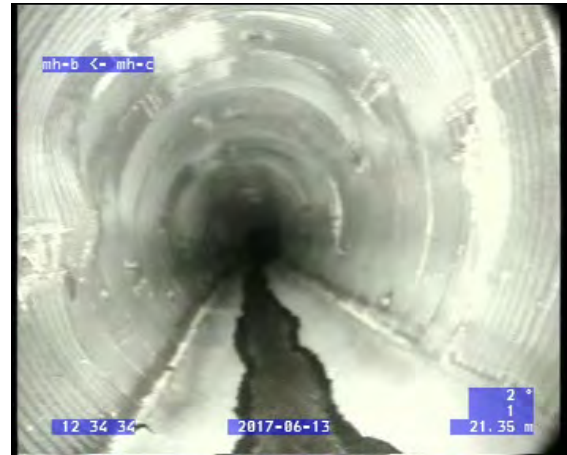
Photo: SW001 (Section 3B)\_MH B\_MH  
C\_20062017\_120355\_A.jpg  
21.35m, Defective repair , other defects: Bulging of corrugated iron, General Comments on left hand side of pipe wall

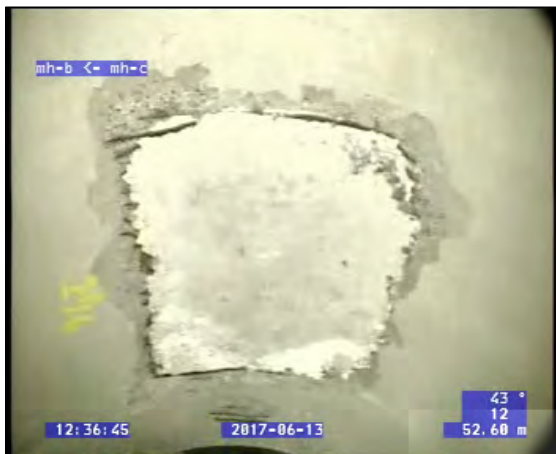
Photo: SW001 (Section 3B)\_MH B\_MH  
C\_20062017\_120712\_A.jpg  
52.6m, General Comments Large repair

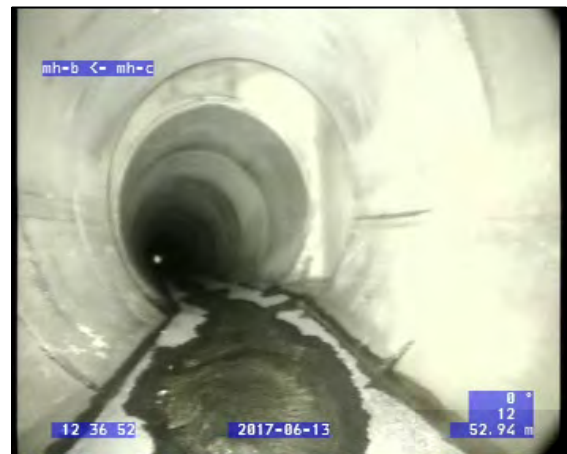
Photo: SW001 (Section 3B)\_MH B\_MH  
C\_20062017\_120811\_A.jpg  
53.45m, Dropped invert , depth of drop 8mm, General Comments slight dip in invert

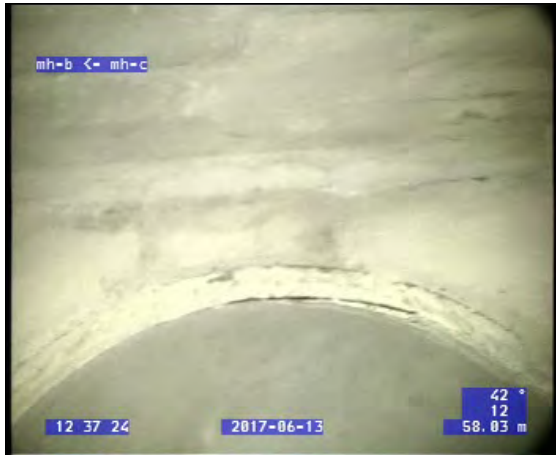
Photo: SW001 (Section 3B)\_MH B\_MH  
C\_20062017\_120915\_A.jpg  
58.03m, General Comments Unknown Pit found

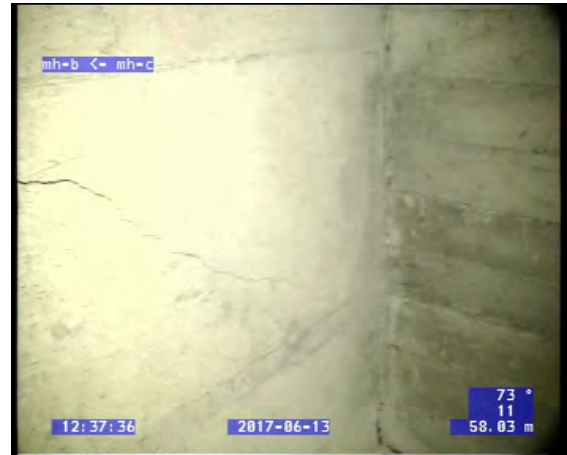
Photo: SW001 (Section 3B)\_MH B\_MH  
C\_20062017\_121016\_A.jpg  
58.03m, Longitudinal wall crack , width 2mm, General  
Comments on unknown pit wall, at 11 o'clock

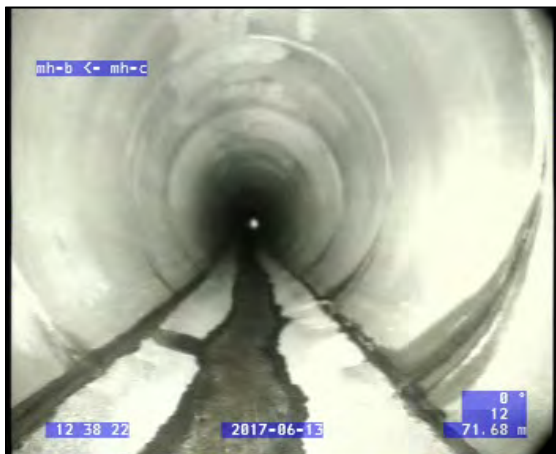
Photo: SW001 (Section 3B)\_MH B\_MH  
C\_20062017\_121123\_A.jpg  
71.65m, Suspected Infiltration , General Comments at pipe joint,  
from 4 to 6 o'clock

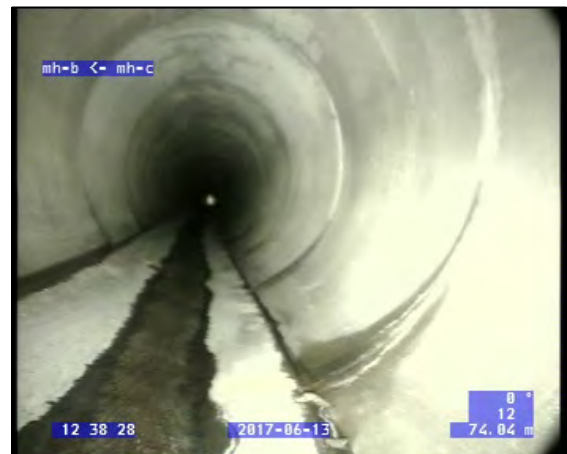
Photo: SW001 (Section 3B)\_MH B\_MH  
C\_20062017\_121153\_A.jpg  
74.02m, Suspected Infiltration, at joint, General Comments from  
pipe joint, from 4 to 6 o'clock

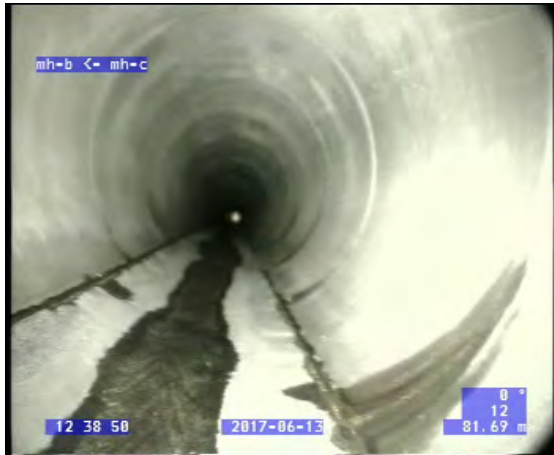
Photo: SW001 (Section 3B)\_MH B\_MH  
C\_20062017\_121227\_A.jpg  
82m, Suspected Infiltration, at joint, General Comments at joint, from 4 to 6 o'clock

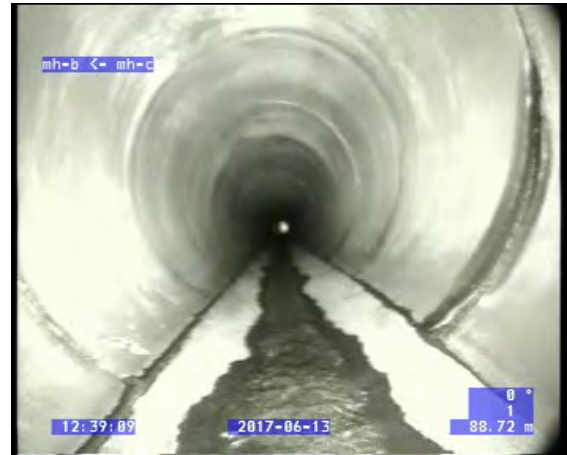
Photo: SW001 (Section 3B)\_MH B\_MH  
C\_20062017\_121306\_A.jpg  
88.72m, Suspected Infiltration, at joint , from 2 to 6 o'clock

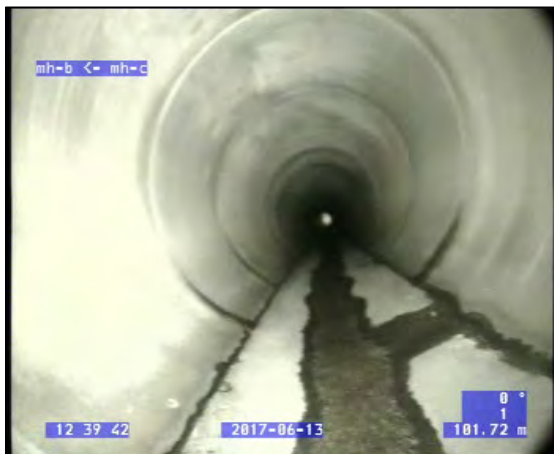
Photo: SW001 (Section 3B)\_MH B\_MH  
C\_20062017\_121447\_A.jpg  
101.72m, Vertical deformation , change in diameter 5-10%, length of deformation 200mm, General Comments pipe has been squashed, at 10 o'clock

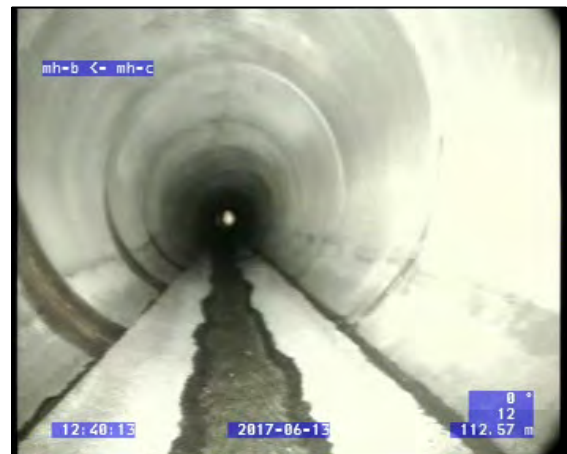
Photo: SW001 (Section 3B)\_MH B\_MH  
C\_20062017\_121530\_A.jpg  
112.54m, Suspected Infiltration, at joint , from 6 to 9 o'clock

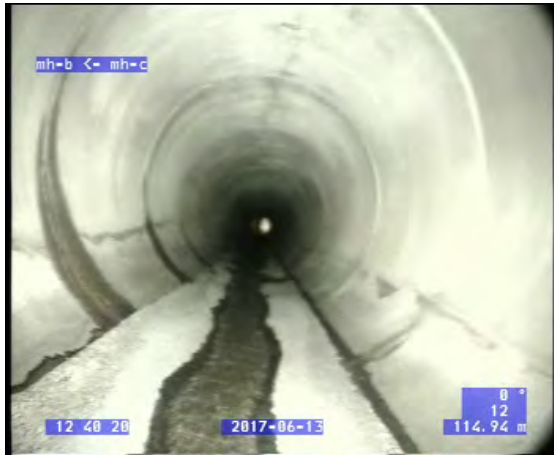
Photo: SW001 (Section 3B)\_MH B\_MH  
C\_20062017\_121553\_A.jpg  
114.94m, Suspected Infiltration, at joint , from 6 to 9 o'clock

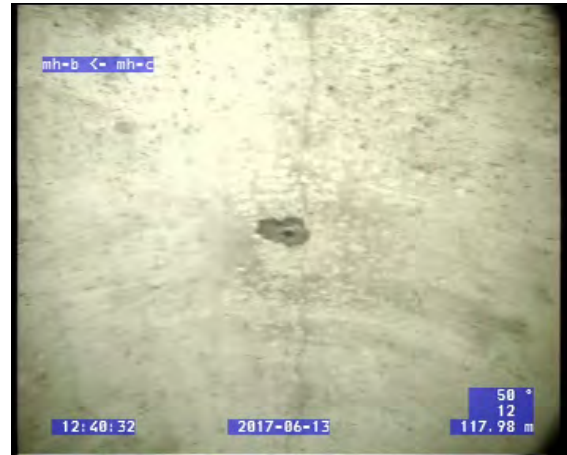
Photo: SW001 (Section 3B)\_MH B\_MH  
C\_20062017\_121637\_A.jpg  
117.98m, Longitudinal wall crack , width 2mm, General  
Comments runs through to pipe sections, at 12 o'clock, Start

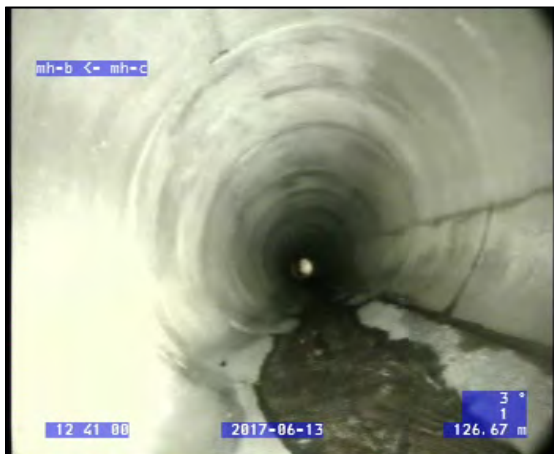
Photo: SW001 (Section 3B)\_MH B\_MH  
C\_20062017\_121722\_A.jpg  
127.22m, Vertical deformation , change in diameter 5-10%,  
length of deformation 300mm , at 12 o'clock

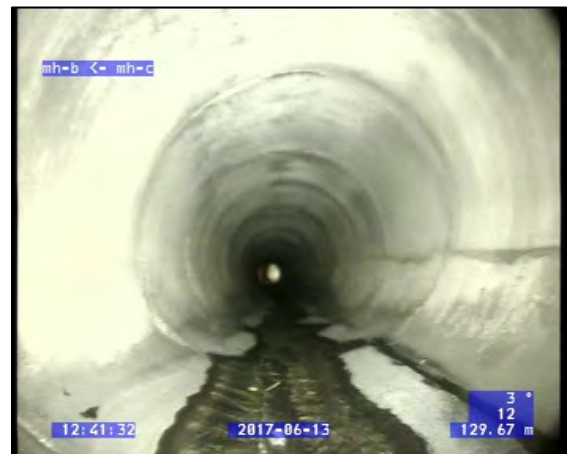
Photo: SW001 (Section 3B)\_MH B\_MH  
C\_20062017\_121827\_A.jpg  
129.67m, Vertical deformation , change in diameter 5-10%,  
length of deformation 200mm , at 12 o'clock

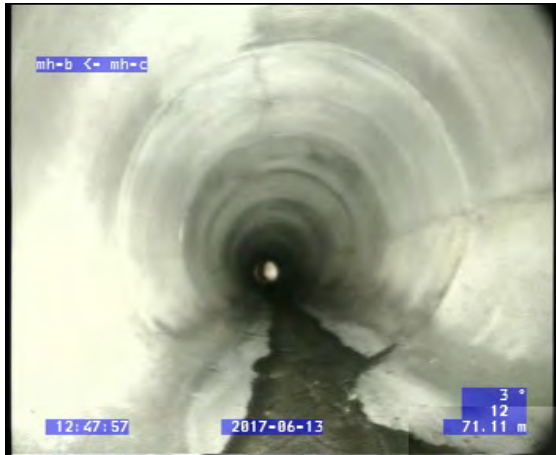
Photo: SW001 (Section 3C)\_MH B\_MH  
C\_20062017\_122312\_A.jpg  
71.04m, Longitudinal wall crack , width 2mm , at 12 o'clock,  
Start

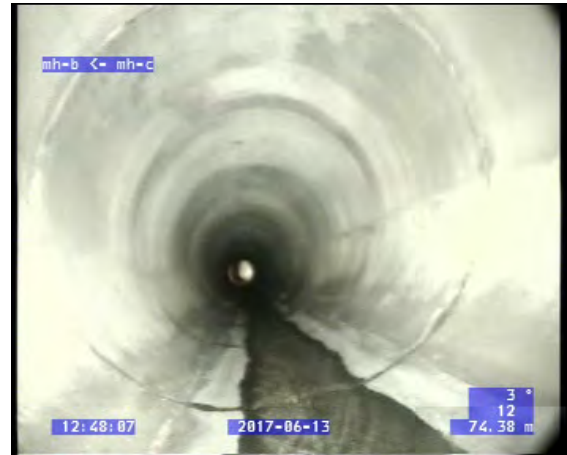
Photo: SW001 (Section 3C)\_MH B\_MH  
C\_20062017\_122345\_A.jpg  
74.34m, Vertical deformation , change in diameter 5-10%,  
length of deformation 200mm , at 11 o'clock

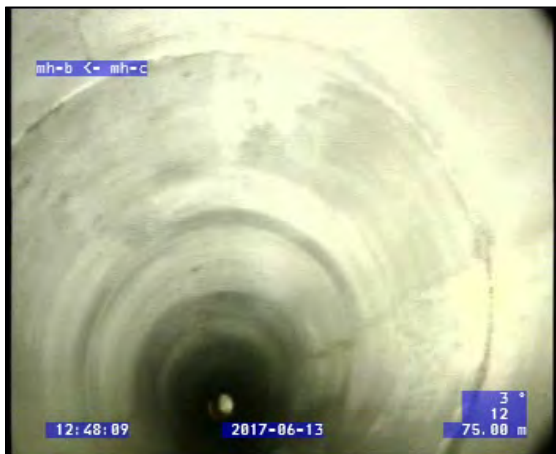
Photo: SW001 (Section 3C)\_MH B\_MH  
C\_20062017\_122402\_A.jpg  
74.96m, Longitudinal wall crack , width 2mm , at 12 o'clock,  
End

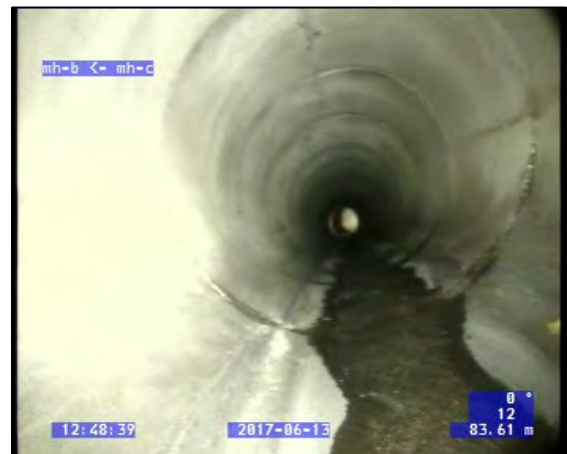
Photo: SW001 (Section 3C)\_MH B\_MH  
C\_20062017\_122457\_A.jpg  
83.61m, Longitudinal surface crack , width 2mm , at 12 o'clock

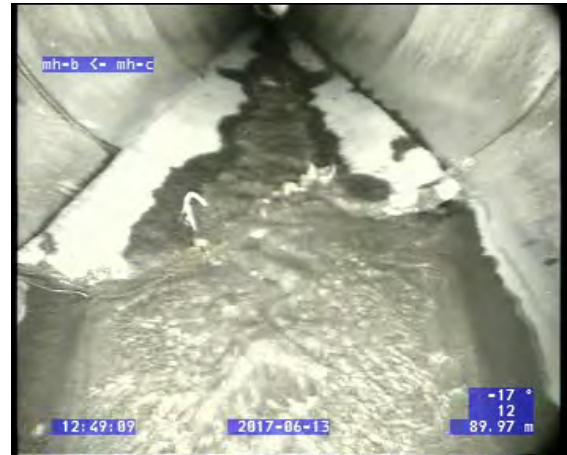
Photo: SW001 (Section 3C)\_MH B\_MH  
C\_20062017\_122614\_B.jpg  
88.95m, Dropped invert , depth of drop 10mm, General  
Comments dip in pipe invert

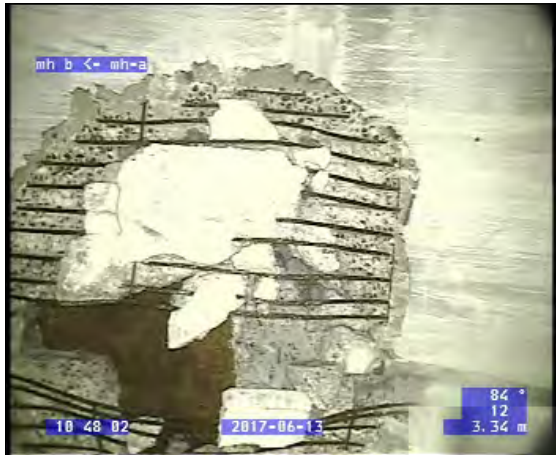
Photo: SW001 (US Part 1)\_MH A\_MH B\_20062017\_123939\_A.jpg  
3.34m, Steel reinforcement is visible with little or no corrosion evident , from 11 to 1 o'clock

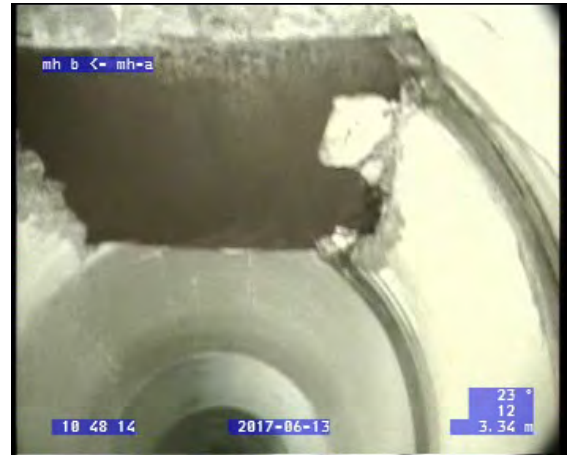
Photo: SW001 (US Part 1)\_MH A\_MH B\_20062017\_124126\_A.jpg  
3.34m, Suspected Surface Damage , Obstruction: 5-20%, General Comments Hole in pipe obvert has been repaired using a steel sheet, from 10 to 2 o'clock

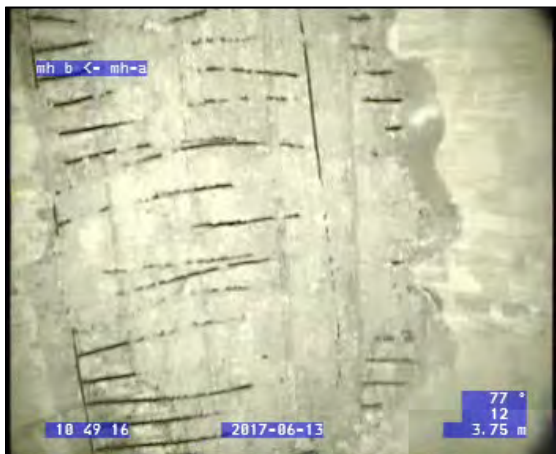
Photo: SW001 (US Part 1)\_MH A\_MH B\_20062017\_124203\_A.jpg  
3.75m, Steel reinforcement is visible with little or no corrosion evident , from 11 to 1 o'clock

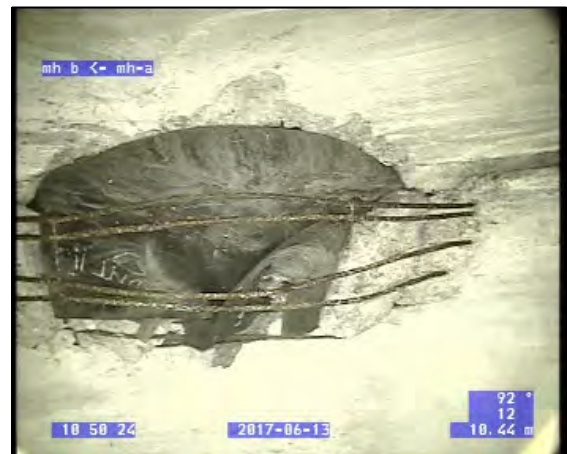
Photo: SW001 (US Part 1)\_MH A\_MH B\_20062017\_124258\_A.jpg  
10.44m, Reinforcement is exposed and corroded , General Comments possible repair of pipe hole, from 11 to 1 o'clock

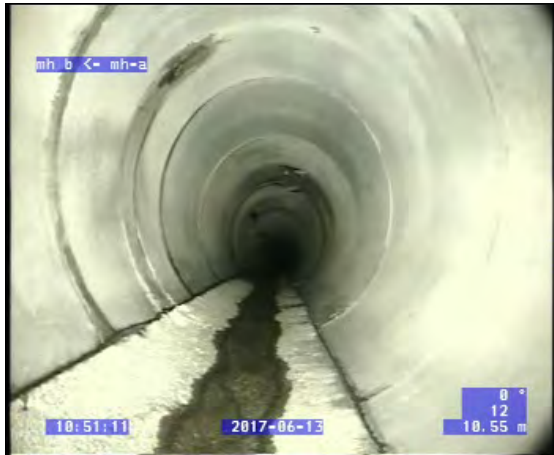
Photo: SW001 (US Part 1)\_MH A\_MH B\_20062017\_124444\_A.jpg  
10.55m, Encrustation/Scale is attached to the wall above the water line , Obstruction: <5%, General Comments Possibly caused by infiltration , at 10 o'clock

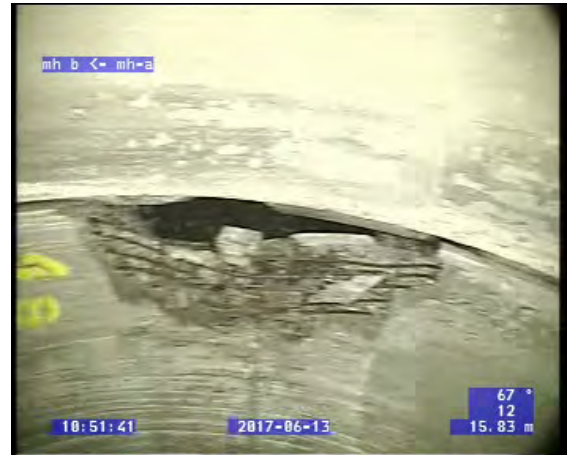
Photo: SW001 (US Part 1)\_MH A\_MH B\_20062017\_124517\_A.jpg  
15.83m, Steel reinforcement is visible with little or no corrosion evident , at 12 o'clock

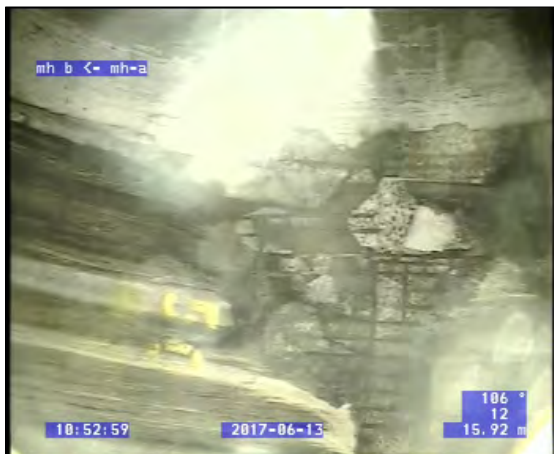
Photo: SW001 (US Part 1)\_MH A\_MH B\_20062017\_124615\_A.jpg  
15.92m, Hole in wall, at joint, General Comments with reinforcement exposed, at 12 o'clock

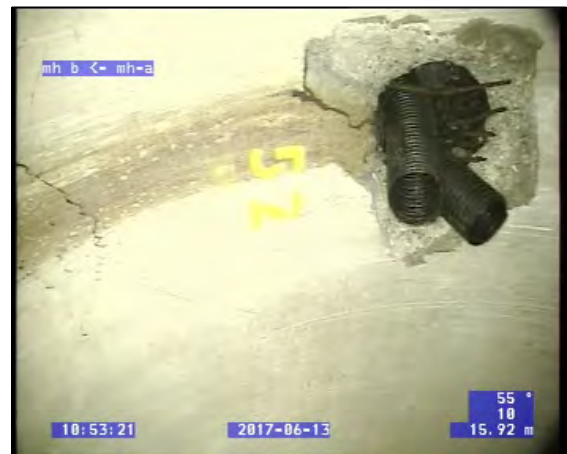
Photo: SW001 (US Part 1)\_MH A\_MH B\_20062017\_124734\_A.jpg  
15.92m, Intruding connection, magnitude of intrusion: 5-20%, General Comments protruding into line with reinforcement exposed, at 10 o'clock

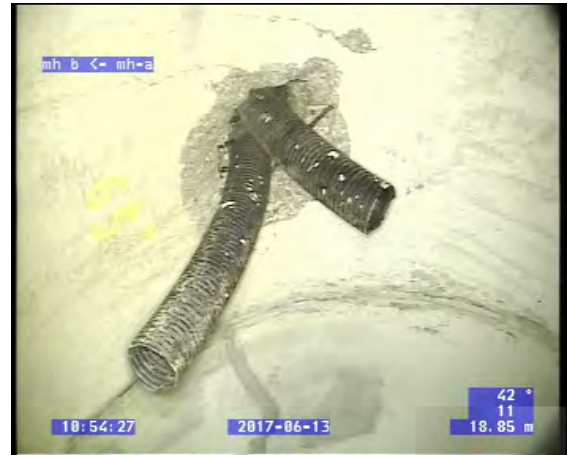
Photo: SW001 (US Part 1)\_MH A\_MH B\_20062017\_124838\_A.jpg  
18.85m, Intruding connection, magnitude of intrusion: 5-20%,  
General Comments Protruding into line, at 10 o'clock

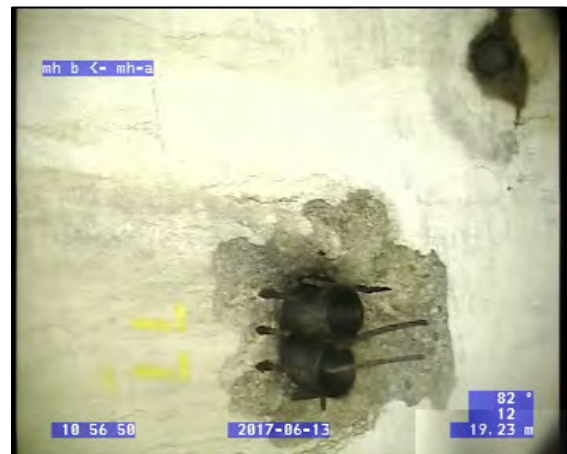
Photo: SW001 (US Part 1)\_MH A\_MH B\_20062017\_125011\_A.jpg  
19.23m, Intruding connection, magnitude of intrusion: 5-20%,  
General Comments Protruding into line with reinforcement exposed, at 12 o'clock

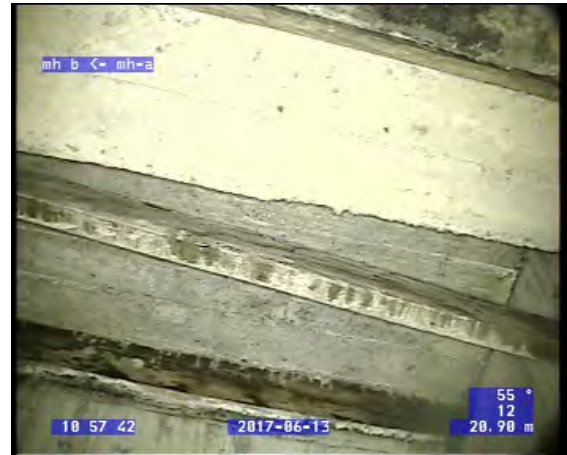
Photo: SW001 (US Part 1)\_MH A\_MH B\_20062017\_125105\_A.jpg  
20.9m, General Comments Unknown Pit found

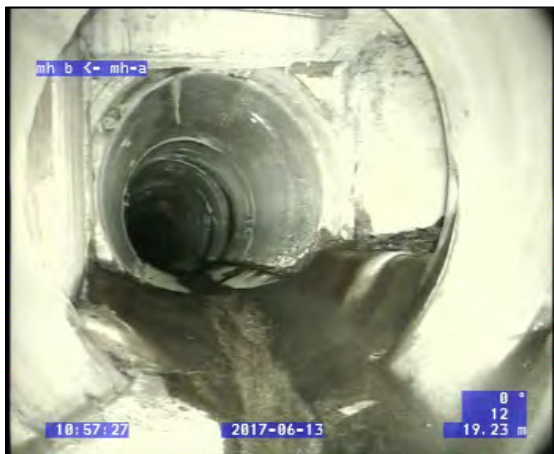
Photo: SW001 (US Part 1)\_MH A\_MH B\_20062017\_125115\_B.jpg  
20.9m, General Comments Unknown Pit found

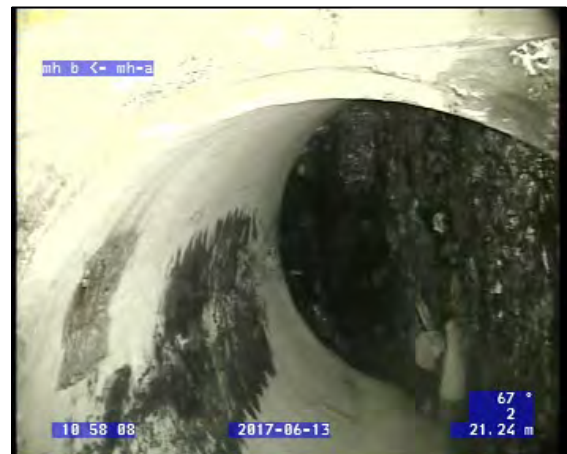
Photo: SW001 (US Part 1)\_MH A\_MH B\_20062017\_125206\_A.jpg  
21.24m, Defective Connection - The connecting pipe is damaged, magnitude of obstruction 51-75%, General Comments Collapsed 600mm junction, at 3 o'clock

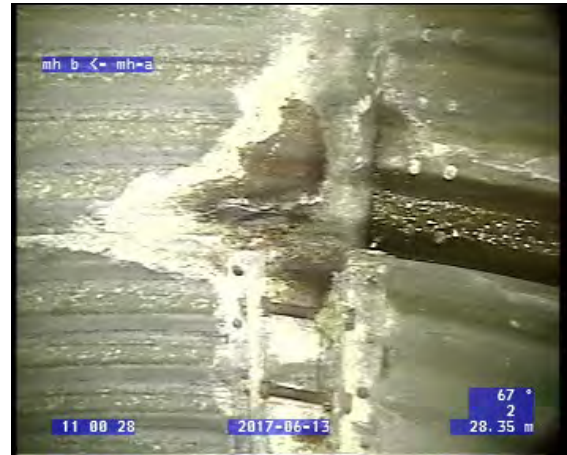
Photo: SW001 (US Part 1)\_MH A\_MH  
B\_20062017\_125504\_A.jpg  
28.35m, Suspected Infiltration , General Comments through  
corrugated iron, at 2 o'clock

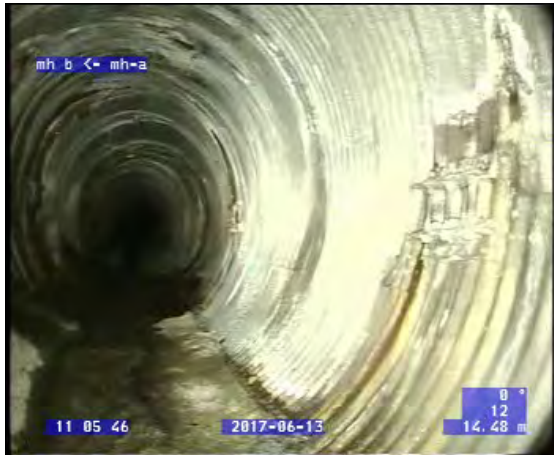
Photo: SW001 ( US Part 2)\_MH A\_MH  
B\_20062017\_132300\_A.jpg  
14.48m, Encrustation/Scale is attached to the wall above the water line , Obstruction: <5%, General Comments possibly due to infiltration , from 2 to 6 o'clock

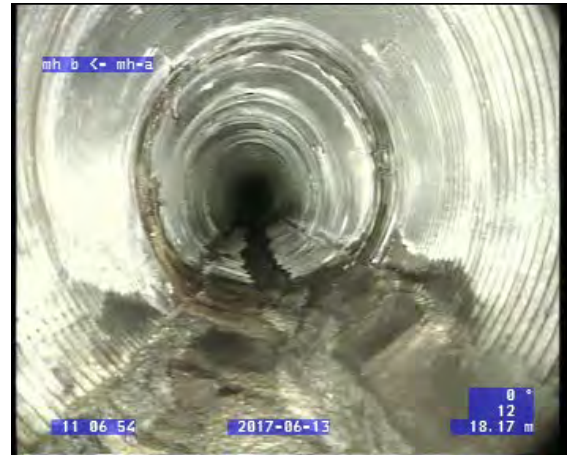
Photo: SW001 ( US Part 2)\_MH A\_MH  
B\_20062017\_132436\_A.jpg  
18.17m, Dropped invert , depth of drop 10mm, General Comments drop in invert of pipe- uneven surface

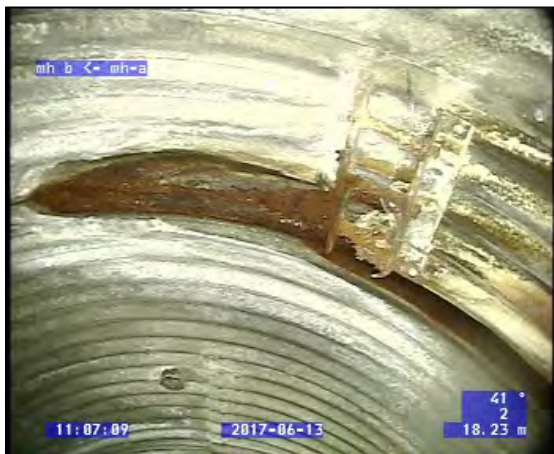
Photo: SW001 ( US Part 2)\_MH A\_MH  
B\_20062017\_132535\_A.jpg  
18.23m, Other Deposits on the wall, Jointing Material , Obstruction: <5%, General Comments rusting/staining of joining mechanism, from 12 to 4 o'clock

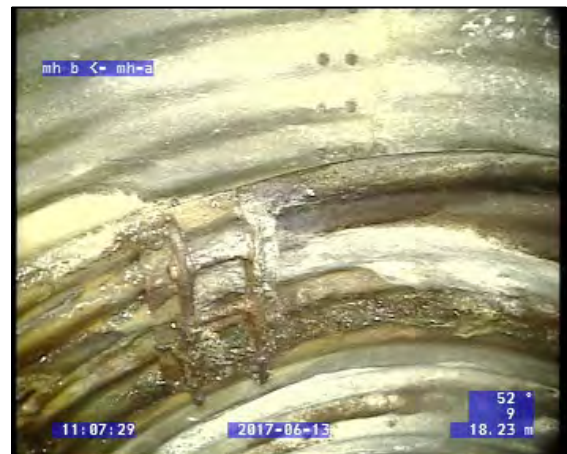
Photo: SW001 ( US Part 2)\_MH A\_MH  
B\_20062017\_132632\_A.jpg  
18.23m, Encrustation/Scale is attached to the wall above the water line , Obstruction: <5%, General Comments rusting/staining/possible infiltration of joining mechanism , from 7 to 12 o'clock

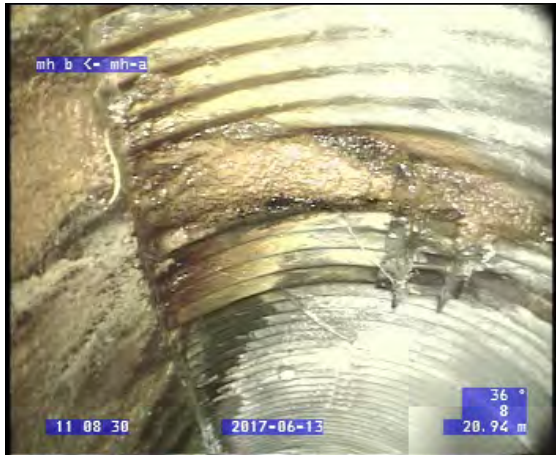
Photo: SW001 ( US Part 2)\_MH A\_MH  
B\_20062017\_132806\_A.jpg  
20.94m, Infiltration, running , General Comments spurting out  
pipe wal, from 7 to 8 o'clock

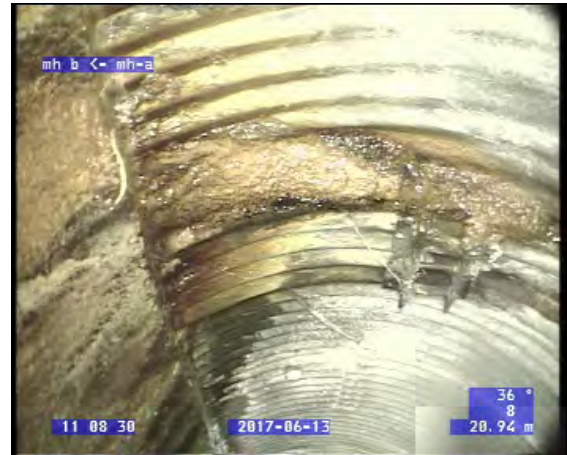
Photo: SW001 ( US Part 2)\_MH A\_MH  
B\_20062017\_132803\_A.jpg  
20.94m, Encrustation/Scale is attached to the wall above the  
water line , Obstruction: <5%, General Comments due to  
infiltration , from 6 to 12 o'clock

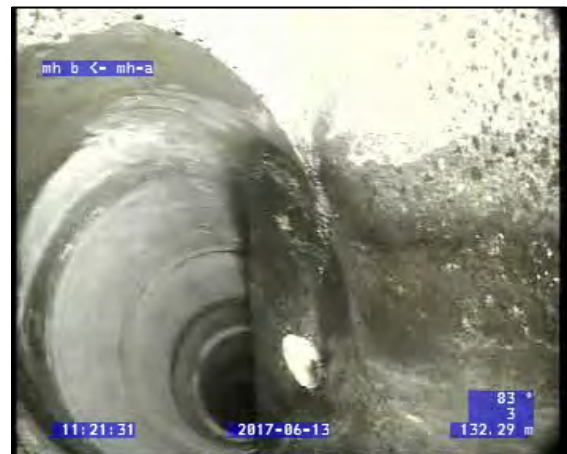
Photo: SW001 ( US Part 2)\_MH A\_MH  
B\_20062017\_133414\_A.jpg  
132.29m, Connection, good workmanship, connection appears  
to be open, diameter approx 600mm , at 3 o'clock, General  
Comments Large wooden object wedged at pipe entrance

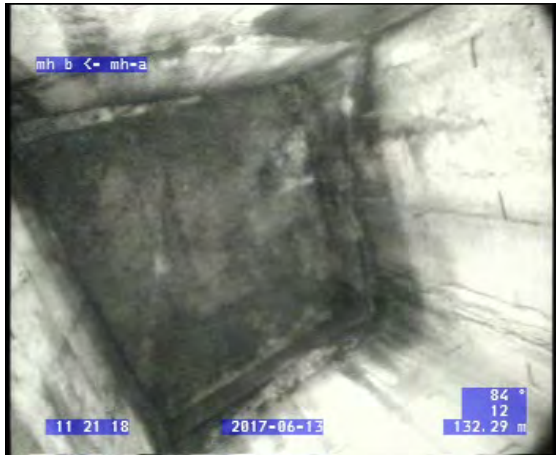
Photo: SW001 ( US Part 2)\_MH A\_MH  
B\_20062017\_133306\_A.jpg  
132.31m, General Comments Unknown pit found

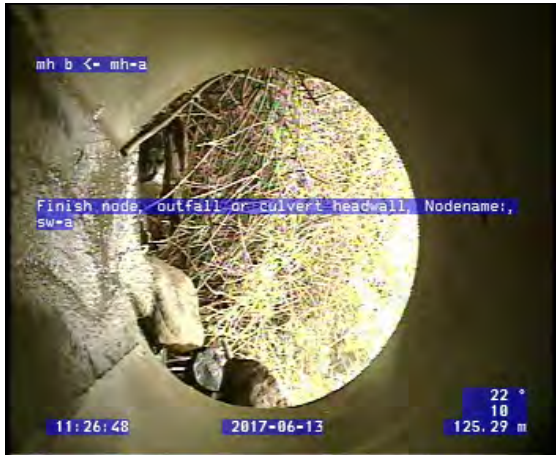
Photo: SW001 (US Part 3)\_MH A\_MH  
B\_20062017\_134032\_A.jpg  
125.29m, Finish node, outfall or culvert headwall, Nodename:  
, General Comments Unable to completely reach end
