Tasman Extension Project Environmental Impact Statement

PRIVATE DRIVEWAY/ GEORGE BOOTH DRIVE REVIEW

Tasman Extension Project

Safety Review of George Booth Drive Shoulder Widening

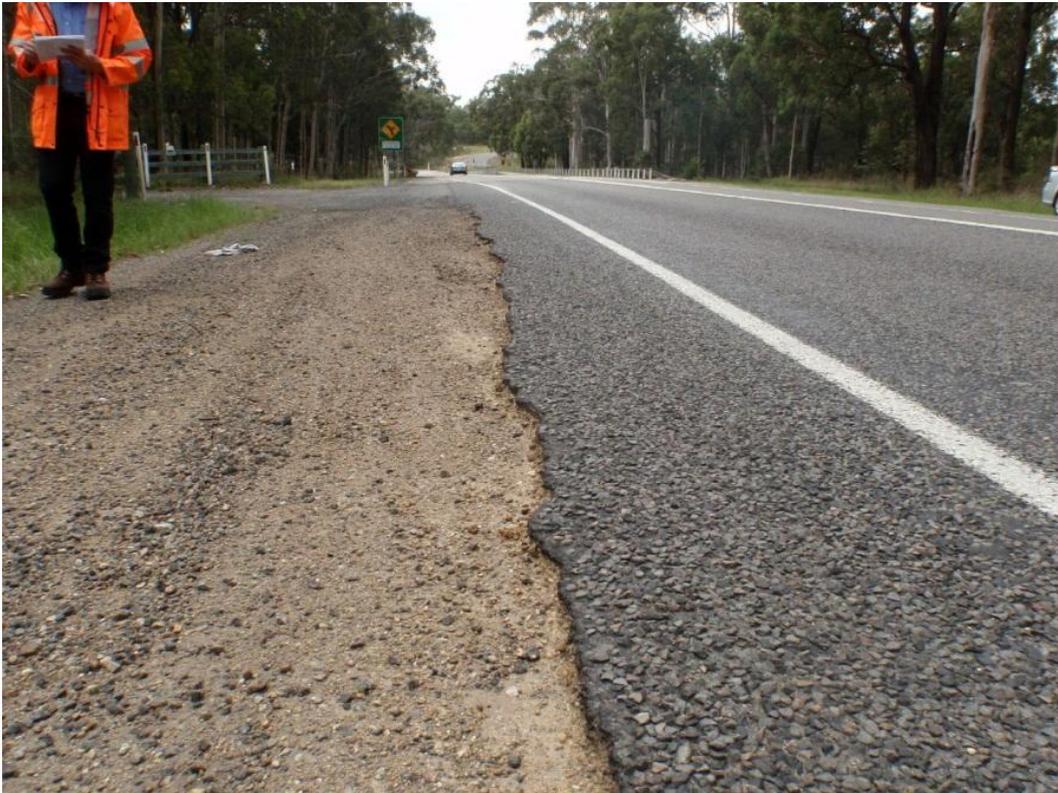
- ▶ Some minor erosion has occurred at the edge of the seal on both sides of the road, creating a small drop to the unsealed shoulder – Refer Appendix A, Photo 1 and Photo 2;
- ▶ Both sides of the road have wide unsealed areas that are clear of non-frangible hazards; and
- ▶ Sight distance to a vehicle propped to turn right into the driveway is reduced due to the sharp right hand curve to the south of the driveway. Vehicles travelling north on George Booth Drive will not see a propped vehicle until they have negotiated the curve. However, the speed of the through vehicle is reduced due to the tightness of this curve.

Photo 1 No. 1332 Southbound Pavement Edge Drop Off

- ▶ Provide a short length of sealed shoulder widening for the left turn into the property, which would require repairs to the existing Telstra pit.

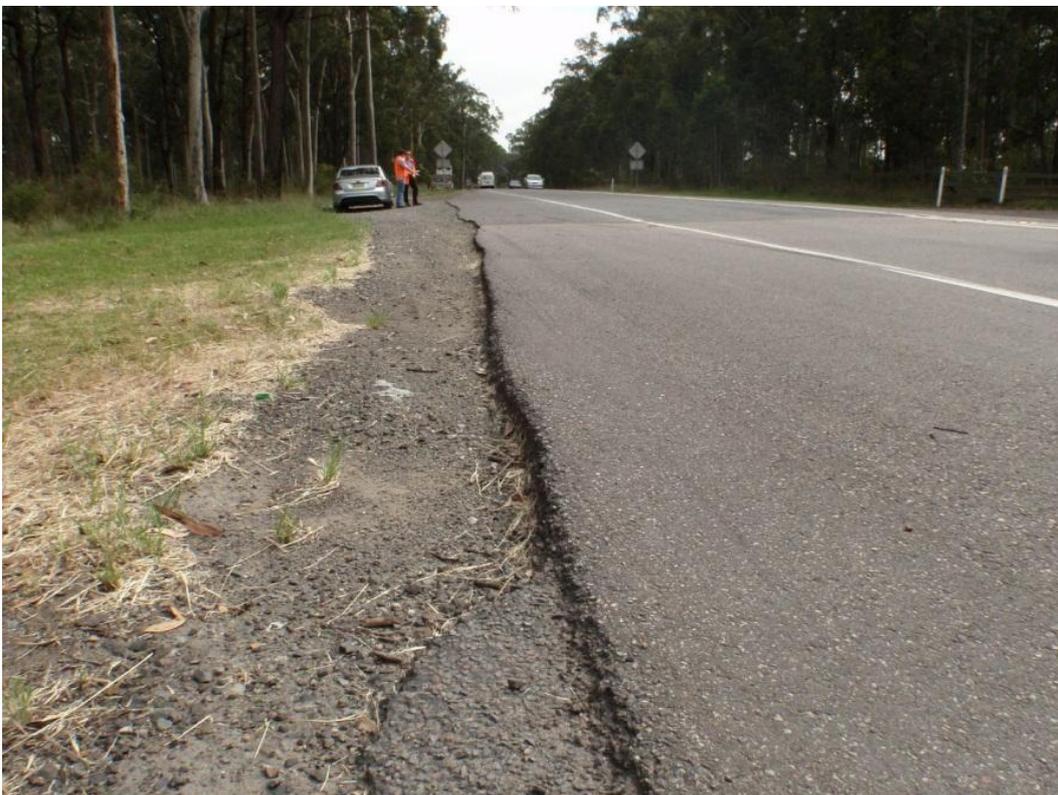
Photo 2 No. 1332 Northbound Pavement Edge Drop Off

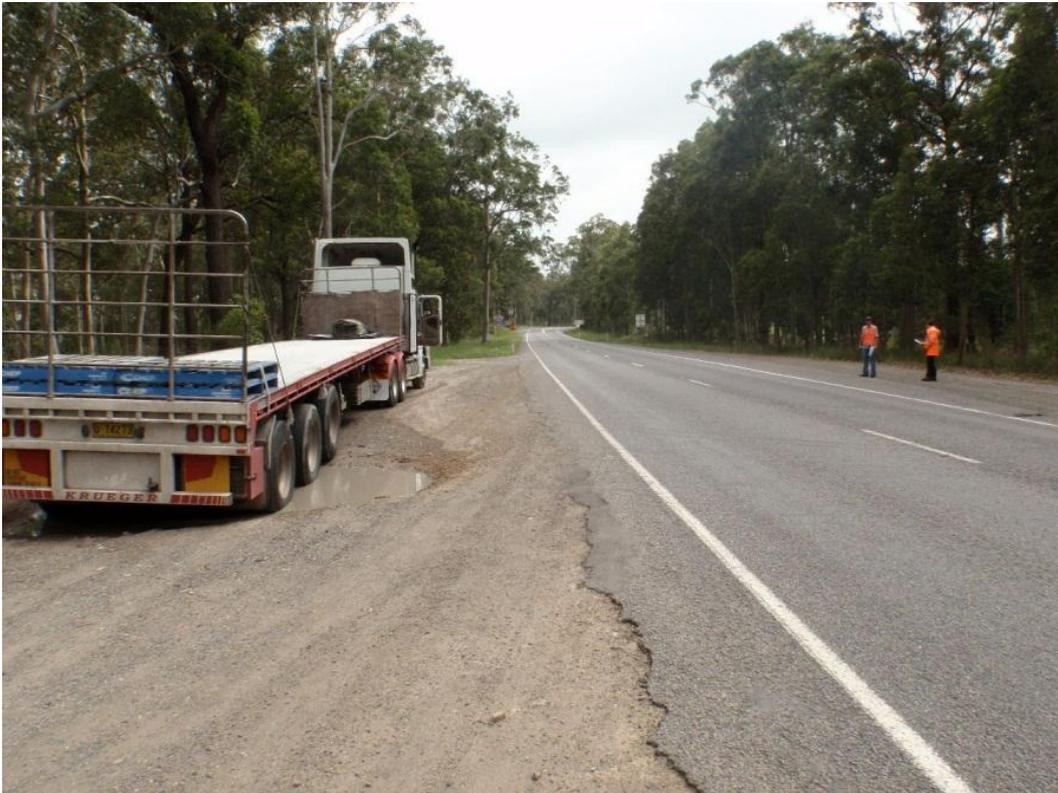
- Both sides of the road have wide unsealed areas that are clear of non-frangible hazards. A semi-trailer was observed to be parking in one of the widened unsealed verges;
- A large hole is present in the road verge on left turn approach to the driveway – Refer Appendix A, Photo 3;
- Some minor erosion has occurred at the edge of seal on both sides of the road, creating a small drop to the unsealed shoulder – Refer Appendix A, Photo 4;

Photo 3 No. 1353 Hole in Northbound Verge (Beneath Semi Trailer Back Wheels)

Provide sealed shoulder widening for the left turn into the driveway.

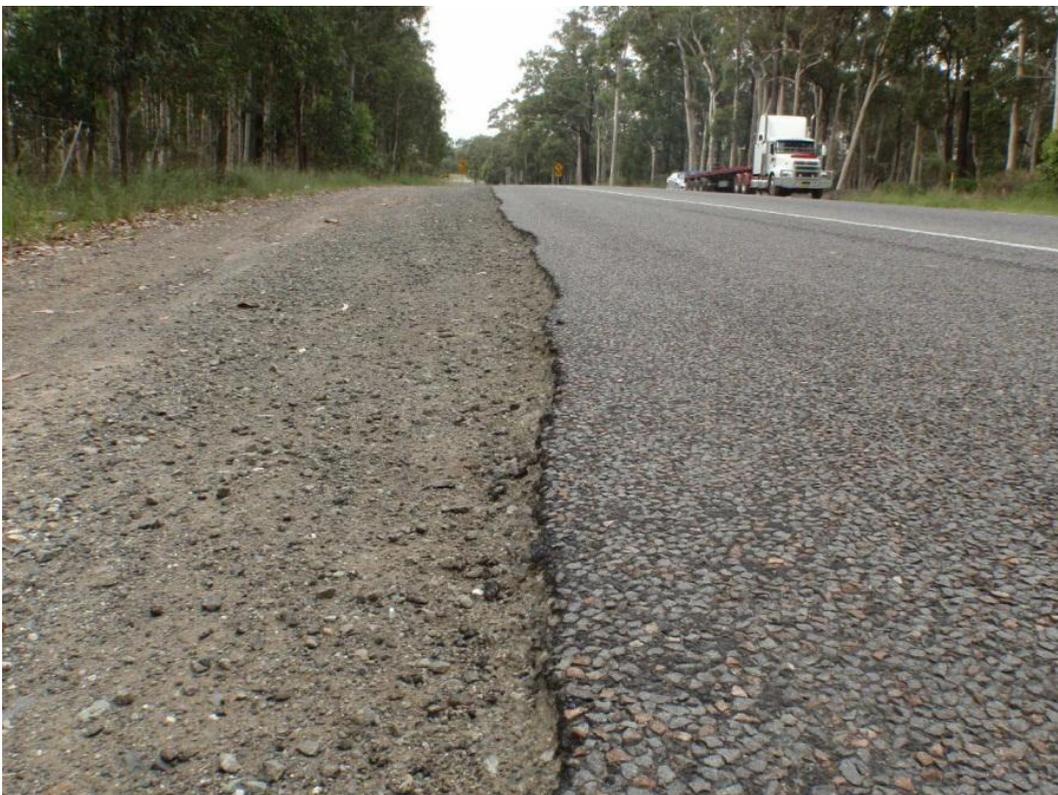
Photo 4 No. 1353 Southbound Pavement Edge Drop Off

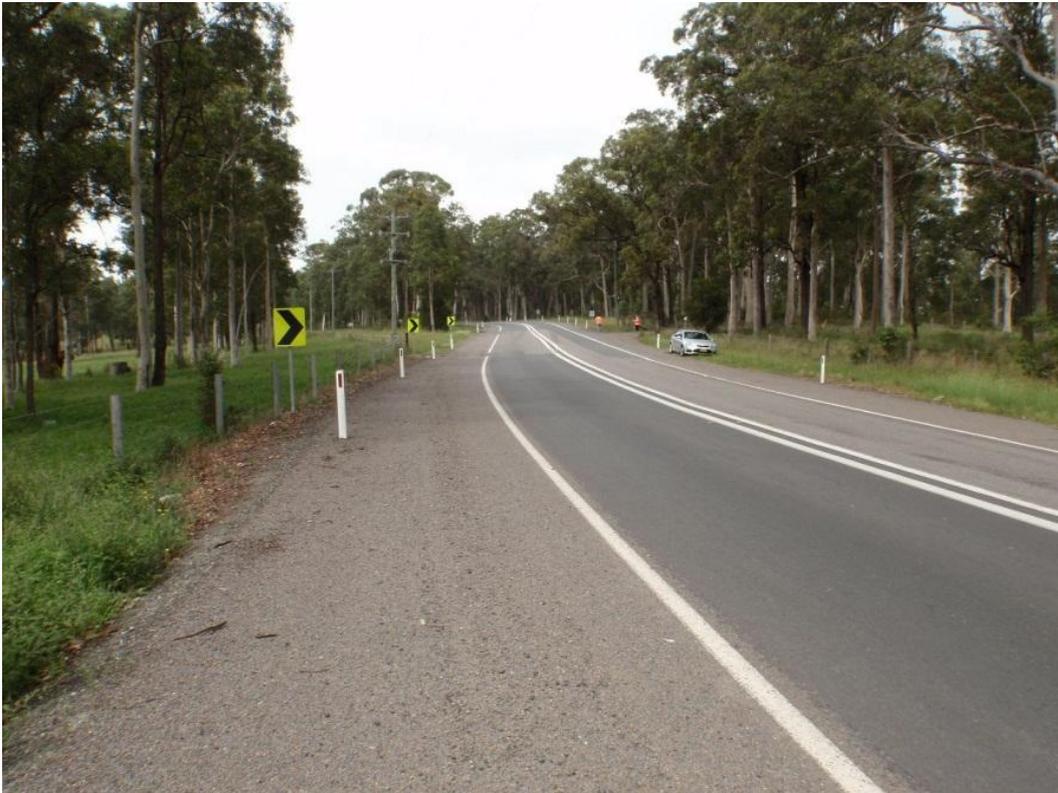
- While the sealed right turn shoulder widening does extend out to 2.5m (approximately), the actual available shoulder width is limited by the position of the guideposts at this location which are offset approximately 200mm from the edge of seal. It is noted that the guide posts have not been provided in the immediate vicinity of the driveway – Refer Appendix A, Photo 5; and

Photo 5 No. 1395 Guide Posts Restricting Available Shoulder Width

- ▶ Provide additional width for the right turn shoulder widening; and
- ▶ Guide posts to be relocated to outside the sealed pavement area.

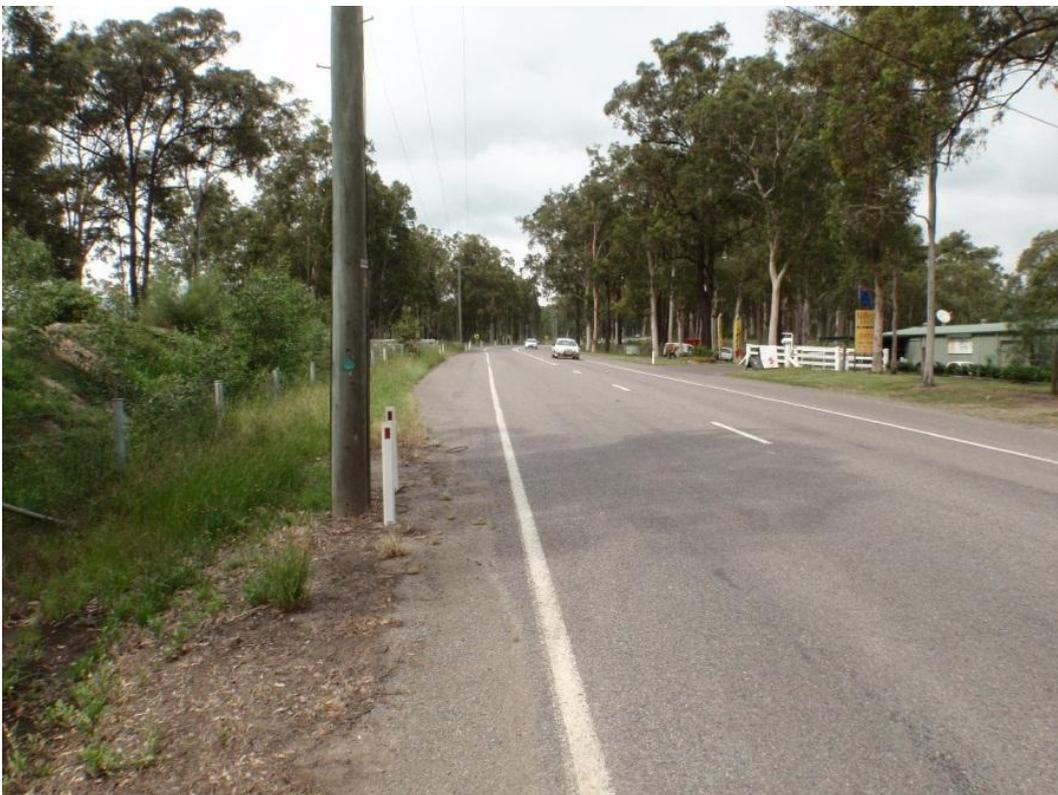
- At end of widened shoulder (2.75m from edge line on road).These poles will create a non-frangible hazard for an errant vehicle on George Booth Drive – Refer Appendix A, Photo 6 and Photo 7;

Photo 6 No. 1408 Power Pole in the Clear Zone

- ▶ Consider the relocation of the power poles to outside of the clear zone for the road. These poles restrict the extents of the widened shoulders. It is also noted that should a vehicle overshoot the widened shoulder at this location it would travel straight into one of the poles; and
- ▶ Trim or remove vegetation on the southbound side of the road, north of the driveway into property No. 1408 to improve sightlines out of the driveway to approaching vehicles.

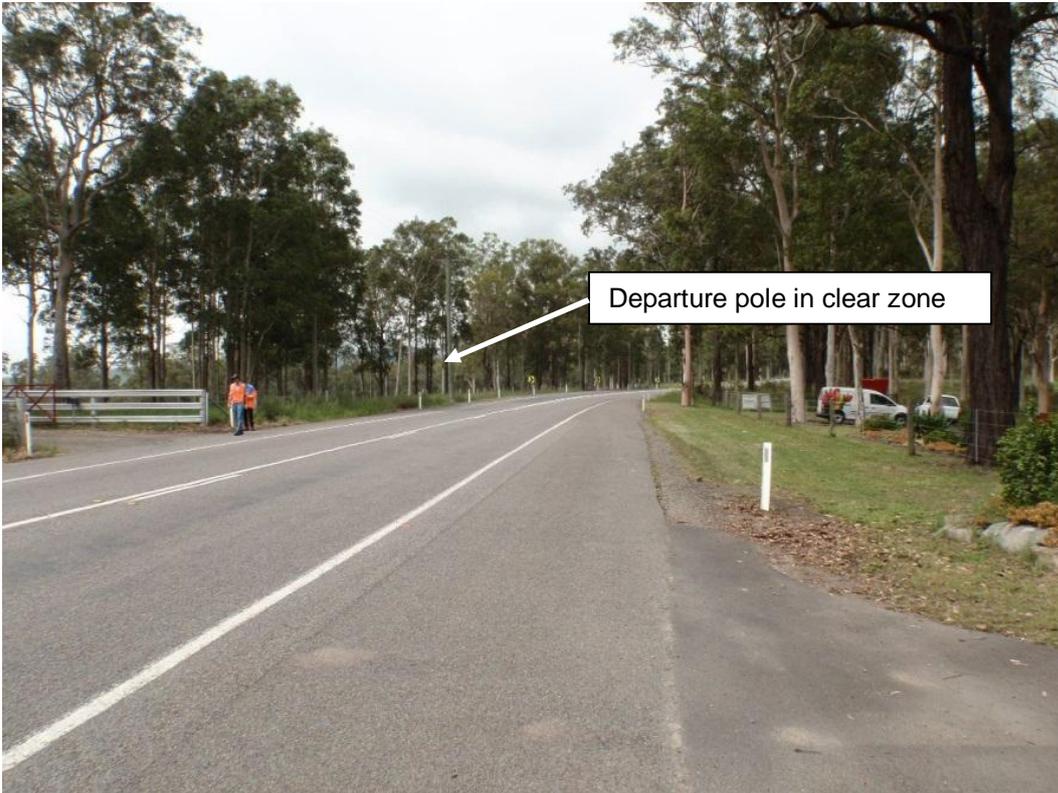
Photo 7 No. 1408 Power Pole in the Clear Zone

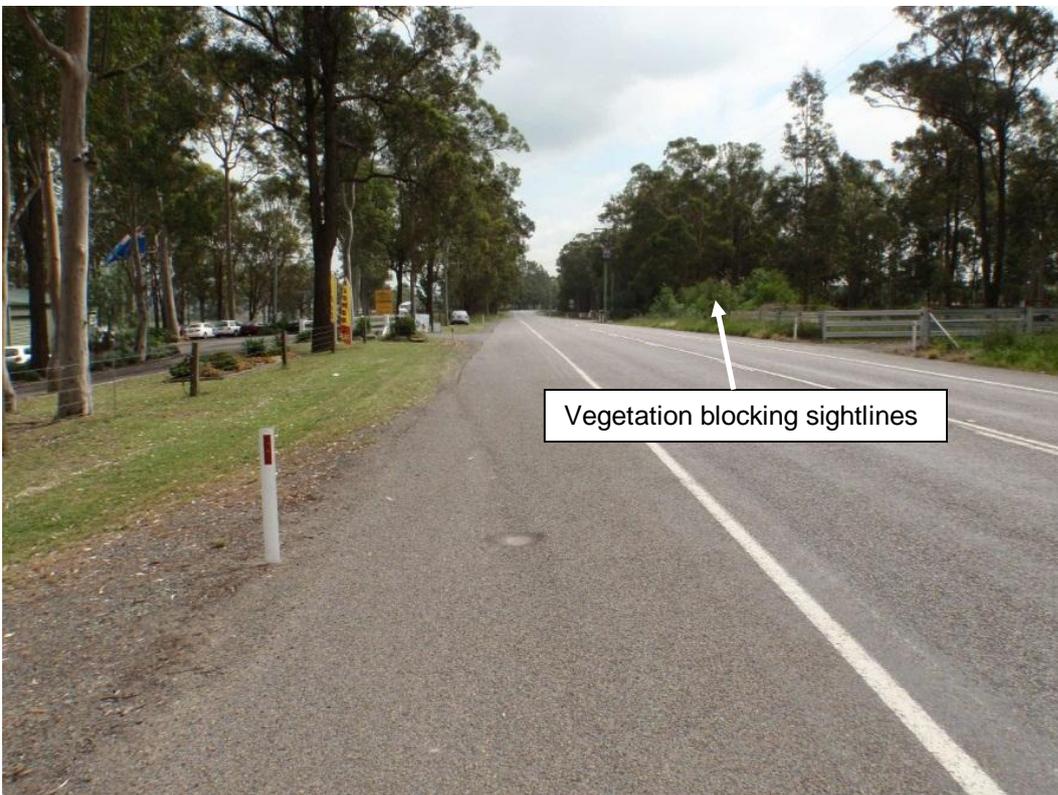
Photo 8 No. 1408 Vegetation Blocking Sightlines

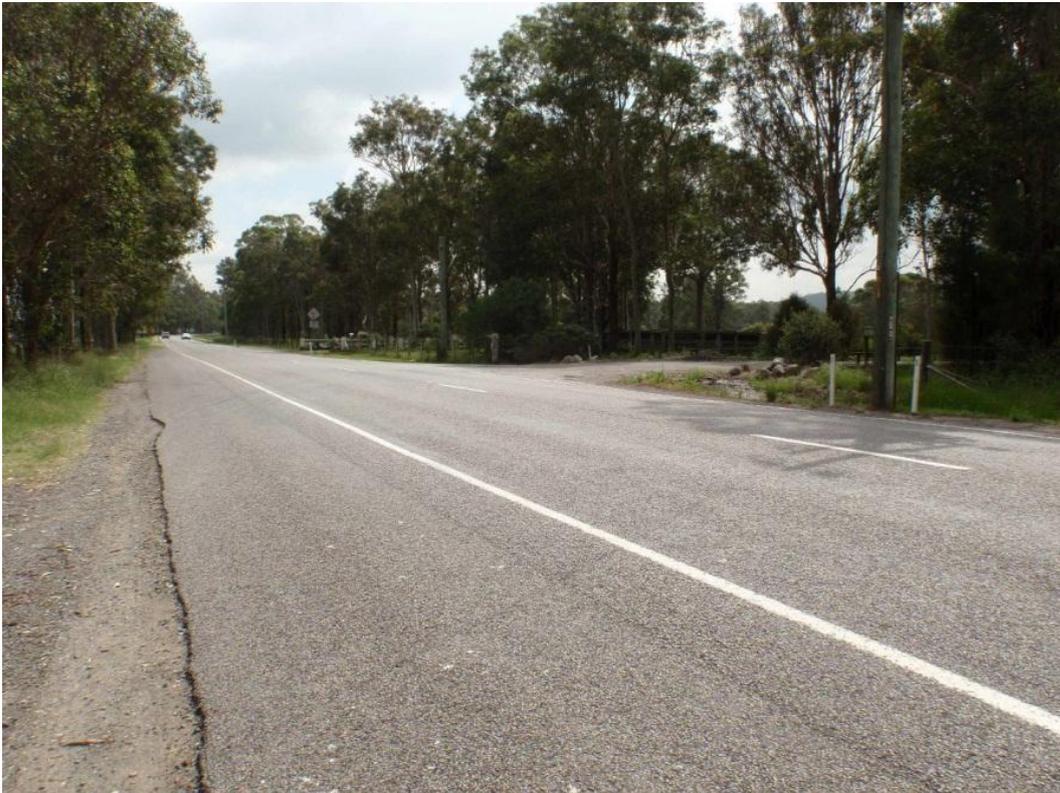
Photo 9 “Henholme” Extended Widened Right Turn Shoulder

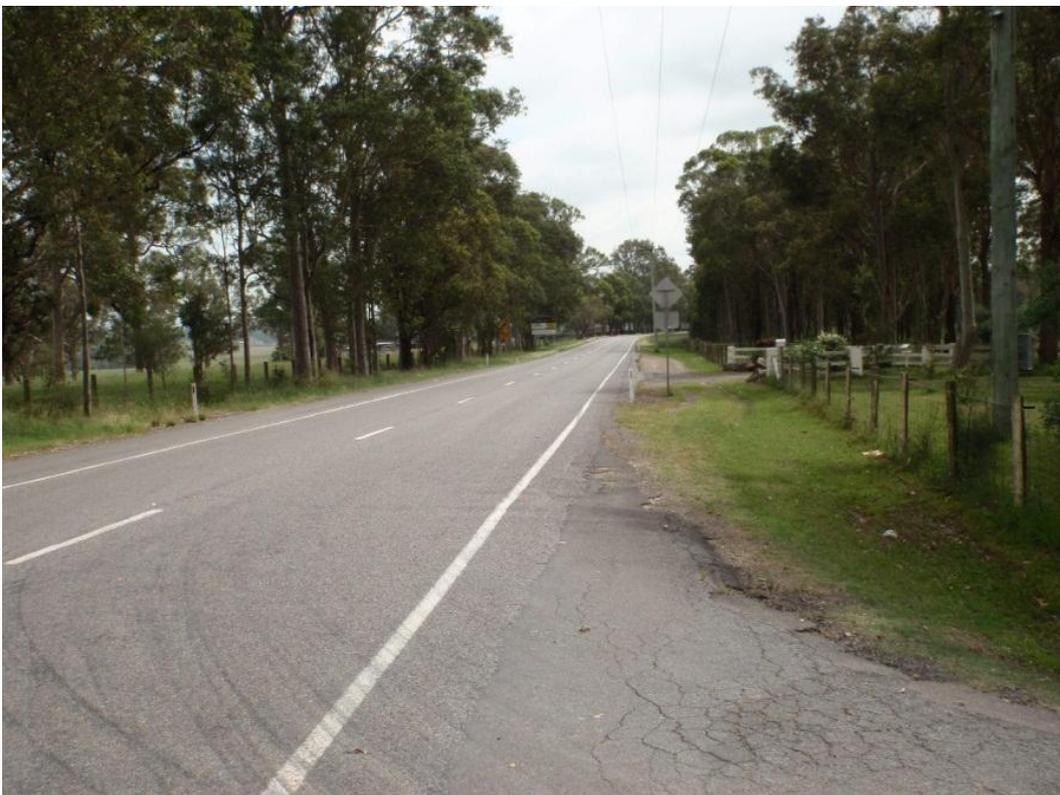
- ▶ The driveway pavement was observed to be damaged with signs of crocodile cracking and potholes. This is thought to be attributed to the number of heavy vehicles that enter and leave the property – Refer Appendix A, Photo 10;

Photo 10 “Henholme” Damaged Driveway Pavement

It is considered that the issues associated with this driveway are due to the commercial nature of the property. However, some shoulder widening could be provided for the left turn into the driveway. Any existing damage to the existing driveway should be the responsibility of the property owner given that the driveway is used by heavy vehicles associated with these commercial premises.

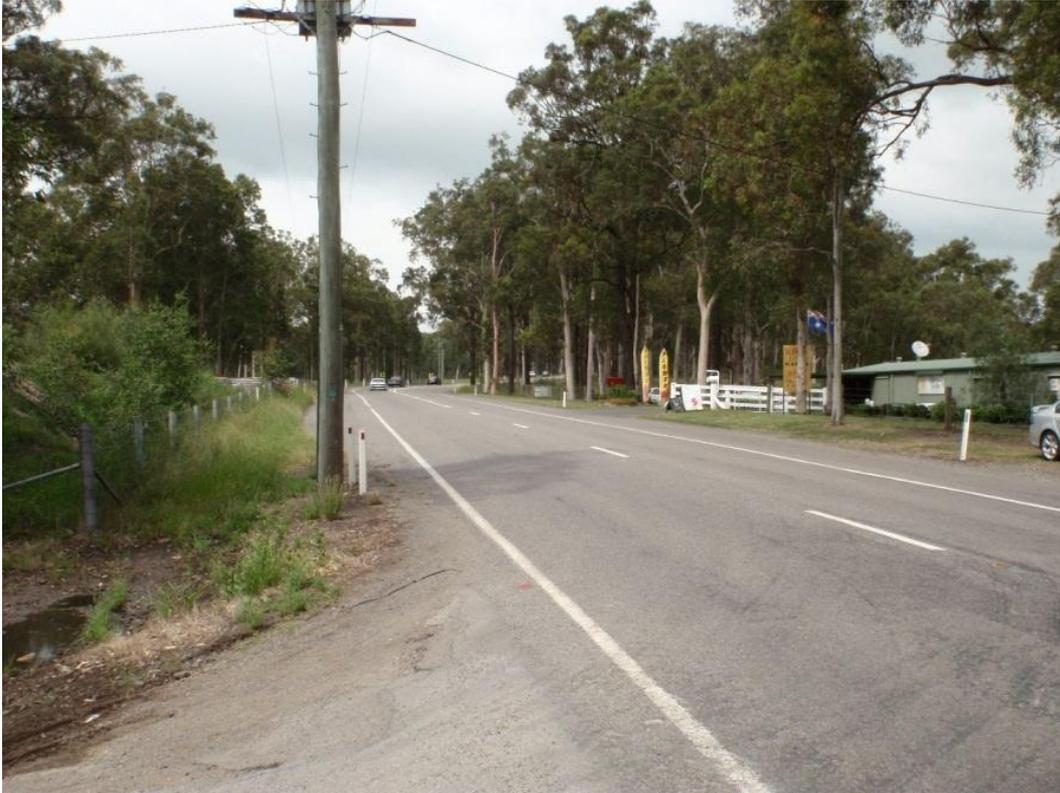
- ▶ At the throat of the driveway deep tyre tracks were observed into the unsealed pavement to the south – Refer Appendix A, Photo 11;
- ▶ Tyre marks on the road indicate that there are large numbers of heavy vehicles that turn into and out of the property, and that these vehicles regularly use the road shoulders to be able to make the manoeuvre. During the time of the safety review a B-Double vehicle was observed to turn right out of the property, this vehicle used the entire northbound road shoulder for the movement and encroached into the unsealed shoulder for a section while exiting the property – Refer Appendix A, Photo 12 and Photo 13. It can be seen in Photo 13, how a light vehicle has pulled over in the unsealed verge to turn left.

Photo 11 “Henholme” Tracks in Unsealed Verge

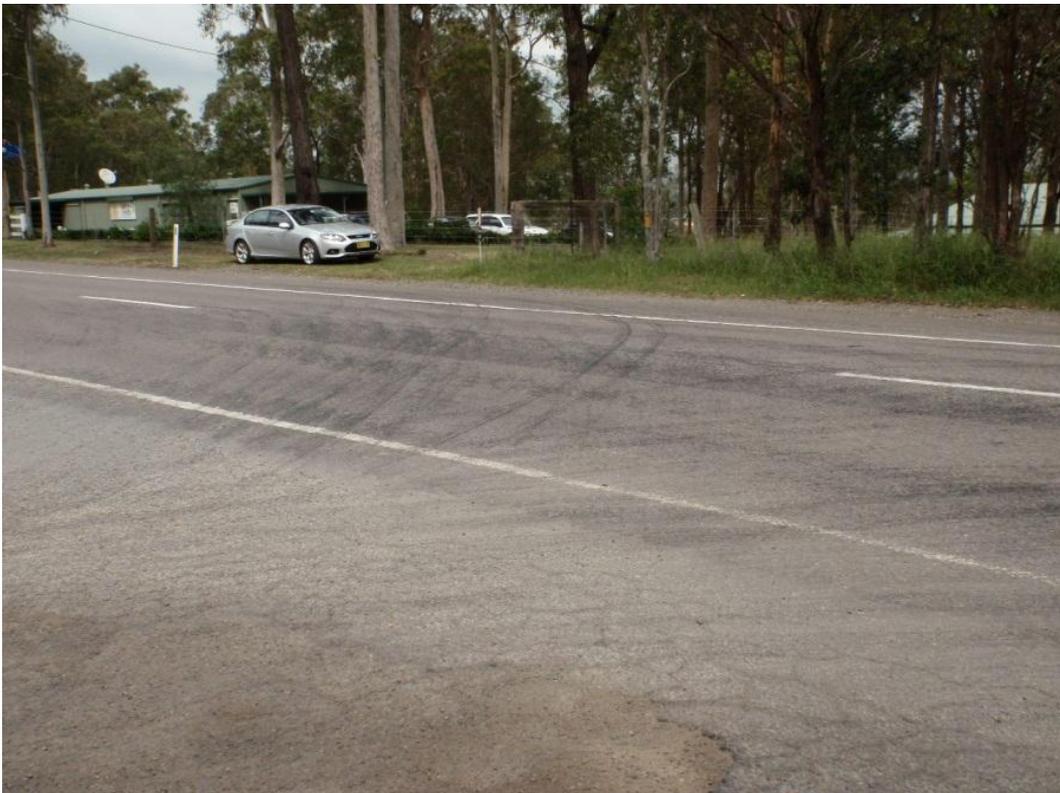
Photo 12 “Henholme” Tyre Marks on Road

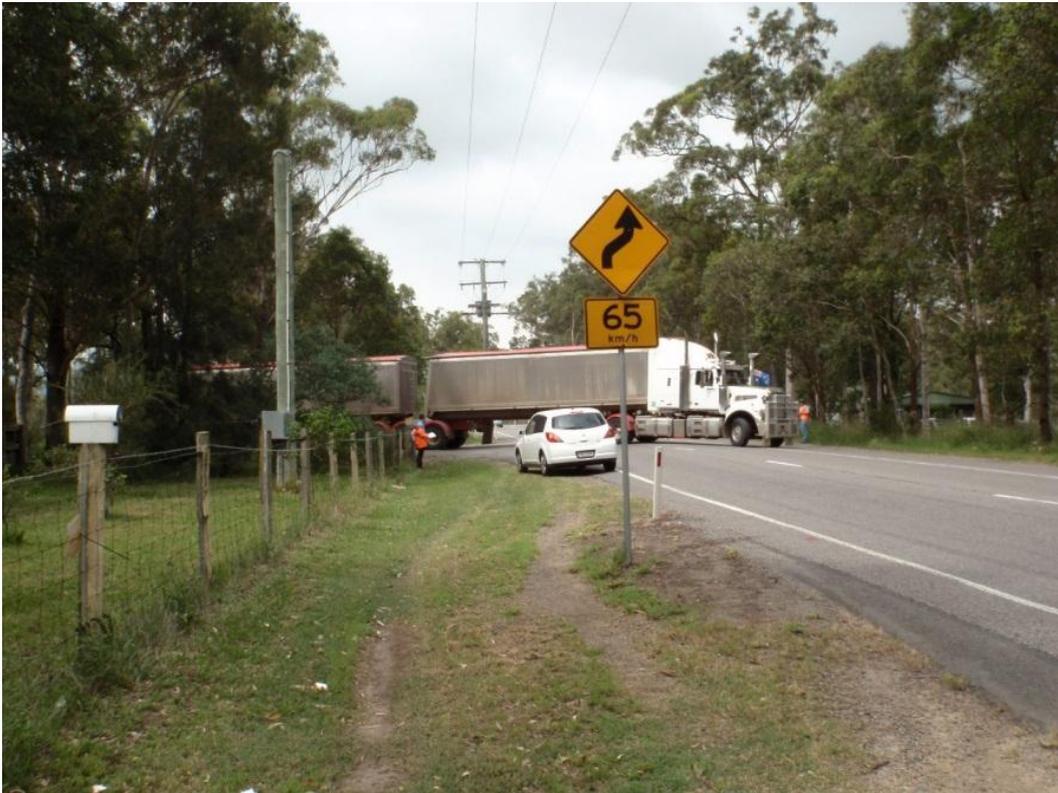
Photo 13 “Henholme” B Double Turning Out of Driveway

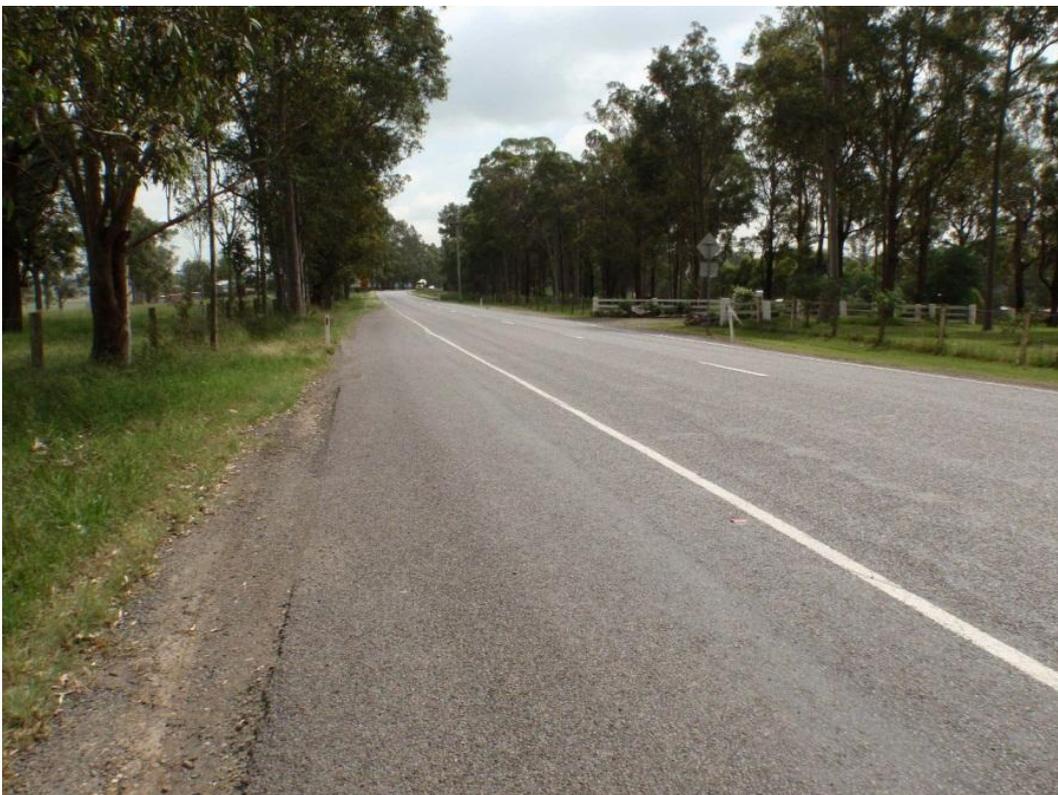
Photo 14 No. 1424 Right Turn Shoulder Widening Ends Immediately After Driveway

- ▶ Provide a sealed widened shoulder for the left turn into the property; and
- ▶ Extend the existing widened sealed shoulder to approximately 20m past the driveway prior to tapering back to the existing.

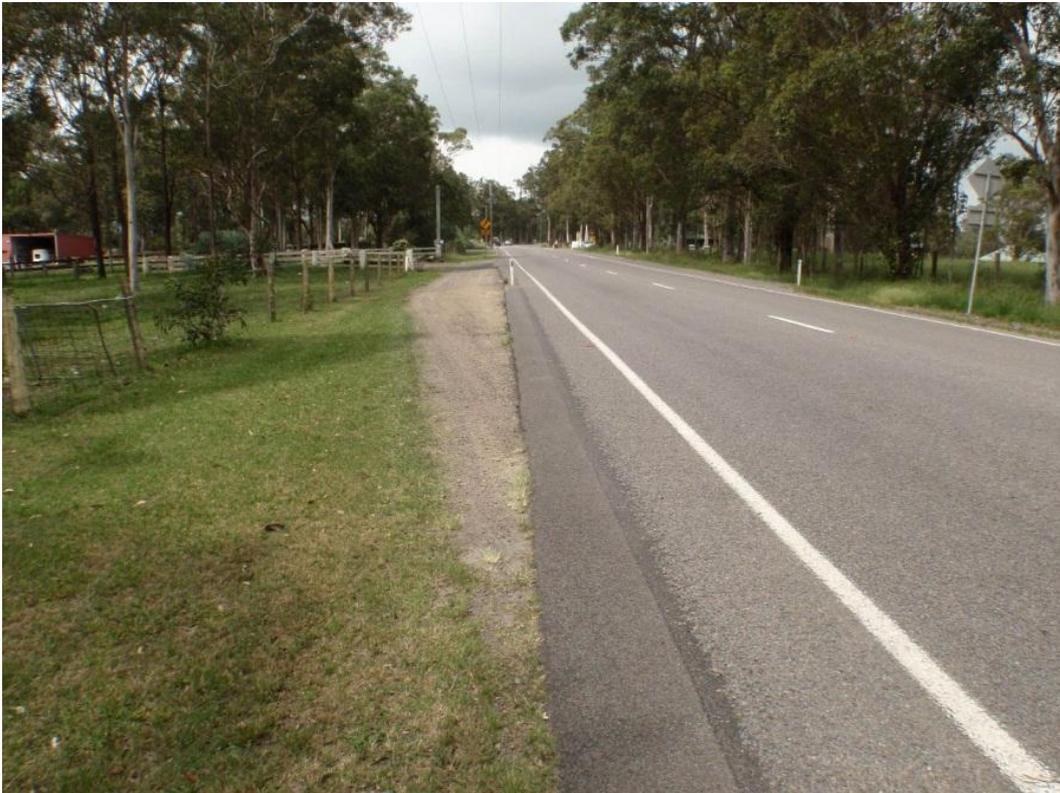
Photo 15 No. 1424 Wheel Paths in Left Turn Verge

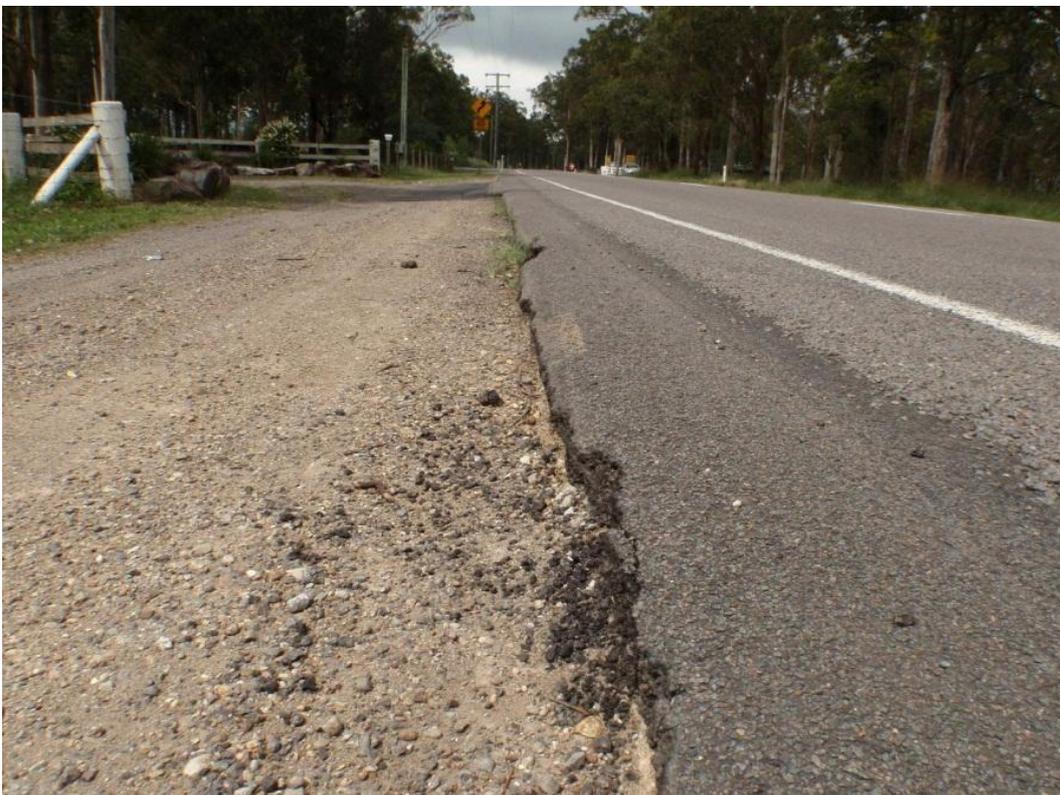
Photo 16 No. 1424 Southbound Pavement Edge Drop Off

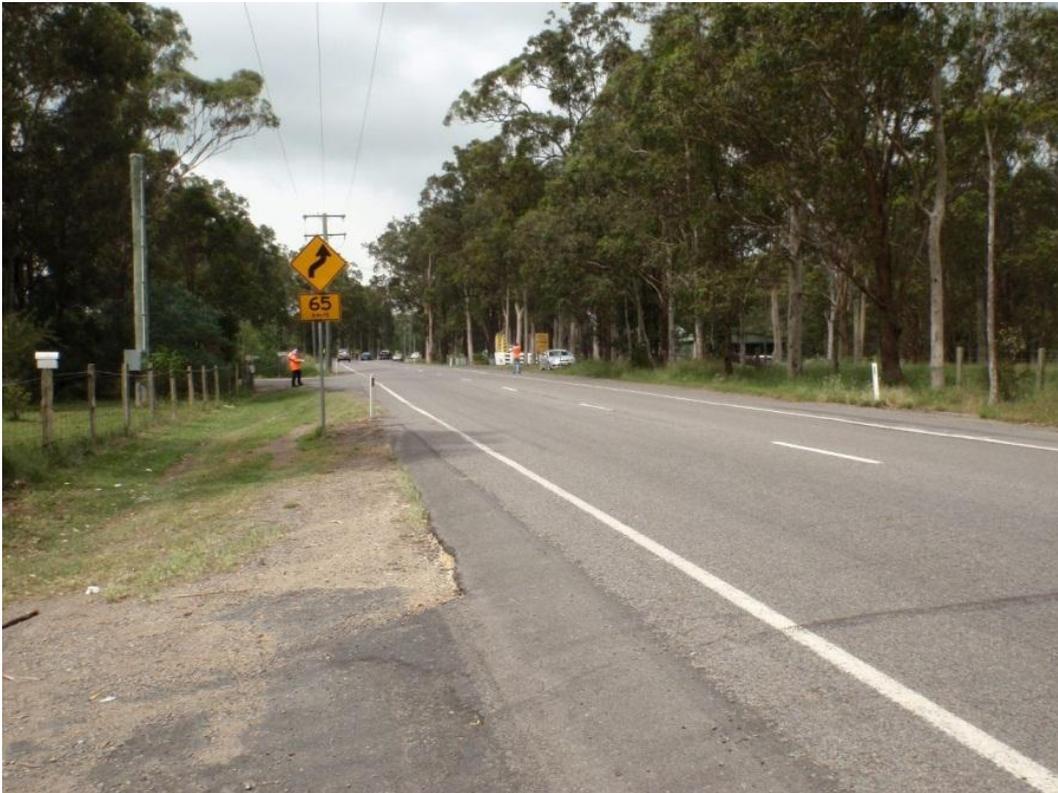
Photo 17 No. 1424 Informal Track Between Driveways

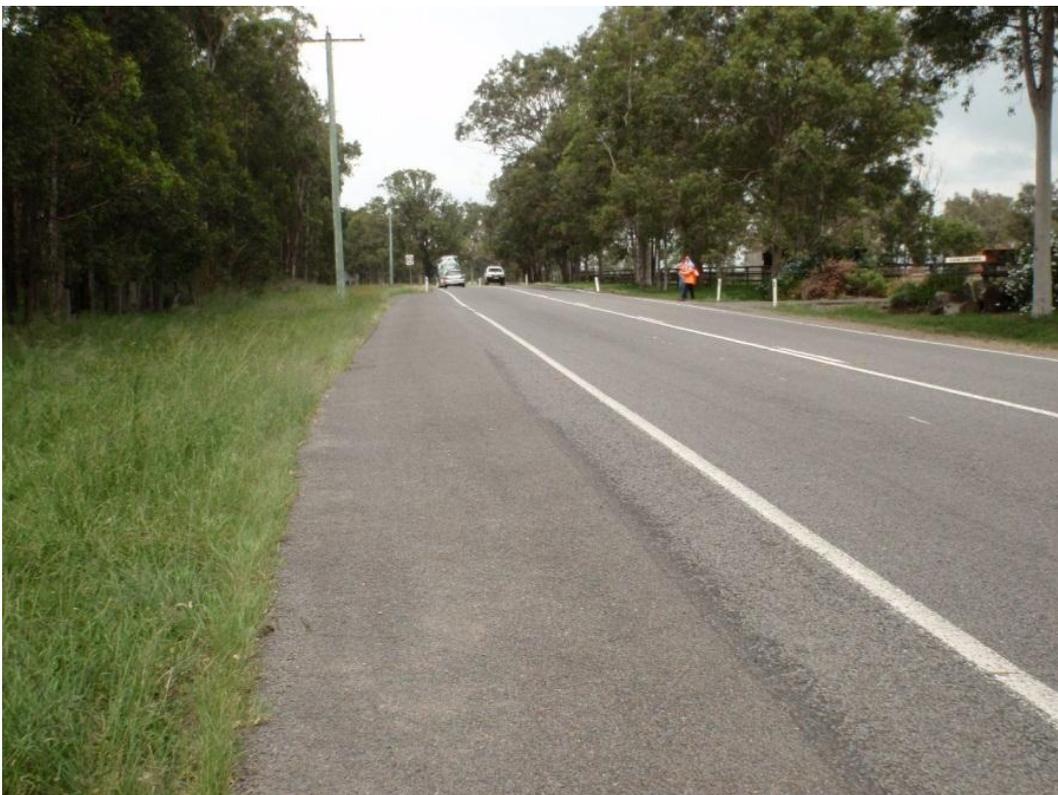
- ▶ There is a power pole that is within the clear zone for the road, directly opposite the driveway. The pole is located 4.5 metres from the lane edge line and adjacent to the shoulder widening and poses as a hazard should a vehicle be clipped or clip another when passing around a stationary vehicle – Refer Appendix A, Photo 18;

Photo 18 No. 1459 Power Pole in Southbound Clear Zone

- ▶ Provide a sealed widened shoulder for the left turn into the property; and
- ▶ Consider the relocation of the power pole to outside of the clear zone.

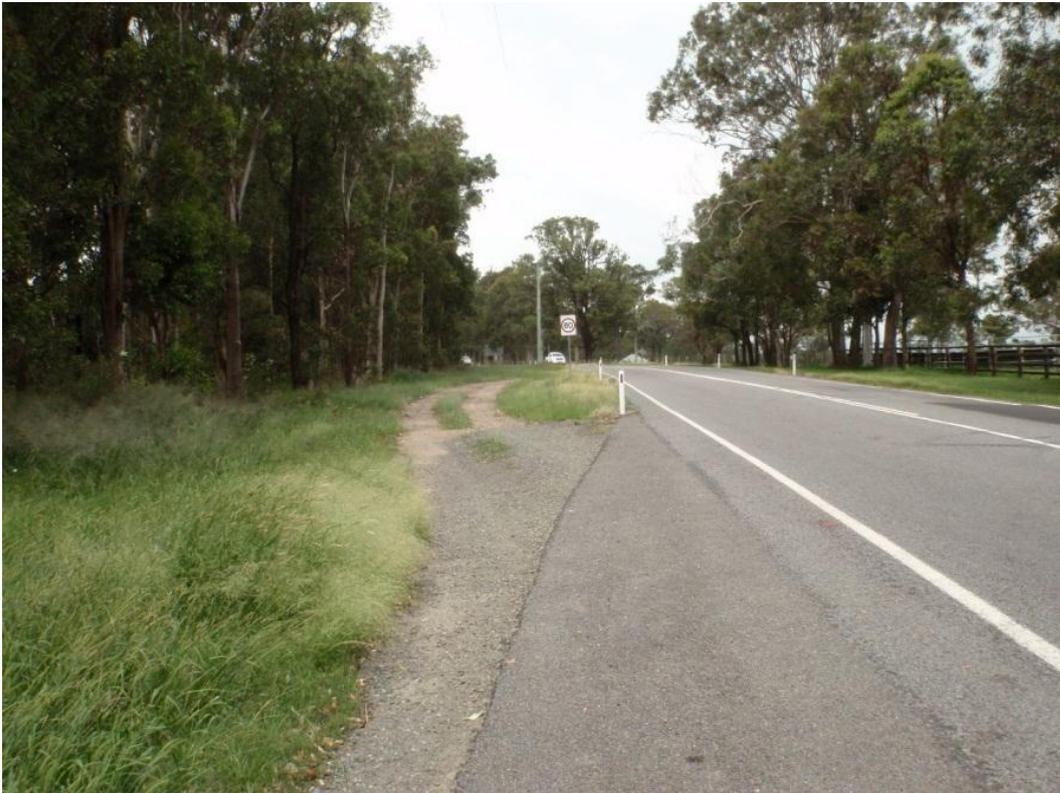
Photo 19 Informal Track South of Driveway

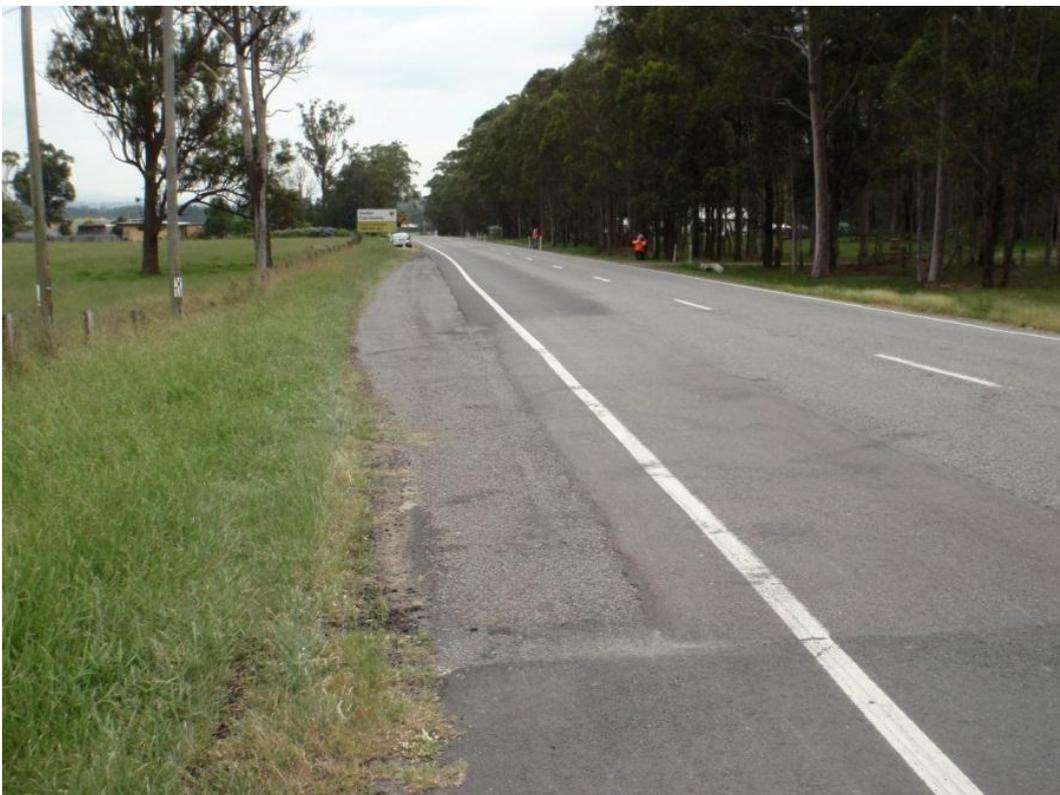
- The road widening for right turning vehicles is inconsistent in width and appears to be inadequate for vehicles to pass turning vehicles. At the critical area where overtaking/passing will occur the shoulder widening is 2.5m wide. There is no additional unsealed shoulder width for vehicles to use in order to pass a vehicle propped to turn right into the property. Wheel tracks were observed in the unsealed shoulder suggesting that it is used for the left turn into the property – Refer Appendix A, Photo 20;

Photo 20 Insufficient Right Turn Shoulder Widening

- ▶ Provide a sealed widened shoulder for the left turn into the property;
- ▶ Consider relocation of the Hunter Expressway sign to outside of the clear zone for the road. This should be requested / referred to the Hunter Expressway Alliance office; and
- ▶ Provide additional widening for the northbound shoulder and smooth off the drop in pavement due to the rehabilitation works.

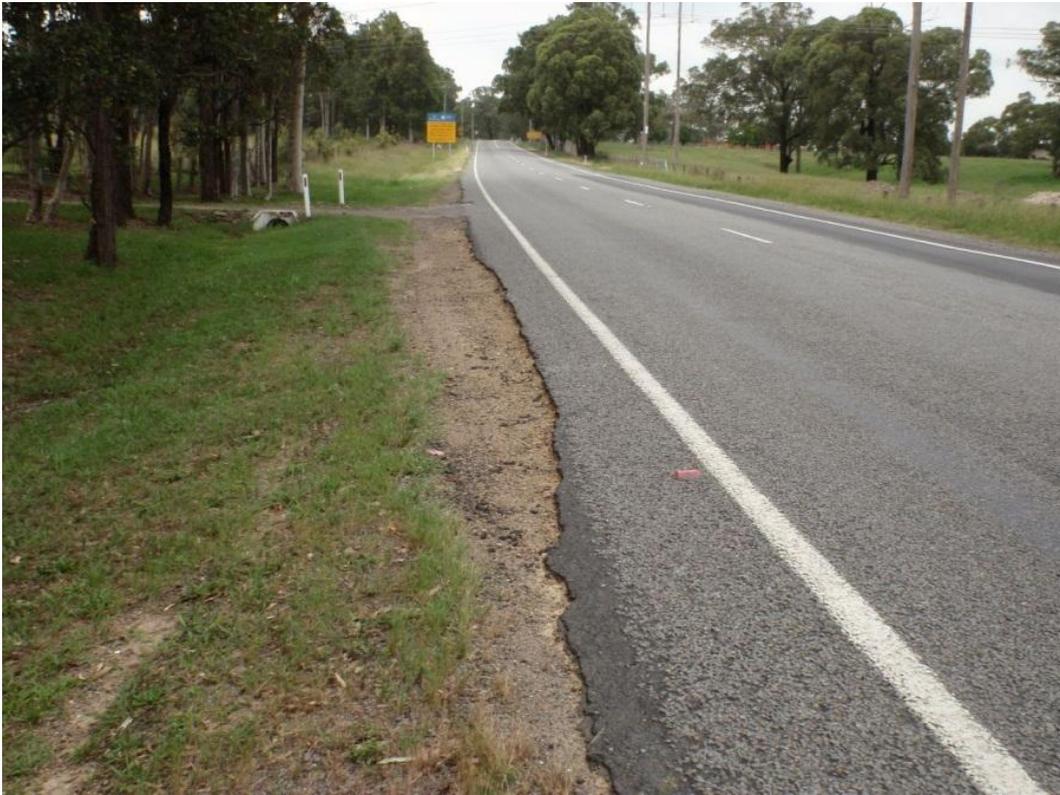
Photo 21 Edge Drop Off and Left Turn Tyre Tracks

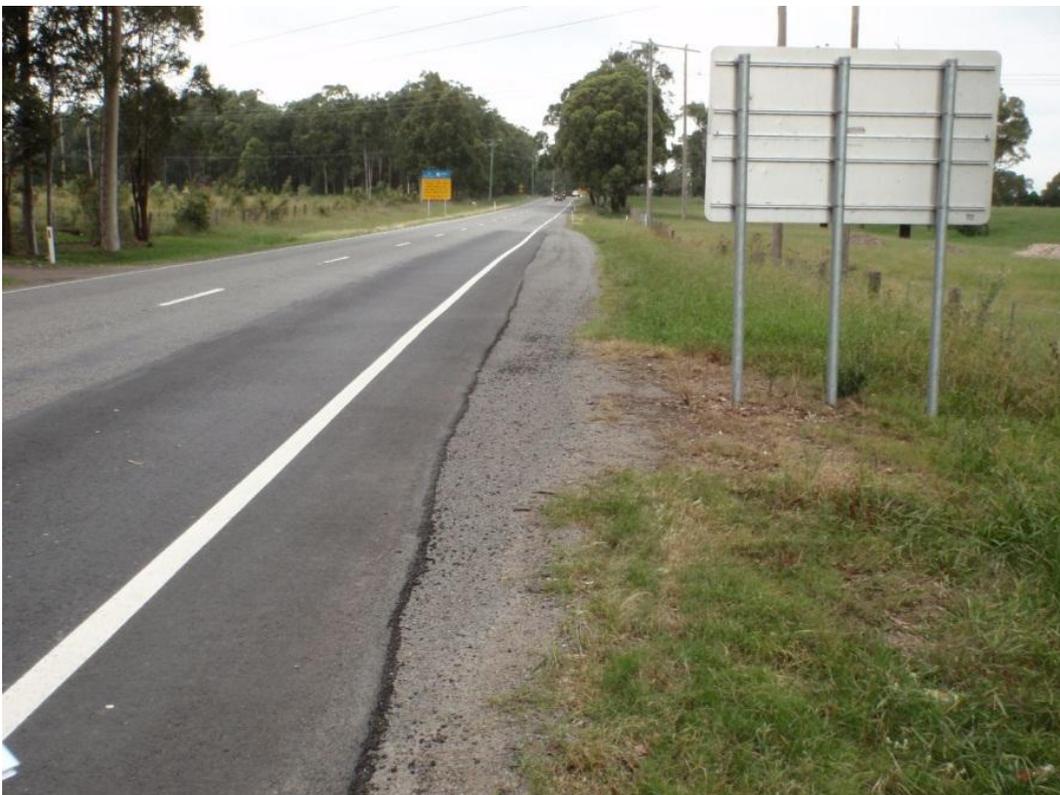
- ▶ A Hunter Expressway construction sign, located opposite the property access, has 3 x 90 mm diameter posts spaced at 0.8 metres, with the first post located 3.1m from the edge line. These poles create a non-frangible hazard within the clear zone for the road – Refer Appendix A, Photo 22;

Photo 22 Rehabilitation Works stop in Shoulder and Sign in Clear Zone

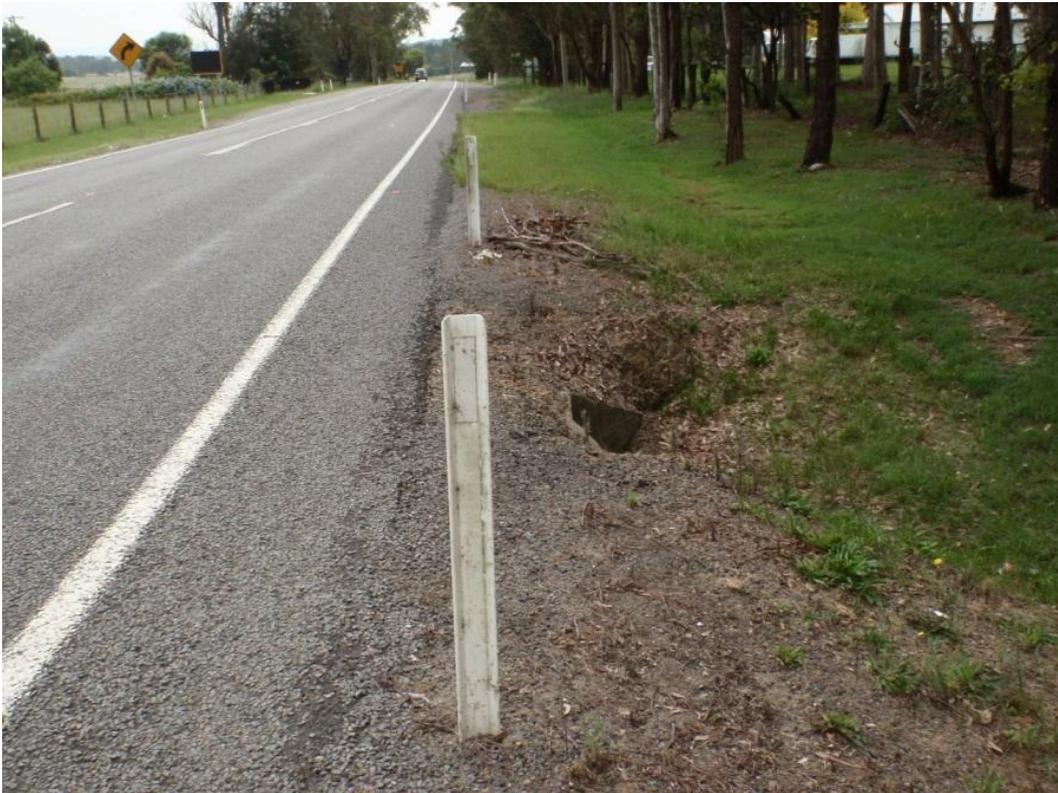
Photo 23 Culvert in the Southbound Clear Zone

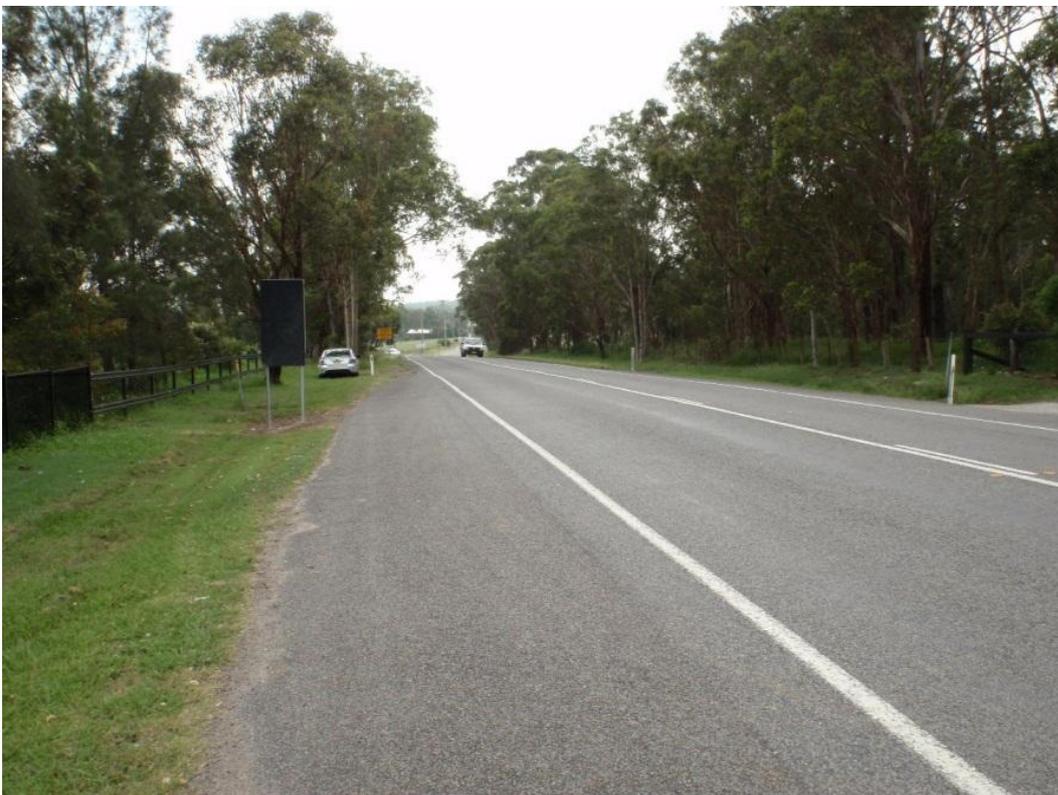
Photo 24 Northbound Shoulder Looking North

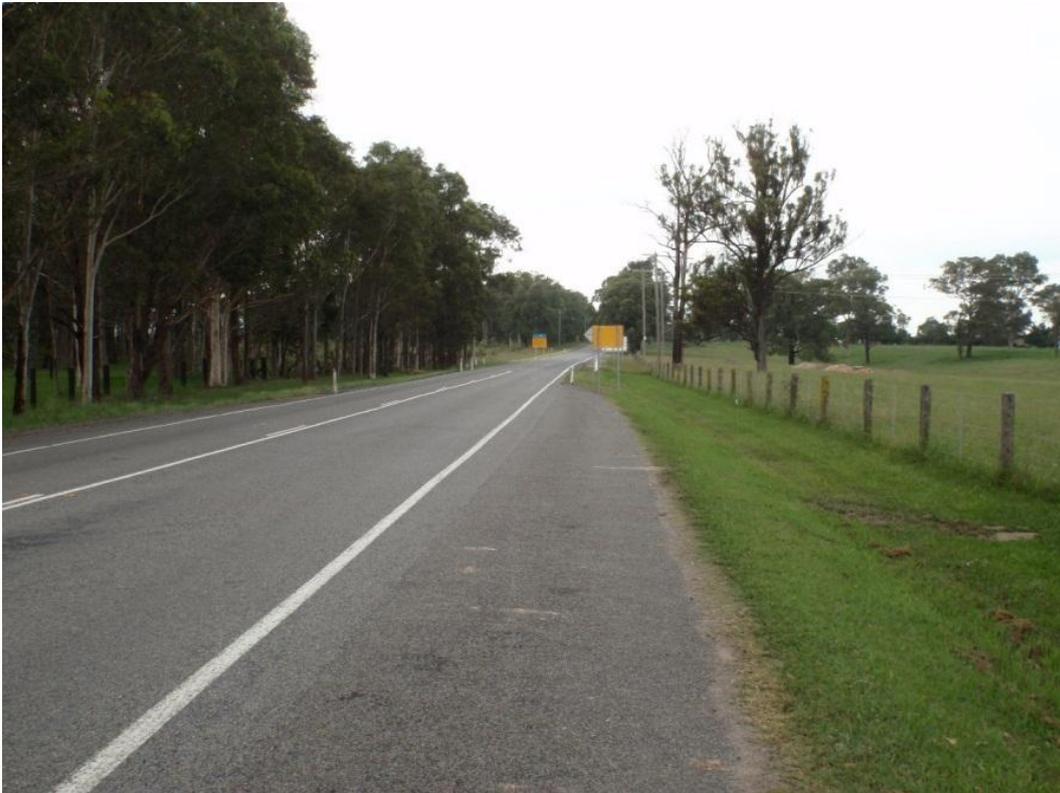
Photo 25 Northbound Shoulder Looking South
