Tasman Extension Project Environmental Impact Statement

PRIVATE DRIVEWAY/ GEORGE BOOTH DRIVE REVIEW

Tasman Extension Project

Safety Review of George Booth Drive Shoulder Widening

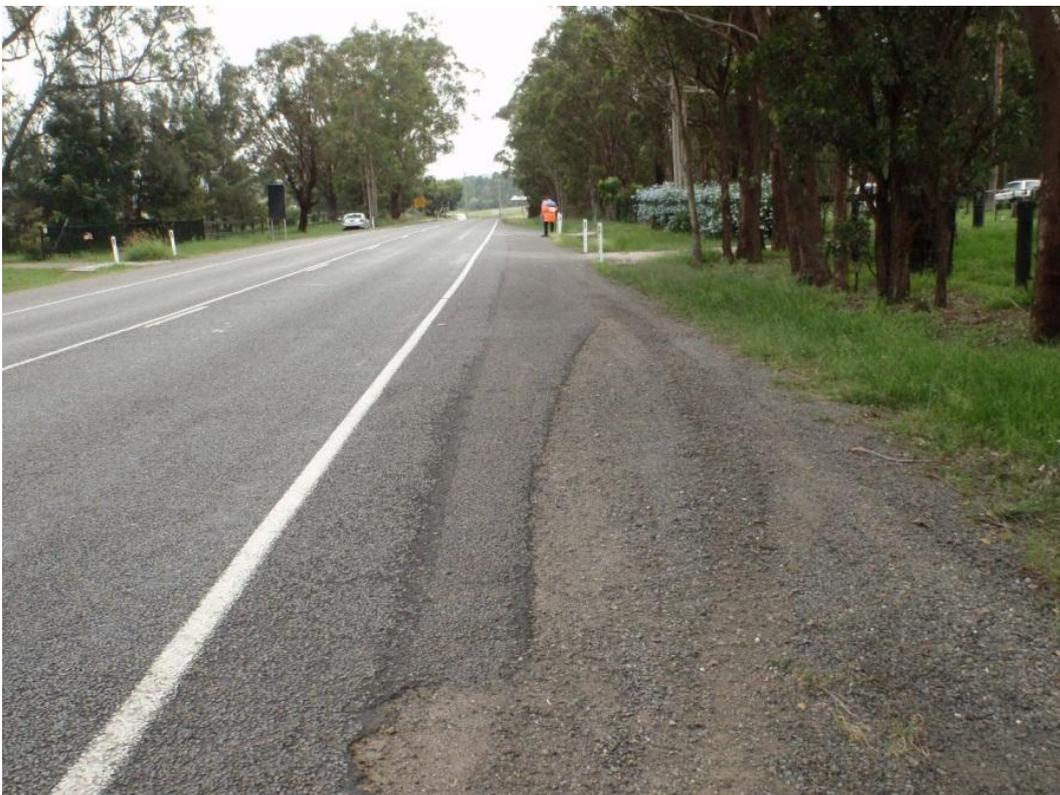
Photo 26 Southbound Shoulder Looking North

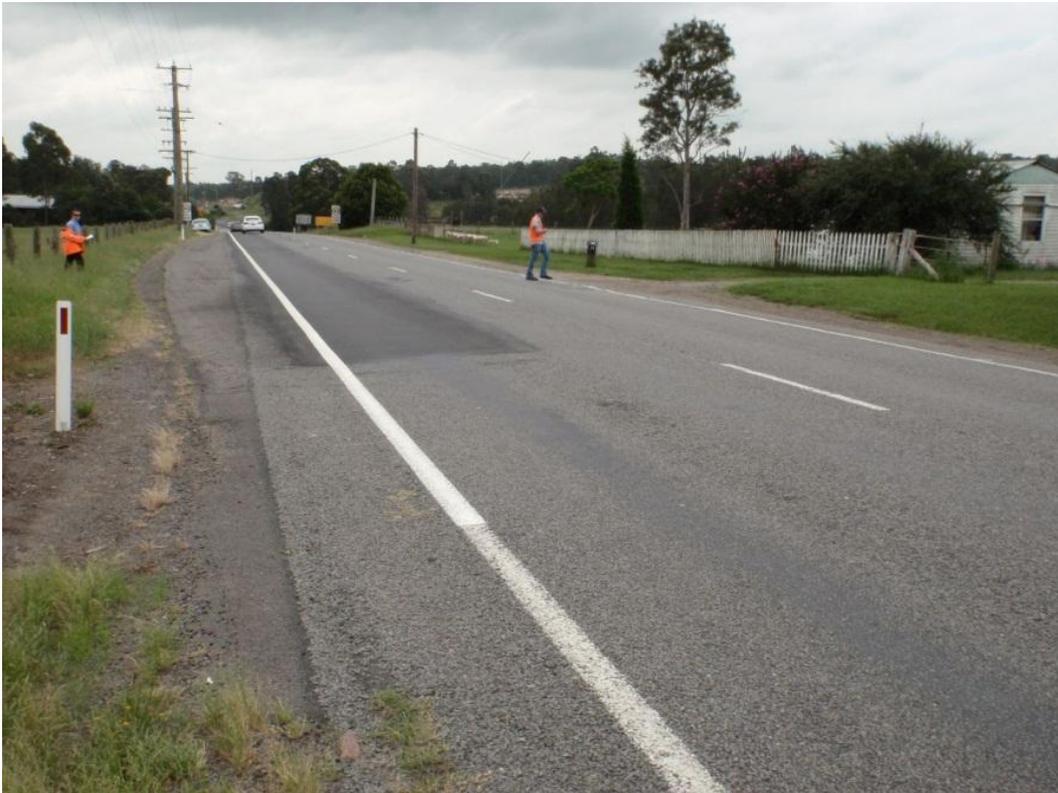
Photo 27 Right Turn Shoulder Widening Doesn't Cover the First Driveway

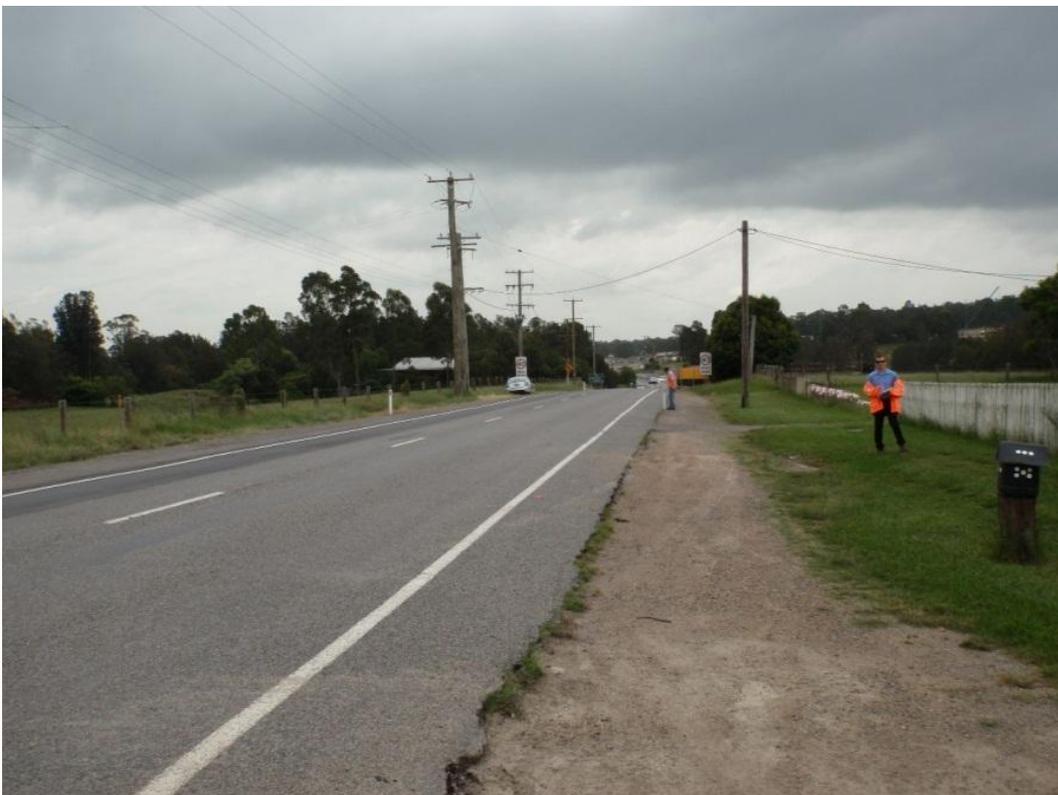
- ▶ Some minor erosion has occurred at the edge of the southbound sealed pavement – Refer Appendix A, Photo 28;
- ▶ There is a large unsealed shoulder for the left turns into the properties, with wheel tracks suggesting that they are used regularly – Refer Appendix A, Photo 28; and
- ▶ A power pole is located approximately 3.5 meters from the edge of the travel lane, at the end of the widened shoulder taper. This is within the designated clear zone for the road environment and poses as a hazard to errant vehicles – Refer Appendix A, Photo 29.

Photo 28 Unsealed Left Turn Shoudler

- ▶ Extend the northbound shoulder widening to the south of property No. 1530 so that it will allow the safe overtaking of a vehicle propped to turn right into the property. Consider the relocation of the power pole adjacent to the widening; and
- ▶ Provide sealed shoulder widening for the left turns into the driveways.

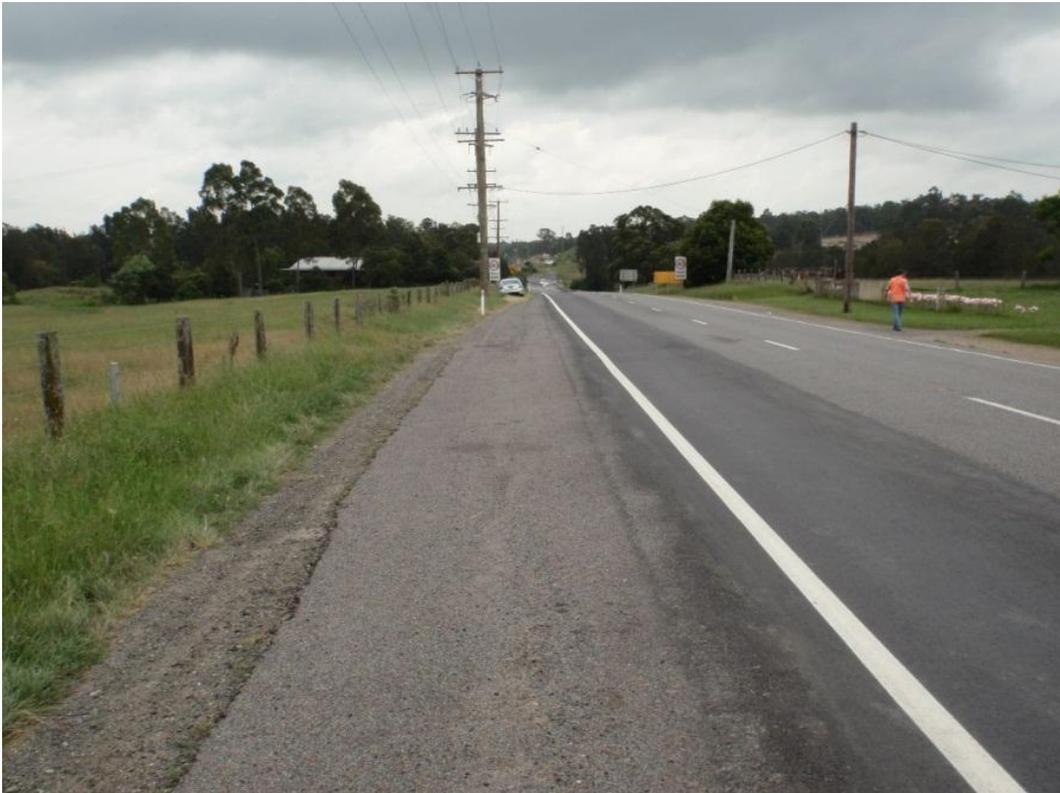
Photo 29 Pole in the Northbound Clear Zone
