Appendix K Cultural Heritage Archival Recordings

7.5 Sample Set of Photographic Prints

8. B99 BUILDING

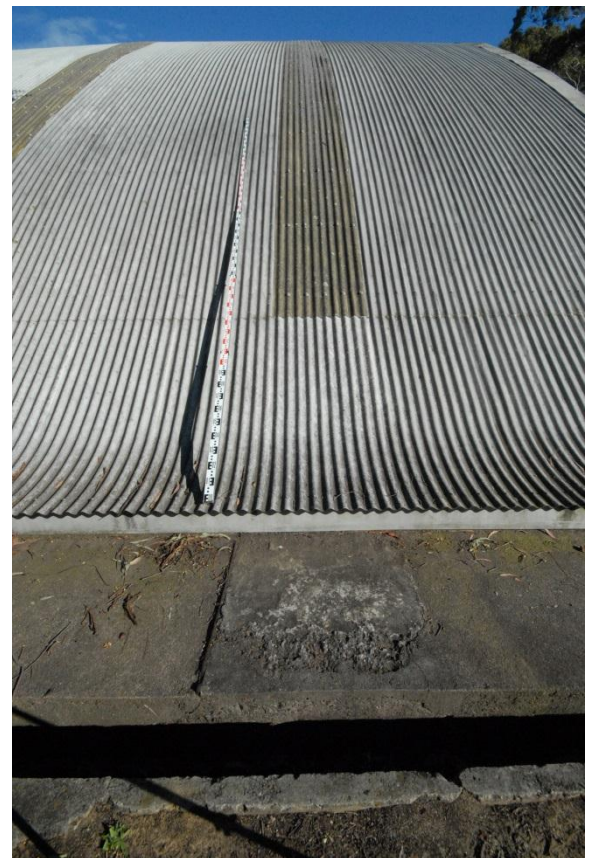
Figure 7.18 Looking S across northern side of building, along a truss alignment, showing edge drain and original concrete footing for truss, refer figure 7.19 for detail of this footing (image no. CUST 0019)

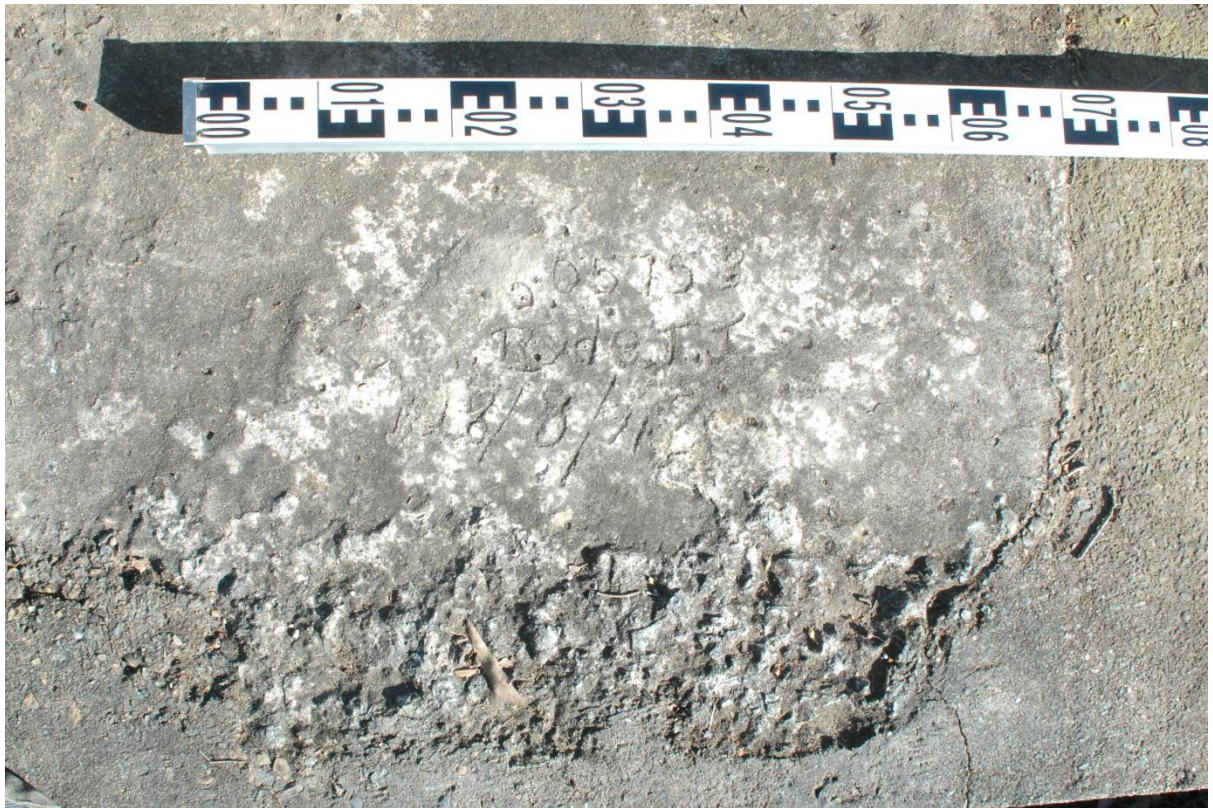
Figure 7.19 Exterior section of an original truss concrete footing, with a by-hand inscription (it is unclear if the inscription is contemporaneous with the footing construction, or has been applied subsequently), (image no. CUST 0020)

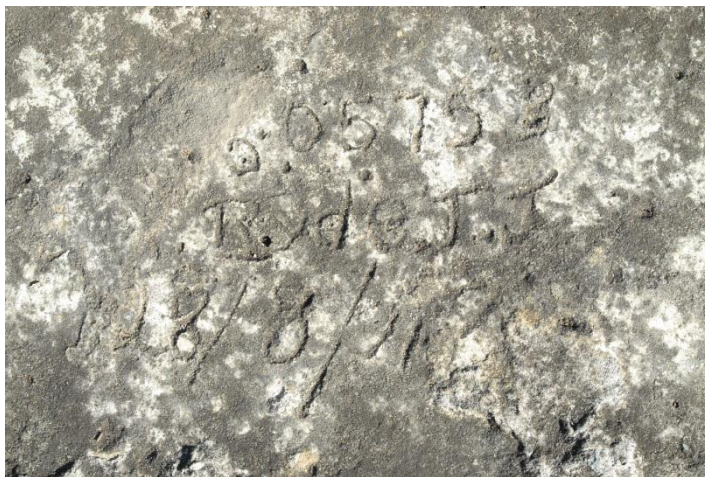
Figure 7.20 Photo detail of inscription (left), and interpretation (right) (image no. CUST 0023)

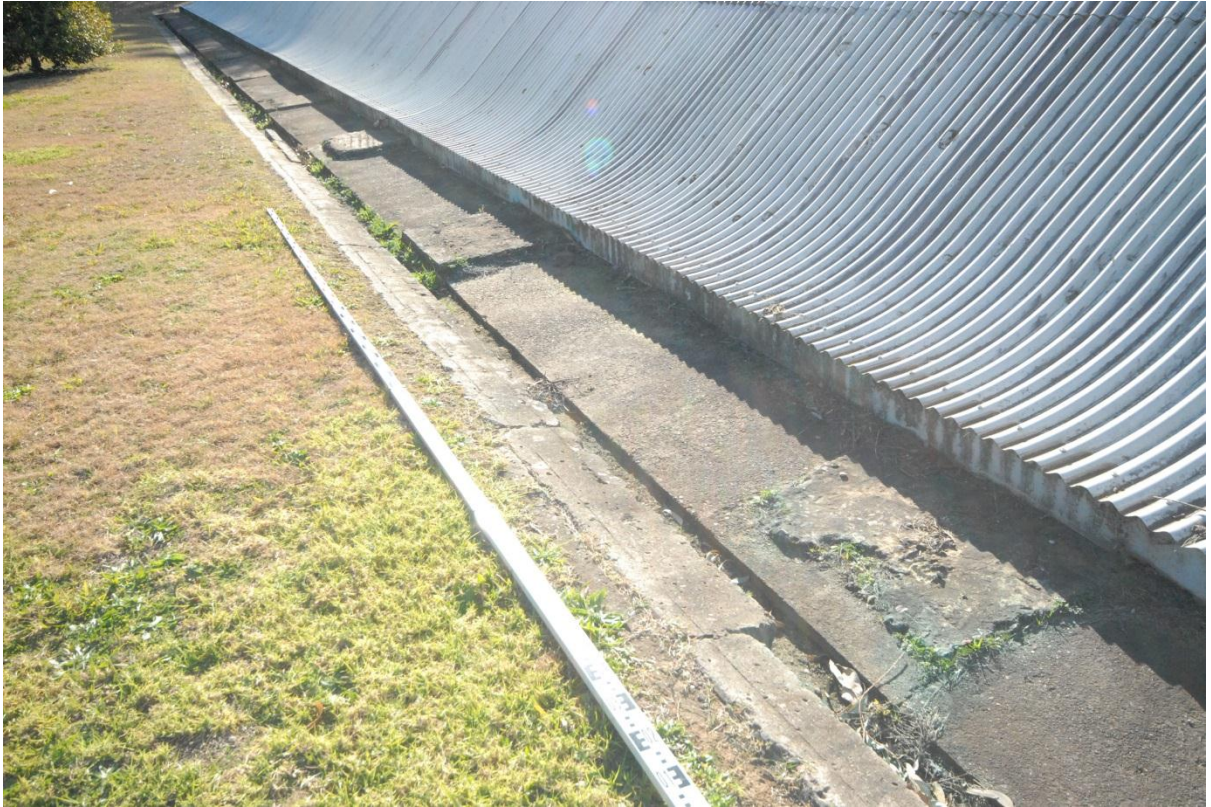
Figure 7.27 Looking NW across the southern drain and building edge, showing top of original truss concrete footings surrounded by a later slab, (image no. CUST 0041)

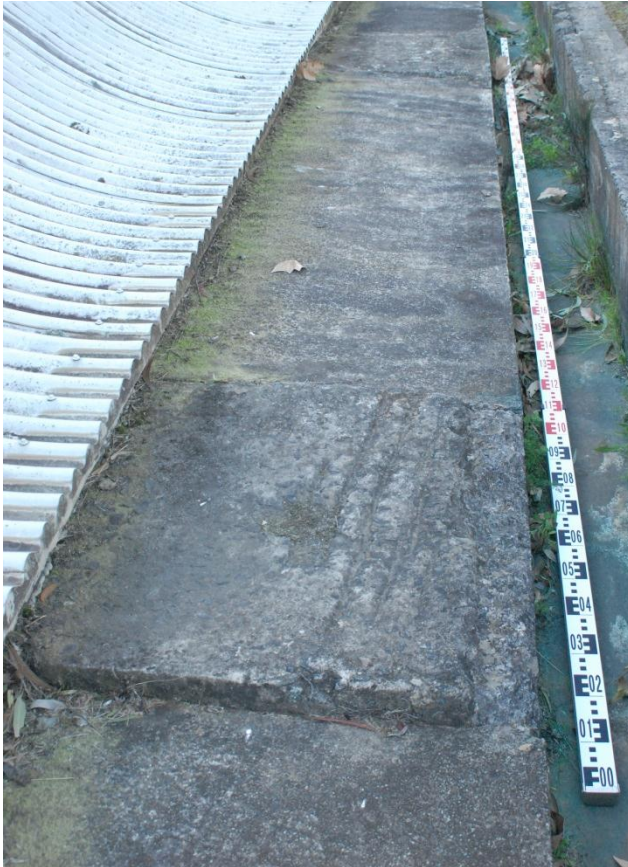
Figure 7.29 Looking ESE midway along Southern side of building, showing raised edge of original truss concrete footing, (image no. CUST 0066)

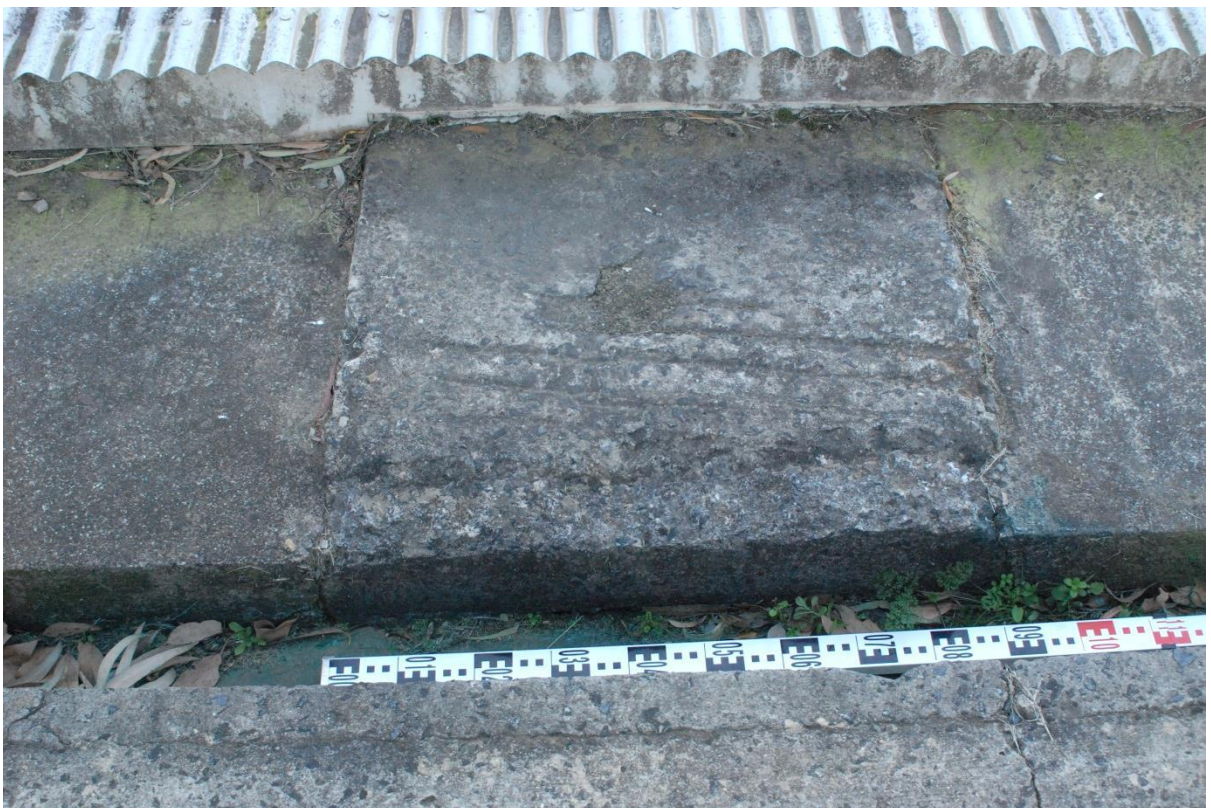
Figure 7.30 Detail of concrete footing showing abutting remnant block forming part of the drain wall, (image no. CUST 0067)

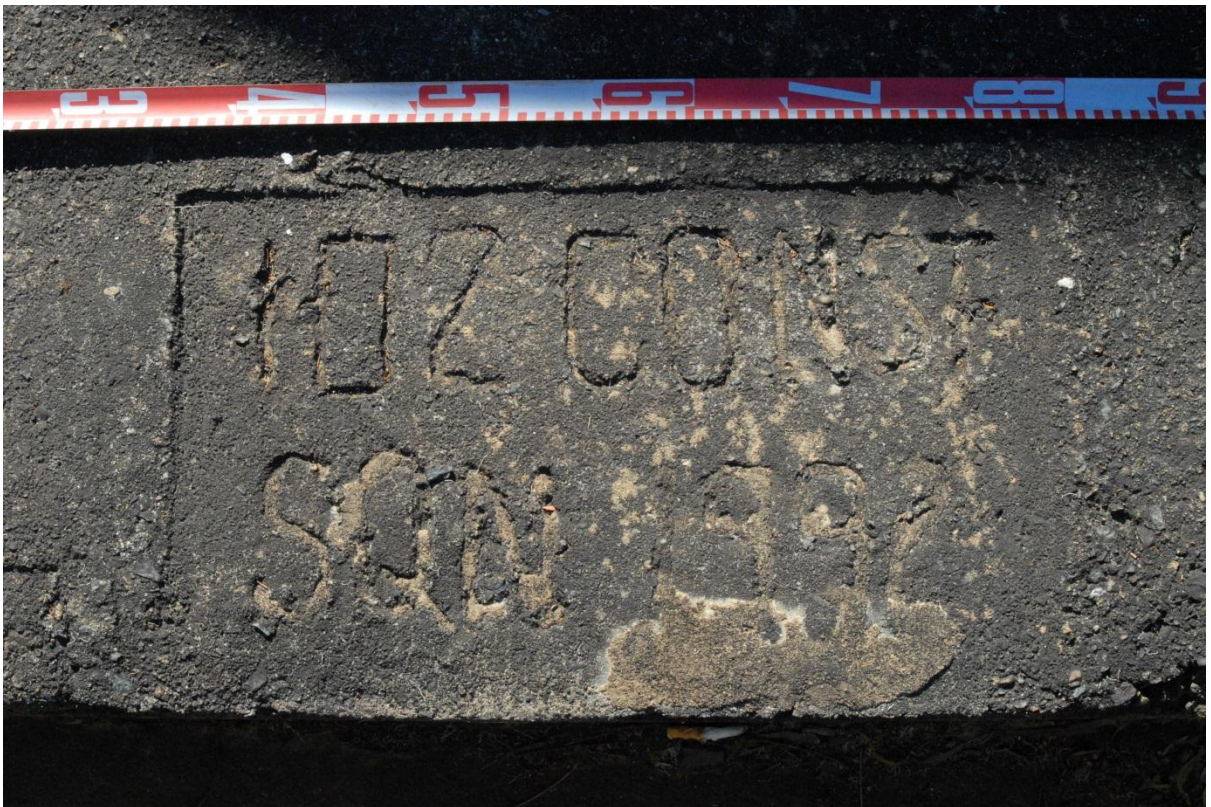
Figure 7.32 Inscription near SW corner of building, located on concrete infill between the original truss footings. The inscription is contemporaneous with the infill installation. Interpretation at right. (image no. CUST 0194)

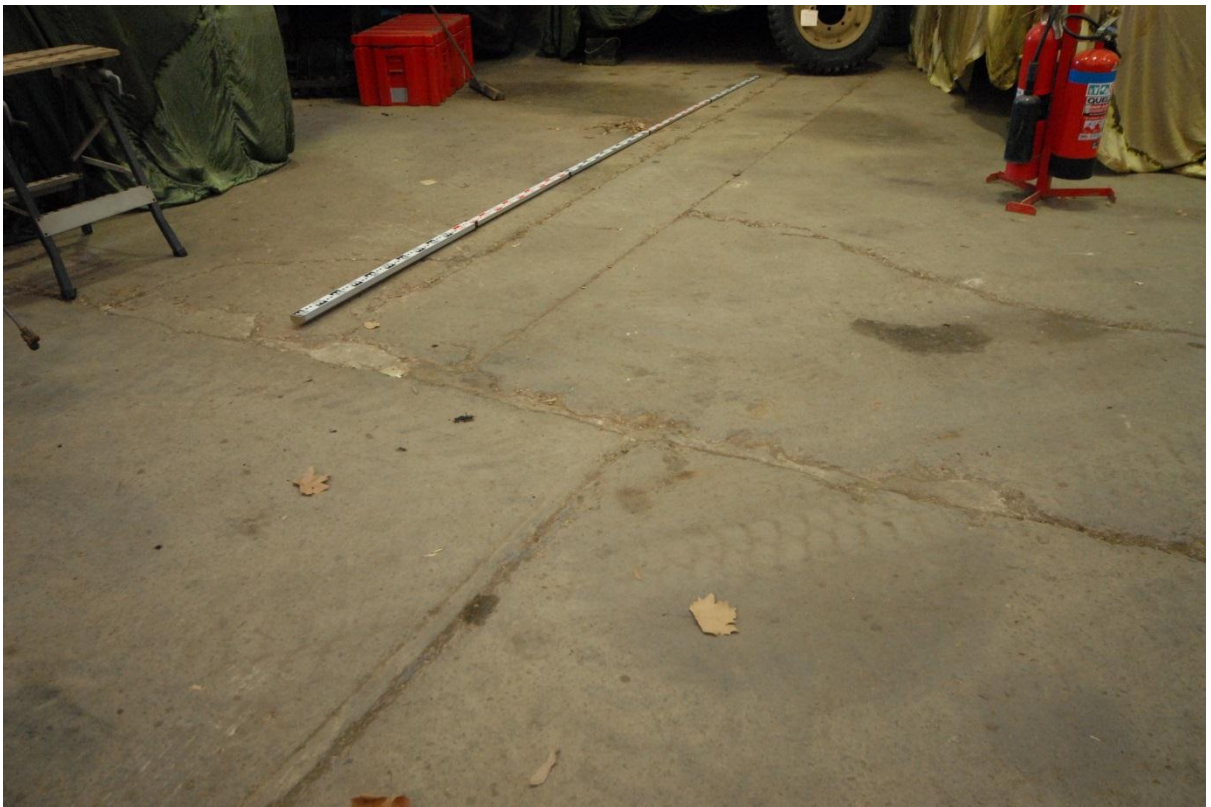
Figure 7.38 Detail of concrete floor showing central axis slabs (foreground) abutting apparently thinner (and later?) side slabs, Note also infilled trench (parallel to scale) which suggests a former internal wall present at the time of the side slab installation, looking SE. (image no. CUST 0121)

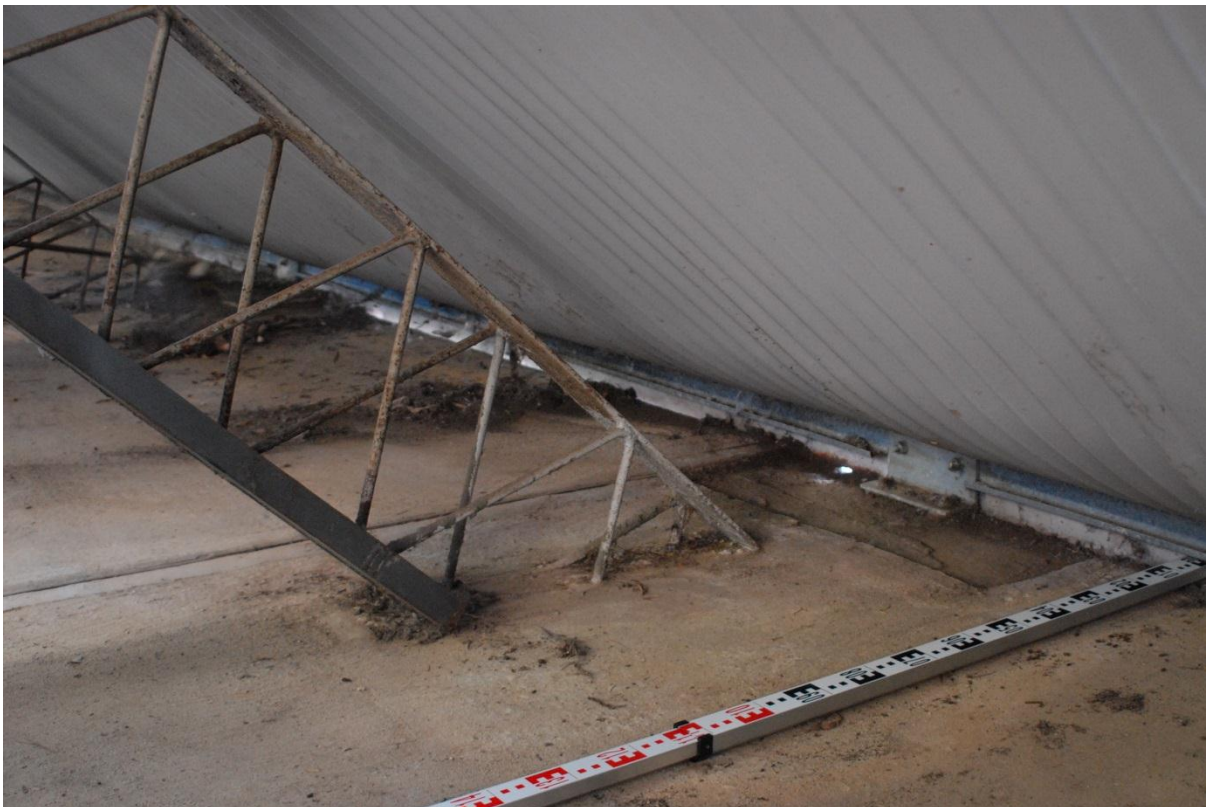
Figure 7.46 The junction of a truss with the concrete floor. The top of the original footing can be seen to the right of the truss. The truss is probably bolted to an angled face on the footing. Looking SE (image no. CUST 0180)

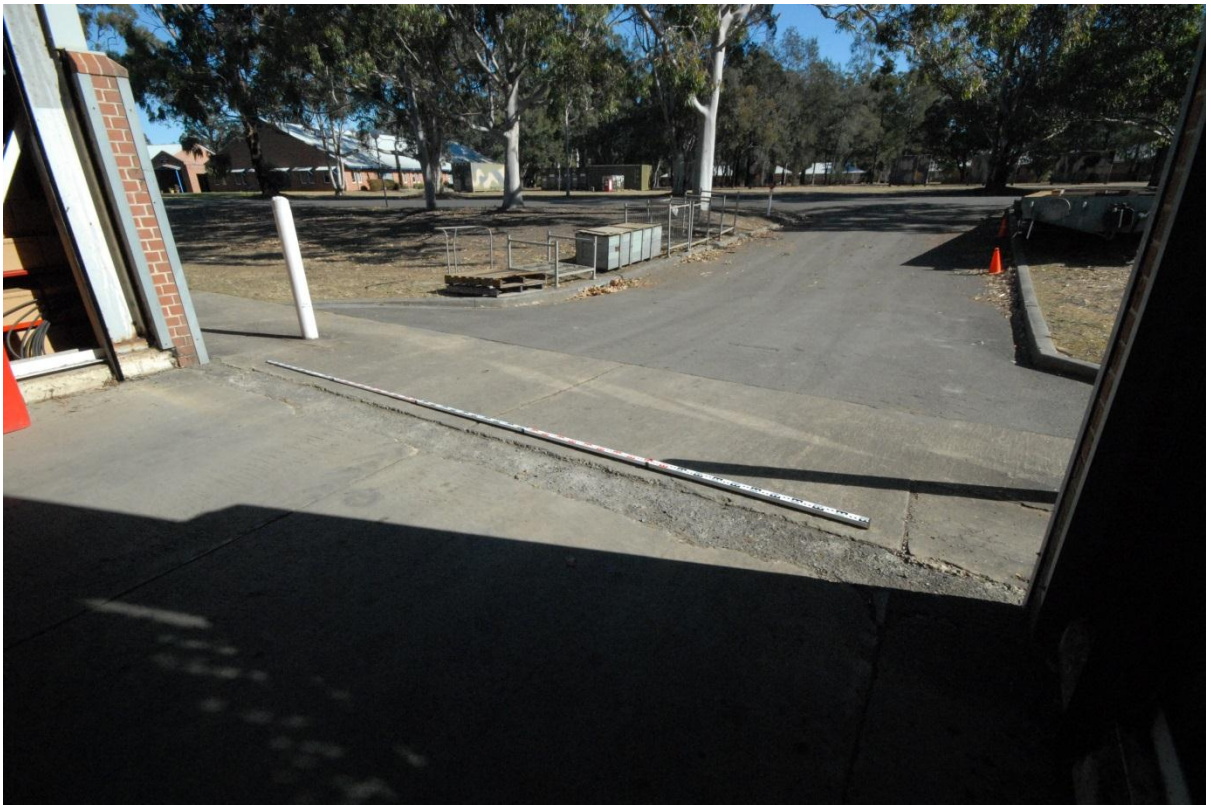
Figure 7.52 View of western roller door entrance, showing (now infilled) cut trench across original central access concrete floor, looking SW, (image no. CUST 0184)

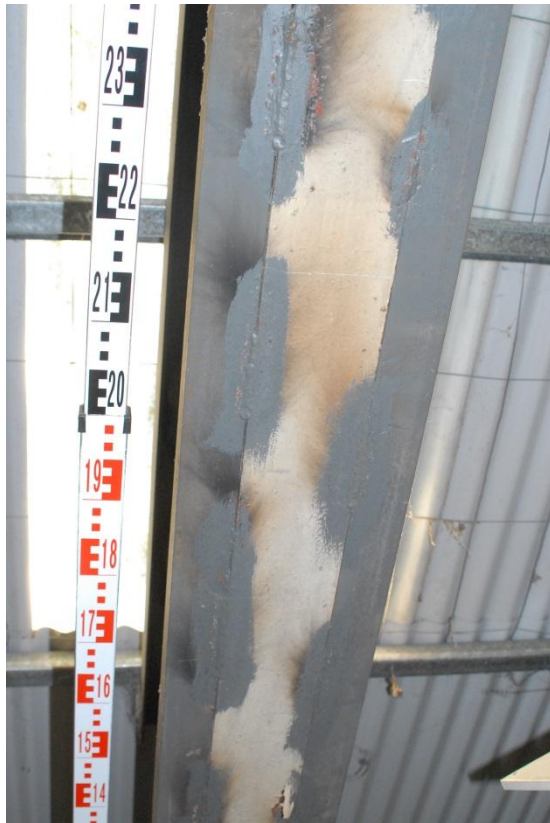
Figure 7.53 Detail of lower section of truss, showing recent reinforcing of edges with the welded attachment of 'L' profile steel, (image no. CUST 0170)

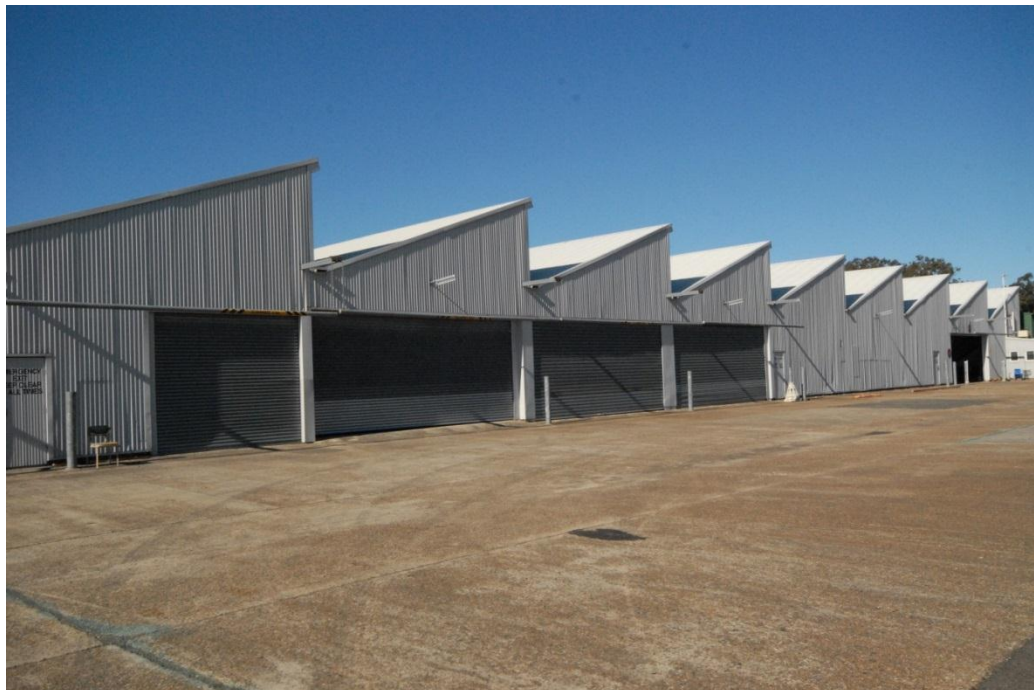
Figure 8.5 Contemporary photo taken from a position close to the 1944 photo, to provide an equivalent comparative view (and avoid modern obstacles). Note the loss of some door apertures and the replacement of sliding with roller doors. Also note the replacement of flat iron with corrugated cladding, and the addition of exterior side lighting (image no. B99 0315).

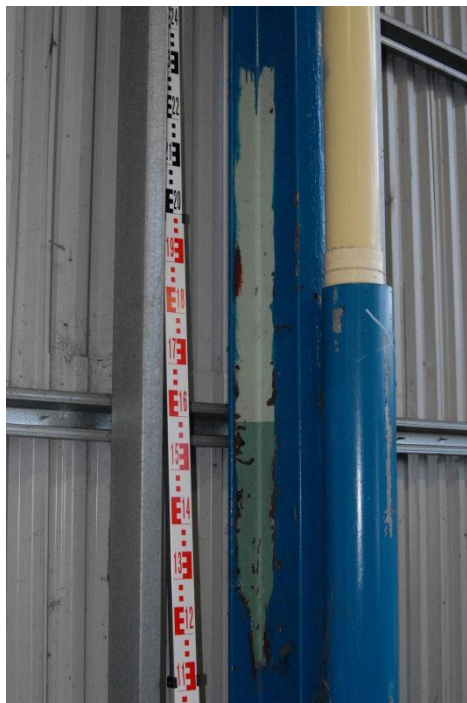
Figure 8.9 Contemporary photo showing remnant of colour scheme preserved on an original wall frame column, which appears to be the same as that shown in the above 1944 photo (image no. B99 0204)

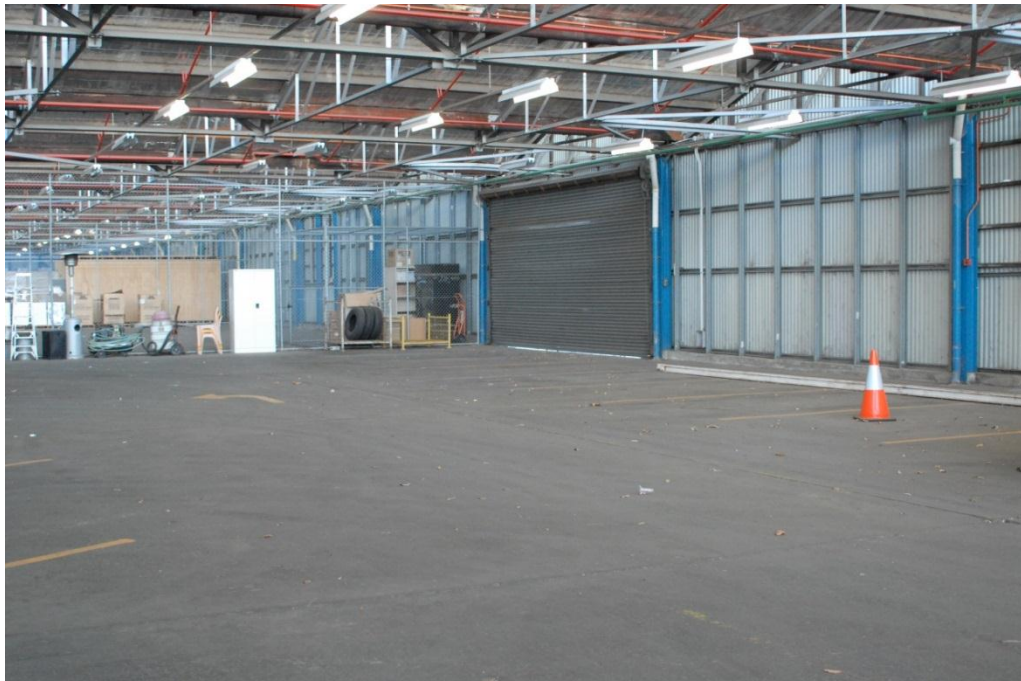
Figure 8.11 Contemporary photo replicating the view and angle of the 1944 photo above. Note the removal of former door apertures with the insertion of modern wall framing (image no. B99 0314)
