# Appendix K Cultural Heritage Archival Recordings

## 9.5 Sample Set of Photographic Prints

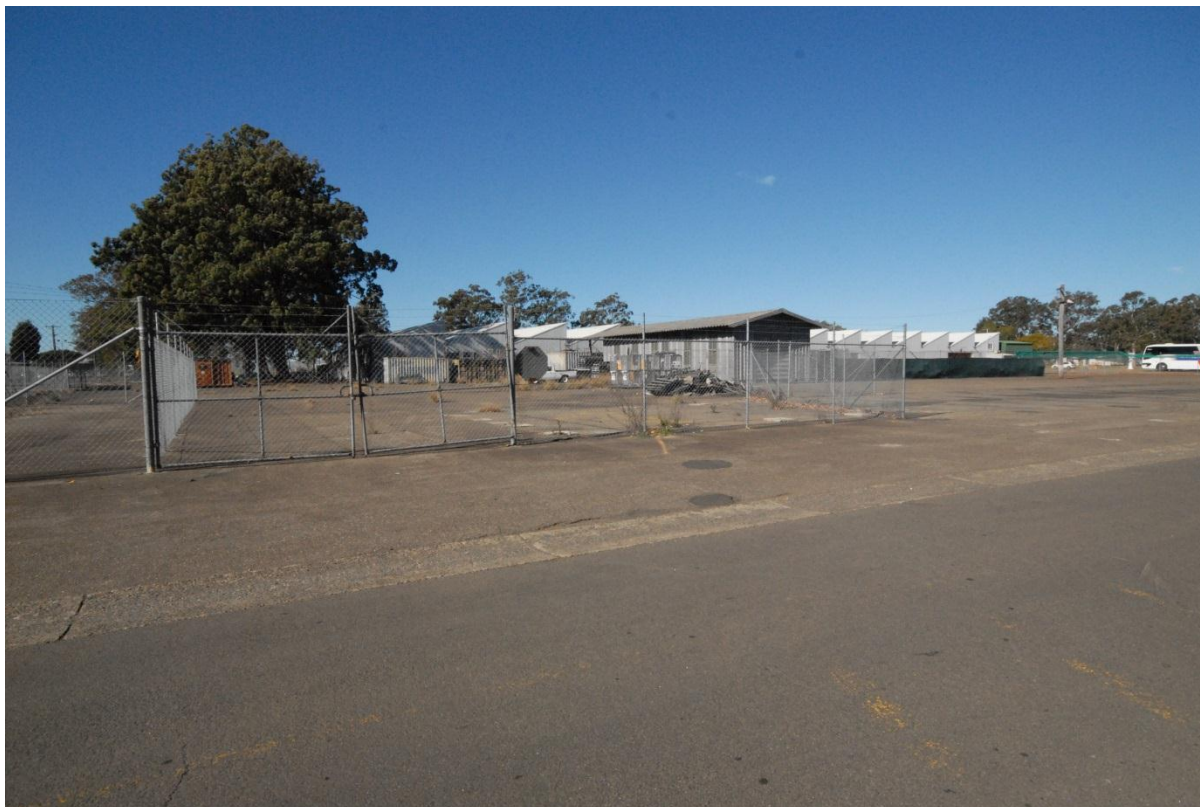
**Figure 8.22 Distant view of W face of B99 building (partly obscured), looking E, (image no. B99 0324)**

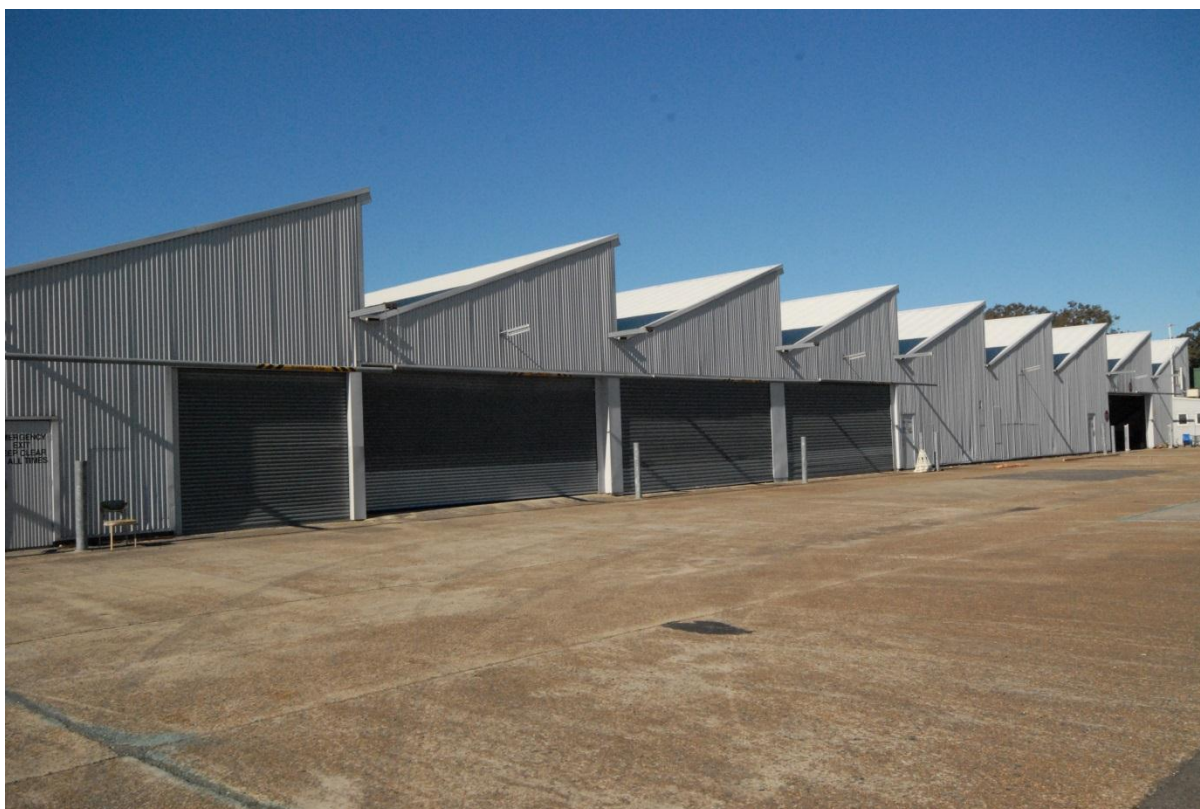
**Figure 8.23 View of multiple roller door mid-way along W face of B99 building, (image no. B99 0315)**

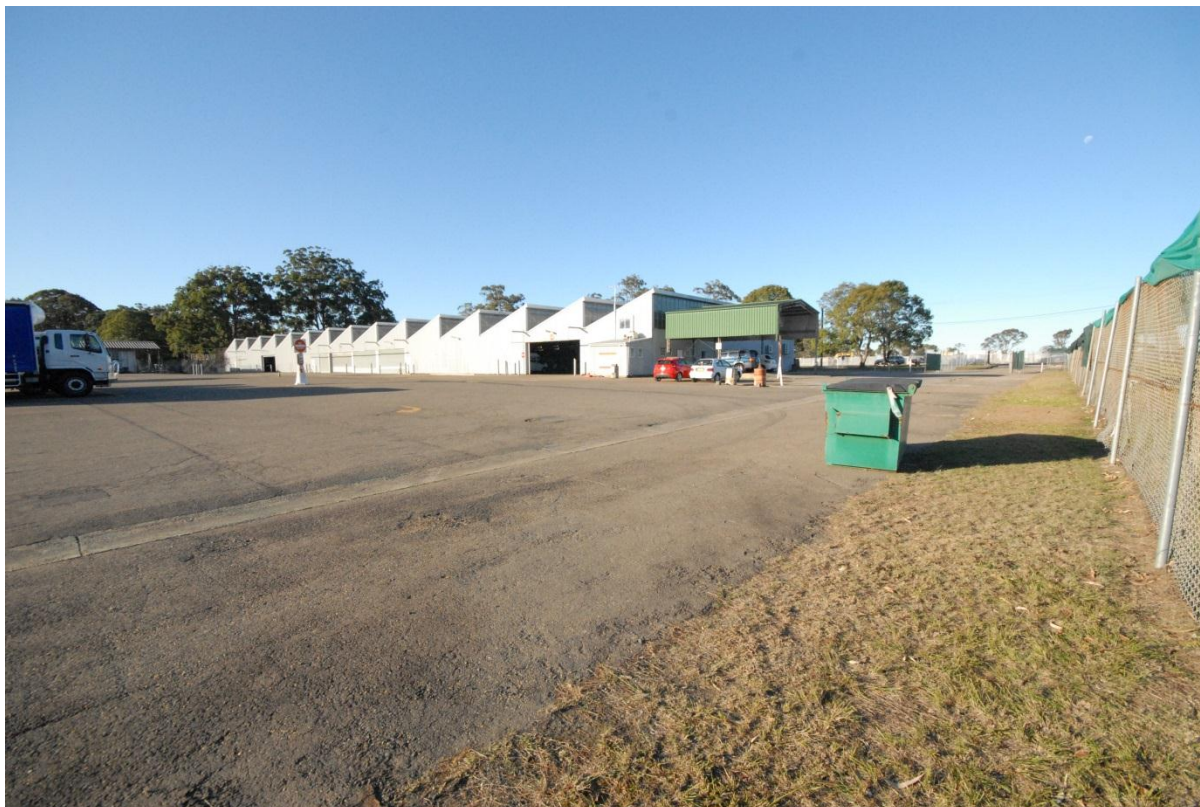
**Figure 8.24 View of whole B99 building looking NE, (image no. B99 0224)**

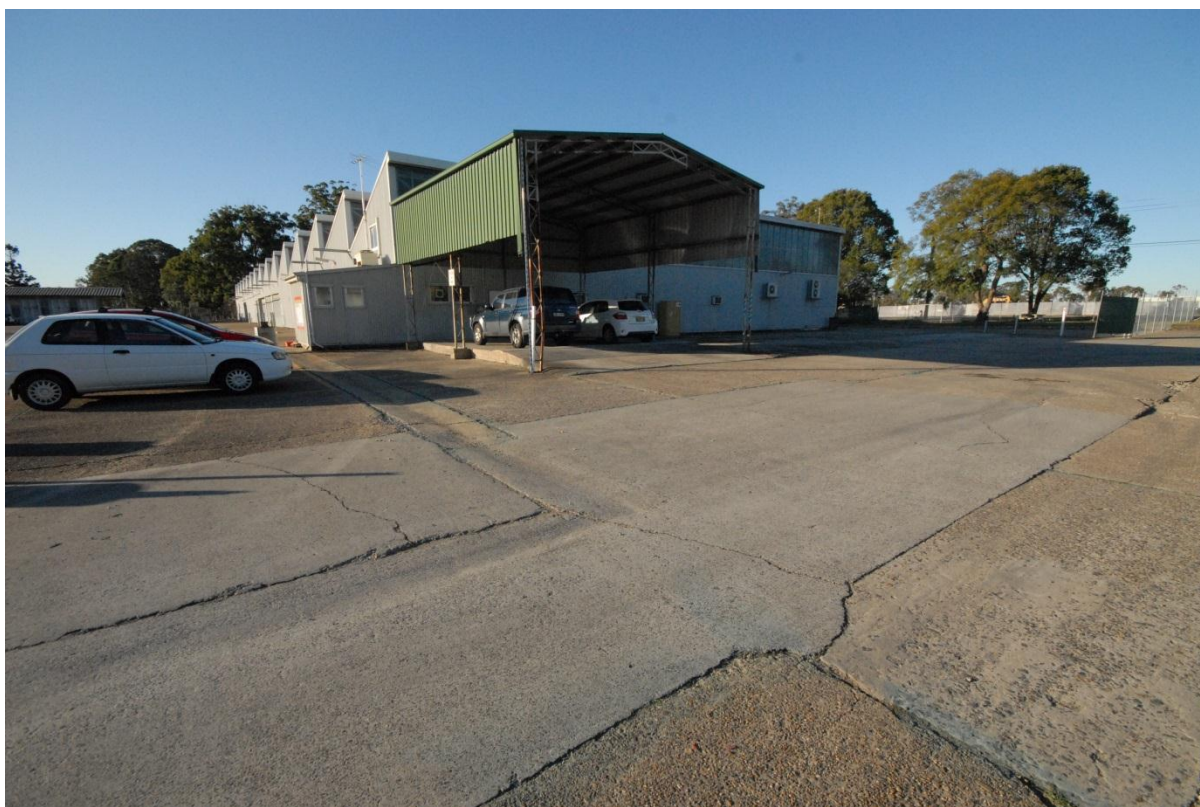
**Figure 8.25 The southern face of B99 building, looking NE, (image no. B99 0225)**

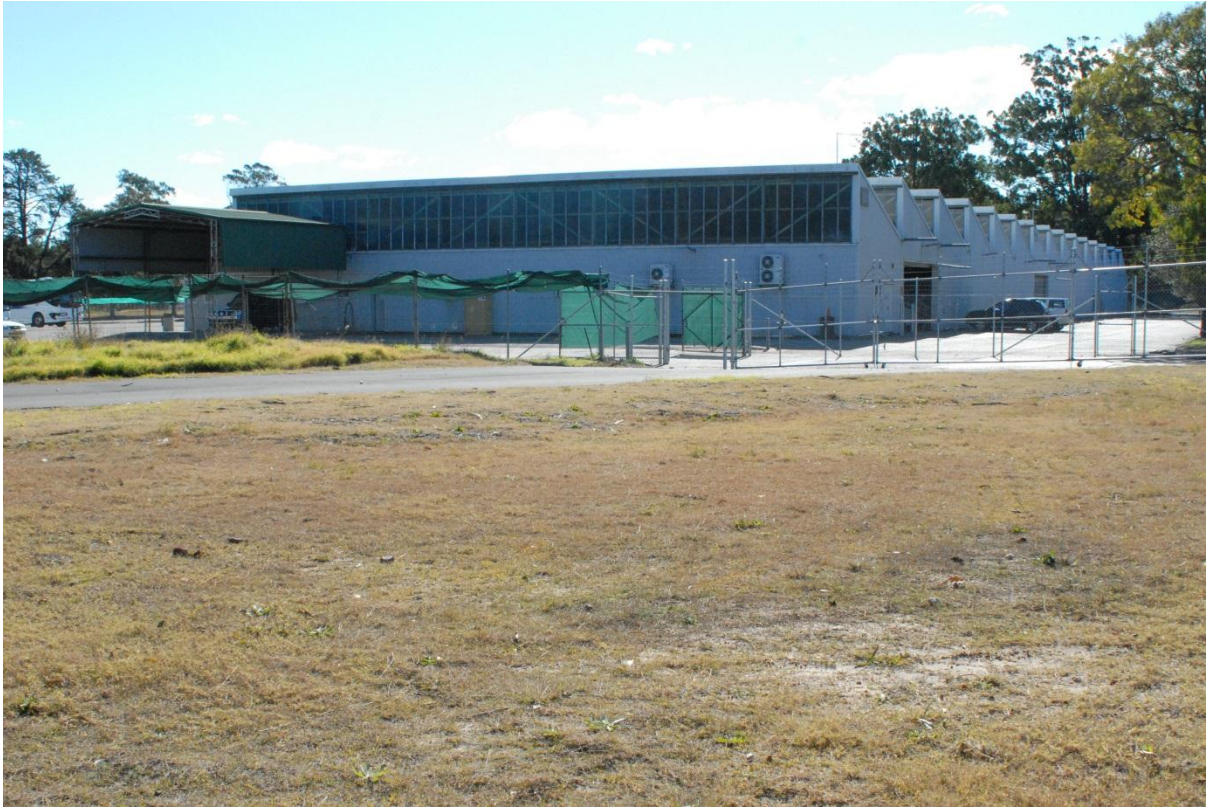
**Figure 8.26 The S face of B99 building, looking N, (image no. B99 0322)**

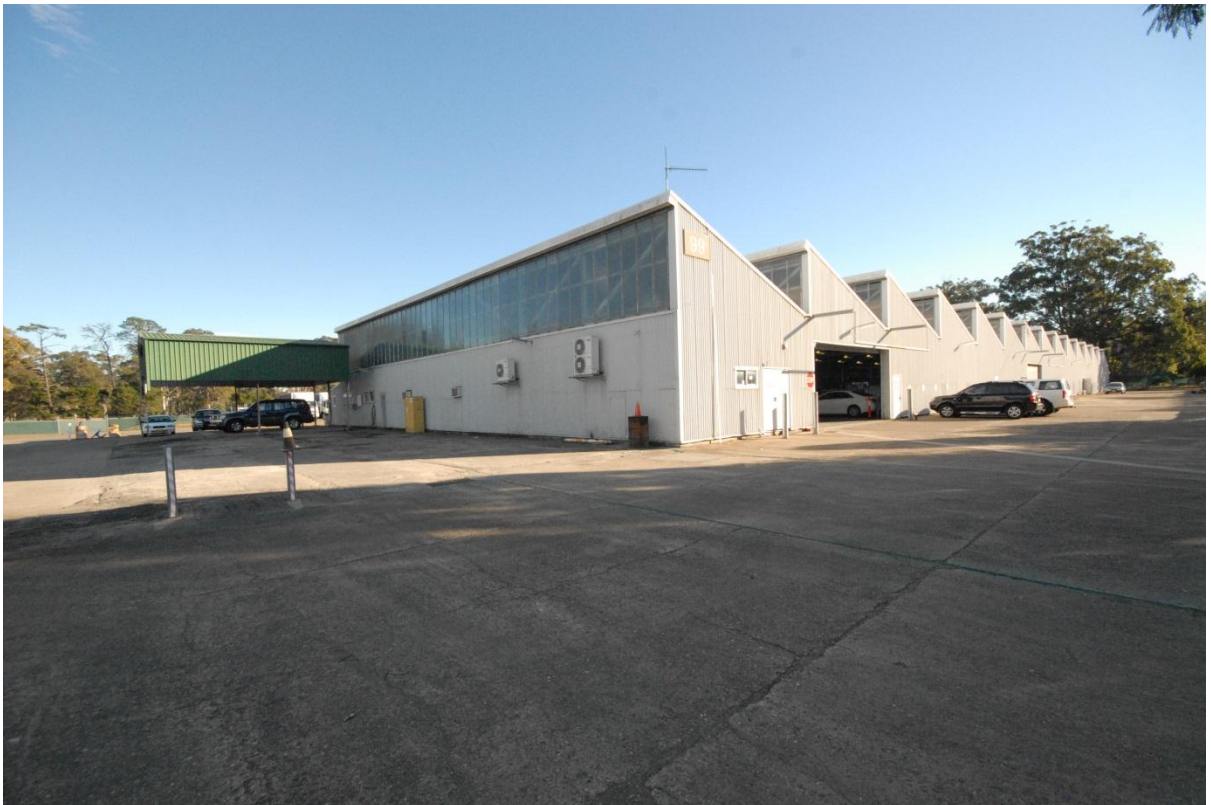
**Figure 8.27 The S and E faces of B99 building, looking NW, (image no. B99 0242)**

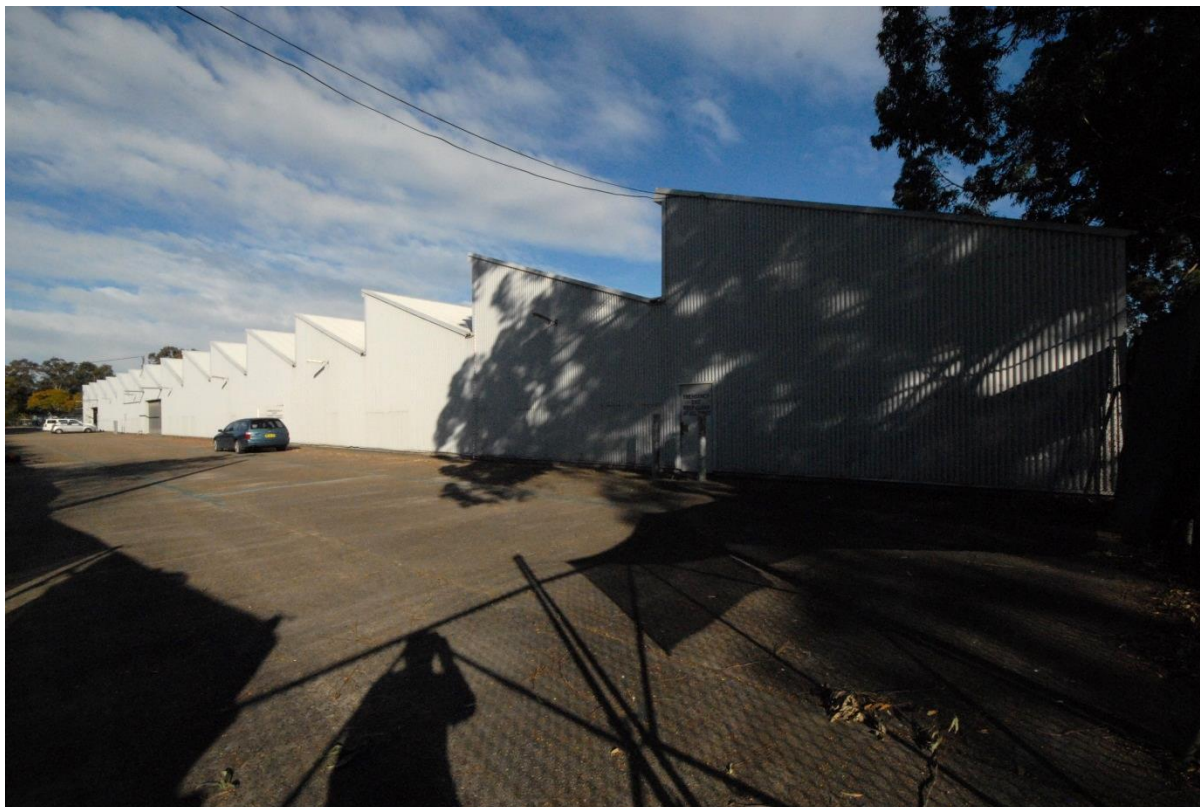
**Figure 8.28 The whole of the E face of B99 building, looking SW, (image no. B99 0255)**

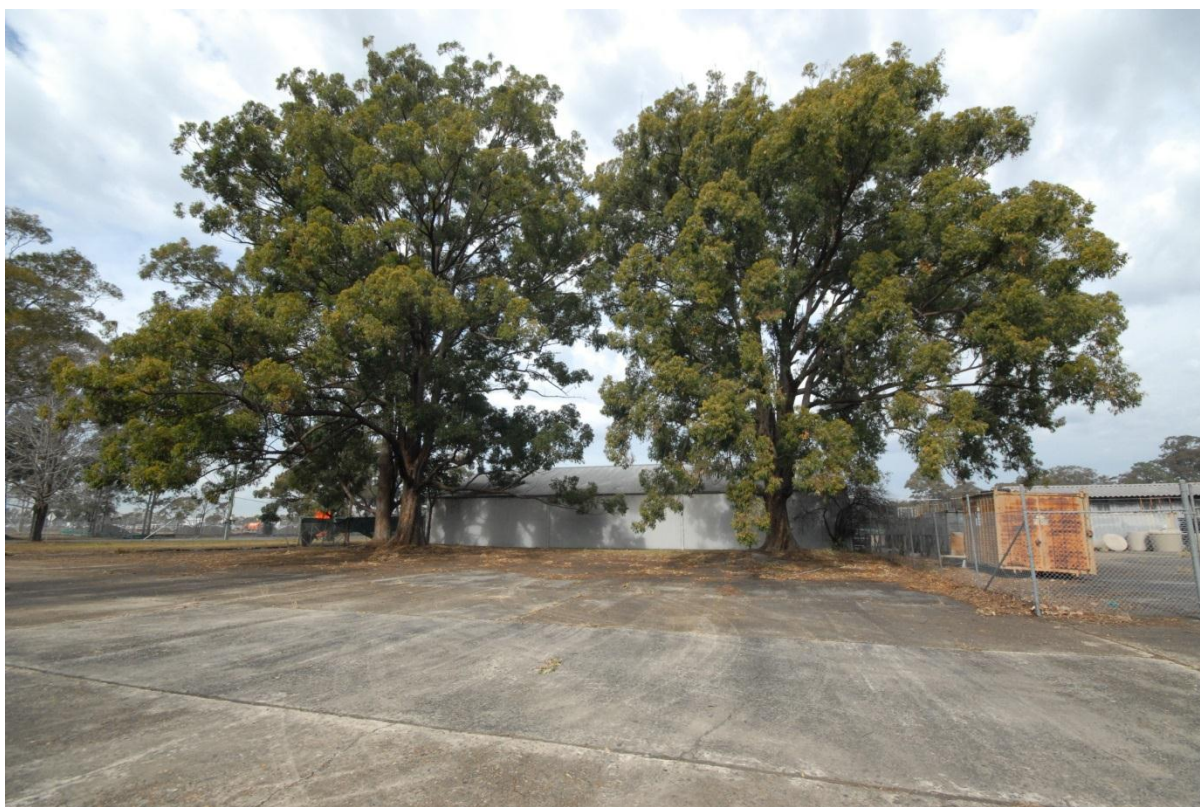
**Figure 8.29 The N face of building B99, looking S, the large Eucalypts are not evident in 1944 photography, (image no. 0337)**

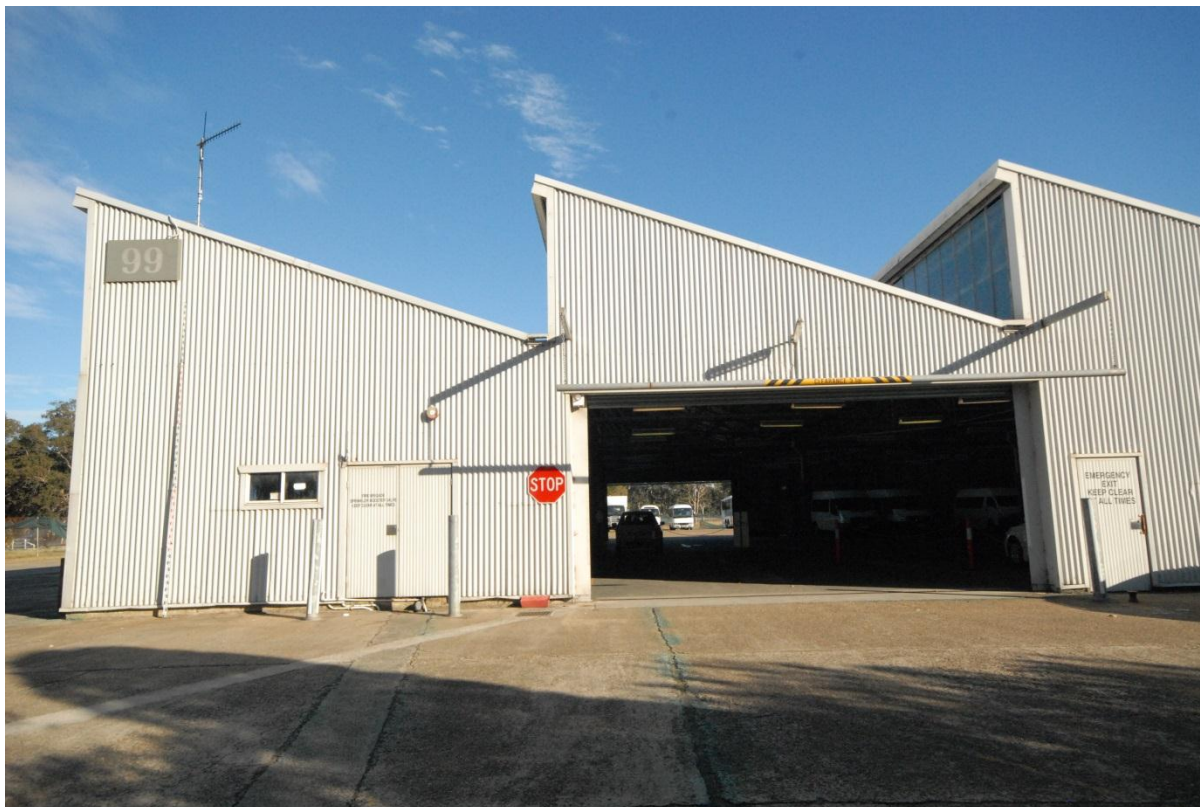
**Figure 8.30 The roller door entrance at the SE corner of the B99 building, looking W, (image no. B99 0245)**

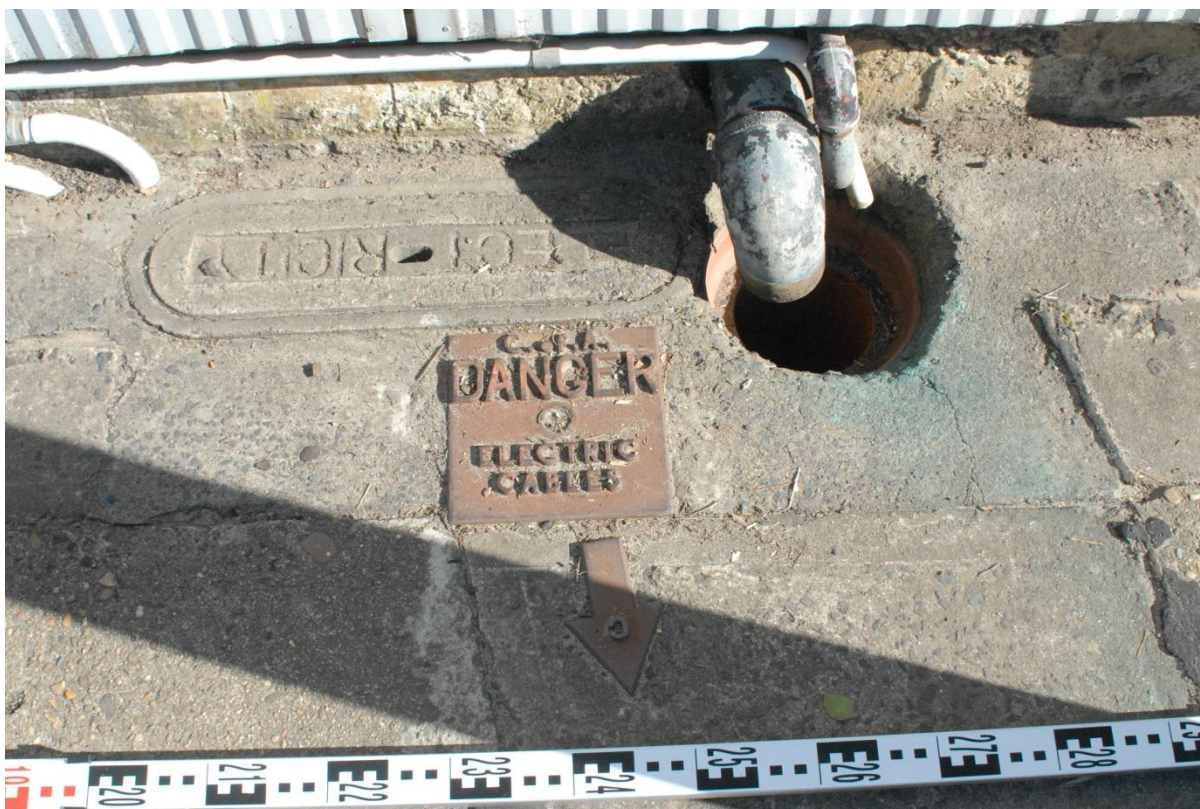
**Figure 8.31 Detail of service and trenches installed subsequent to original construction, SE corner of B99 building, looking W, (image no. B99 0284)**

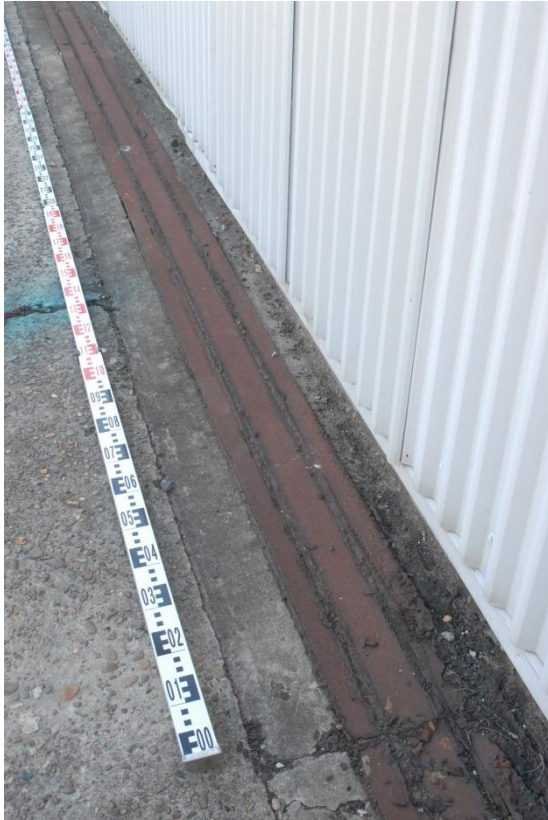
**Figure 8.32 Remnant section of sliding door track on W side of building, (image no. B99 0293)**

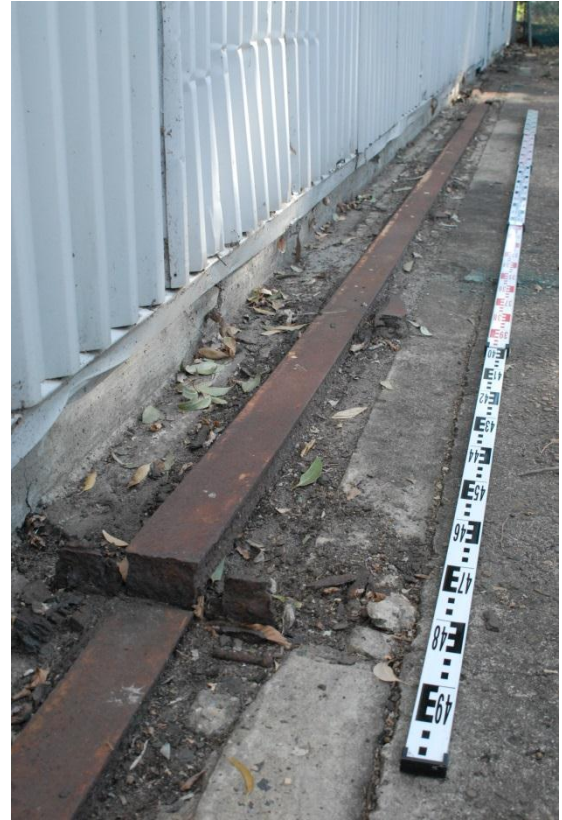
**Figure 8.33 Remnant section of sliding door track on E side of building, (image no. B99 0263)**

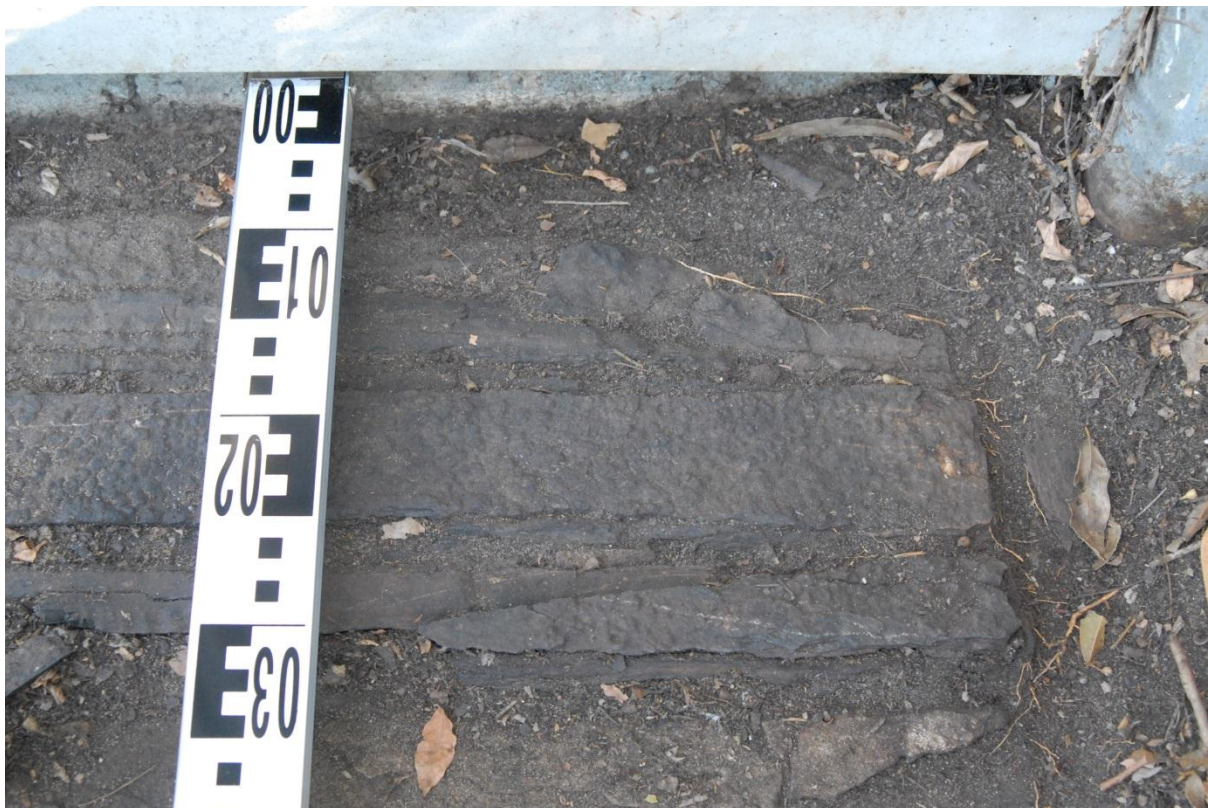
**Figure 8.34 End of remnant sliding door track at NE corner of building, (image no. B99 0266)**

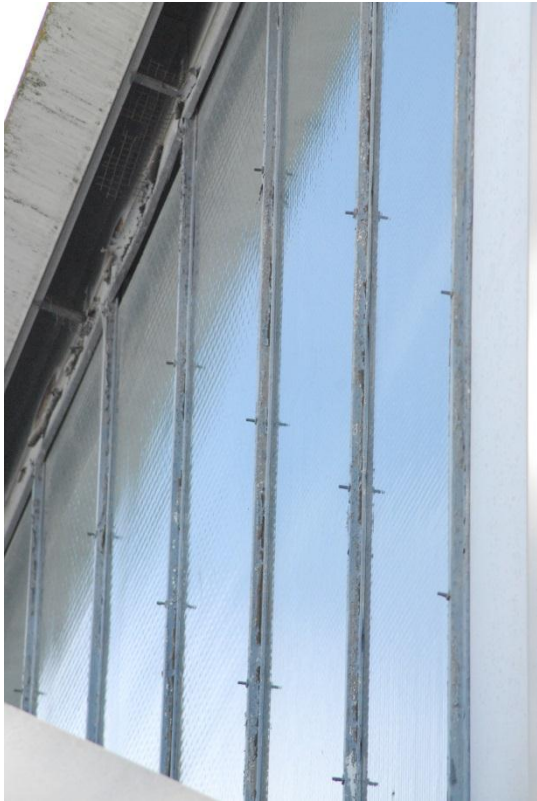
**Figure 8.35 Detail (oblique view) of exterior of clerestory windows, (image no. B99 0271)**

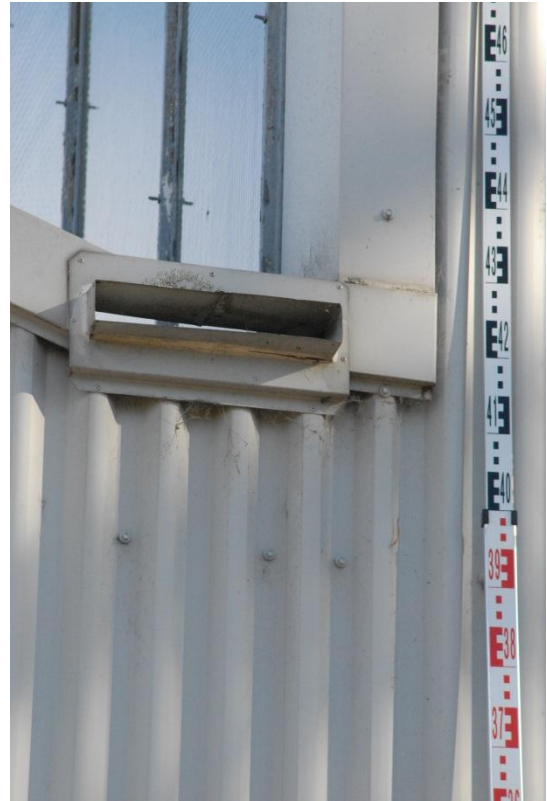
**Figure 8.36 Detail of spout end of box gutter, (image no. B99 0262)**

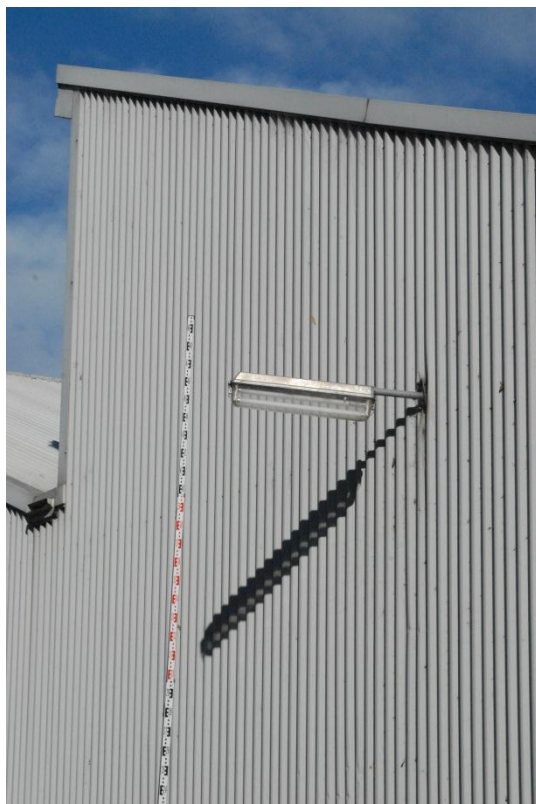
**Figure 8.37 Detail of exterior lighting, looking SW, (image no. B99 0273)**

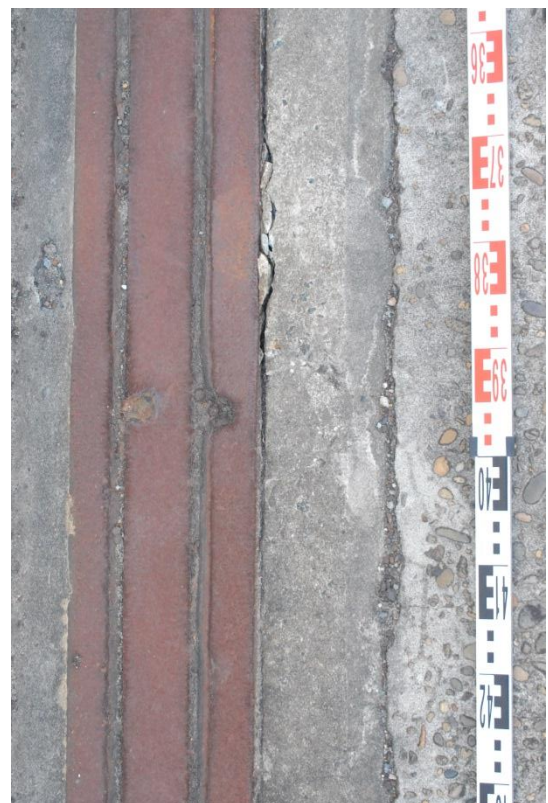
**Figure 8.38 Detail of possible 'stop' fitting on sliding door rail, (image no. B99 0296)**

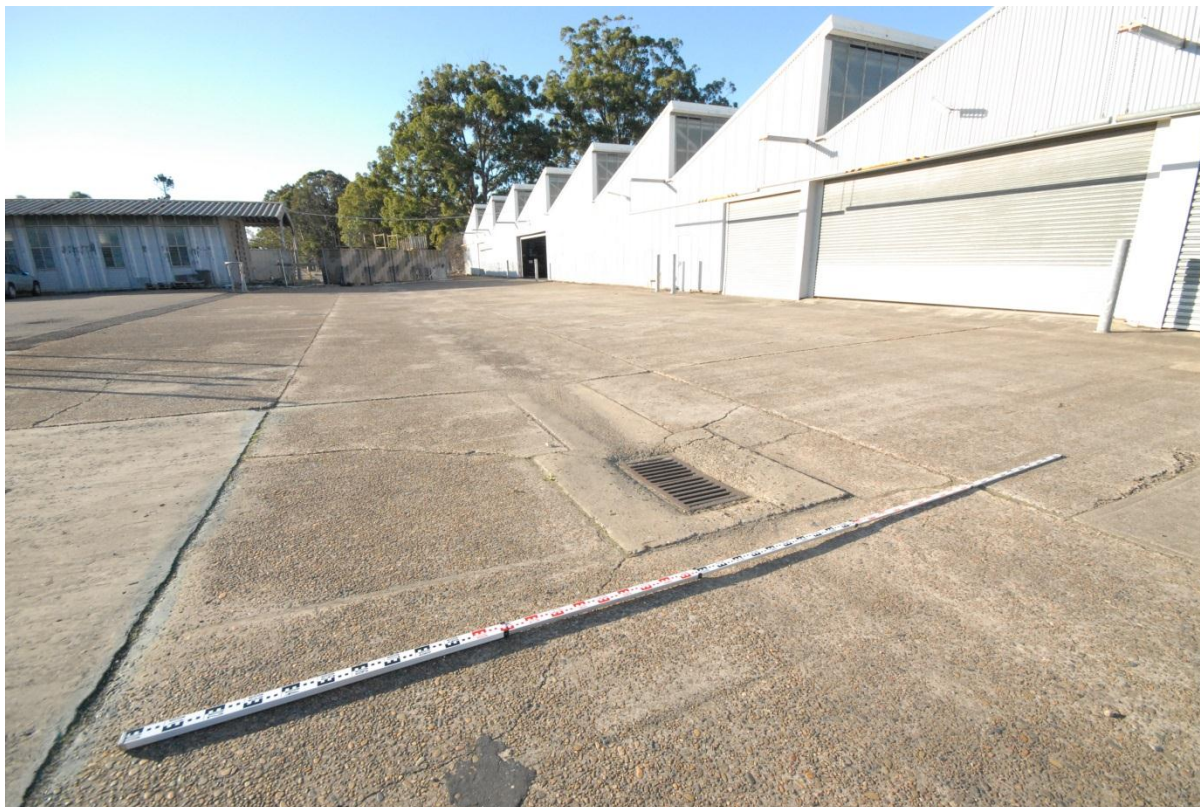
**Figure 8.39 General view of paving on W side of building, looking NNE, (image no. B99 0217)**

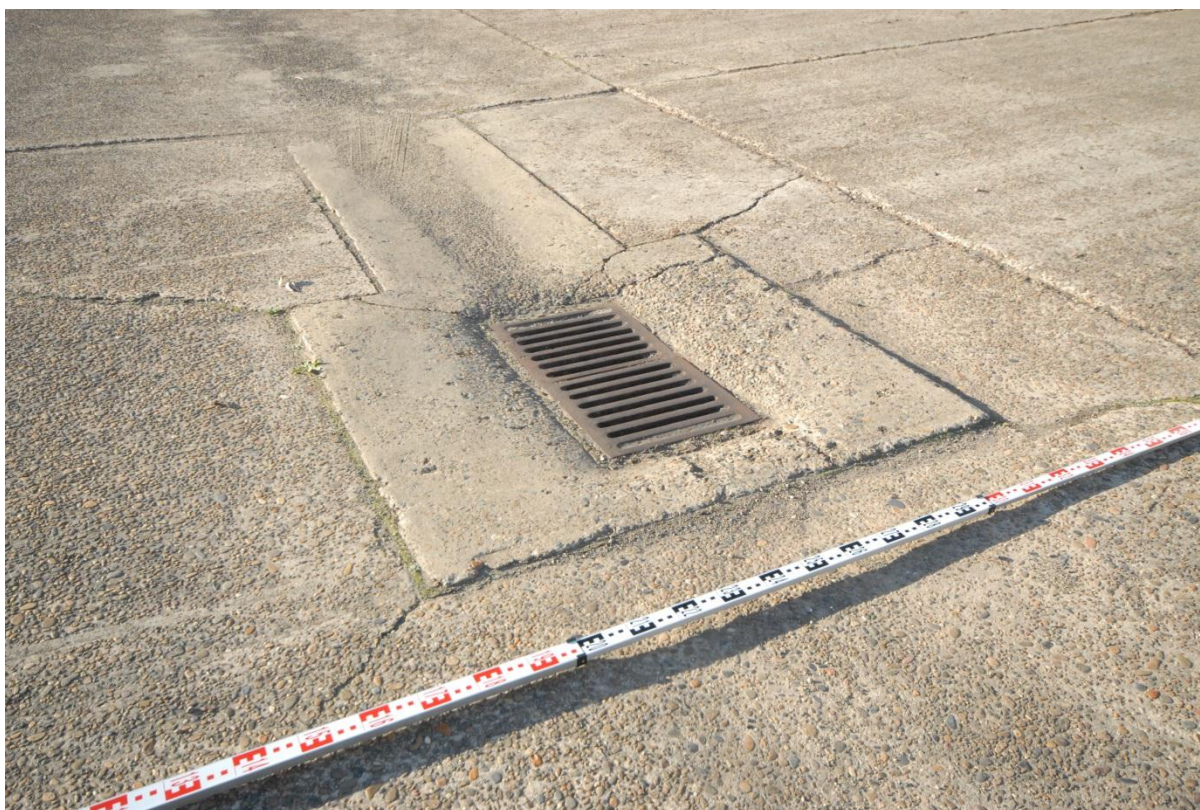
**Figure 8.40 Detail of original surface drainage grill, (image no. B99 0218)**

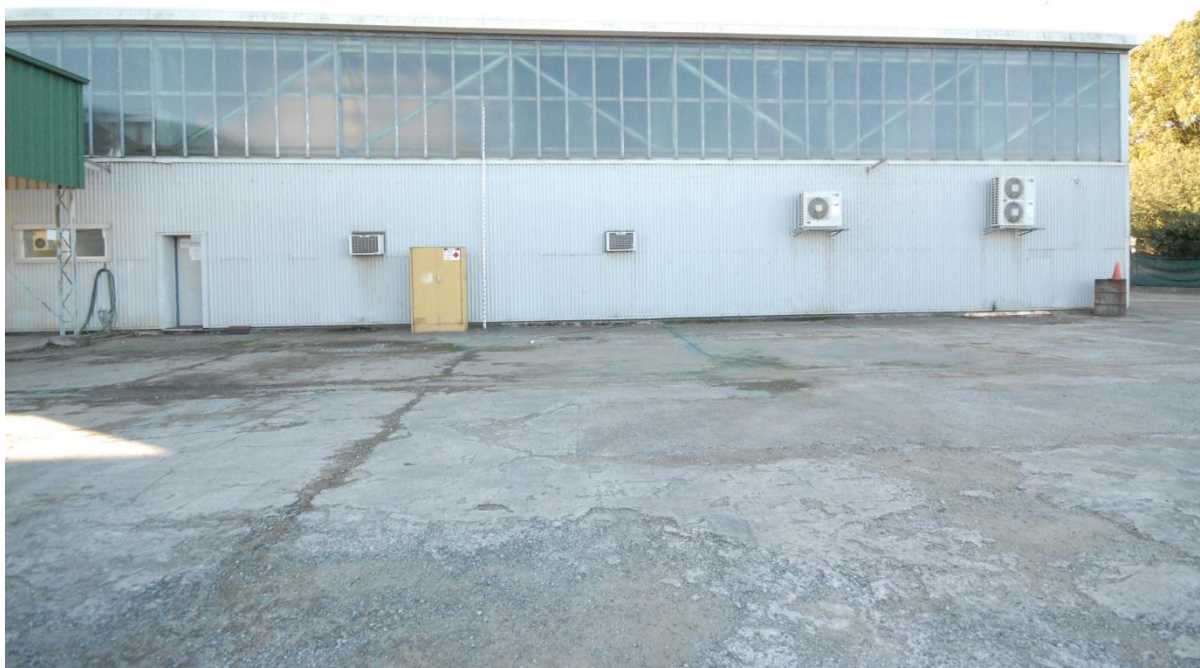
**Figure 8.41 Face-on detail of exterior clerestory window on S face of building, looking N, (image no. B99 0232)**

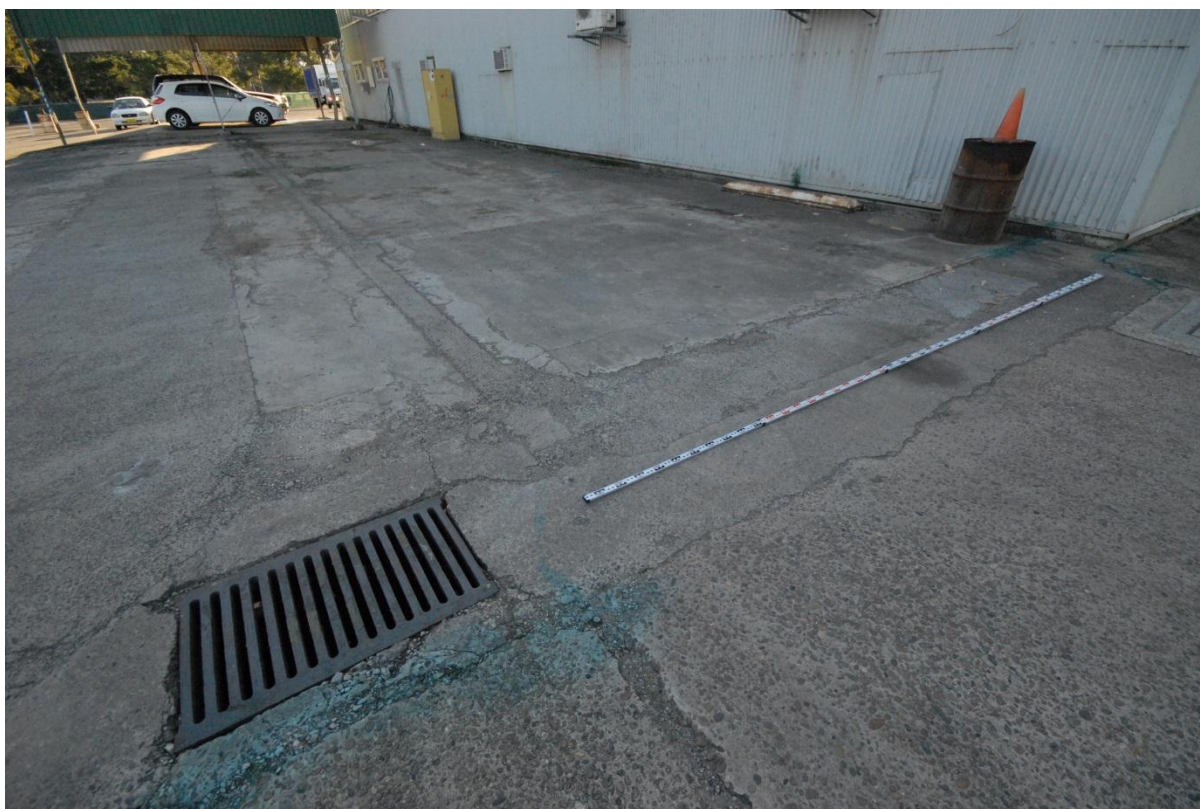
**Figure 8.42 Detail of infilled trenches in concrete paving on S side of building, indicating former walls of 'Paintshop', looking NW, (image no. B99 0239)**

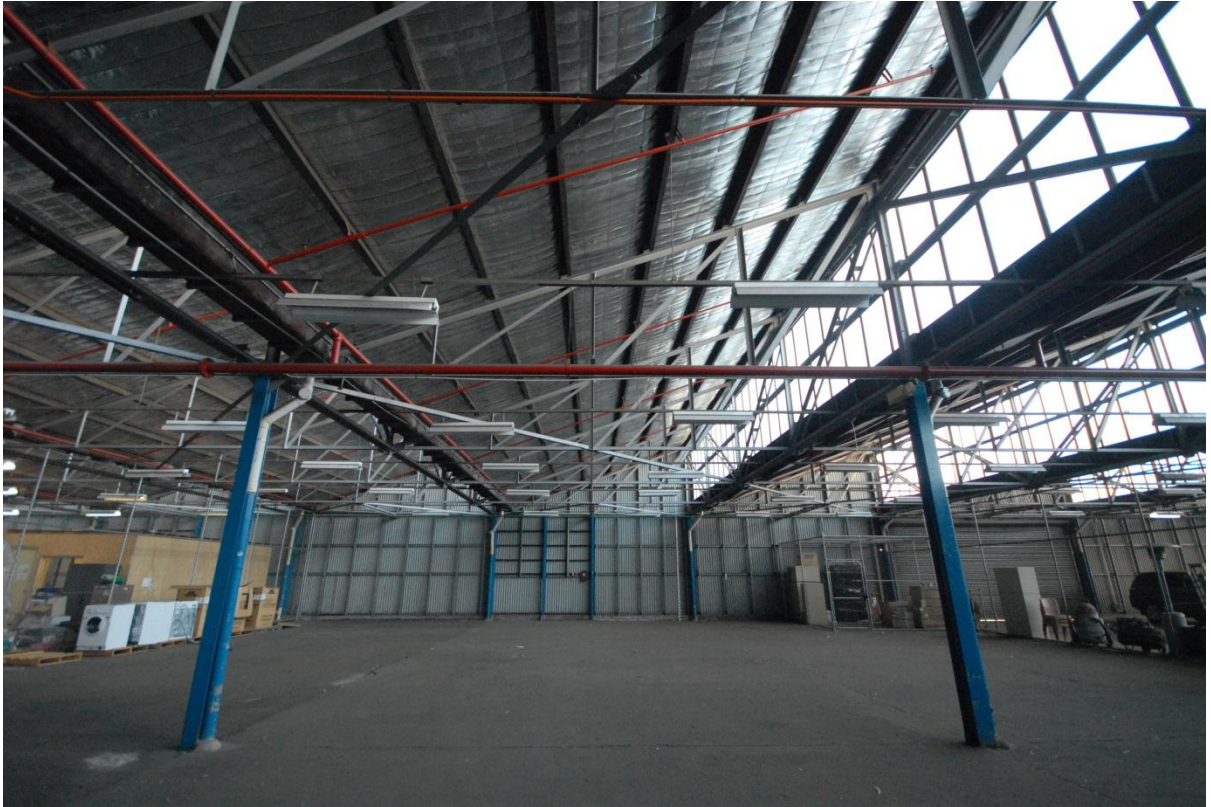
**Figure 8.43 Internal view of E wall from mid-section of building, note combination of original and new wall framing, (image no. B99 0002)**

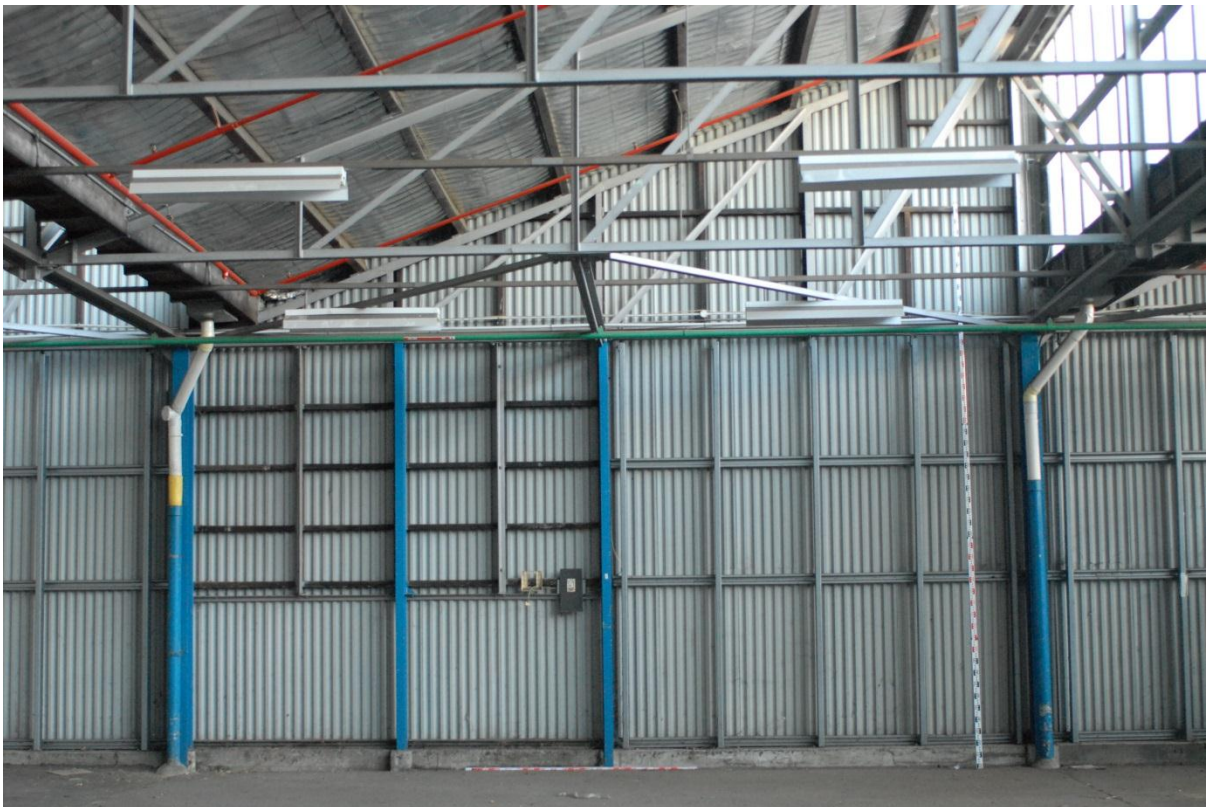
**Figure 8.44 Detail of E wall showing original framing on left and later framing infill of former door opening on right, looking E, (image no. B99 0011)**

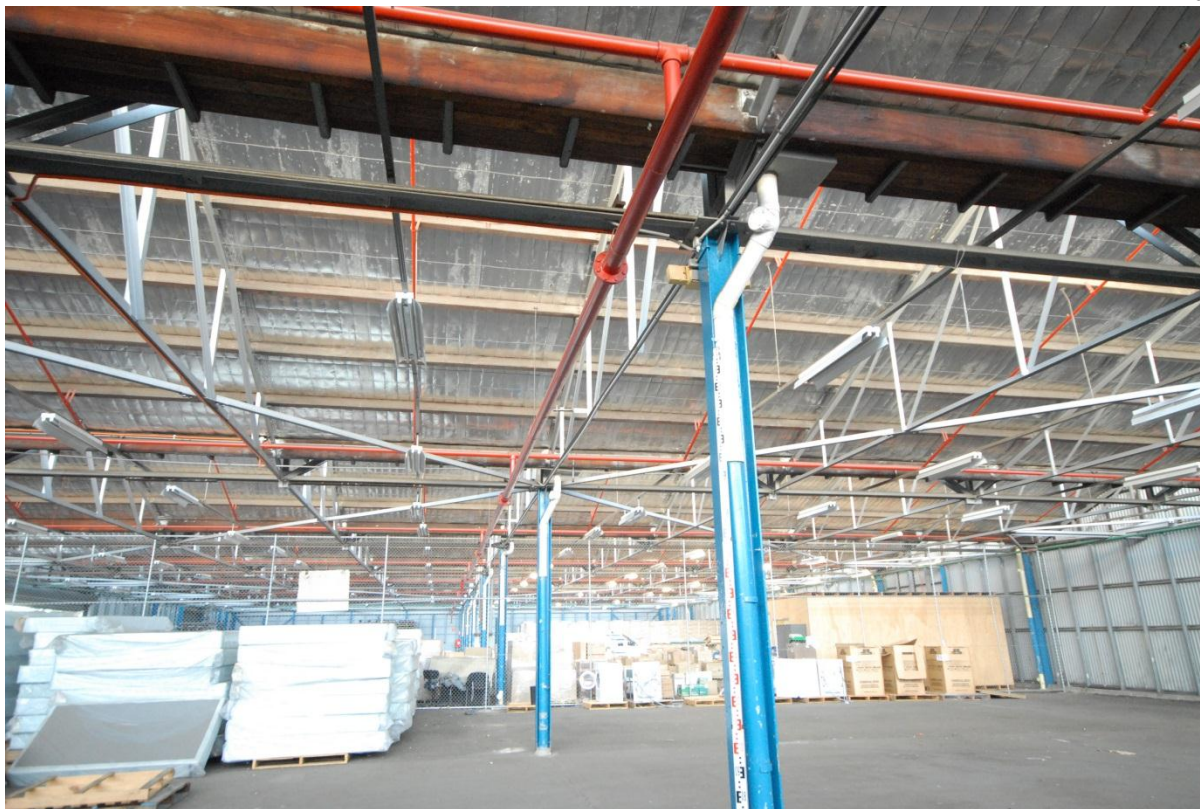
**Figure 8.45 View looking N from midpoint of building, showing roof girders, box drain (top foreground) and cross bracing, (image no. B99 0031)**

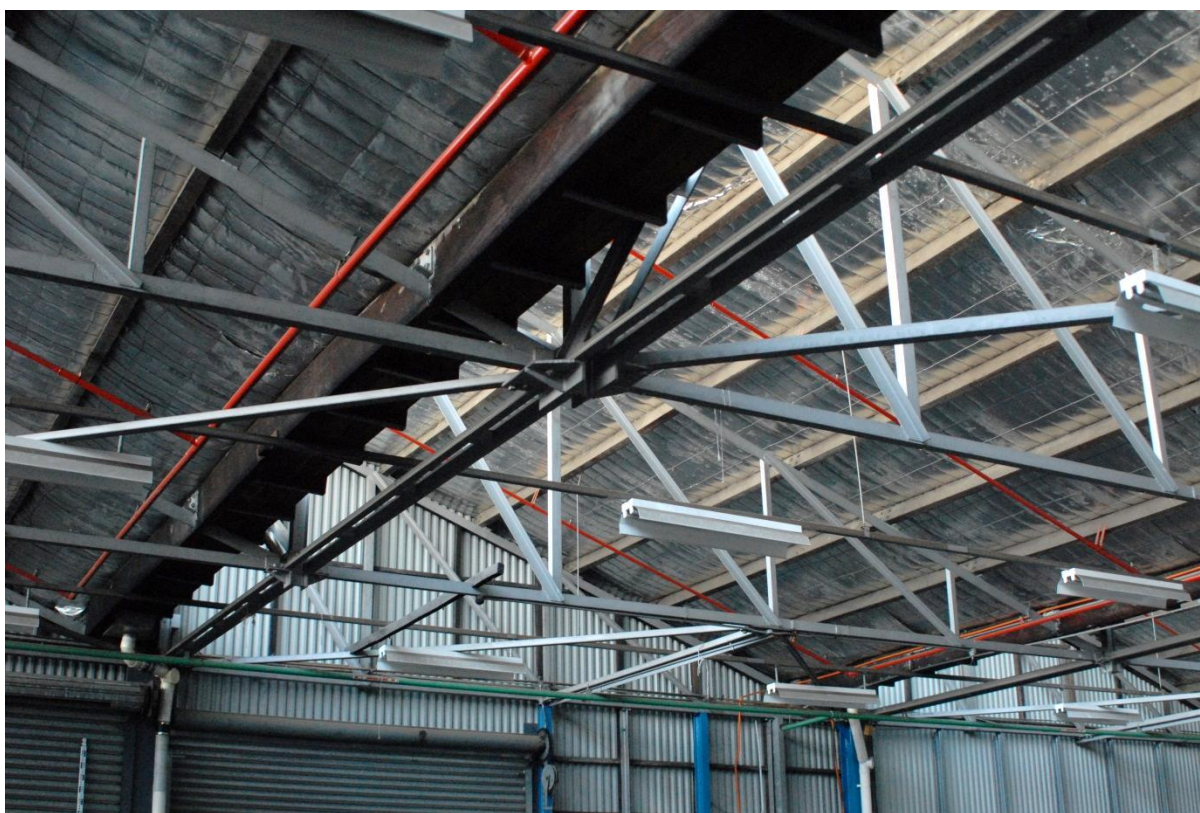
**Figure 8.46 Looking at W margin of roof, showing trusses, joining plates, box drain, and cross bracing adjacent to wall, looking NW, (image no. B99 0027)**

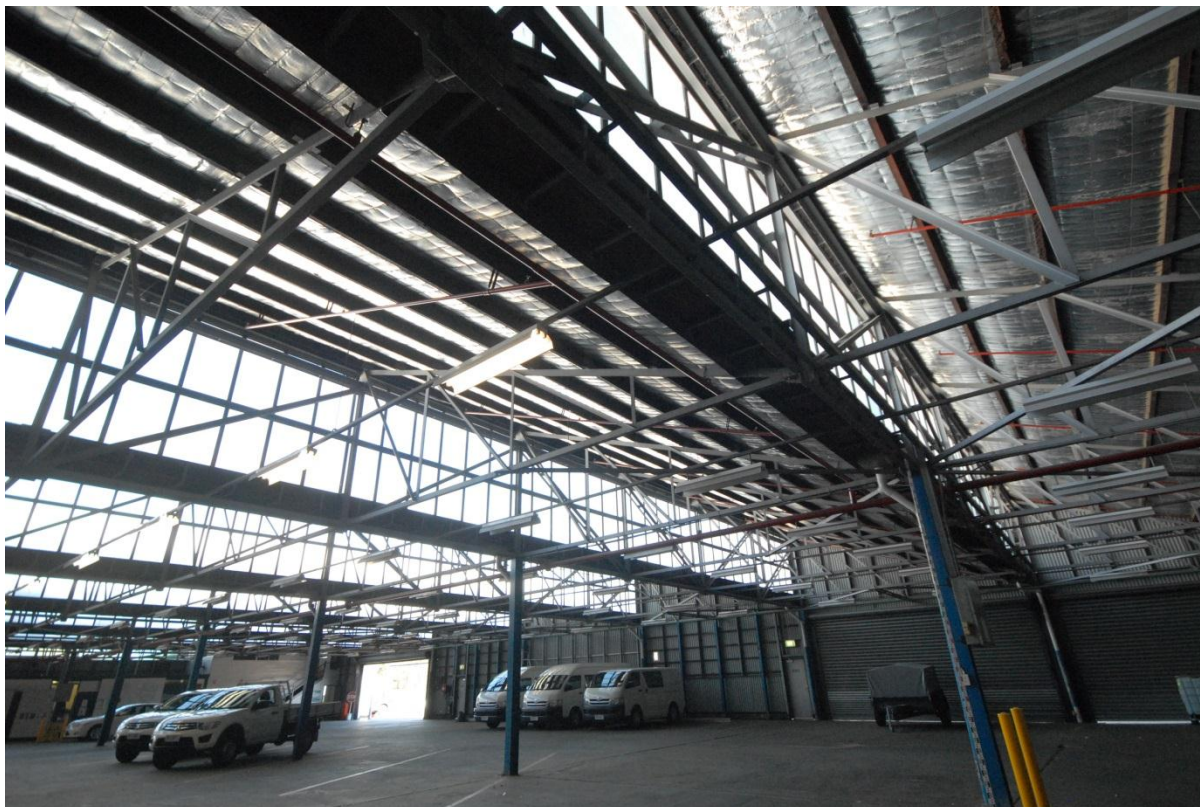
**Figure 8.47 Wide view looking SW towards SW corner of building, showing clerestory window framing, (image no. B99 0076)**
